# Heathfield Farm Phase 1, Gartcosh: Archaeological Works Data Structure Report

*AOC Project No: 24857*

## Data Structure Report

**On Behalf of:** **Persimmon Homes North Scotland**  
Broxden House,  
Broxden Buisness Park  
Lamberkine Drive  
PH1 1RA

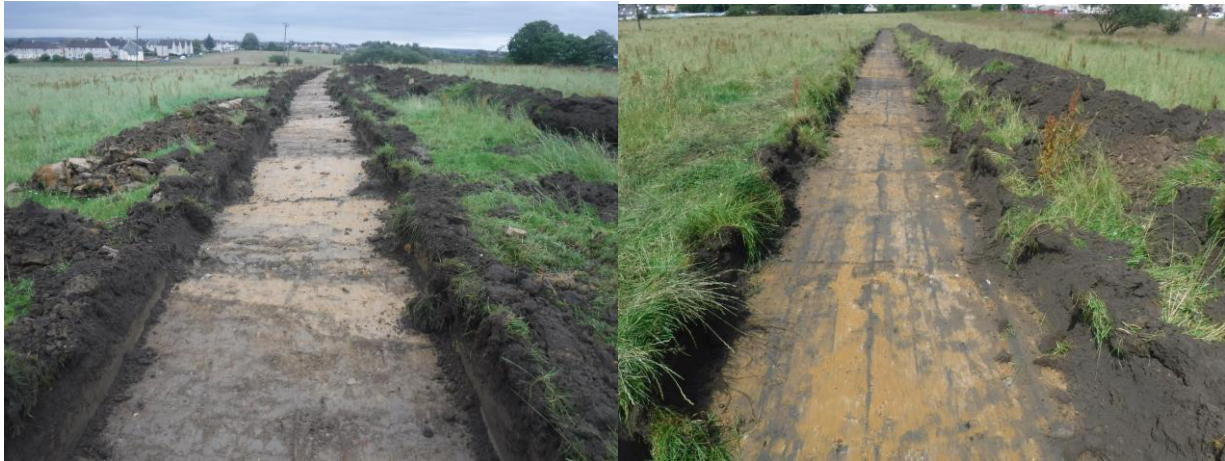
**Plate 1 Post-excavation of Trench 3 showing furrows (left) and Trench 18 showing plough scarring (right)**

- 4.3 The topsoil overlay a consistent mid orange mottled grey clay natural across the site. Plough scarring, field drains and post-medieval furrows were observed in all trenches. The furrows were on a north-south orientation ranging 1.2-2m in width to 0.14m in depth and occurred in regular spacings of every c.6m.

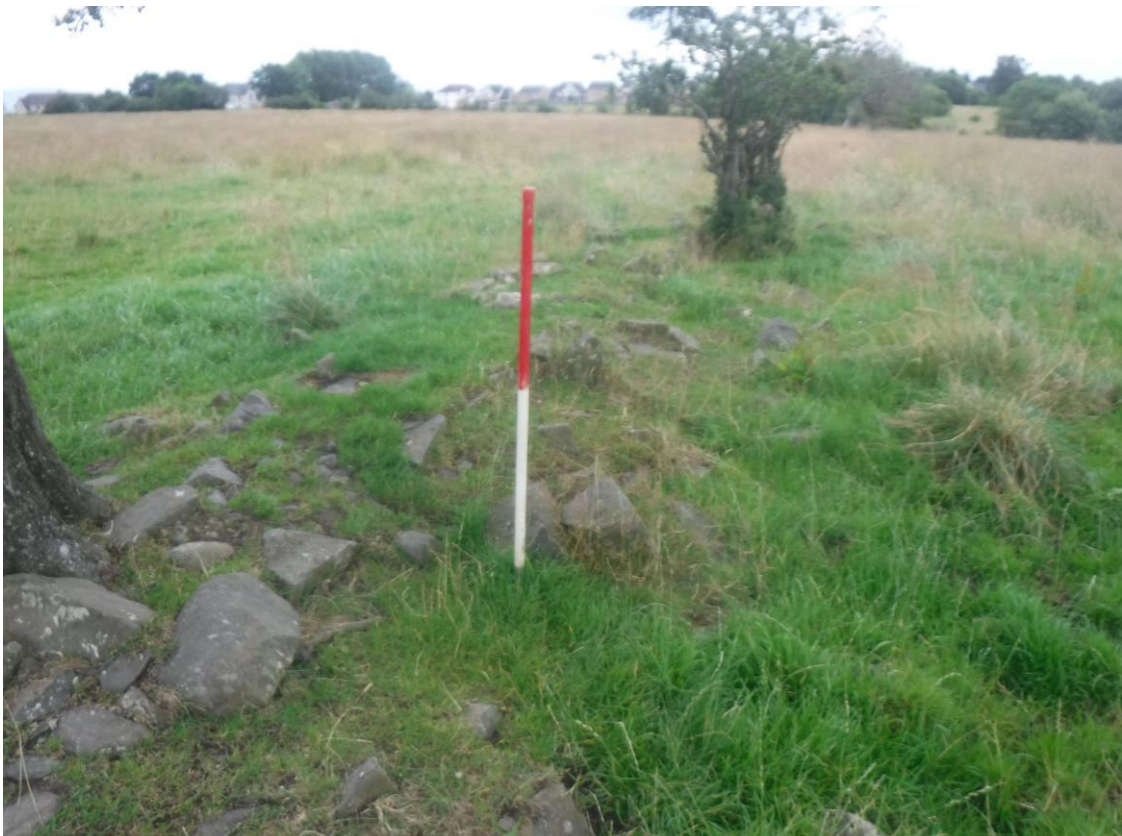
**Plate 2 View of remains drystone dyke**

- 4.4 No significant archaeological finds or features were recorded during the evaluation.
- 4.5 Only one historic boundary was observed during the evaluation works at the southern boundary of the eastern field. This consisted of an overgrown truncated drystone dyke (Site 65). It survived to a height of 0.3m (Plate 2)

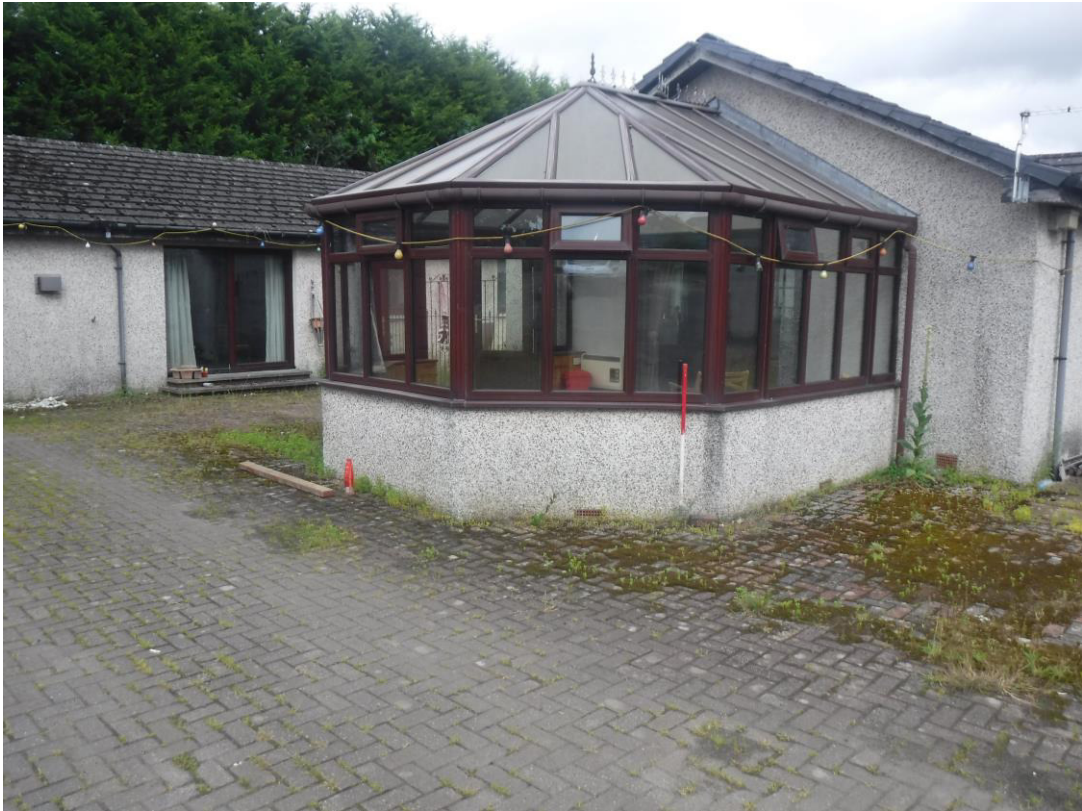
**Plate 3 Conservatory of Mossvale Cottage**

- 4.6 A level one HBR survey was conducted on the building listed as Site 60 Mossvale/Slakiewood Cottage. The cottage consisted of main bungalow building with attached garage and conservatory. The cottage was a u-shape plan with small abutting landing area with elevations covered in pebbled render and modern glazing with a concrete tiled angled roof.
- 4.7 The cottage and ancillary buildings are unlikely to be associated with the building detailed on earlier maps which has likely been demolished and rebuilt into its present form.

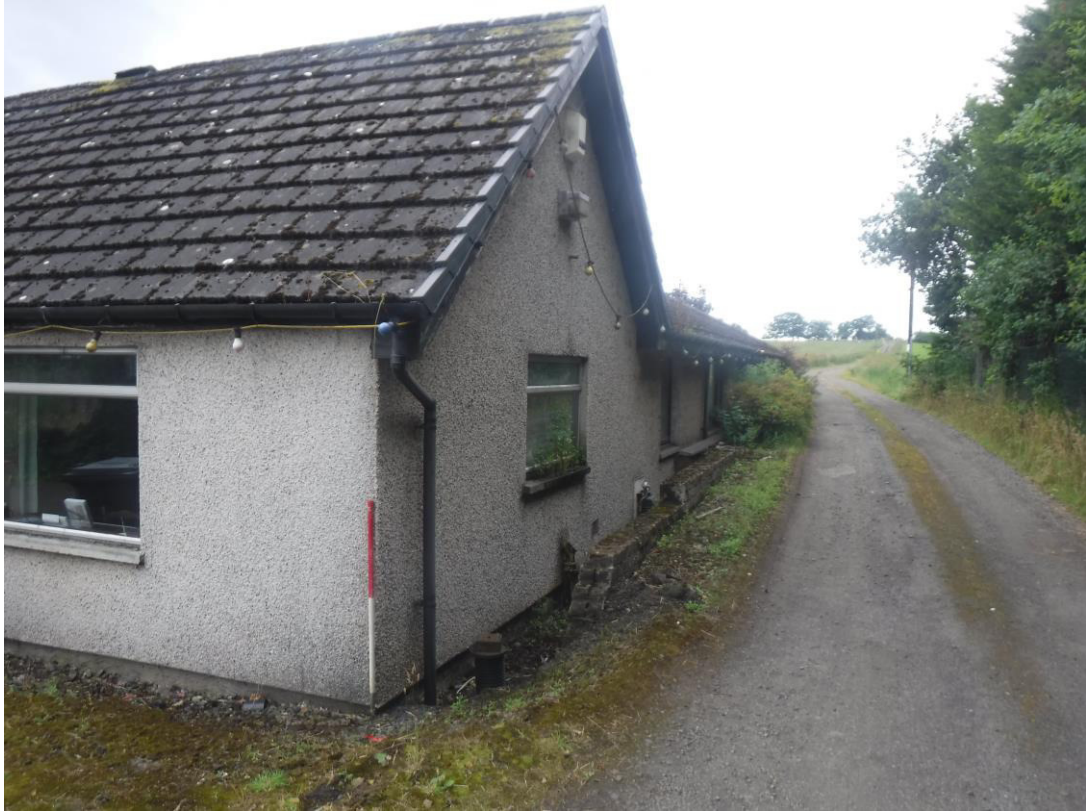
**Plate 4 View looking up the farm track showing west facing elevation of Mossvale cottage**

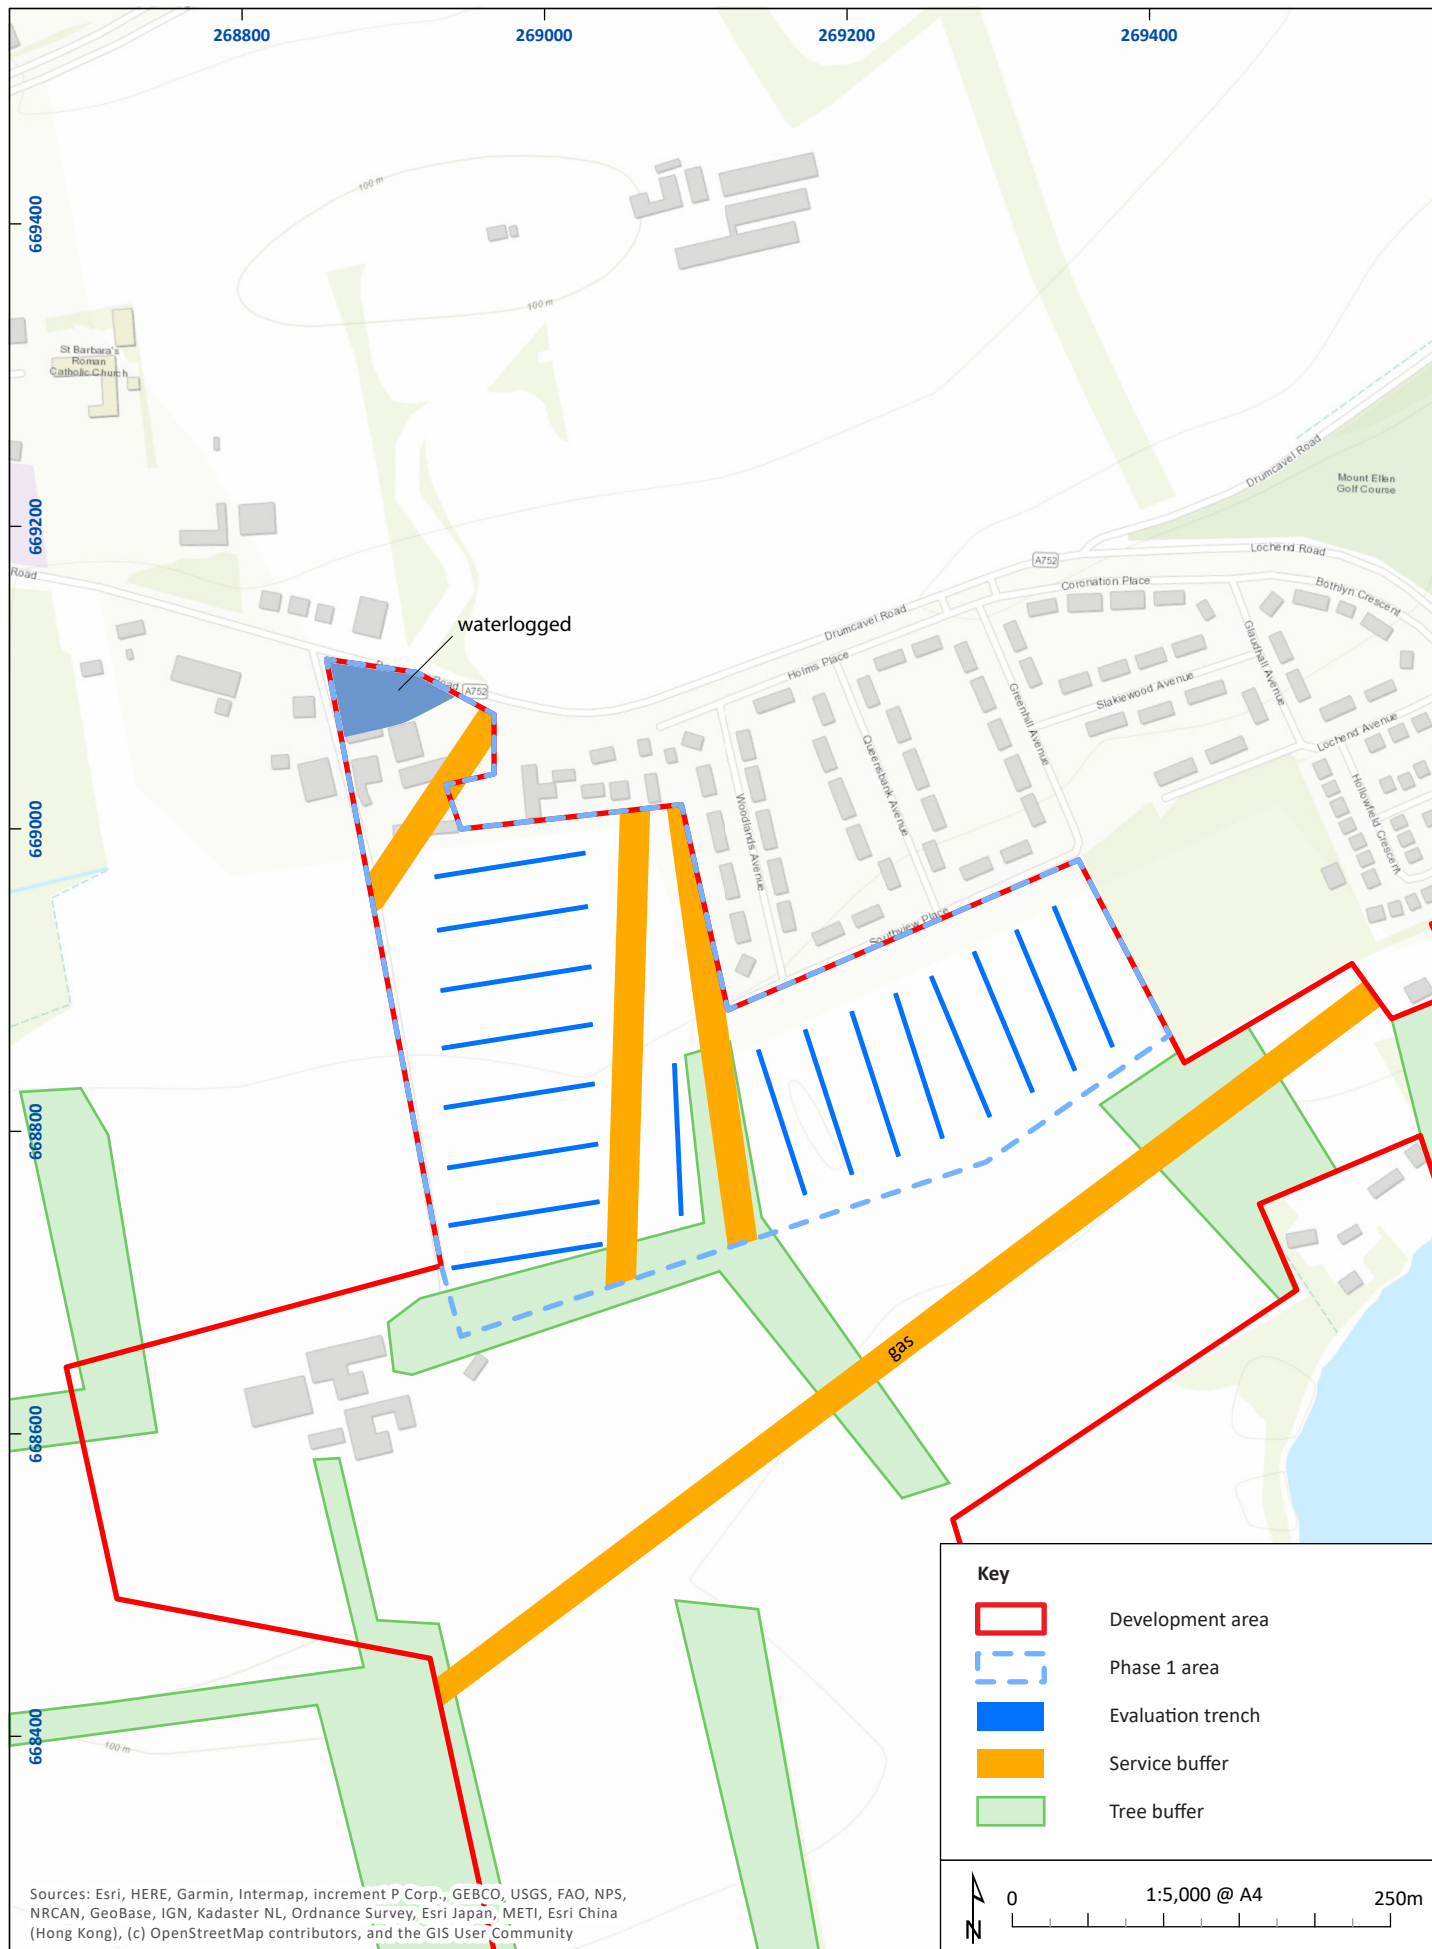
01/24857/DSR/03/01

4.1 A site plan showing the location of trenches can be found in Figure 2. The topsoil consisted of a dark brown clayey loam ranging from 0.20 m to 0.50 m in depth. It contained a small amount of anthropic material, with numerous fragments of white glazed ceramics, none of which was retained.

Figure 3: Trench location plan
