Quarry Extension on Land at Loak Farm, Bankfoot, Perth & Kinross Phase 2a, Strip, Map and Record Data Structure Report

AOC 70440
November 2019

Phase 2a, Strip, Map and Record

Data Structure Report

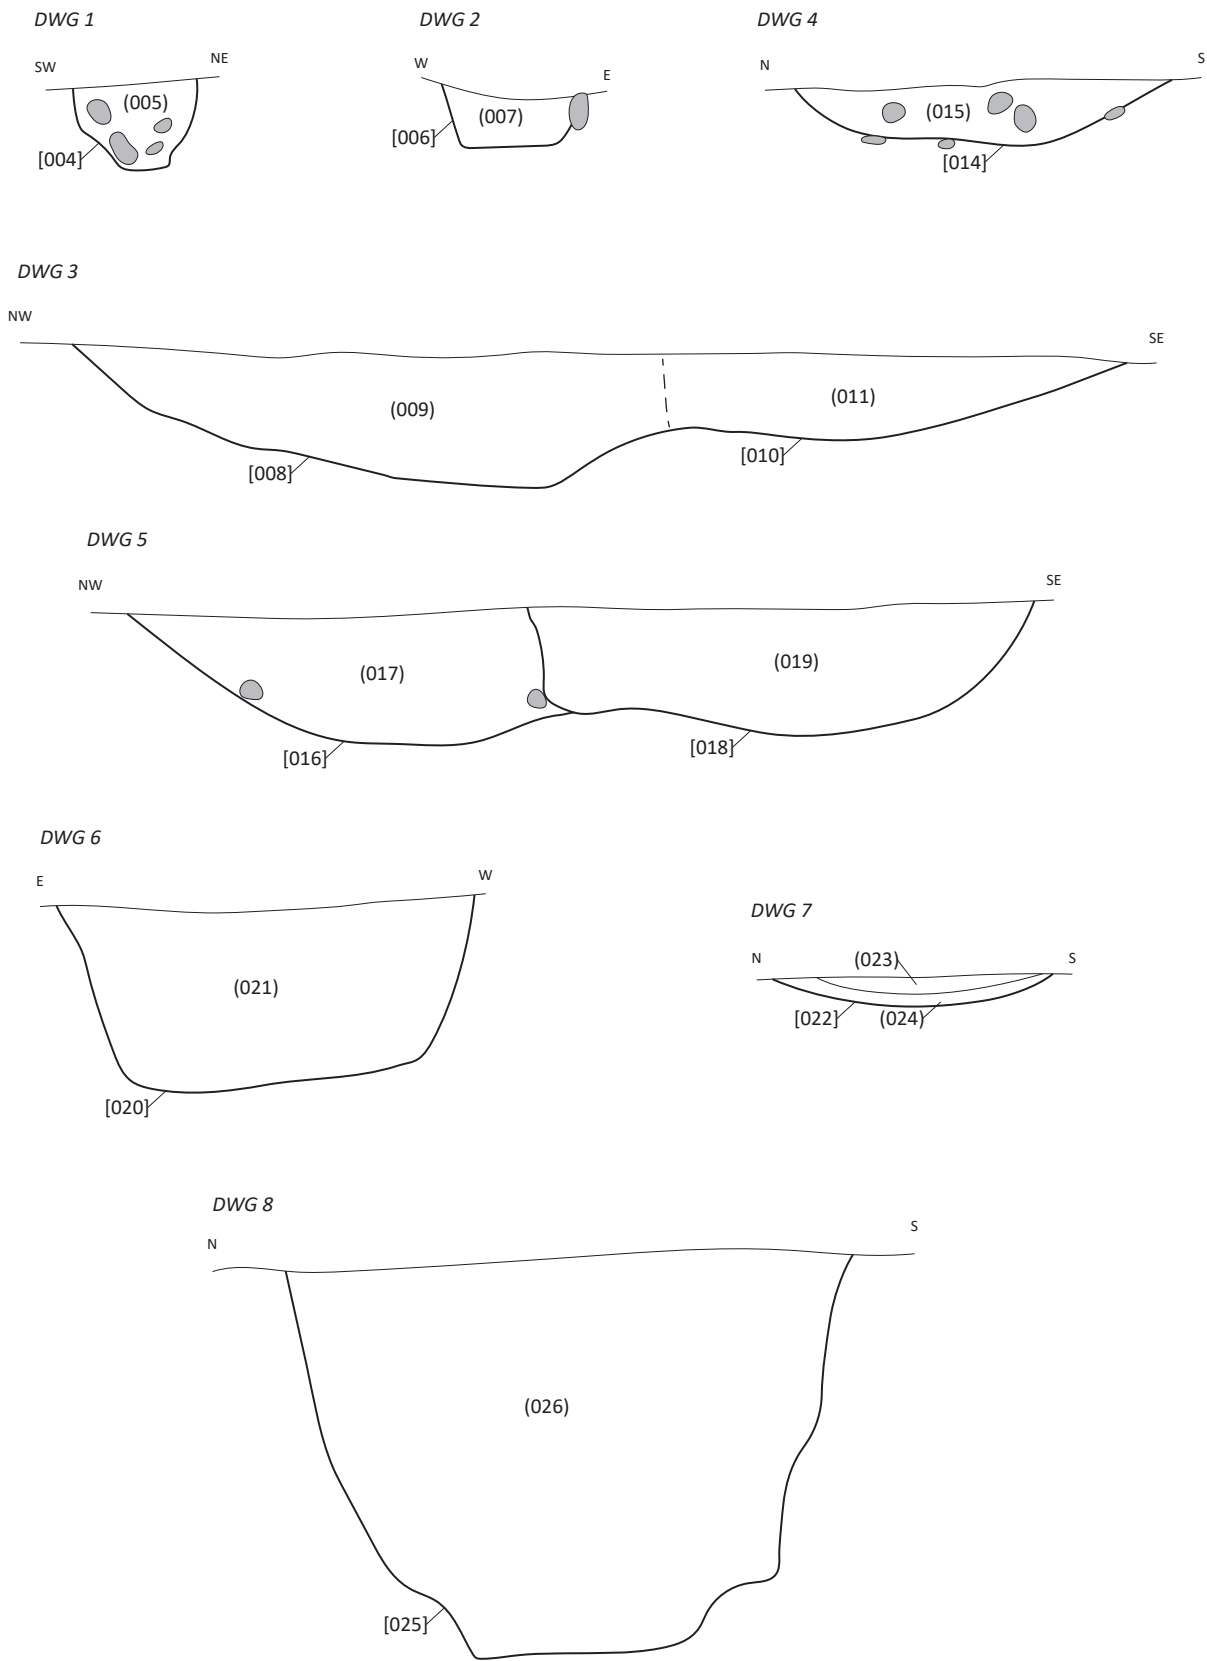
Figure 4: Section drawings of archaeological features

- 5.3 [004] (Plate 5; DWG 1 on Figure 4) and [006] (Plate 6; DWG 2 on Figure 4) were two small features in the north-western corner of the development area. They were located 2m apart and appeared to have the shape of postholes. They each measured 0.4m in diameter, with [004] having a depth of 0.25m and [006] having a depth of 0.15m. These may have been postholes, but due to their size and the geology of the area, it is also very possible that these are natural stone holes. Neither feature contained any artefacts.

- 5.4 There were also two pairs of intercutting pits, both of which did not seem to be related to any other features within the Phase 2a area. [008] and [010] had identical fills, and it was therefore impossible to see any stratigraphic relationship. Both pits were roughly oval but slightly amorphous, and so it is possible that this is more than two intercutting pits. The overall alignment of the pair ran NW-SE. [008] measured 1.6m x 1.1m and was 0.4m deep, and [010] measured 1.2m x 0.85m and was 0.25m deep (Plate 7; DWG 3 on Figure 4).

- 5.5 The other pair of intercutting pits, [016] and [018], was similar in shape and size, however there was a difference in fills, allowing for some understanding of a stratigraphic relationship. (017), the fill of [016], comprised several lenses of burning material, formed of charcoal, grey ash, and pink ash. This pit measured 1.2m x 0.9m and had a depth of 0.35m. It would have originally been longer than 1.2m, but was truncated by [018]. (019), the fill of [018], was mainly a loamy soil, with only a small number of charcoal inclusions. Pit [018] cut that of [016], meaning that [018] was cut after [016] had been cut and filled. This pit measured 1.2m x 0.7m and had a depth of 0.3m. The overall alignment of the pair ran NE – SW (Plate 8; DWG 5 on Figure 4). Neither of the pairs of pits contained any artefacts.

- 5.6 Pit [025] was the largest of all eleven potential features, measuring 1.5m in diameter and 1.2m in depth (Plate 9; DWG 8 on Figure 4). It was also the only pit to contain any artefacts. These consisted of a potential fragment of a rotary quern (SF1), and sherds of pottery (SF2), including an almost intact jug rim, with part of the handle attached (SF3). All of the pottery found has been provisionally identified as green-glazed redware, which would place the pit in the medieval period, although this will have to be clarified as part of the post-excavation analysis. This is distinct from the primarily prehistoric pottery identified in Phase 1.

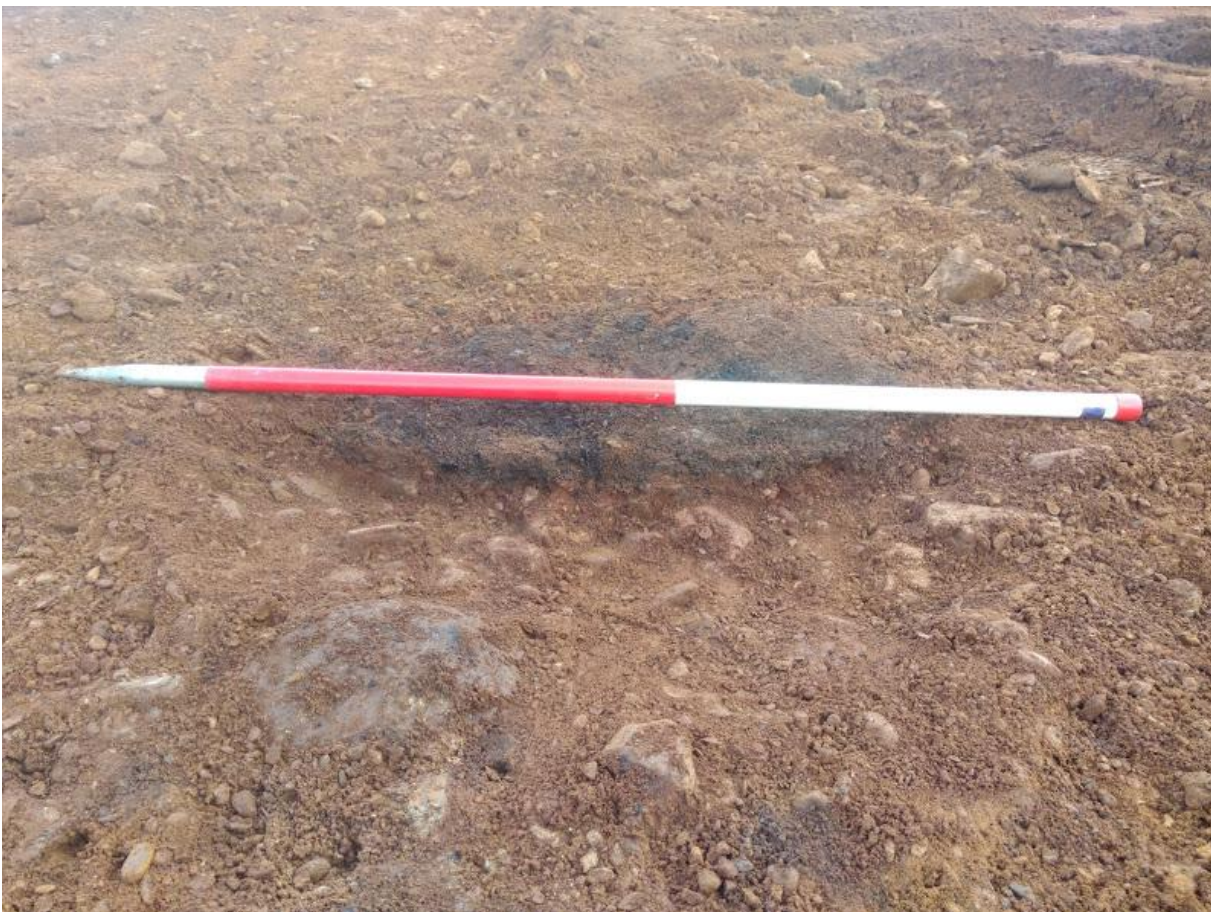
Plate 4: Section of [022]

(Plate 4; DWG 7 on Figure 4). This was the only feature with an upper and lower fill, both of which appeared to consist of burned material. Neither feature contained any artefacts.
