Penwortham Bridge, Preston: Archaeological Watching Brief Report

28th February 2007

National Grid Reference (NGR): SD 3530 4282

AOC Archaeology Project No: 20435

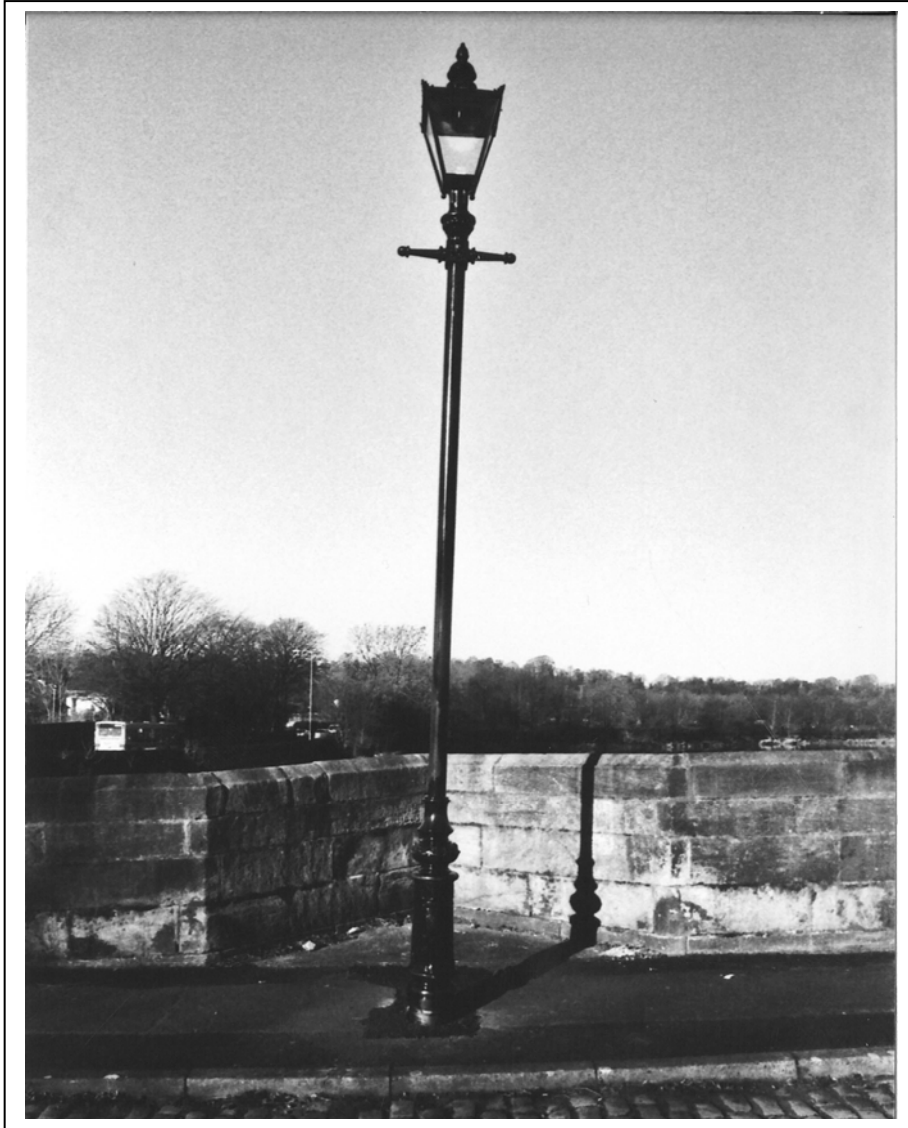
Figure 4: Lamp-post 3 from south

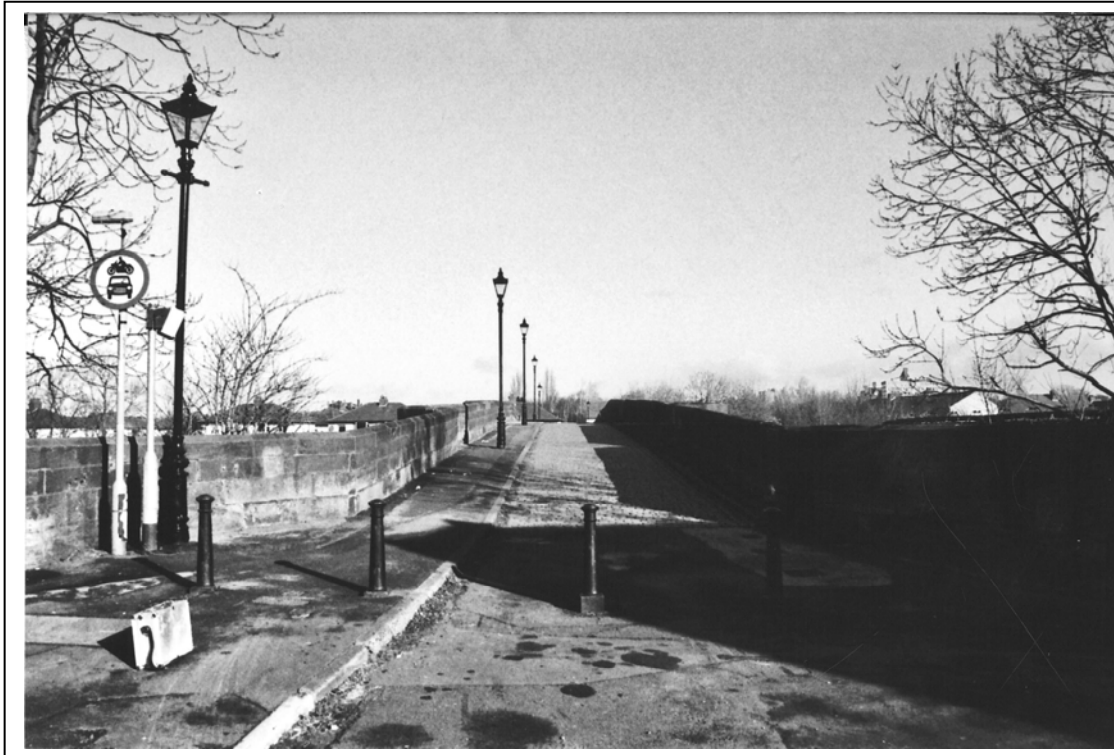
Figure 5: Penwortham Bridge from west following works
