Caius House, Holman Road, Battersea, London Borough of Wandsworth, An Archaeological Evaluation and Historic Building Recording Report

Site Code: HLB 08

AOC Project No.: 7899

An Archaeological Evaluation and Historic Building Recording Report

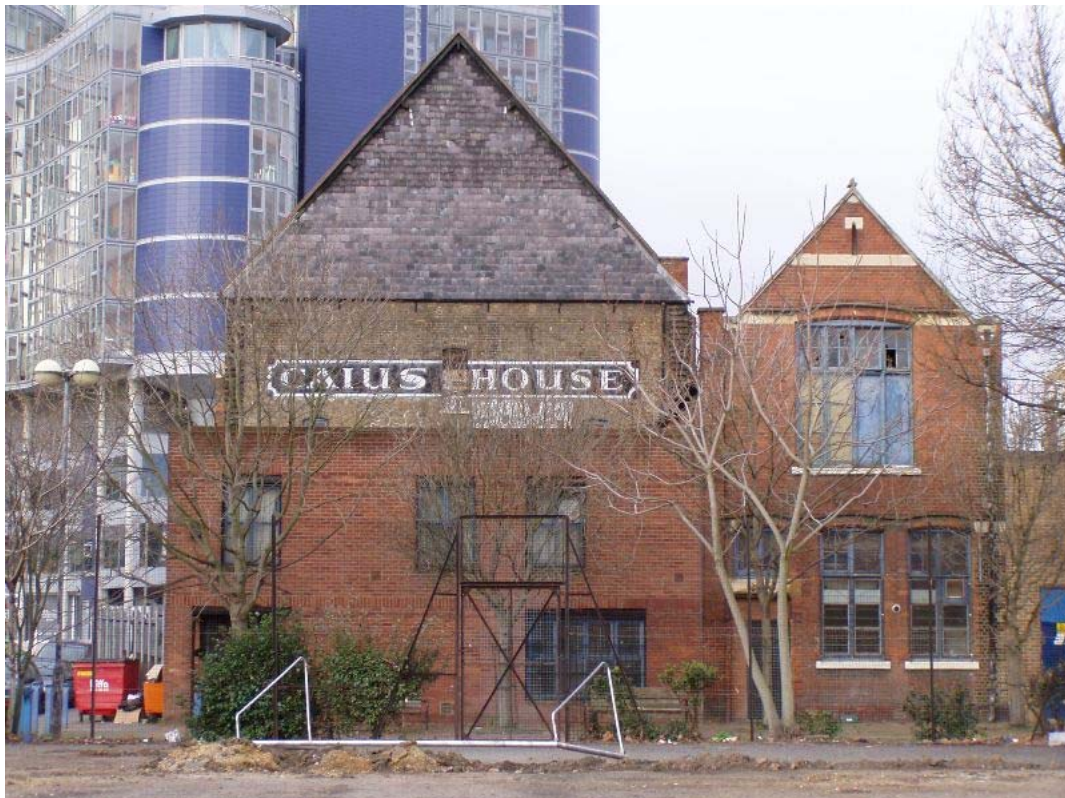
Plate 2, East Elevation, looking west

- 5.18 The east elevation of the main church building comprises a brick and timber gable with a painted sign 'Caius House' (white lettering on black background). A late 20th century two storey brick structure with flat roof and metal framed windows adjoins this gable to the east. There are three openings in the brick gable; the central one has a timber door, flanked by two which are glazed. (Plates 1 – 2)
- 5.19 A further building to the north adjoins both the main church and the 1980's 2 storey addition. It has a tiled pitched roof running east - west and the gable fronts directly onto the Harroway Road. The ground floor comprises 3 bays separated by chamfered brick piers; two bays are timber windows with stone sills, the third bay forms a door with glazed brick sides and simple stone decorated lintel over. Each bay had a 4 paned swivel top light under a red brick arch and

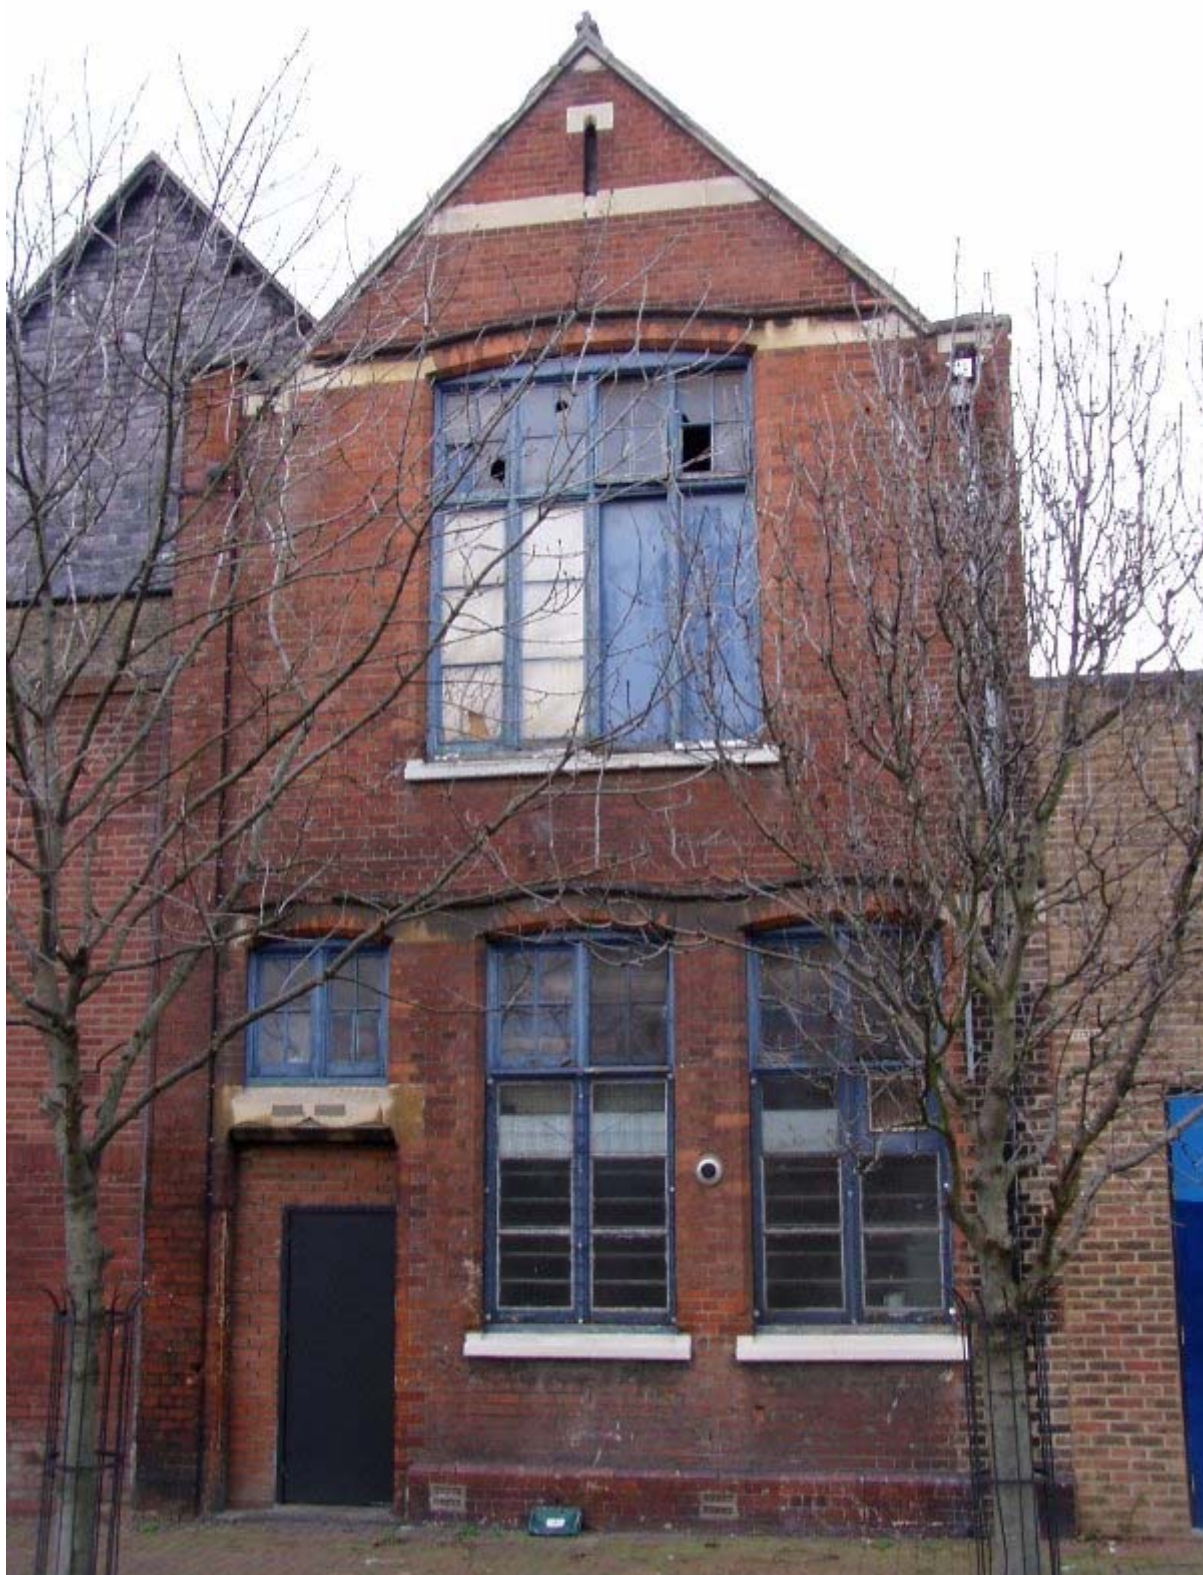
Plate 3, 1906 addition, east elevation, looking west

moulding. (Plates 3 – 4) The first floor had a single timber window; 4 casements with timber mullions and 4 paned swivel top lights all under a single red brick arch with moulding. (Photo 5)

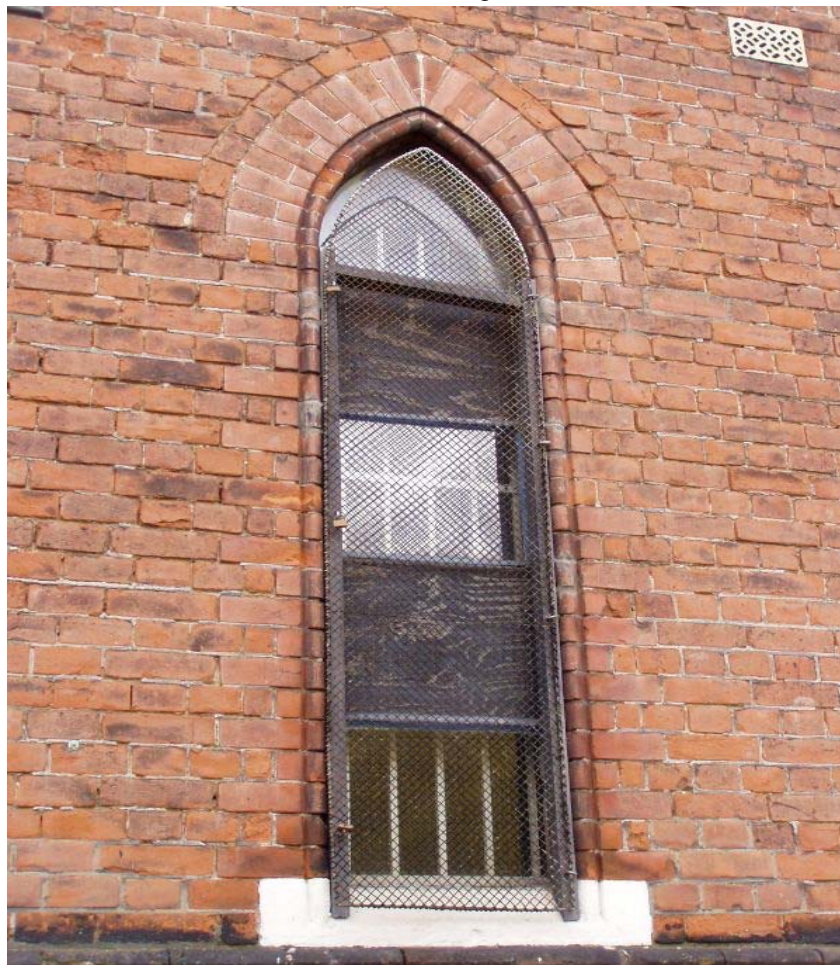
Plate 7, Ground floor window detail, south elevation, looking north

- 5.20 The south elevation was red brick in English bond. The ground floor nave had 4 pairs of tall narrow windows in between 5 brick buttresses. The windows had stone sills, bead moulded edging and pointed brick arches. The first floor had four large apertures with ogee mouldings and similar pointed brick arches. Each aperture had stone window frames which comprised two trefoils with a single quatrefoil above. (Plates 6 - 12)

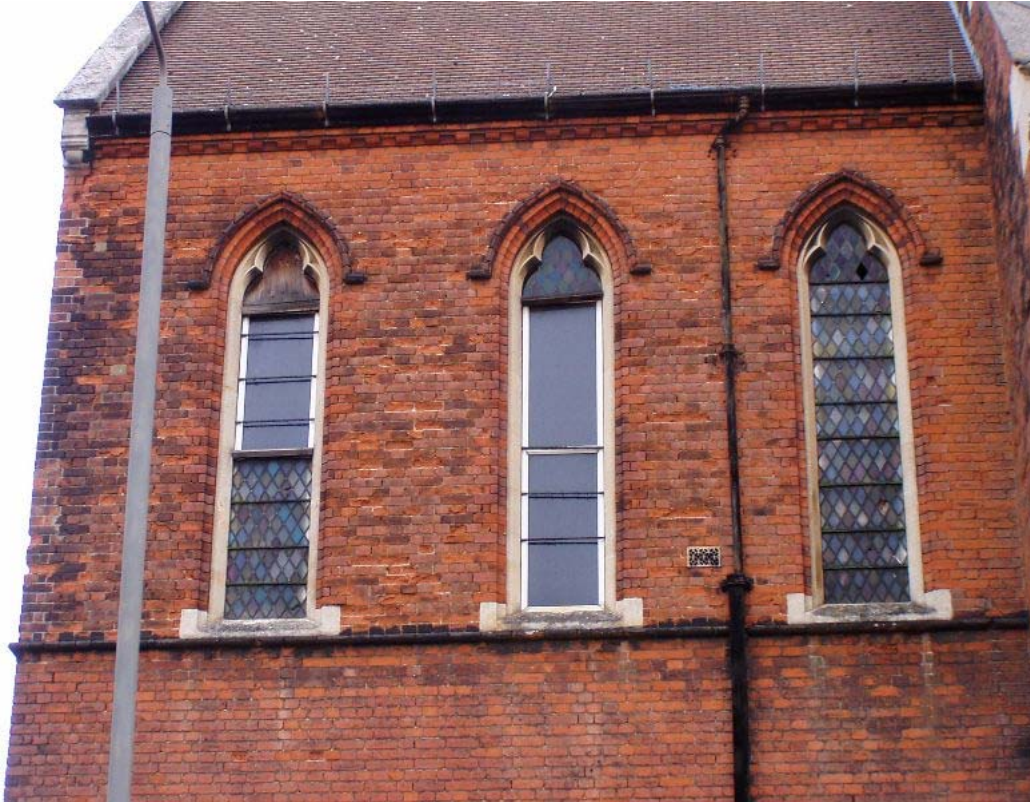
Plate 10, First floor chancel windows, south elevation

- 5.21 The ground floor chancel area had 3 single windows maintaining a similar style to the pairs seen to the east; the first floor had three ogee windows each containing a single trefoil. There was a date stone on the south west corner of the building, approximately 1.5m from ground level.

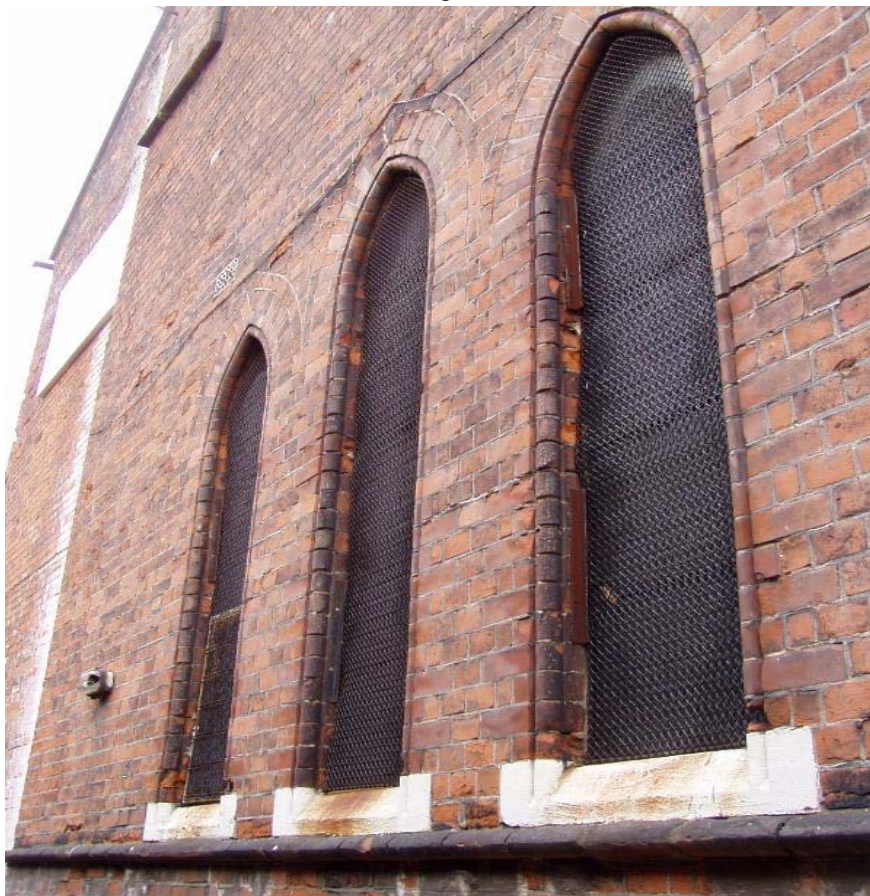
Plate 13, Ground floor windows, west elevation, looking north east

- 5.22 The west elevation had three single windows in a similar style to the south side of the chancel area. The first floor housed a stained glass window as previously described in 3.2 - 3.3. (Plates 13 – 15)

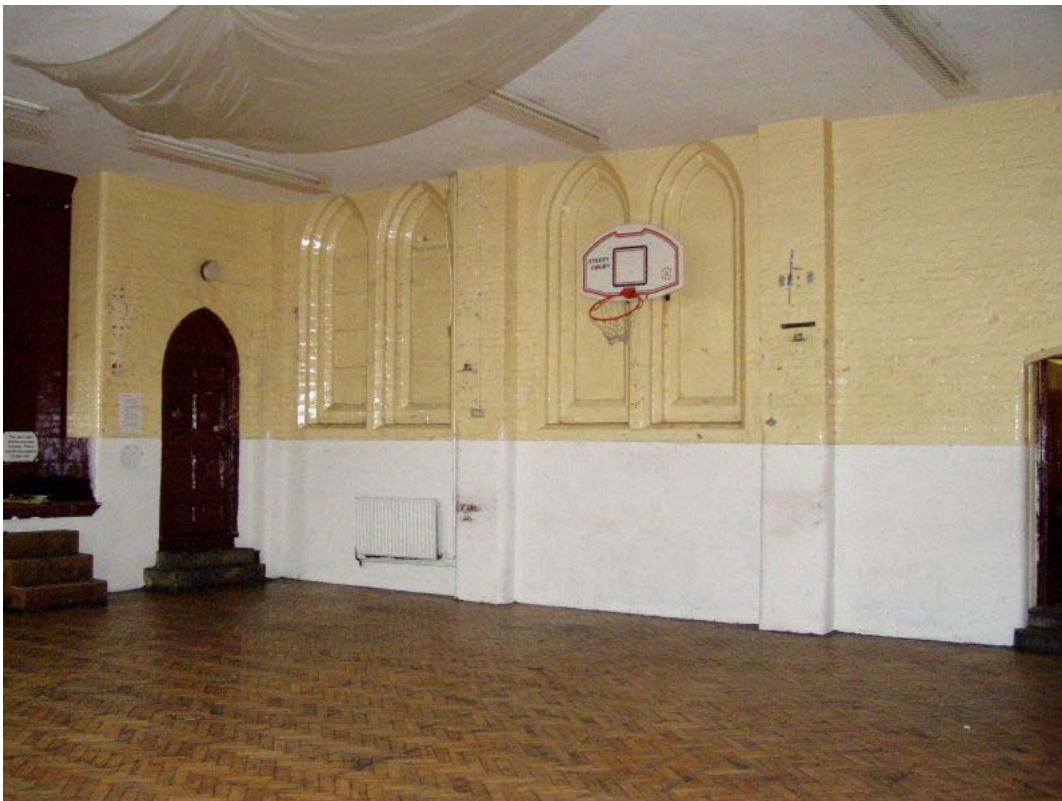
Plate 17, Main Hall, blocked windows to north in early 20th century, looking north west

- 5.24 A white painted brick porch with pointed arch led to double swing doors and into the main hall. The main hall was a large open space (approx. 15.0m x 11.5m) with an inserted raised plinth and wall to the west forming a stage area. The stage was flanked by two heavy timber doors leading to the outside and an inner hallway respectively. There were 7 windows to the south (i.e. 3 pairs and a single window) and 4 blocked windows to the north (i.e. 2 pairs), all were unfortunately truncated by the late 20th century lowered ceiling (Plates 17 - 21)

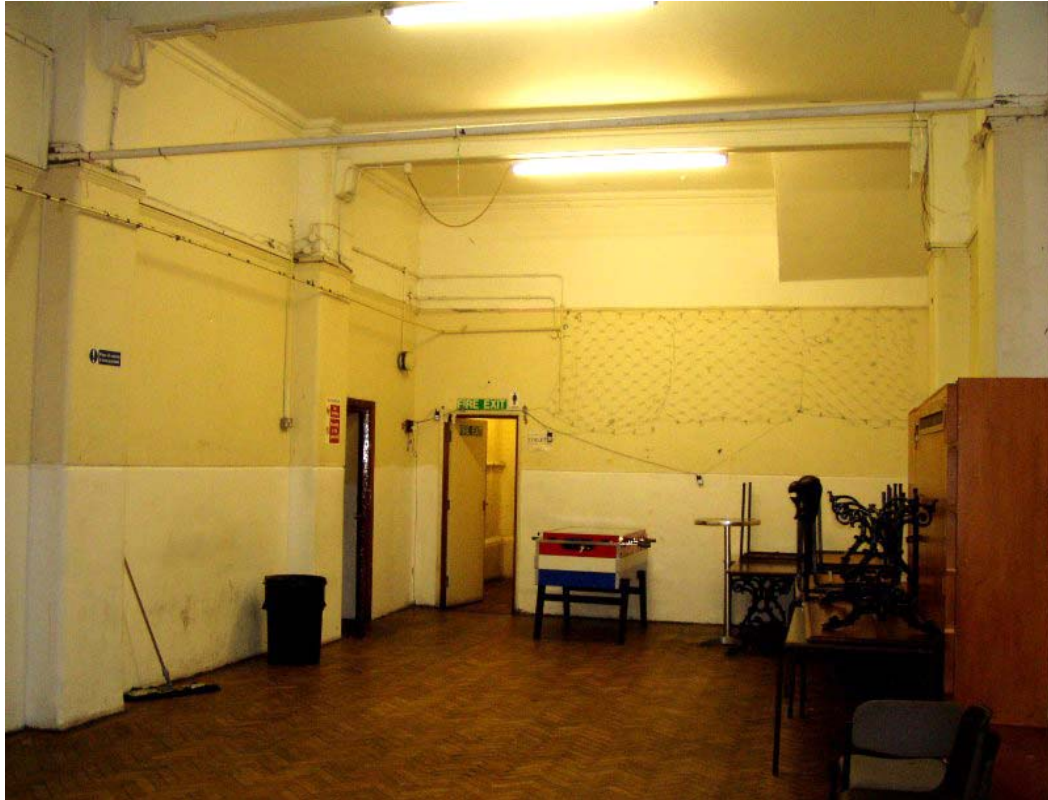
Plate 22, 1908 extension, looking west

- 5.25 There was a further large hall located to north east via a pointed brick arch doorway and 2 steps up (Photo 22). The timber floor is in herringbone pattern (as in the main hall) with bull nose brick piers, corbels and white painted timber beams. The kitchen to the east is in a separate room with a door leading to the pedestrian area of the Harroway Road. Corridors to the west lead to a toilet block, stairs down to the basement and steps up to the vestry (Plates 22 – 24)

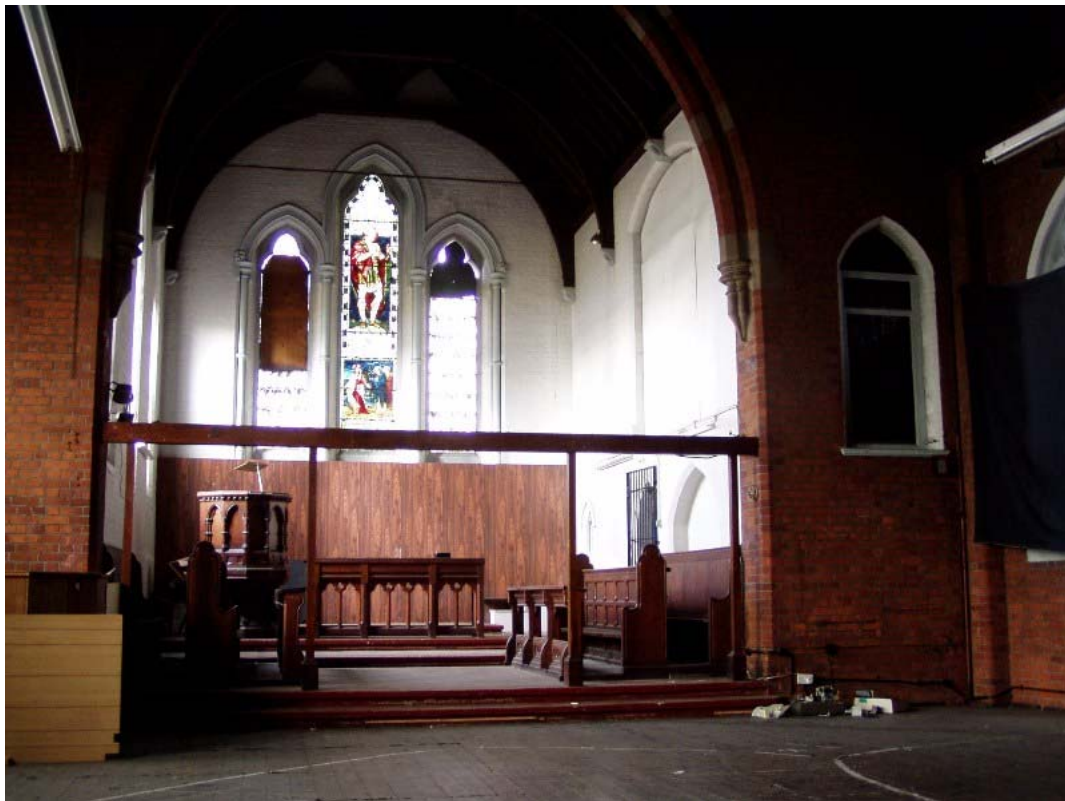
Plate 25, First floor comprising nave, chancel arch and chancel, looking west

- 5.26 The first floor was accessed via return stairs leading off the ground floor lobby. The nave formed a large rectangular open space with chancel to the west, divided by brick chancel arch in gothic style with decorative stone quoins and plain keystone (Plate 25)

- 5.27 The nave had 2 large windows to the north and 4 to the south, each with stone sills. There were 4 bull nose brick piers supporting 4 timber trusses; each truss comprised bolted planks and hammer beams resting on scrolled stone brackets (Plate 25)

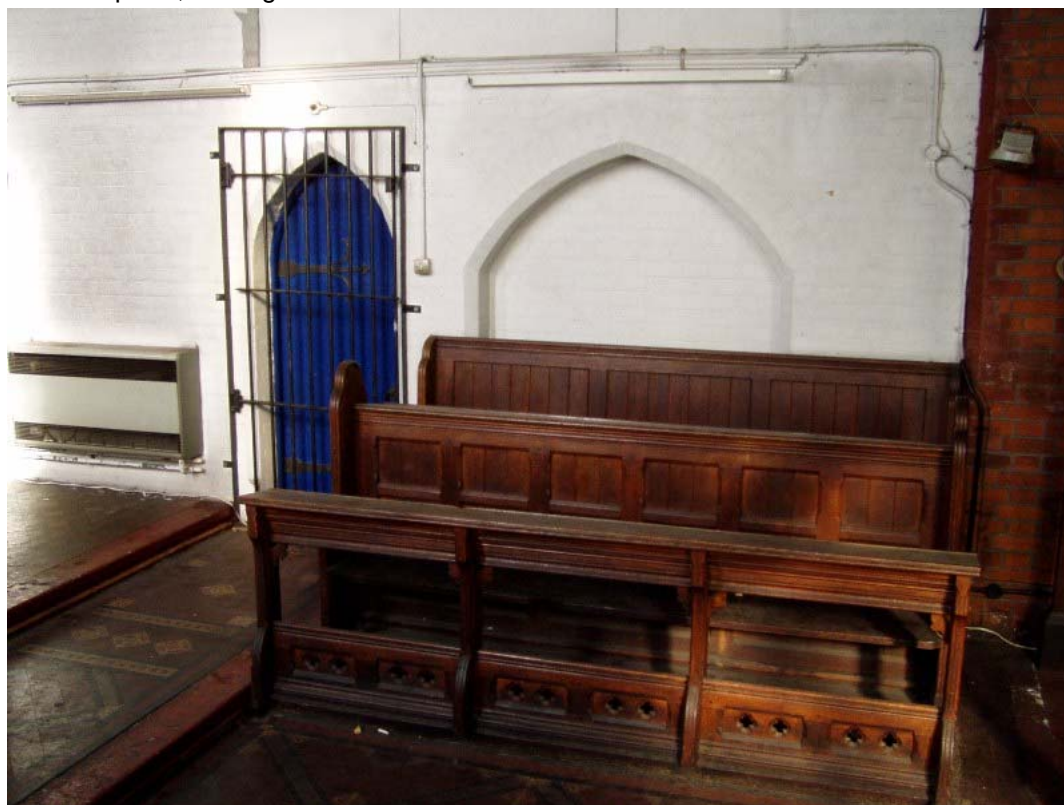
Plate 26, Chancel pews, looking north

- 5.28 The chancel area (Photos 26 – 27) comprised patterned red ceramic floor tiles, two sets of pews facing each other, a piscina in the north wall, altar, timber pulpit, and blue painted door to the vestry. The stained glass window (previously described in 3.2 – 3.3) had a tall central stained glass window flanked by shorter lancets in plain glass. 4 columns were present with circular bases and capitals. The vestry door led to stairs connecting to the ground floor and stairs up to the vestry (Plate 29).
