# 31 Barnton Avenue West Excavation Data Structure Report

## Excavation Data Structure Report

**On Behalf of:** M&M Construction

**AOC Project No:** 20278

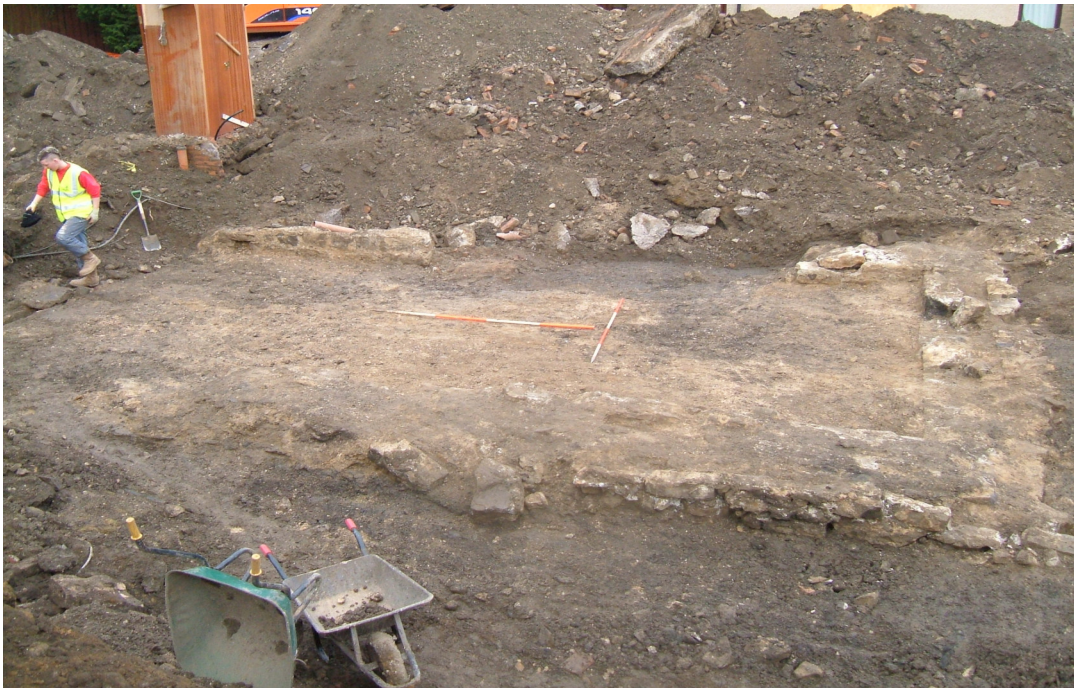
**Plate 3 Building [027] from the south**

- 5.4 *Structure [027]*. This comprised the heavily truncated remains of a substantial rectilinear sandstone building incorporating a probable north-facing entrance. This structure was excavated into the natural boulder clay, a cut being visible along the exterior of the eastern and southern walls. The

building had general dimensions of 7.5 m north to south and 12.0 m east to west. The walls were lime mortar bonded and consisted of inner and outer faces with a rubble core [017]. These walls were approximately 1.20 m wide and survived to a maximum of two courses in height. The west wall [009] was heavily truncated by modern service works along its entire length and survived as a single course. The north-western corner of this wall appeared to be slightly overlaid by a sandstone wall [022] running north to south. The southern wall [018] was truncated to ground level in the south-western corner and was cut by a partially capped brick built drain [010-012] this feature also cut the north-western wall [013]. The two northern wall fragments [013], in the west and [015], in the east again survived to two courses in height and were separated by a 3.5 m gap. A 2.0 m long slot trench through this gap revealed an absence of both wall remains and/or foundation cut which may suggest a north facing entrance in this location.

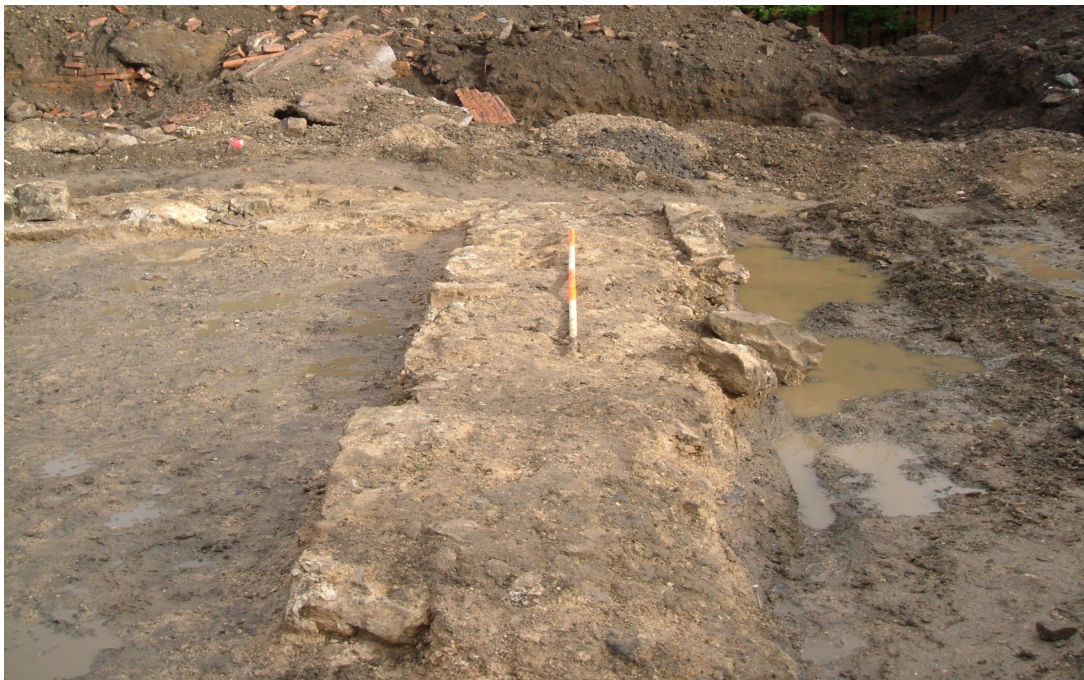
**Plate 4: Southern Wall [018] of Building [027]**

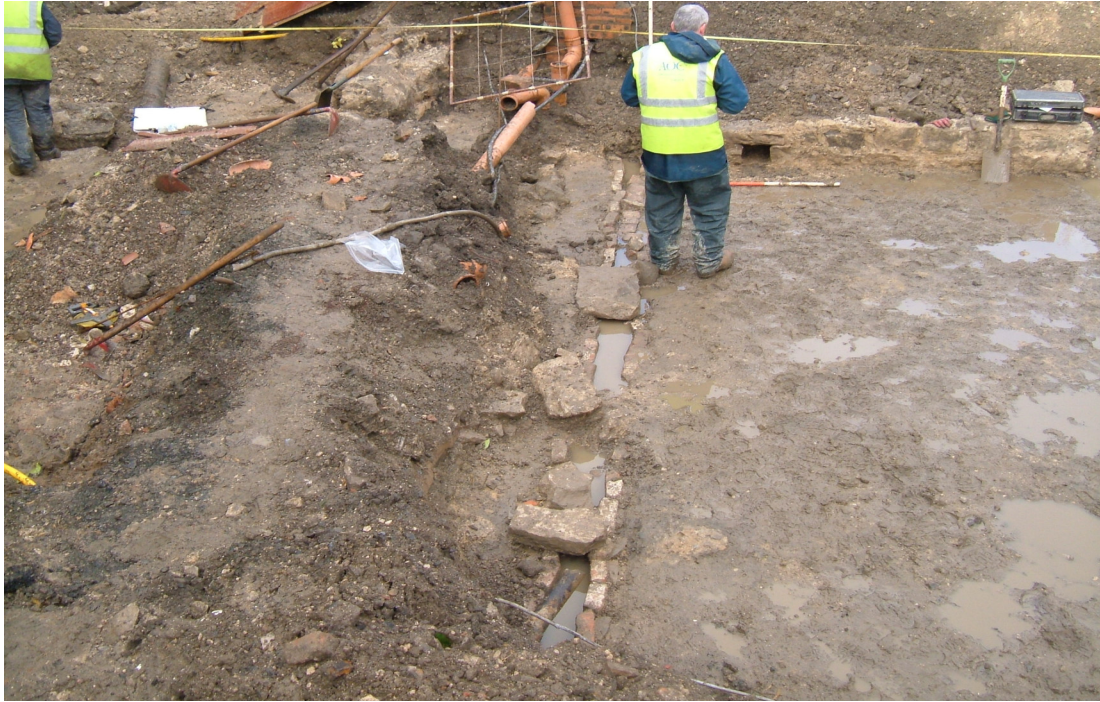
**Plate 5: Brick Drain [010-012] under excavation**

- 5.5 The drain [010-012] cutting both the southern [018] and northern [013] walls in the west of the building (027) was made of hand-made red brick walls [011] with the occasionally surviving sandstone capstones [012]. This feature ran north to south parallel to the western wall [09] and was visible for 7.5 m in length and 0.30 m in width. The feature was cut through the natural and no base stones were observed. A cut for the drain [010] was also visible along the entire length of the feature.

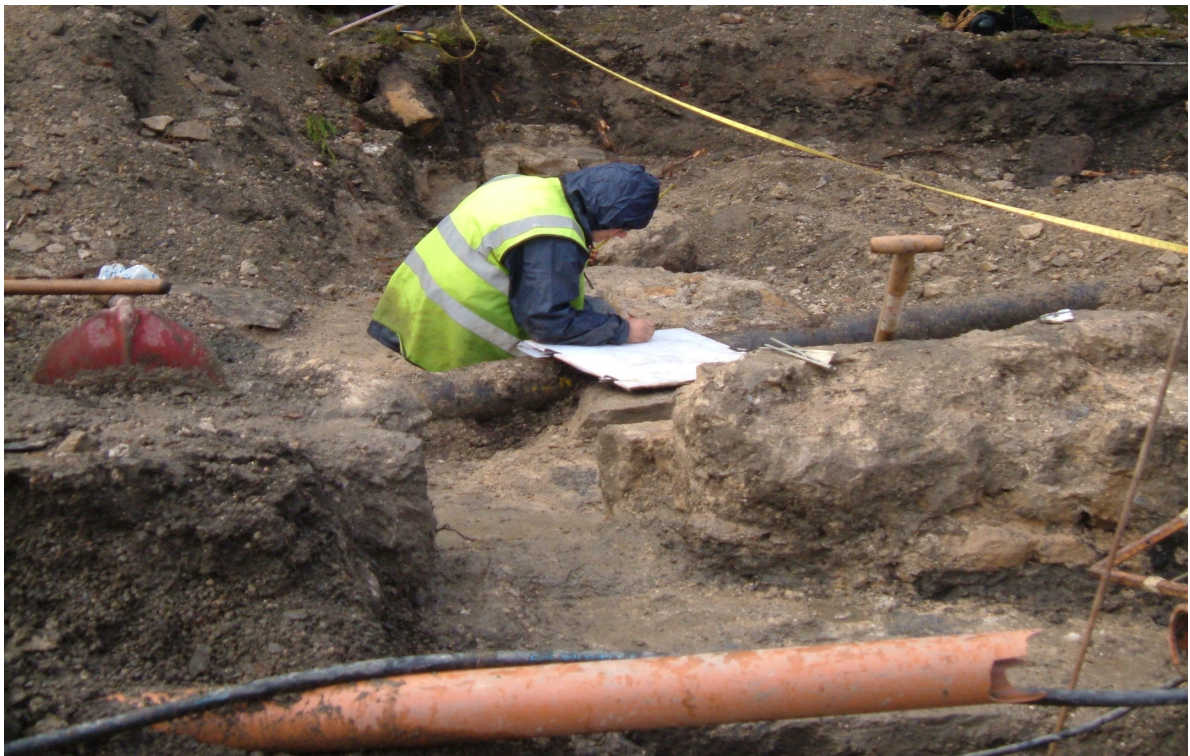
**Plate 6: Culvert/Wall [028] & Wall [022] under excavation**

- 5.8 *Walls [022] & [028].* A fragment of sandstone wall [022] partly overlaid the west wall [09] of Structure [027] in its north-western corner. The wall survived to only 1.0 metre in length being truncated by modern construction works to the immediate north. The wall was set on to the natural subsoil and no cut was observed. The wall was 0.80 m in width and up to 0.5 m in height and consisted of large, lime mortar bonded sandstone blocks. The wall was adjoined to the wall fragment [028] which was aligned east to west and set on top of the probable culvert/wall foundations [03-06]. This was situated to the immediate north-west of Structure [027]. The majority of this structure had been removed by the laying of modern services. The wall survived up to three courses in height within the western excavation boundary. It was also 0.80 m in width and appeared constructed in the same fashion as [028]. Abutting the wall [028] was the disturbed remains of a sandstone and concrete floor [030].

- 5.9 *Culvert/Wall Foundations [003-006].* A large sandstone culvert/wall foundations running east to west was situated to the immediate north-west of Structure [027]. This feature was initially observed and recorded in the evaluation phase of the project. The culvert/wall foundations consisted of two parallel sandstone walls [004] enclosing a dry 0.30 m wide void [005]. This void was 1.0 m in depth. A cut [003] was visible on the south side of the feature. The culvert/wall foundations were capped with large lime mortared sandstone slabs [006]. Wall [028] was built directly on top of these capstones. The culvert appeared to stop 0.50 m short of the north-western corner of Structure [027] with the capstones [005] here appearing keyed into the remnants of the north to south wall [022].
