# Dagenham Borough Control Underground Bunker, London Borough of Barking and Dagenham A Historic Building Record

### A Historic Building Record

On Behalf of:	Stace LLP 273 High Street Epping Essex CM16 4DA
National Grid Reference (NGR):	TQ 4962 8685
AOC Project No:	30088
Prepared by:	Les Capon
Illustration by:	Jon Moller
Photography:	Chris Adams
Date of Record:	26-03-2008
Date of Report:	April 2008

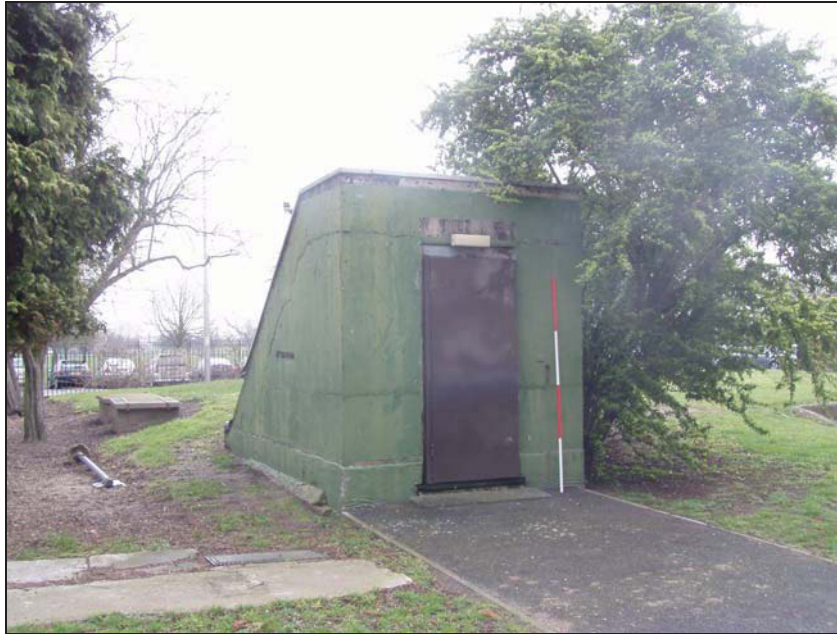
- 3.1.1 The location of the bunker is visible at ground level to the east of the Civic Centre as a low grassed mound c.0.30m high. At the northwestern corner of the mound is the main entrance to the bunker, a small concrete building with a door facing west, the east side slopes down to ground level. The entrance is constructed of concrete walls 0.62m thick. The walls appear to have been constructed within shuttering: above ground there are horizontal ridges along the concrete which indicate four layers of concrete, with a final layer laid at the same time as the precast sloping roof. All the exterior walls were painted dark green, presumably as camouflage. A small rectangular patch with no paint on the north wall indicates a lost sign. There is a second rectangular patch above the entrance, which presumably also held a sign (Plate 1).

*Plate 1: The entrance to the bunker*

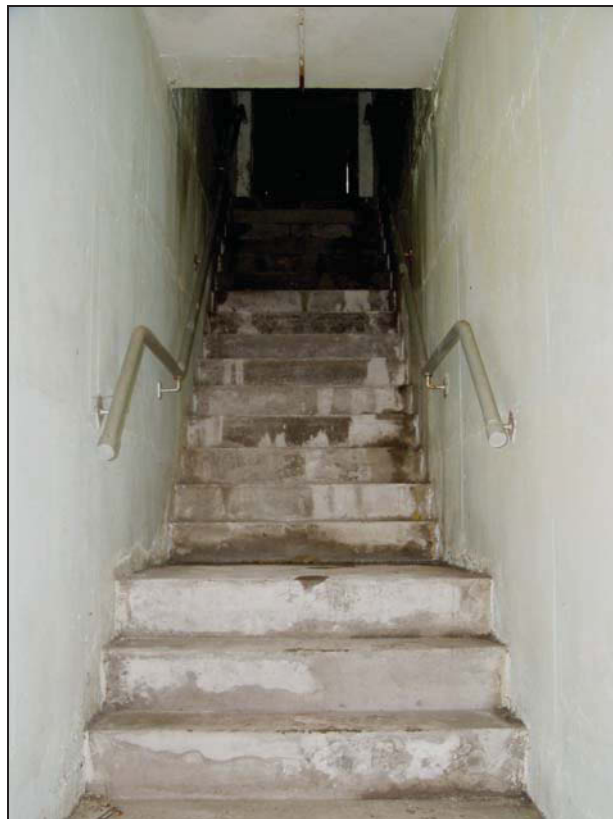
- 3.2.2 The main entrance at ground level leads down fourteen steps to a lower landing, followed by three further steps which lead to an airlock door. The lowest part of the corridor is 3.42m below the surface. The stairway has walls 0.62m thick; the roof slab is 0.58m thick. This may not be strong enough to withstand a direct hit or even a near miss (Plate 2).

*Plate 2: Bunker entrance stairs*

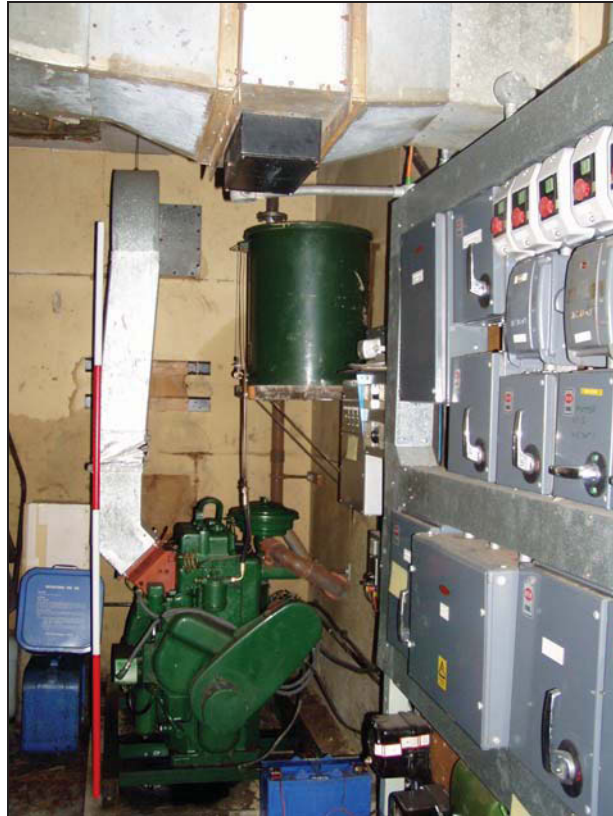
- 3.2.12 The first room west of the main corridor is the Plant Room, and contains the machinery and operating systems for heat, power and ventilation. There is a standby diesel generator in the northeast of the room, manufactured by Lister, and installed in or around 1976, to judge by an instruction manual present within the room. It is a 2-cylinder engine, and its exhaust is enclosed in a lightweight metal duct which runs northwards out of the room at high level, across the entrance corridor and out to the open air via one of the capped brick structures. This is therefore not the generator present in 1953 (Plate 3).
- 3.2.13 The ventilation plant is also in this room, and consists of two three-phase motors set side by side and manufactured by Brook Motors Ltd of Huddersfield (BSS 170-1939). Each of these powers an air intake, and the intakes both have a manufacturers' label:

*Plate 3: Plant Room 3, Diesel generator*

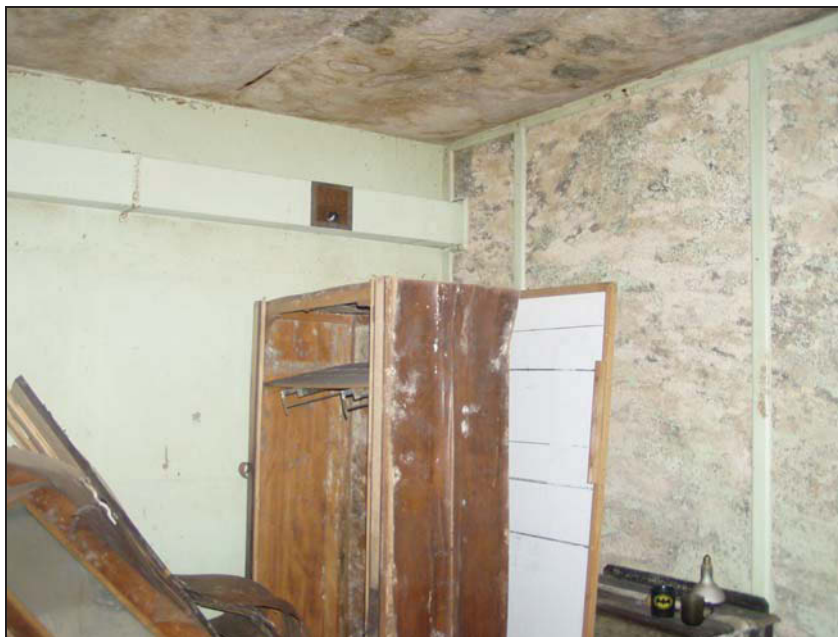
- 3.2.29 A water heater, Butler sink and draining board indicate the use of this room most recently as a kitchen. There are no other kitchen implements or white goods to confirm its use, but in the case of Nuclear Attack, it seems likely that food or water may have been required by the staff within. An enamelled metal bucket and basin in the room may be two items left from the Cold War period. The wall between this room and the male dormitory is a partition wall. All other walls are solid concrete (Plate 4).

*Plate 4: Room 8, Kitchen showing wet rot*

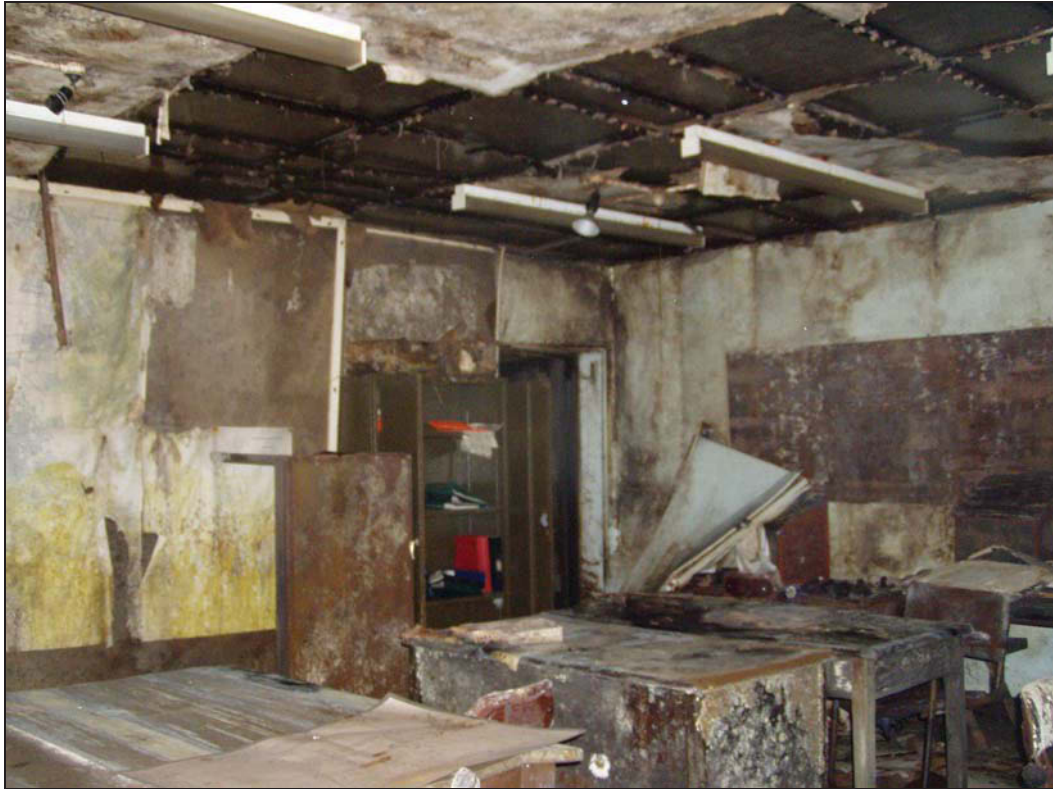
- 3.2.31 This is one of the principal rooms for the successful operation of the bunker as a control centre in the Cold War. It is the largest room, measuring 6.67m by 5.35m, and was the dampest of all the rooms in the bunker, with a puddle of water by a door which leads to the Emergency Exit. The damp has caused the growth of 'cellar fungus', and this has infested wall finishes, furnishings and maps that may have been in good condition until recently. On the east wall are two Ordnance Survey maps of the borough. On the south wall, a large notice board formerly entitled 'LOCATIONS BOARD' has been covered with a coloured A-Z map of the borough. A second board on the wall is entitled 'Special Advisors Display Board and two columns for date and 'to be seen by' (Plate 5).

*Plate 5: The Control Room, Room 9*
