Gasholders Nos 4 & 5, Factory Lane, Croydon, London: Historic Building Recording Final Report

*AOC Project No: 23686_V
3rd August 2021*

On Behalf of:	SGN 2 Woodstock Road Yarnton OX5 1NY
National Grid Reference (NGR):	Gasholder No 4: TQ 31212 65907 Gasholder No 5: TQ 31169 65975
AOC Project No:	23686_V
OASIS No:	411878
Prepared by:	Diana Sproat Gemma Hudson
Illustration by:	Gemma Hudson Jamie Humble Sam O'Leary
Date of Fieldwork:	16th – 18th December 2020 (Phase I) 5th May & 7th July 2021 (Phase II)
Date of Report:	3rd August 2021

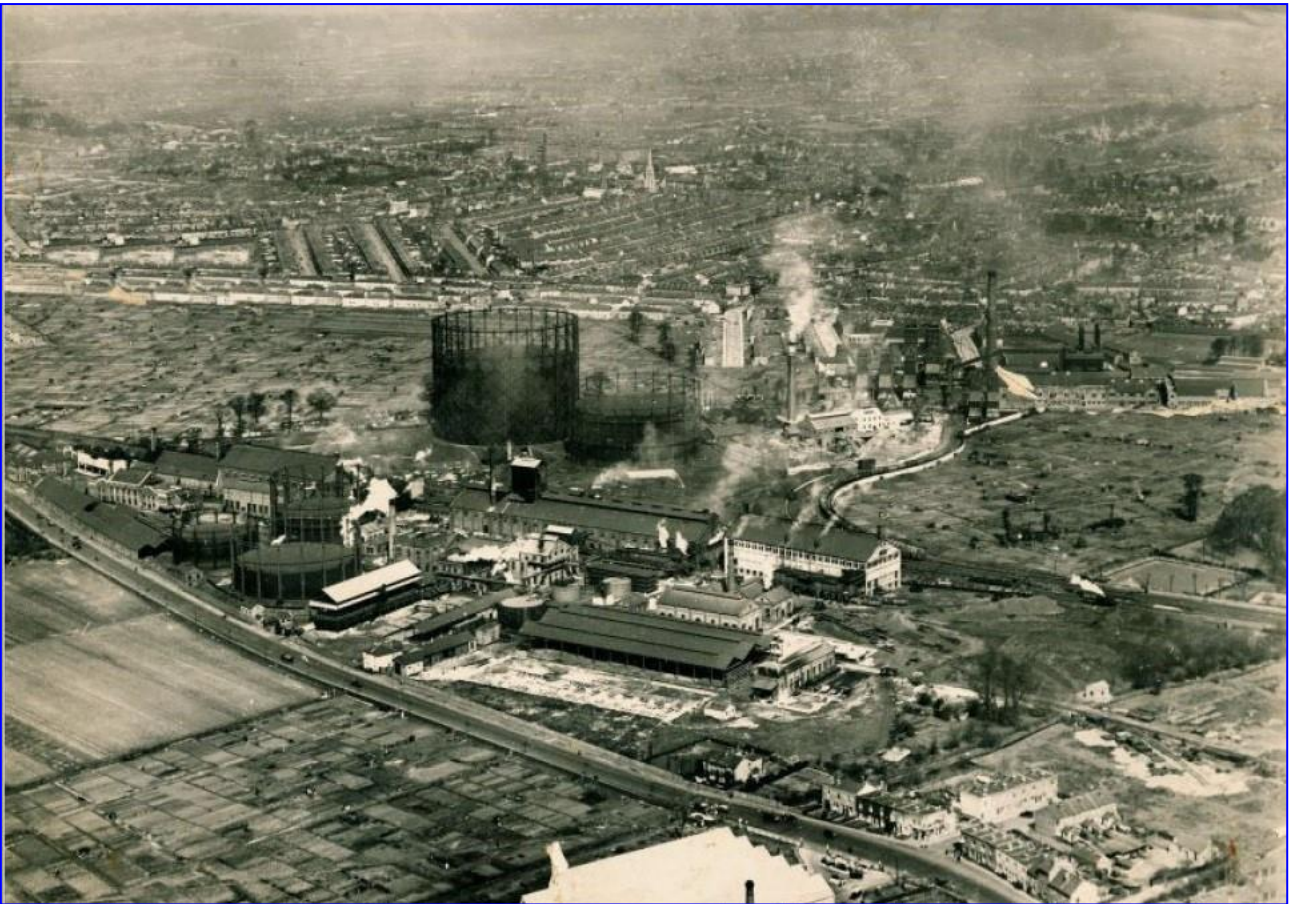
Figure 21: Archive aerial photograph of the Croydon Gasworks, ca. 1930, showing Gasholders No 4 and 5 in operation in the centre with the gasworks to the west (left), including Gasholders Nos 1 – 3 (NGA Ref: SE/CRG/CRO/E/F/3)

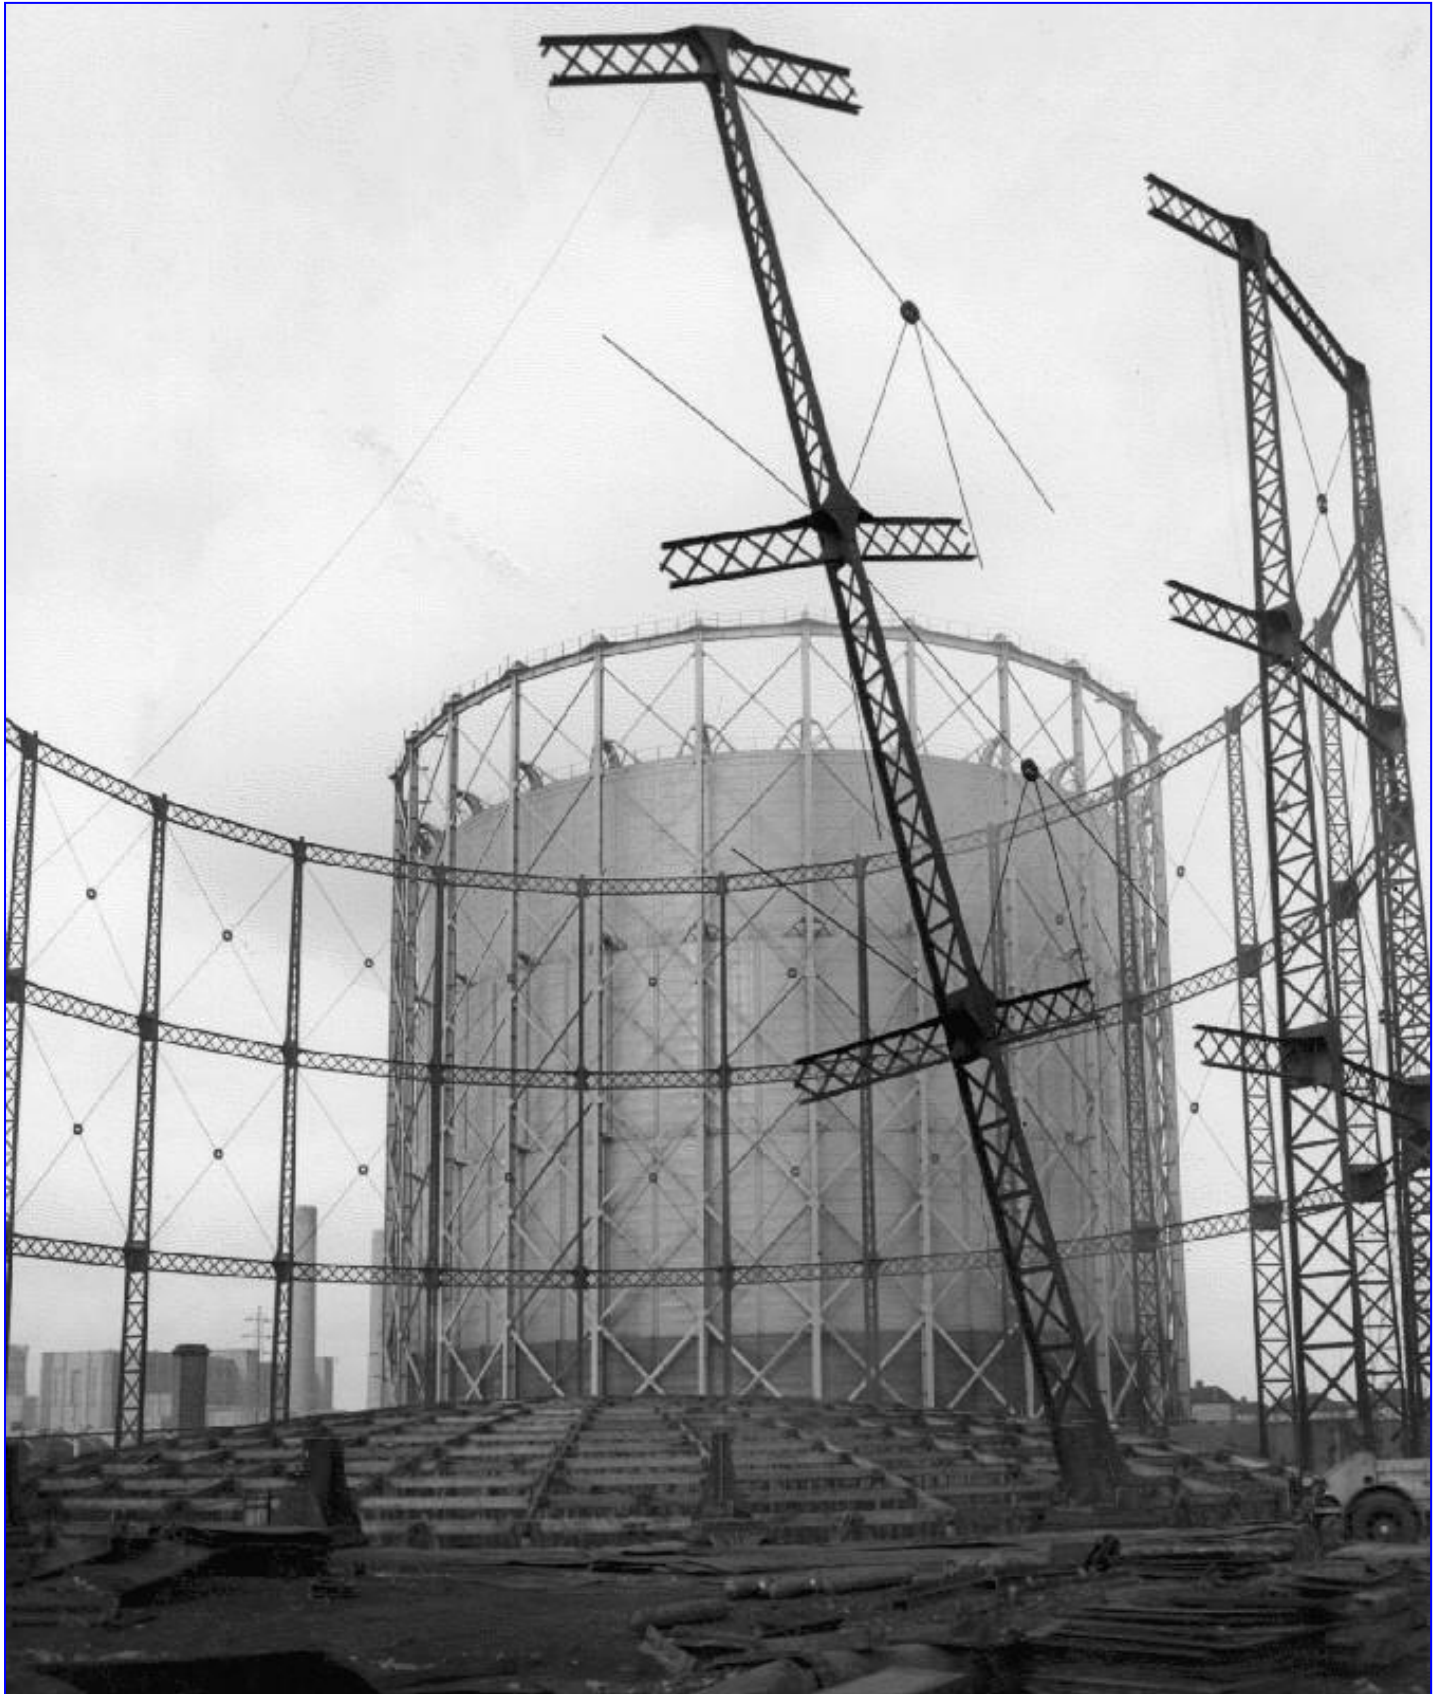
Figure 23: Archive photograph showing the dismantling of the 1890s guide frame of Gasholder No 4, ca. 1954 (NGA Ref: SE/SEG/ES/CRG/E/F/3); Gasholder No 5 is in the background

- 5.5.1 Between 1955–1958, a new spiral-guided holder was constructed after the demolition of the guide frame over the original 1890s below-ground tank of Gasholder No 4, built by R J Dempster Ltd (Montagu Evans (2016, 2). J Dempster Ltd was created in the 1880s by brothers Robert and John Dempster and by 1914 they had established themselves as chemical and gas plant manufacturers (Grace's Guide ud_b). Archive photographs located in the National Gas Archive show the 1890s guide frame of Gasholder No 4 being removed in preparation for the new spiral-guided tank (Figures 23 & 24).

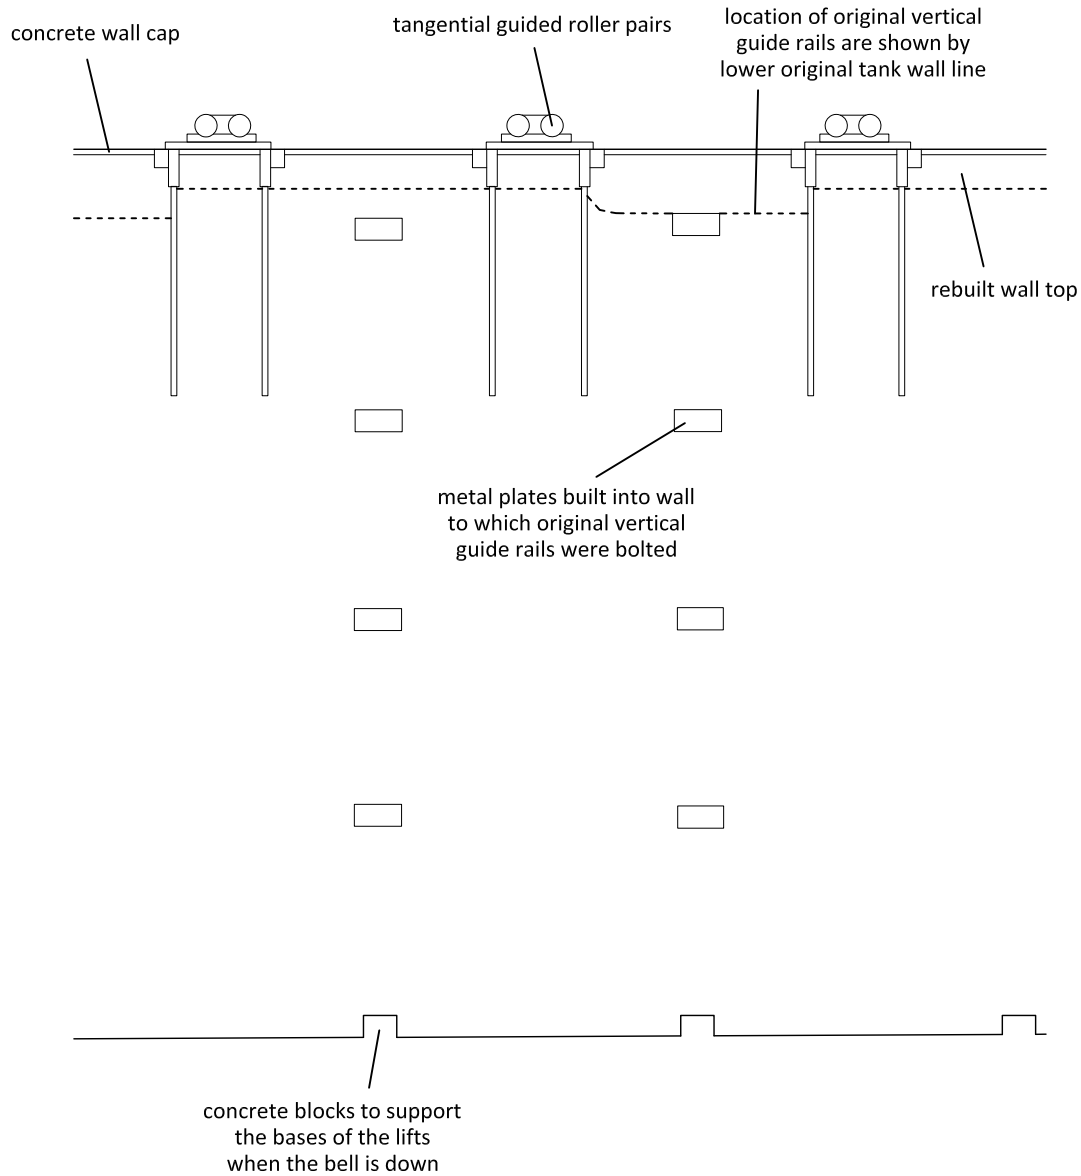
01/23686_V/REP/33/01

Gasholder No 4 has a below-ground brick tank measuring 59.5m in diameter and 11.8m in depth (Plate 18). The tank is original to the 1890 frame-guided design with the exception of the top few courses of bricks which were replaced and capped with concrete blocks when it was converted to a spiral-guided holder (Plate 19). The uneven line of new bricks at the top of the tank wall shows the location of the original standards and vertical guide rails. There were 22 standards and associated guide rails on the original gasholder and an additional guide rail between each pair of neighbouring standards. The original guide rails were bolted to metal plates that were built into the tank wall and were still *in situ* during the survey (Plate 20; Figure 33).

Figure 33: Gasholder No 4, north-facing tank wall elevation sample

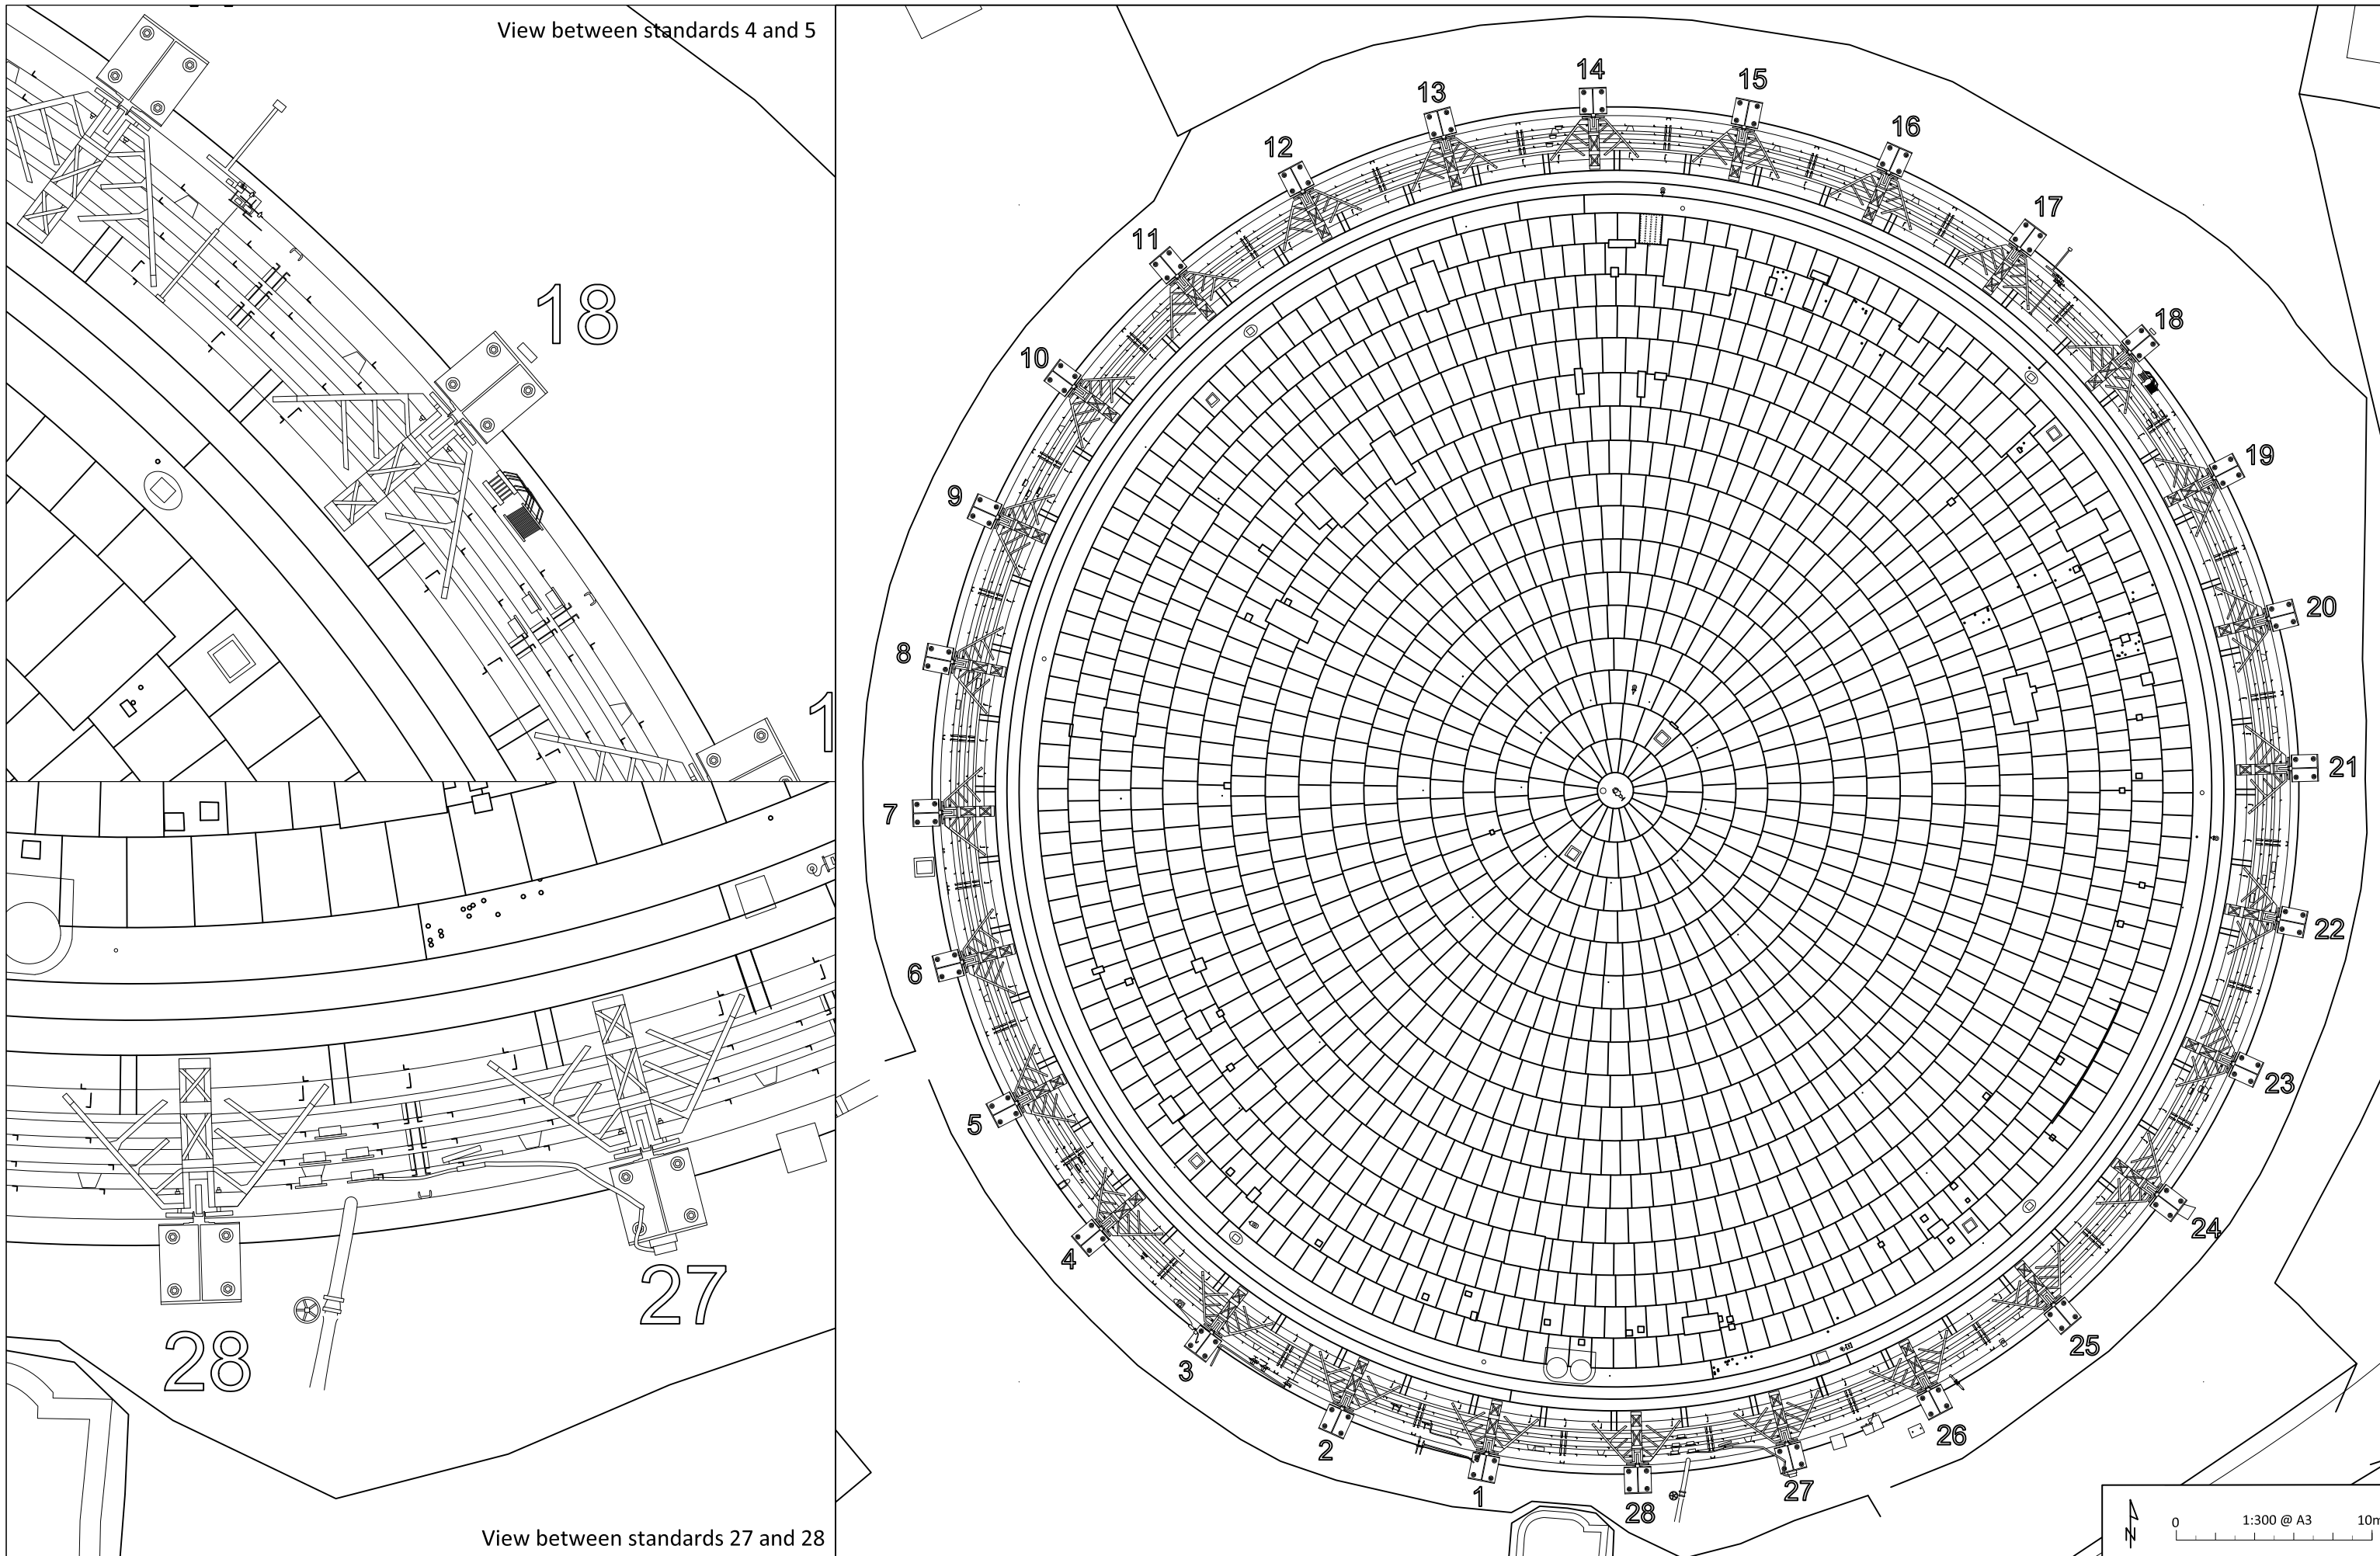
01/23686_V/REP/37/01

- 8.3.1 Now demolished, Gasholder No 5 had a variant of the Type 42 cylindrical shell guide frame designed by Livesey. It had 28 standards arranged clockwise starting from the south side (Figure 37). Only standard 1 was marked via a spray-painted number at its base (Plate 95). The standards were of solid I-shaped construction comprised of steel sheets riveted together with a flared base that was bolted to a concrete foundation with two 12cm diameter bolts on each side (Plates 96–98). The exterior, flared side of the standards had an additional riveted 2m high plate at the base and flange plates bolted every 7.5m connecting the exterior lengths of steel sheet (Plates 99 & 100).

Figure 37: Gasholder No 5, detailed ground plan

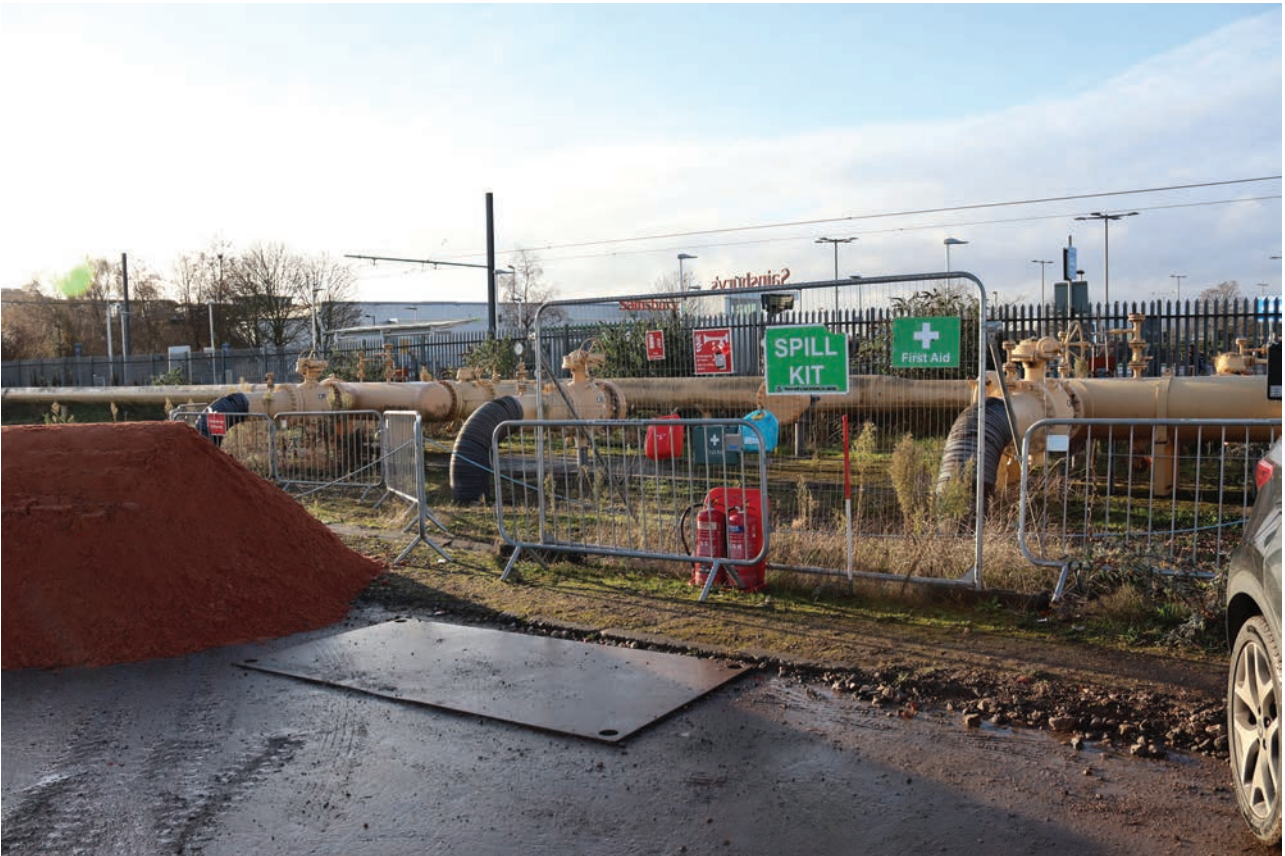
Plate 15: General view of pipework in parallel alignment with the south-west site boundary, from the north

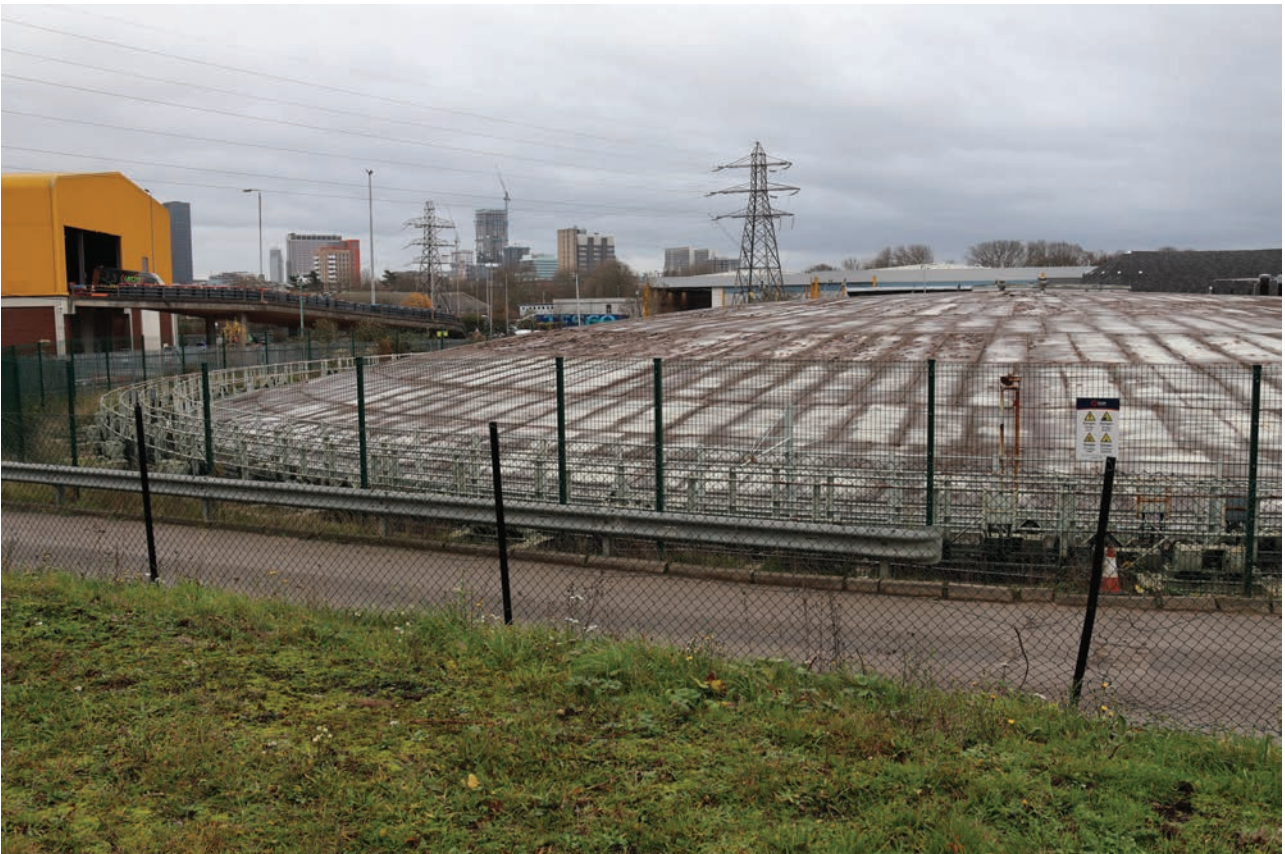
Plate 16: Gasholder No 4, general view of the north side, from the WNW

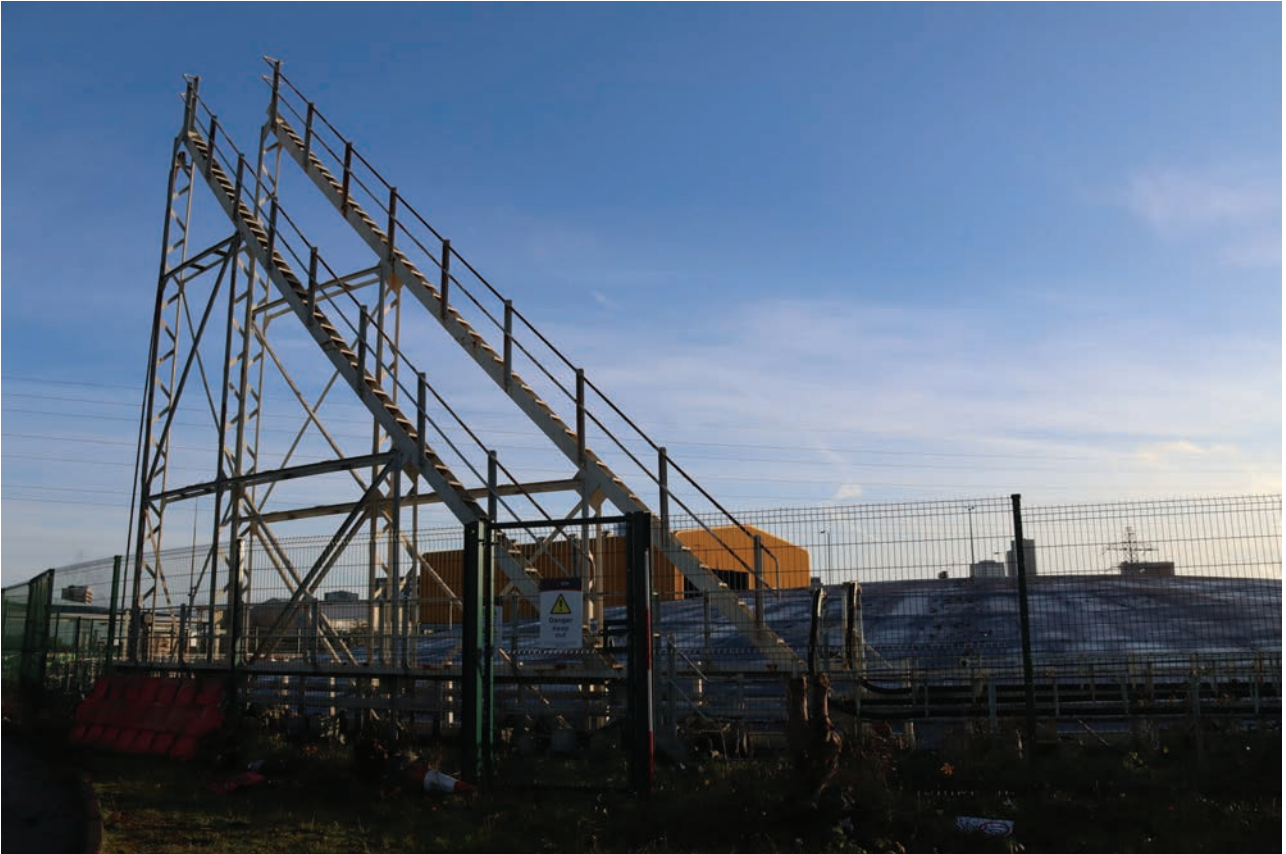
Plate 17: Gasholder No 4, general view of spiral guide rail structures on the north-west side of the holder, from the WSW

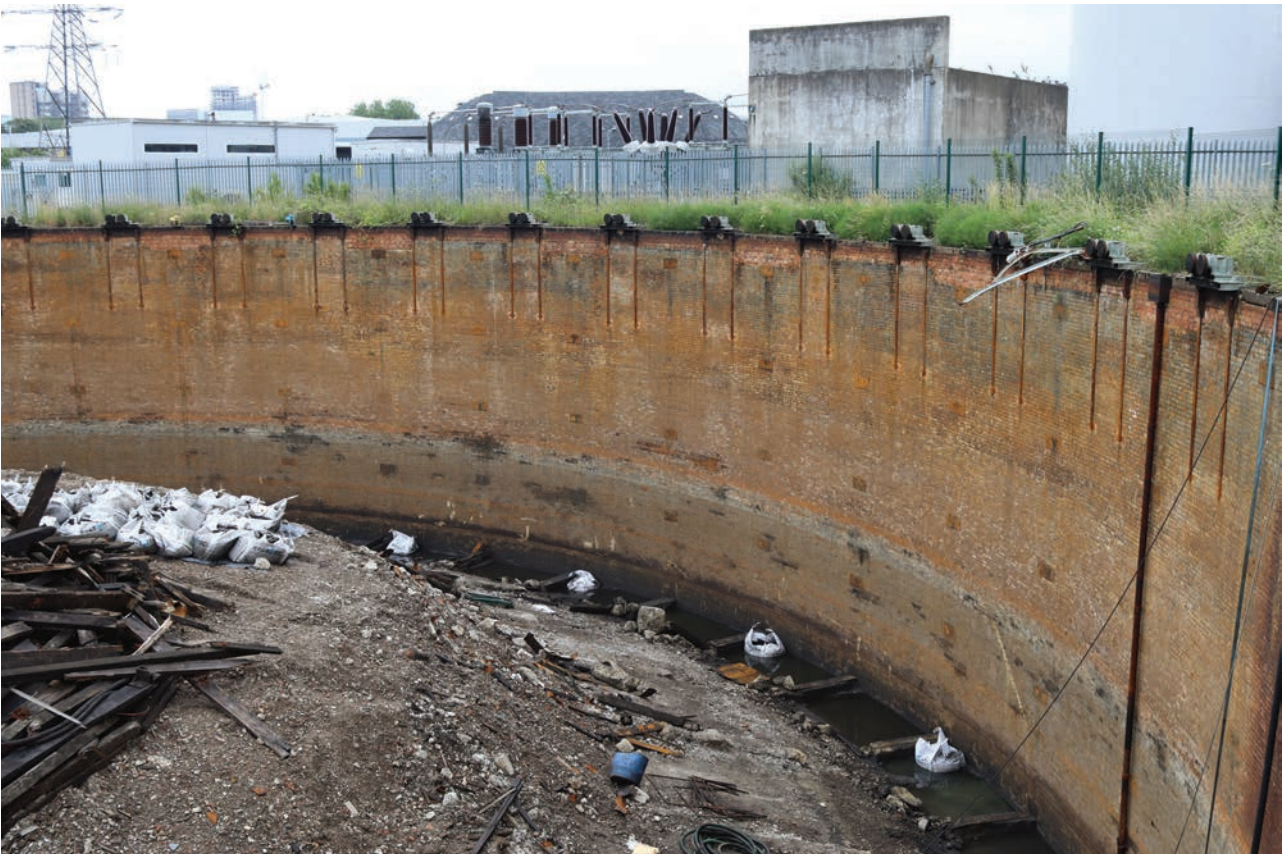
Plate 18: Gasholder No 4, general view of the tank during demolition, from the north-west

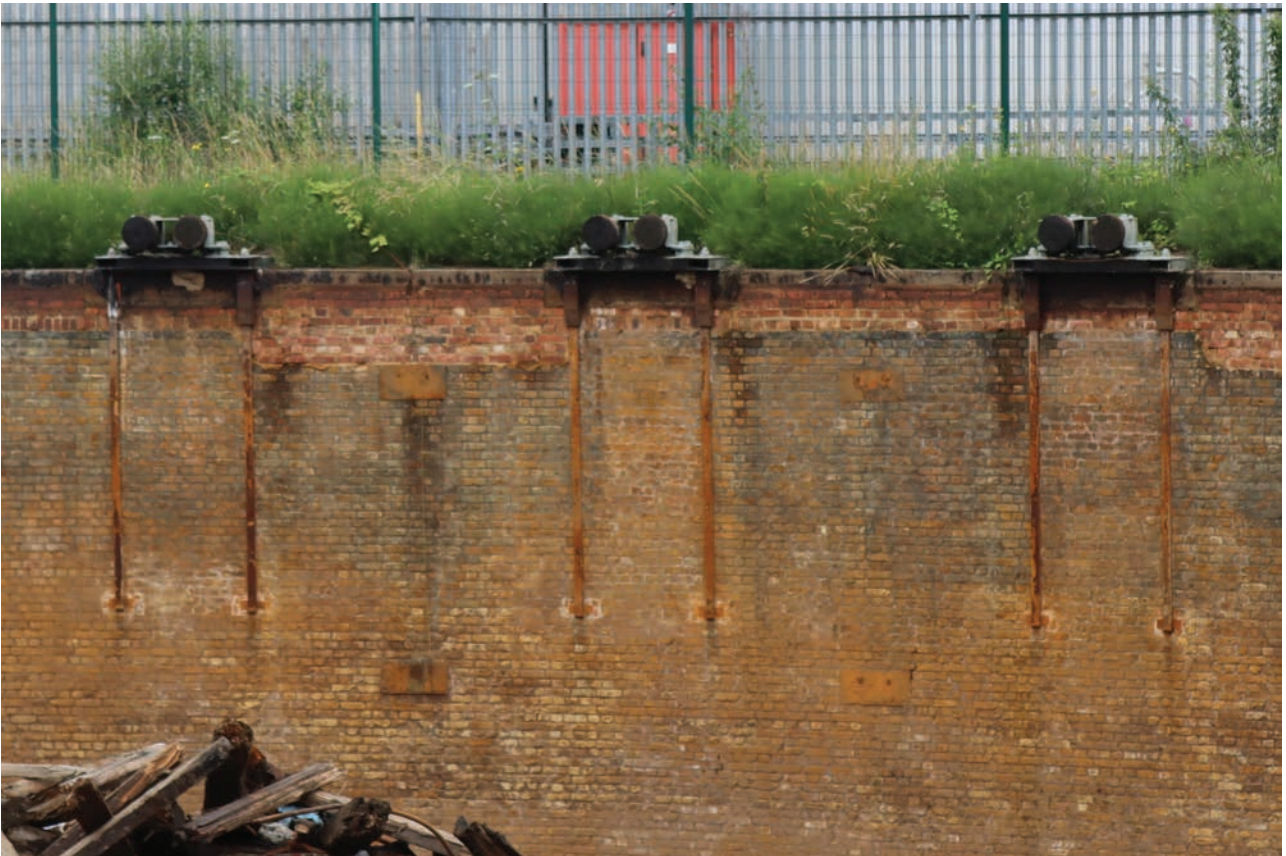
Plate 19: Gasholder No 4, detail view of replaced brick courses at the top of the tank and newer tangential guide roller pair additions, from the NNW

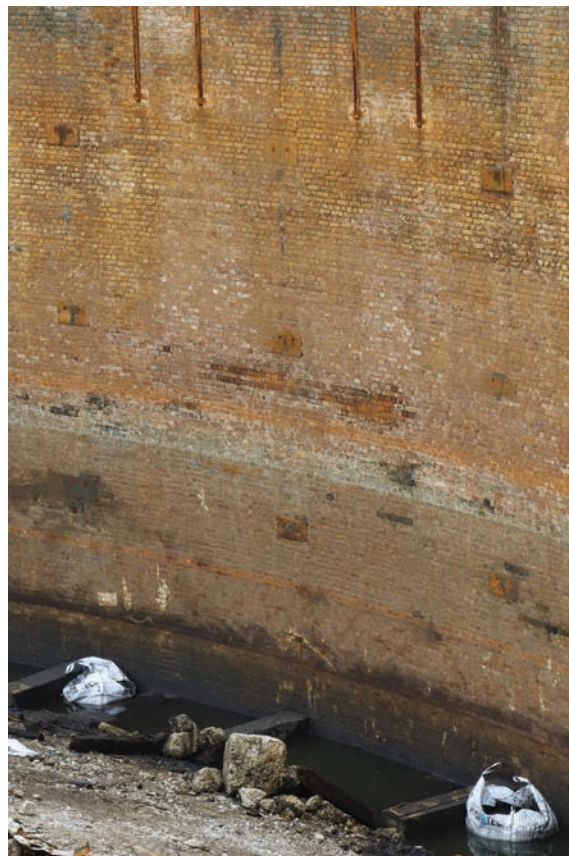
Plate 20: Gasholder No 4, detail view of the metal plates built into the brick tank wall for the original vertical guide rails, from the WNW

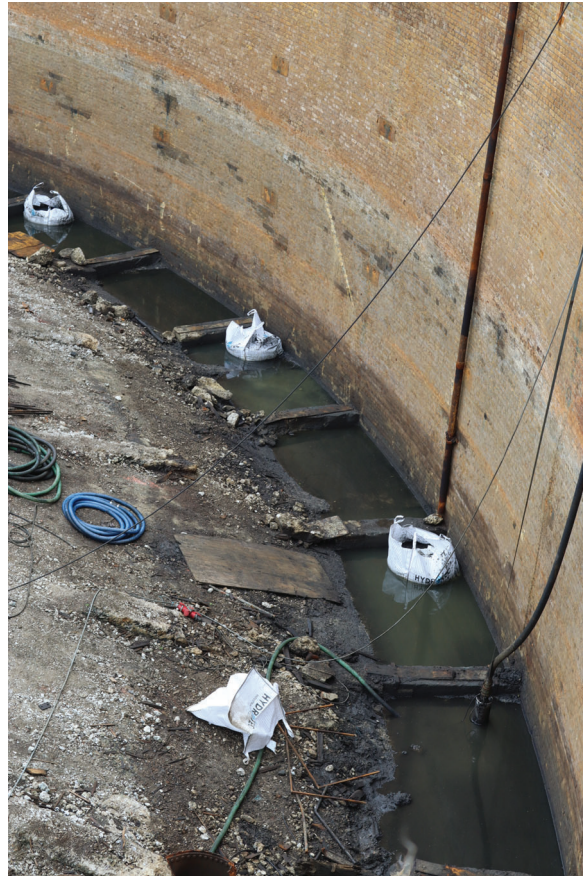
Plate 21: Gasholder No 4, detail view of the concrete blocks supporting the lift grips, from the WNW

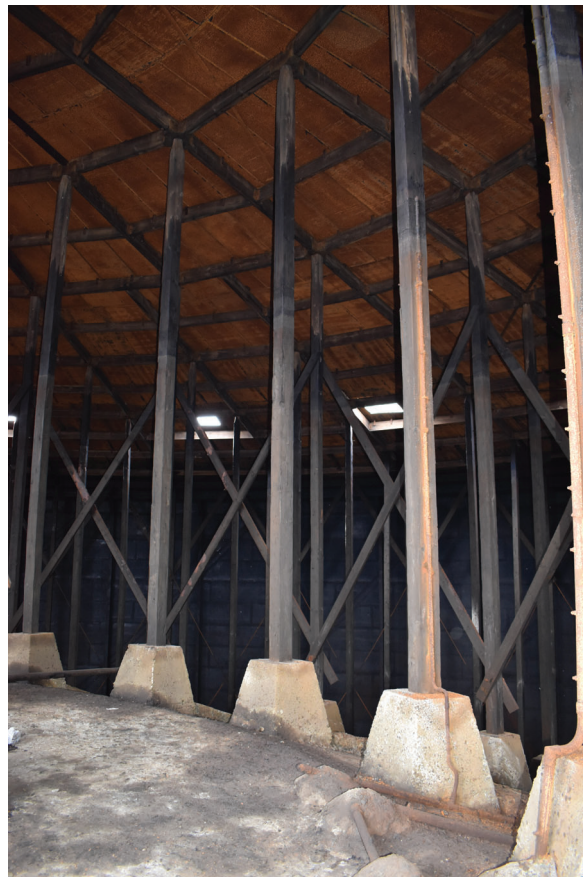
Plate 22: Gasholder No 4, general view of the crown support frame, from the WNW

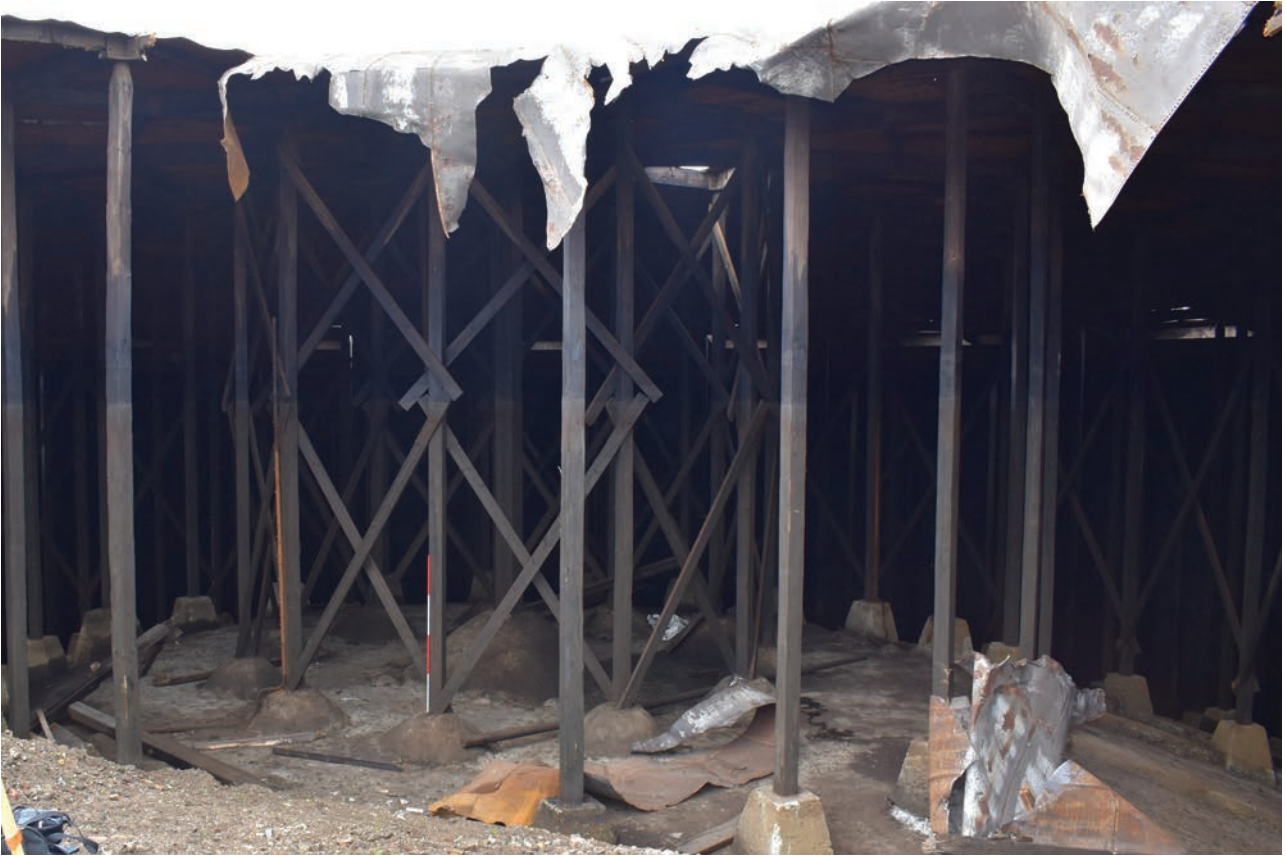
Plate 23: Gasholder No 4, general view of the central post, ring 1 and ring 2, from the NNE

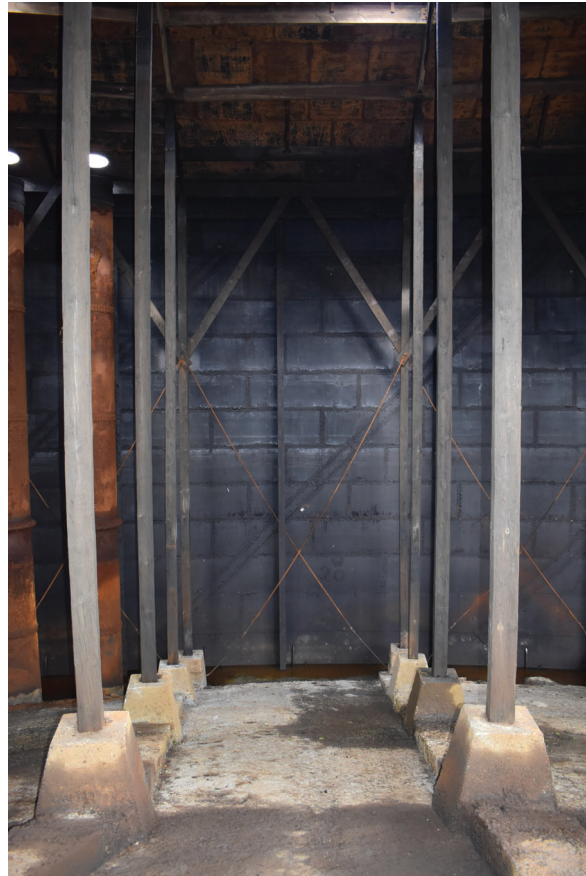
Plate 25: Gasholder No 4, general view of the iron bar and timber plank cross-bracing between vertical posts of ring 7, from the ENE

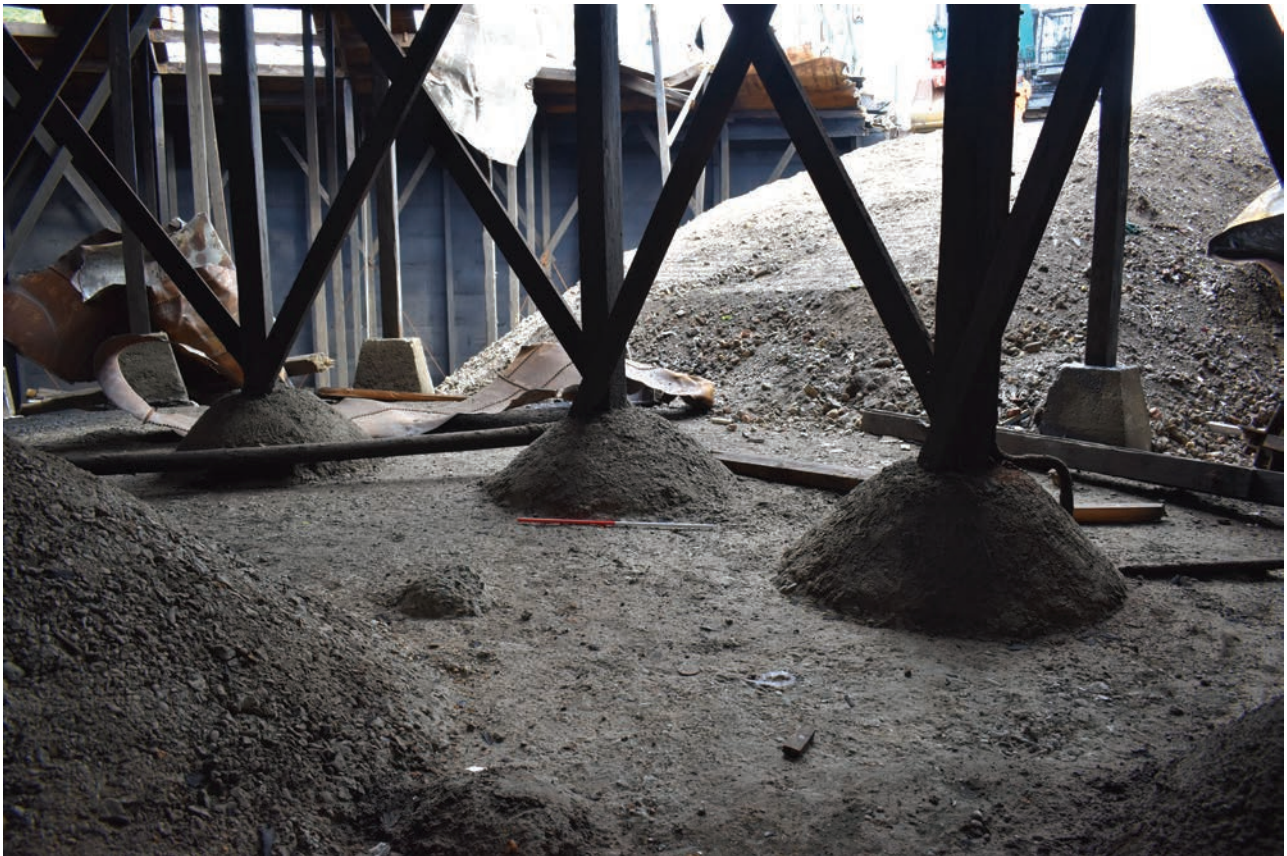
The vertical posts of ring 1 are set into steep-sided concrete mounds securing them to the dumpling (Plate 26). The mounds are sub-circular in plan measuring approximately 1.5m in diameter and 0.5m in height. They are loosely formed with large stone inclusions and a rough consistency matching the concrete surface of the dumpling. The central post is also set within an uneven concrete mound measuring approximately 3.5m in diameter and 1m high. Ring 1 and the central post account for the only vertical posts situated on the flat-top of the dumpling. Rings 2–7 are set within square concrete blocks measuring approximately 0.8m in plan at their base and 0.45m in plan on top (Plate 27). The concrete used is a slightly higher grade than on the bases of ring 1 with smaller stone inclusions and higher percentage of cement to act as a much better support for the posts on the steep dumpling slope. For additional support the concrete blocks of different rings are connected via concrete linears on the dumpling slope (Plate 28). To account for

Plate 26: Gasholder No 4, general view of the uneven concrete mounds supporting the posts of ring 1, from the SSE

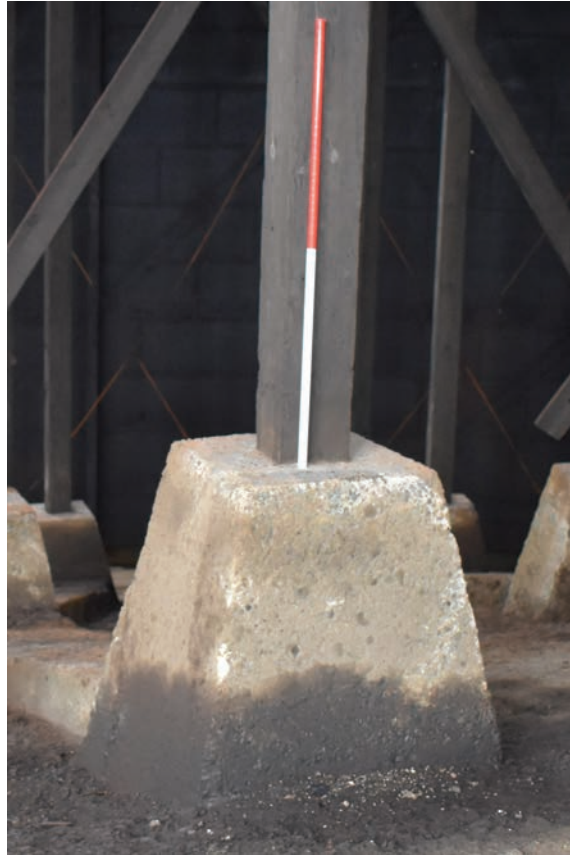
Plate 27: Gasholder No 4, detail view of concrete block base of ring 2, from the WNW

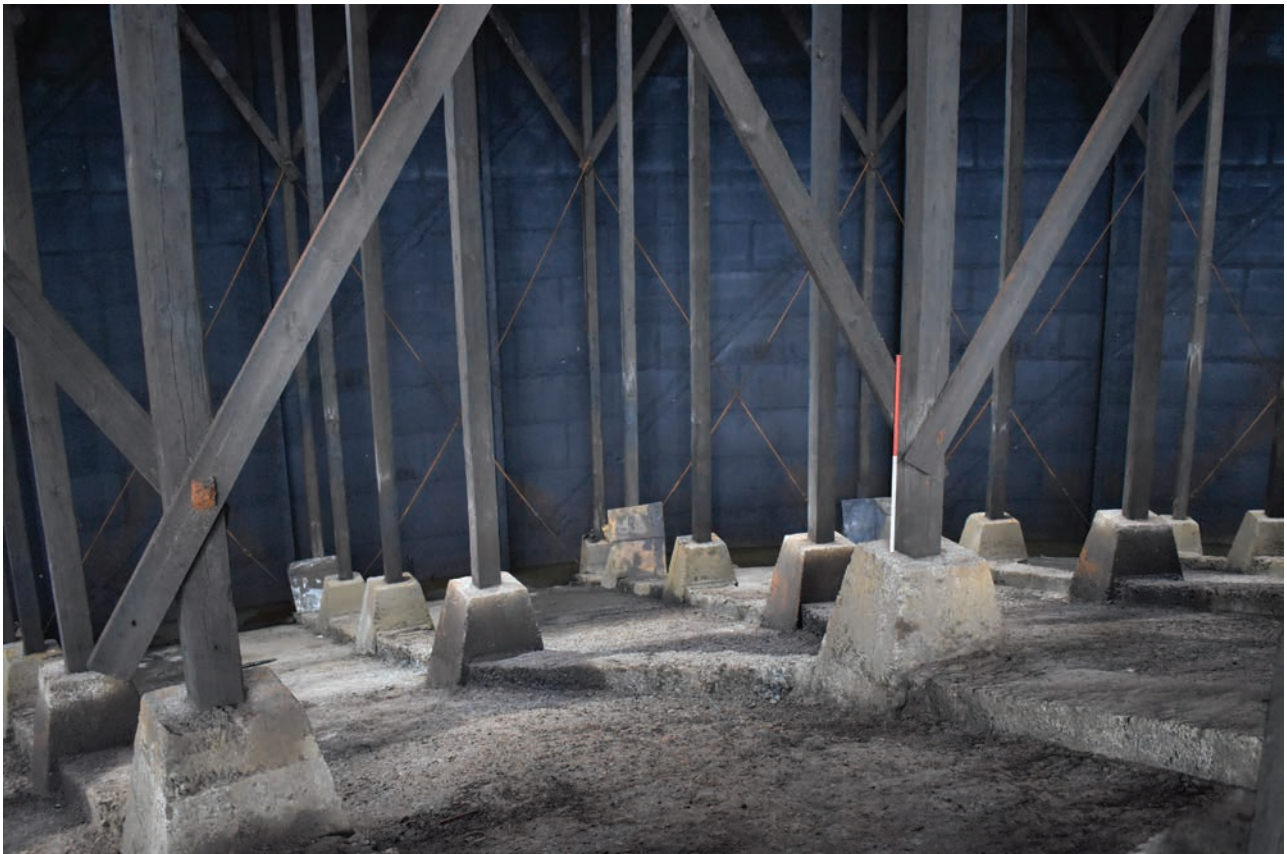
Plate 28: Gasholder No 4, general view of the lines of concrete connecting the concrete block bases of the vertical posts of rings 2–7, from the NNW

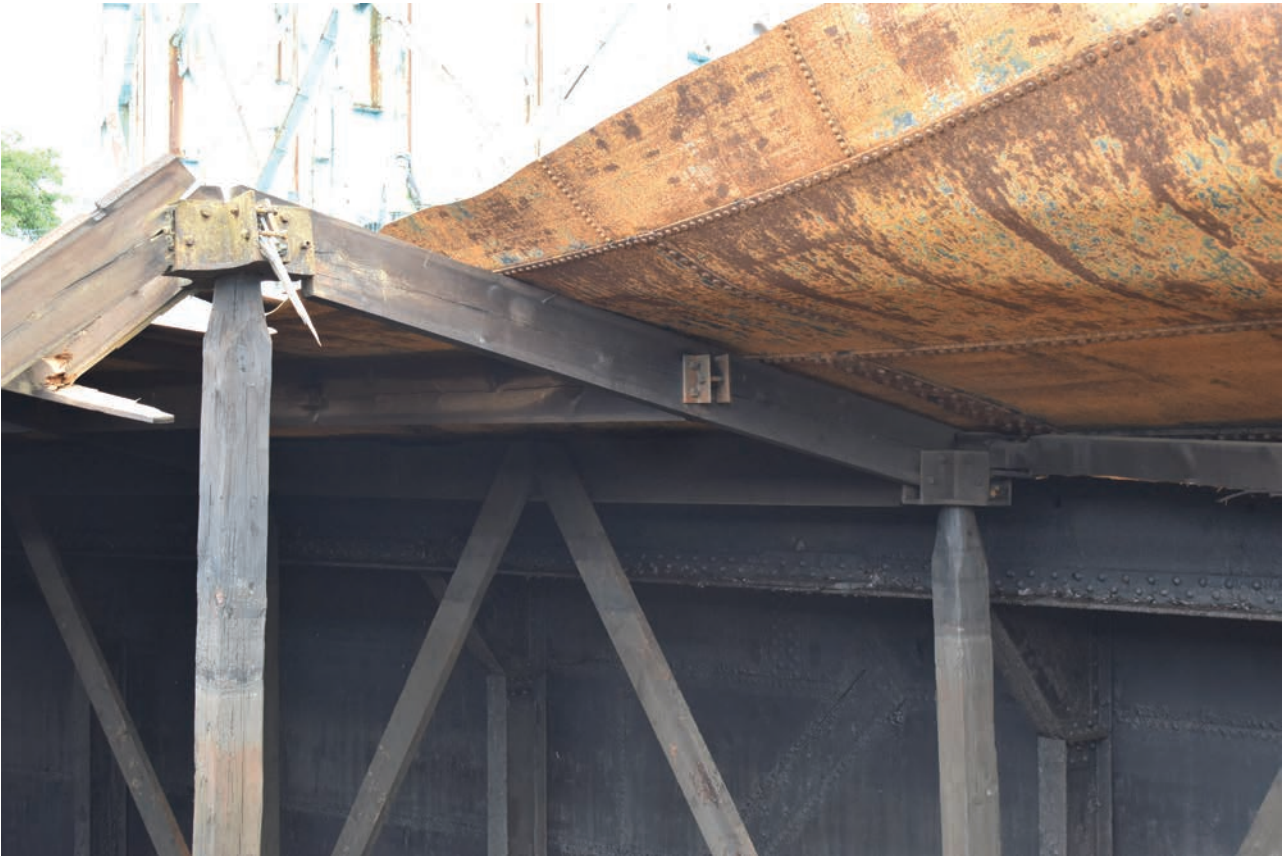
Plate 29: Gasholder No 4, detail view of pointed post tops slotted into cross-shaped fixtures, from the south-east
