Gasholders Nos 4 & 5, Factory Lane, Croydon, London: Historic Building Recording Final Report

*AOC Project No: 23686_V
3rd August 2021*

On Behalf of:	SGN 2 Woodstock Road Yarnton OX5 1NY
National Grid Reference (NGR):	Gasholder No 4: TQ 31212 65907 Gasholder No 5: TQ 31169 65975
AOC Project No:	23686_V
OASIS No:	411878
Prepared by:	Diana Sproat Gemma Hudson
Illustration by:	Gemma Hudson Jamie Humble Sam O'Leary
Date of Fieldwork:	16th – 18th December 2020 (Phase I) 5th May & 7th July 2021 (Phase II)
Date of Report:	3rd August 2021

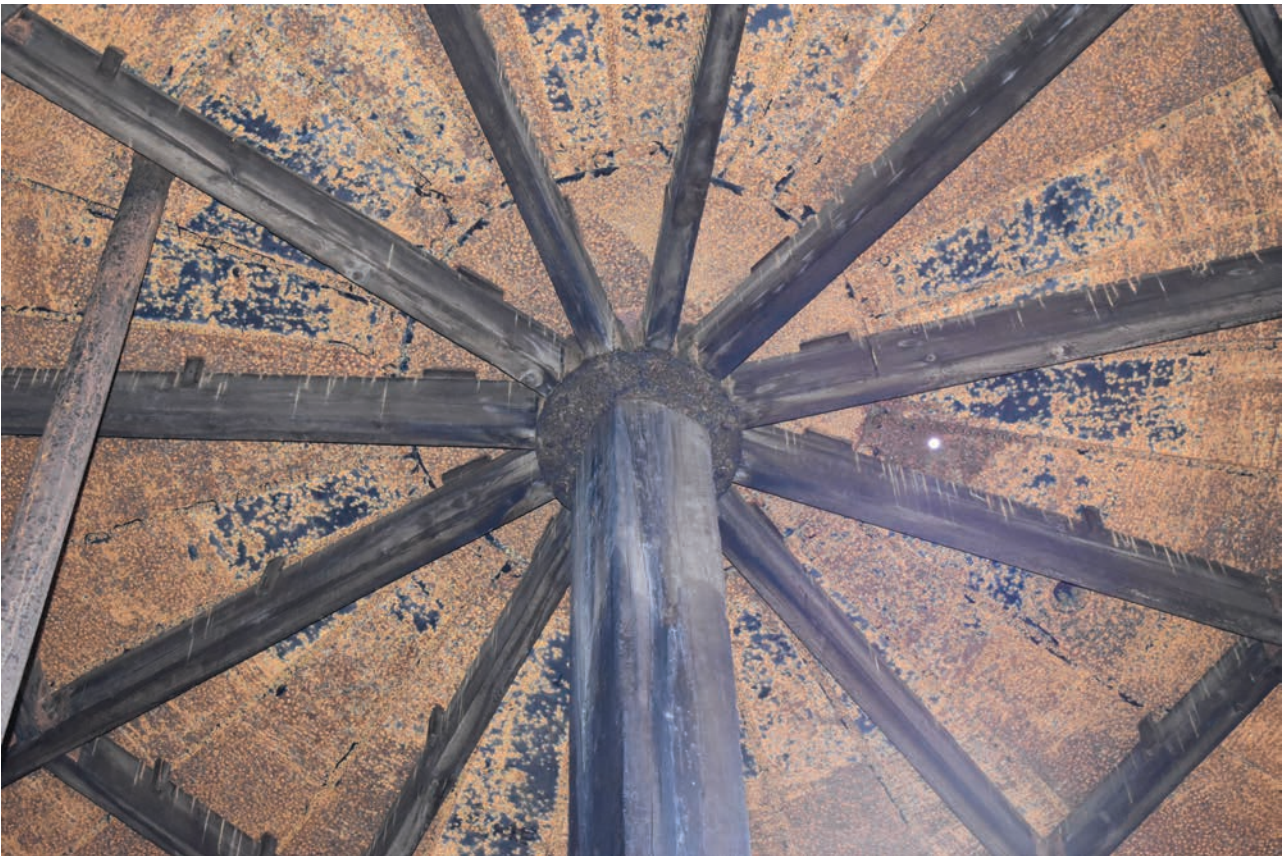
Plate 30: Gasholder No 4, detail view of central vertical post, cylindrical fixture and eleven timber spokes of the crown support frame, from the NNE

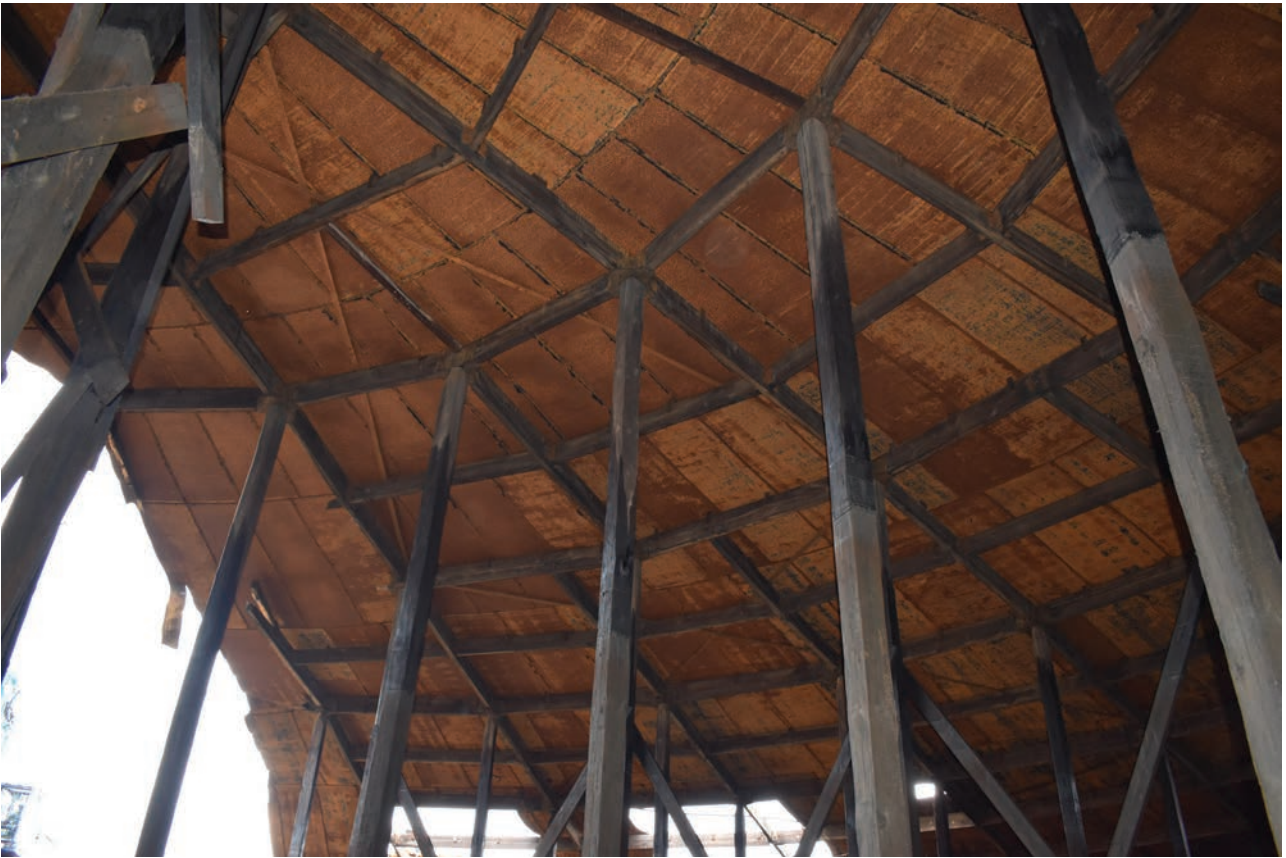
Plate 31: Gasholder No 4, detail view of additional spoke and iron cross-bracing in the timber dome of the crown support frame, from the south-west

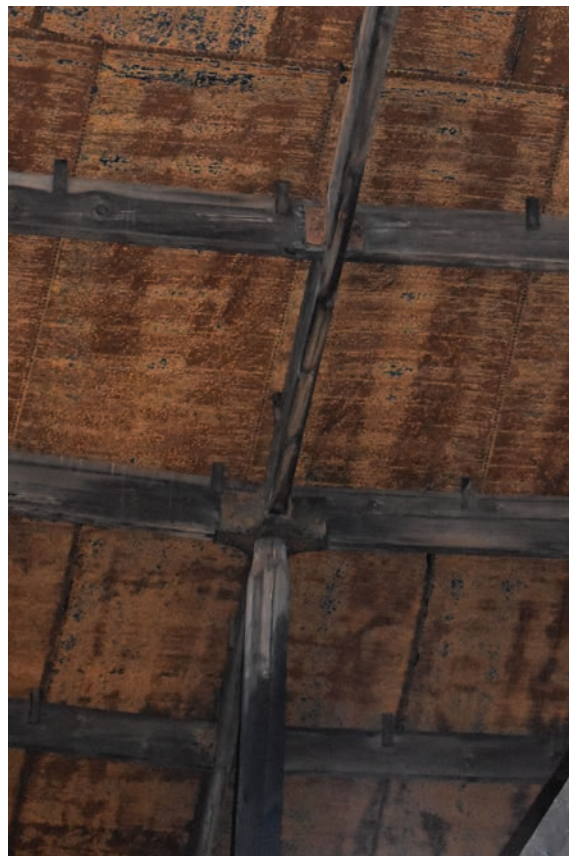
Plate 32: Gasholder No 4, detail view of timber chocks supporting the crown, from the WNW

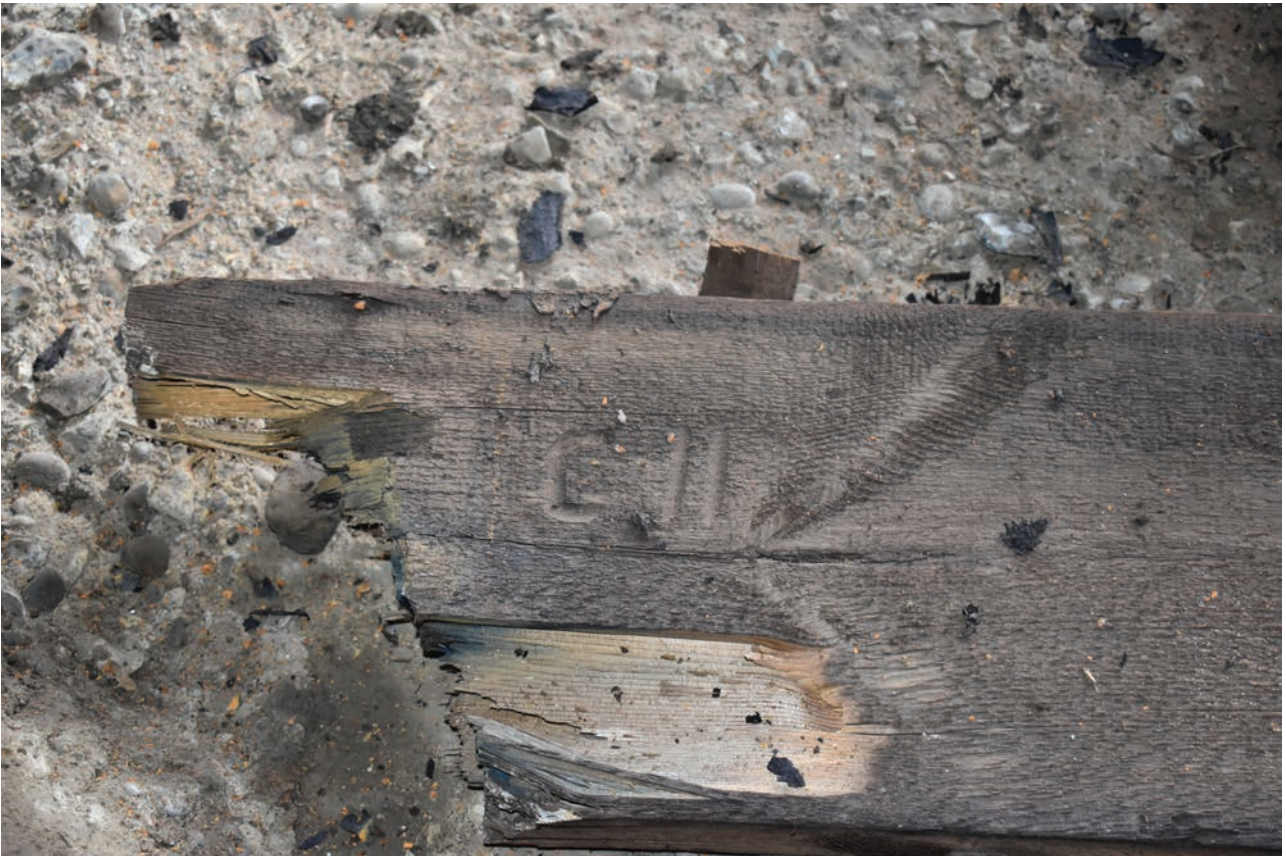
Plate 33: Gasholder No 4, detail view of carved letter and number on a timber associated with building the crown rest frame, not in situ

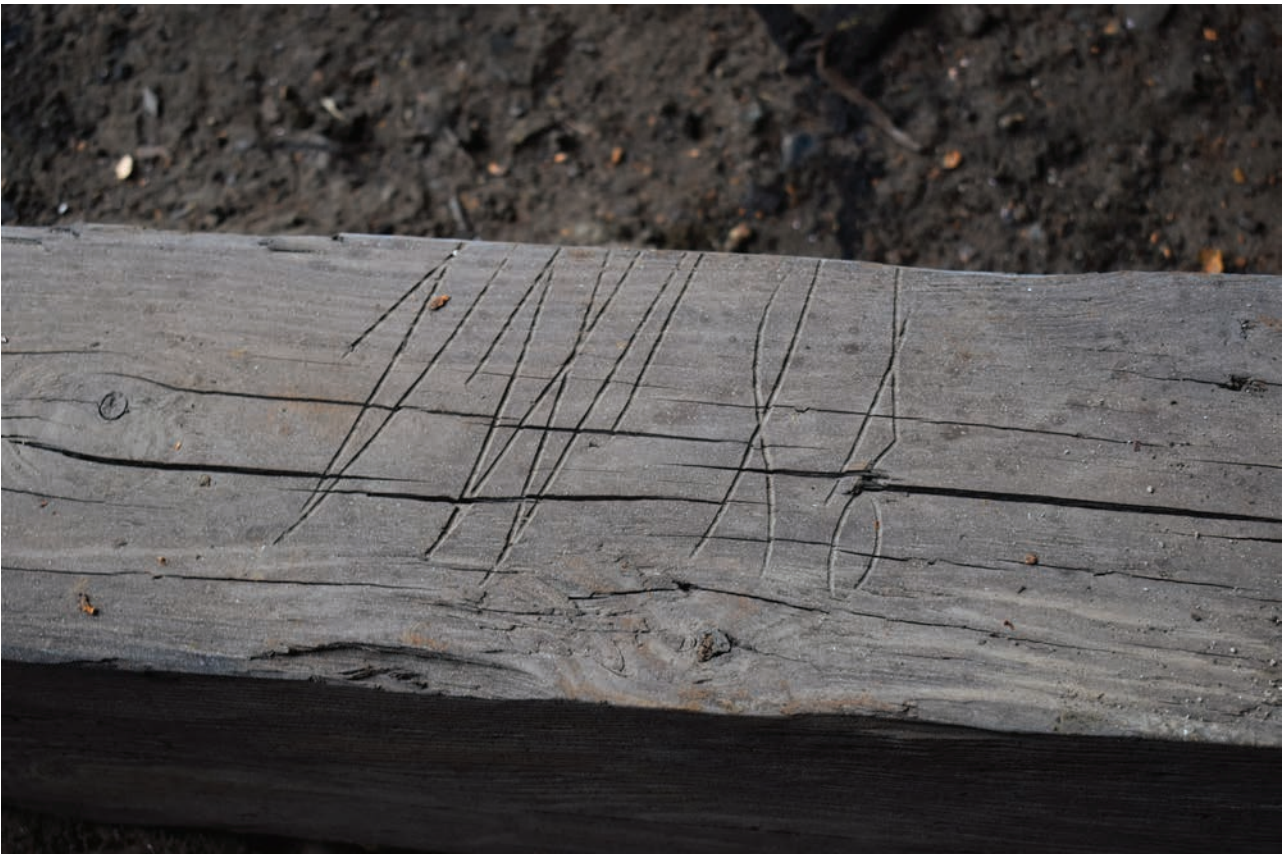
Plate 34: Gasholder No 4, detail view of possible initials and date carved into a displaced timber of the crown rest frame, not in situ

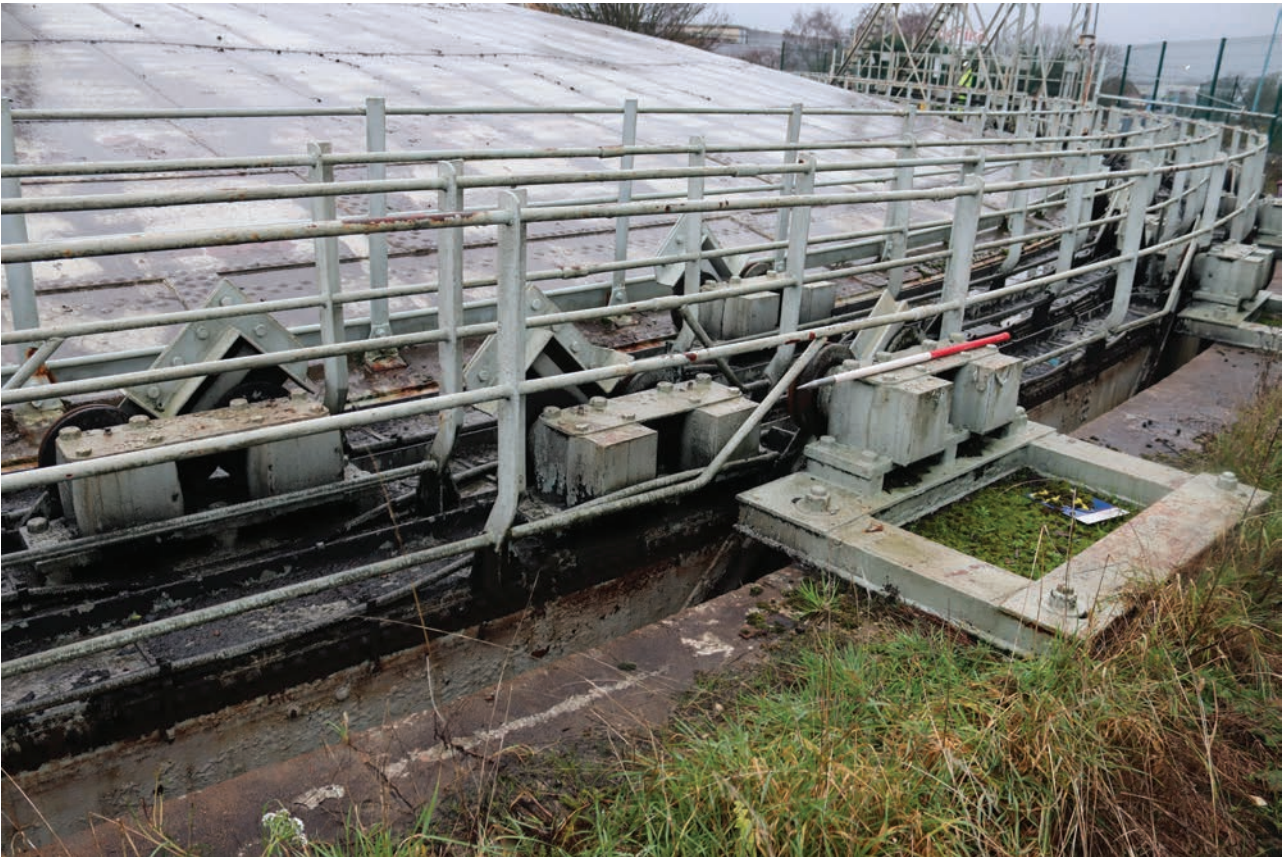
Plate 35: Gasholder No 4, detail view of pairs of tangential guide rollers bolted to the ground and lift tops, from the NNE

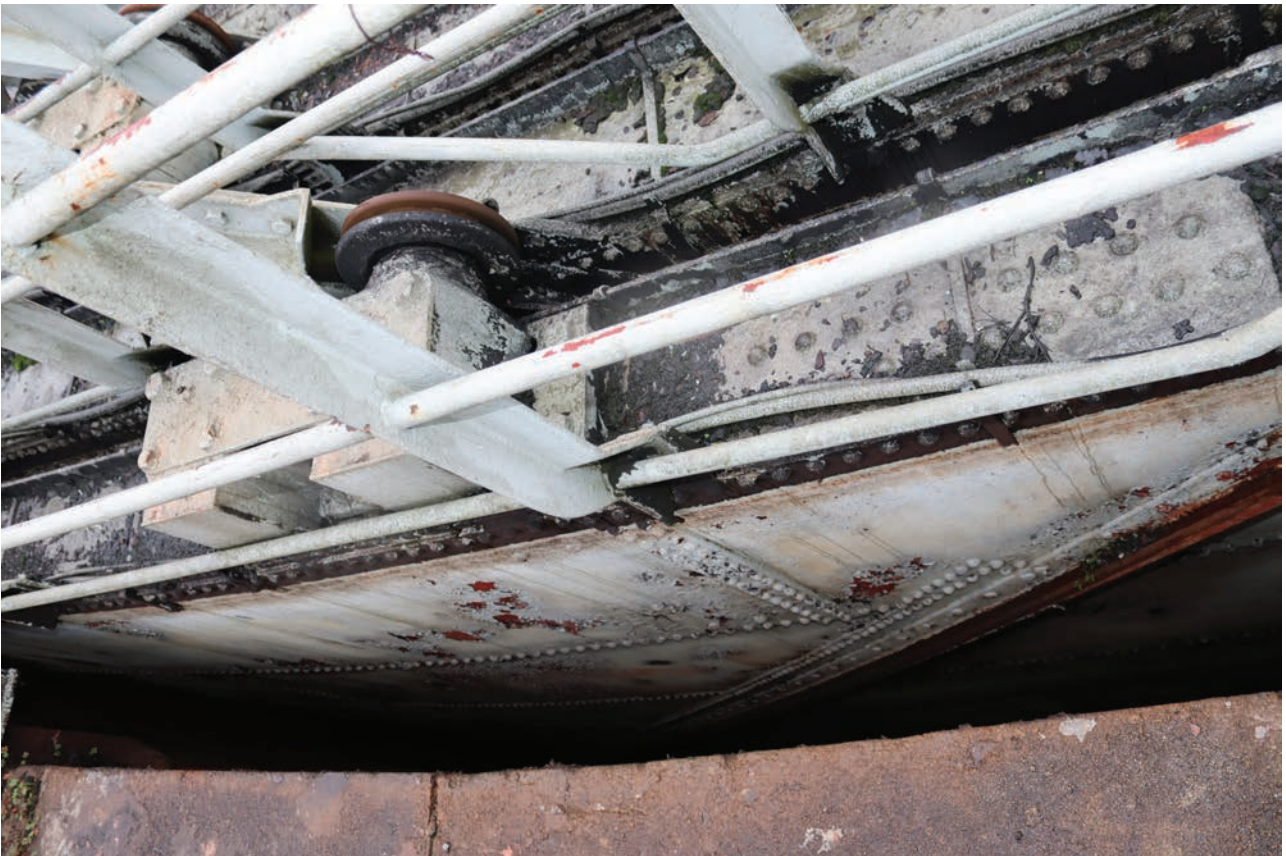
Plate 36: Gasholder No 4, detail view of the outer wall of the bottom lift showing riveted steel sheet construction and helical guide rail, from the NNW

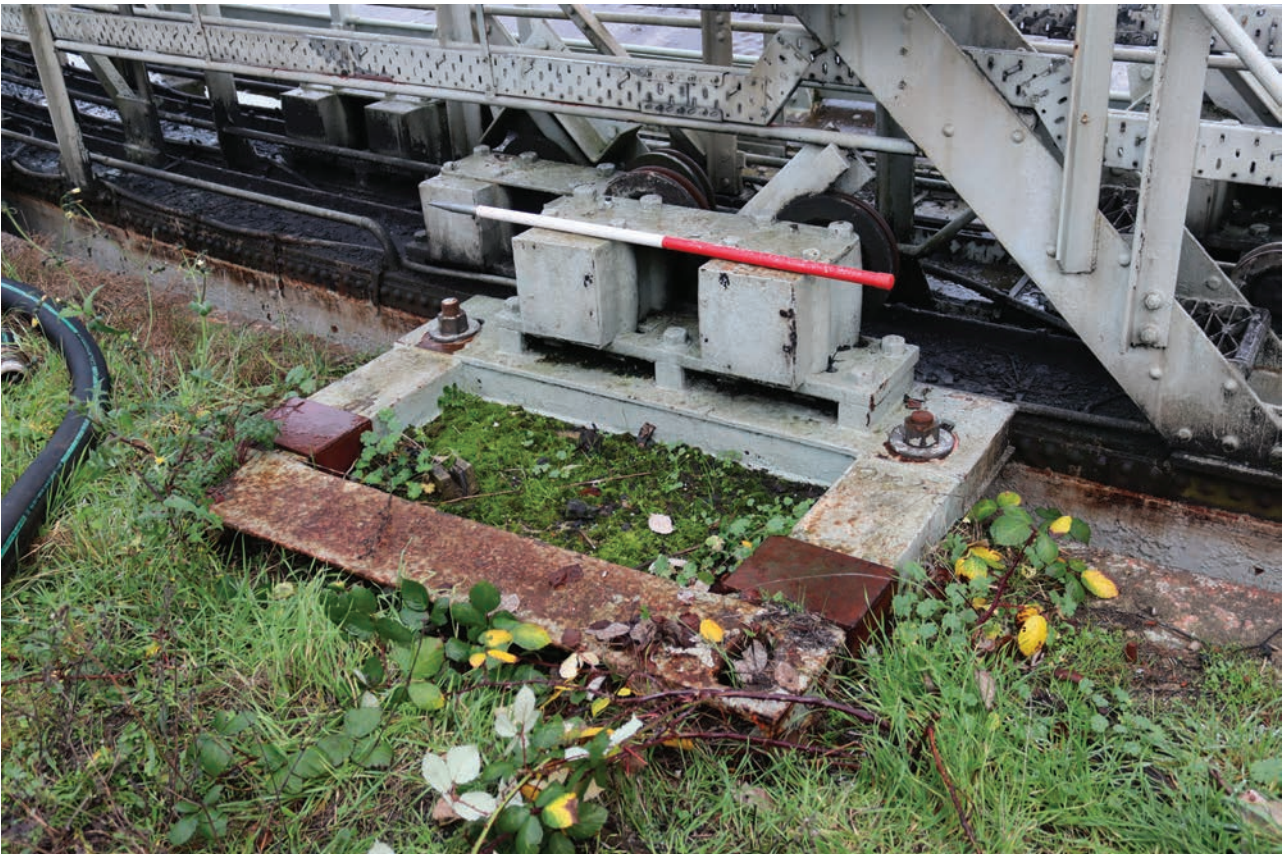
Plate 38: Gasholder No 4, detail view of steel structure supporting the bottom lift guide rollers, from the WSW

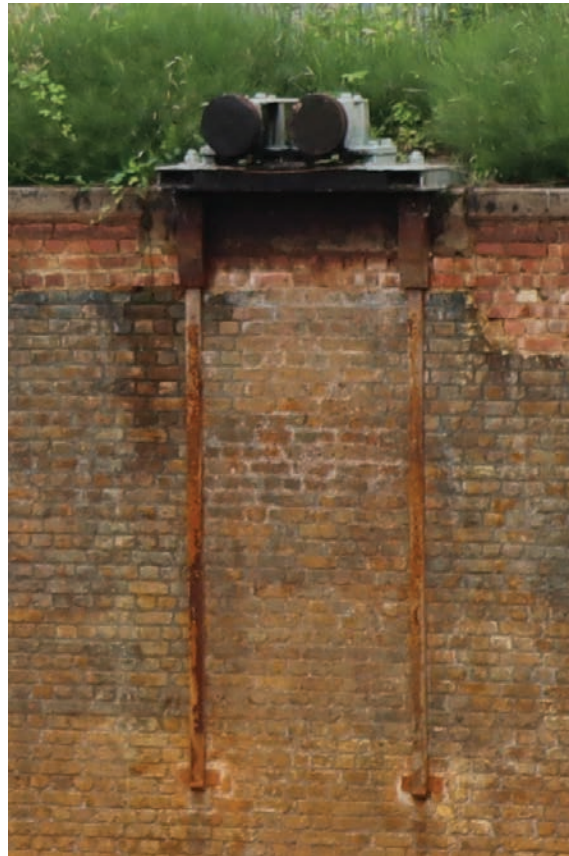
Plate 39: Gasholder No 4, detail view of vertical supports beneath the bottom lift guide rail structure, from the NNW

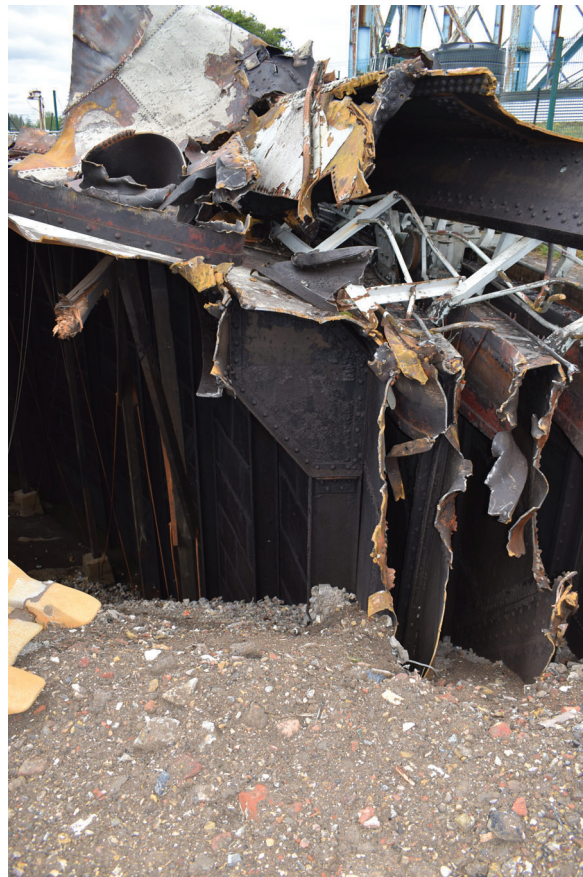
Plate 40: Gasholder No 4, detail view of bracket topping stanchion on the crown lift wall interior, from the east

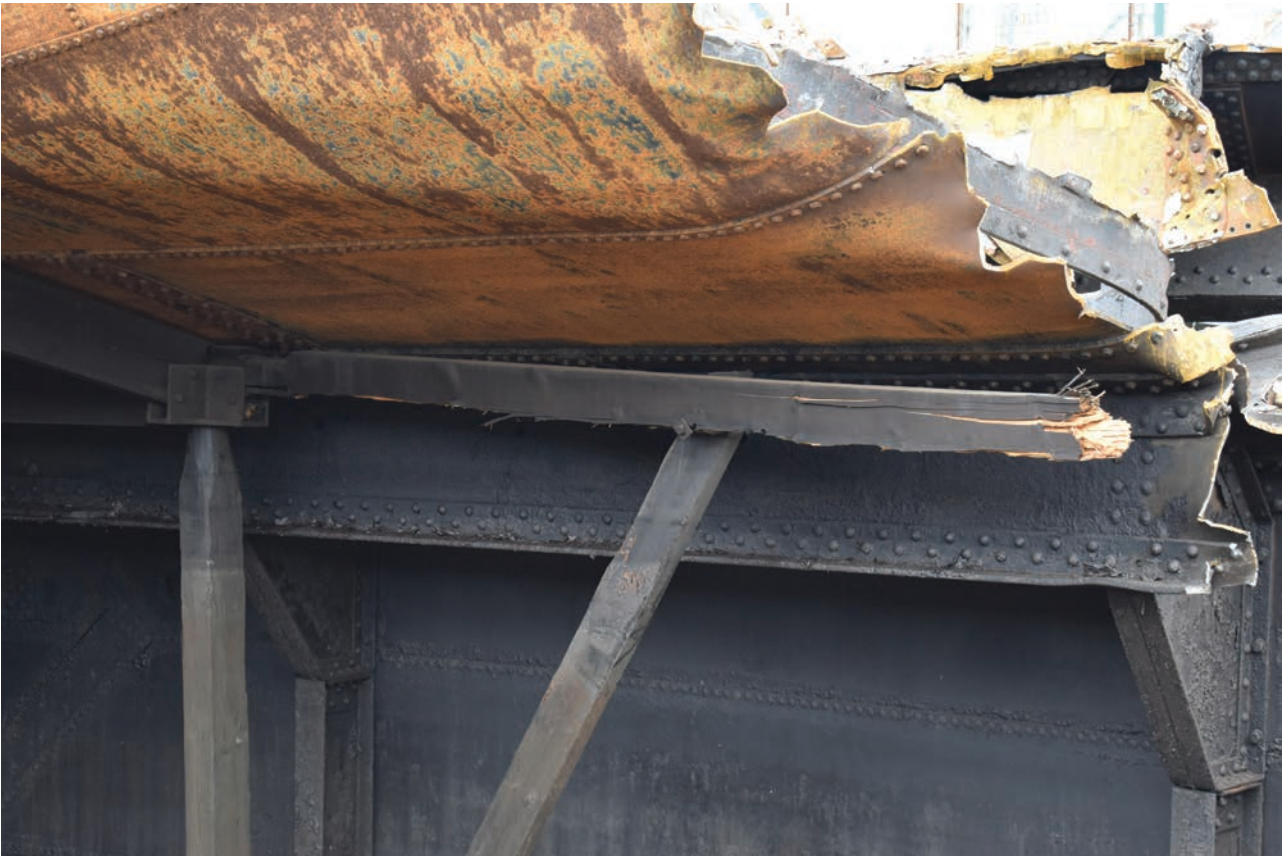
Plate 41: Gasholder No 4, detail view of steel sheet supporting the top curb of the bell, from the south-east

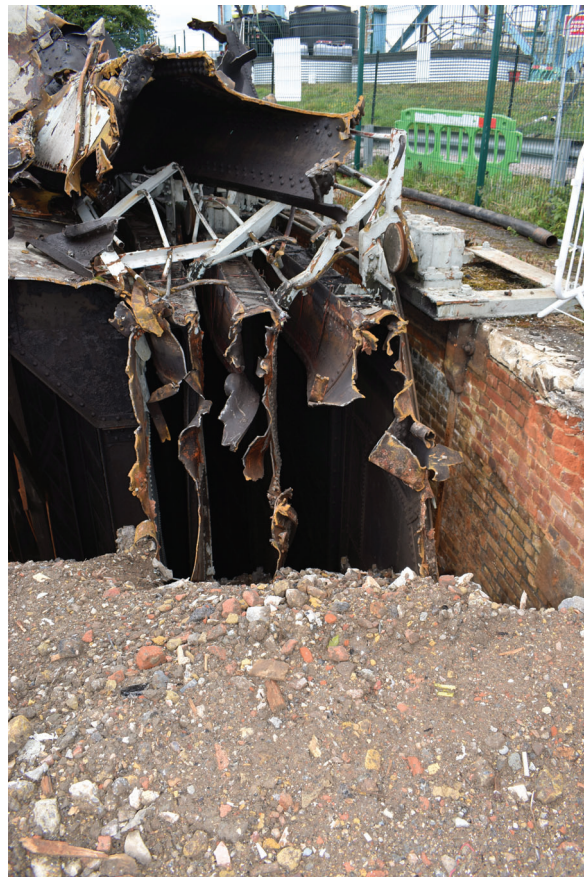
Plate 42: Gasholder No 4, detail view of square grips in section during demolition, from the east

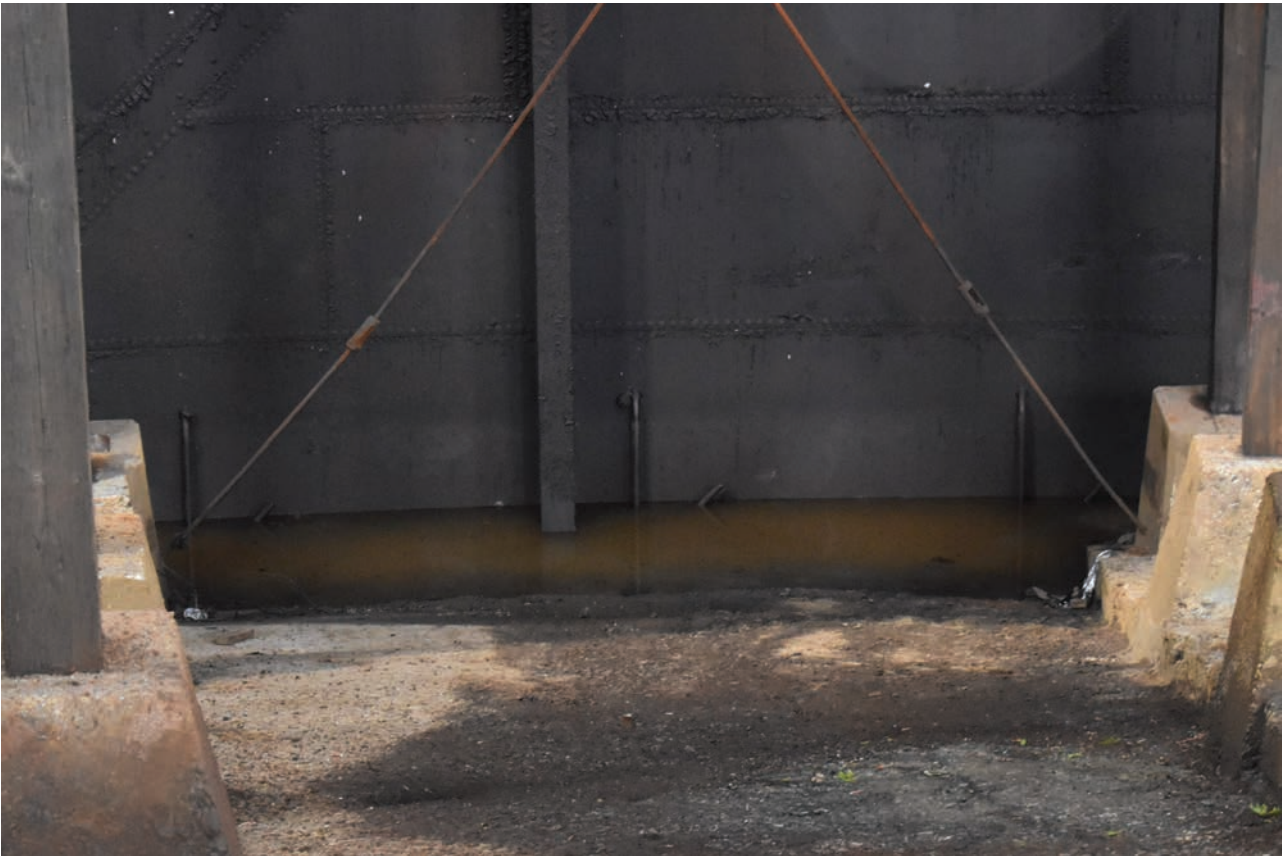
Plate 43: Gasholder No 4, detail view of grip water overflow pipes, from the west

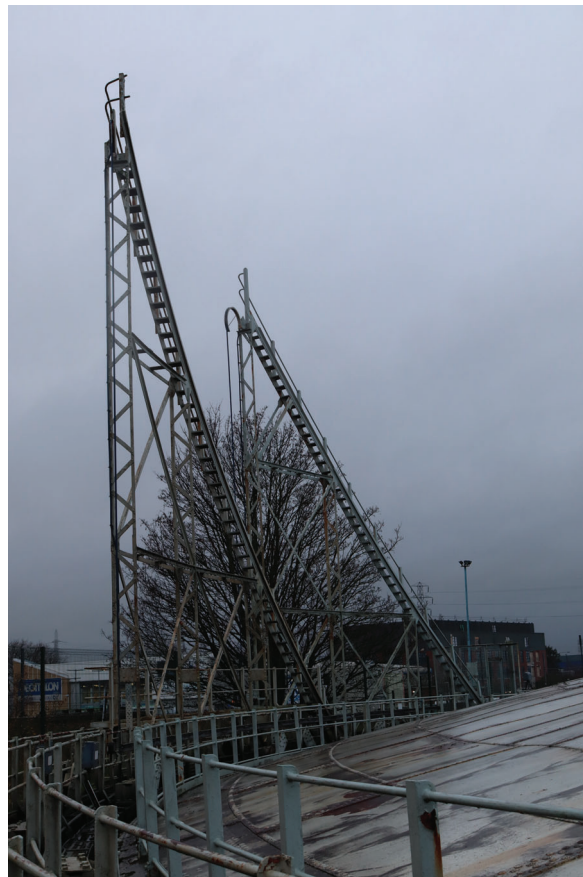
Plate 44: Gasholder No 4, general view of the guide rail and stair structures on the south-west side of the holder, from the east

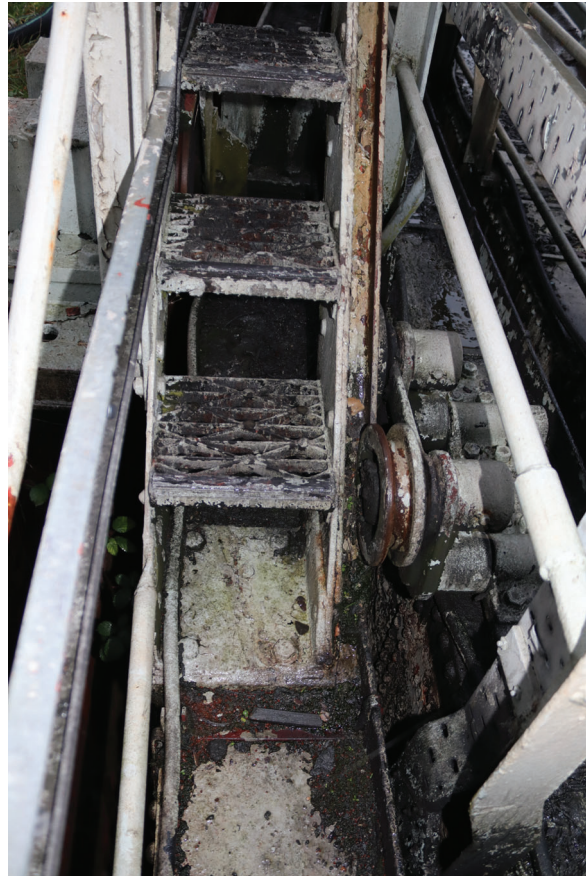
Plate 45: Gasholder No 4, detail view of the tangential rollers gripping the guide rail on the interior of the stair structure, from the SSW

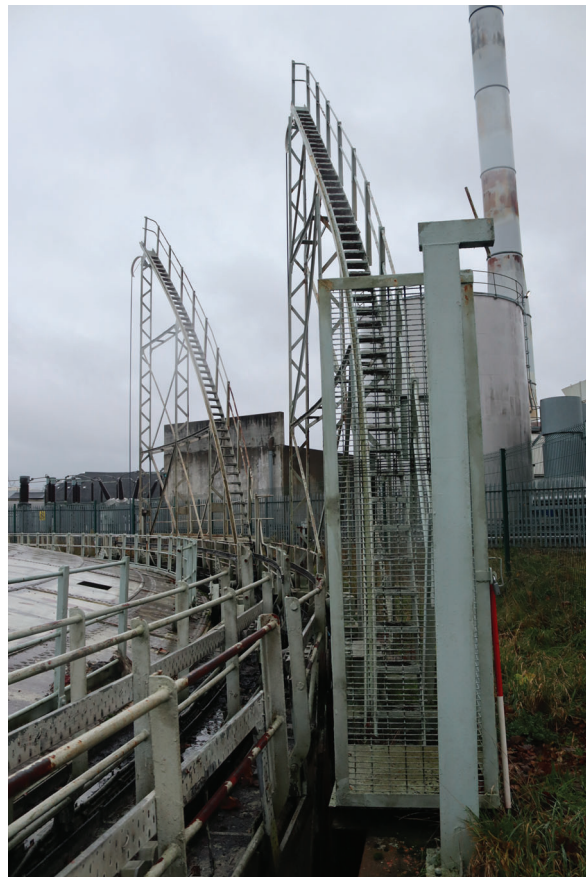
Plate 46: Gasholder No 4, detail view of the padlocked grated gate at the base of the outermost guide rail and stair structure with gap in the handrail of the bottom lift allowing access onto the bottom lift, from the NNW

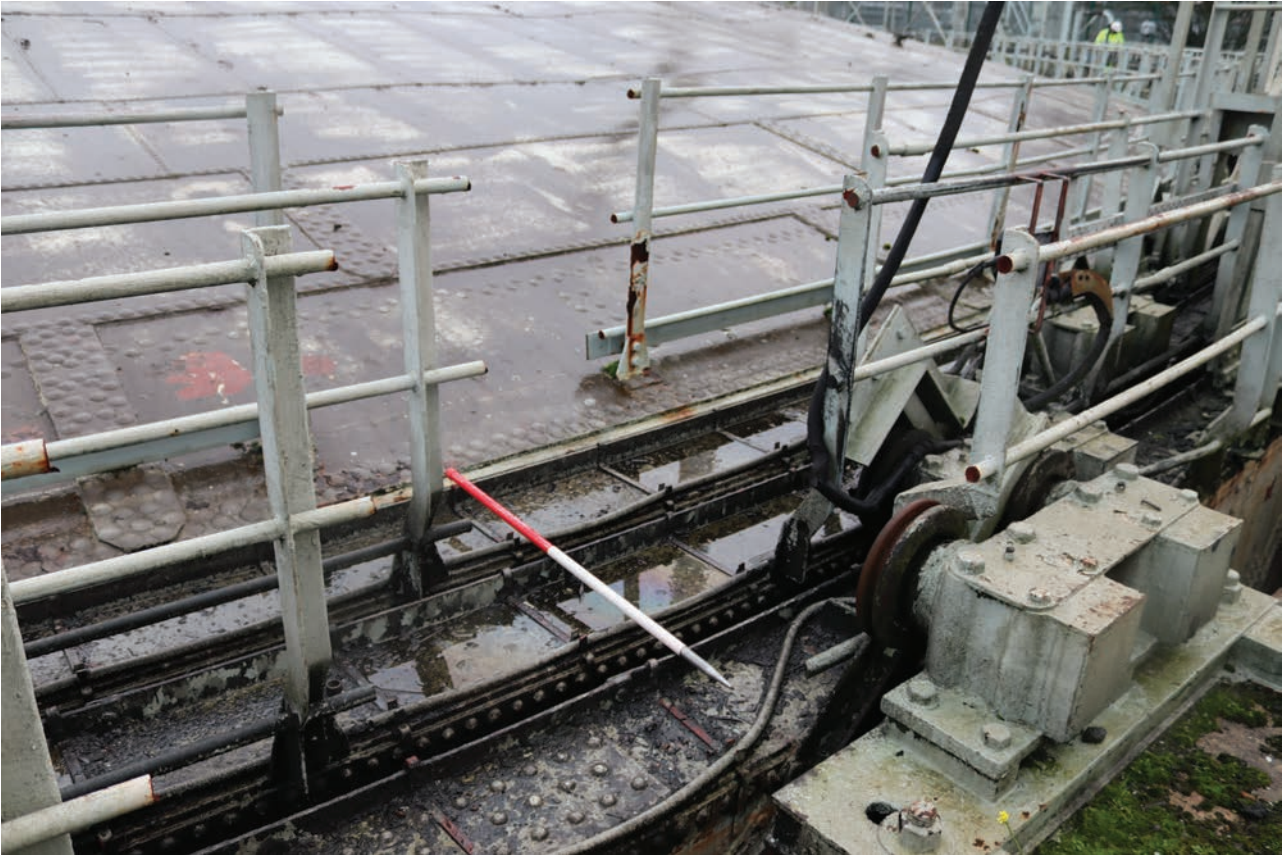
Plate 47: Gasholder No 4, detail view of handrails cut during decommissioning works for clear access onto the crown, from the north-west

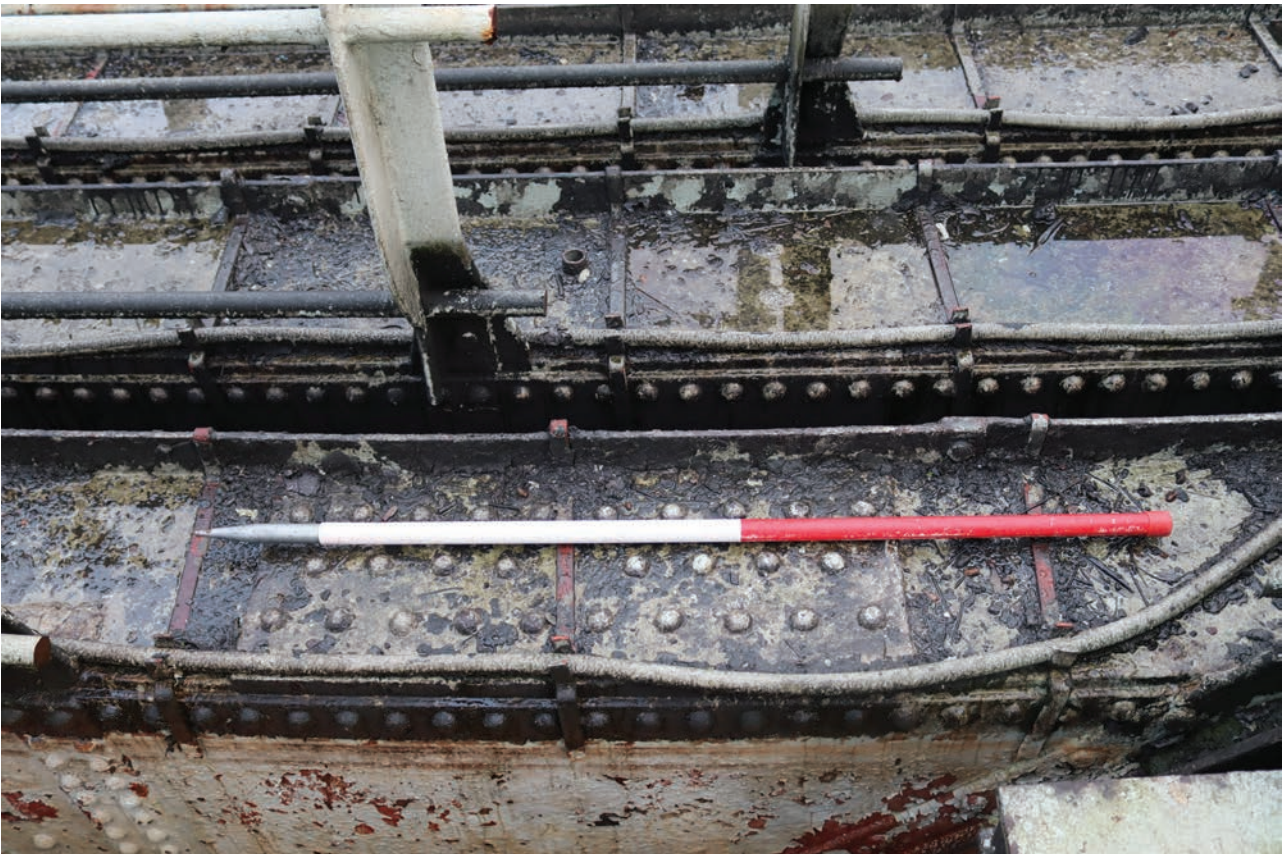
Plate 48: Gasholder No 4, detail view of the lift tops showing riveted plates, rubber tubing clipped into place and decommissioning vent points, from the south-west

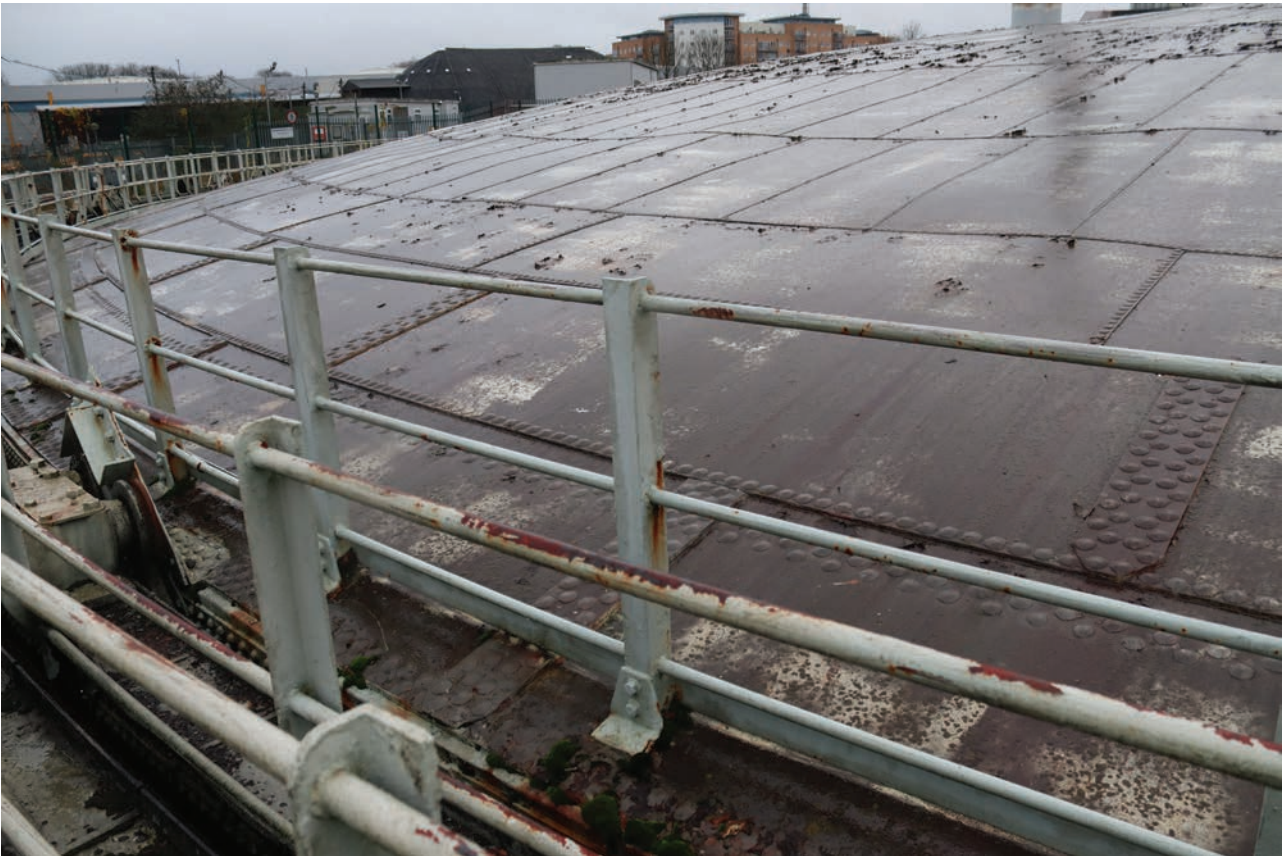
Plate 49: Gasholder No 4, detail view of the crown showing riveted, steel sheets with larger rivets and additional plates covering joints at the top curb, from the north

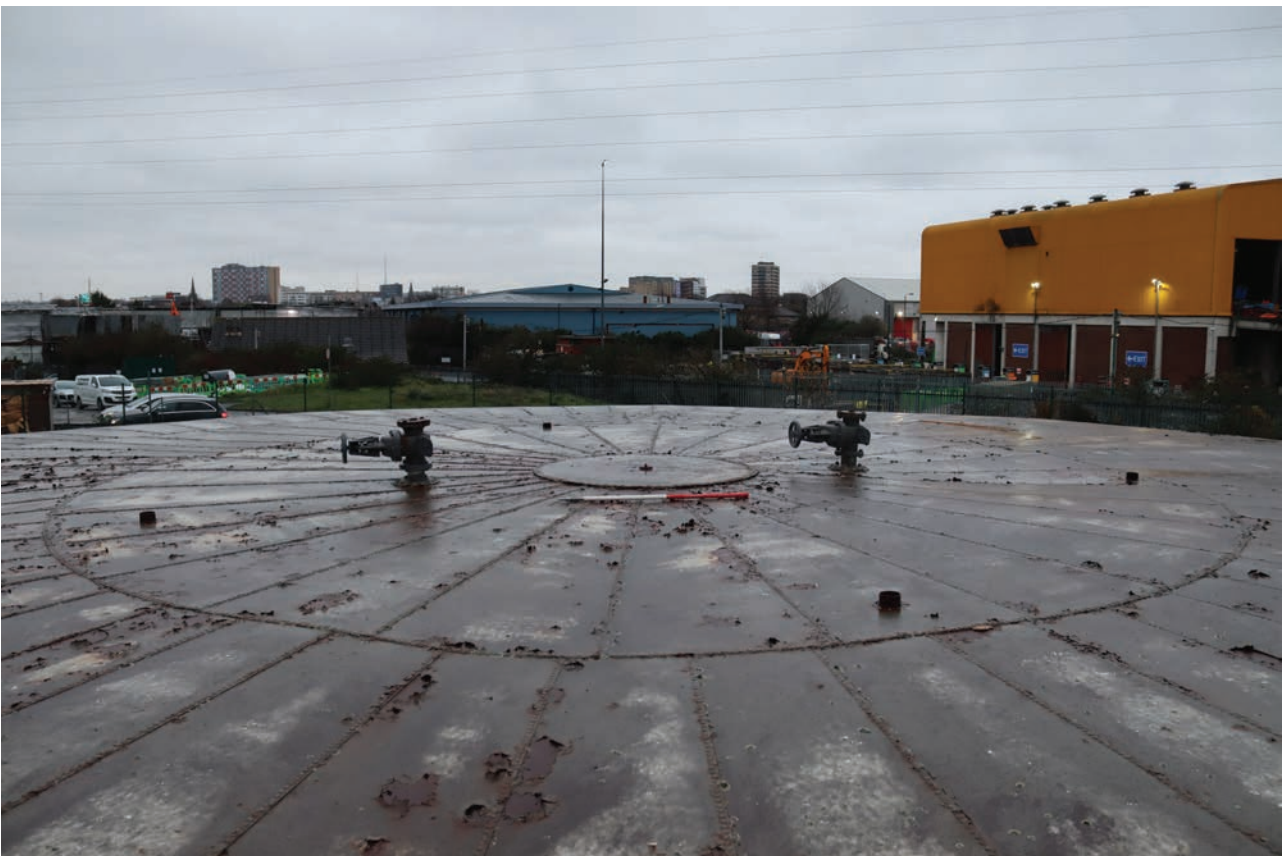
Plate 50: Gasholder No 4, general view of the top of the crown showing central circular steel sheet, crown vents and purge points, from the SSW

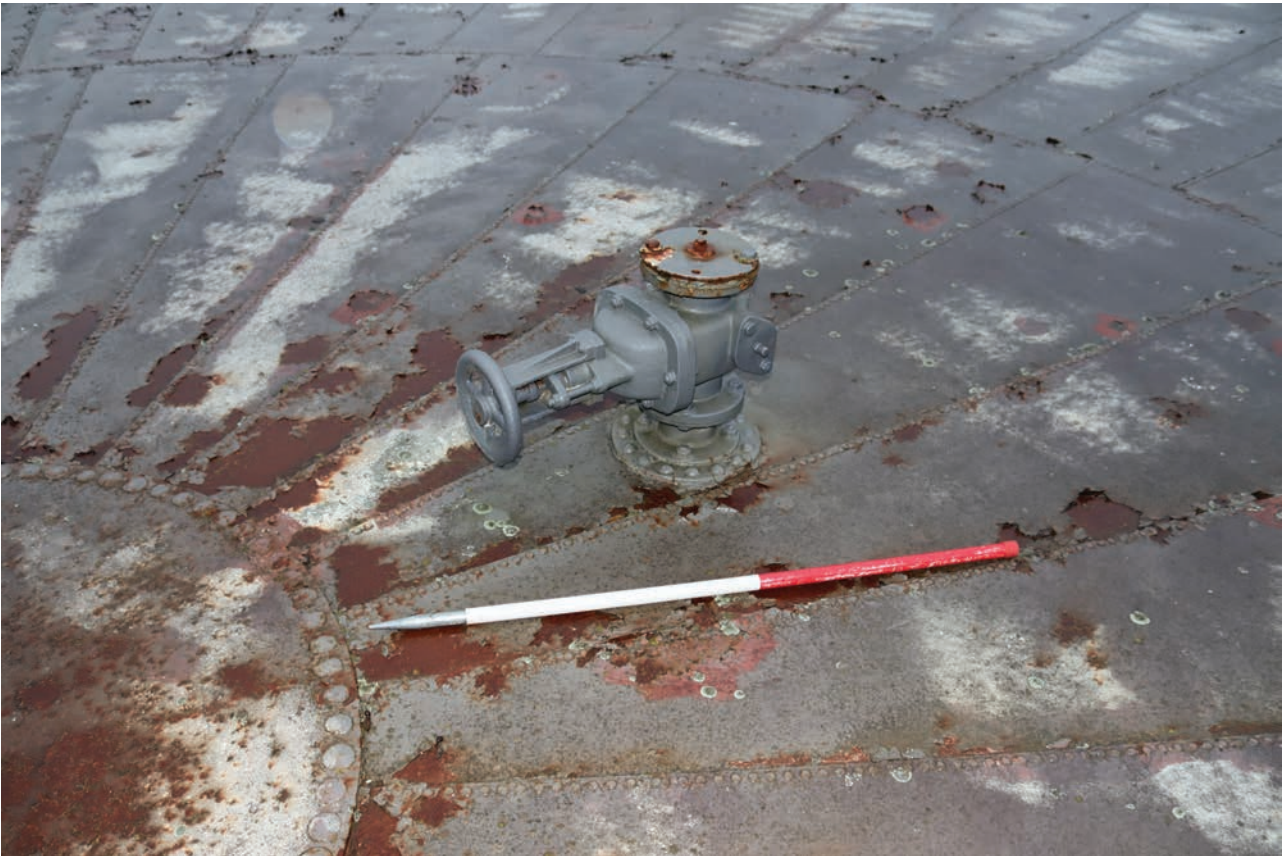
Plate 51: Gasholder No 4, detail view of the crown vent to the south-west of the centre of the crown, from the west

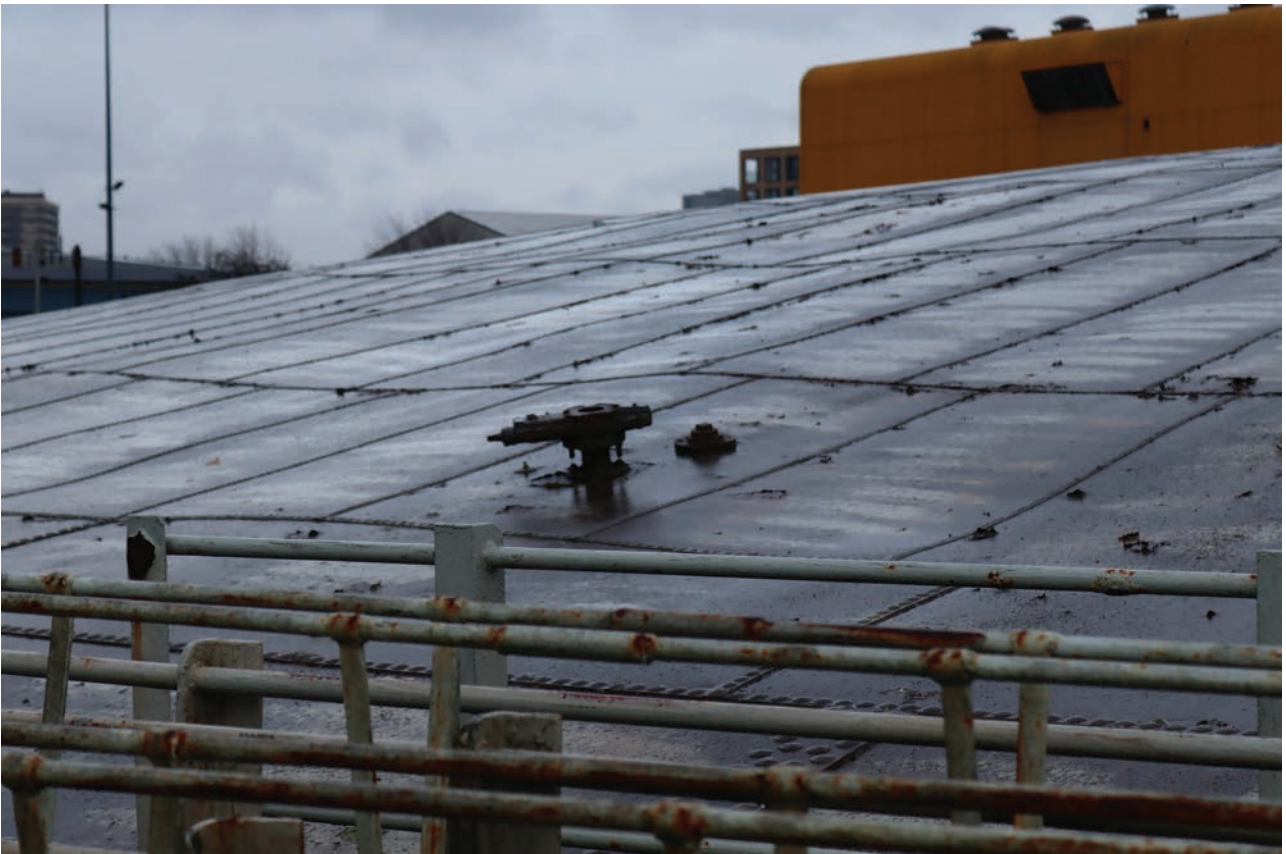
Plate 52: Gasholder No 4, detail view of the crown vent on the north-west side of the holder, from the WSW

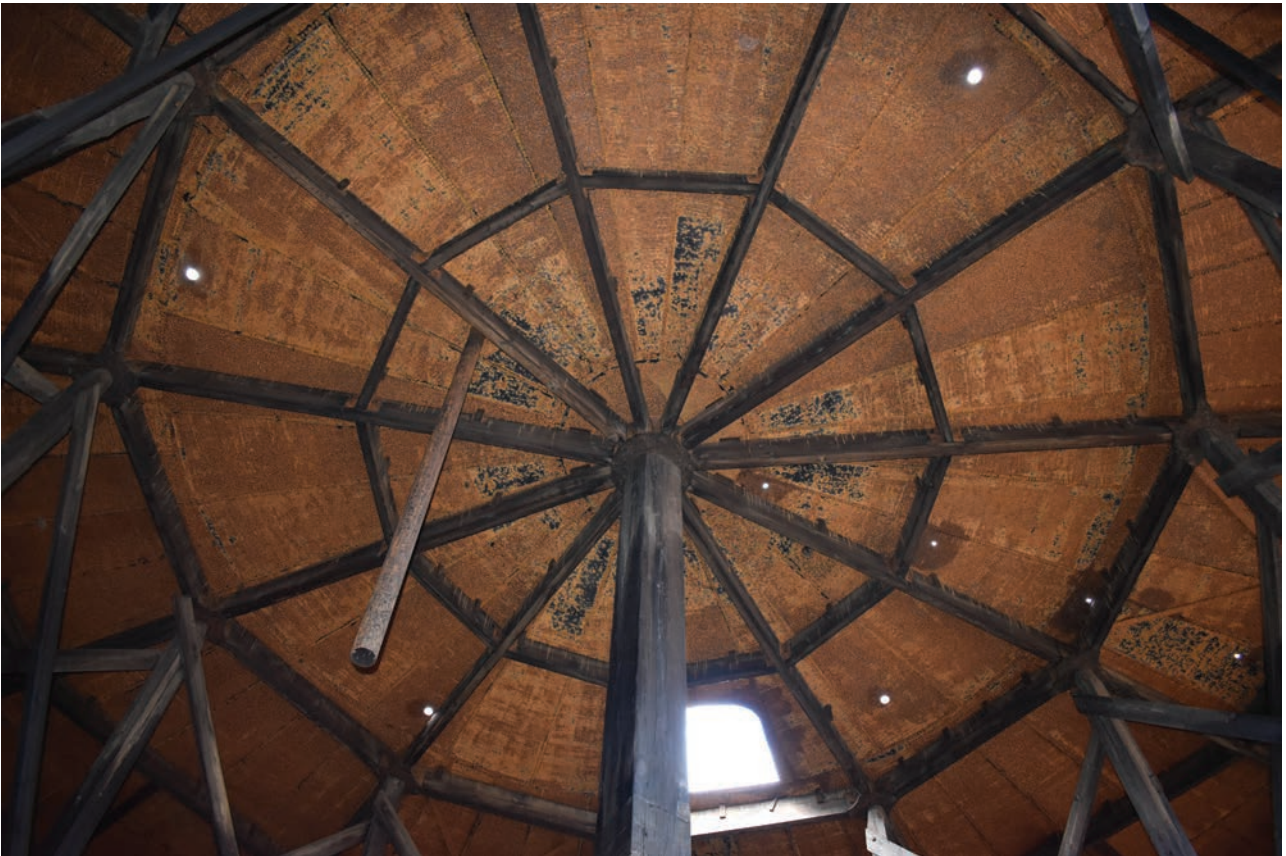
Plate 53: Gasholder No 4, detail view of the pipe beneath the crown vent just south-east of the centre of the crown, from the NNE

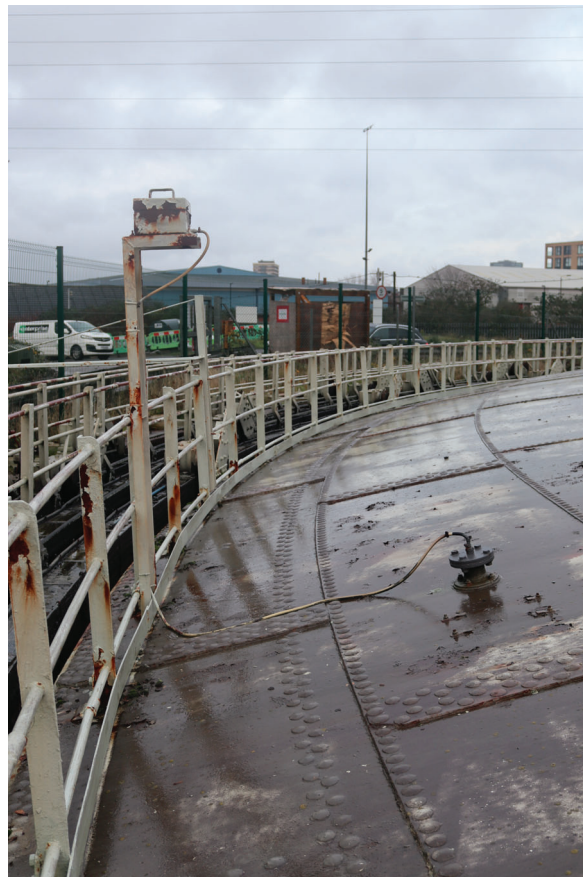
Plate 54: Gasholder No 4, detail view of the glycol pot on the north-west side of the holder and the rubber hose entering the bell, from the south-west
