Gasholders Nos 4 & 5, Factory Lane, Croydon, London: Historic Building Recording Final Report

*AOC Project No: 23686_V
3rd August 2021*

On Behalf of:	SGN 2 Woodstock Road Yarnton OX5 1NY
National Grid Reference (NGR):	Gasholder No 4: TQ 31212 65907 Gasholder No 5: TQ 31169 65975
AOC Project No:	23686_V
OASIS No:	411878
Prepared by:	Diana Sproat Gemma Hudson
Illustration by:	Gemma Hudson Jamie Humble Sam O'Leary
Date of Fieldwork:	16th – 18th December 2020 (Phase I) 5th May & 7th July 2021 (Phase II)
Date of Report:	3rd August 2021

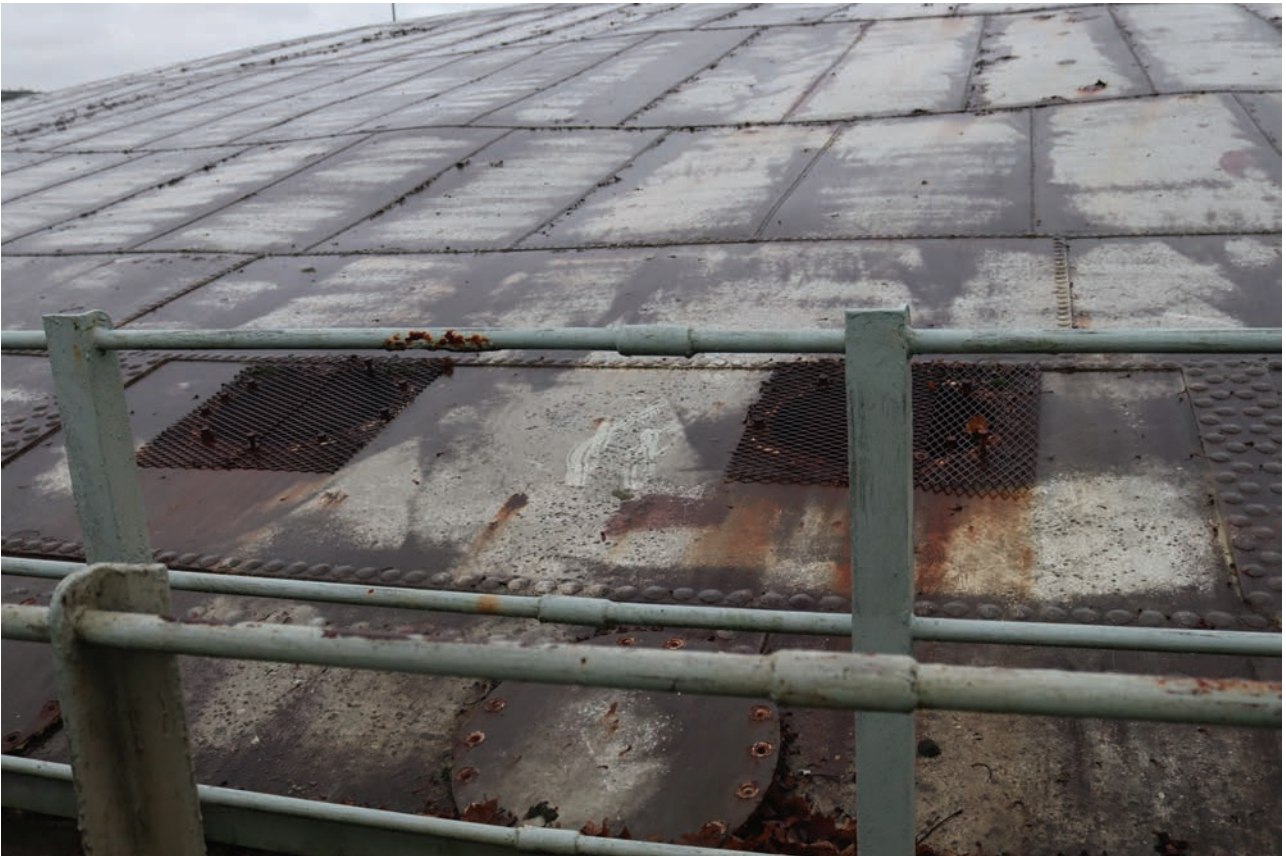
Plate 55: Gasholder No 4, detail view of the two removed cotter plates presumed to be inspection points for the gas inlet and outlet pipes, from the WSW

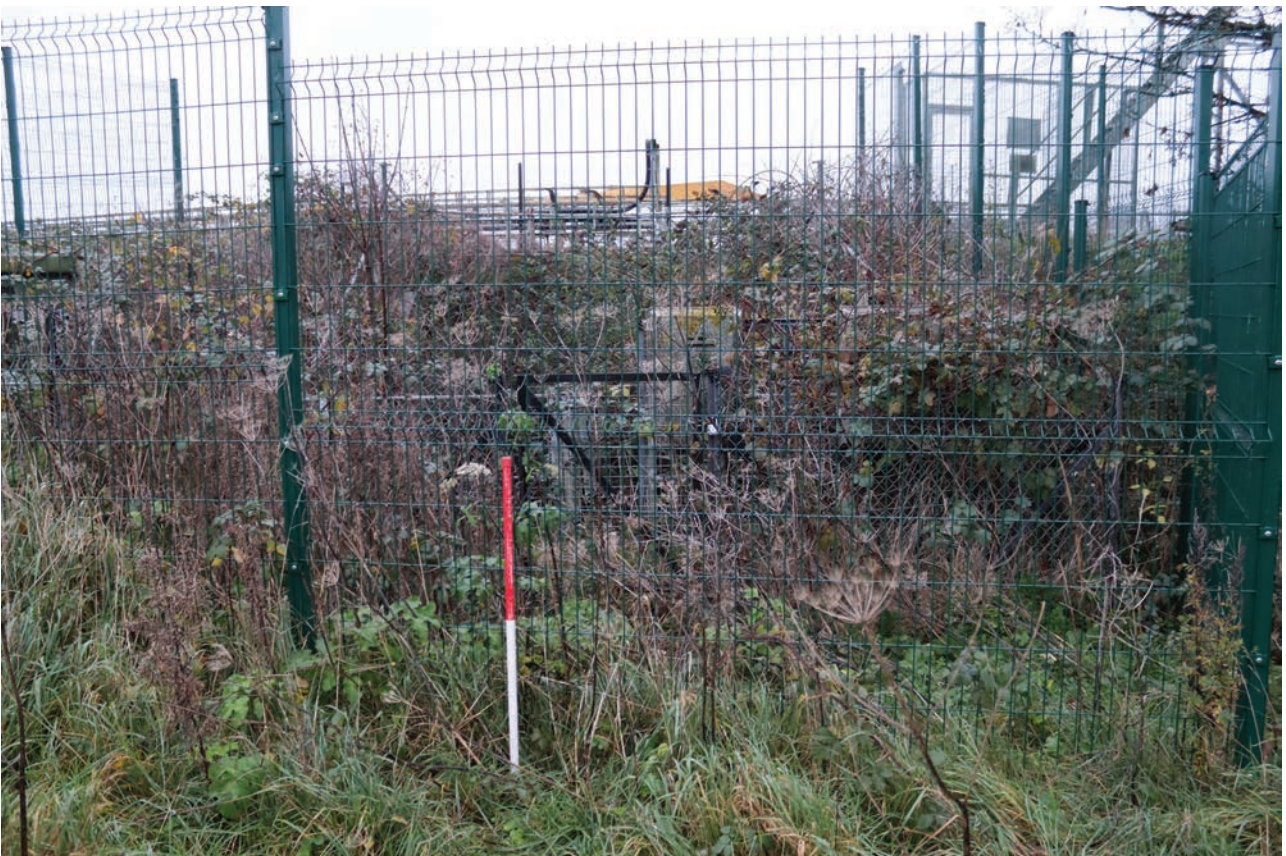
Plate 56: Gasholder No 4, general view of overgrown gas inlet and outlet fenced area, from the west

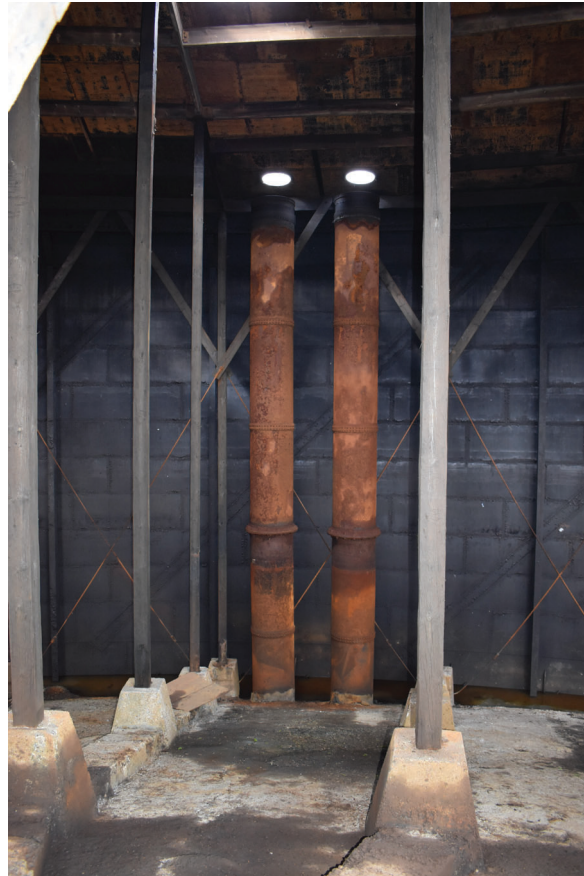
Plate 57: Gasholder No 4, detail view of the gas inlet and outlet pipes, from the ENE

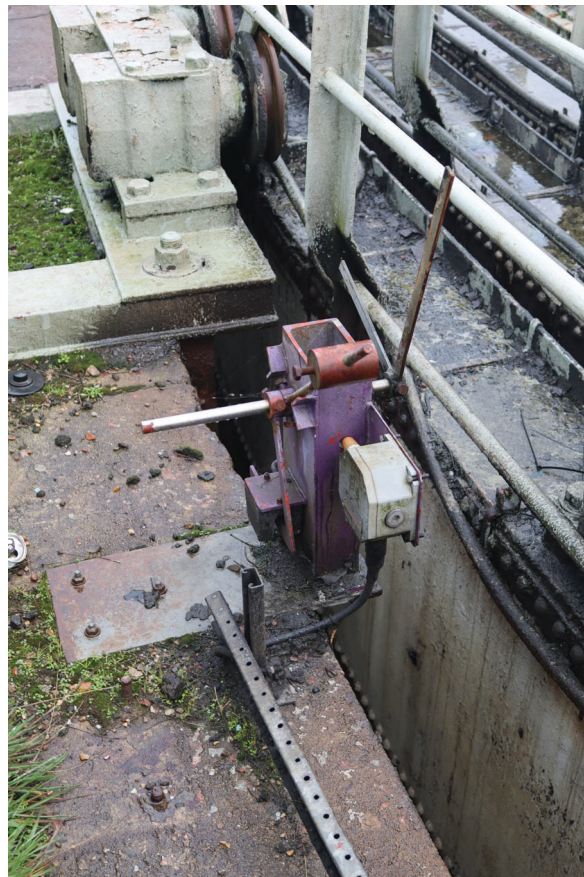
Plate 58: Gasholder No 4, detail view of low knock-off switch on the north-west side of the holder, from the west

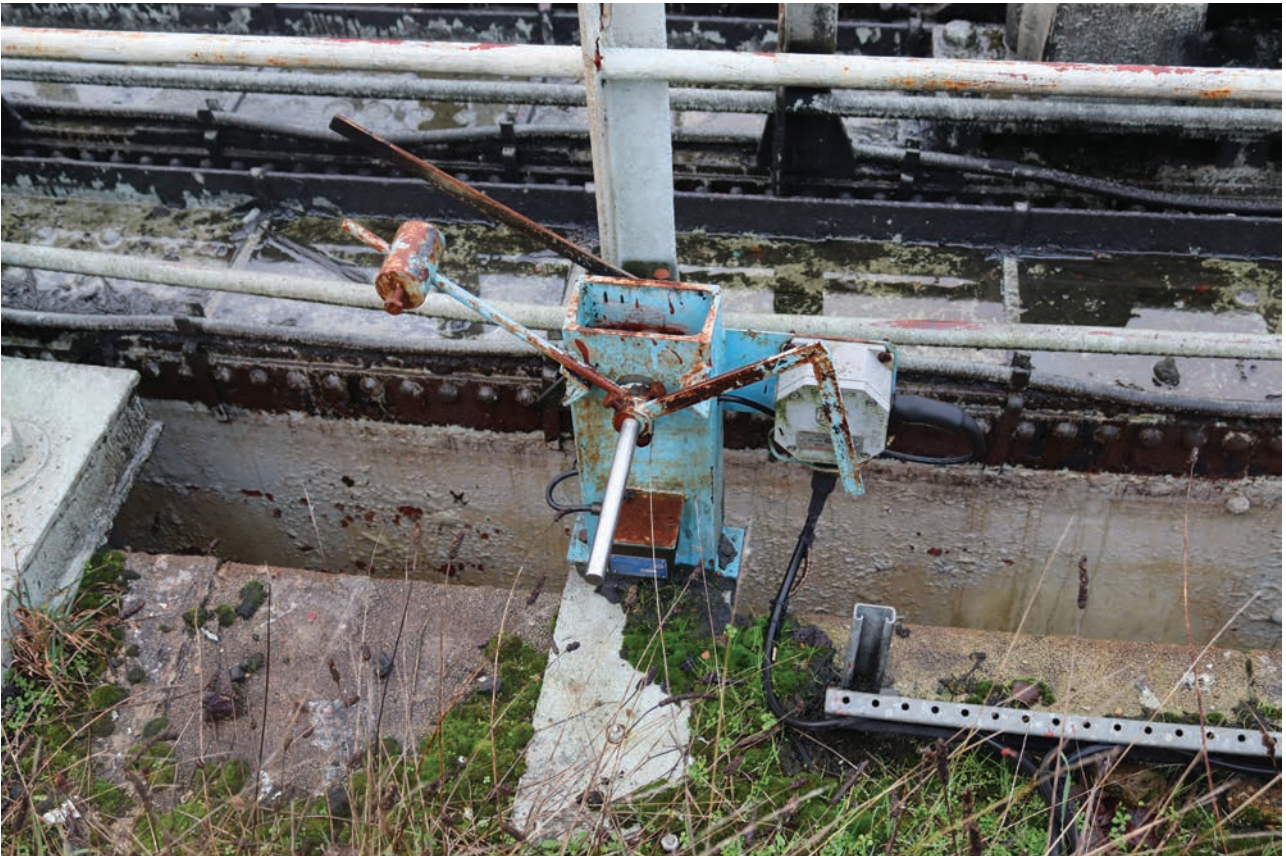
Plate 59: Gasholder No 4, detail view of high knock-off switch located on the south-east side of the holder, from the SSE

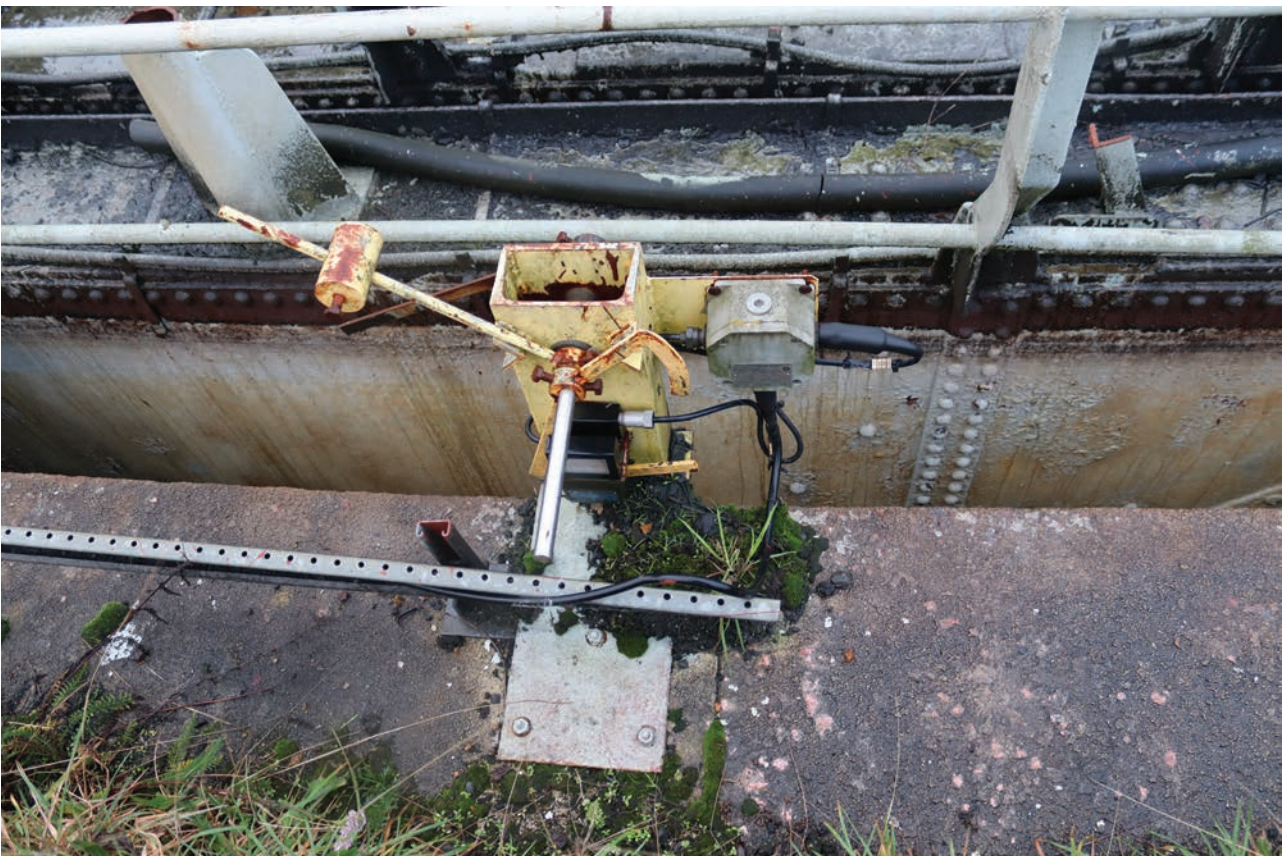
Plate 60: Gasholder No 4, detail view of sunstock knock-off switch located on the south-east side of the holder, from the SSE

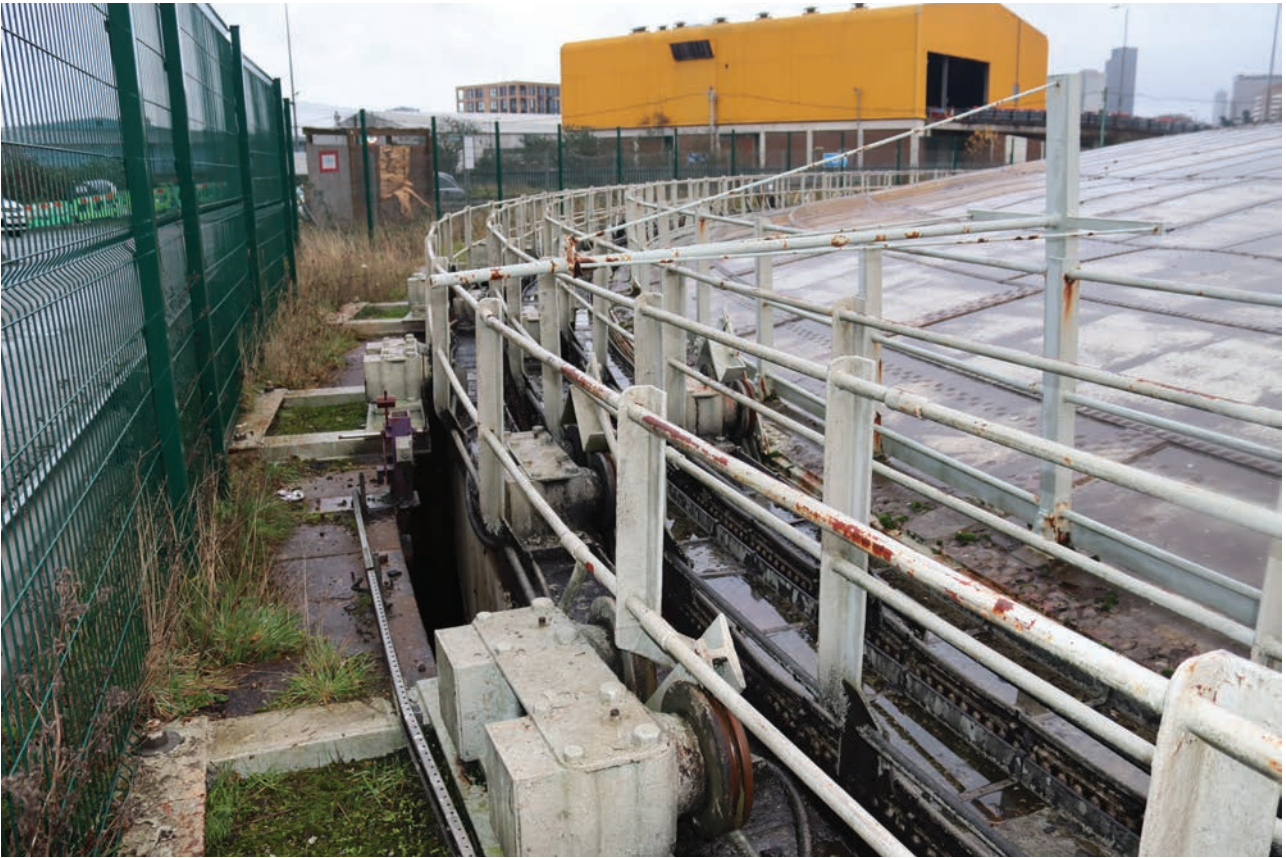
Plate 61: Gasholder No 4, detail view of striker arm with no associated knock-off switch located on the north-west side of the holder, from the west

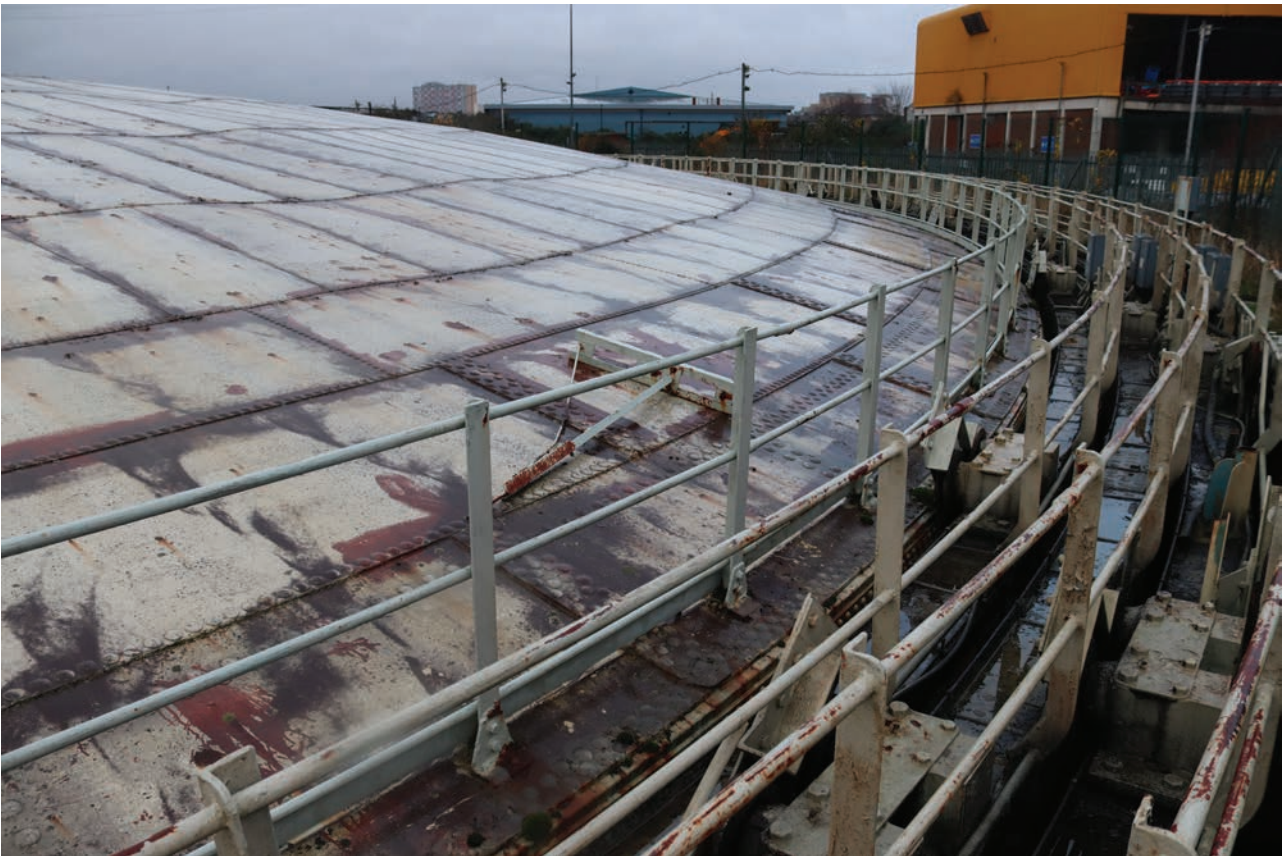
Plate 62: Gasholder No 4, detail view of displaced striker arm on the south-east side of the holder, from the SW

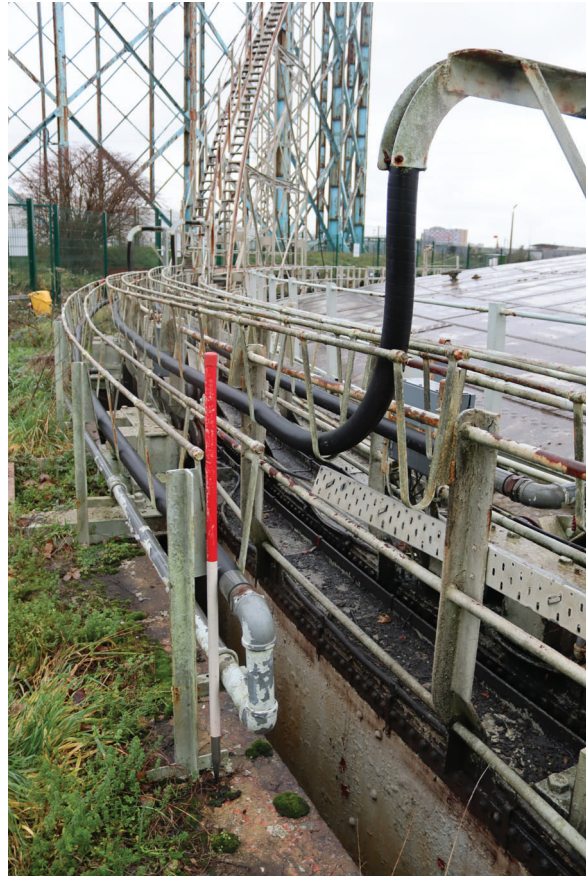
Plate 63: Gasholder No 4, detail view of rubber hose supported by cage and swan neck fixtures, from the SSW

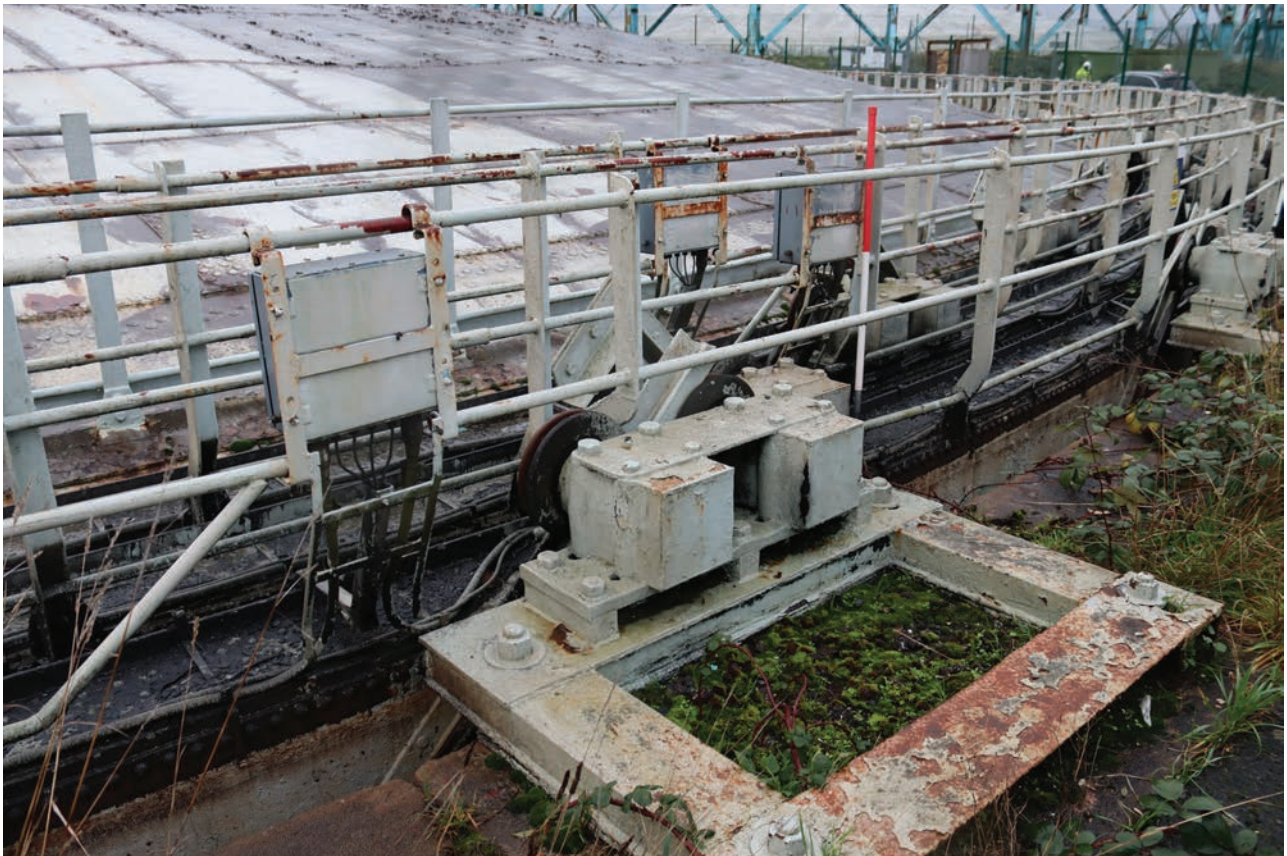
Plate 64: Gasholder No 4, detail view of electrical boxes attached to the handrails, from the ESE

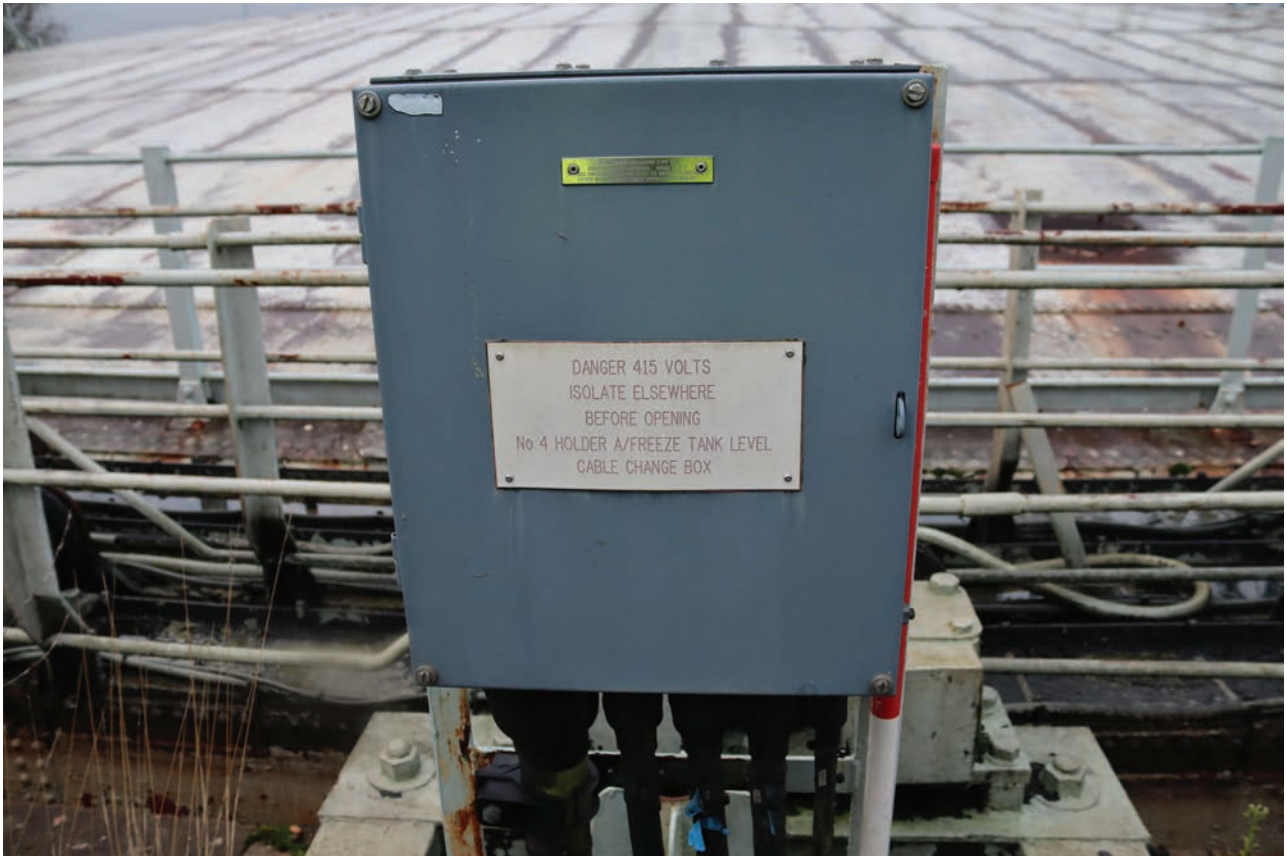
Plate 65: Gasholder No 4, detail view of the anti-freeze tank level cable change box, from the south-east

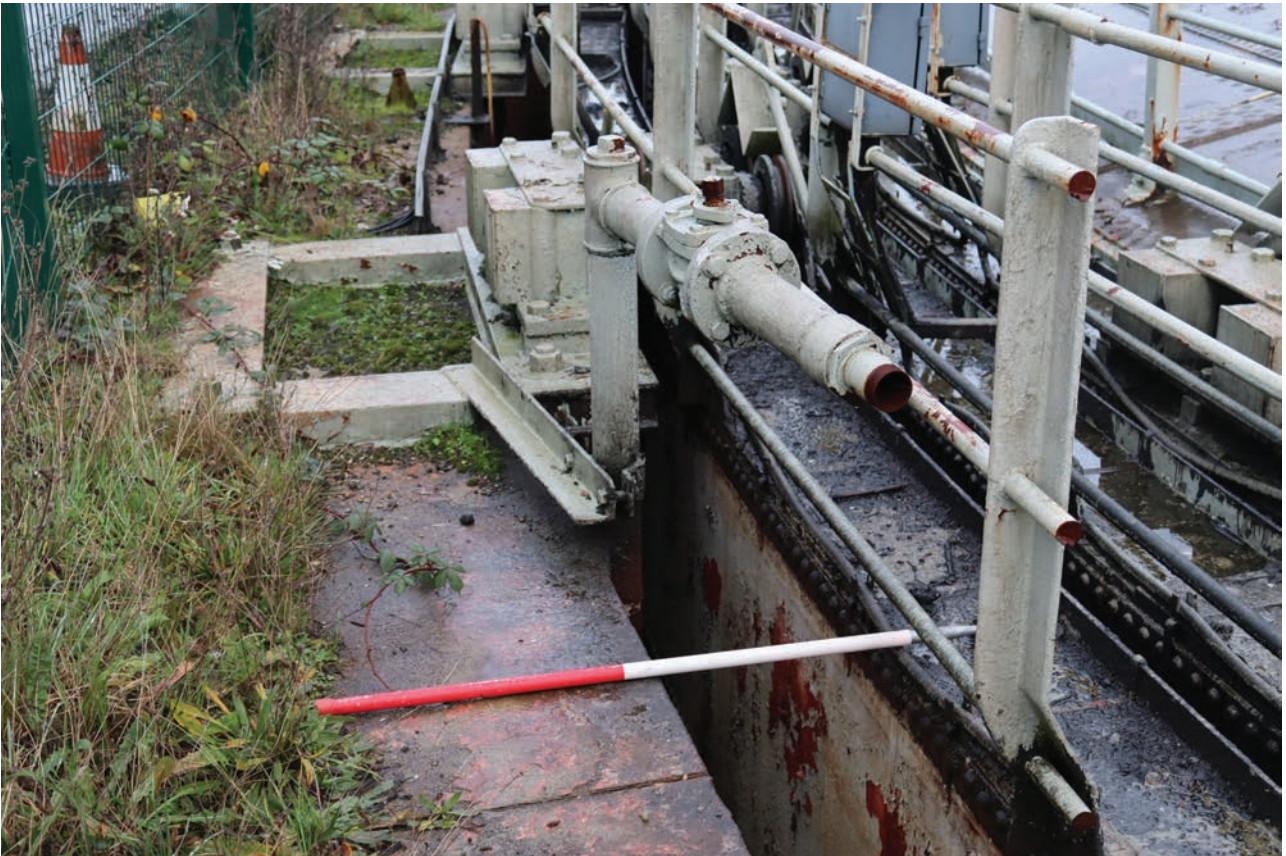
Plate 67: Gasholder No 4, detail view of oil maintenance pipe, from the WSW

Pipework used to maintain the oil-film level in the tank was situated on the north-west side of the holder (Plate 67). Additional pipework was present on the west side of the holder that may have been related to the gas inlet and outlet operations (Plate 68).

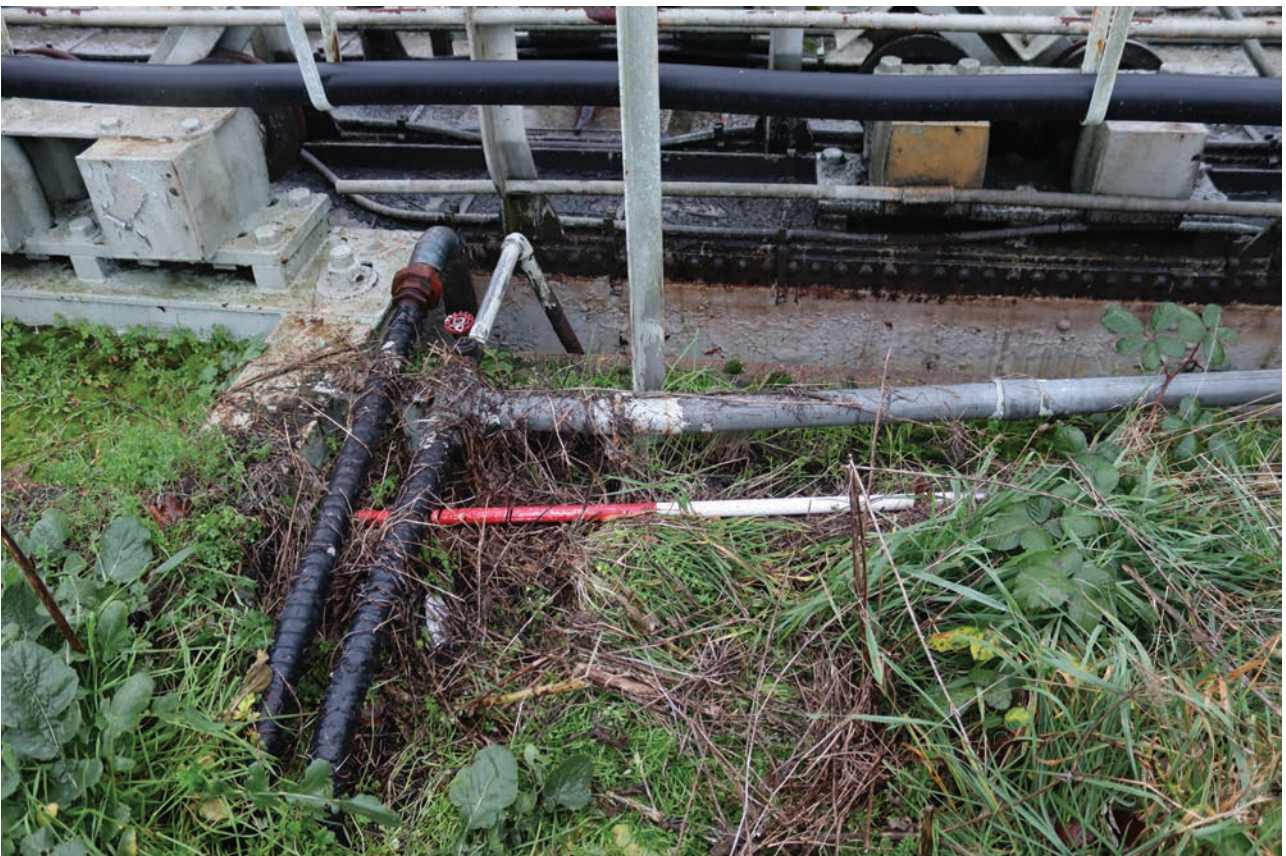
Plate 68: Gasholder No 4, detail view of pipework situated on the west side of the holder, from the WSW

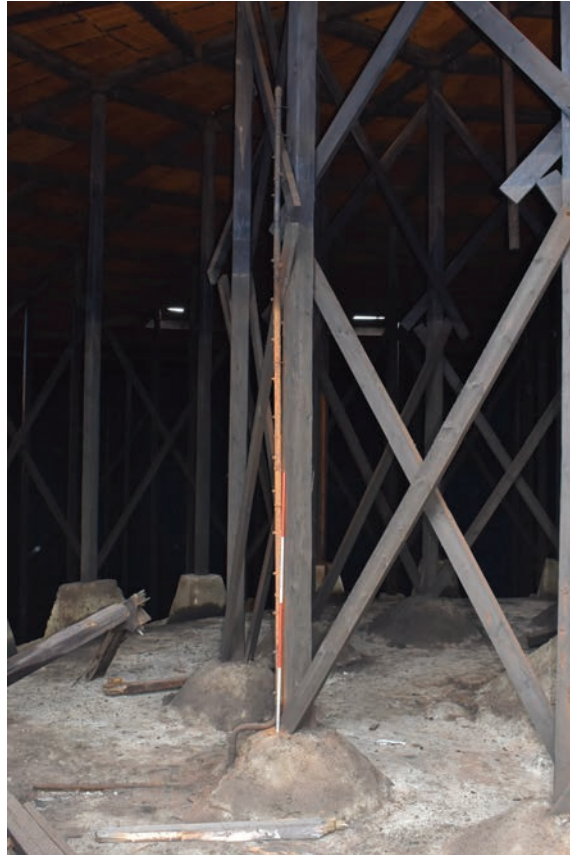
Plate 69: Gasholder No 4, detail view of narrow pipe attached to a vertical post of the crown support frame, from the north-west

Within the tank were four narrow pipes attached to vertical posts of the crown rest frame which were noted as part of the Phase II works (Plate 69; Figure 34). Their functions are unidentified. On the WSW

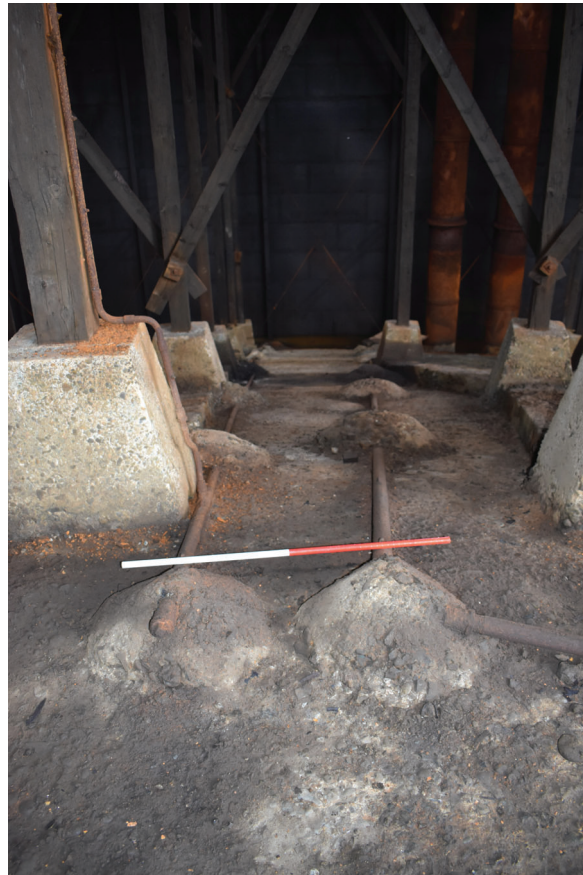
Plate 70: Gasholder No 4, detail view of two narrow pipes secured to the dumpling via concrete mounds, from the ENE

side of the structure two of the pipes were located aligned with the slope of the dumping and were secured in place by uneven concrete mounds (Plate 70).

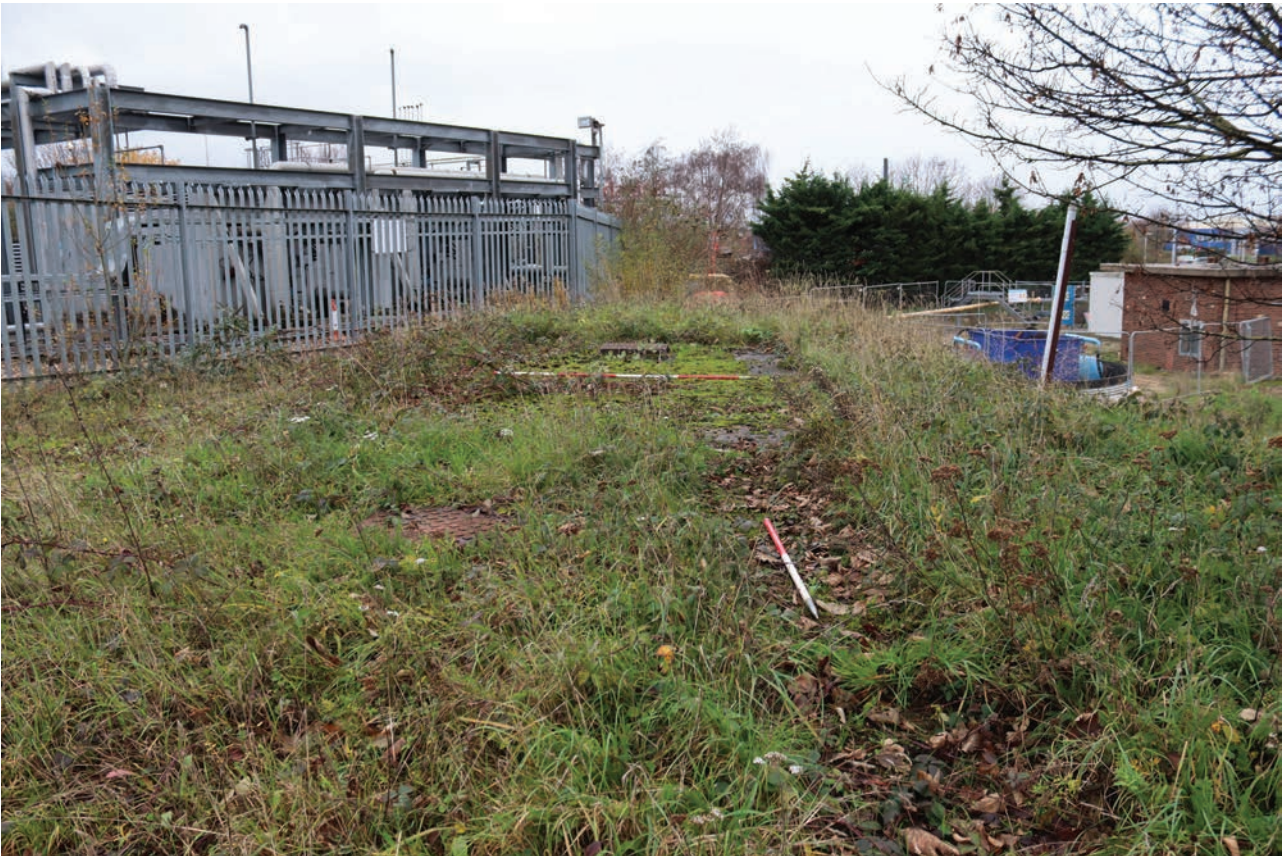
Plate 71: Gasholder No 4, detail view of interceptor tank, from the north-east

To the south-west of the holder was a chambered interceptor tank (Plate 71). On the south-west side of the tank was an overflow pipe that discharged water that joined the interceptor tank via a partially-submerged pipe (Plate 72). To the east of the interceptor tank was a water monitoring borehole, possibly to check the interceptor tank was not leaking into the surrounding earth (Plate 73).

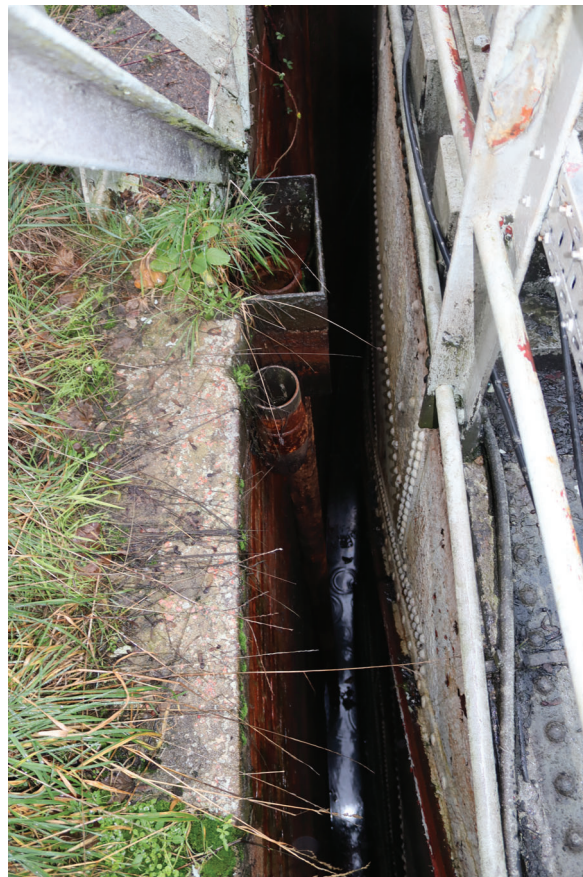
Plate 72: Gasholder No 4, detail view of overflow pipe discharge point, from the SSE

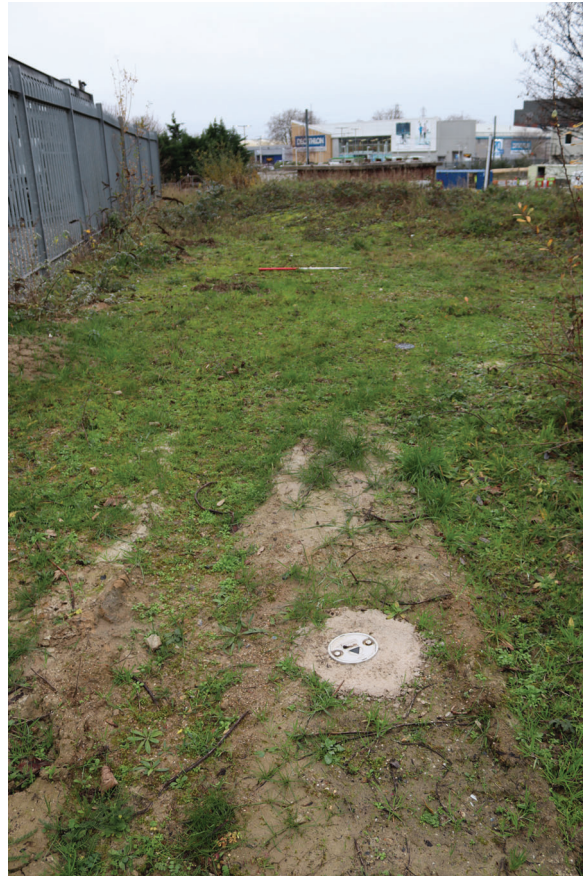
Plate 73: Gasholder No 4, detail view of water monitoring borehole with interceptor tank in the background, from the east

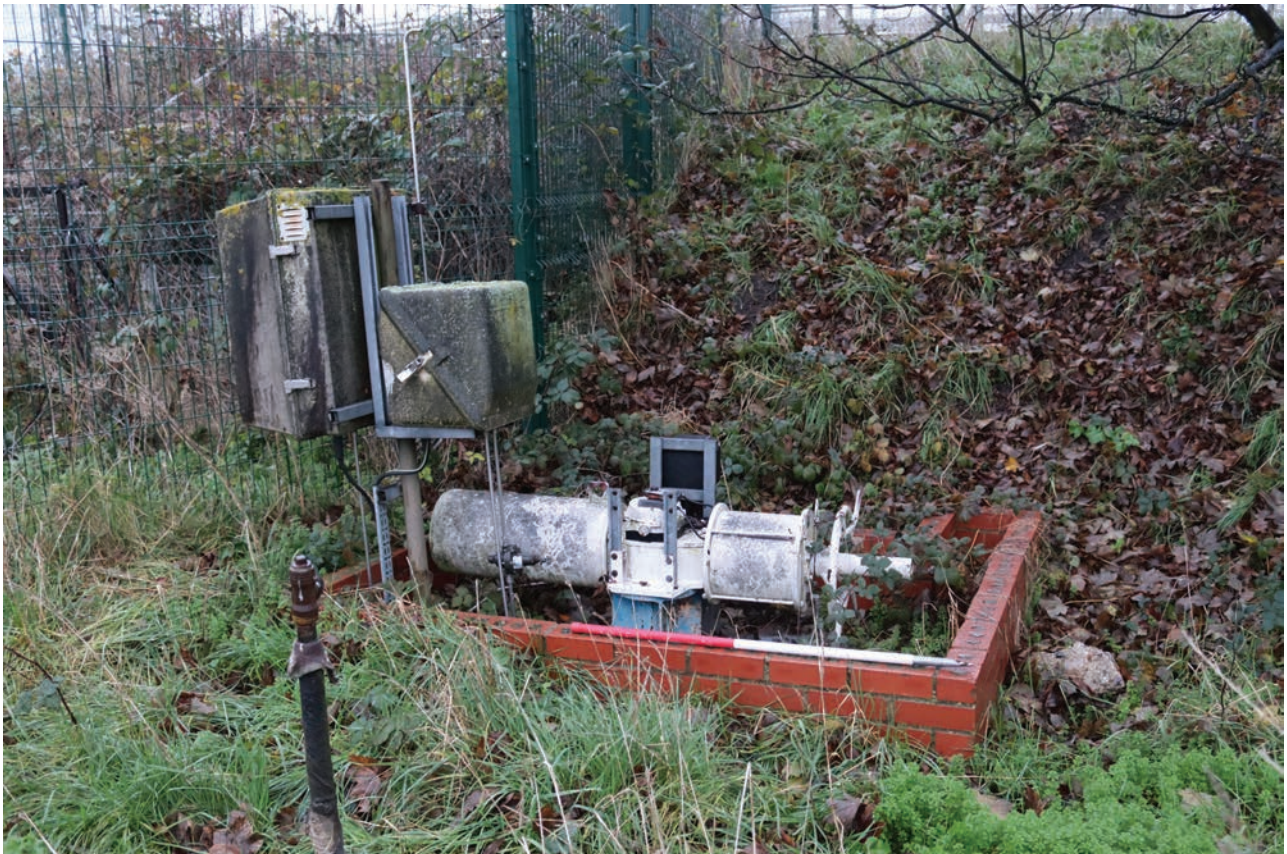
Plate 74: Gasholder No 4, detail view of unidentified electrical machinery within a brick setting, from the west

To the south and west of the gas inlet and outlet area were two pieces of unidentified electrical machinery (Plate 74).

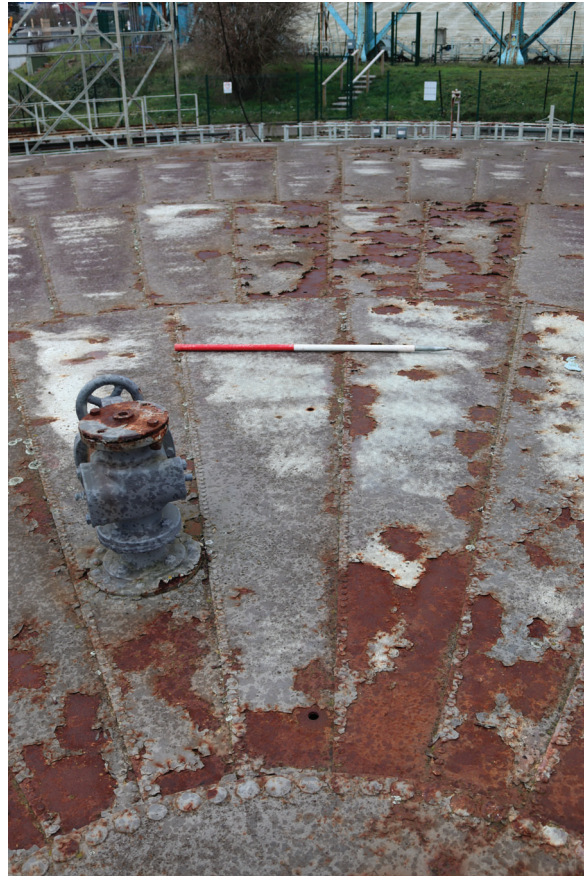
7.6.1 Gasholder No 4 has been out of operation for some years and the crown is suffering badly from rust (Plate 75).

Plate 75: Gasholder No 4, detail view of poor condition rusting crown, from the south-east

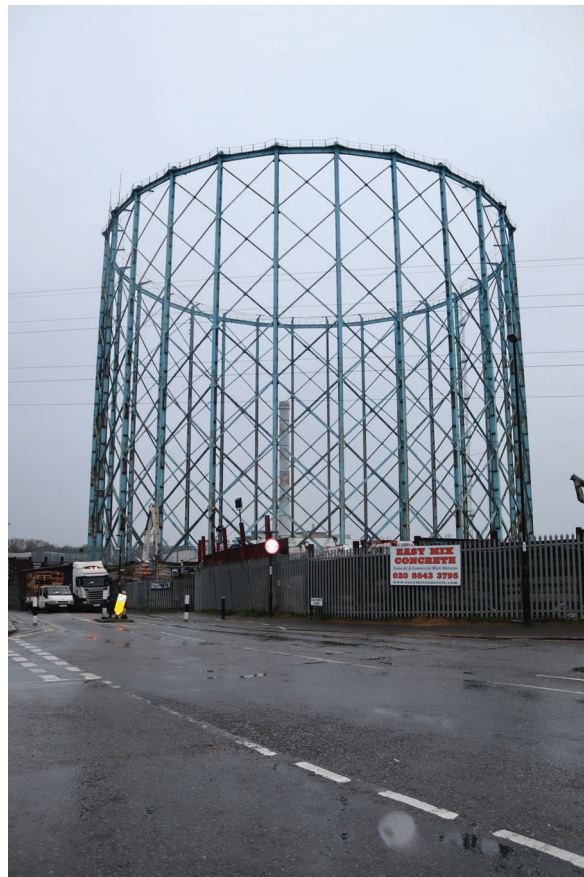
Plate 76: Gasholder No 5, general view of the north side, from the north

8.1.1 Gasholder No 5 is a four-lift, frame-guided variant of the Type 42 cylindrical shell designed by Livesey and constructed in 1921 (Plate 76). It is situated in the centre of the north side of the site (Figure 31).

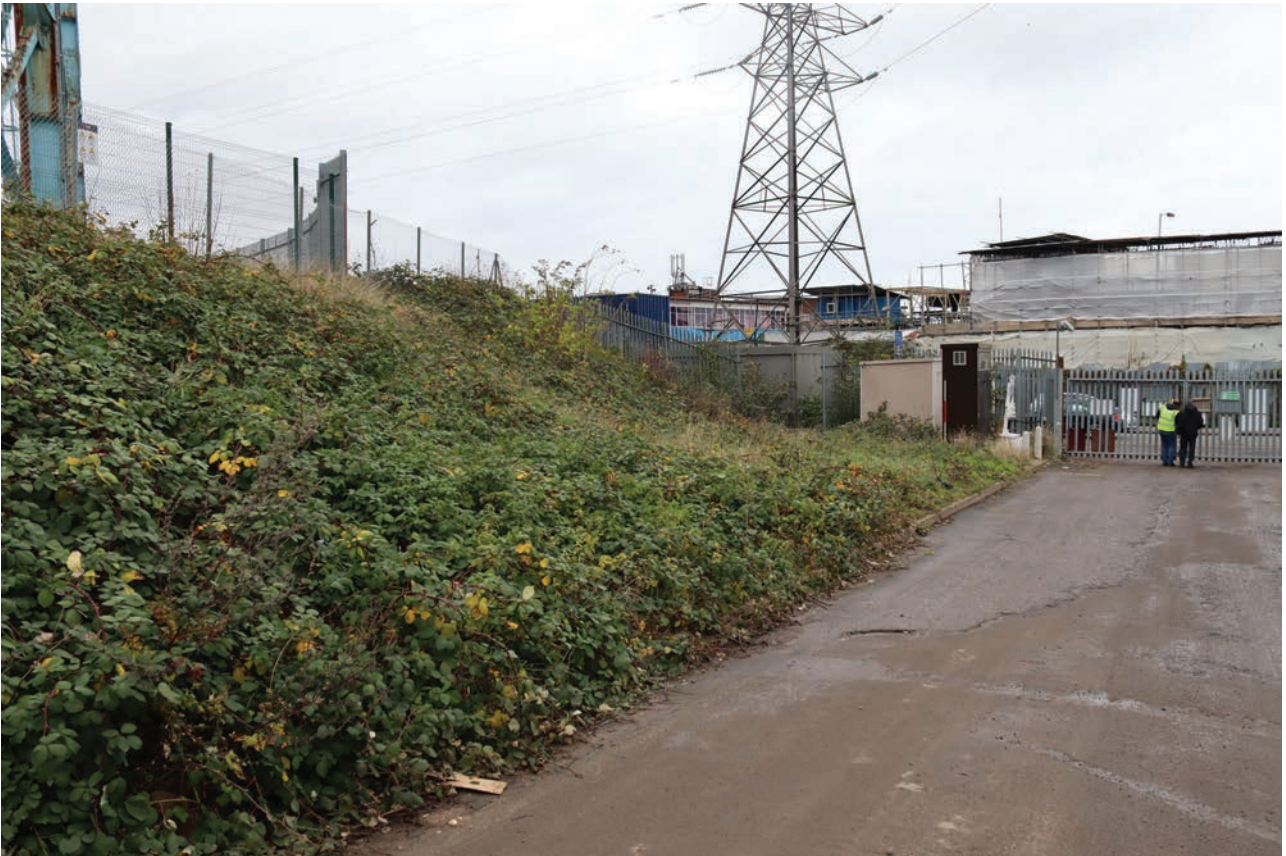
Plate 77: Gasholder No 5, general view of ground sloping up around the east side of the holder, from the SSE

The ground around Gasholder No 5 is built up into a mound which covers the circular, red brick-built below-ground tank (Plates 77 & 78). The tank has a larger, blue brick capping and a hardcore covering the ground surrounding the brickwork, which is damaged in places (Plate 79). The internal diameter of the tank is 69m (Figure 37). During the Phase II survey the depth was measured at 13.4m although there was some residual water in the base of the tank meaning it may be deeper (Figure 41).

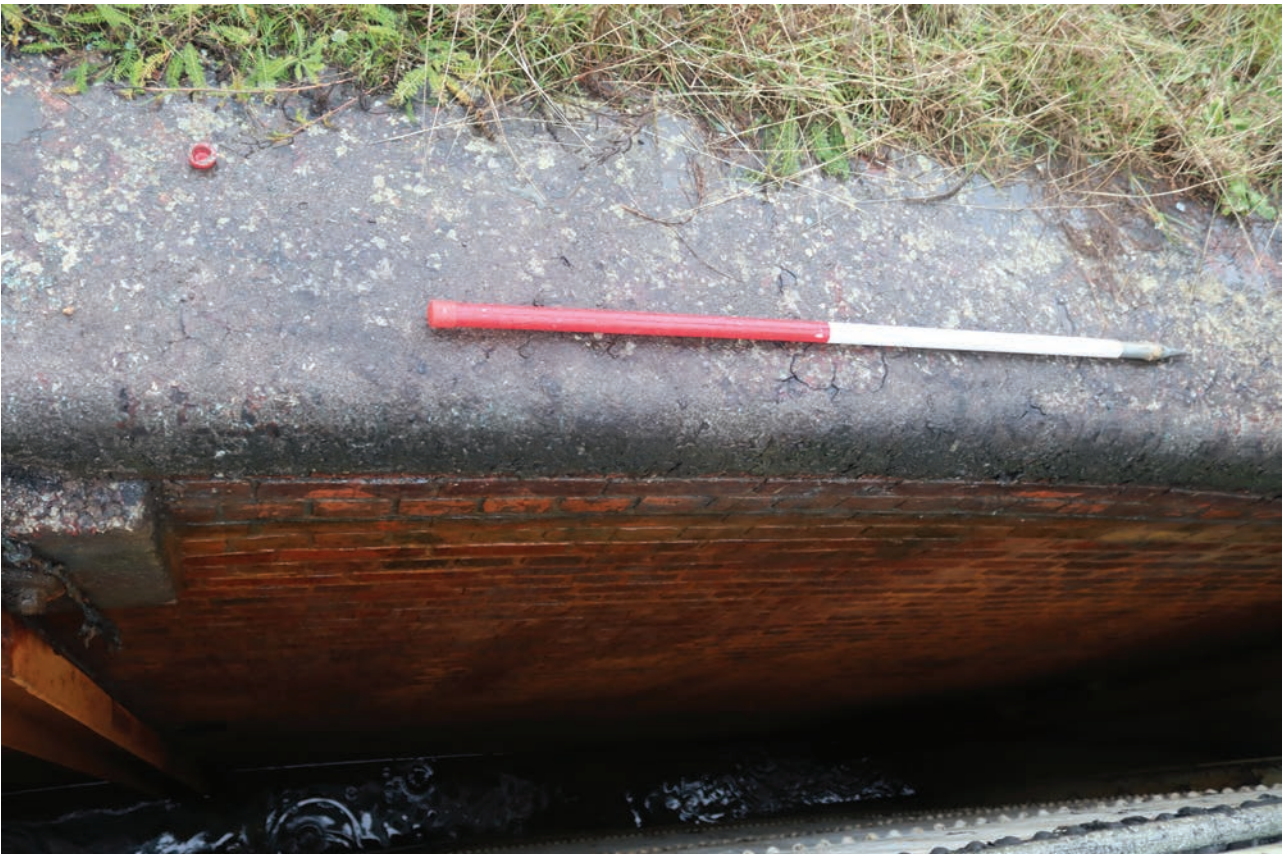
Plate 78: Gasholder No 5, detail view of the red brick tank wall, from the south

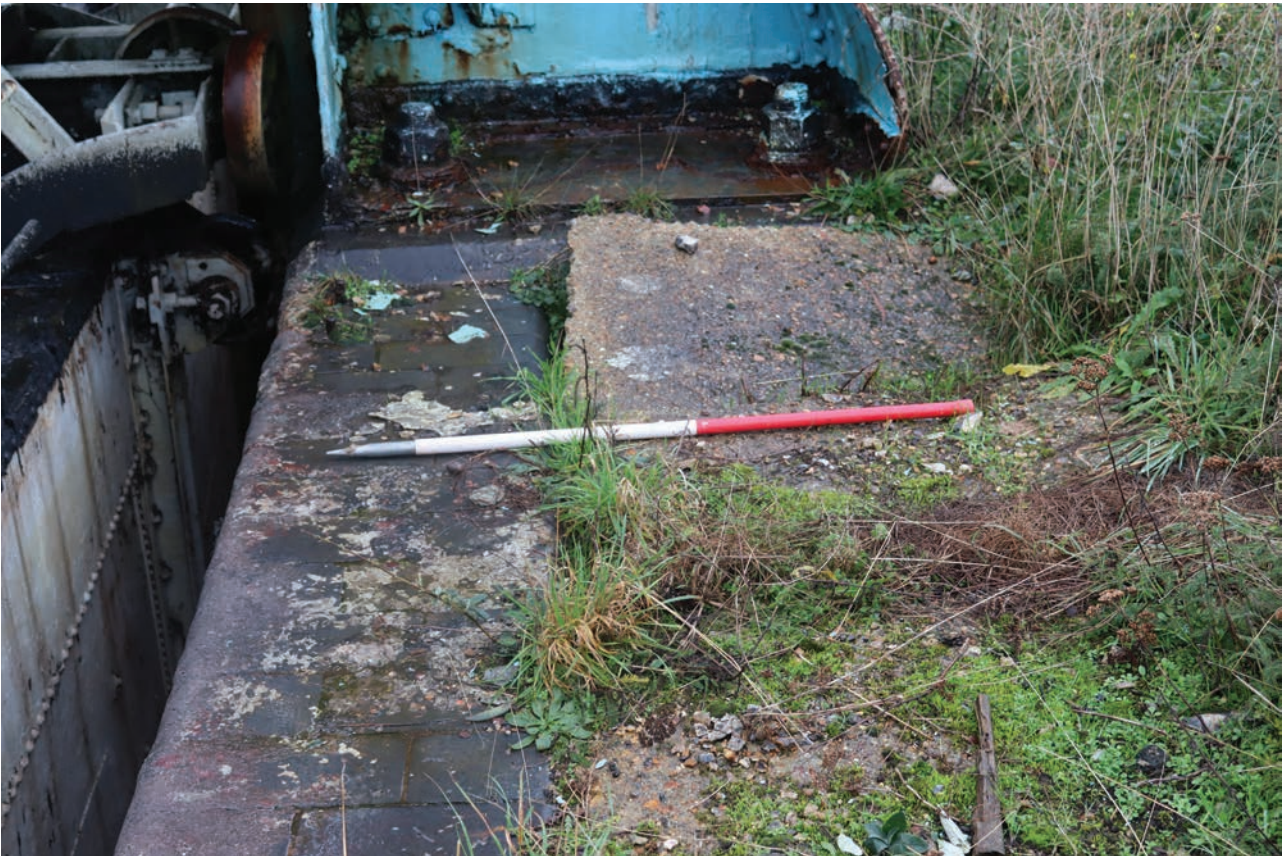
Plate 79: Gasholder No 5, detail view of blue brick tank wall cap and surrounding damaged hardcore, from the SSE

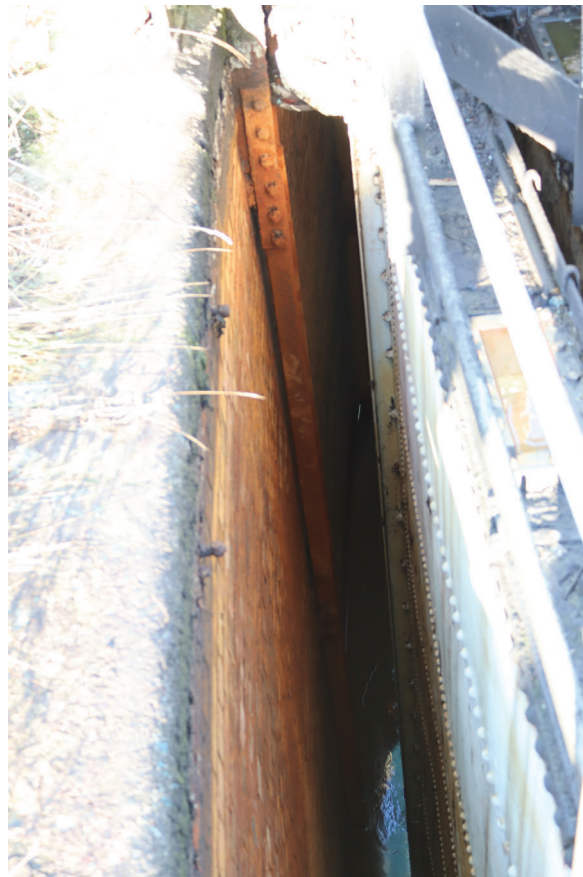
Plate 80: Gasholder No 5, detail view of guide rail set within the tank wall beneath standard 8, from the south

Metal fixtures are built within the tank wall to which guide rails are bolted beneath the standards and in the centre of each bay between neighbouring standards (Plates 80 & 81).
