Gasholders Nos 4 & 5, Factory Lane, Croydon, London: Historic Building Recording Final Report

*AOC Project No: 23686_V
3rd August 2021*

On Behalf of:	SGN 2 Woodstock Road Yarnton OX5 1NY
National Grid Reference (NGR):	Gasholder No 4: TQ 31212 65907 Gasholder No 5: TQ 31169 65975
AOC Project No:	23686_V
OASIS No:	411878
Prepared by:	Diana Sproat Gemma Hudson
Illustration by:	Gemma Hudson Jamie Humble Sam O'Leary
Date of Fieldwork:	16th – 18th December 2020 (Phase I) 5th May & 7th July 2021 (Phase II)
Date of Report:	3rd August 2021

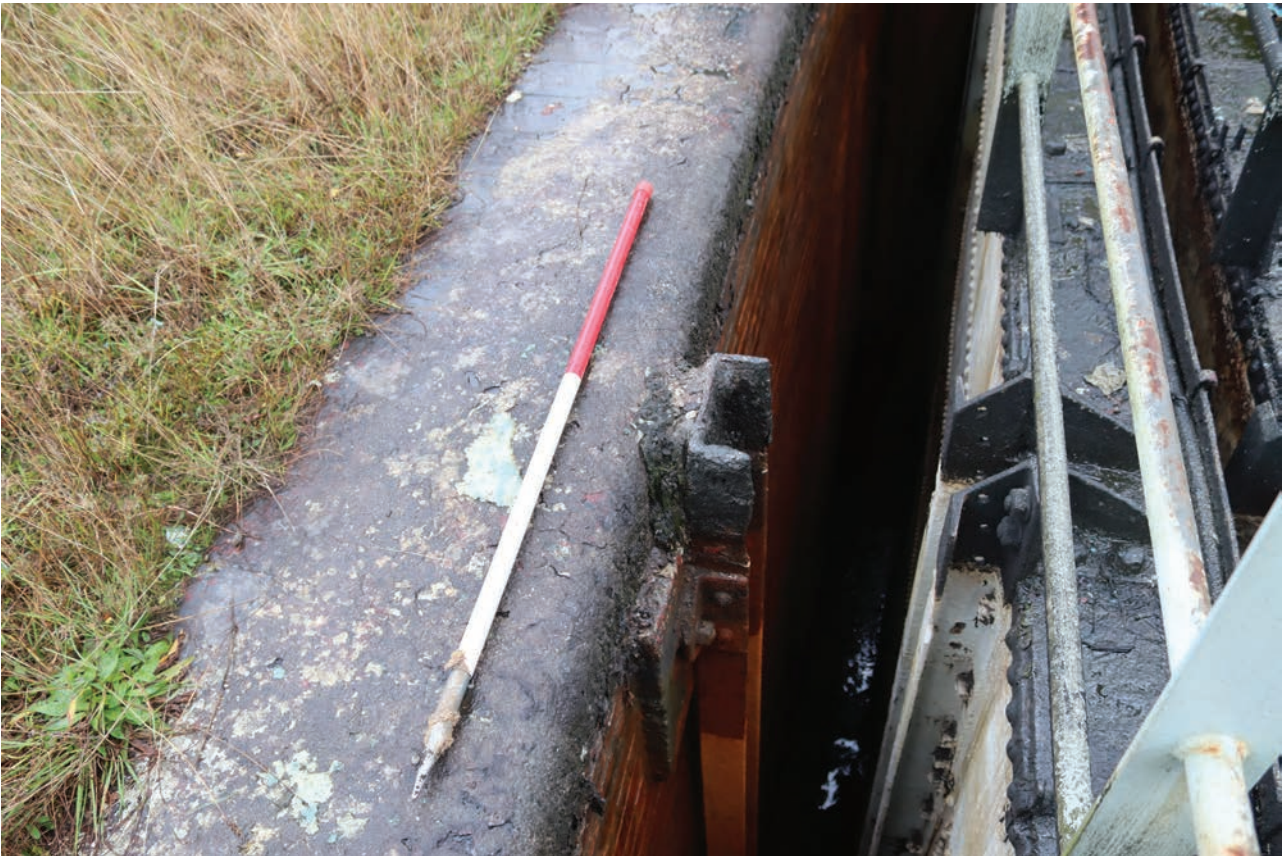
Plate 81: Gasholder No 5, detail view of guide rail set within the tank wall between neighbouring standards, from the WSW

Metal fixtures are built within the tank wall to which guide rails are bolted beneath the standards and in the centre of each bay between neighbouring standards (Plates 80 & 81).

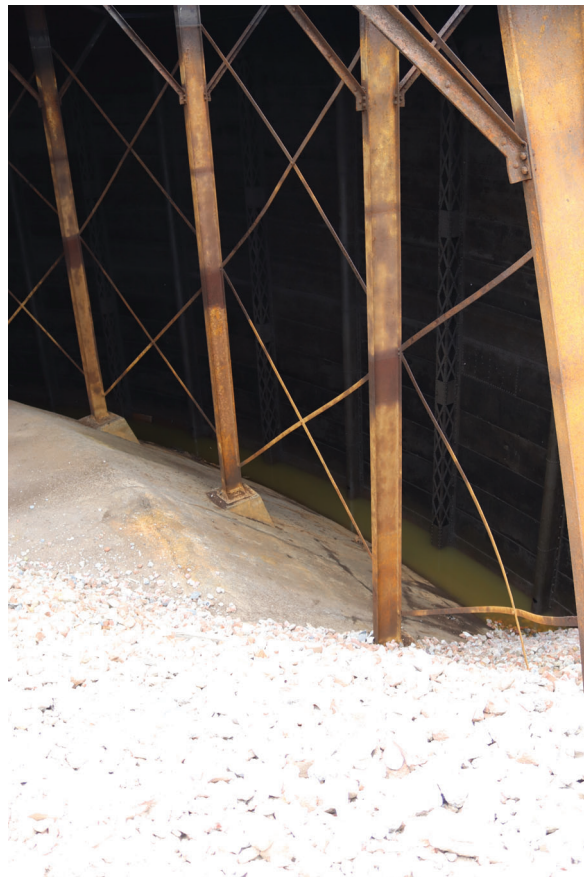
Plate 82: Gasholder No 5, general view of the steep dumping slope, from the SSE

The base of the tank slopes up in the centre to form a dumpling with a 36° slope and rise of 5m (Plate 82; Figure 41). The 48m-wide dumpling top appears to be flat although there is a further 2° slope leading to an additional central rise of 0.8m (Figure 38). The dumpling is finished with a relatively smooth layer of concrete, with small stone inclusions, and is assumed to have undisturbed ground material beneath. The dumpling has visible cracks in its top.

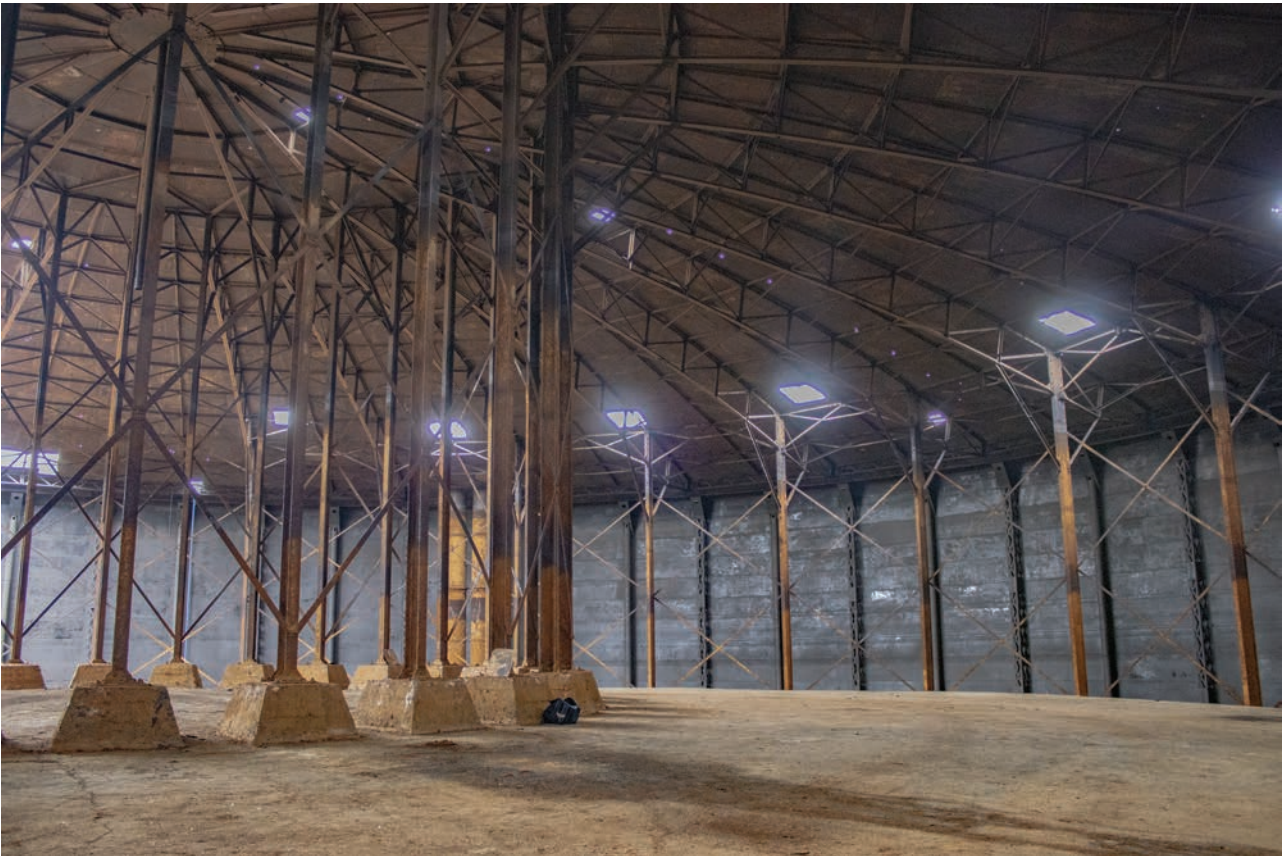
Plate 83: Gasholder No 5, general view of the tank interior showing vertical supports and dome of the crown support frame, from the NNW

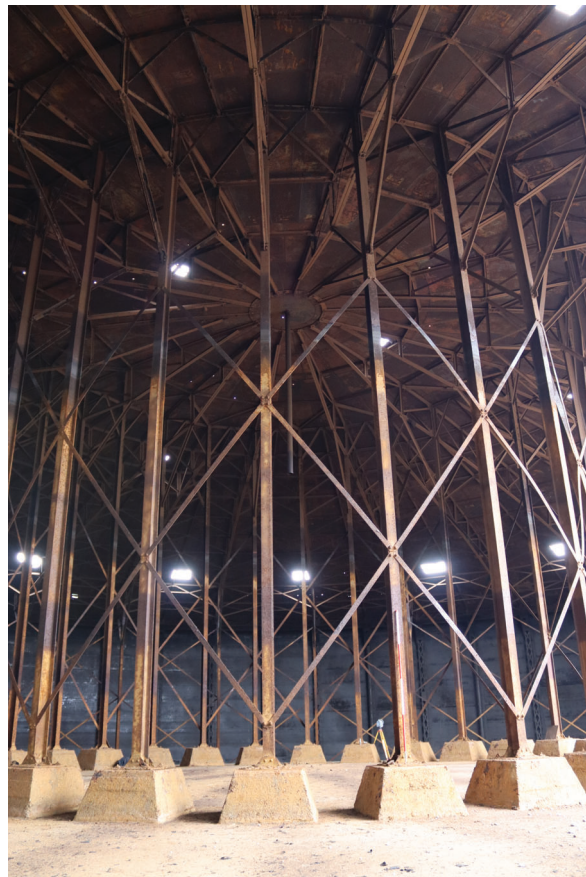
Plate 84: Gasholder No 5, general view of crown rest frame inner ring of steel supports with bracing latticework, from the SSE

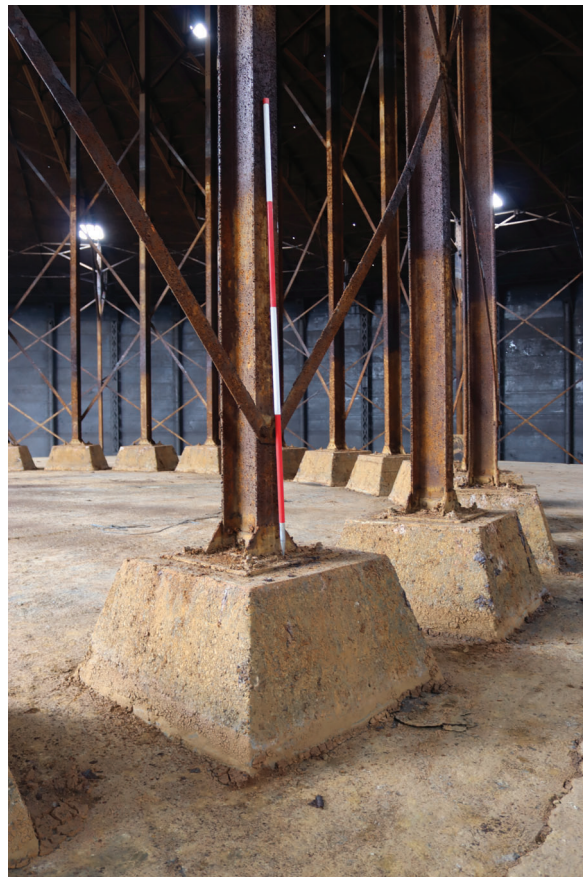
Plate 86: Gasholder No 5, general view of the concrete blocks beneath the vertical supports of the crown rest frame, from the north-east

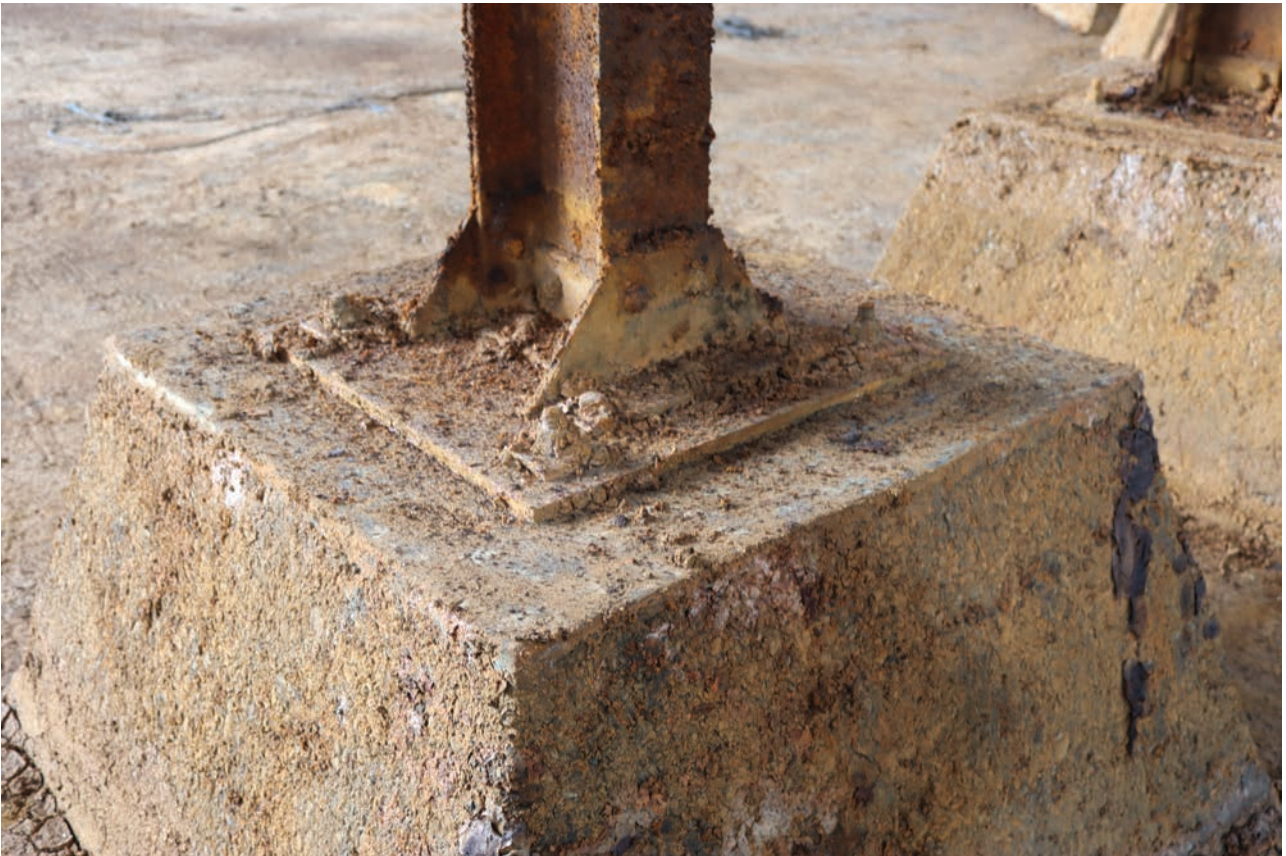
Plate 87: Gasholder No 5, detail view of the joint between the vertical steel support and concrete block beneath of the crown rest frame, from the north-east

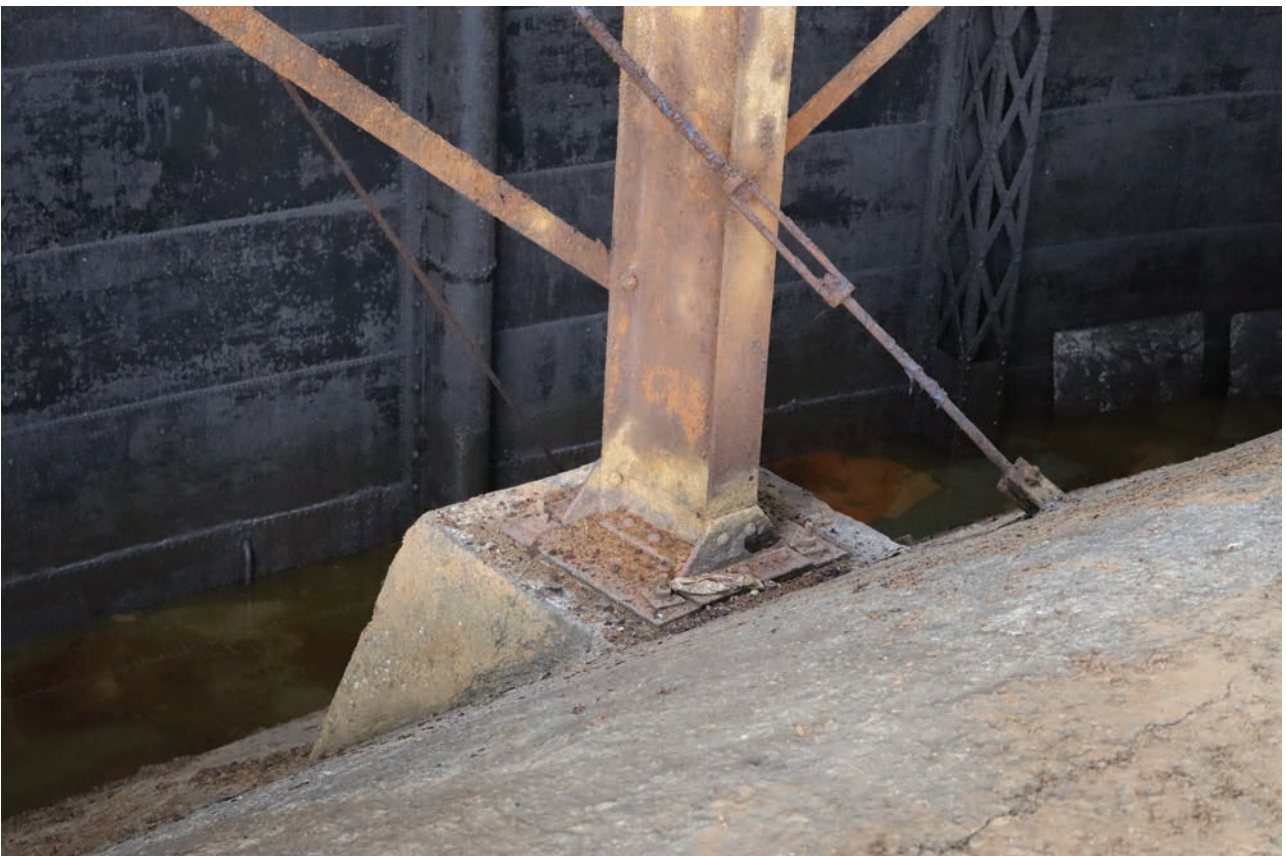
Plate 88: Gasholder No 5, detail view of the angled concrete blocks beneath the outer ring of steel supports of the crown rest frame, from the north-east

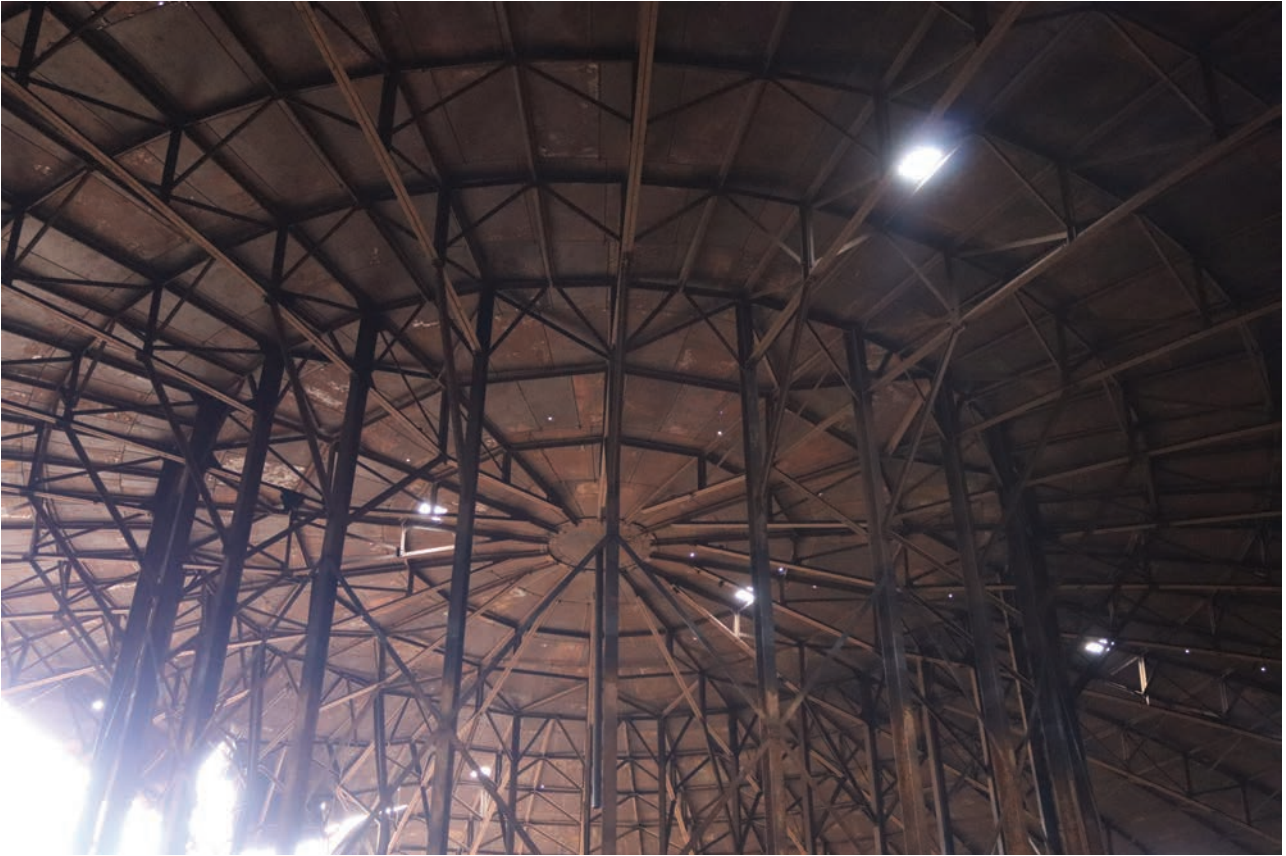
Plate 89: Gasholder No 5, general view of the centre of the crown rest frame dome with ring and spoke design, from the NNW

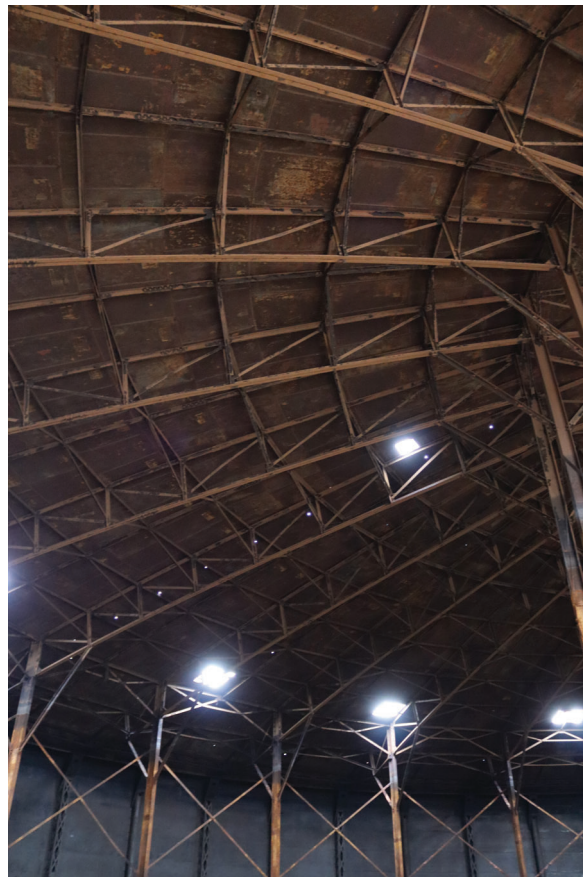
Plate 90: Gasholder No 5, general view of trussed beams supporting the dome crown rest frame, from the south-east

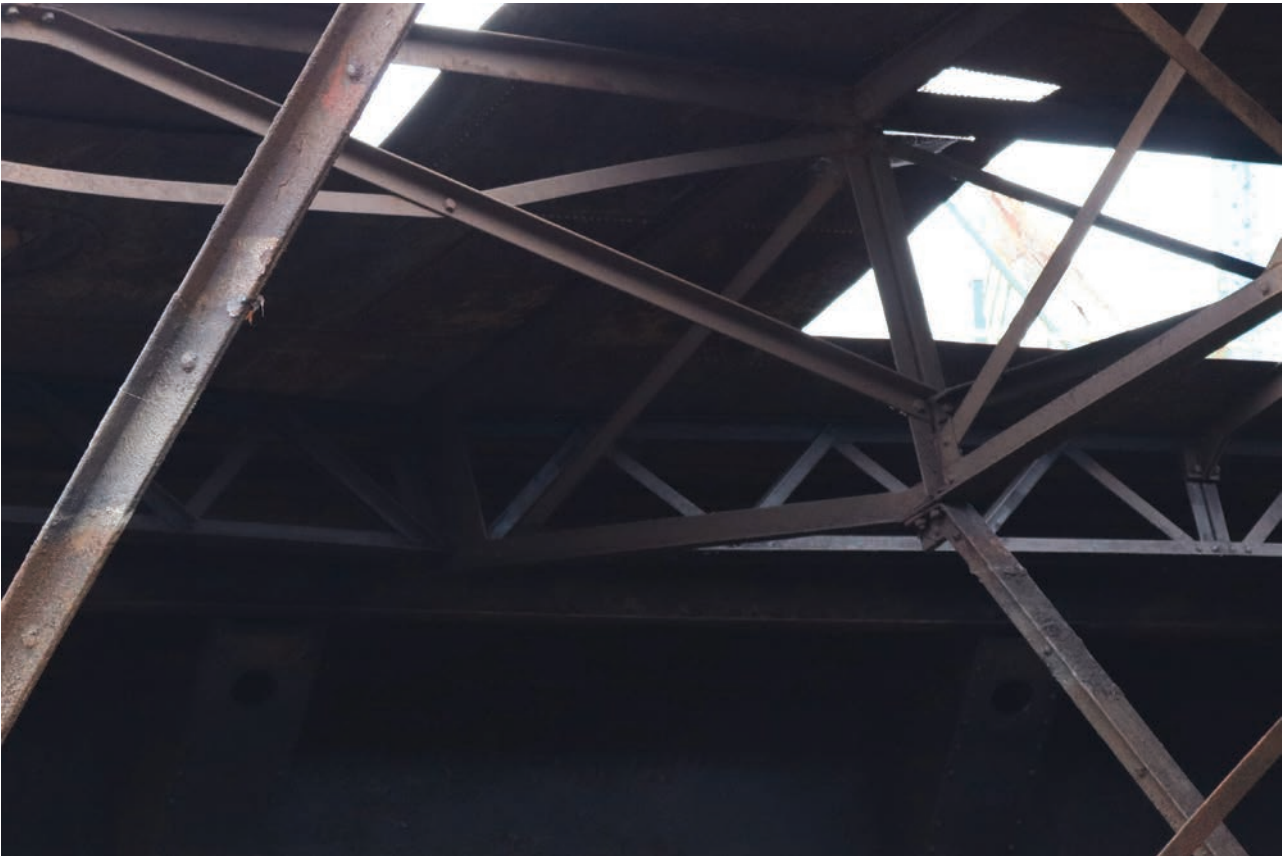
Plate 91: Gasholder No 5, general view of the multi-directional trussing of the crown support frame, from the north-east

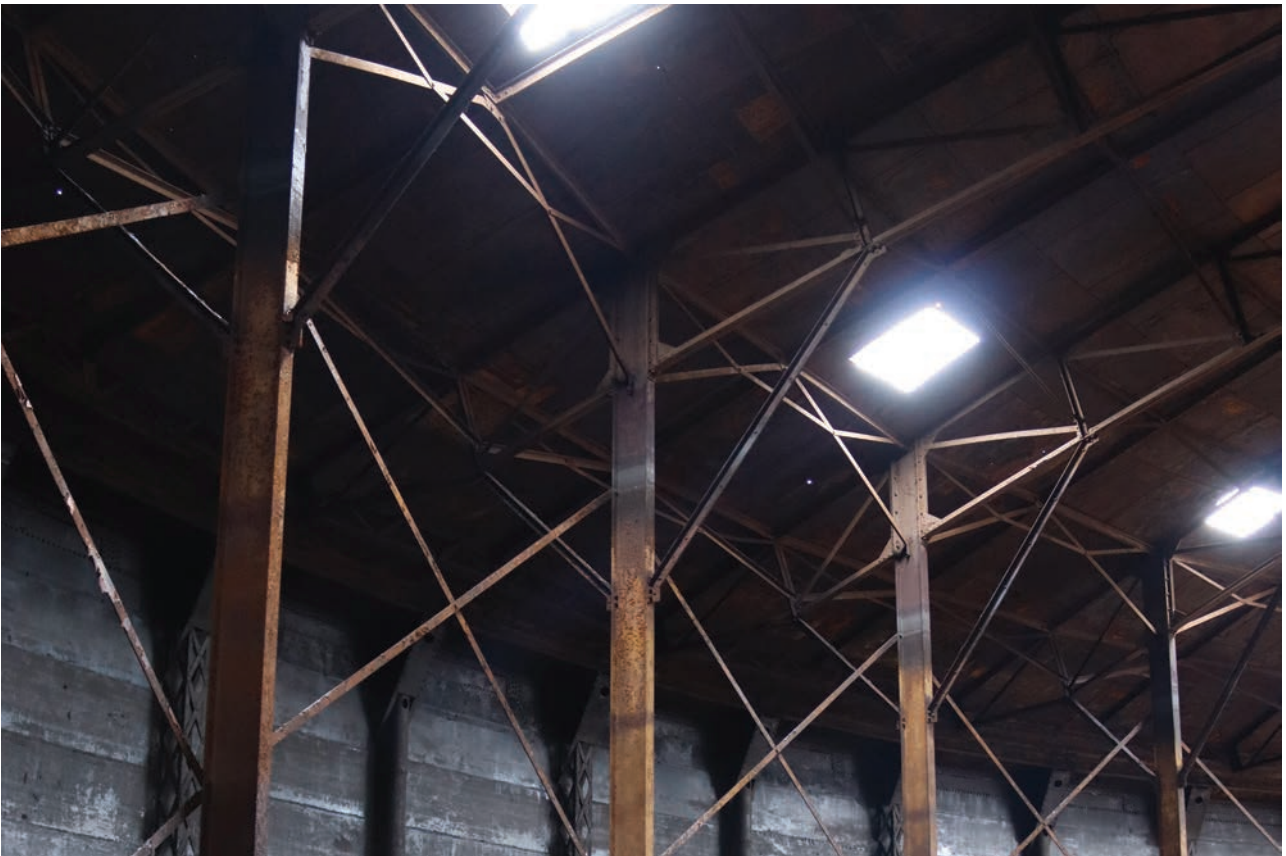
Plate 92: Gasholder No 5, detail view of the trussed ring at the outer edge of the crown rest frame, from the south-west

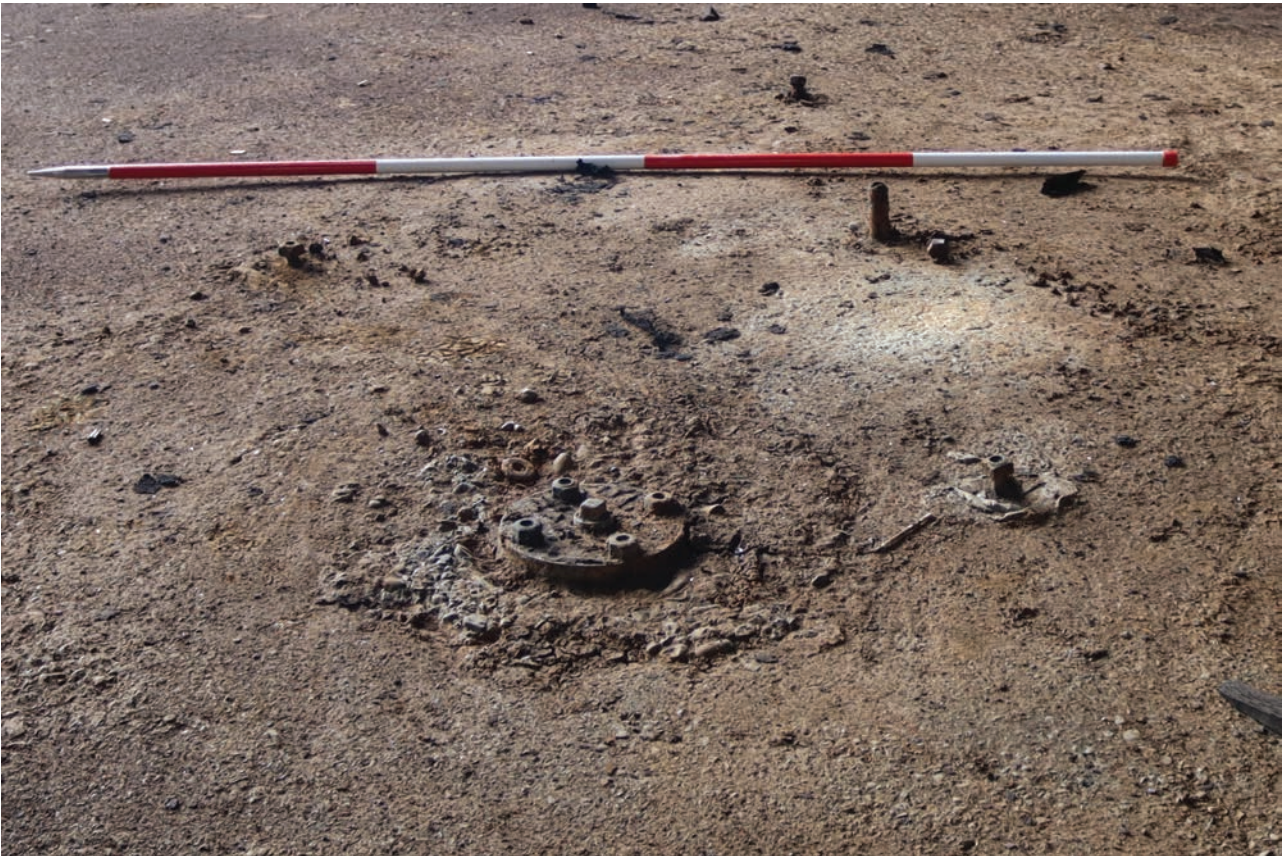
Plate 93: Gasholder No 5, general view of disused iron fixtures set within the centre of the dumpling, from the NNW

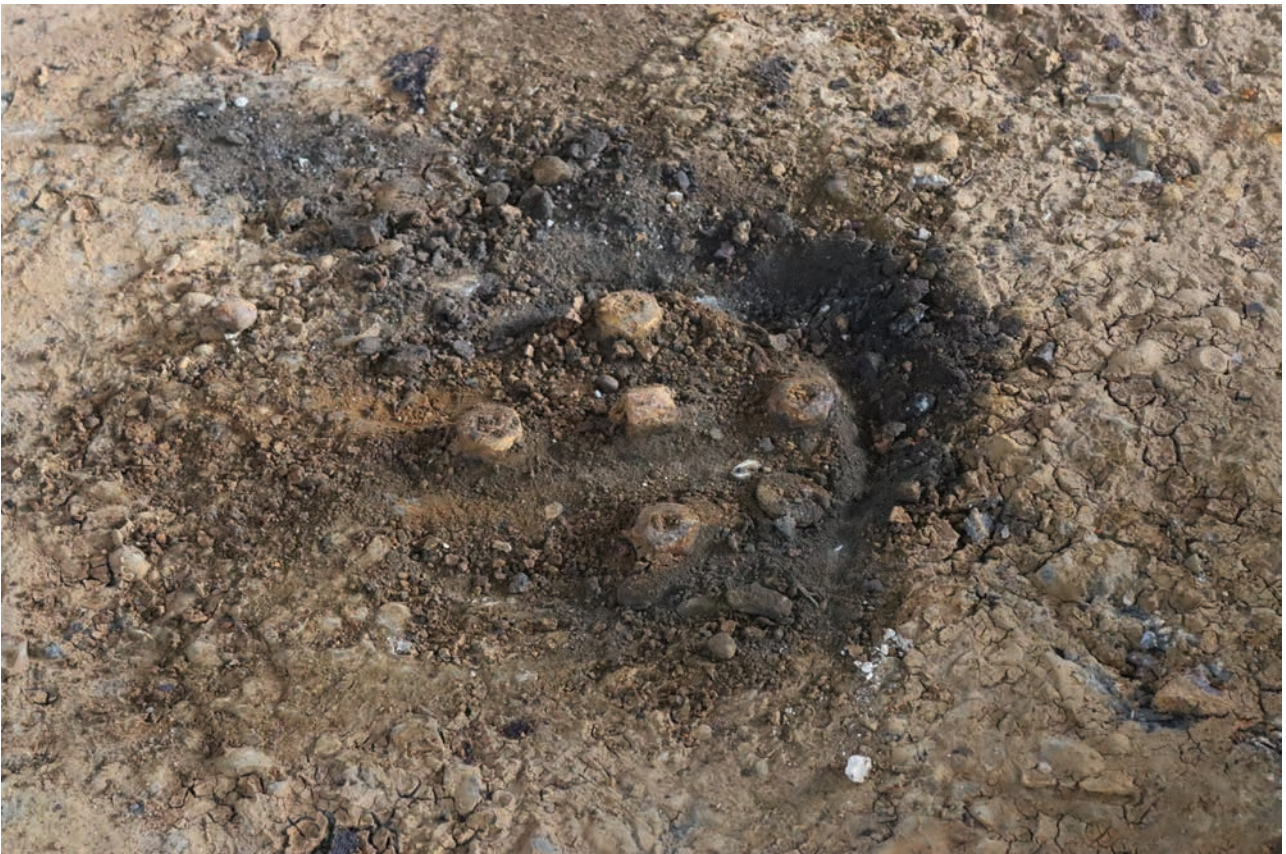
the inner ring of crown rest frame supports. Additional bolts and other irregular iron fixtures are set within the centre of the dumpling which are assumed to be related (Figure 38). These may once have attached to the crown rest frame giving additional support. One of the circular fixtures appears to have sunk into the dumpling, although it is possible that the dumpling has been resurfaced after the fixture fell into disrepair (Plate 94).

Plate 94: Gasholder No 5, detail view of possibly sunken iron fixture on the west side of the dumpling, from the south

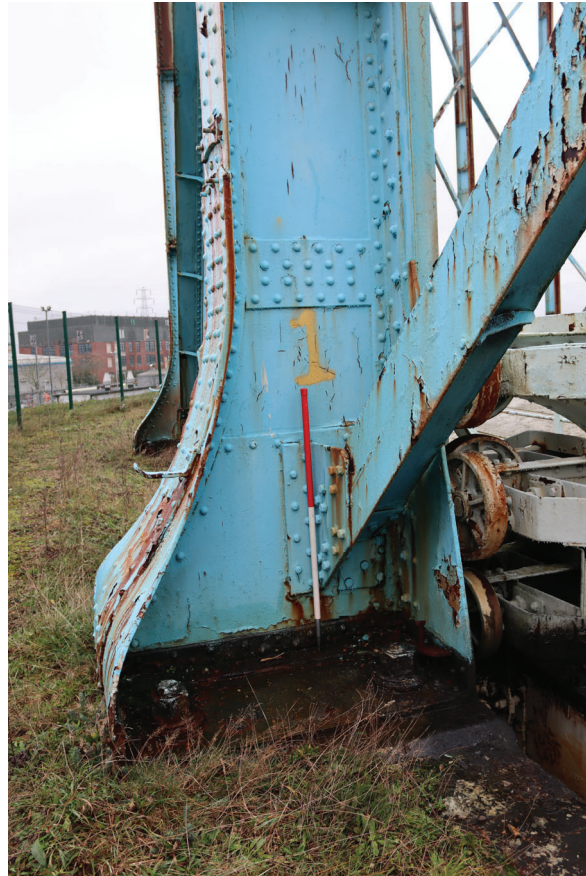
- 8.3.1 Now demolished, Gasholder No 5 had a variant of the Type 42 cylindrical shell guide frame designed by Livesey. It had 28 standards arranged clockwise starting from the south side (Figure 37). Only standard 1 was marked via a spray-painted number at its base (Plate 95). The standards were of solid I-shaped construction comprised of steel sheets riveted together with a flared base that was bolted to a concrete foundation with two 12cm diameter bolts on each side (Plates 96–98). The exterior, flared side of the standards had an additional riveted 2m high plate at the base and flange plates bolted every 7.5m connecting the exterior lengths of steel sheet (Plates 99 & 100).

Plate 95: Gasholder No 5, detail view of standard 1 base east side showing spray-painted number, from the east

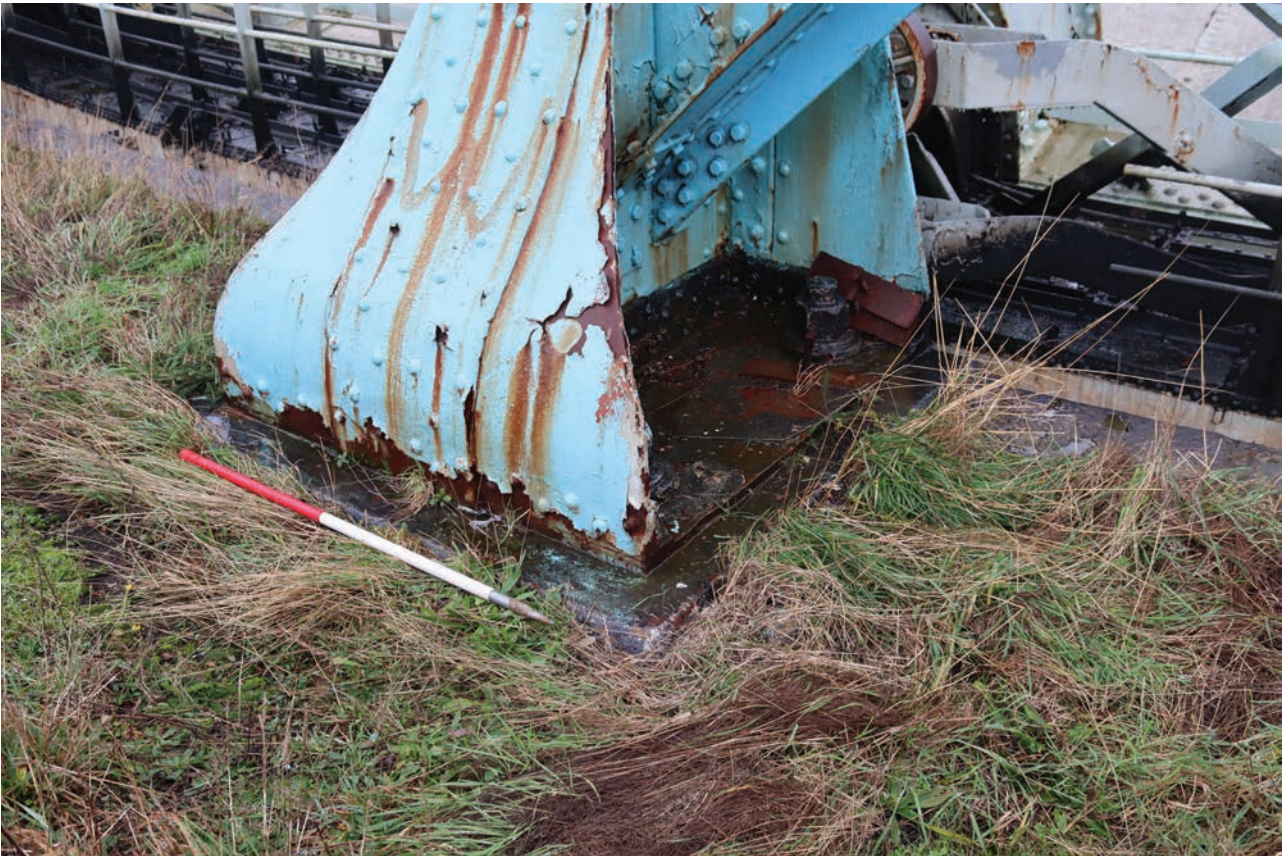
Plate 97: Gasholder No 5, detail view of concrete foundation that standard 8 is bolted to at the base, from the south-west

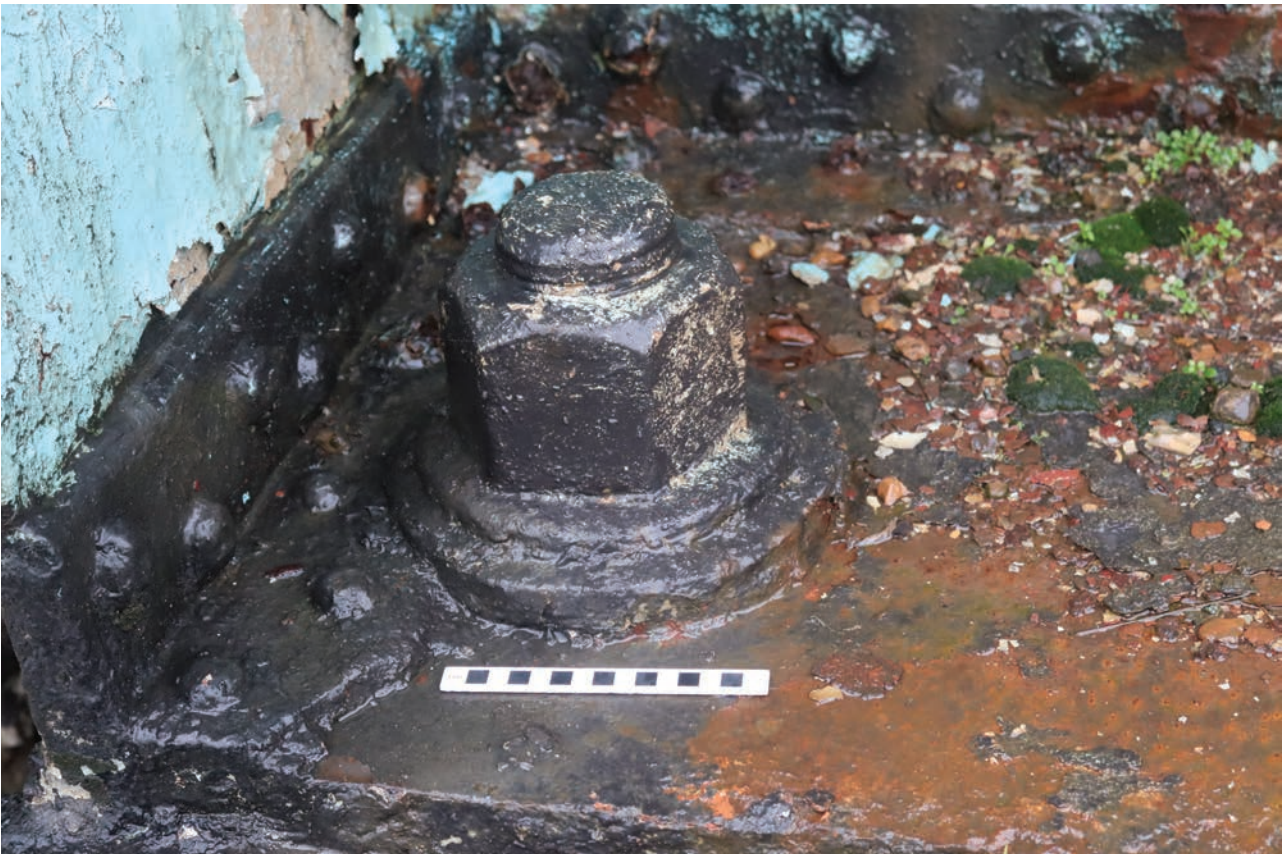
Plate 98: Gasholder No 5, detail view of 12cm diameter bolt at the base of standard 22, from the north

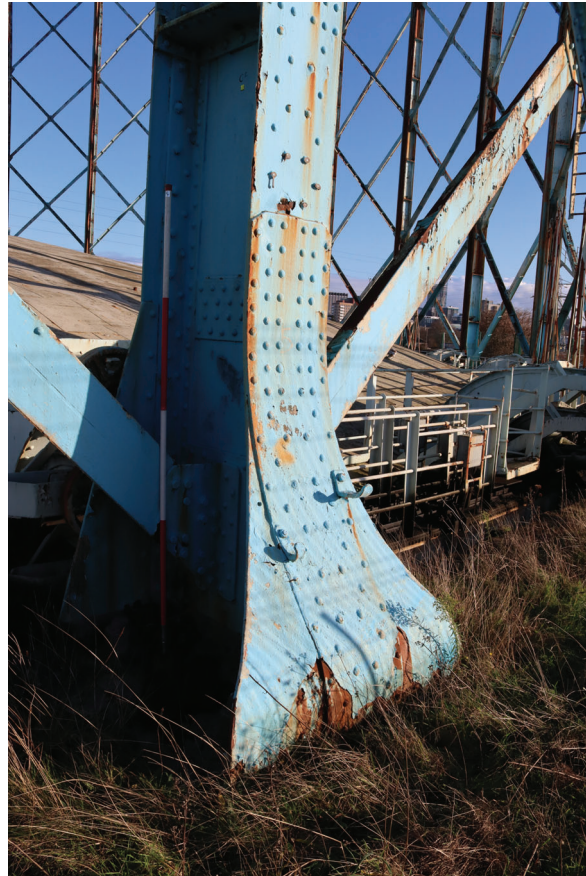
Plate 99: Gasholder No 5, detail view of the riveted rectangular plate on the exterior side of standard 5, from the NW

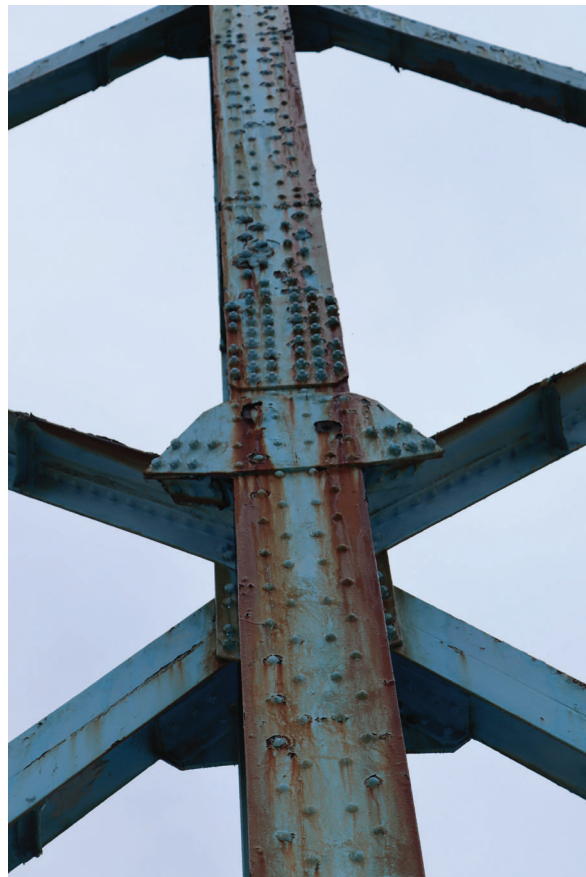
Plate 100: Gasholder No 5, detail view of bolted flange plate and riveted gusset plate on the exterior side of standard 12, from the NNW

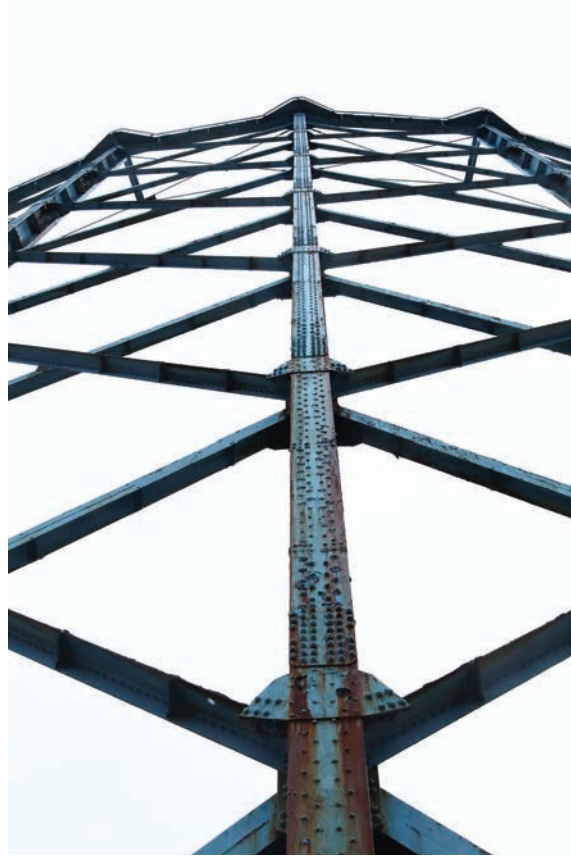
- 8.3.2 Neighbouring standards were secured together via diagonal, T-section, cross-bracing struts connected to standards via gusset plates riveted to either the interior side, exterior side or middle of the standards (Plates 101–103). Seven pairs of bracing struts formed a cross shape between each neighbouring set of standards with the struts facing alternatively inwards or outwards at the same horizontal level between the next set of neighbouring standards (Plate 104; Figure 40). The struts were joined centrally by a riveted, hexagonal plate (Plate 105).

Plate 101: Gasholder No 5, detail view of bolted flange plates and riveted gusset plates on the entire exterior side of standard 12, from the NNW

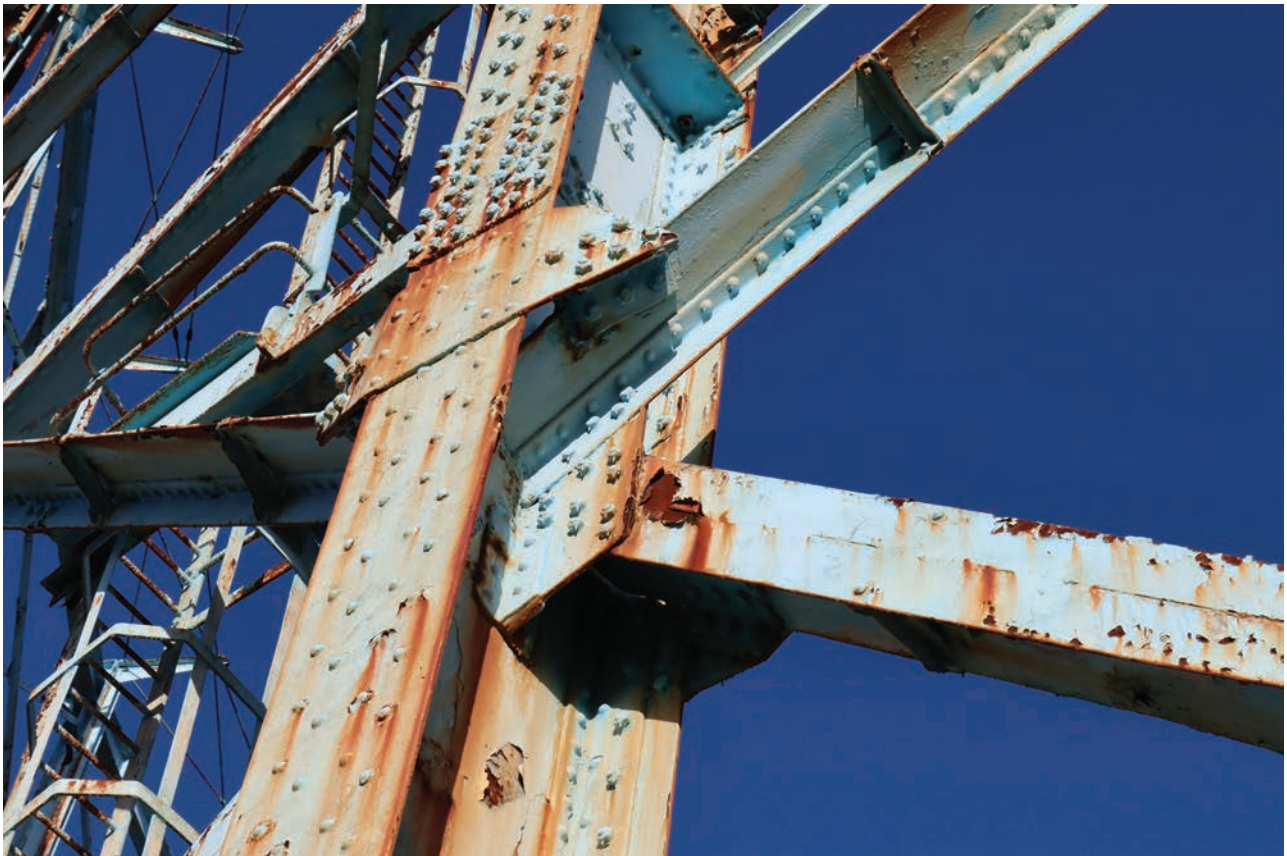
Plate 102: Gasholder No 5, detail view of gusset plates on the exterior side and middle of standard 4, from the south

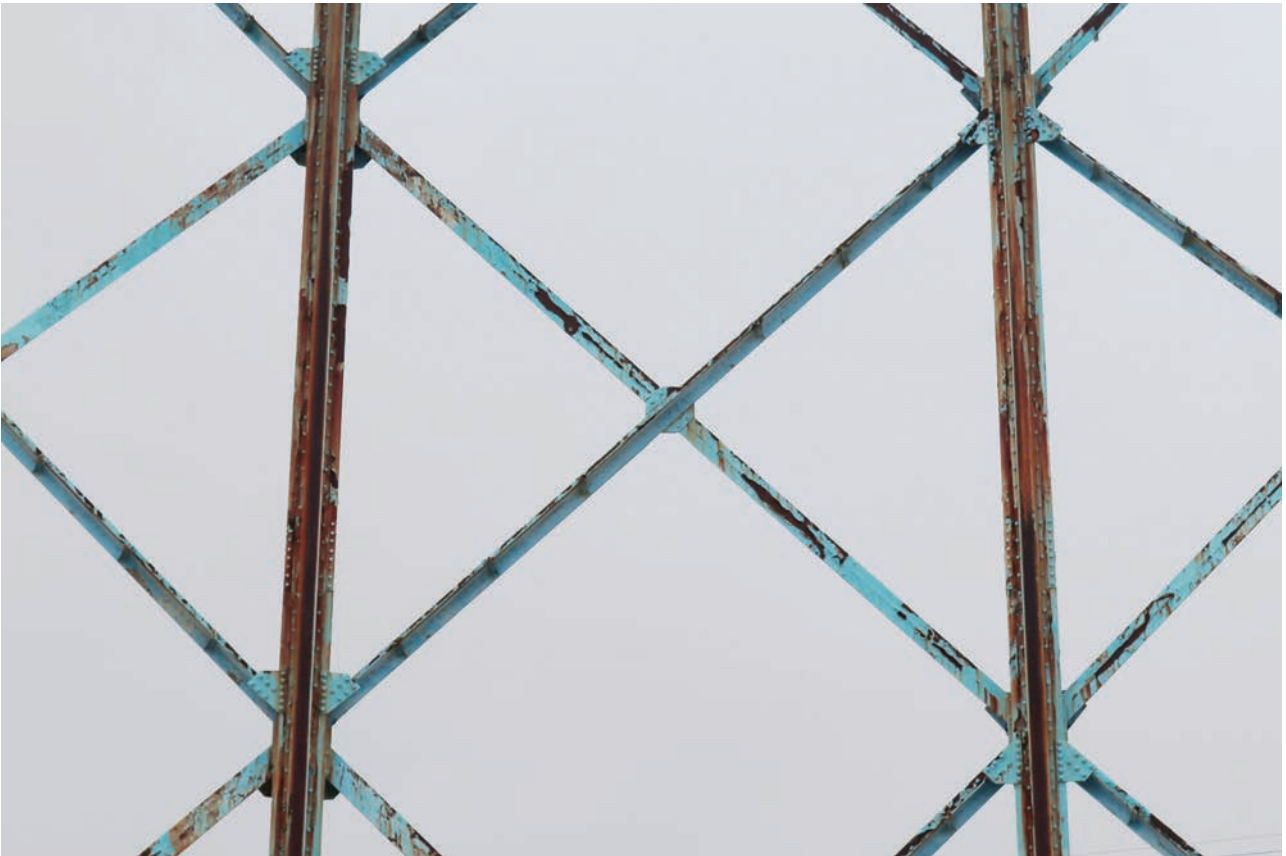
Plate 103: Gasholder No 5, detail view of diagonal struts attached to the interior side of standards 6 and 7 via gusset plates, from the ENE

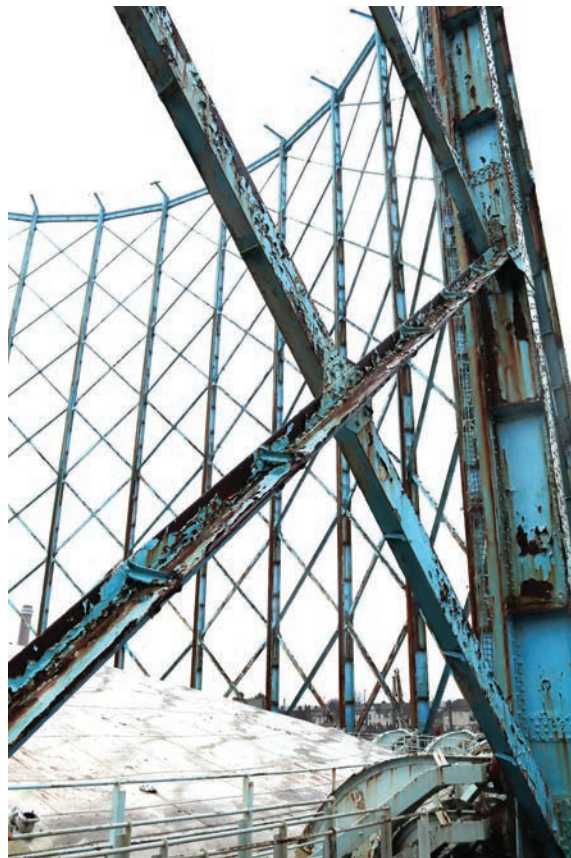
Plate 104: Gasholder No 5, detail view of T-shaped diagonal strut pair facing opposite directions, from the ENE

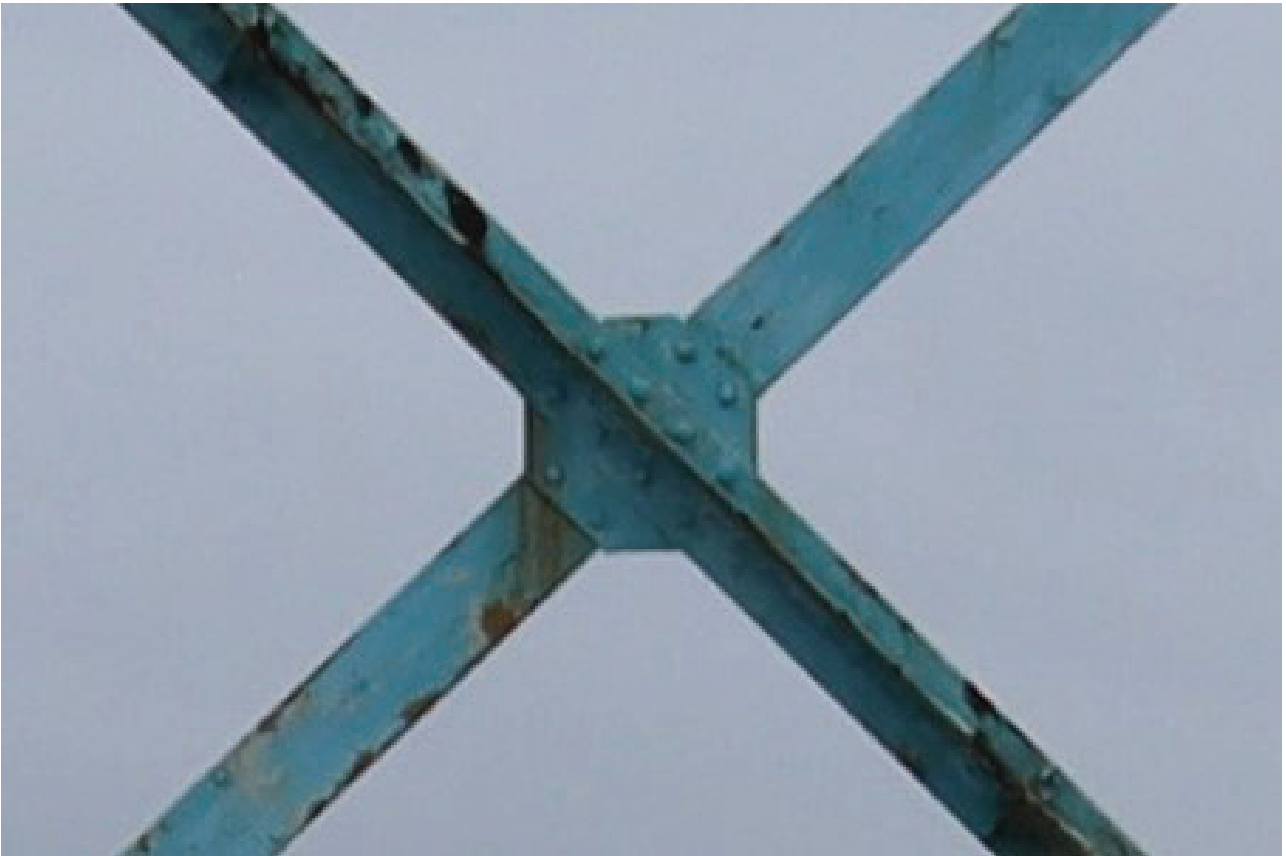
Plate 105: Gasholder No 5, detail view of hexagonal plate riveted at the centre of each strut, from the south

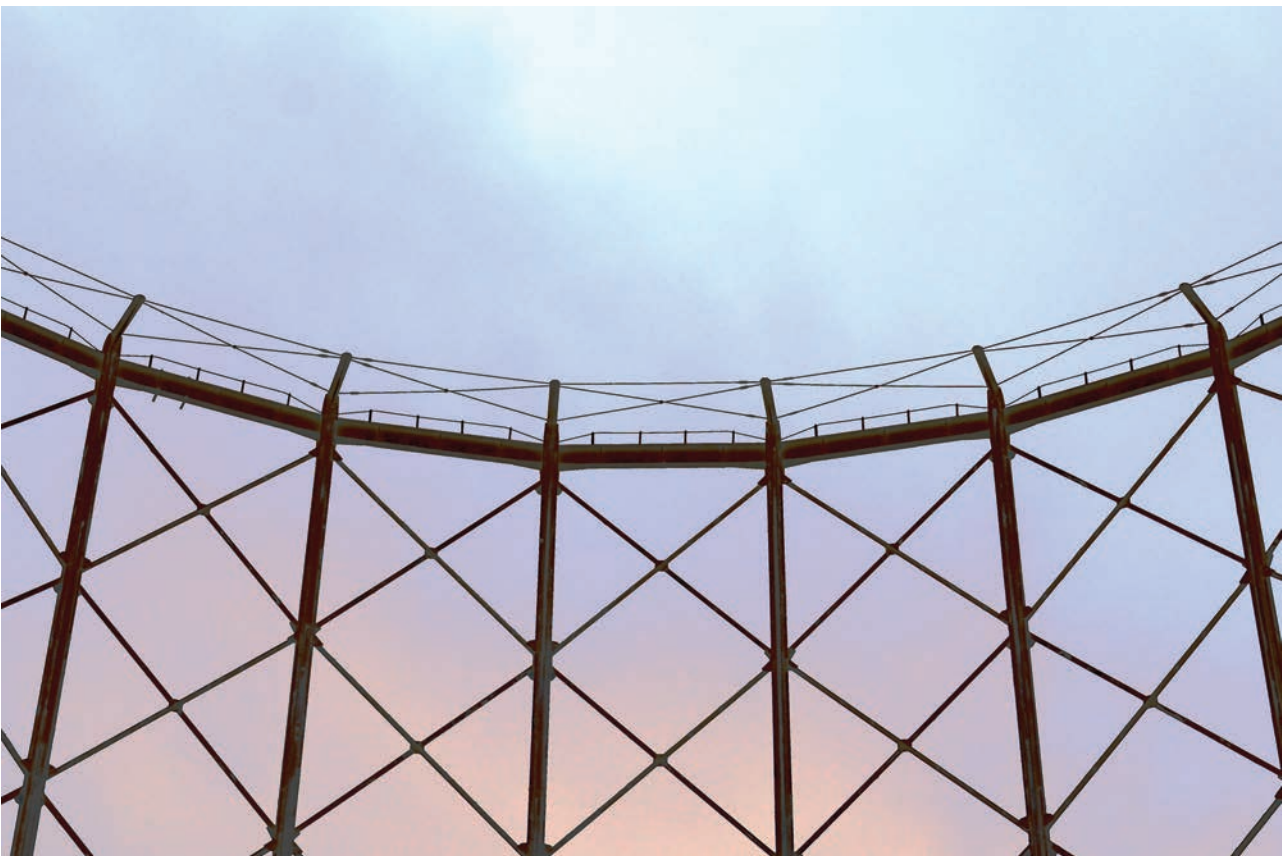
- 8.3.3 The top of the guide frame had cross-bracing bars between projecting lengths at the top of each standard to aid rigidity against wind (Plate 106).

Plate 106: Gasholder No 5, detail view of cross tie bars to steady the top of the frame in high wind, from the north
