Gasholders Nos 4 & 5, Factory Lane, Croydon, London: Historic Building Recording Final Report

*AOC Project No: 23686_V
3rd August 2021*

On Behalf of:	SGN 2 Woodstock Road Yarnton OX5 1NY
National Grid Reference (NGR):	Gasholder No 4: TQ 31212 65907 Gasholder No 5: TQ 31169 65975
AOC Project No:	23686_V
OASIS No:	411878
Prepared by:	Diana Sproat Gemma Hudson
Illustration by:	Gemma Hudson Jamie Humble Sam O'Leary
Date of Fieldwork:	16th – 18th December 2020 (Phase I) 5th May & 7th July 2021 (Phase II)
Date of Report:	3rd August 2021

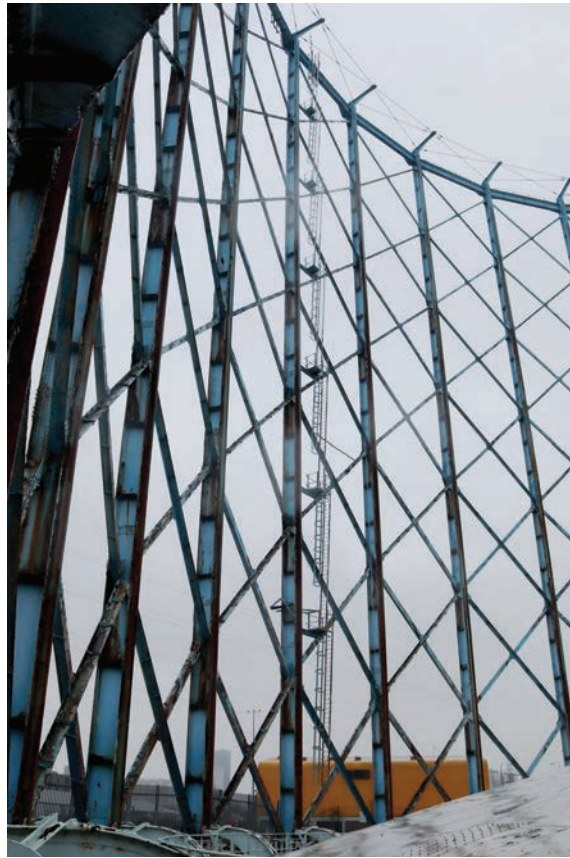
- 8.3.4 Access to the top of the guide frame was via two sets of seven ladders situated between standards 4 and 5, and 18 and 19 (Plate 107). The ladders each had safety cage hoops surrounding them on three sides so the lift tops could be accessed via the open side when the bell was raised with a small platform where each ladder connects with the one above. The base of the ladders were cut off for safety reasons after the holder was decommissioned, although the original base ladder and safety cage hoop design is represented in Figure 28.

Plate 107: Gasholder No 5, detail view of set of ladders situated between standards 18 and 19, from the WNW

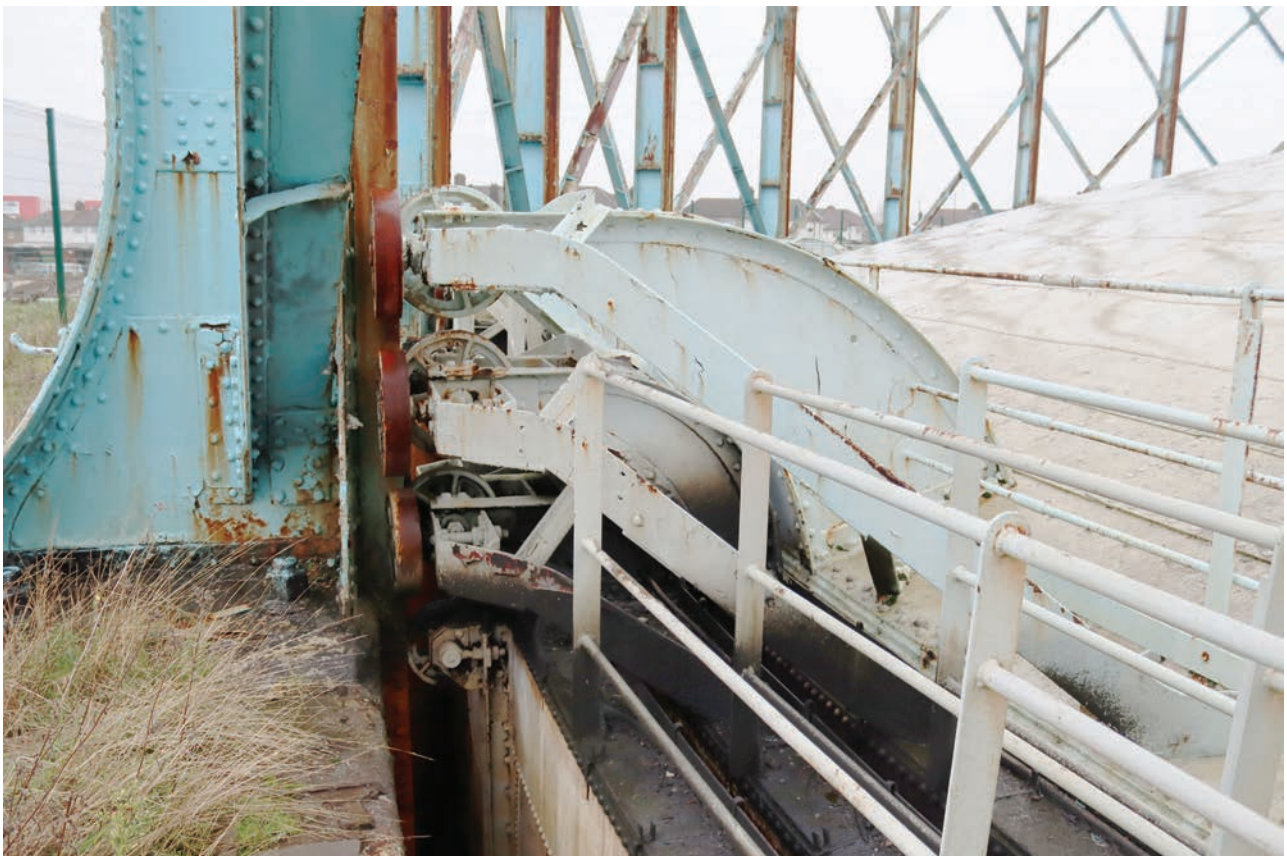
The telescopic bell was divided into four lifts which were each topped with guide rollers and carriages at each standard (Figure 41; Plate 108). The carriages of the crown, top and middle lifts had single rollers that slotted into the vertical guide rails on the interior side of the standards. They also had dual rollers that were situated to either side of the vertical guide rail so the rail was gripped on three sides by the three rollers. The rollers were mounted on carriages that were comprised of mirror-image steel sheets which were semi-circular design and riveted together using cross braces. The carriages were bolted to the lift tops at their base as well as via splayed arms to either side (Plate 109). The guide roller of the bottom lift was singular and was bolted to the interior wall of the bottom lift (Plate 110).

Plate 108: Gasholder No 5, detail view of the four guide rollers and carriages attached to the lifts at each standard, from the east

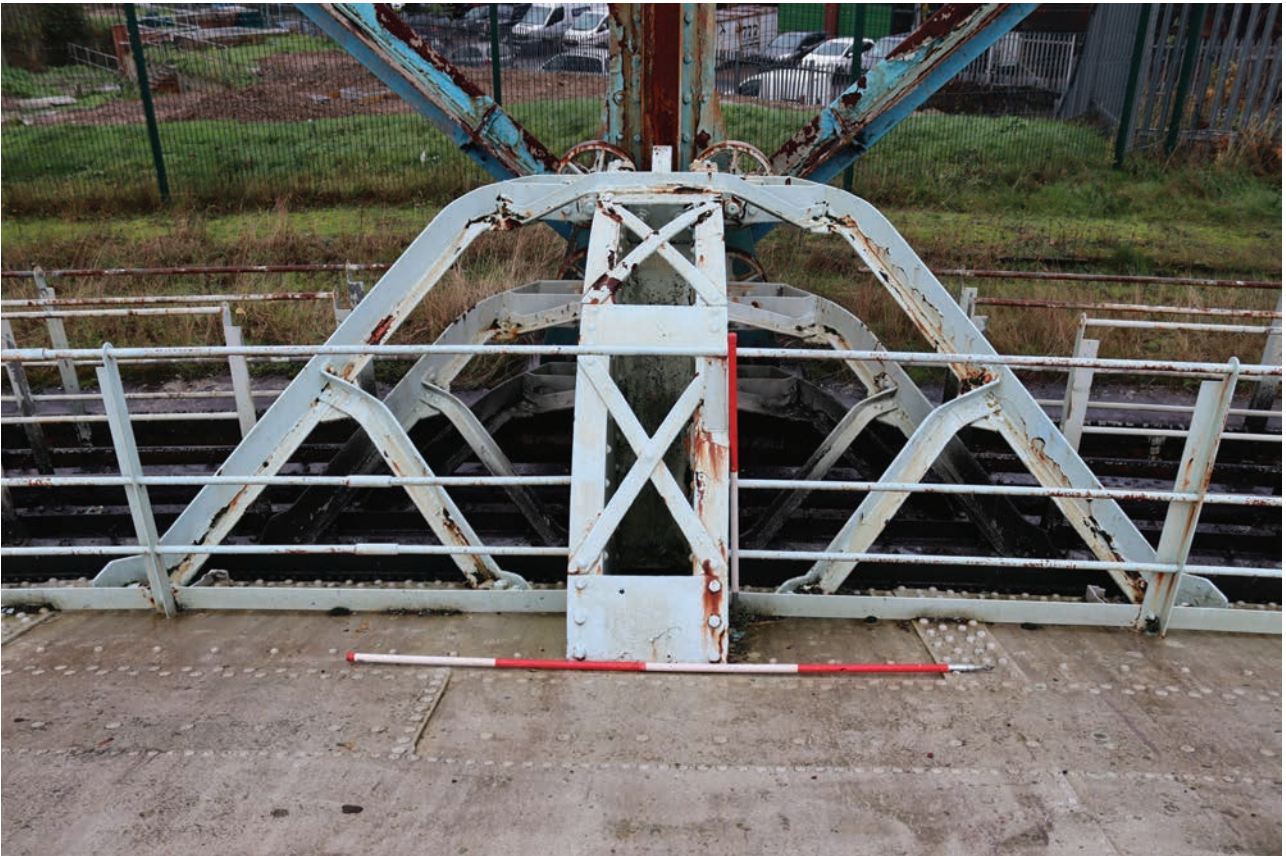
Plate 109: Gasholder No 5, detail view of the roller carriages with cross braces and splaying arms at standard 11, from the south-east

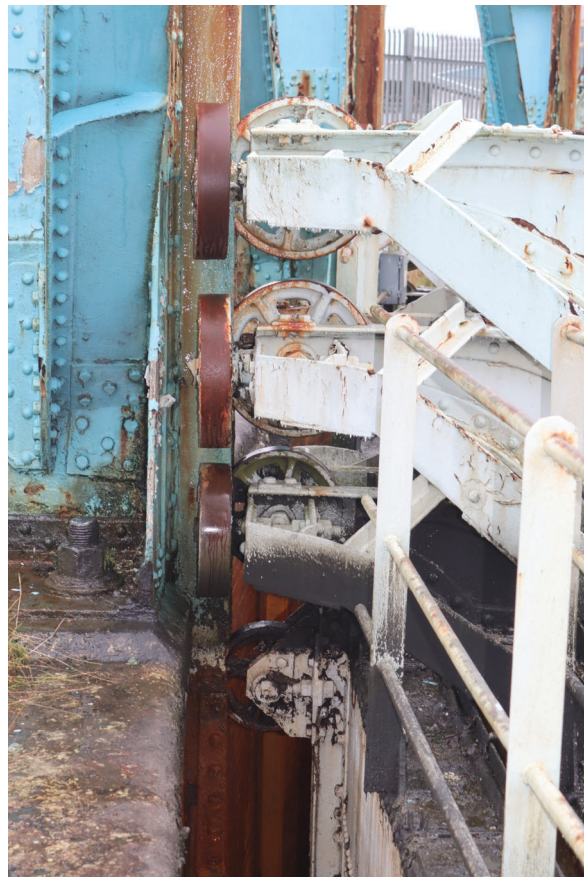
Plate 110: Gasholder No 5, detail view of single or triple roller sets on the west side of standard 13, from the WSW

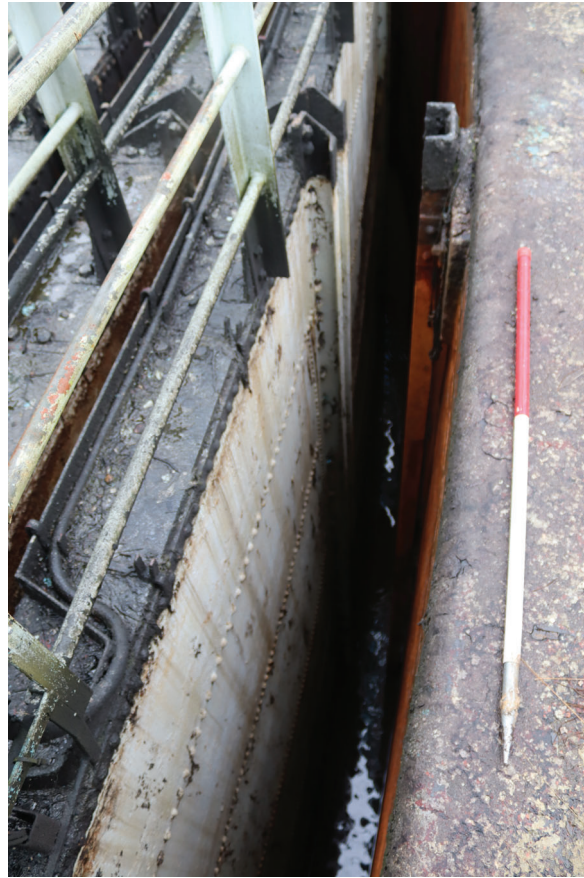
The lifts were constructed of riveted steel sheets with square cup-and-grips (Plates 111 & 112). The exterior sides of the lift walls had rolled steel stanchions bolted to them for increased rigidity, which were then bolted to the lift tops (Plate 113). On the interior side of the crown lift wall there were two types of vertical supports, a semi-circular in section column made of steel sheets riveted together, and a latticework steel column (Plate 114). There were holes in the top and bottom of the column which, together with the latticework column design, allowed the water in the tank to easily run out of the structures as the bell was raised (Plate 115). Both types of verticals were topped with triangular-shaped brackets which added additional support to the top curb (Plate 116). A steel sheet was riveted to the crown and the side of the triangular brackets facing into the structure (Plate 117). The sheet may be situated there to help support the crown at the highly pressurised point of the top curb.

Plate 111: Gasholder No 5, detail view of the external wall of the bottom lift constructed of riveted steel sheets, from the east

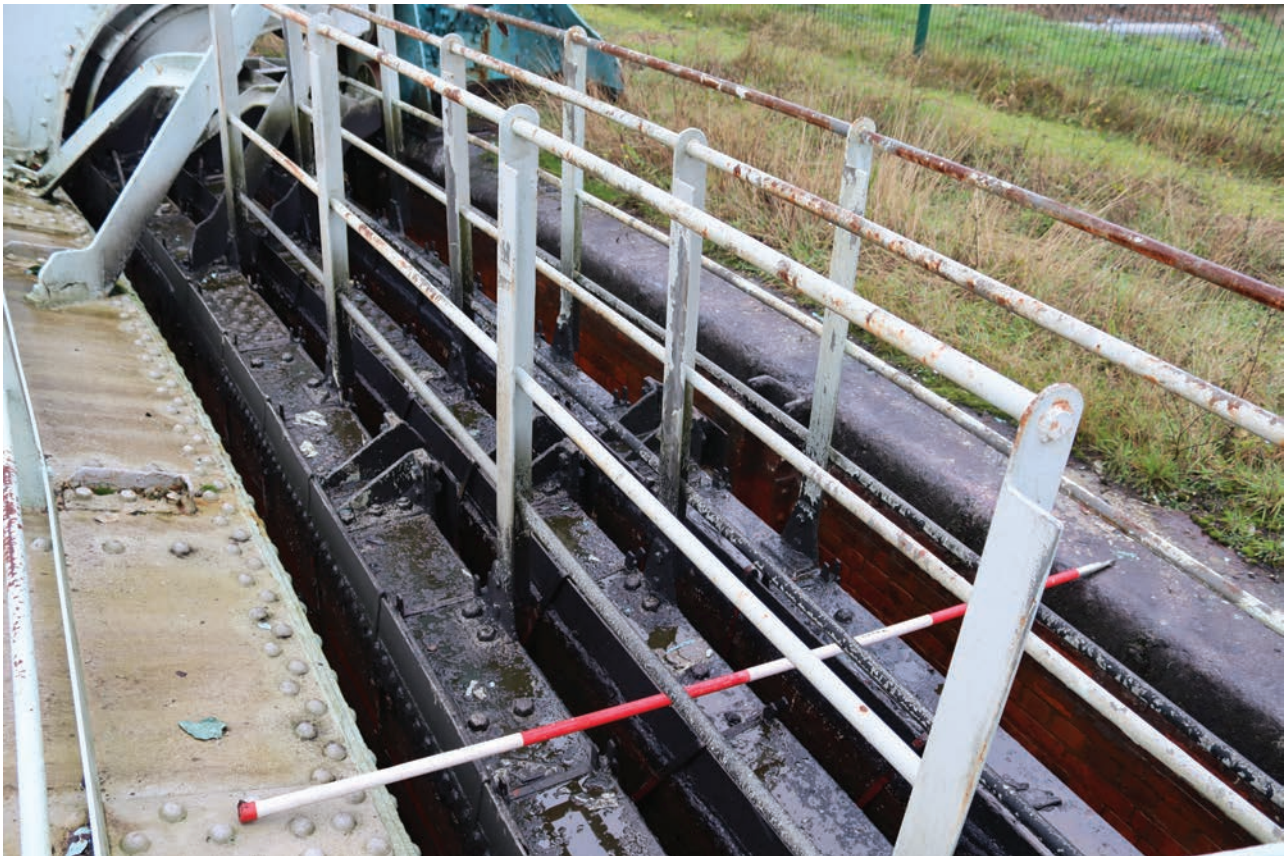
Plate 112: Gasholder No 5, general view of lift tops showing square grips, from the ENE

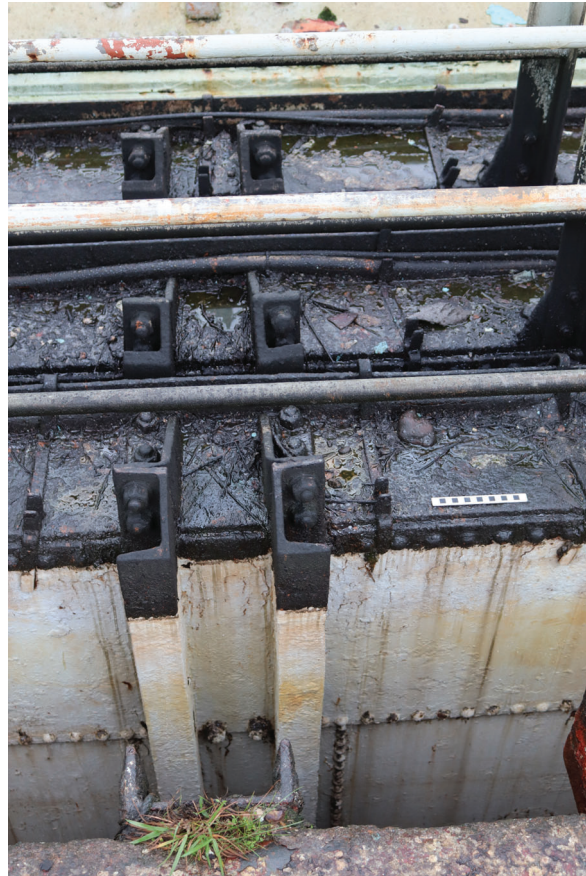
Plate 113: Gasholder No 5, detail view of stanchions bolted to the lift tops to give rigidity to the lifts, from the south-east

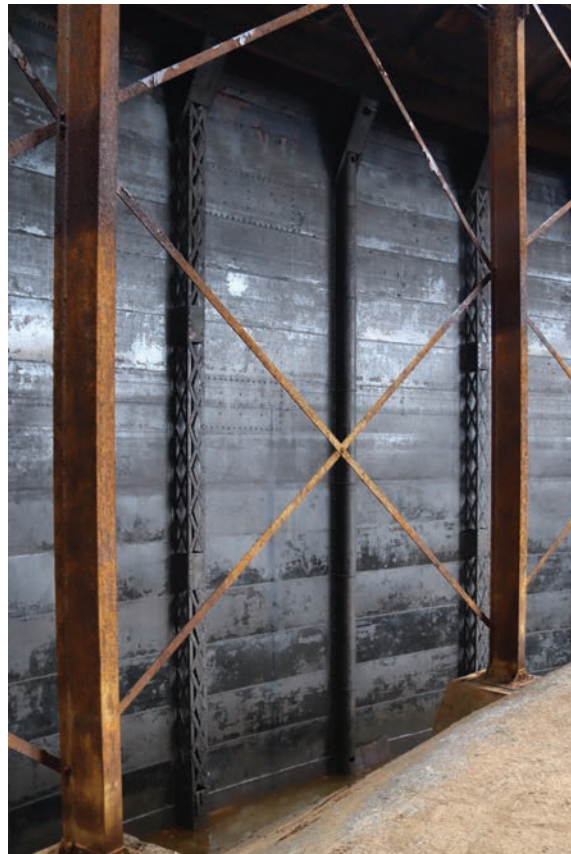
Plate 114: Gasholder No 5, general view of the two types of vertical support on the internal face of the crown lift wall, from the south-west

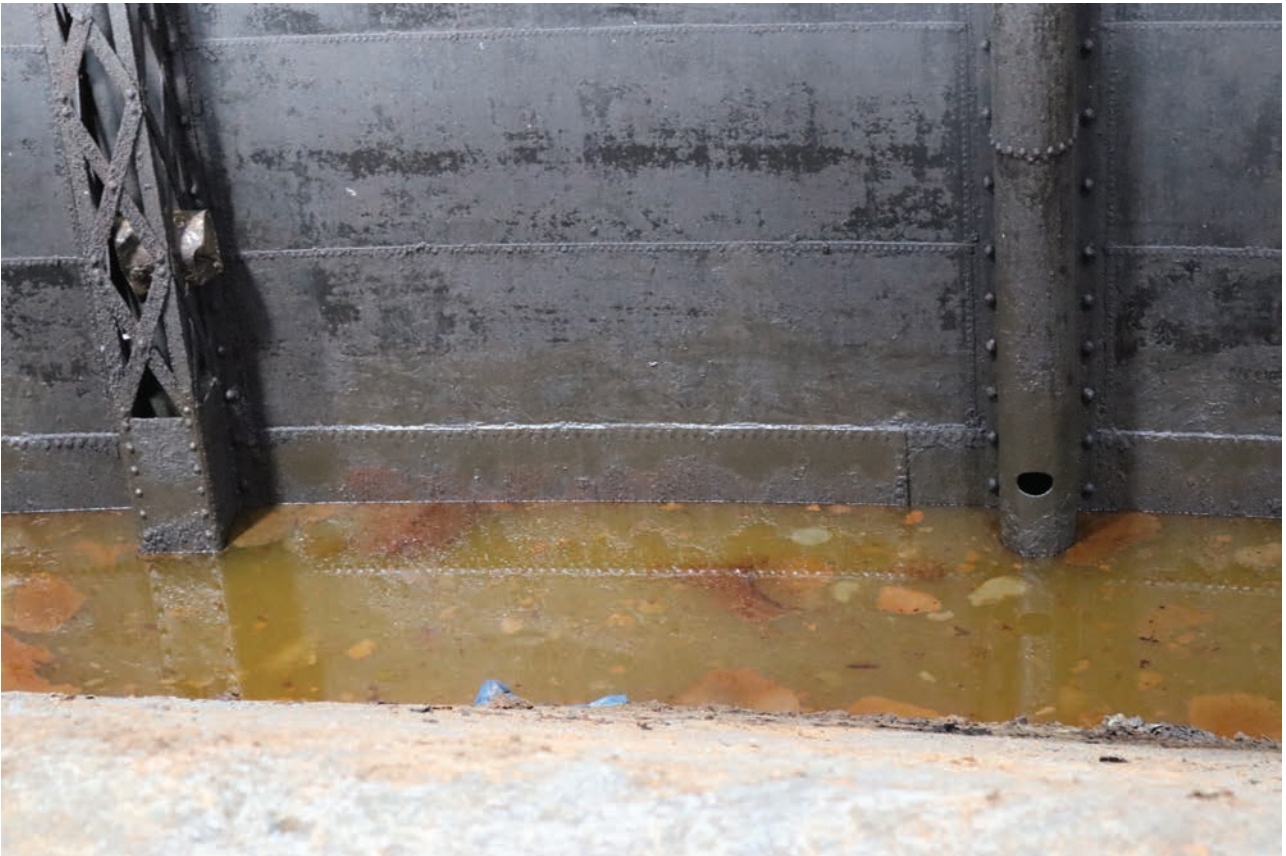
Plate 115: Gasholder No 5, detail view of latticework design and hole in the column support for releasing tank water easily, from the north-east

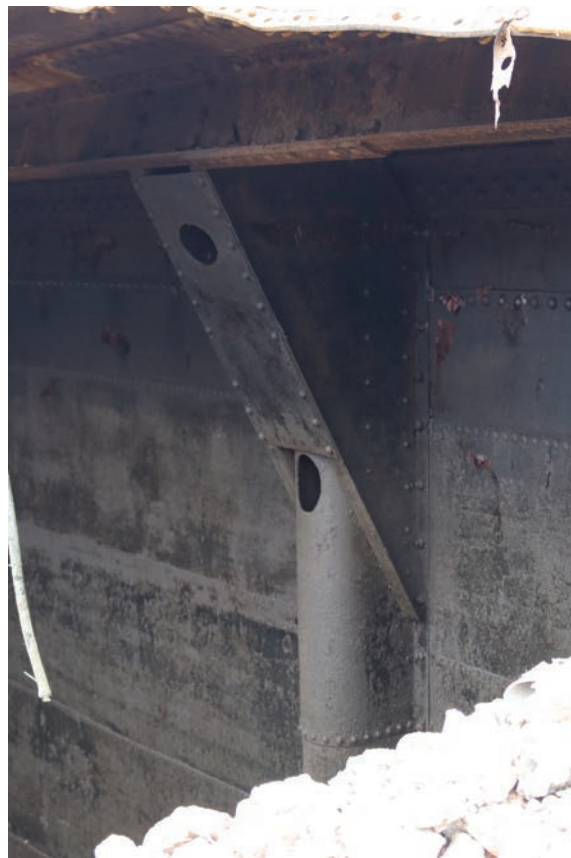
Plate 116: Gasholder No 5, detail view of the triangular-shaped bracket supporting the top curb of the bell, from the south

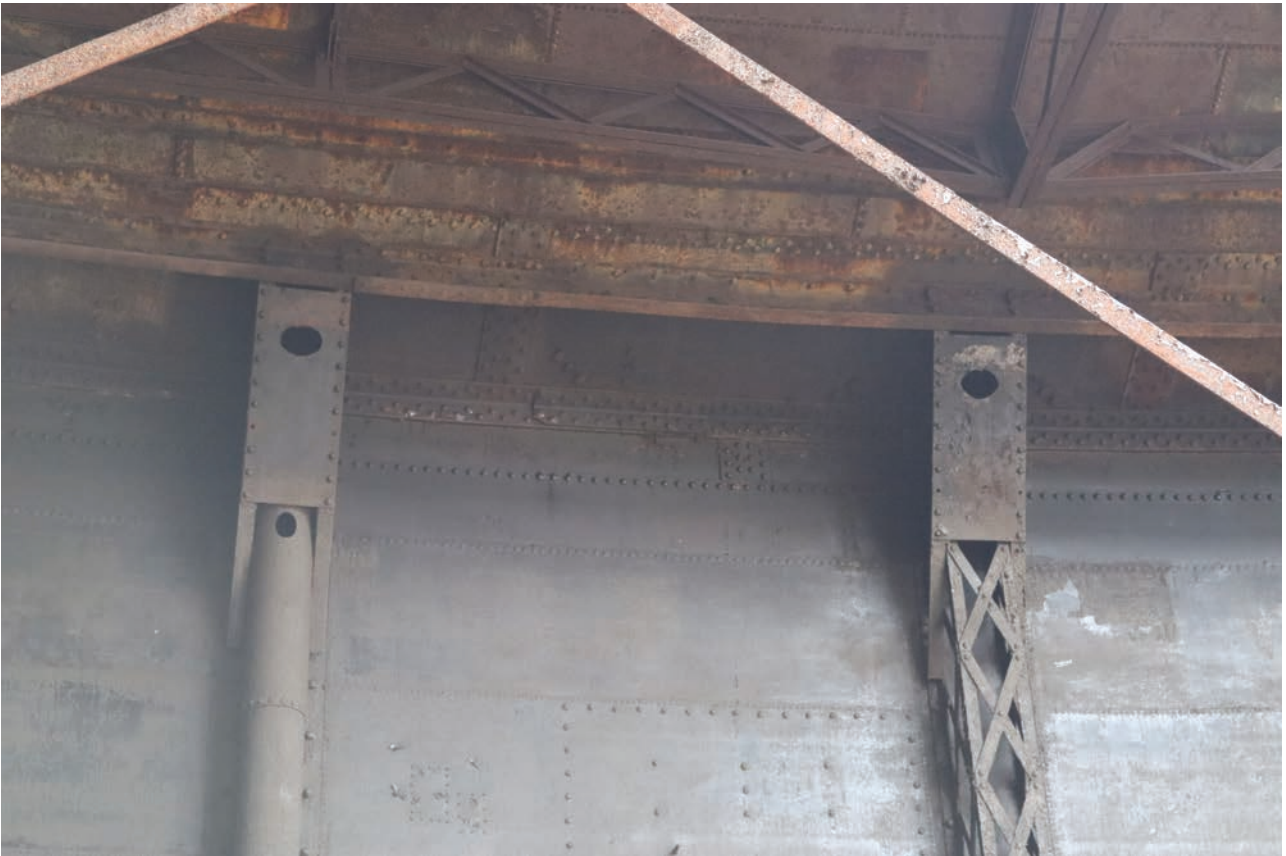
Plate 117: Gasholder No 5, detail view of the steel sheet riveted to the crown and triangular brackets adding rigidity to the top curb, from the south-west

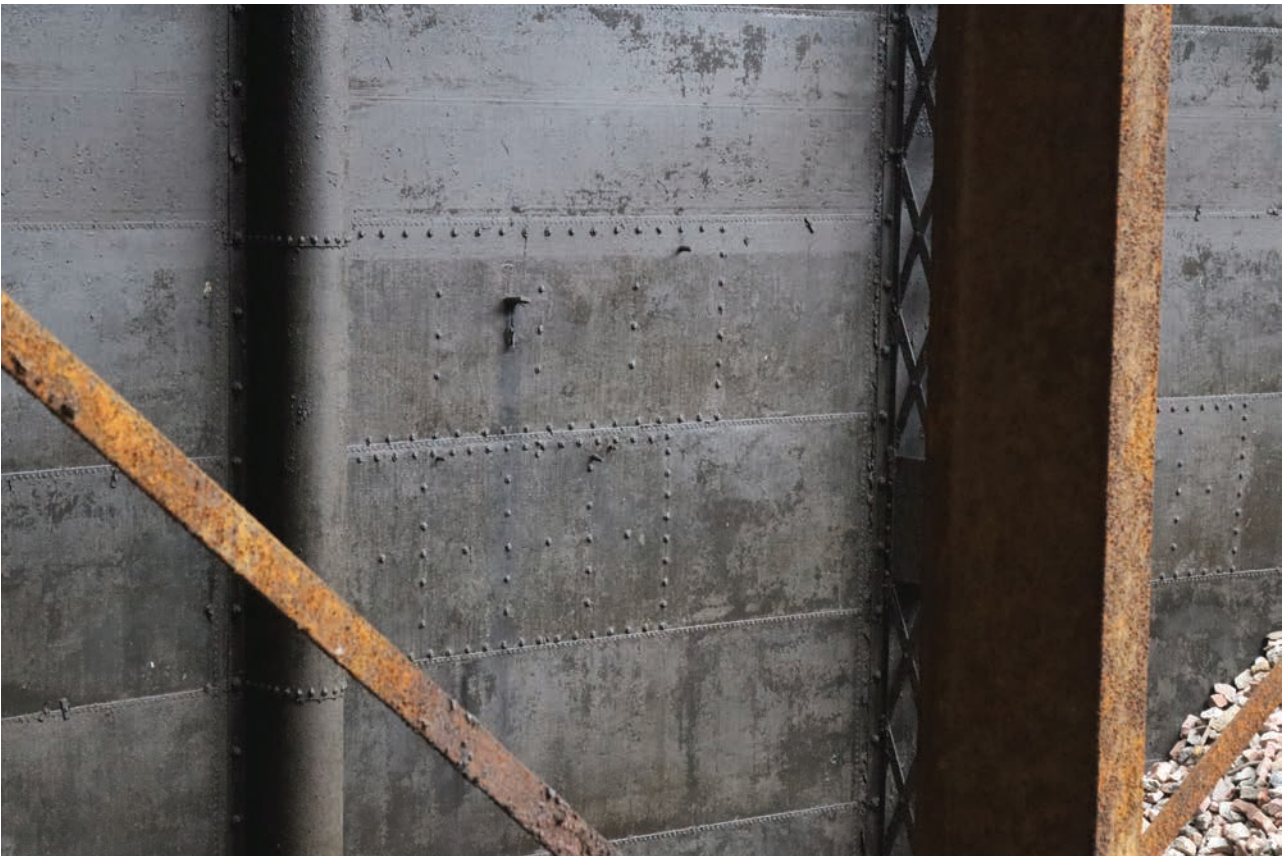
Several areas of bolts forming a pattern were located on the north side of the crown lift wall interior during the Phase II works (Plate 118). The bolts may have marked the location of a previous fixture that has since been removed or an area of repair that had been added to the outer face of the wall.

Plate 118: Gasholder No 5, detail view of unidentified use bolt arrangements on the north-east side of the top lift wall interior base, from the WSW

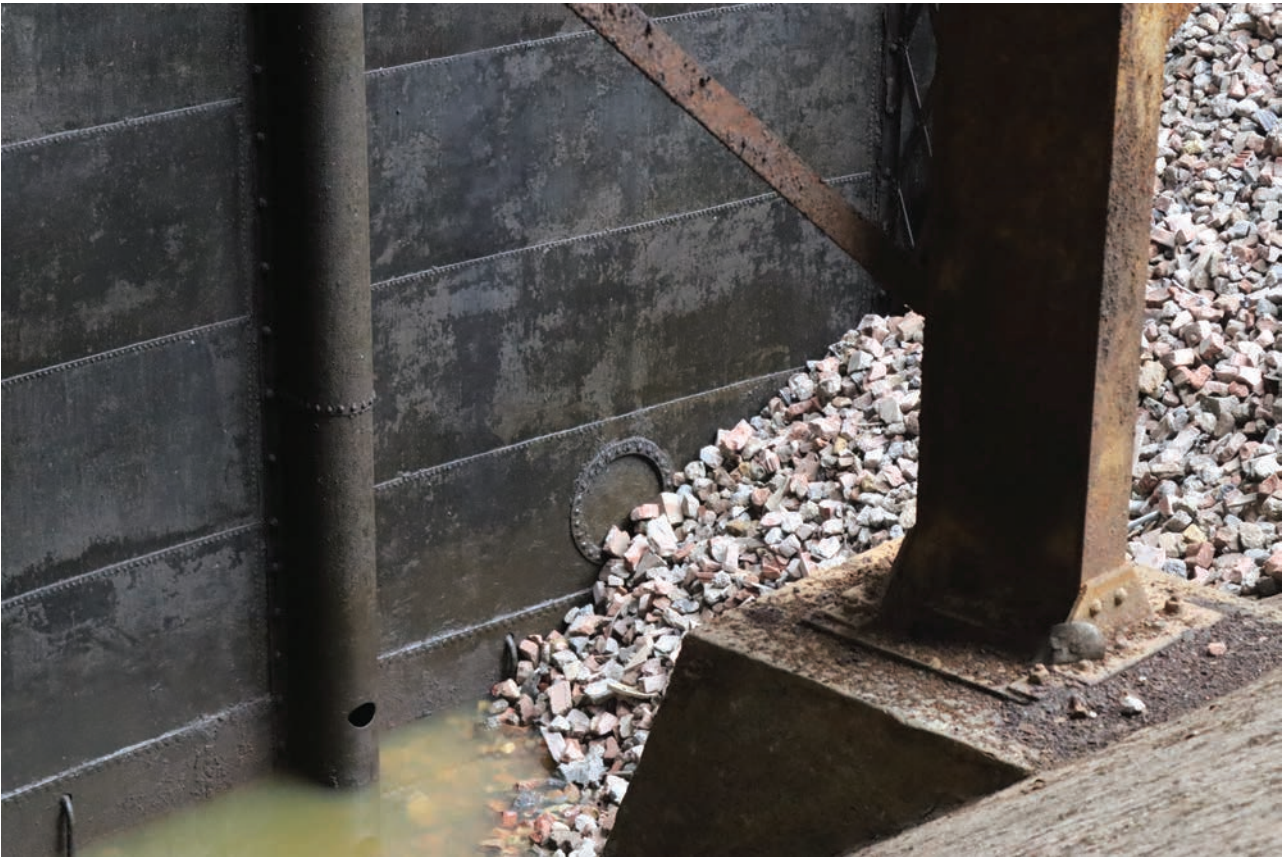
Two cotter plates were present on the north and WSW sides of the base of the crown lift wall, which were assumed to have been for access during construction and maintenance works. Several pipes related to the water levels in the cups were also present at the base of the wall (Plate 119).

Plate 119: Gasholder No 5, detail view of cotter plate and water regulating grip pipe at the base of the top lift wall interior, from the WSW

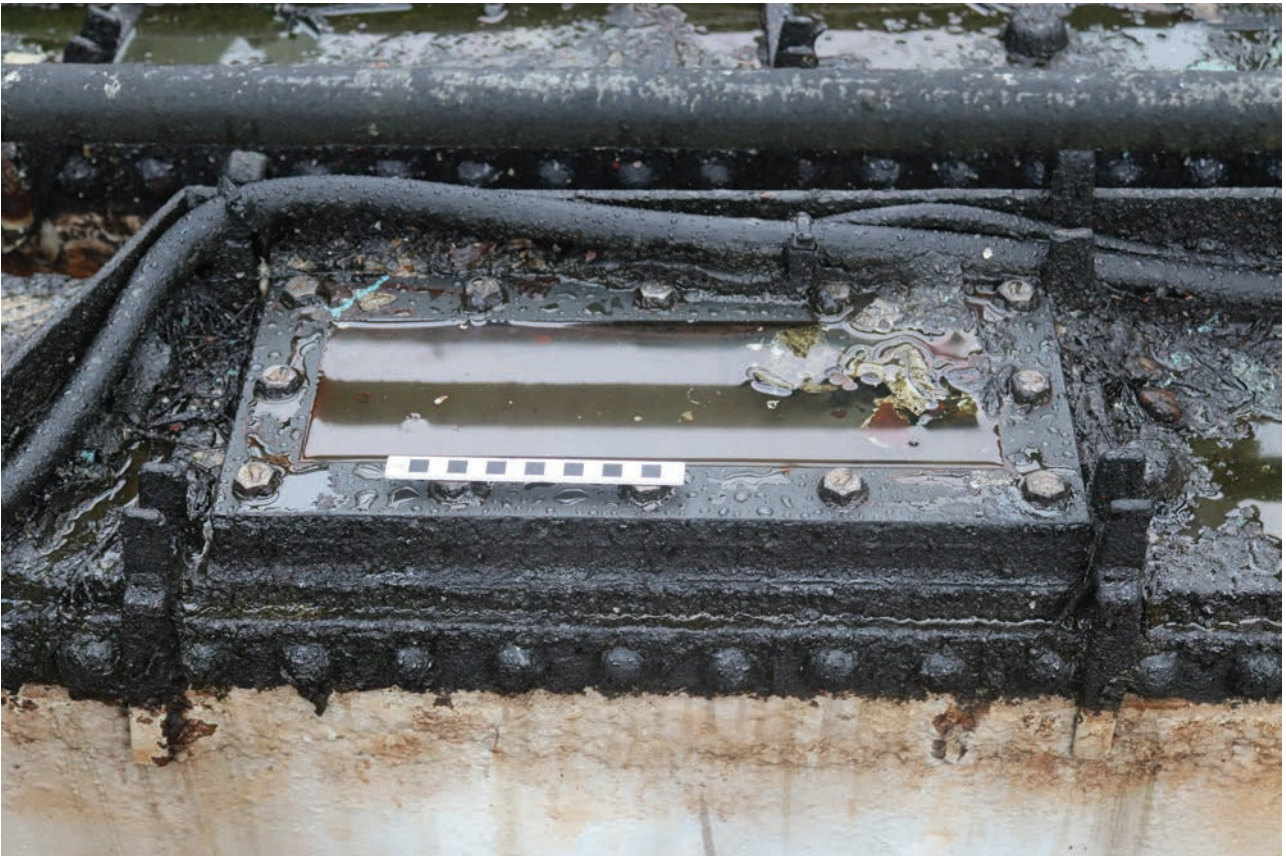
The holder was oil-filmed so there were regular oil wells on the lift tops and in some places glass windows which were presumed to be for viewing within the cup and grips (Plates 120 & 121). The safety handrails on the lift tops were continuous around the holder except for the only access platform onto the crown which is situated between standards 4 and 5, and between standards 26 and 27 where they have been cut during the dewatering works (Plates 122 and 123).

Plate 121: Gasholder No 5, detail view of cup-and-grip viewing window, from the east

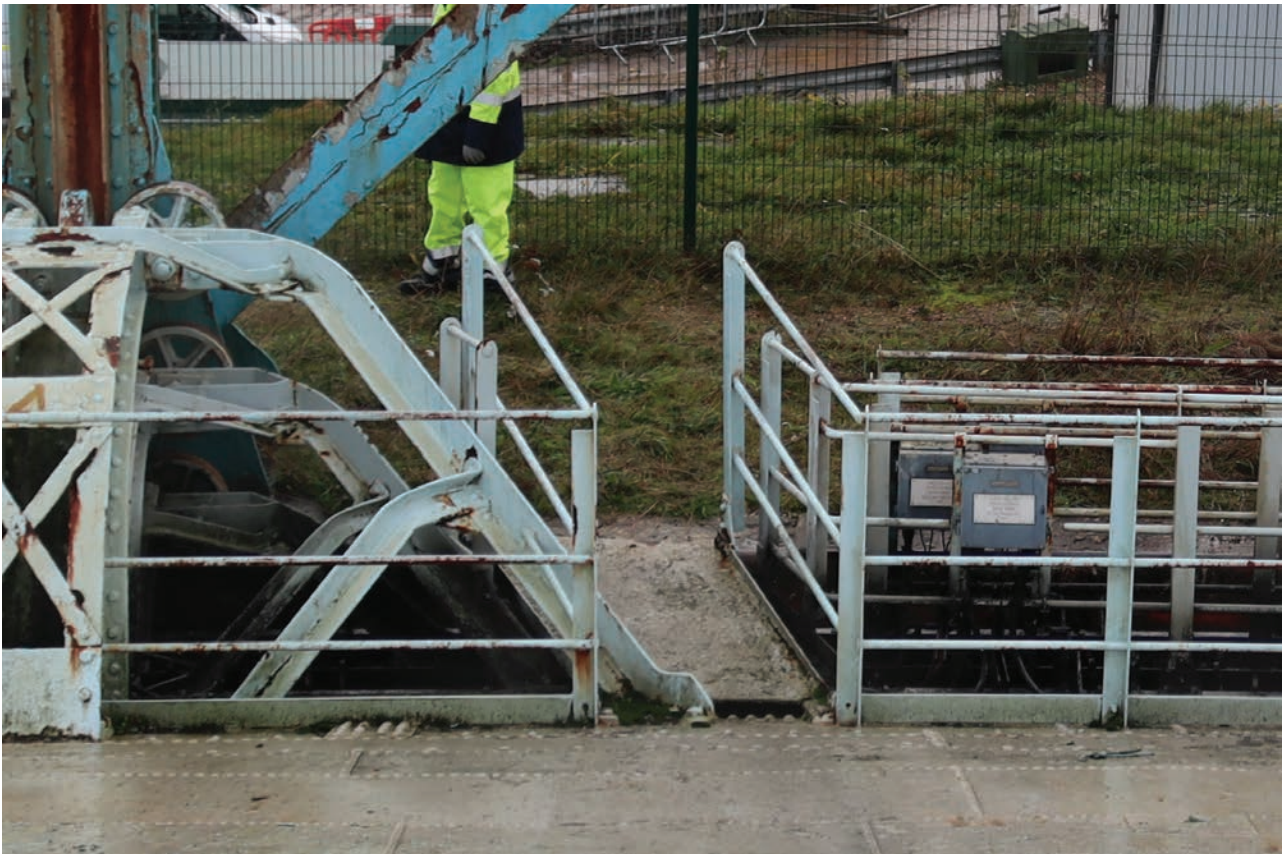
Plate 122: Gasholder No 5, detail view of platform access onto the crown between standards 4 and 5, from the NNE

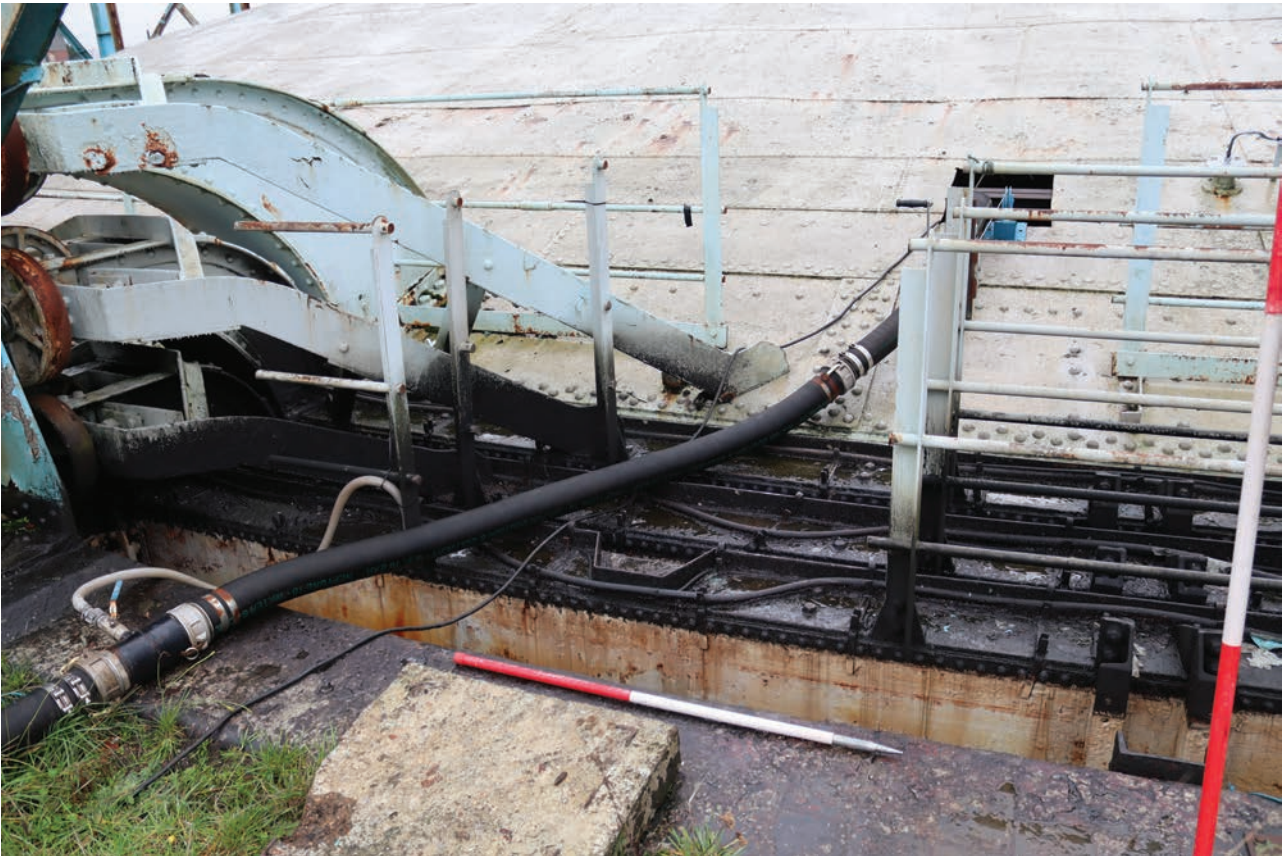
Plate 123: Gasholder No 5, detail view of cut handrails between standards 26 and 27 related to dewatering works, from the SSE

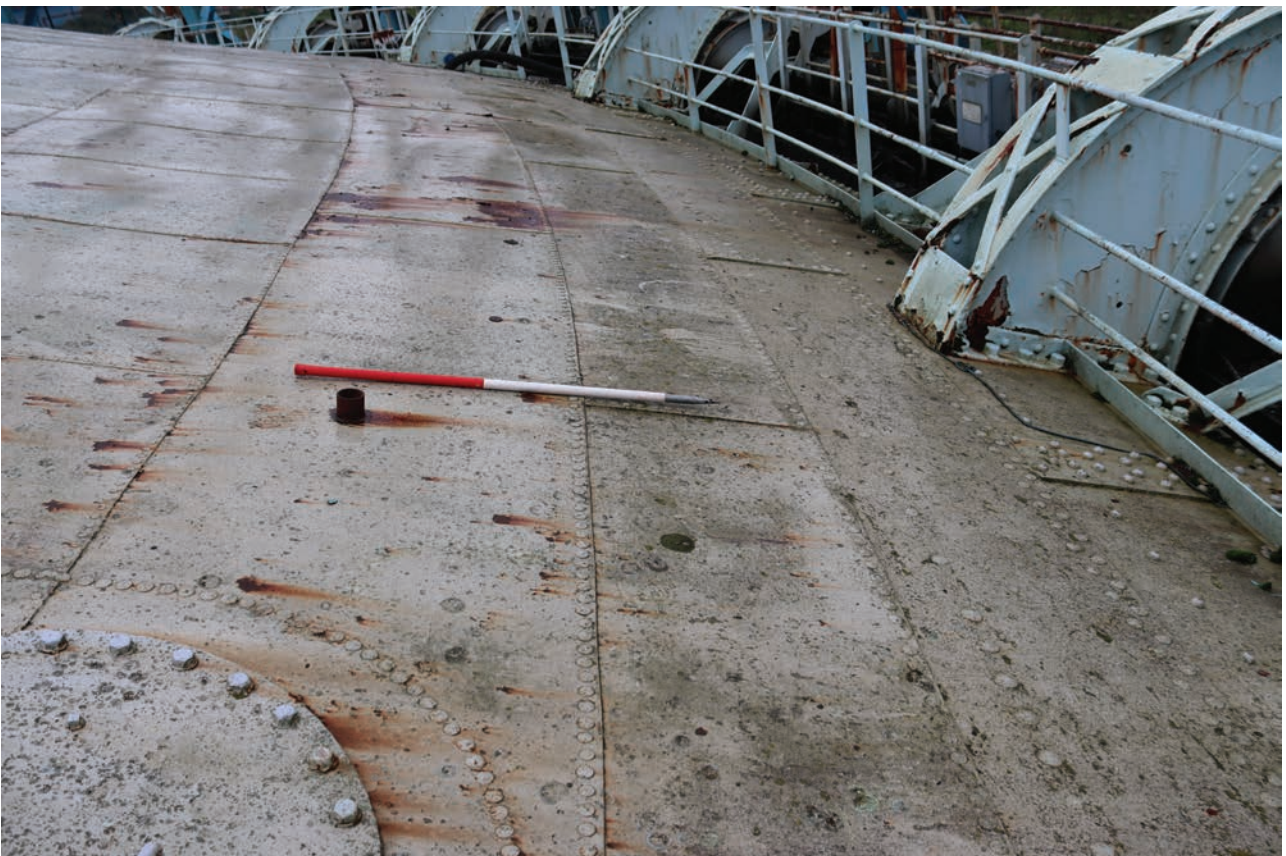
Now removed, the crown was constructed of trapezoidal and rectangular steel sheets riveted together to form a dome with a rise of 5.5m (Figures 37 & 41; Plate 124). They were arranged in seventeen rings of vertically-aligned sheets, with a central circular sheet, and four rings of horizontally-aligned sheets at the outside of the crown. At the top curb there were larger sized rivets than those on the other rings and there are also additional lines of rivets. The two outermost rings had additional sheets overlying each joint (Plate 125). These design features strengthened the top curb which was the most highly pressured point of the structure.

Plate 124: Gasholder No 5, detail view of rectangular riveted sheets of the crown, from the west

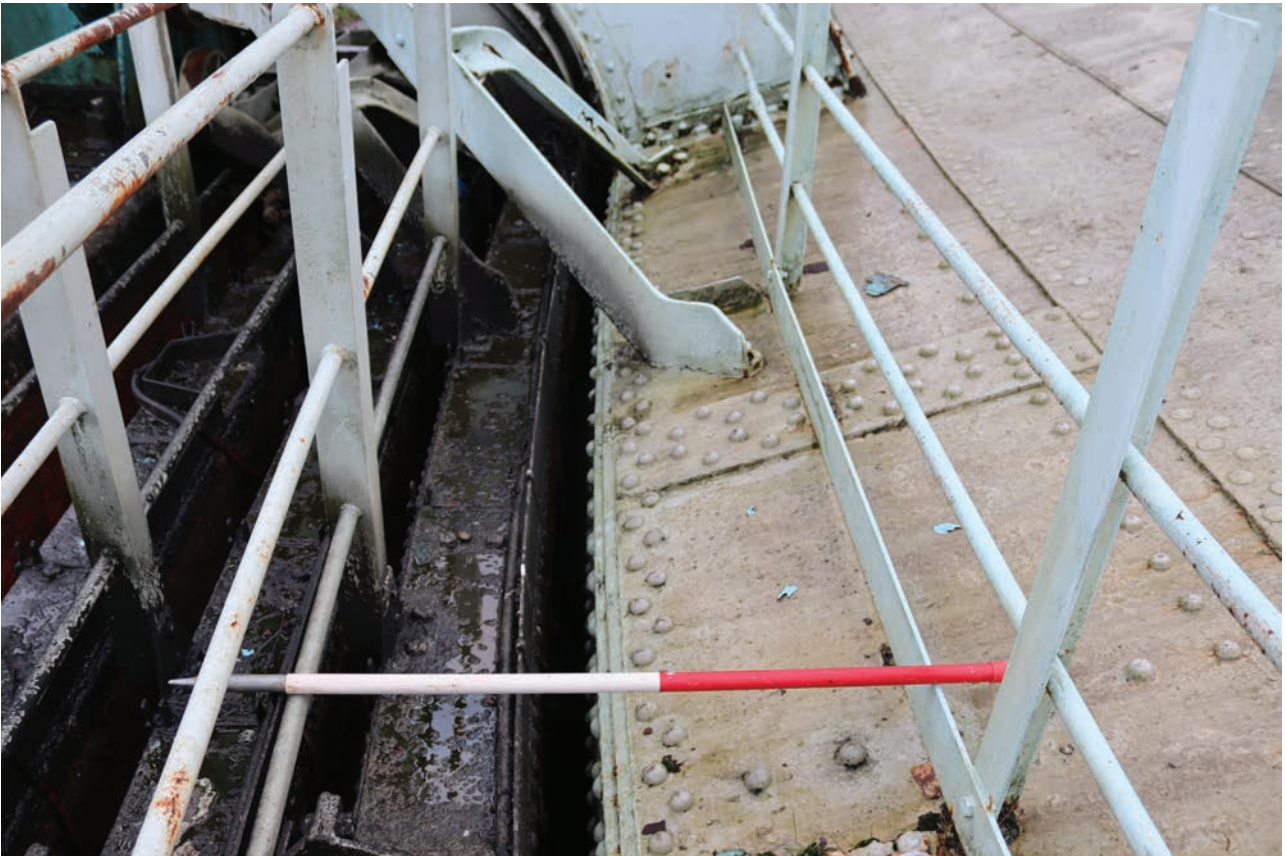
Plate 125: Gasholder No 5, detail view of larger rivets and additional sheeting over joints at the curb, from the NNW

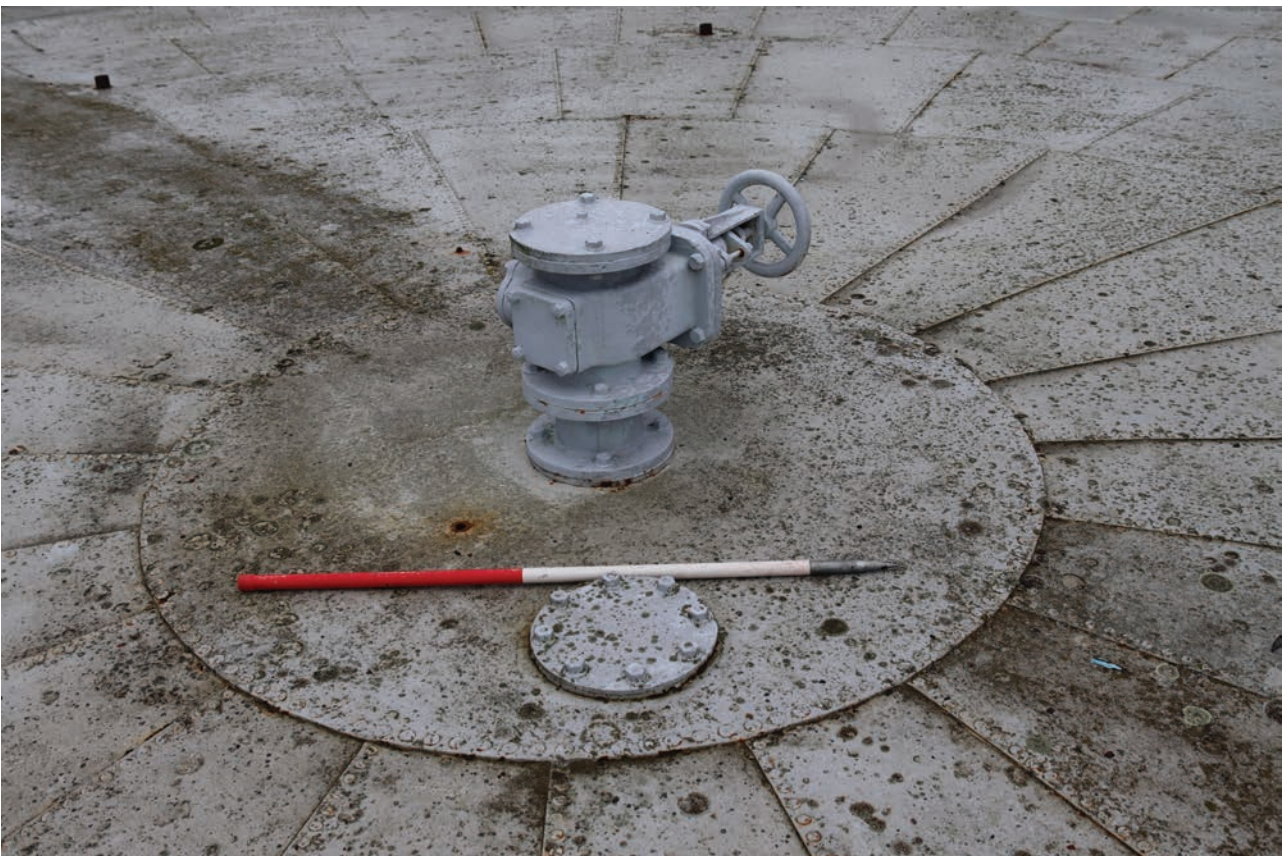
Crown vents were present in the centre of the crown and near the top curb in several places (Plates 126 & 127). The central crown vent had a pipe connected to it on the interior of the bell, noted during the Phase II works (Plate 128).

Plate 126: Gasholder No 5, detail view of the centre of the crown showing circular steel sheet and crown vent, from the west

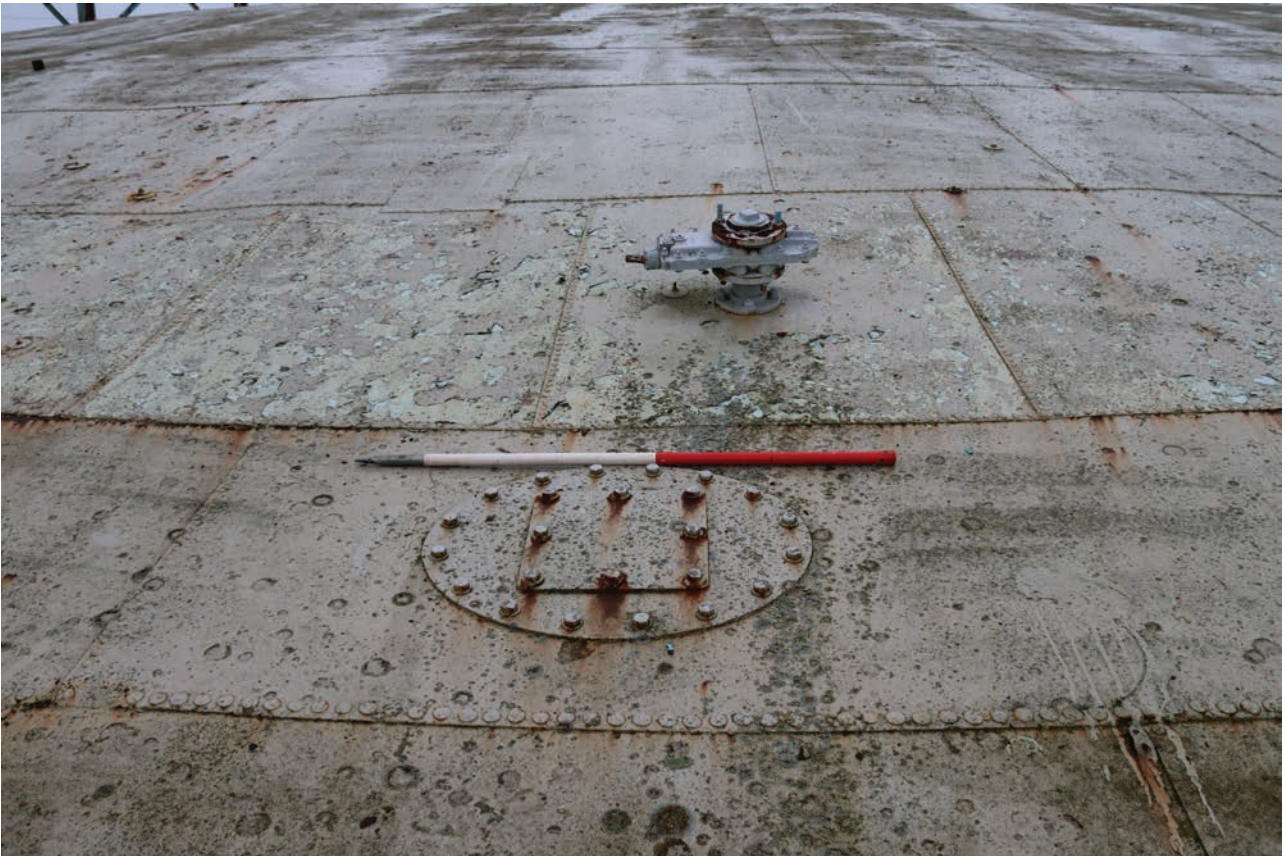
Plate 127: Gasholder No 5, detail view of crown vent and cotter plate on the south-west edge of the crown, from the south-west

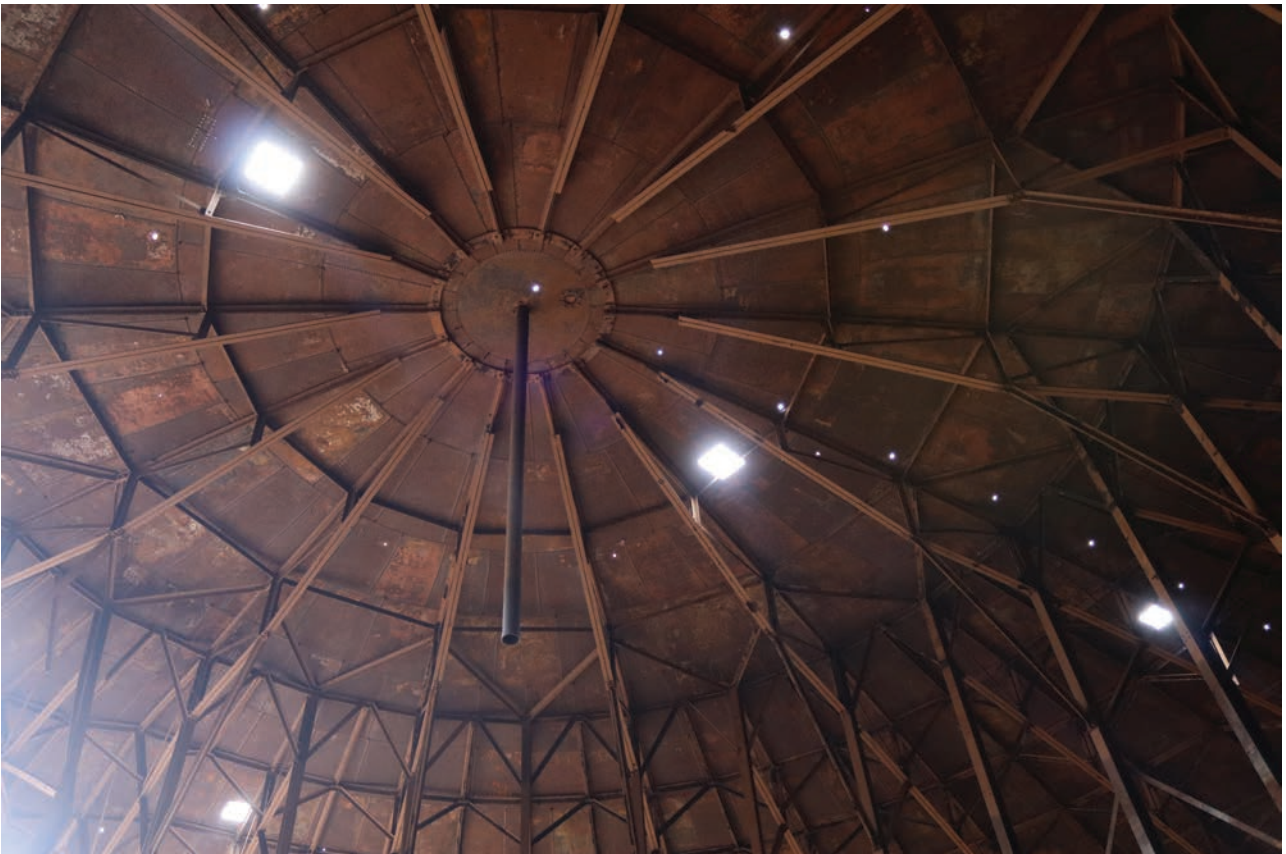
Plate 128: Gasholder No 5, detail view of pipe within the bell connected to the central crown vent on the exterior, from the north

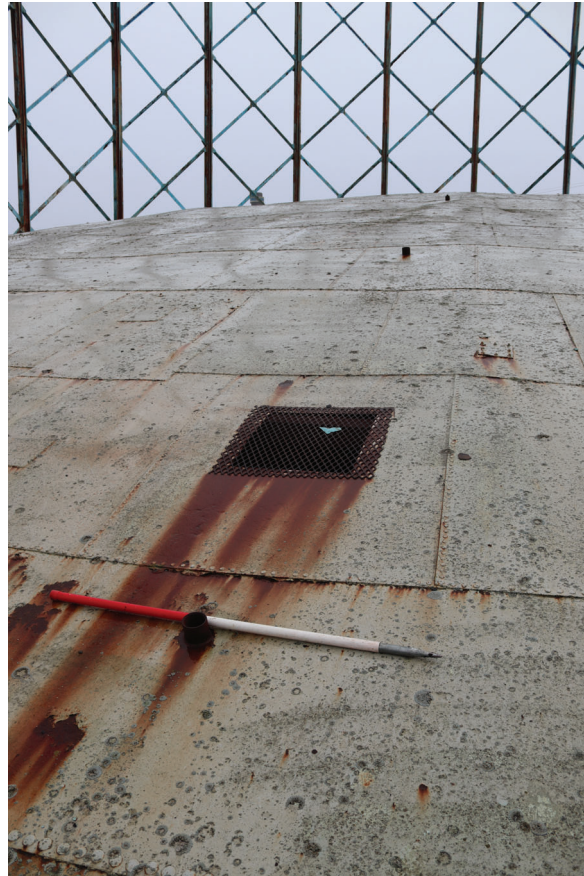
Plate 131: Gasholder No 5, detail view of holes and purge points added to the crown during decommissioning works, from the south-east

The crown also had several holes cut into it and purge points which were added during the decommissioning works (Plate 131). The crown had many areas of repair across it including welded sheets of various sizes and small bolted circles (Plates 132 & 133).
