Gasholders Nos 4 & 5, Factory Lane, Croydon, London: Historic Building Recording Final Report

*AOC Project No: 23686_V
3rd August 2021*

On Behalf of:	SGN 2 Woodstock Road Yarnton OX5 1NY
National Grid Reference (NGR):	Gasholder No 4: TQ 31212 65907 Gasholder No 5: TQ 31169 65975
AOC Project No:	23686_V
OASIS No:	411878
Prepared by:	Diana Sproat Gemma Hudson
Illustration by:	Gemma Hudson Jamie Humble Sam O'Leary
Date of Fieldwork:	16th – 18th December 2020 (Phase I) 5th May & 7th July 2021 (Phase II)
Date of Report:	3rd August 2021

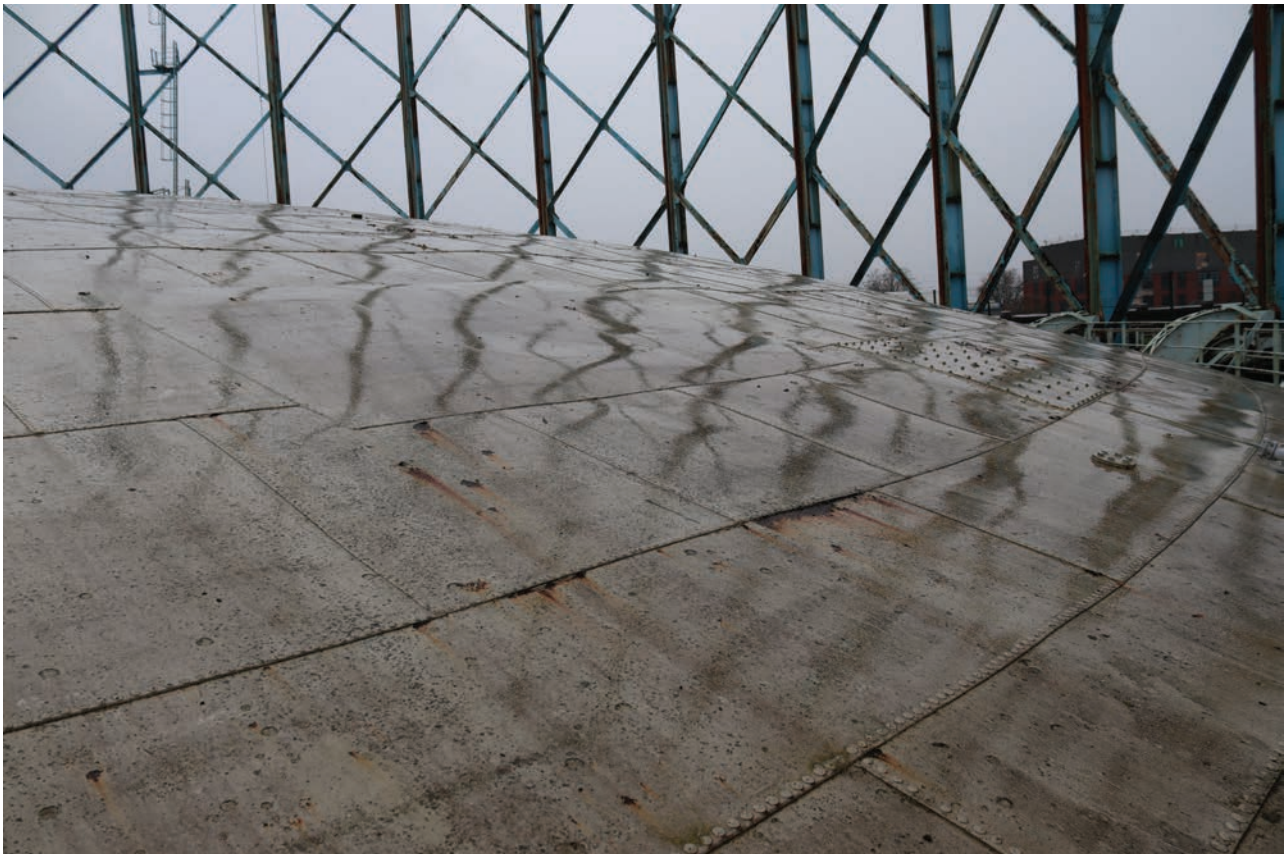
The crown also had several holes cut into it and purge points which were added during the decommissioning works (Plate 131). The crown had many areas of repair across it including welded sheets of various sizes and small bolted circles (Plates 132 & 133).

Plate 132: Gasholder No 5, detail view of different sheet repairs, from the east

- 10.7 Safety was a priority on site with handrails built on the lift tops during the 1990s and remote automation systems allowing for less need to go onto the holder. The areas of repair to the crown of Gasholder No 5 show that the system was well maintained.

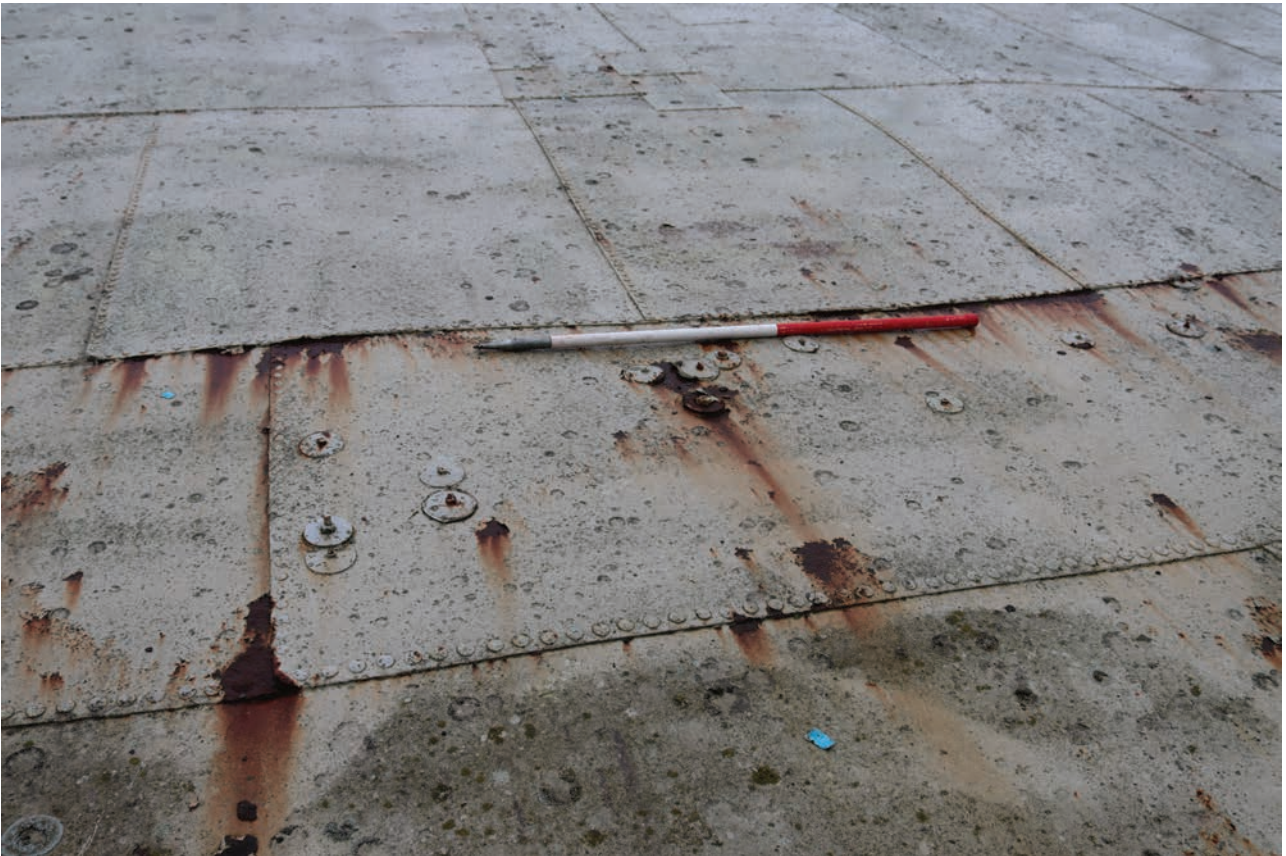
Plate 133: Gasholder No 5, detail view of small bolted circle repairs, from the SSW

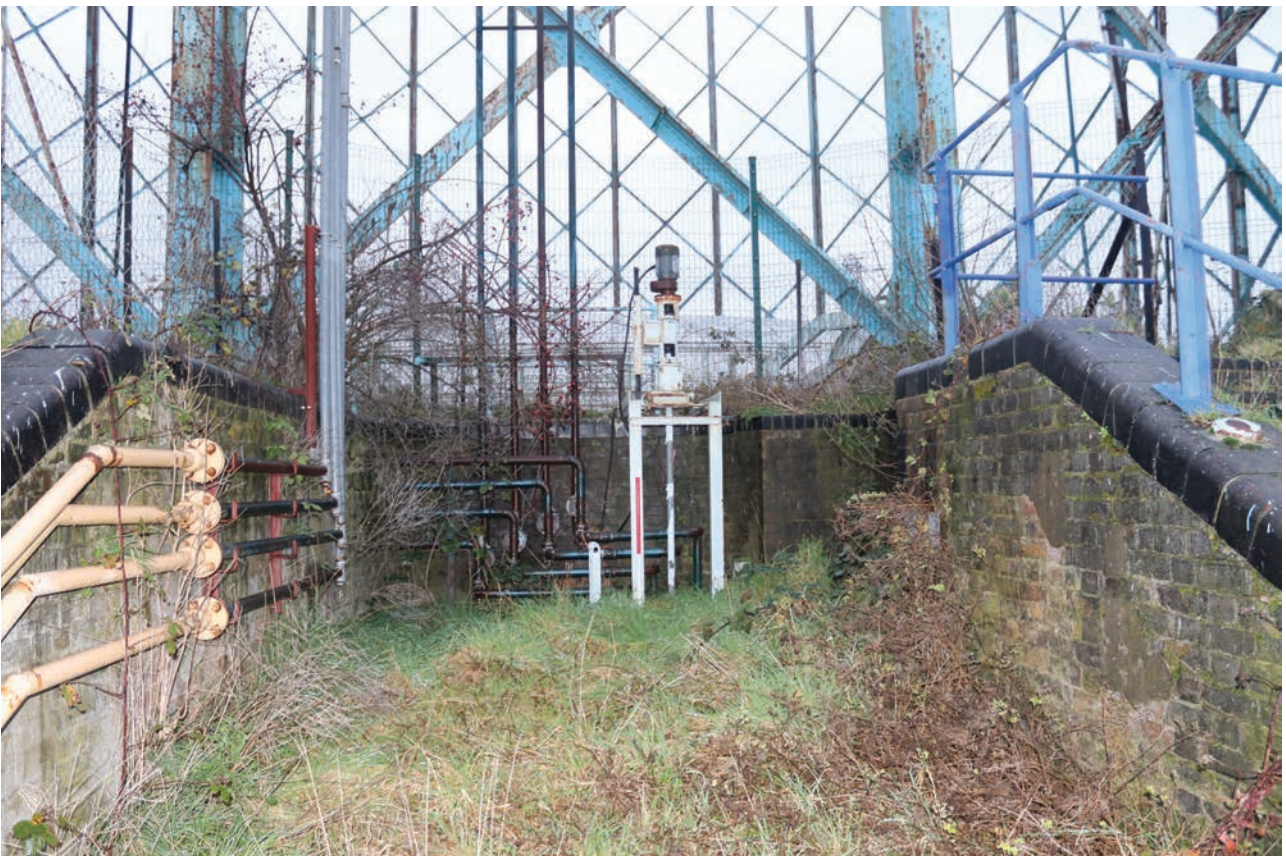
Plate 134: Gasholder No 5, detail view of horseshoe-shaped brick-walled area of pipework to the south of the holder, from the south

8.5.1 The gas inlet and outlet pipes were situated on the south of the holder as shown by the previously mentioned cotter plates. To the direct south of the holder was a horseshoe-shaped brick-walled area housing various pipework some of which was presumed to be linked to the inlet and outlet (Figure 31; Plates 134 & 135).

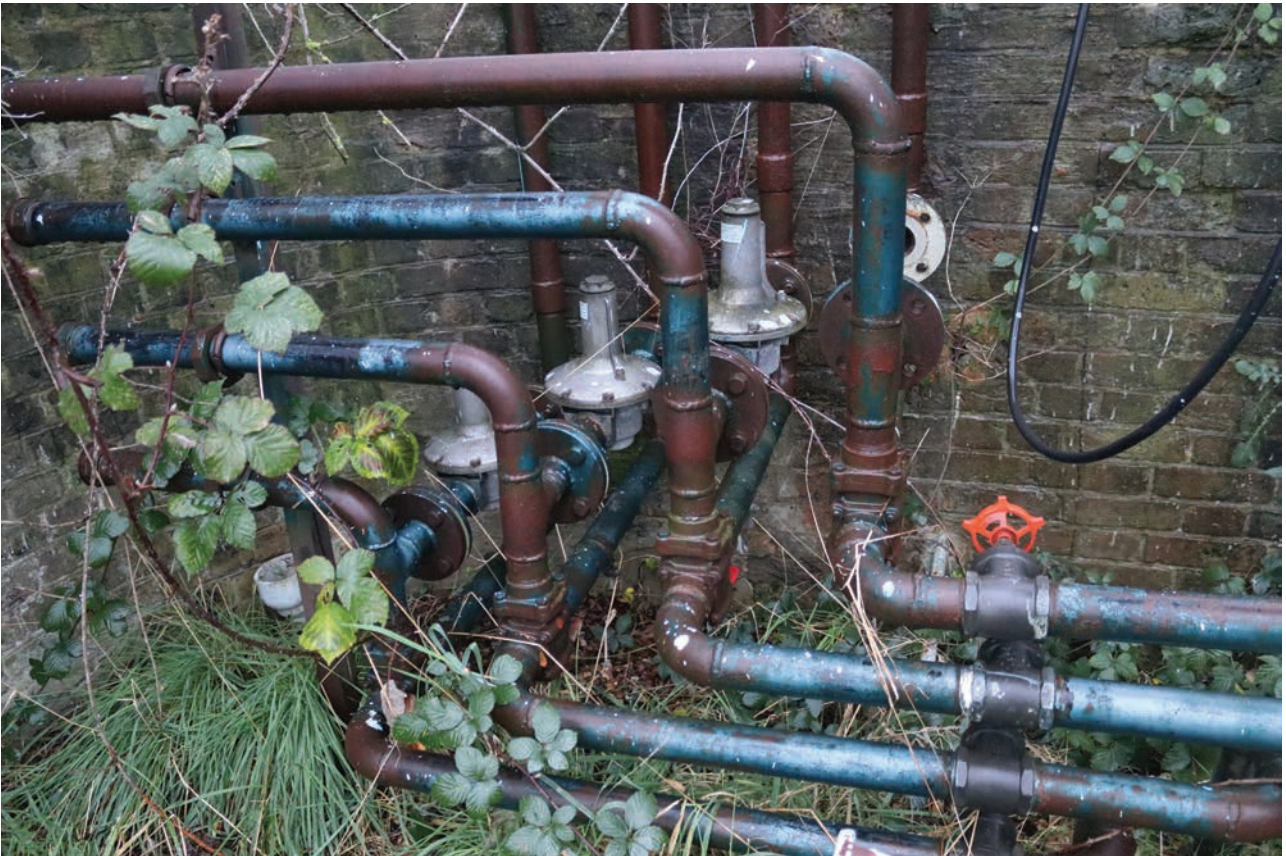
Plate 135: Gasholder No 5, detail view of pipework with small diaphragms, from the SSE

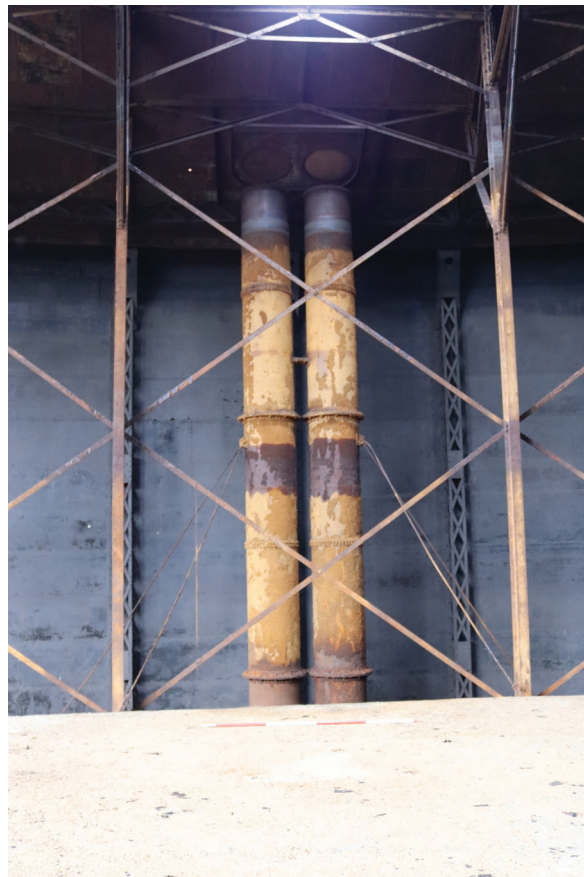
Plate 136: Gasholder No 5, general view of the gas inlet and outlet pipes within the bell with supporting struts, from the north

8.5.2 Within the tank the pipes were also situated on the south side of the holder near the outer edge of the tank, as noted during the Phase II works. The visible areas of pipe were 0.95m wide comprised of rolled steel, cylindrical lengths riveted together in pairs with bolted flange joints connecting the pairs (Figure 38; Plate 136). The pipes were set within the dumpling and were supported via four steel bars bolted to the sides of the pipes and the dumpling.

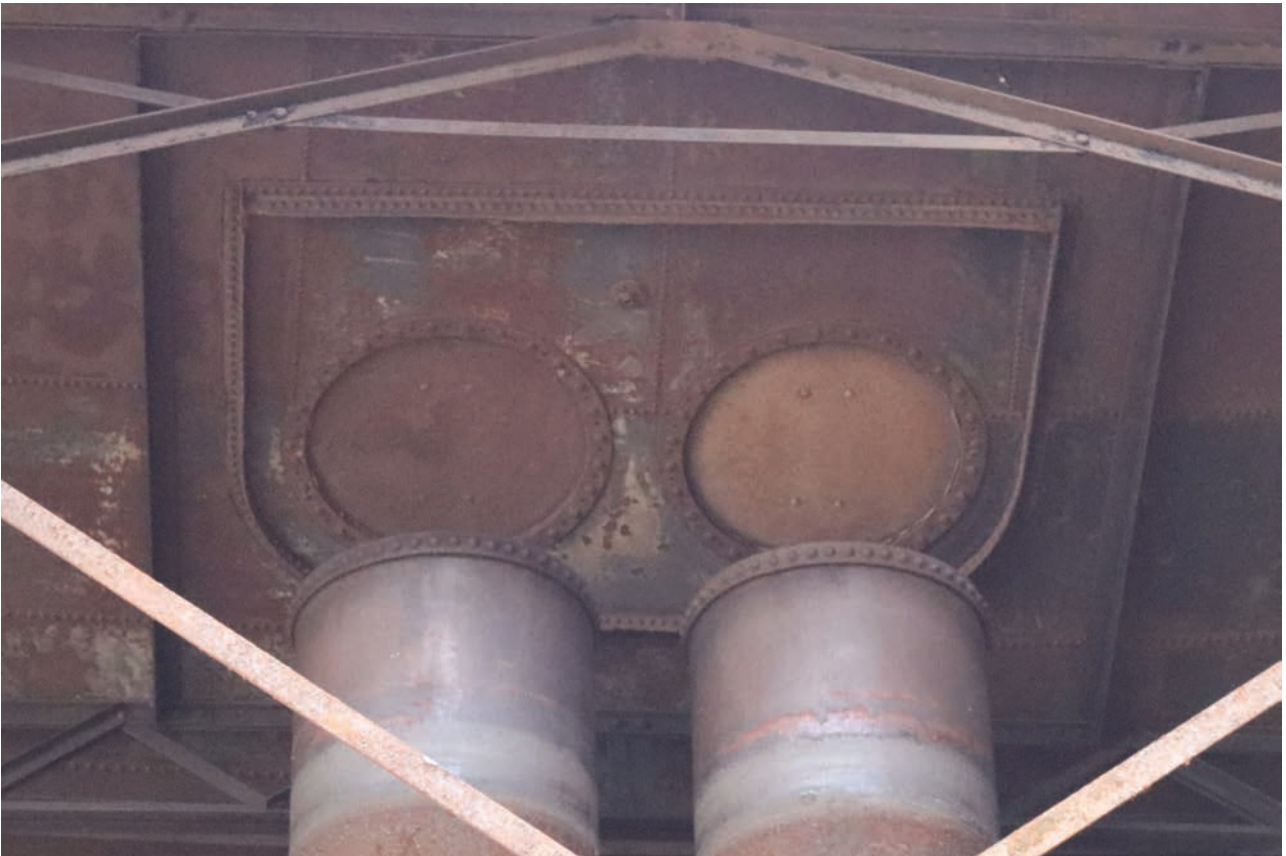
Plate 137: Gasholder No 5, detail view of inspection cotter plates and D-shaped surrounding support above the gas inlet and outlet pipes, from the north

8.5.3 The inspection cotters plates previously mentioned were visible from within the tank along with a D-shaped surround riveted to the crown (Figure 39; Plate 137). The surround may have helped support the crown at a highly pressured point.

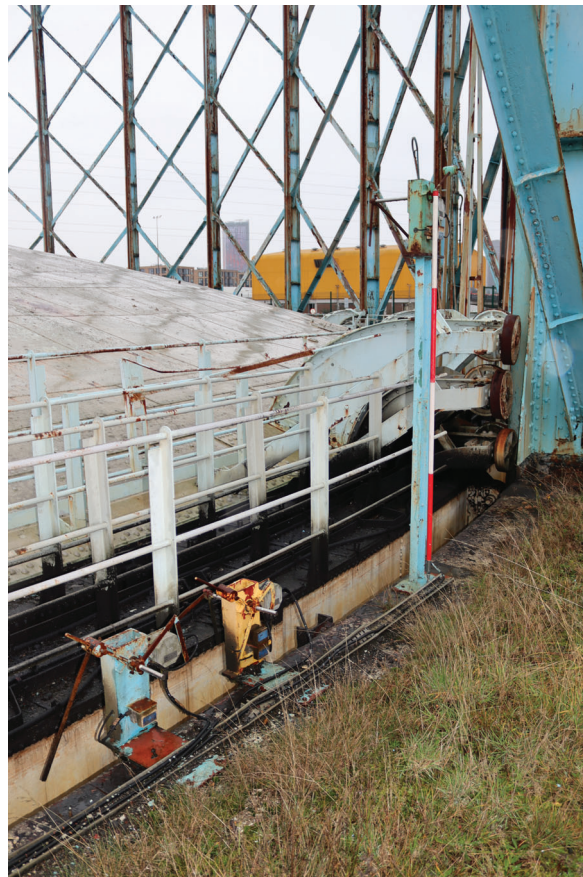
Plate 138: Gasholder No 5, detail view of low, high and sunstock knock-off switches between standards 2 and 3, from the west

Five electrical knock-off switches were present on the gasholder. A low, high and sunstock knock-off was situated on the south-west side between standards 2 and 3 (Plates 138 & 139). An extra high and an extra low knock-off were also situated on the north-east side of the holder between standards 17 and 18 (Plate 140). The striker arms for the low and extra low knock-off switches were still attached to the handrails on the lift tops.

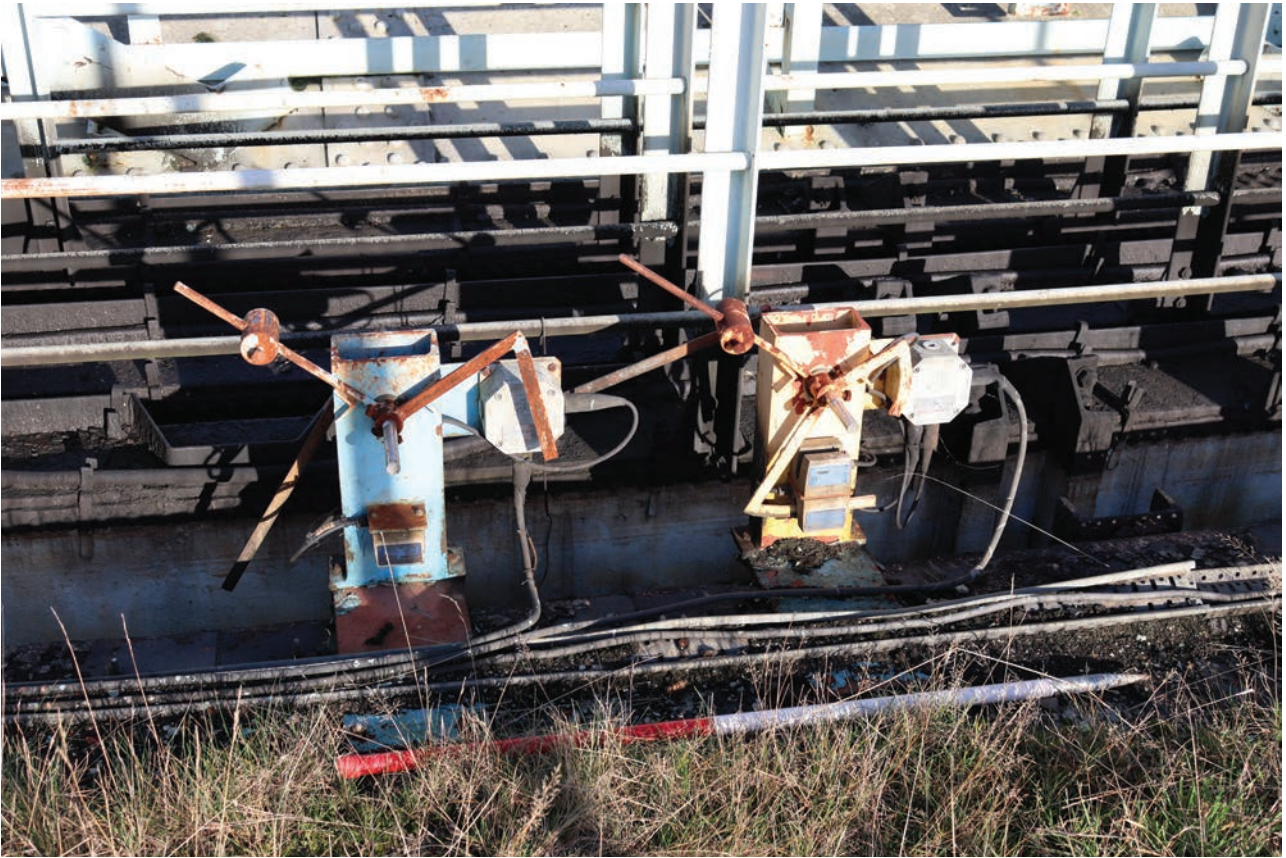
Plate 139: Gasholder No 5, detail view of high and sunstock knock-off switches bolted to the top of the tank, from the SSW

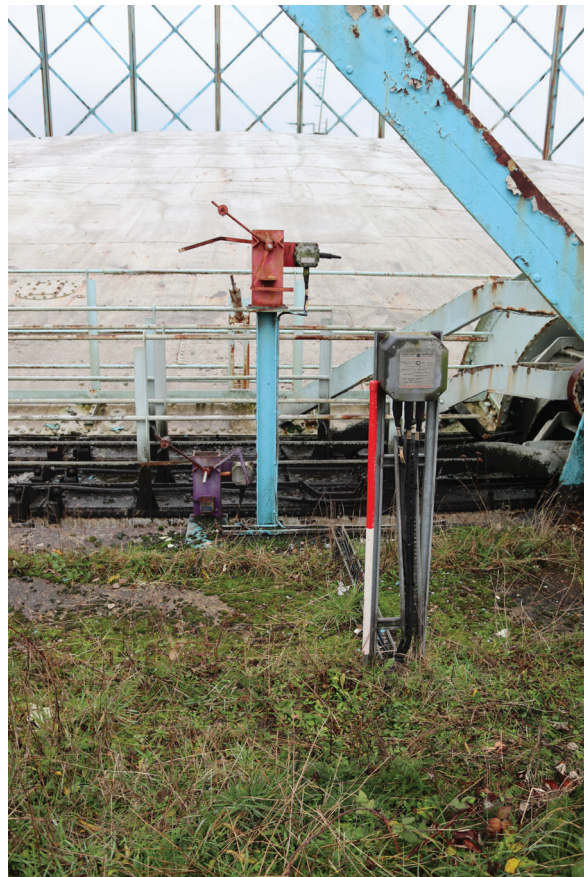
Plate 140: Gasholder No 5, detail view of extra low and extra high knock-off switches between standards 16 and 17, from the NNE

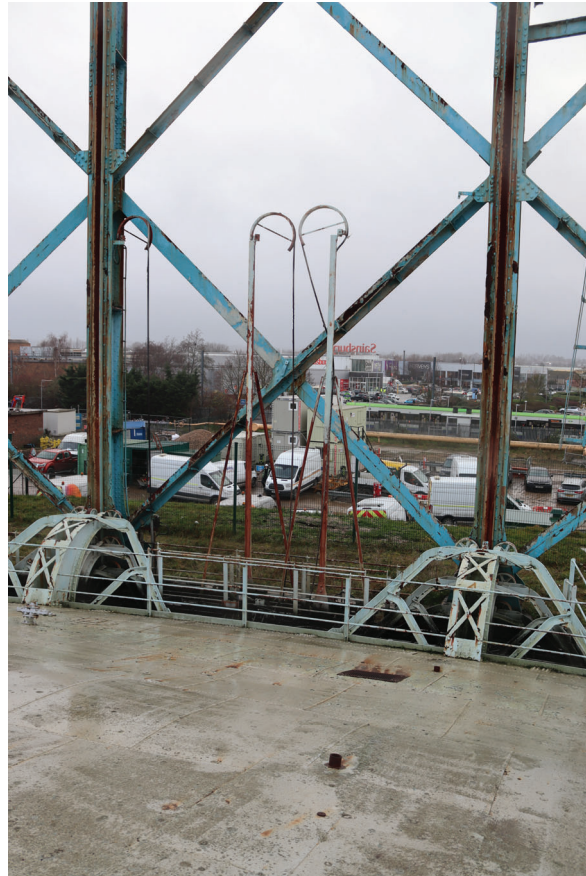
Plate 141: Gasholder No 5, detail view of swan neck fixture situated between standards 3 and 4, from the north

Automated electrical systems existed on the holder related to the water levels in the tank and cup-and-grips, and the anti-freeze system. The systems were comprised of rubber hoses which were either covering electrical cables or carrying a water supply to the necessary area. Swan neck and cage fixtures ensured that the hoses did not tangle as the bell raised and lowered. Electrical panel boxes and float switches were also present (Plates 141–143). The rubber hoses and swan necks were only on the south-west side of the holder, however the electrical boxes were scattered across the holder (Plates 144 & 145).

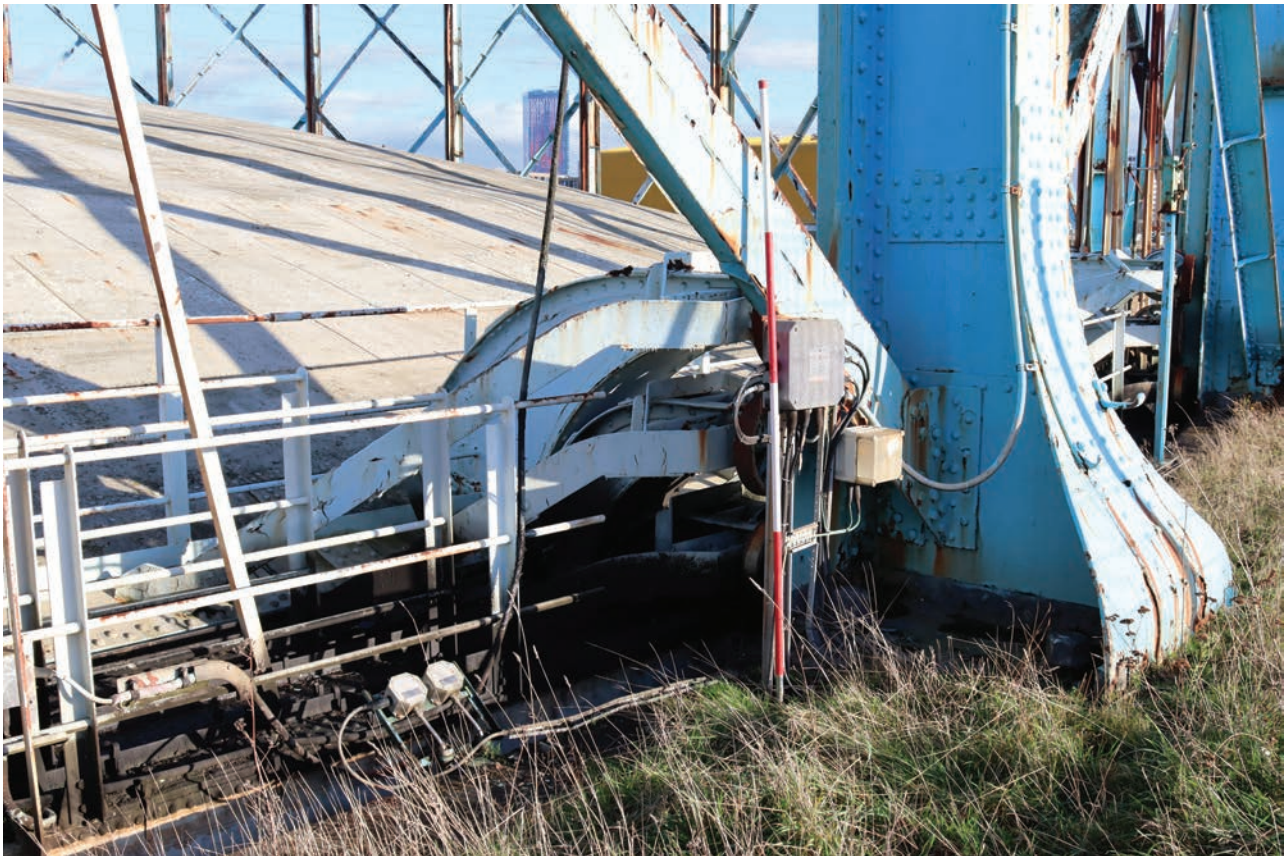
Plate 142: Gasholder No 5, detail view of electrical boxes and float switches on the west side of standard 3, from the WNW

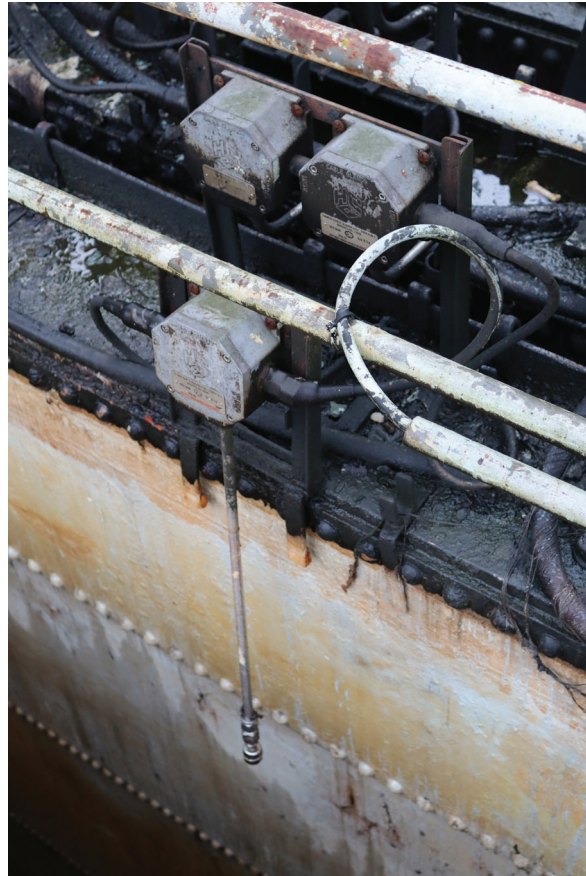
Plate 143: Gasholder No 5, detail view of float switch monitoring the tank water level, from the south-east

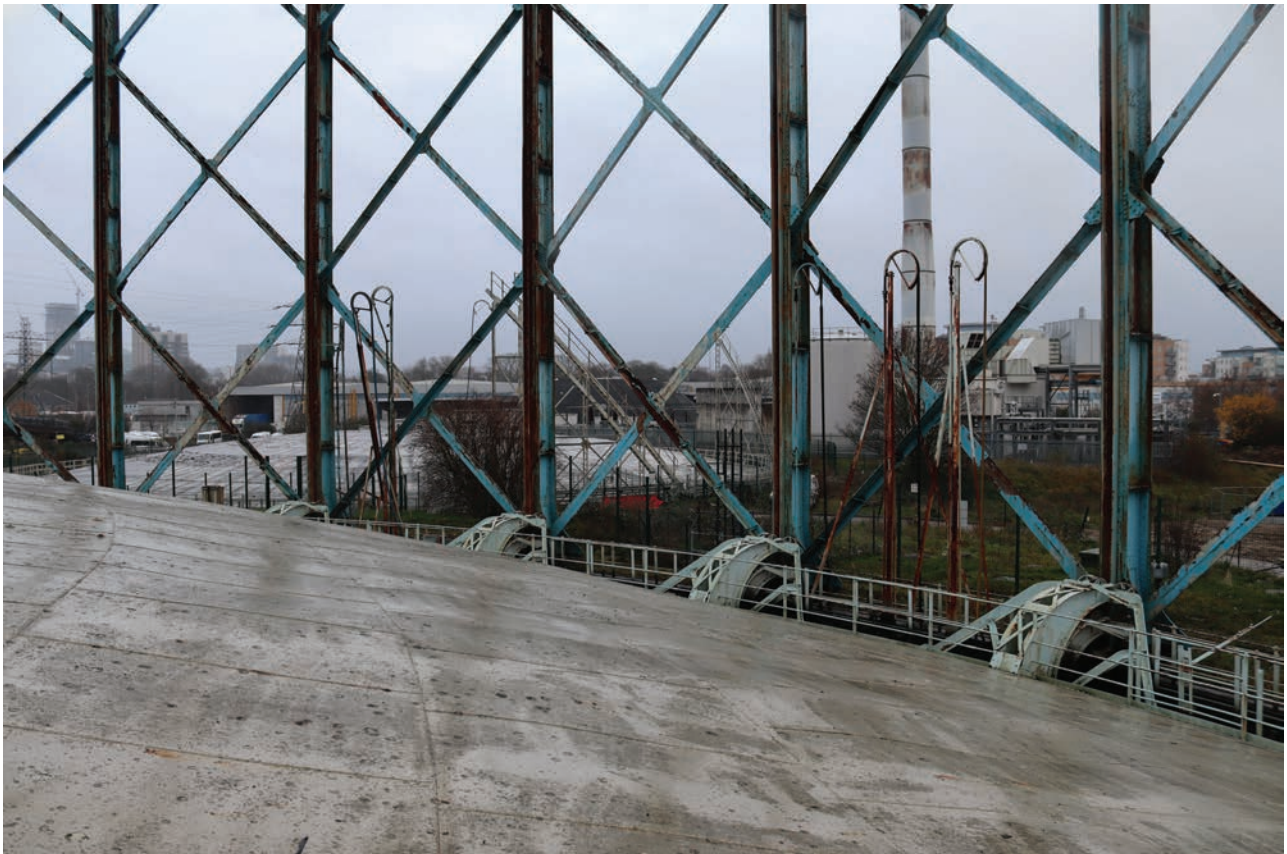
Plate 144: Gasholder No 5, general view of swan neck fixtures between standards 1 and 2, and 27 and 28, from the NNW

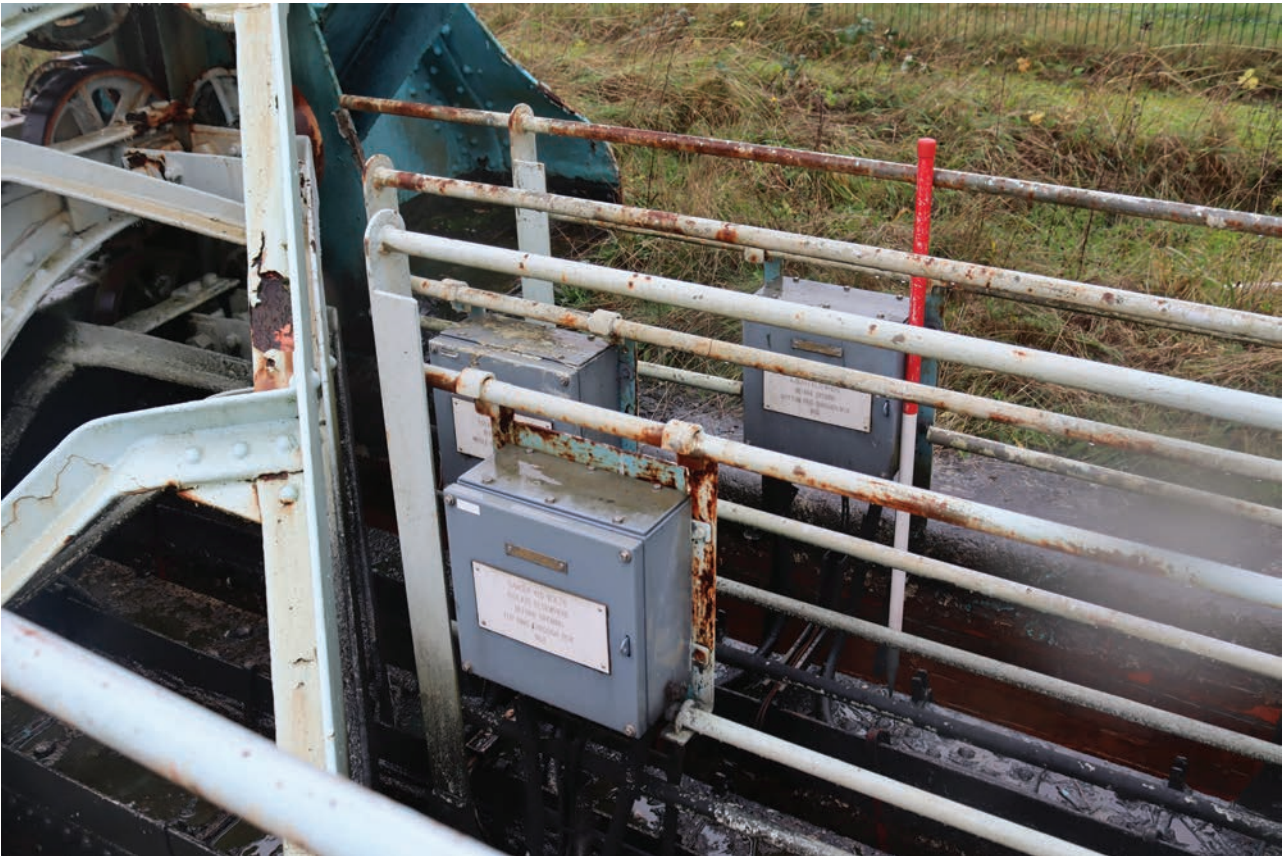
Plate 145: Gasholder No 5, detail view of electrical boxes related to automated systems situated between standards 9 and 10, from the east

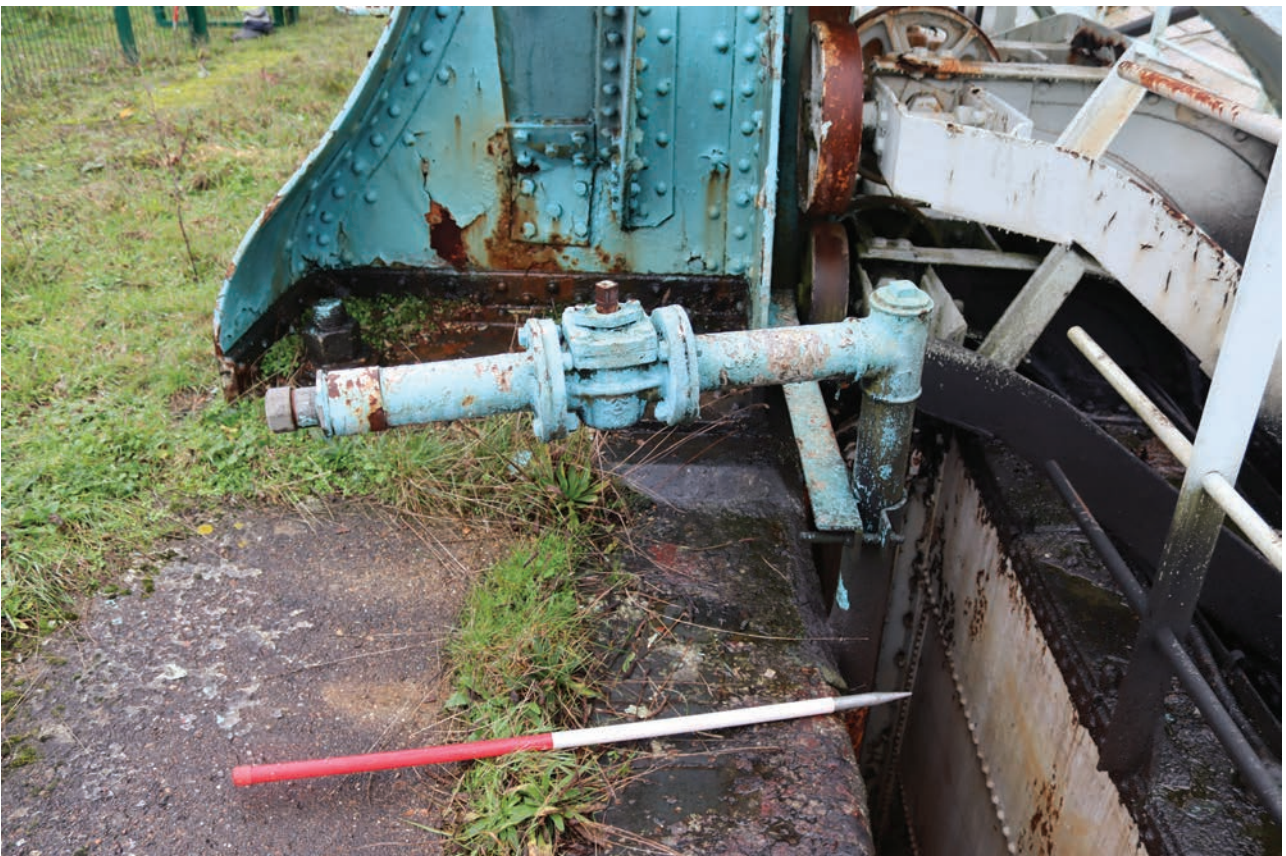
Plate 146: Gasholder No 5, detail view of oil pipe on the east side of standard 26, from the ENE

Pipework used to maintain the oil-film level in the tank was situated on the south-west side of the holder between standards 25 and 26 (Plate 146). A large water pipe to maintain tank water levels was present on the south of the holder between standard 27 and 28 (Plate 147). Additional pipework was present on the south side of the holder between standards 1 and 2 that may have been related to the gas inlet and outlet operations (Plate 148). There were two possible water discharge points between standards 4 and 5, and 25 and 26 (Plates 149 & 150). A valve pit was also present between standards 6 and 7 (Plate 151). Many of the standards have disused hooks to their base on the external side which may have supported pipework previously (Plate 152).

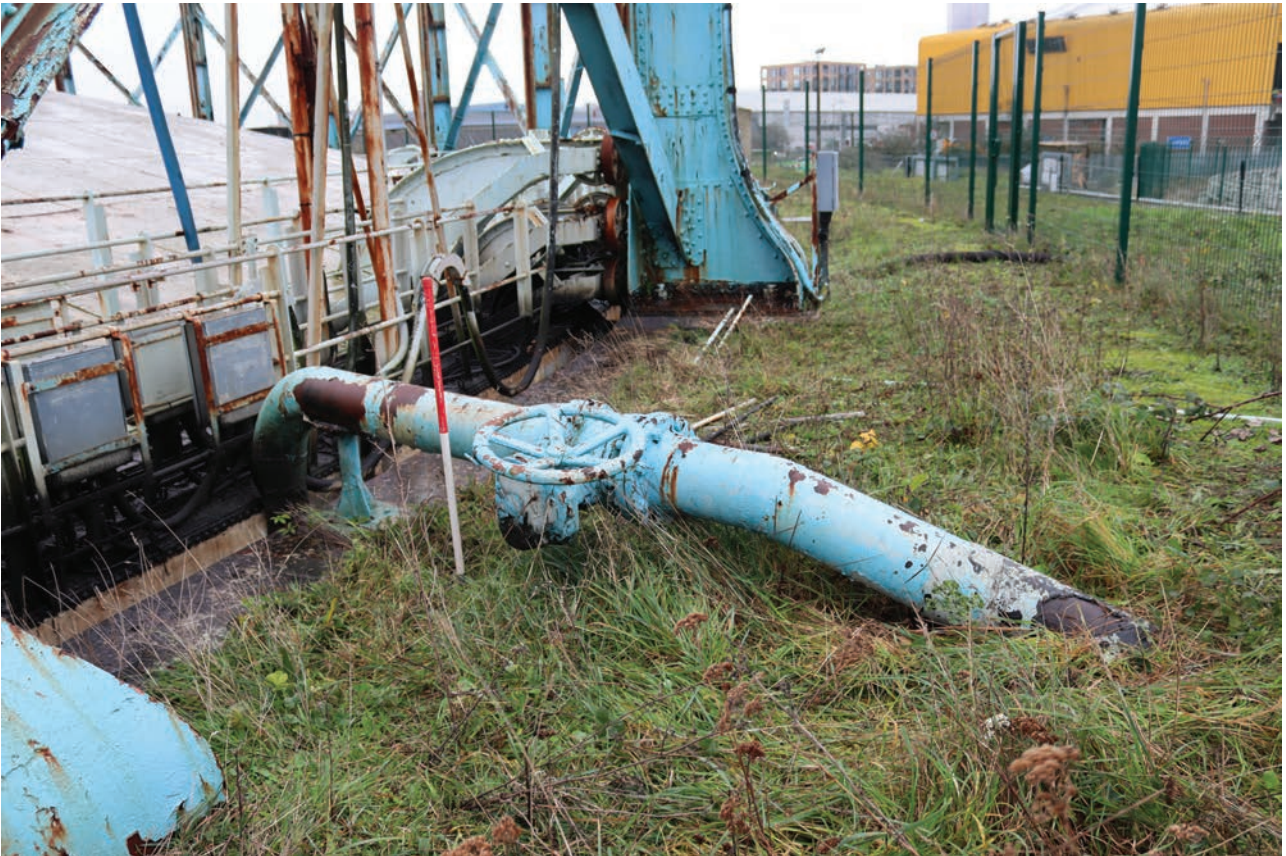
Plate 147: Gasholder No 5, detail view of water pipe between standards 27 and 28, from the south-west

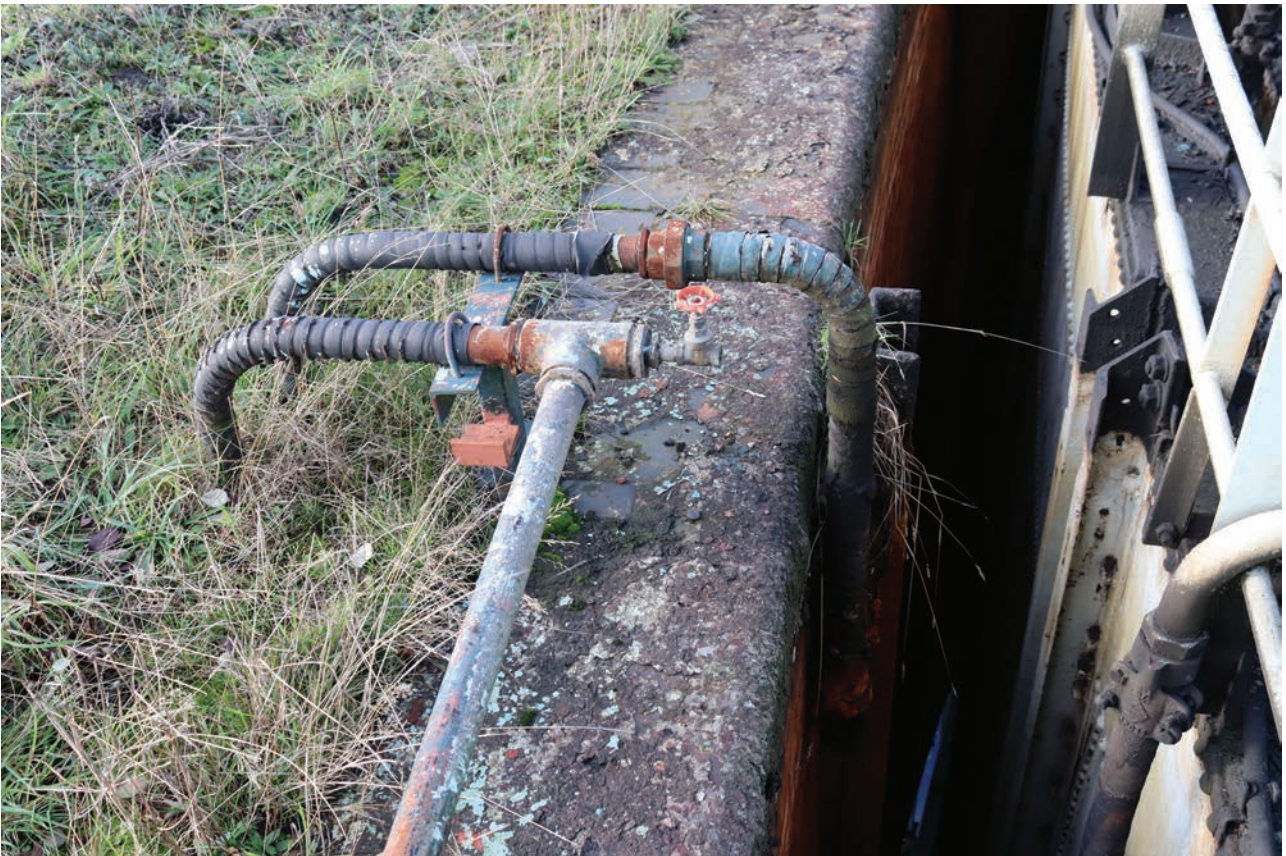
Plate 148: Gasholder No 5, detail view of pipework presumed related to the gas inlet and outlet, from the ESE

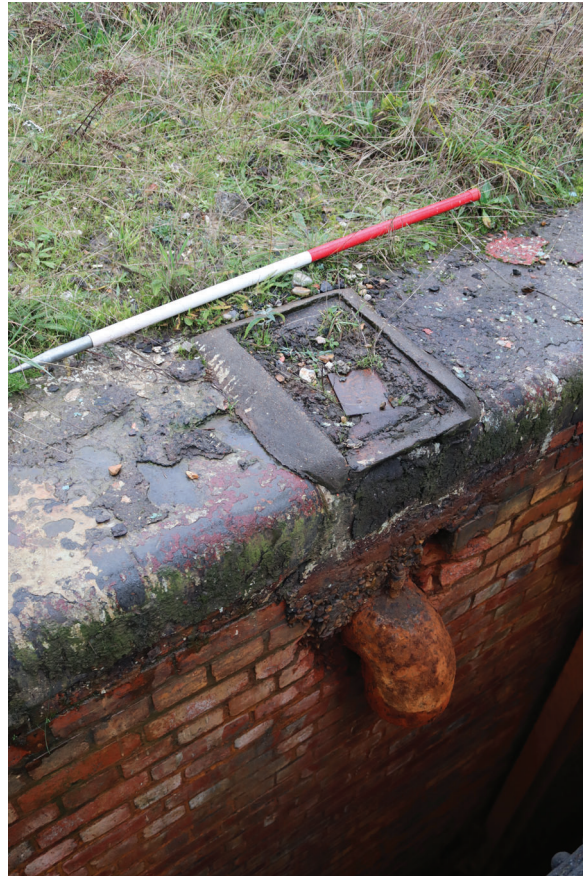
Plate 149: Gasholder No 5, detail view of possible water discharge point between standards 4 and 5, from the east

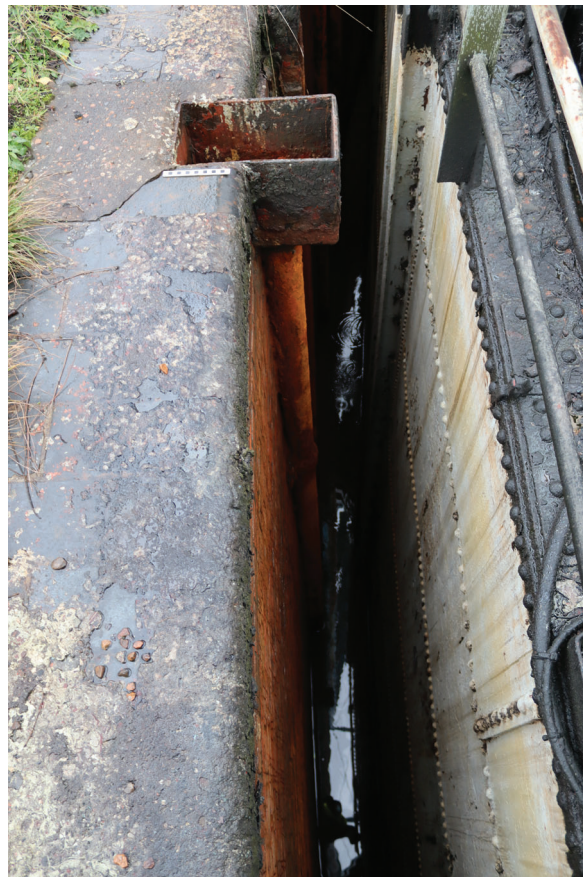
Plate 150: Gasholder No 5, detail view of possible water discharge point between standards 25 and 26, from the ENE

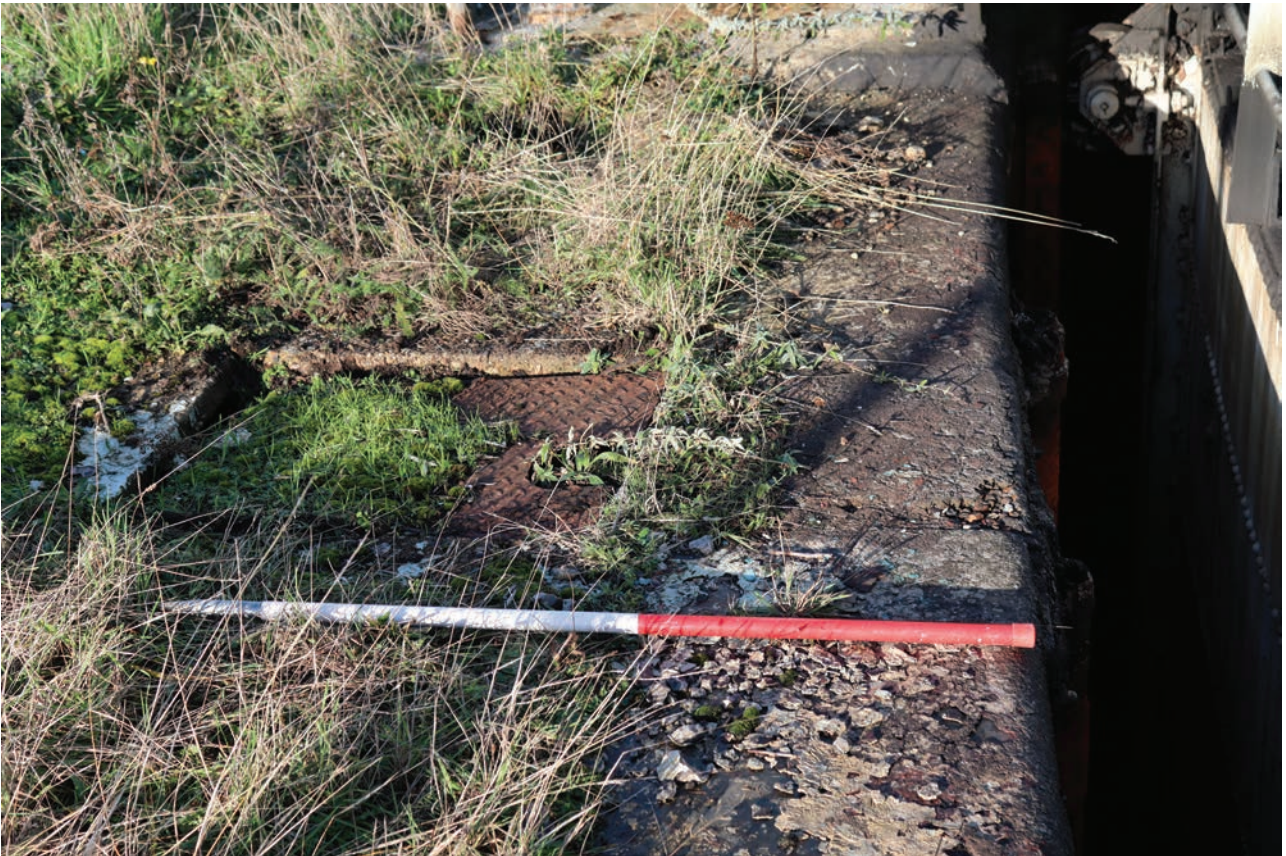
Plate 151: Gasholder No 5, detail view of valve pit between standards 6 and 7, from the south

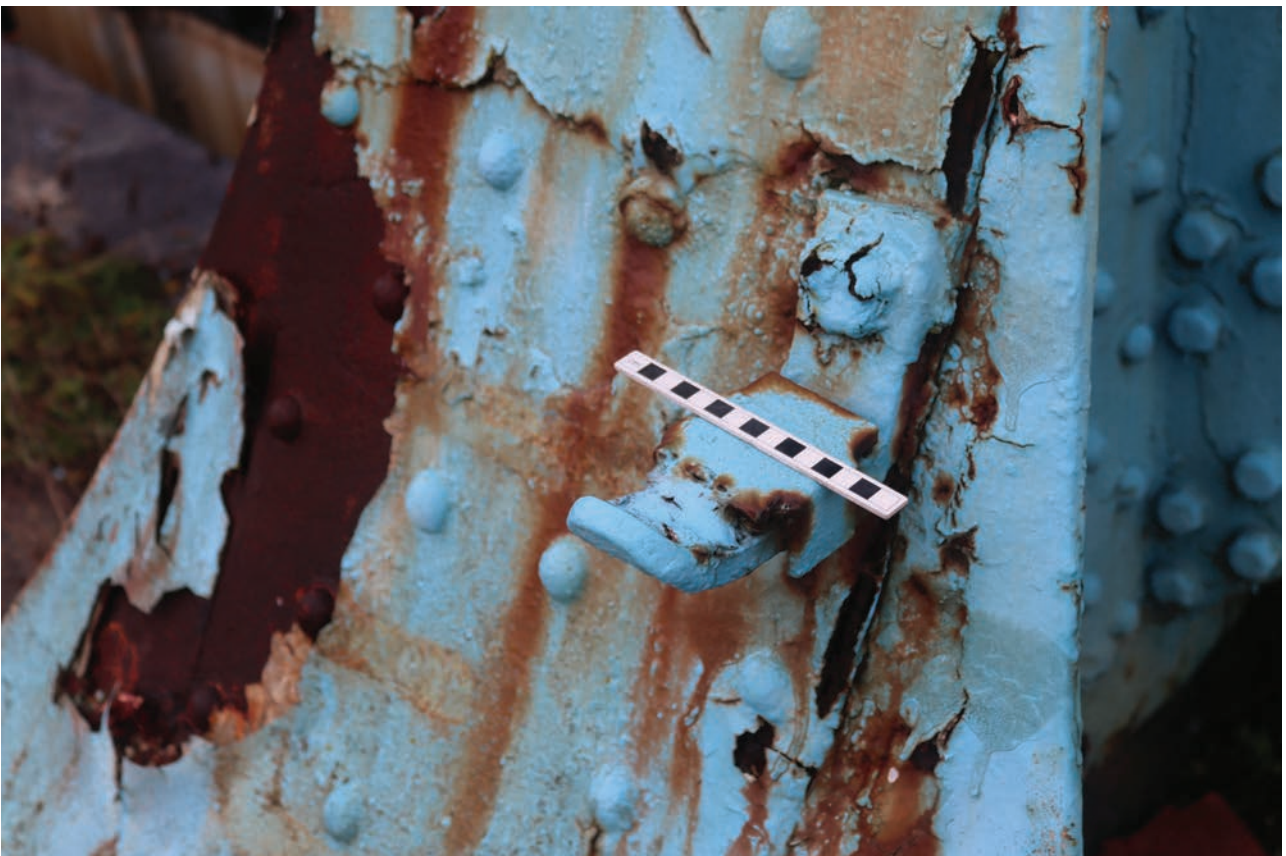
Plate 152: Gasholder No 5, detail view of disused hook on the exterior of many of the standards, from the ESE

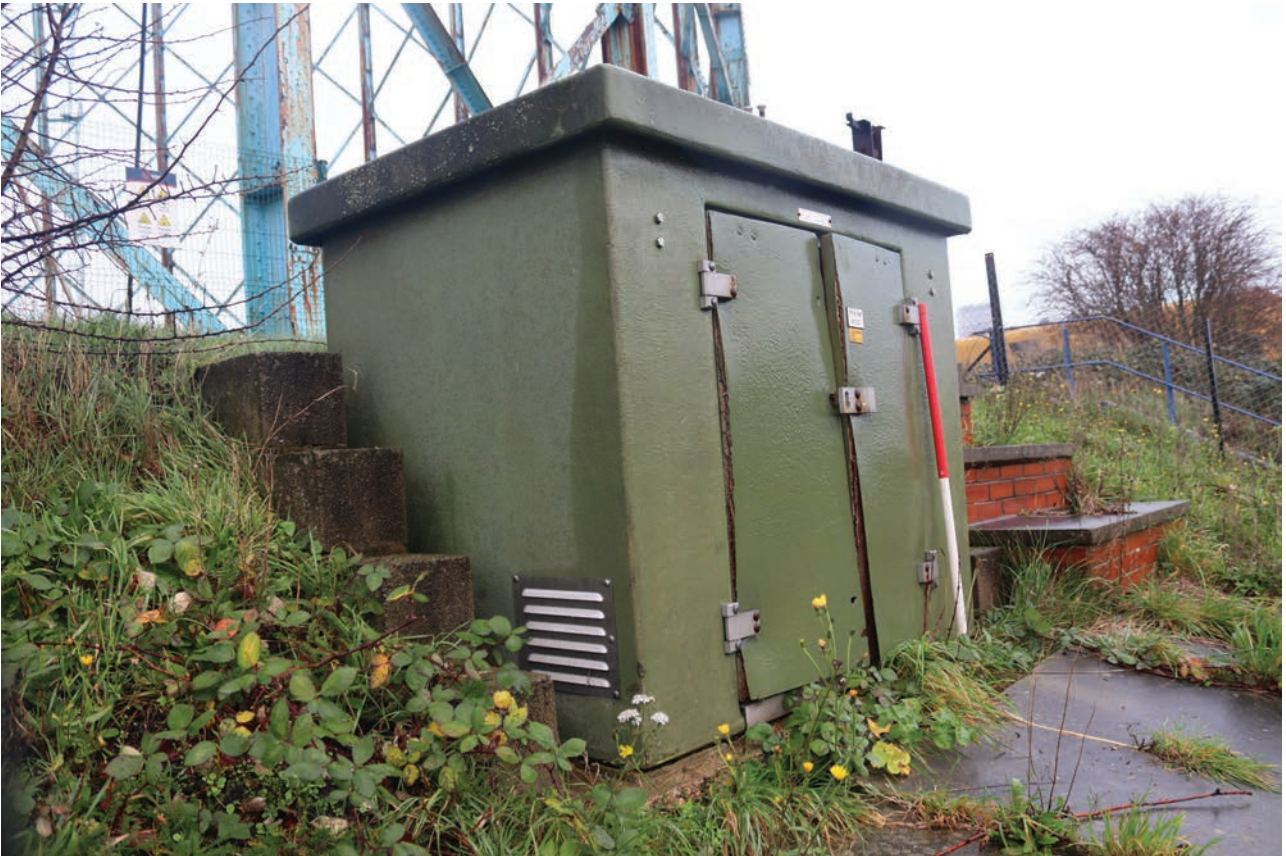
Plate 153: Gasholder No 5, detail view of top up pump hut, from the south-west

To the south of the gasholder there is an electronically-controlled top-up pump hut (Plates 153 & 154).

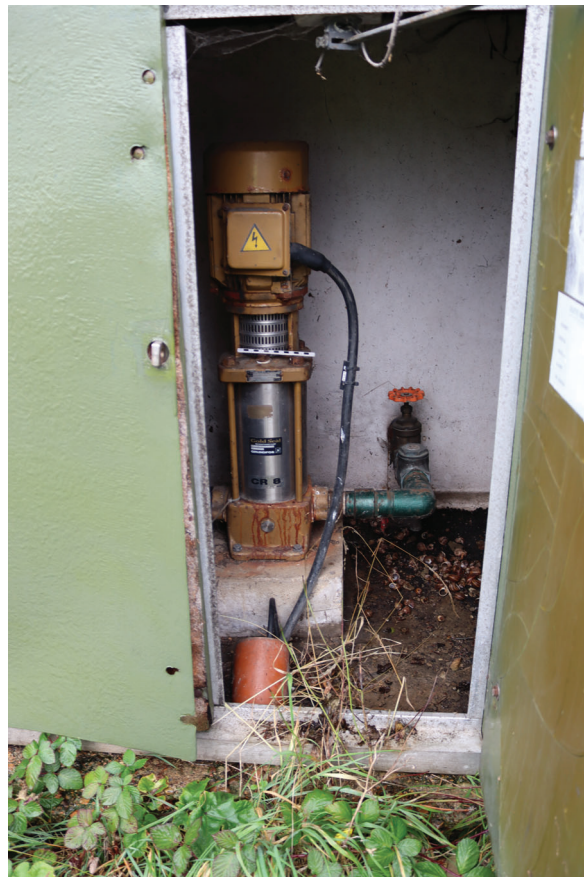
Plate 154: Gasholder No 5, detail view of the top up pump, from the south

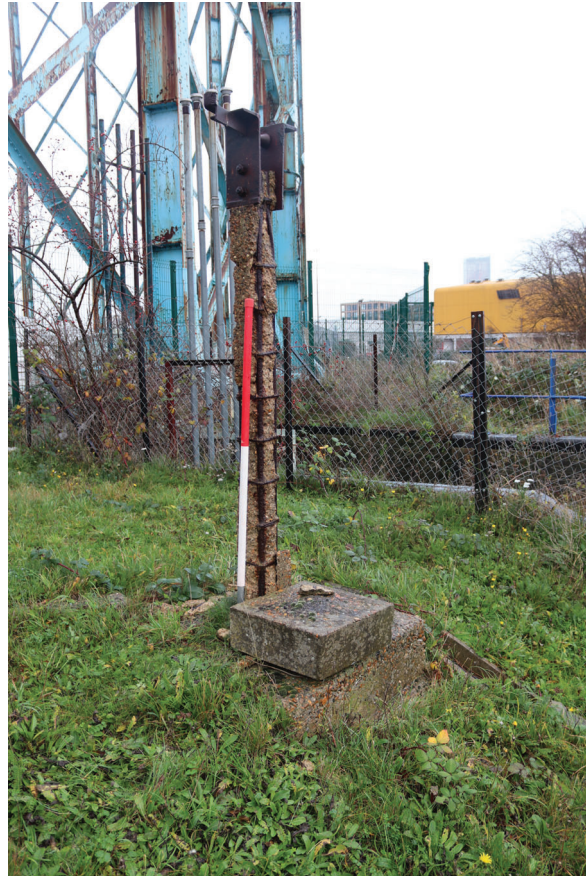
Plate 155: Gasholder No 5, detail view of removed equipment setting, from the south-west

To the south-east of Gasholder No 5 there are several concrete settings of equipment that are presumed to be related to the holder operation, that have been cut off (Plates 155–157).
