Gasholders Nos 4 & 5, Factory Lane, Croydon, London: Historic Building Recording Final Report

*AOC Project No: 23686_V
3rd August 2021*

On Behalf of:	SGN 2 Woodstock Road Yarnton OX5 1NY
National Grid Reference (NGR):	Gasholder No 4: TQ 31212 65907 Gasholder No 5: TQ 31169 65975
AOC Project No:	23686_V
OASIS No:	411878
Prepared by:	Diana Sproat Gemma Hudson
Illustration by:	Gemma Hudson Jamie Humble Sam O'Leary
Date of Fieldwork:	16th – 18th December 2020 (Phase I) 5th May & 7th July 2021 (Phase II)
Date of Report:	3rd August 2021

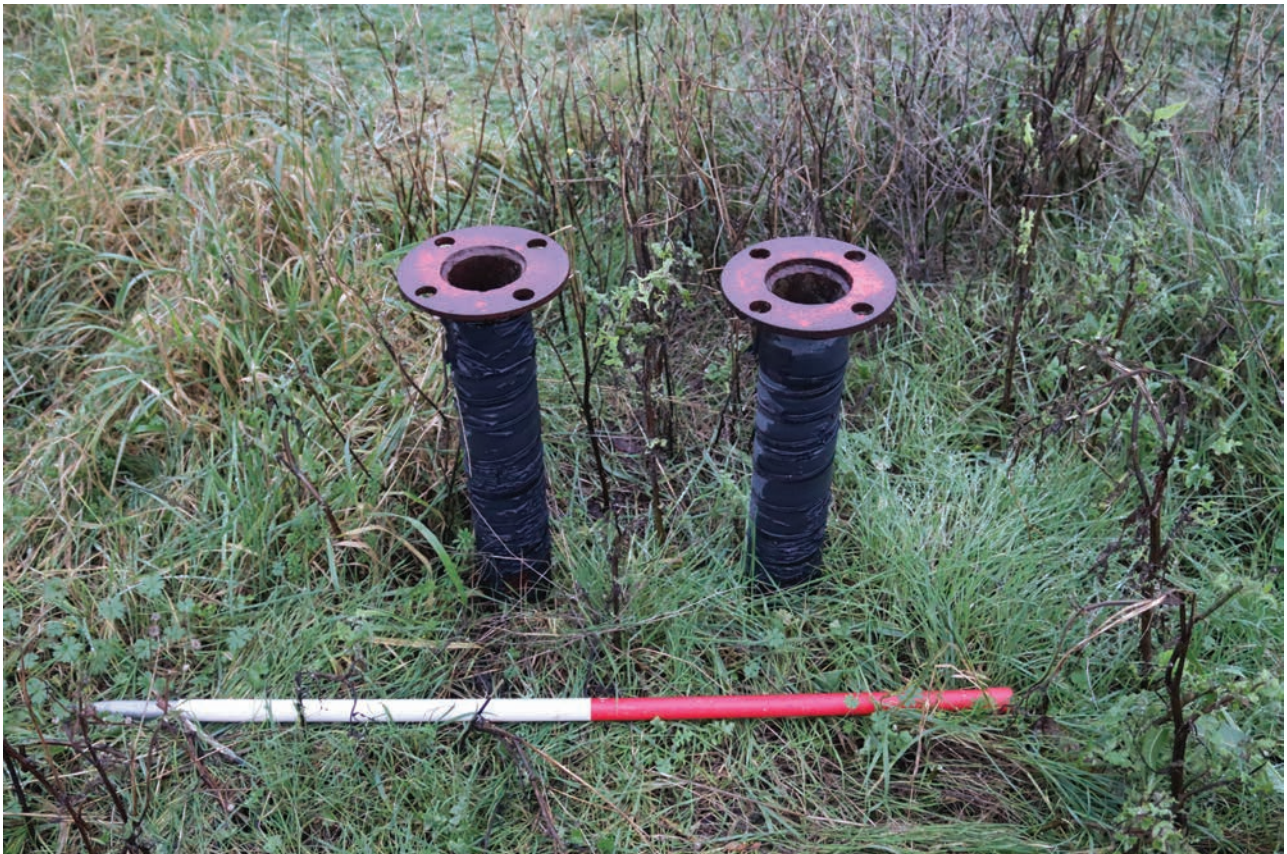
Plate 156: Gasholder No 5, detail view of removed equipment setting, from the north

To the south-east of Gasholder No 5 there are several concrete settings of equipment that are presumed to be related to the holder operation, that have been cut off (Plates 155–157).

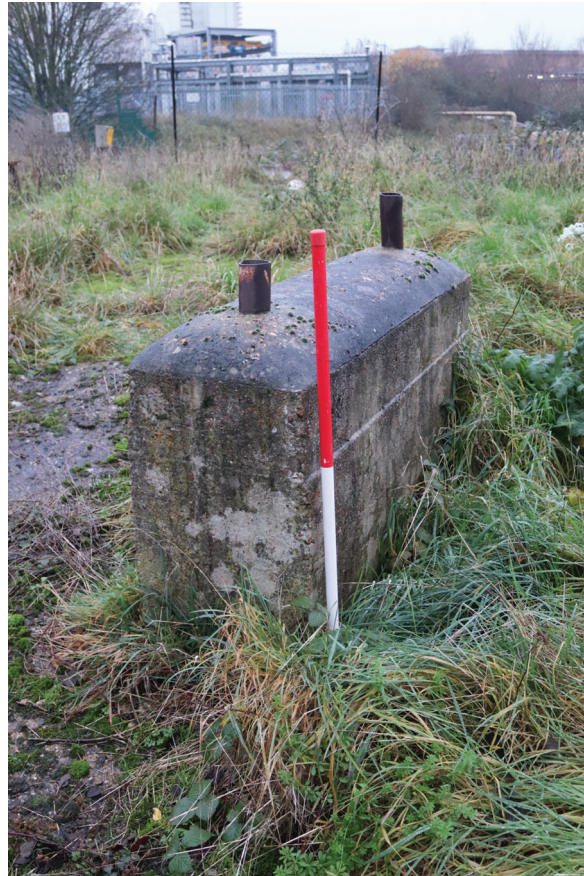
Plate 157: Gasholder No 5, detail view of cut-off steel bars, from the north

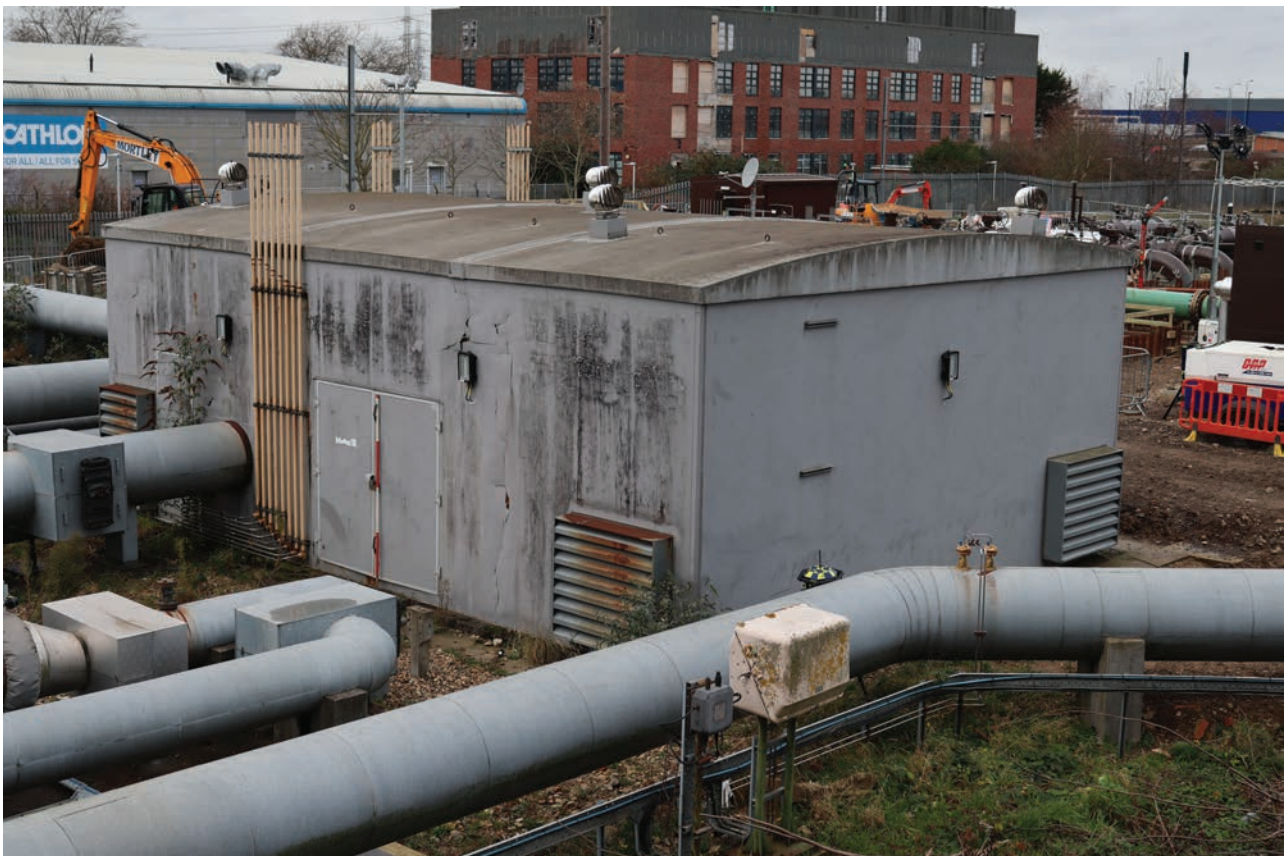
Plate 158: Structure 1, general view of District Governor House, from the east

9.2.1 The District Governor House is situated in the centre of the site (Plate 158). It measures 10.3m x 7.7m in a NE-SW orientation and is constructed of steel sheets. The equipment within is mostly Bryan Donkin made, and used to filter and modify the pressure of the gas before it is sent out to the district (Plates 159 & 160). At the time of the Phase I survey some of the equipment was not in use and had been blanked (Plate 161). The floor is concrete and there are some sections of steel sheeting on the floor which are removeable to access the pipework beneath (Plate 162). The building also has a wall of pressure monitoring devices related to boosters on the holders (Plate 163).

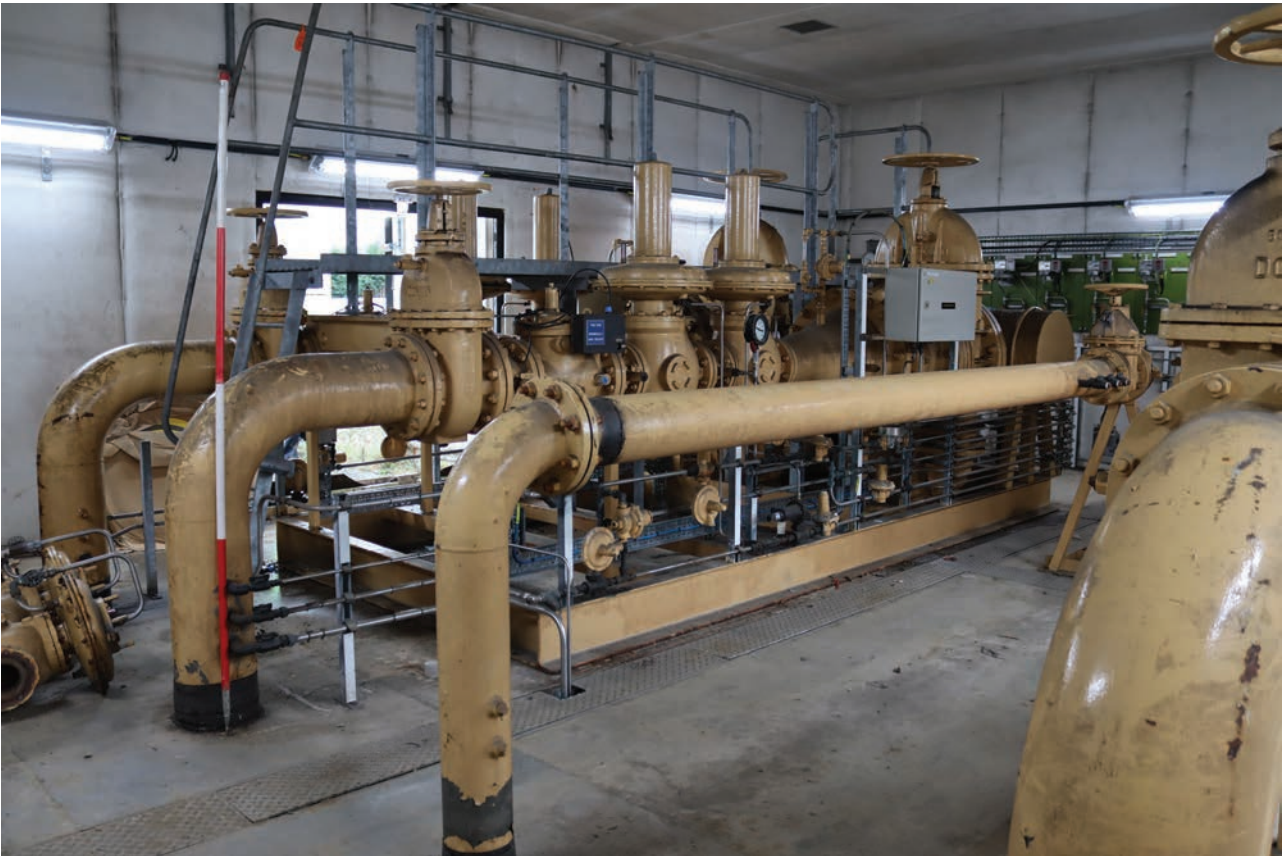
Plate 159: Structure 1, general view of equipment within the District Governor House, from the NNE

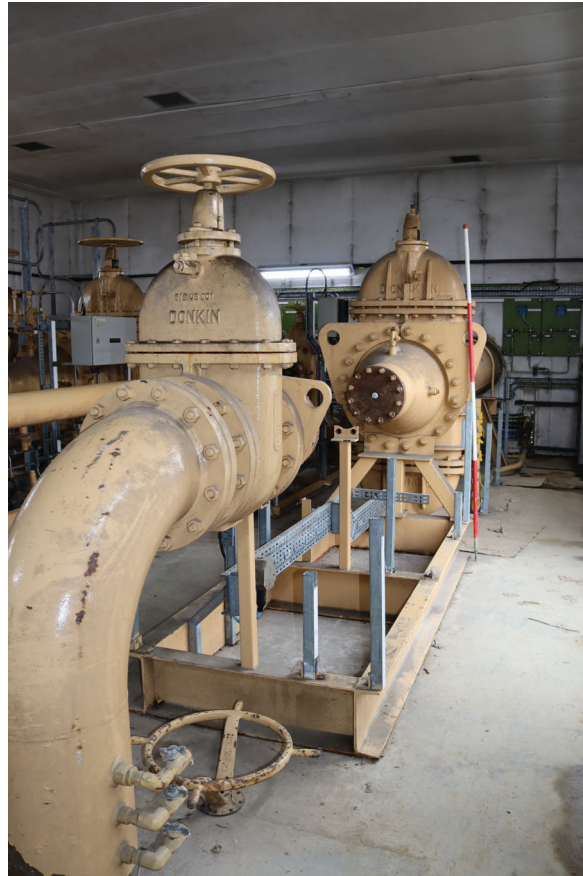
Plate 161: Structure 1, blanked pipework within the District Governor House, from the north-east

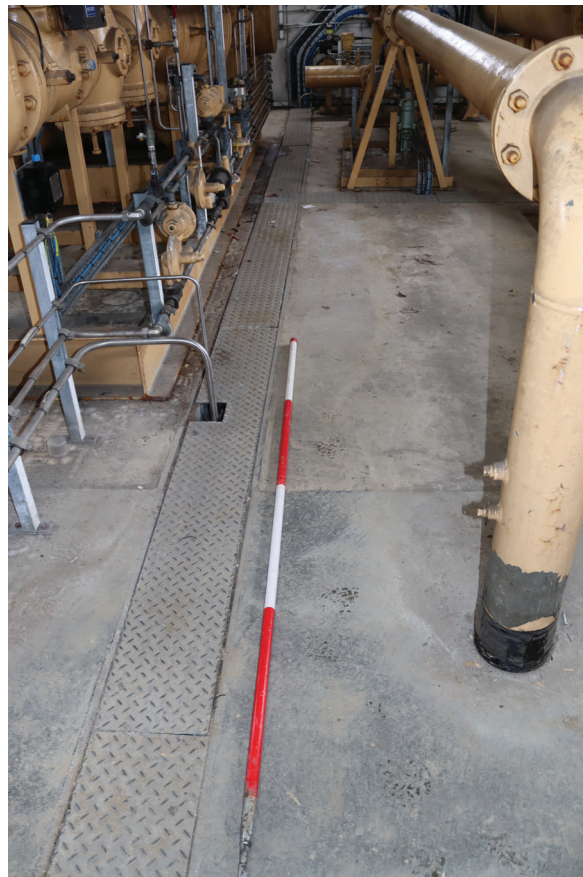
Plate 162: Structure 1, detail view of removeable steel plate in the concrete floor of the District Governor House, from the ENE

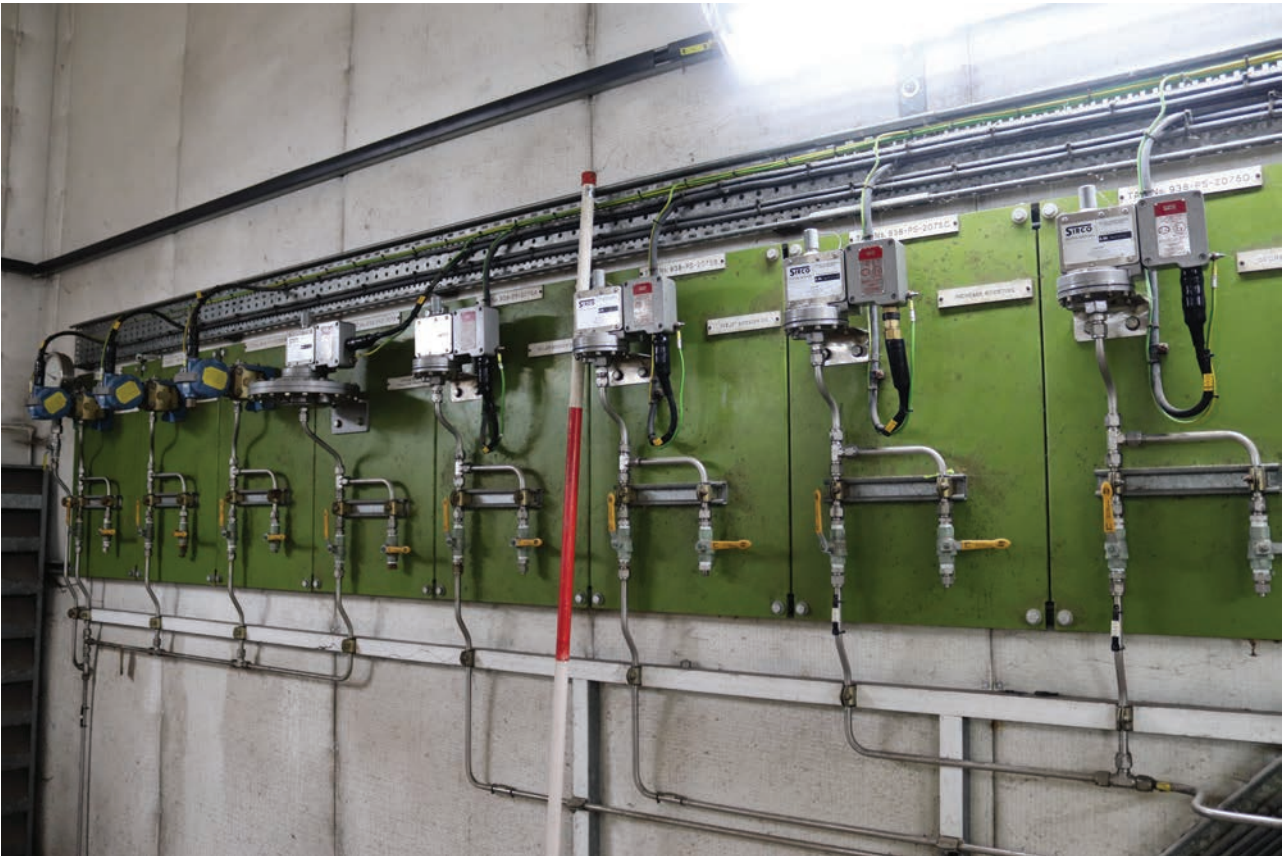
Plate 163: Structure 1, detail view of monitoring panels for boosters within the District Governor House, from the NNE

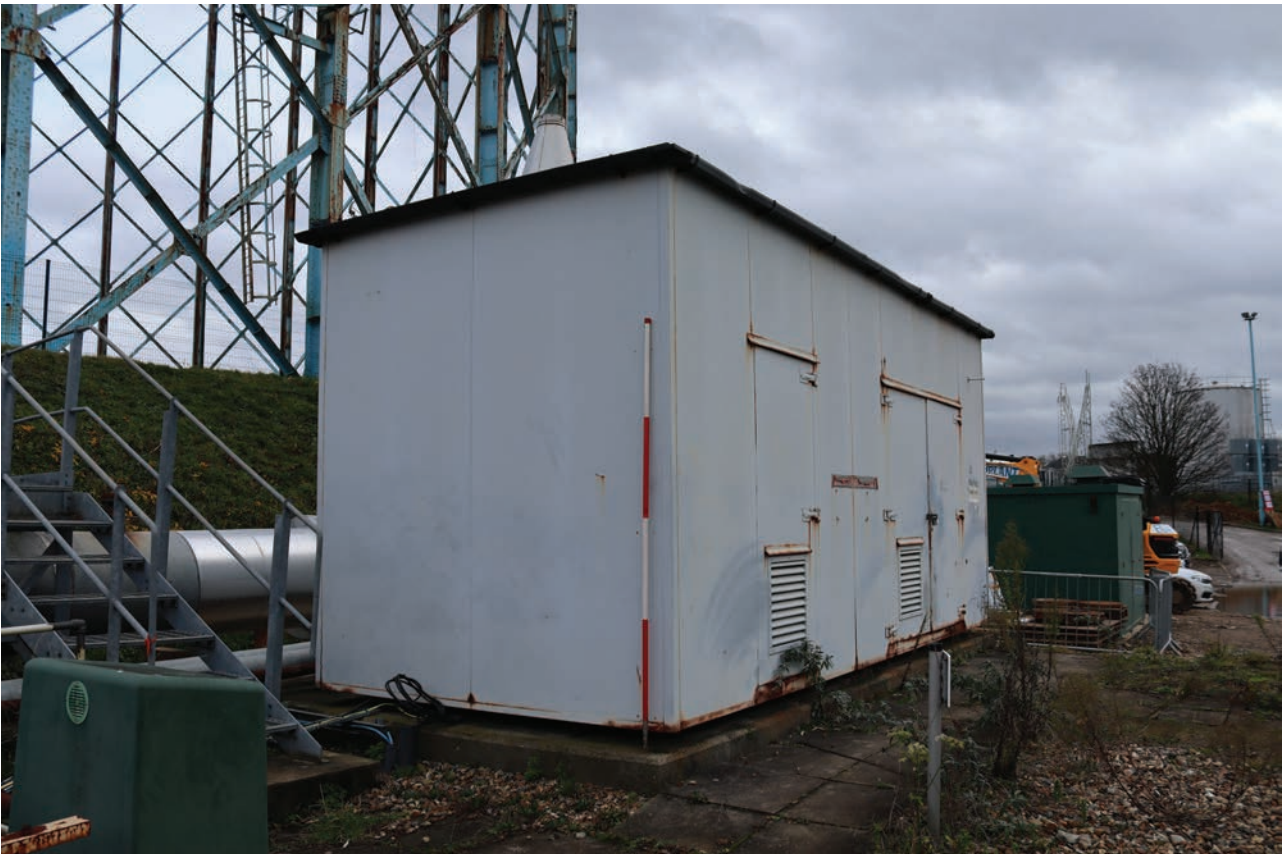
Plate 164: Structure 1, general view of the Boiler House (Structure 2), from the west

9.3.1 To the south-east of Structure 1 is the Boiler House (Plate 164). It measures 6.1m x 2.1m in a north-west/south-east alignment. It is constructed of steel sheets set in a concrete foundation. The building houses two boilers, a pressurisation unit, heat monitoring units and switches controlling heat pumps (Plates 165–167). Above ground pipework is present between the Boiler House and the District Governor House connecting the two to ensure the temperature of the gas is correct before being sent out to the district (Plate 168).

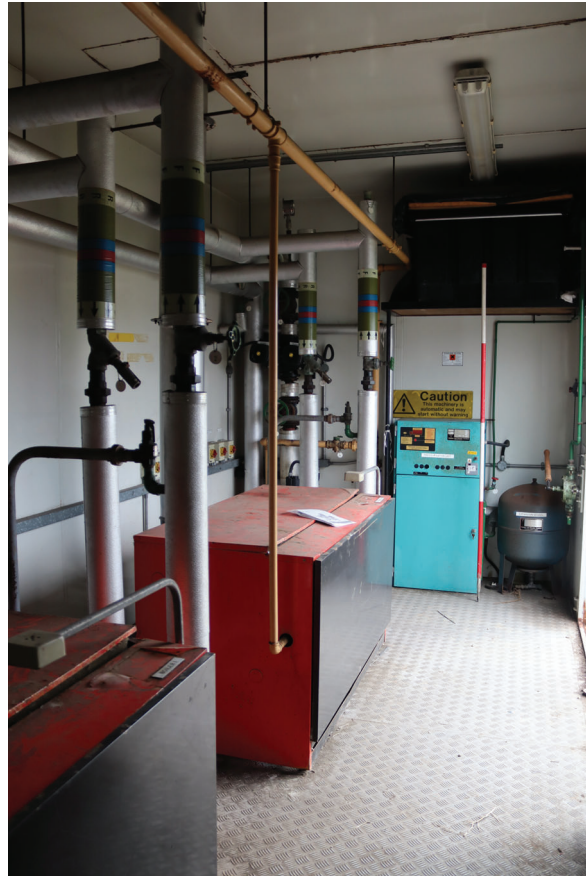
Plate 165: Structure 2, general view of the equipment within the Boiler House, from the north-west

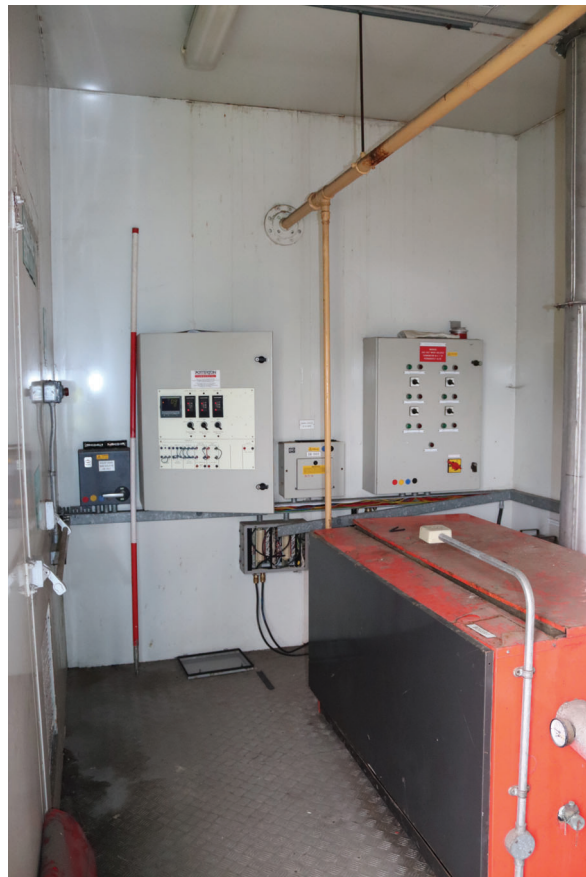
Plate 166: Structure 2, detail view of the heat monitoring panels within the Boiler House, from the south-east

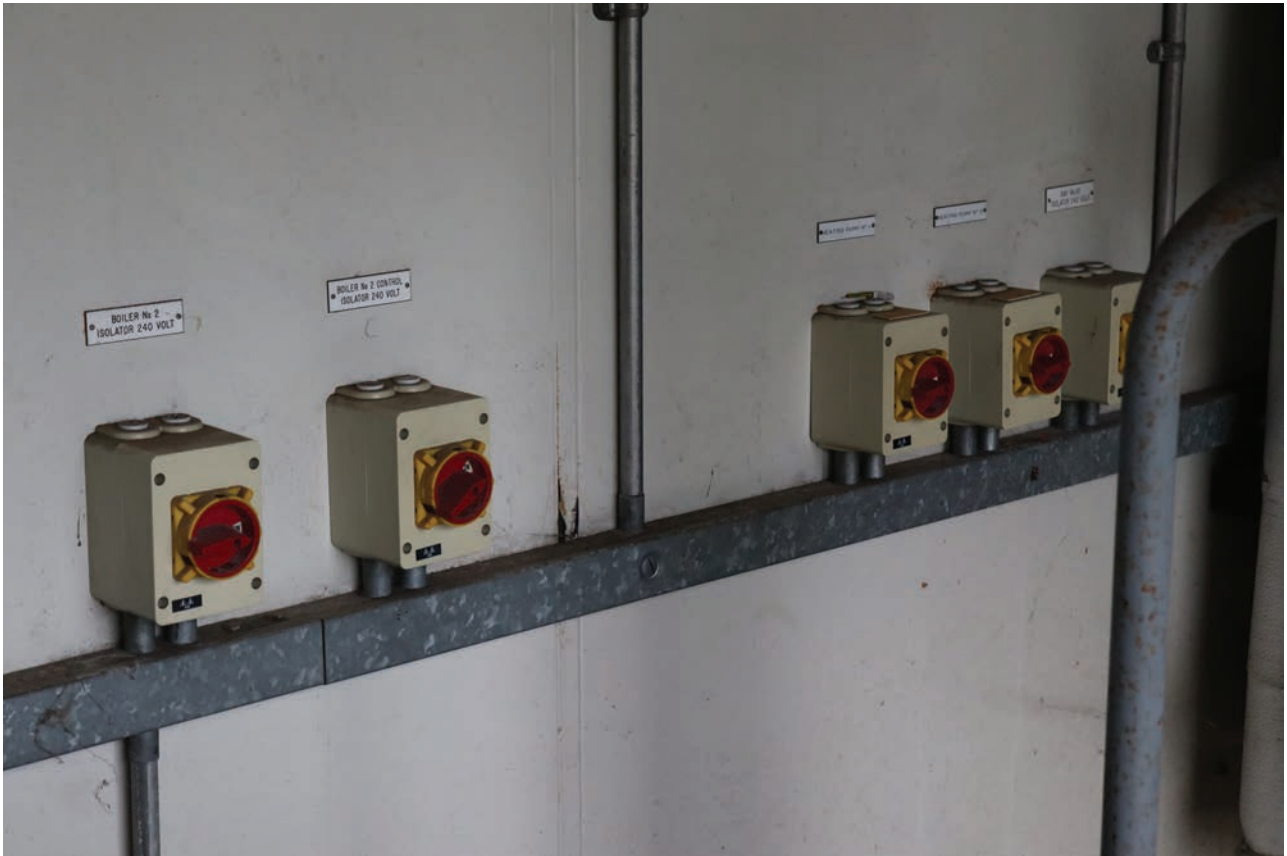
Plate 167: Structure 2, detail view of switches controlling heat pumps within the Boiler House, from the west

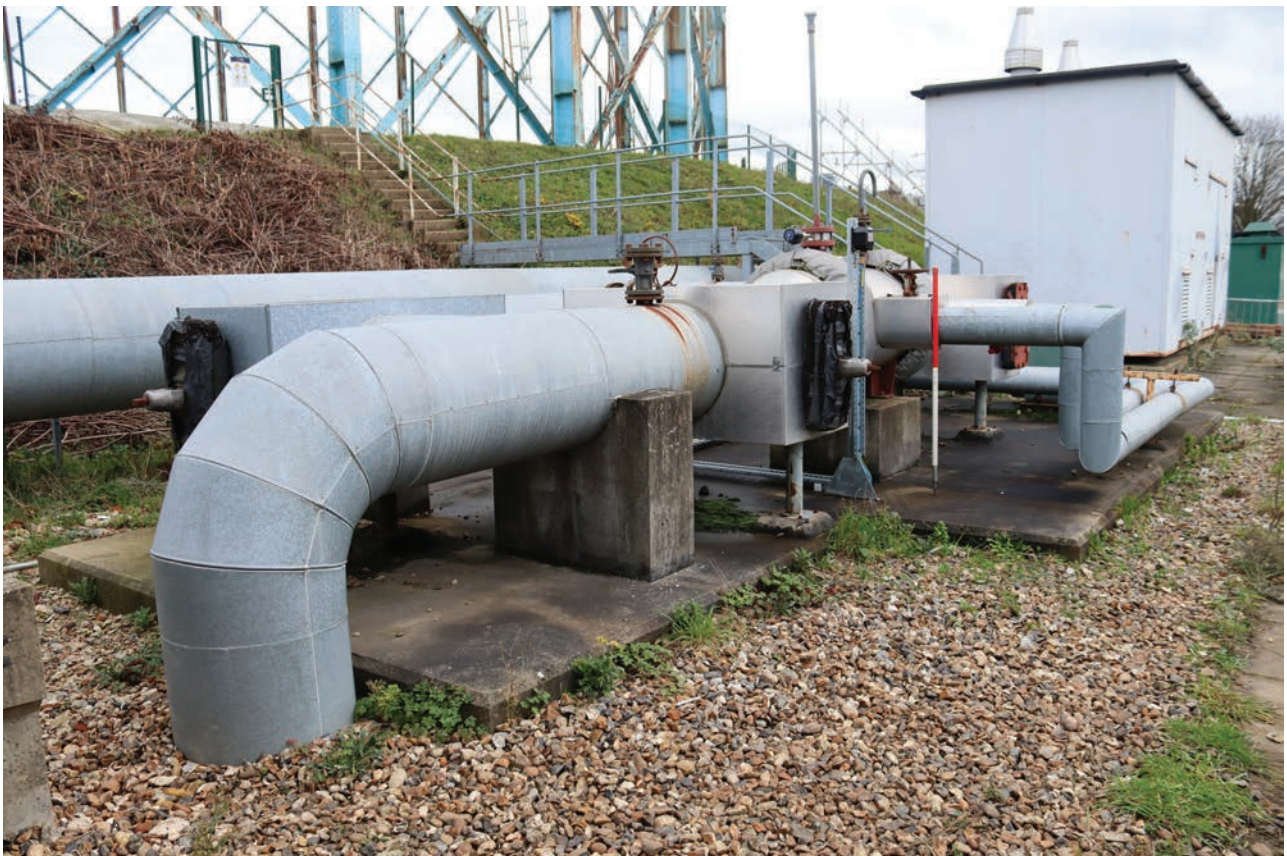
Plate 168: Structures 1 & 2, general view of pipework between the District Governor House and the Boiler House, from the WNW

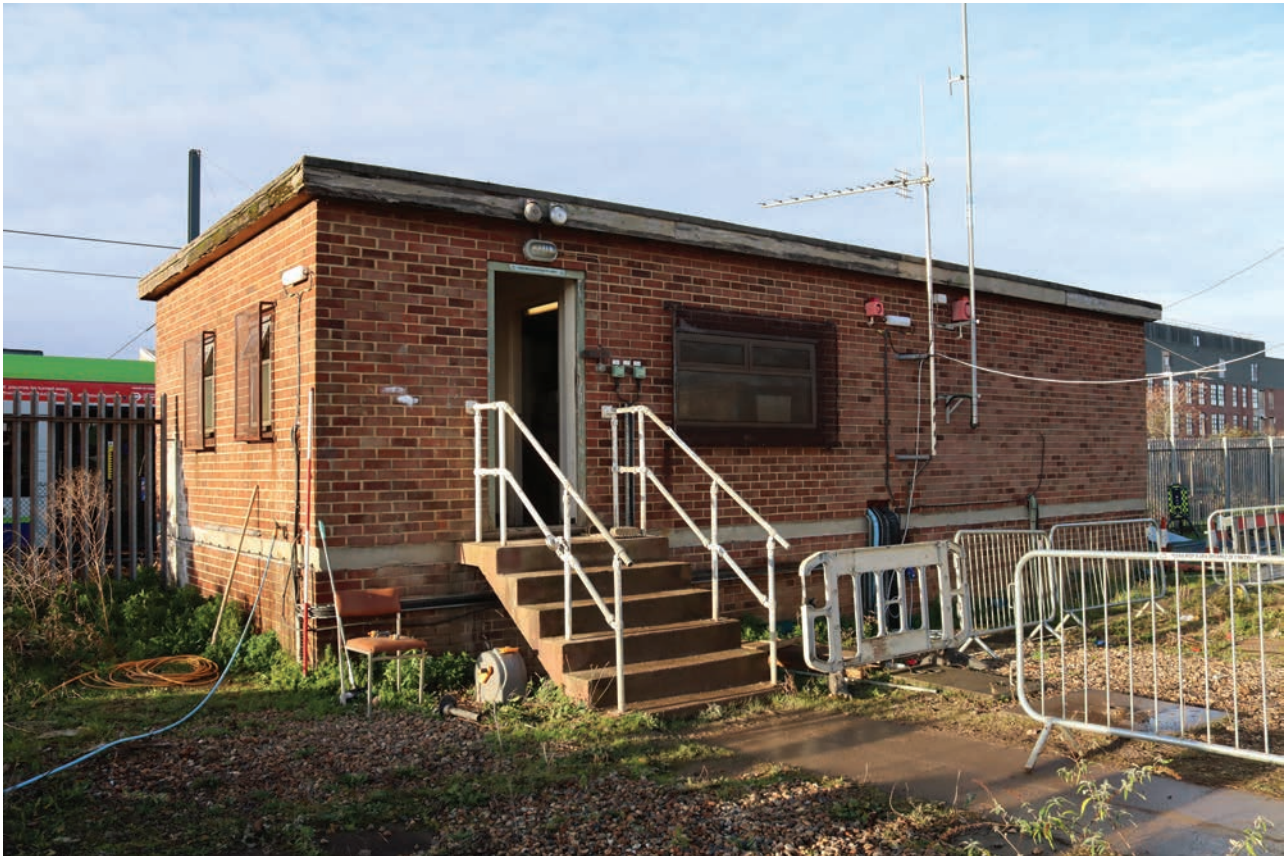
Plate 169: Structure 3, general view of the Control Room exterior, from ESE

9.4.1 The Control Room is situated in the centre of the south-west boundary. It is a red brick building measuring 11.7m x 5.2m in a north-west/south-east alignment. It is raised up with concrete steps allowing entry at the south end of the north-east elevation (Plate 169). The interior has an entrance hall, toilet and two working rooms (Plate 170). The central room has monitoring and control panels related to the movement and storage of gas in the holders and the fogger system (Plates 171 & 172).

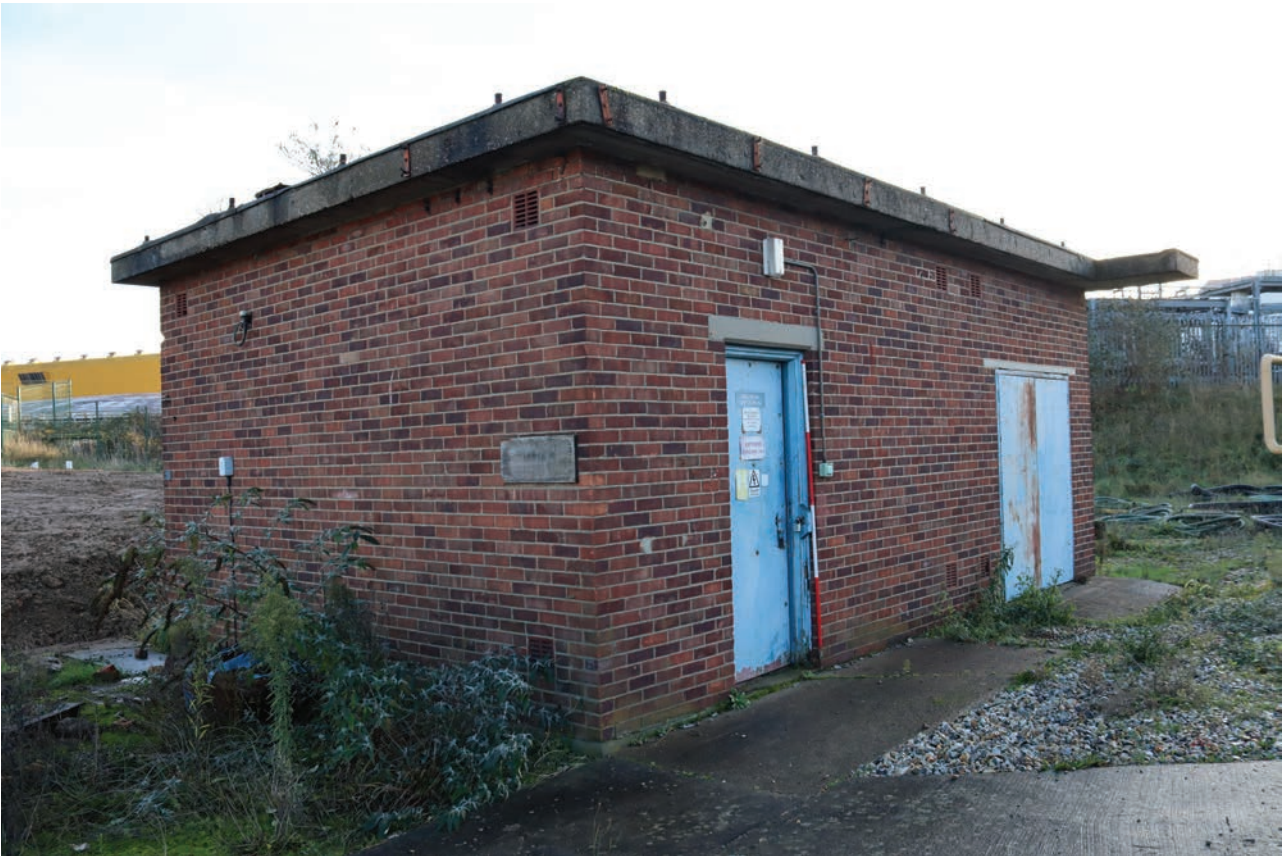
Plate 173: Structure 4, general view of the Switch Room exterior, from the west

9.5.1 The Switch Room is situated in the south of the site. It is a red brick building measuring 8m x 5.3m in a north-west/south-east alignment. The south-west side has two entrances, a single door at the north end and double doors at the south end (Plate 173). There is a grated window acting as a vent in the centre of the north-east elevation; a painted patch at the north end of the same elevation suggests there was once a small additional abutting structure here that has since been removed (Plate 174). The building houses a booster motor and instrumentation panels related to Gasholder Nos 4 & 5 heating systems (Plates 175–177).

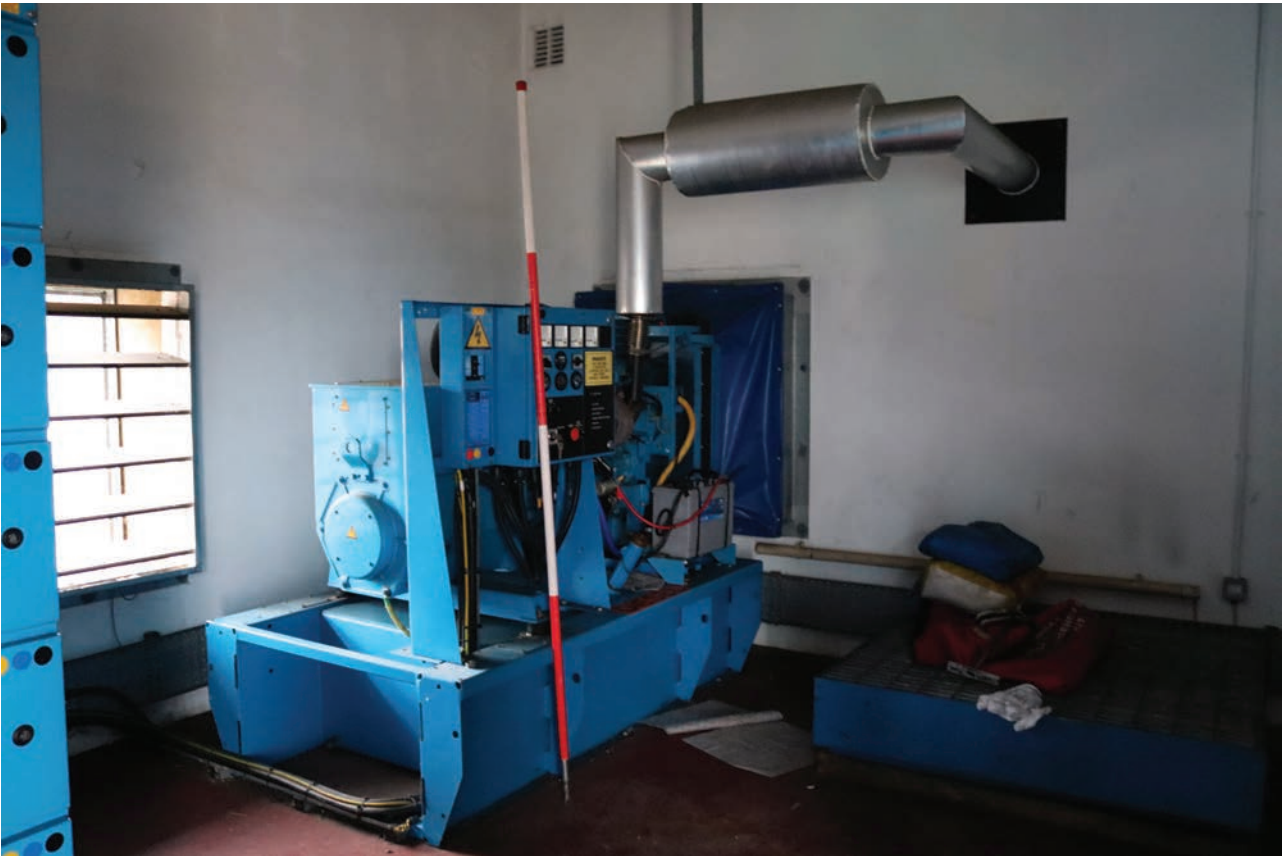
Plate 175: Structure 4, detail view of the booster motor within the Switch Room, from the WNW

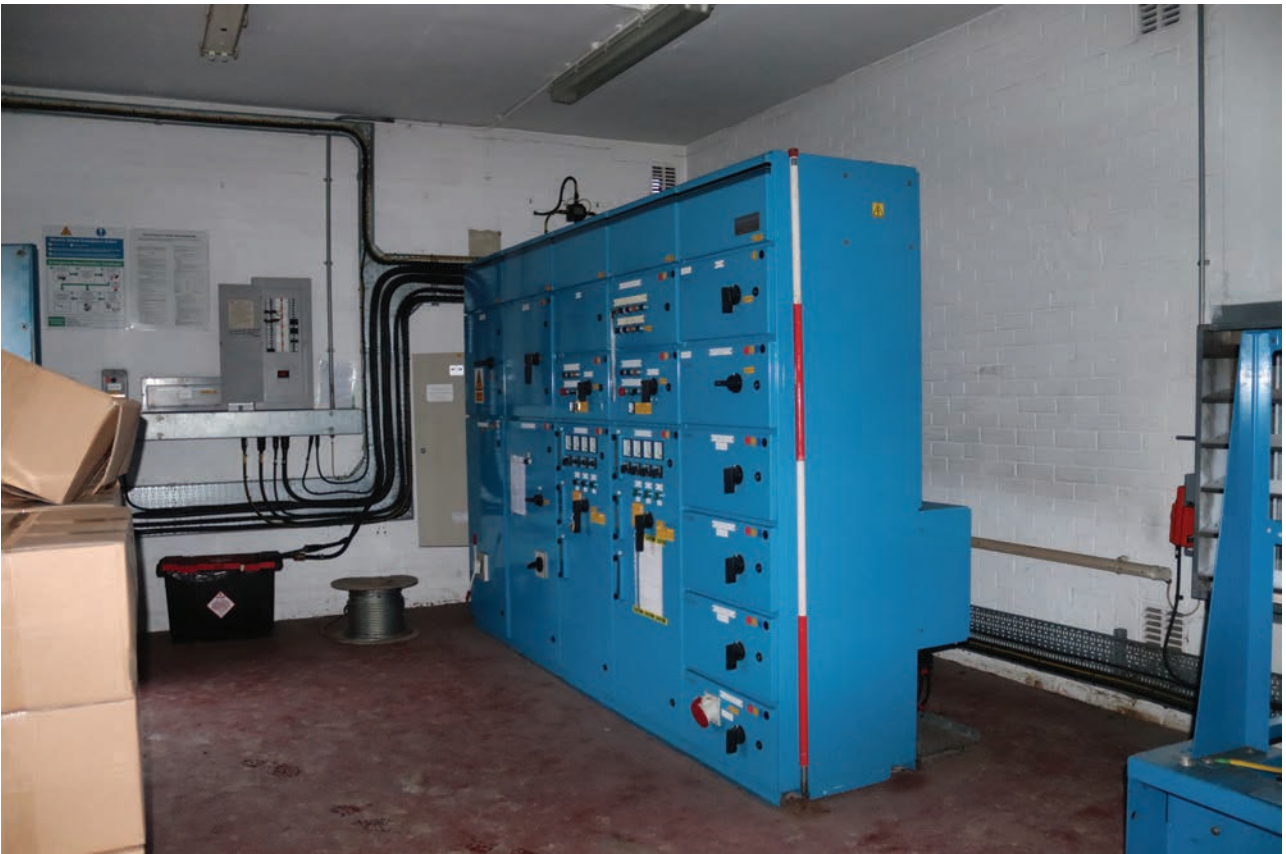
Plate 176: Structure 4, general view of the instrumentation panels within the Switch Room, from the SSE

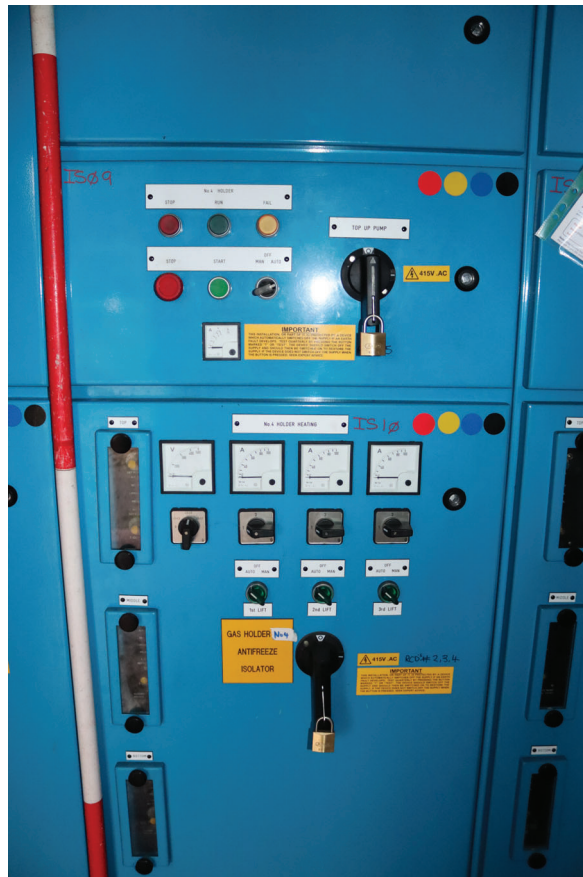
Plate 177: Structure 4, detail view of holder heating system control panel within the Switch Room, from the south-west

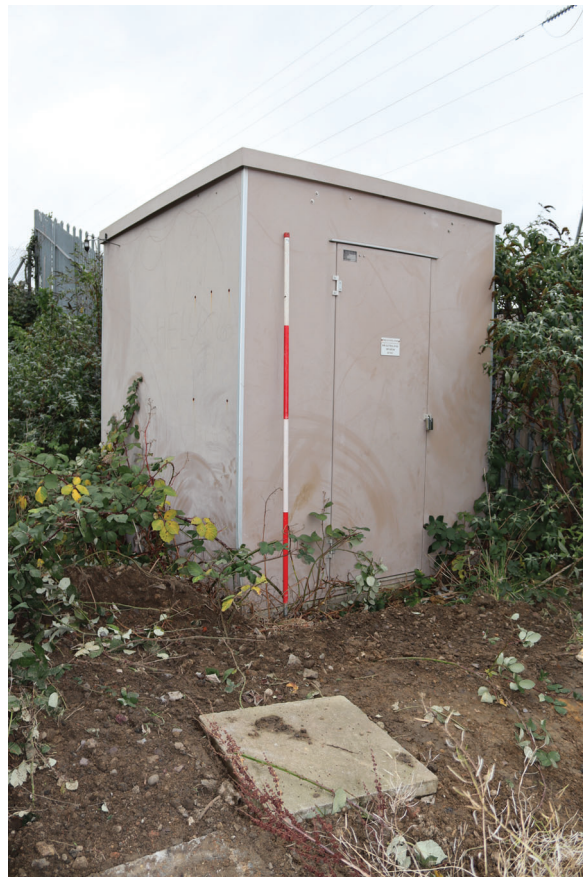
Plate 178: Structure 5, general view of the exterior of the Electrical Room, from the south-east

9.6.1 To the west of the site entrance are two Electrical Rooms constructed of steel panels on concrete foundations which contain electrical panels. Structure 5 measures 2.1m x 2m in an east/west alignment with a single entrance door on the east side (Plate 178). It contains electrical control panels (Plate 179). Structure 6 measures 2m x 0.9m in a north/south orientation (Plate 180). The interior of Structure 6 was not accessed during the survey.

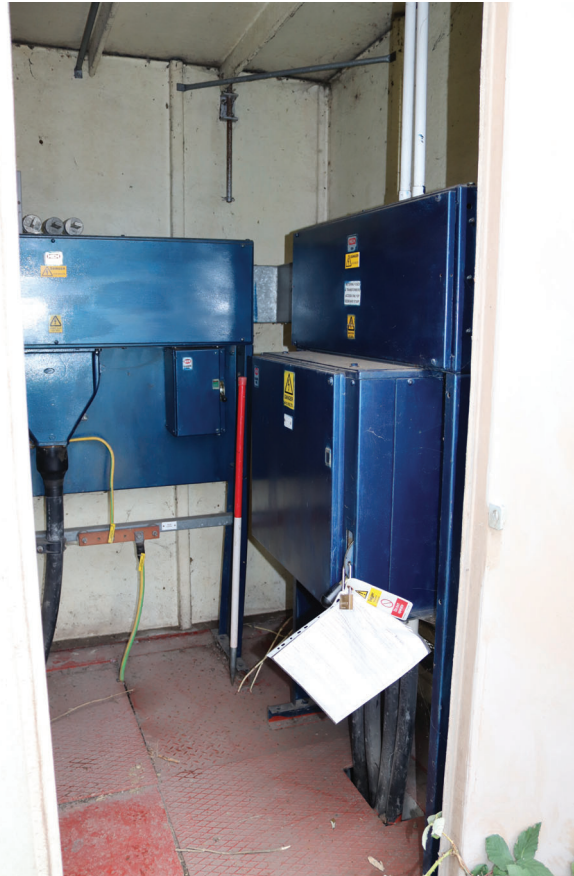
Plate 179: Structure 5, general view of the interior of the Electrical Room, from the ESE

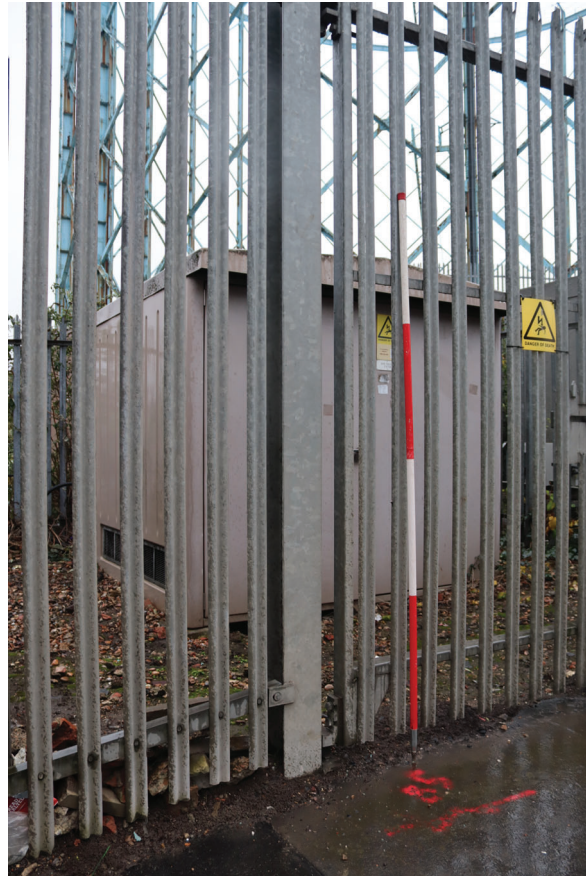
Plate 181: Structure 7, general view of the exterior of the Unidentified Building, from the north-east

9.7.1 To the north of Structures 5 & 6 is a steel-panelled building measuring 2.7m x 2.6m in an west/west orientation (Plate 181). It was not accessed during the survey.

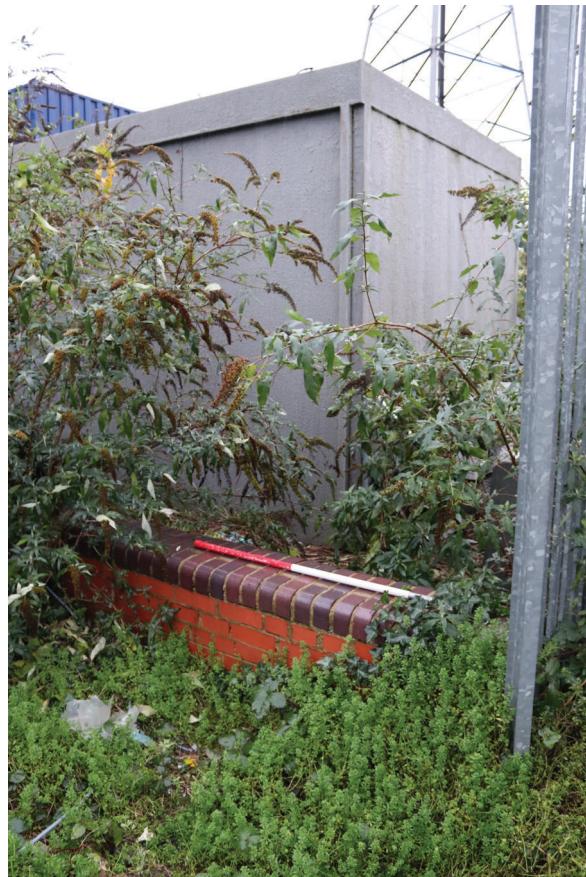
Plate 182: Structure 8, general view of the electrical building, from the south

9.8.1 To the west of Structure 7 is a steel-sheeted building measuring 6.1m x 3.2m in a WNW/ESE orientation (Plate 182). It has a single entrance door on the west wall and contains electrical control panels (Plate 183).

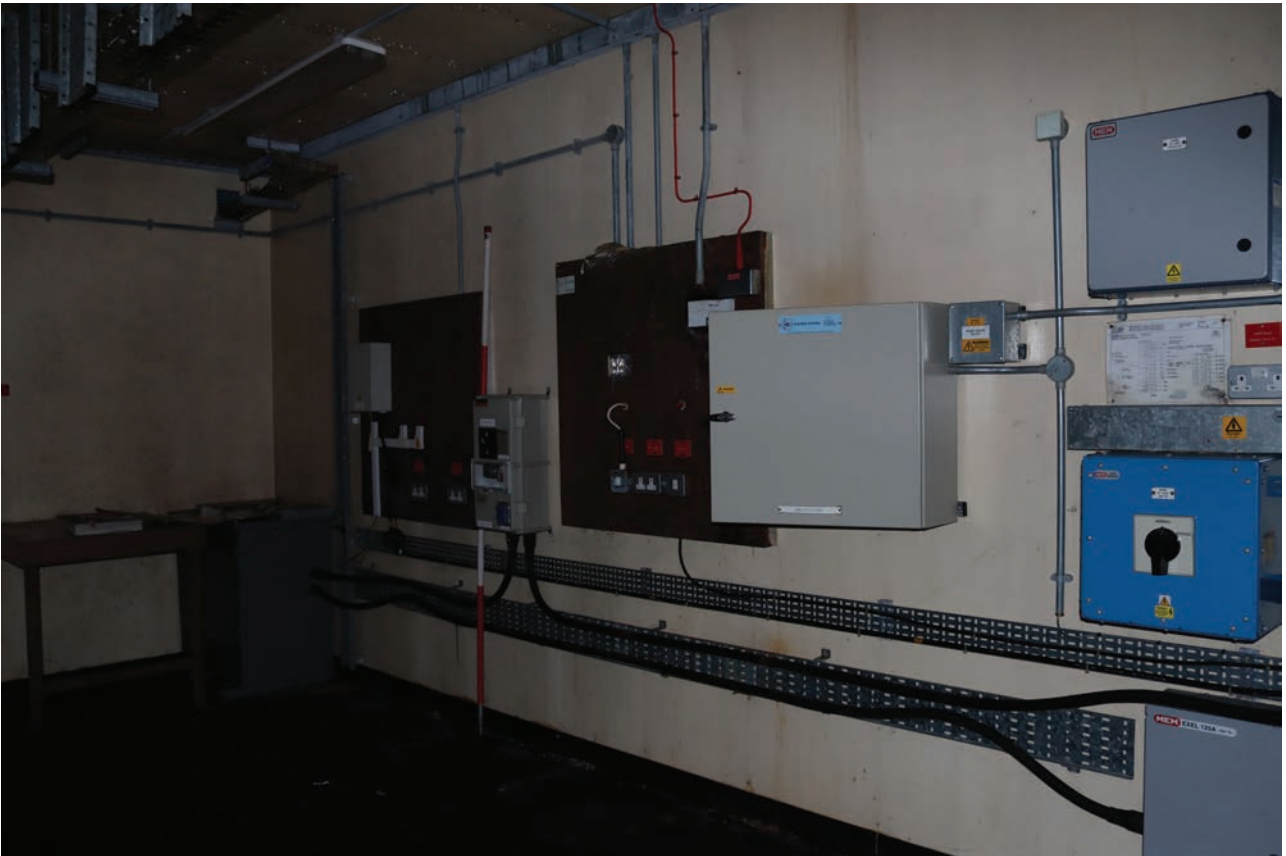
Plate 183: Structure 8, general view of Electrical Building interior showing electrical control panels, from the WNW

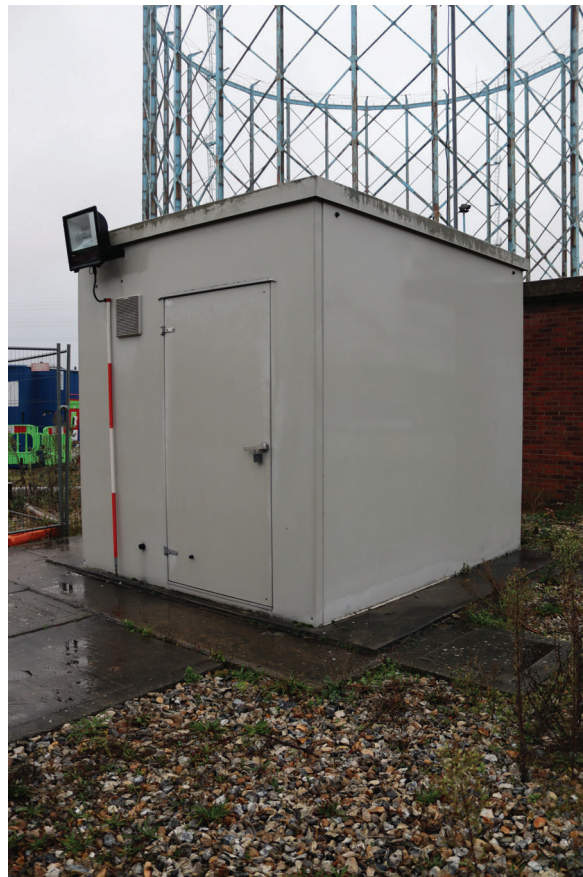
Plate 184: Structure 9, general view of unidentified building, from the south

9.9.1 To the south of Structure 4 is an unidentified building of steel sheet construction on a concrete foundation (Plate 184). It measures 3m x 2.5m in a north-east/south-west orientation. A single entrance door is present on the south-west elevation. The interior was not accessed during the survey.
