Gasholders Nos 4 & 5, Factory Lane, Croydon, London: Historic Building Recording Final Report

*AOC Project No: 23686_V
3rd August 2021*

On Behalf of:	SGN 2 Woodstock Road Yarnton OX5 1NY
National Grid Reference (NGR):	Gasholder No 4: TQ 31212 65907 Gasholder No 5: TQ 31169 65975
AOC Project No:	23686_V
OASIS No:	411878
Prepared by:	Diana Sproat Gemma Hudson
Illustration by:	Gemma Hudson Jamie Humble Sam O'Leary
Date of Fieldwork:	16th – 18th December 2020 (Phase I) 5th May & 7th July 2021 (Phase II)
Date of Report:	3rd August 2021

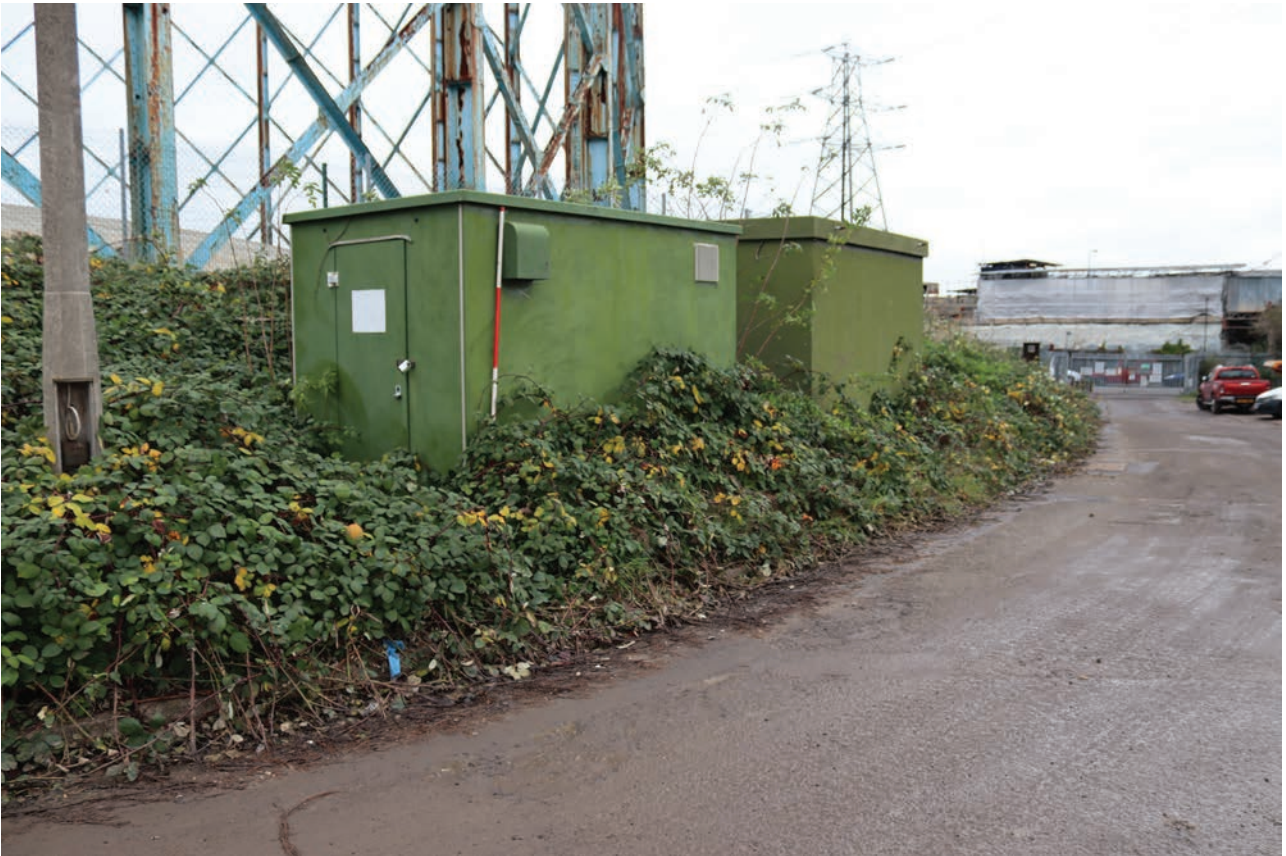
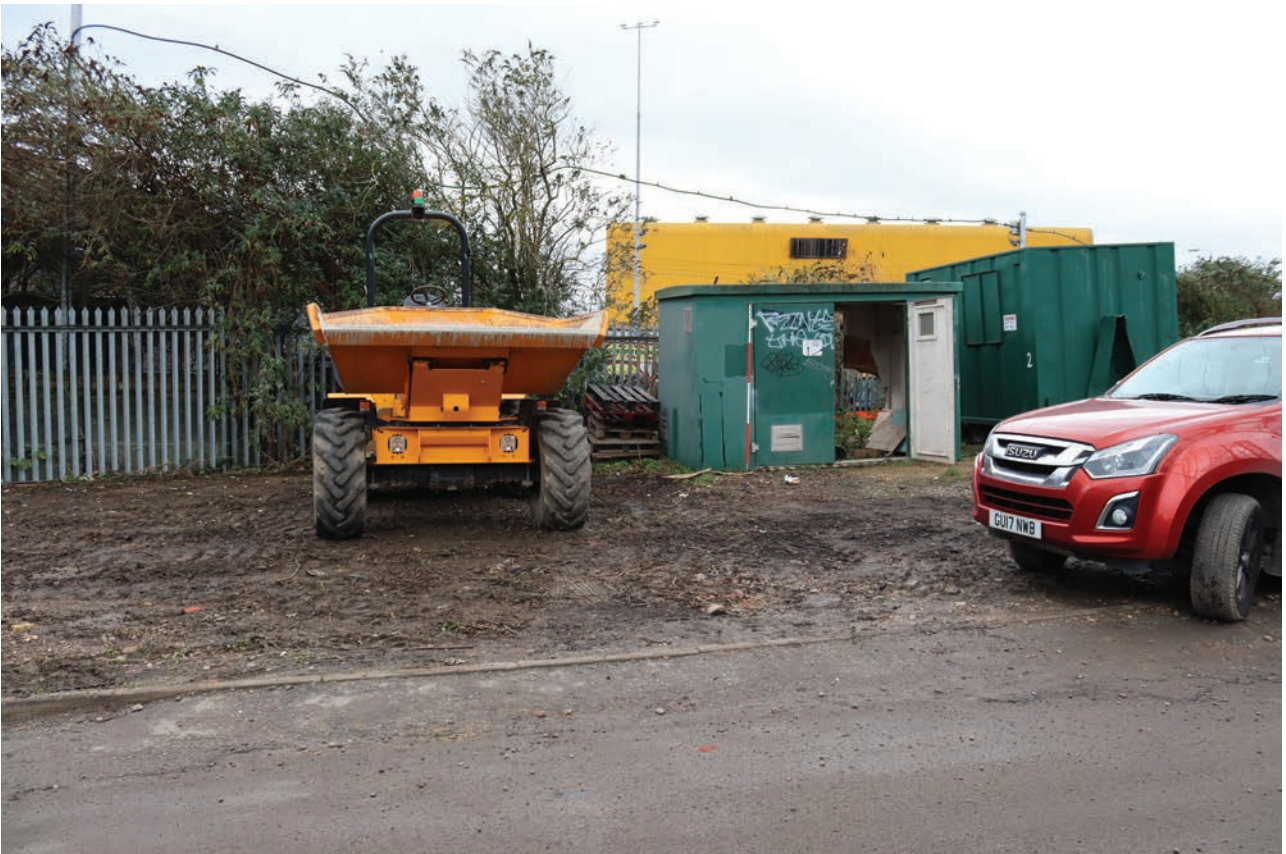
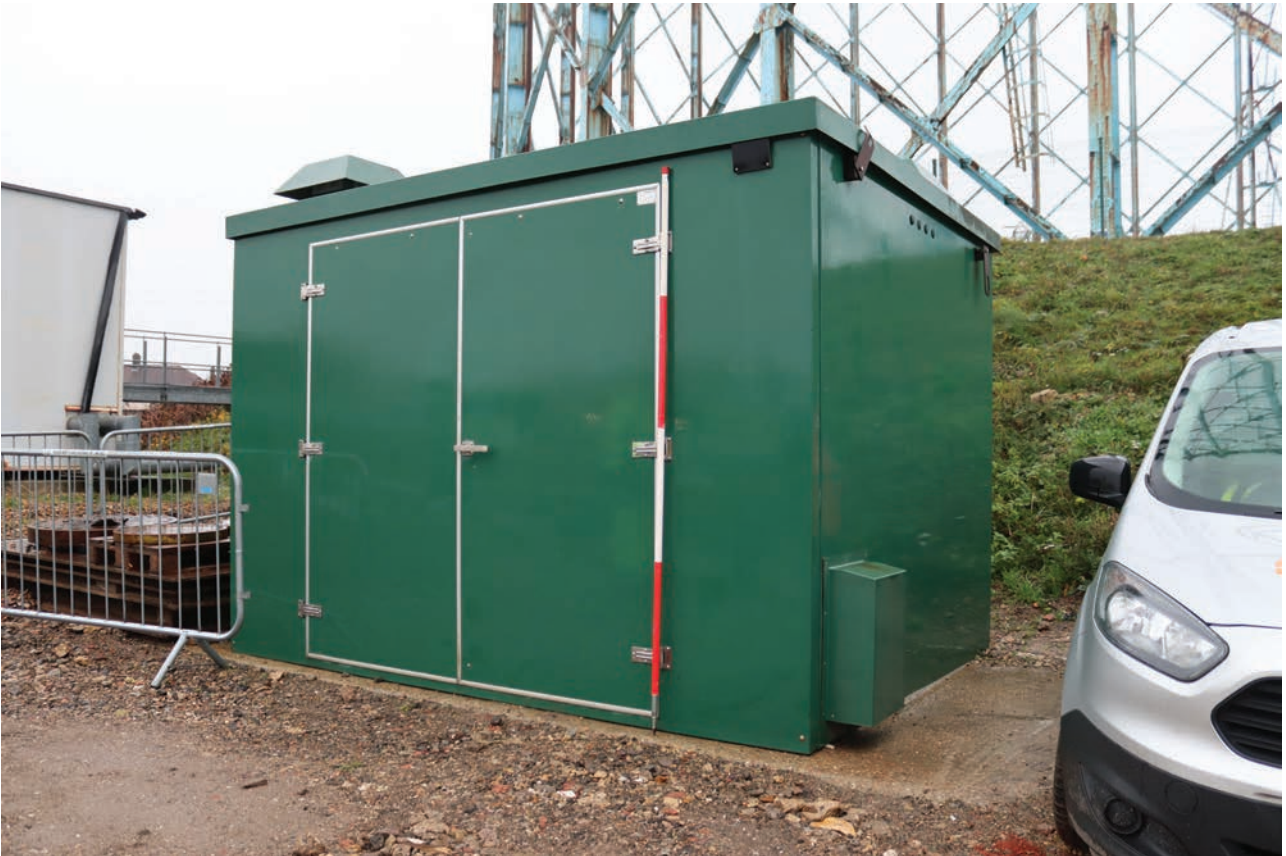
9.10.1 There are five buildings on the site that are disused governor houses (Plates 185–187). They are being stored on the site and have never been in use in their present locations.

Plate 185: Structures 10a & 10b, general view of disused governor house, from the south

Plate 186: Structures 10c and 10d, general view of disused governor houses, from the north-west

Plate 187: Structure 10e, general view of disused governor house, from the south-east

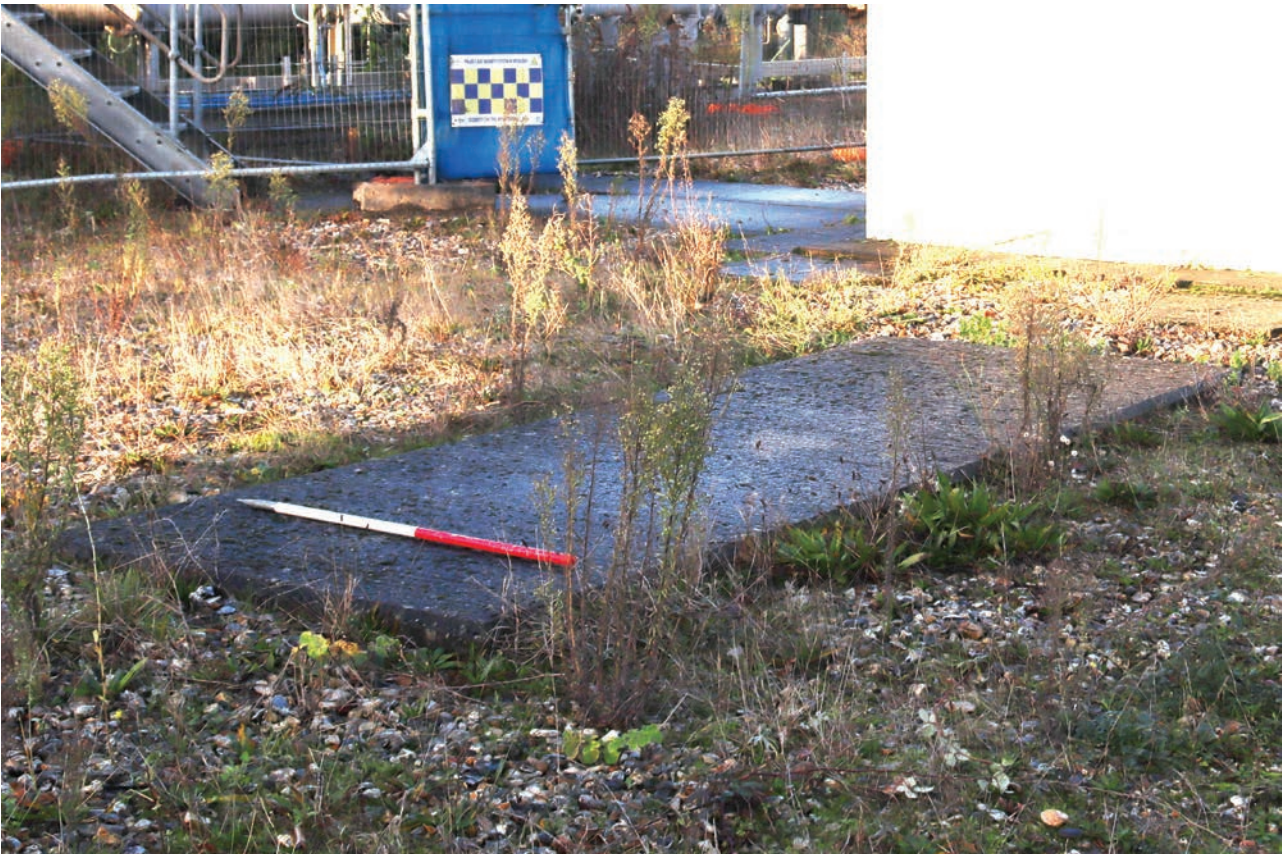
9.11.1 A concrete footing (Structure 11a) measuring 3.2m² in the north of the site and another in the south (Structure 11b) measuring 3.8m x 1.7m in a north-west/south-east orientation, may be footings for previous buildings on site (Plate 188). To the north-east of Structure 11b there are four smaller 1.3m² concrete footings (11c-f) which may be settings for previous machinery (Plate 189).

Plate 188: Structure 11b, detail view of concrete footing, from the north-east

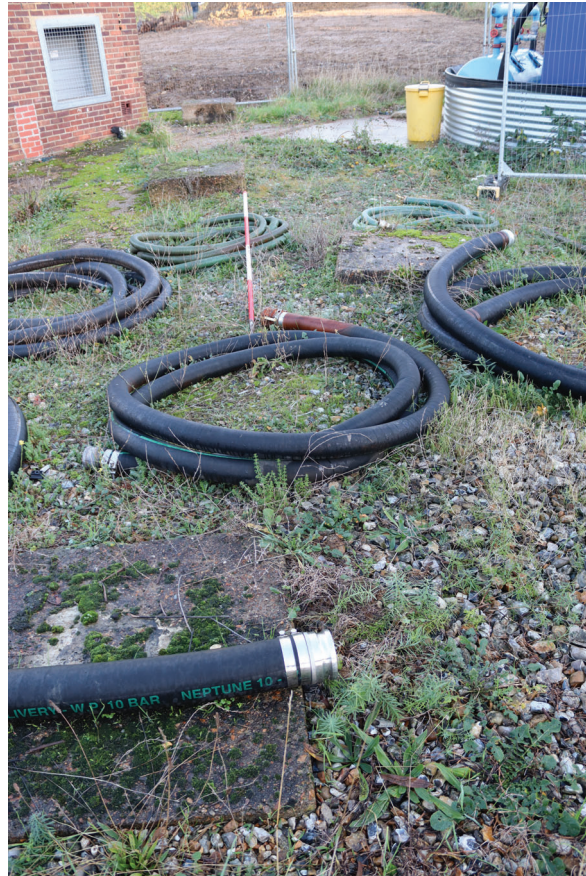
Plate 189: Structures 11b-f, general view of concrete footings, from the south

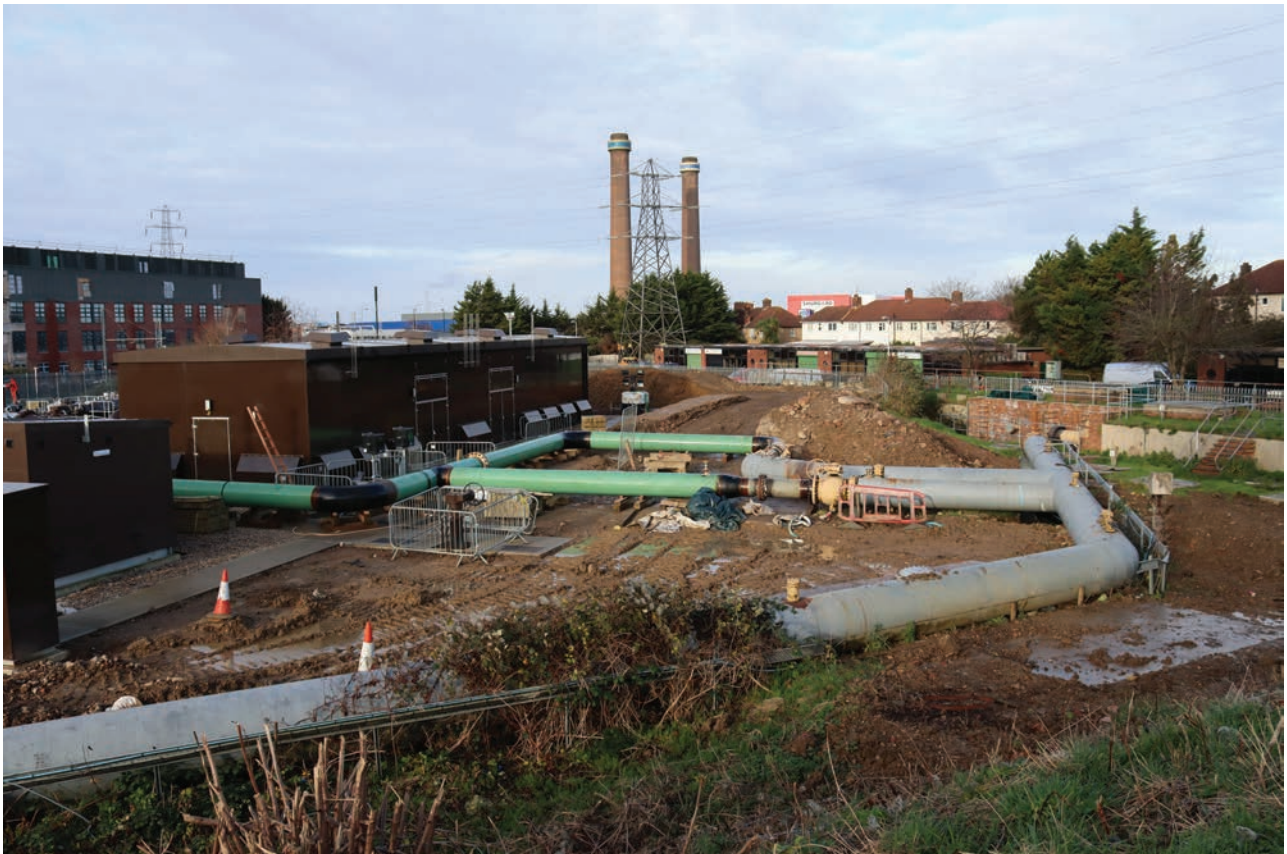
9.12.1 There are large sections of above-ground pipework on the site. In the centre of the site to the north-west of the District Governor House some old grey pipework meets the new green pipework, which was installed in 2020 as part of the high-pressure works (Plates 190). In the west corner of the site the above-ground pipework contains entry points for an intelligent pig to be put into the system to check the pipes are clear from blockages, general debris and damage (Plates 191 & 192). These sections of pipe contain AUDCO valves, Cameron Ball valves and air operated valves (Plates 193–196). The pipework was mostly made by General Descales Co Ltd of Worksop (Plate 197).

Plate 190: Pipework, general view of old grey pipework meeting new green pipework to the north of the high-pressure works, from the east

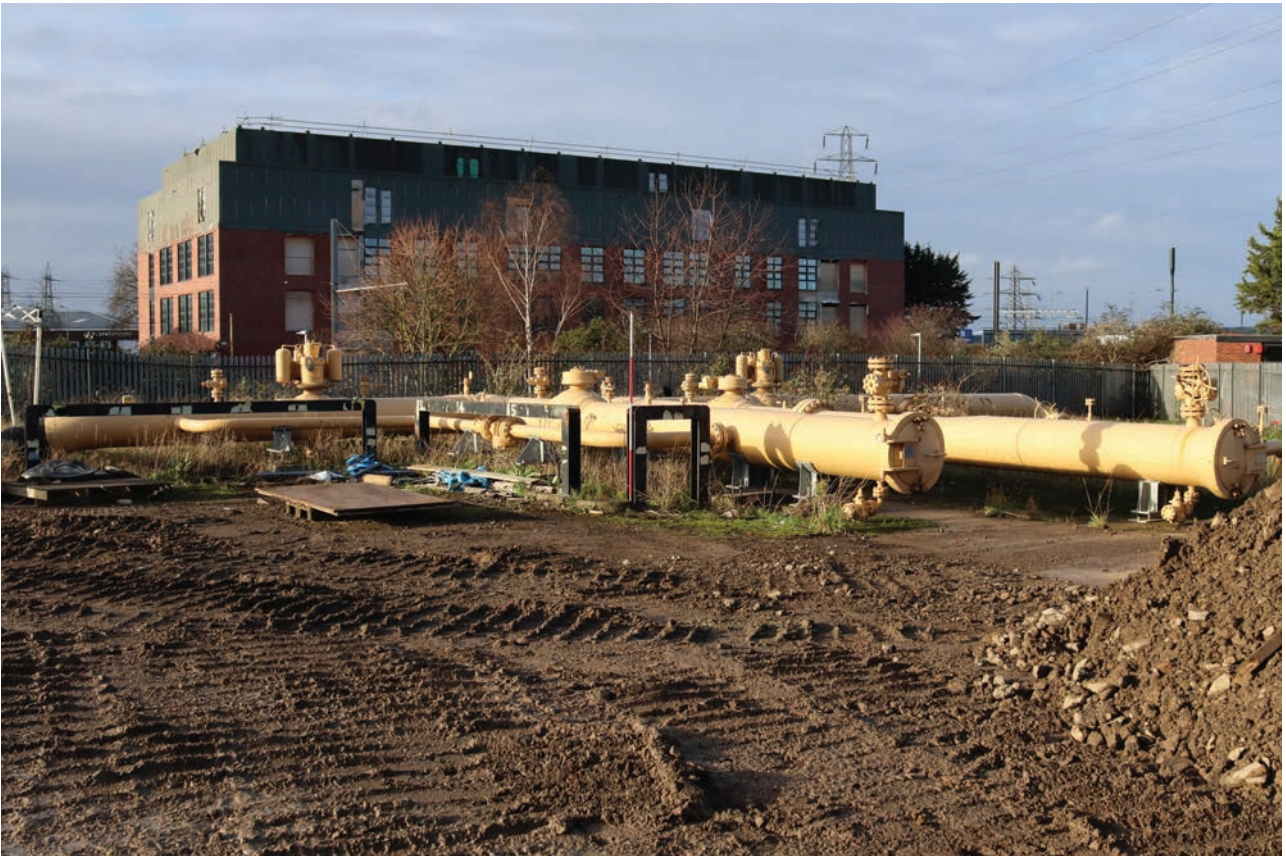
Plate 191: Pipework, general view of above ground pipework in the west corner of the side, from the east

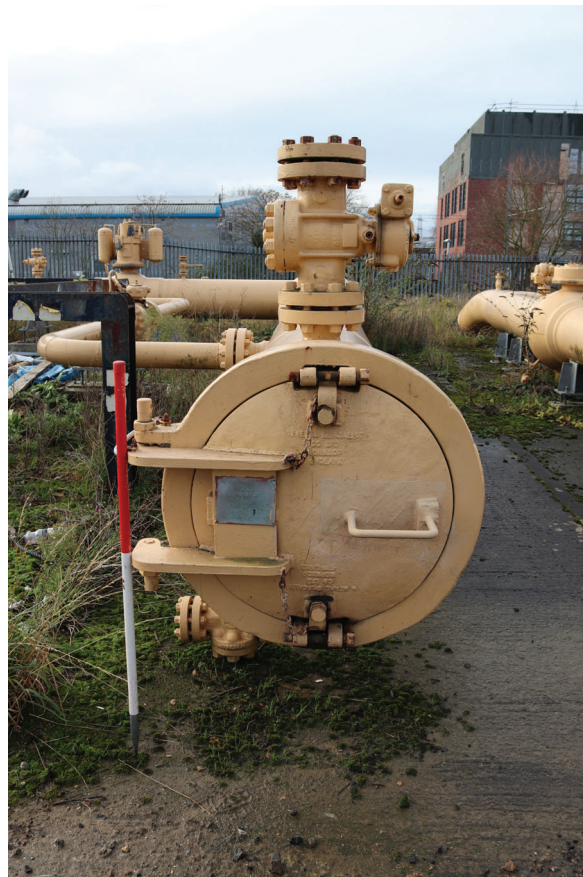
Plate 192: Pipework, detail view of entrance for intelligent pig, from the ENE

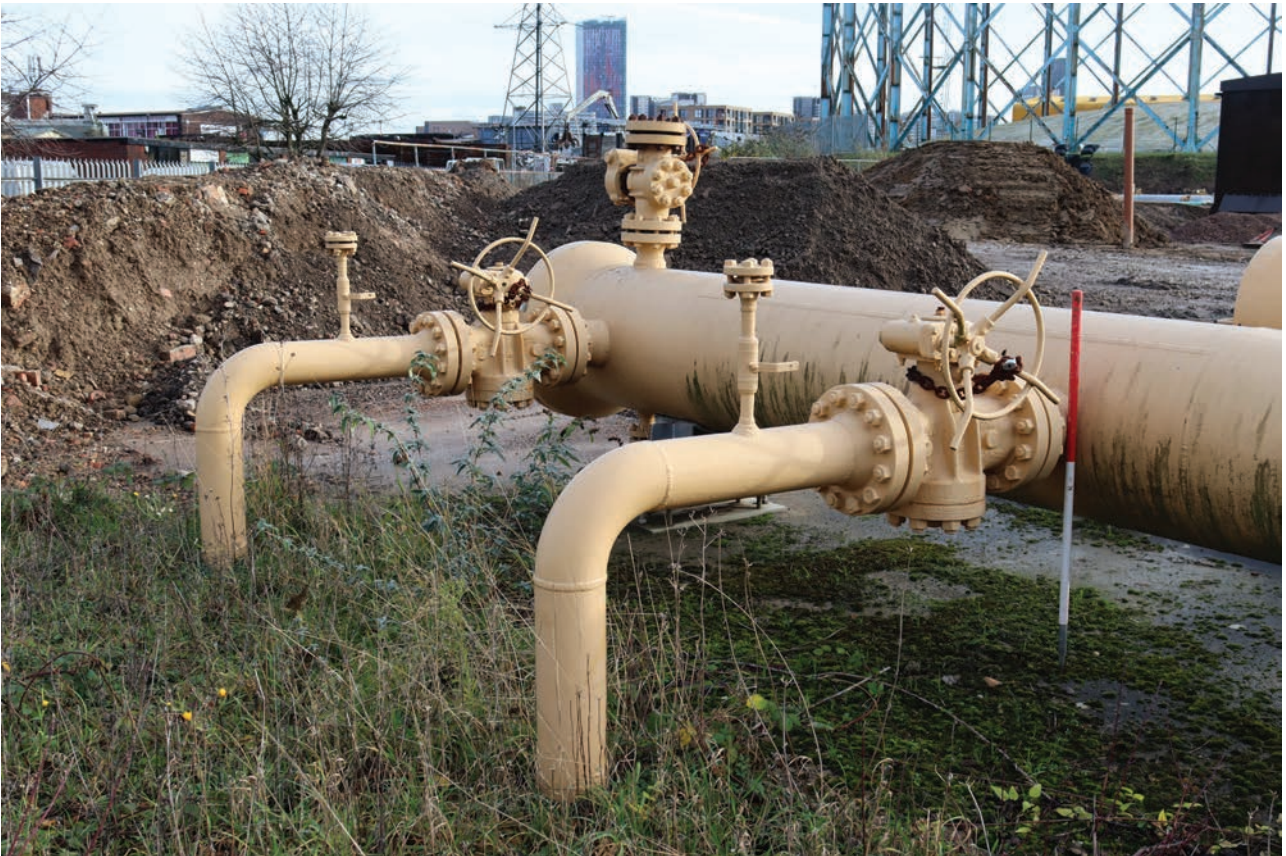
Plate 193: Pipework, general view of AUDCO valve, from the north-west

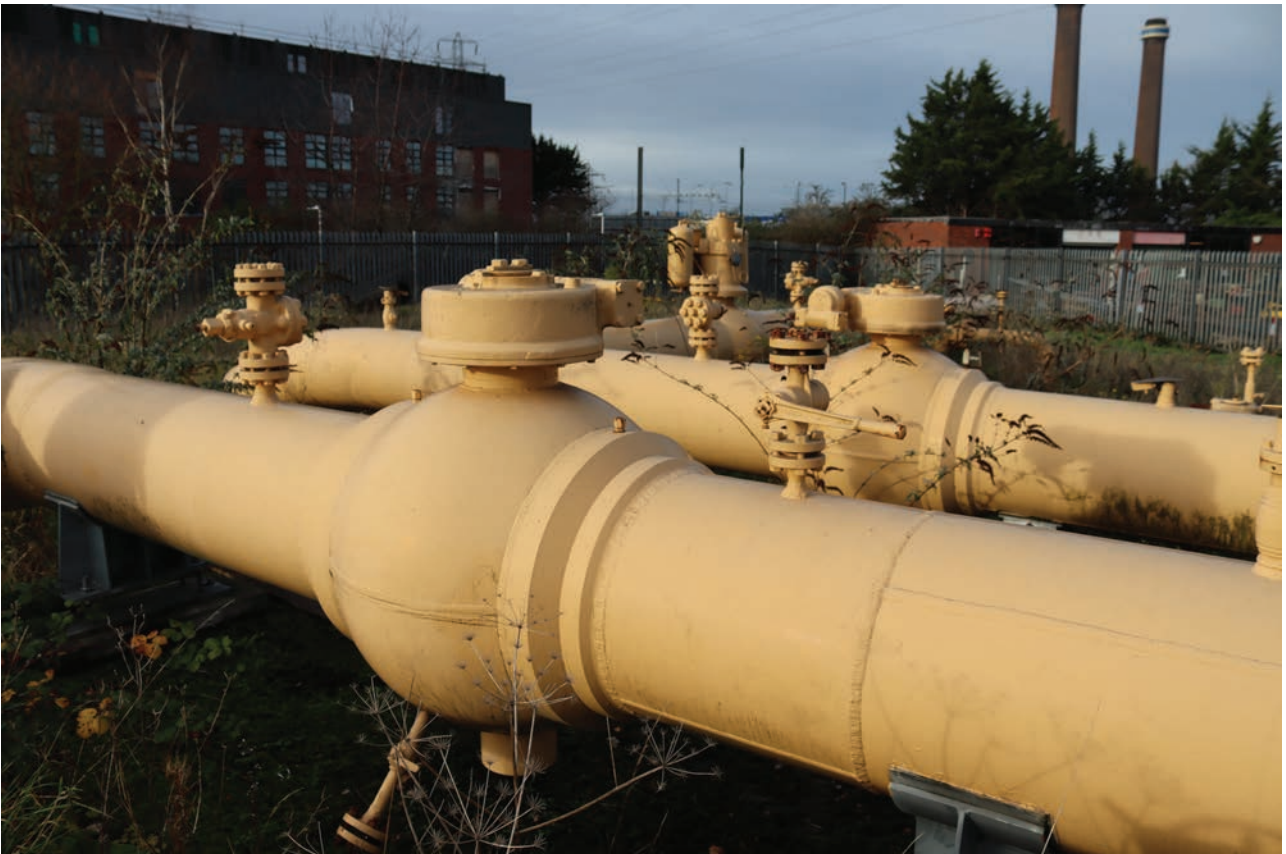
Plate 194: Pipework, detail view of Cameron ball valve, from the north-west

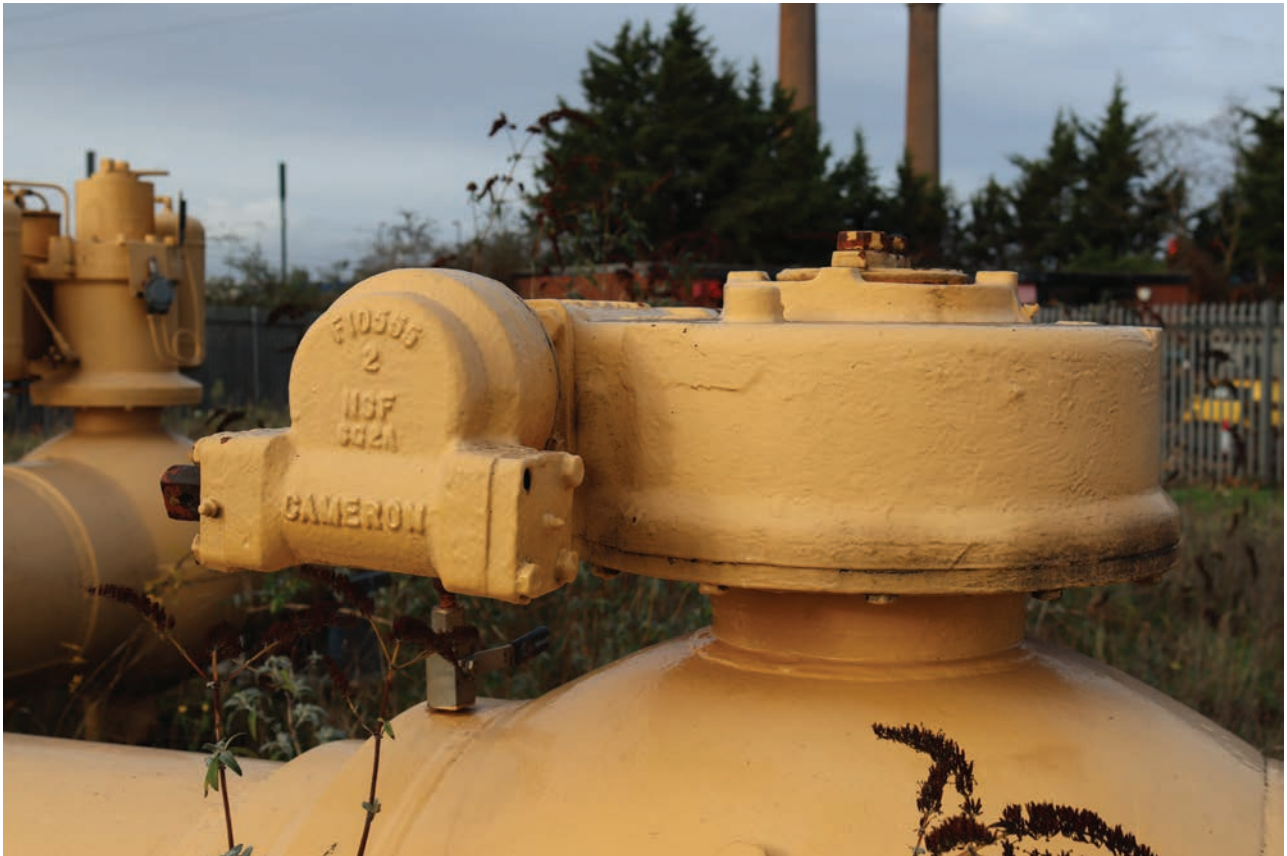
Plate 195: Pipework, detail view of Cameron maker's mark on the ball valve, from the south-east

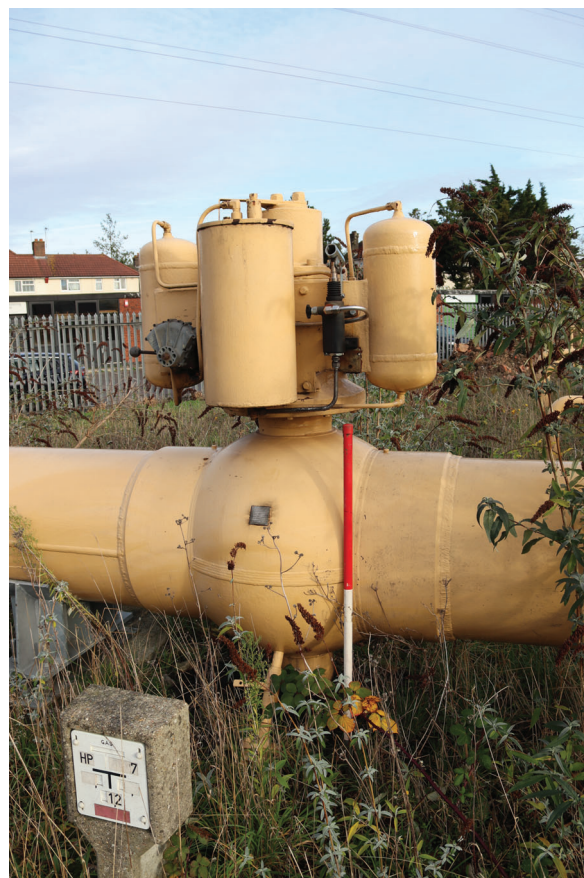
Plate 196: Pipework, detail view of air operated valve, from the WSW

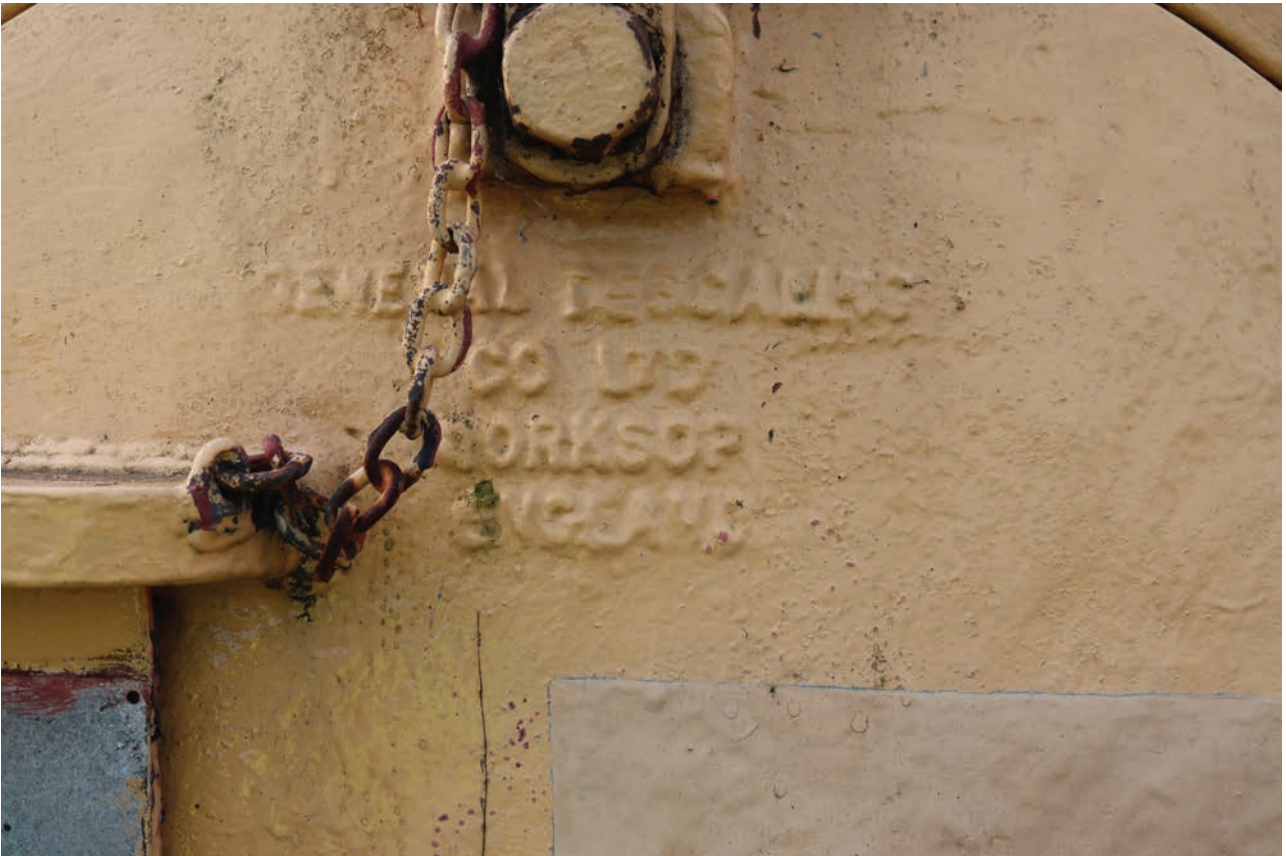
Plate 197: Pipework, detail view of General Descalles Co Ltd maker's mark, from the ENE

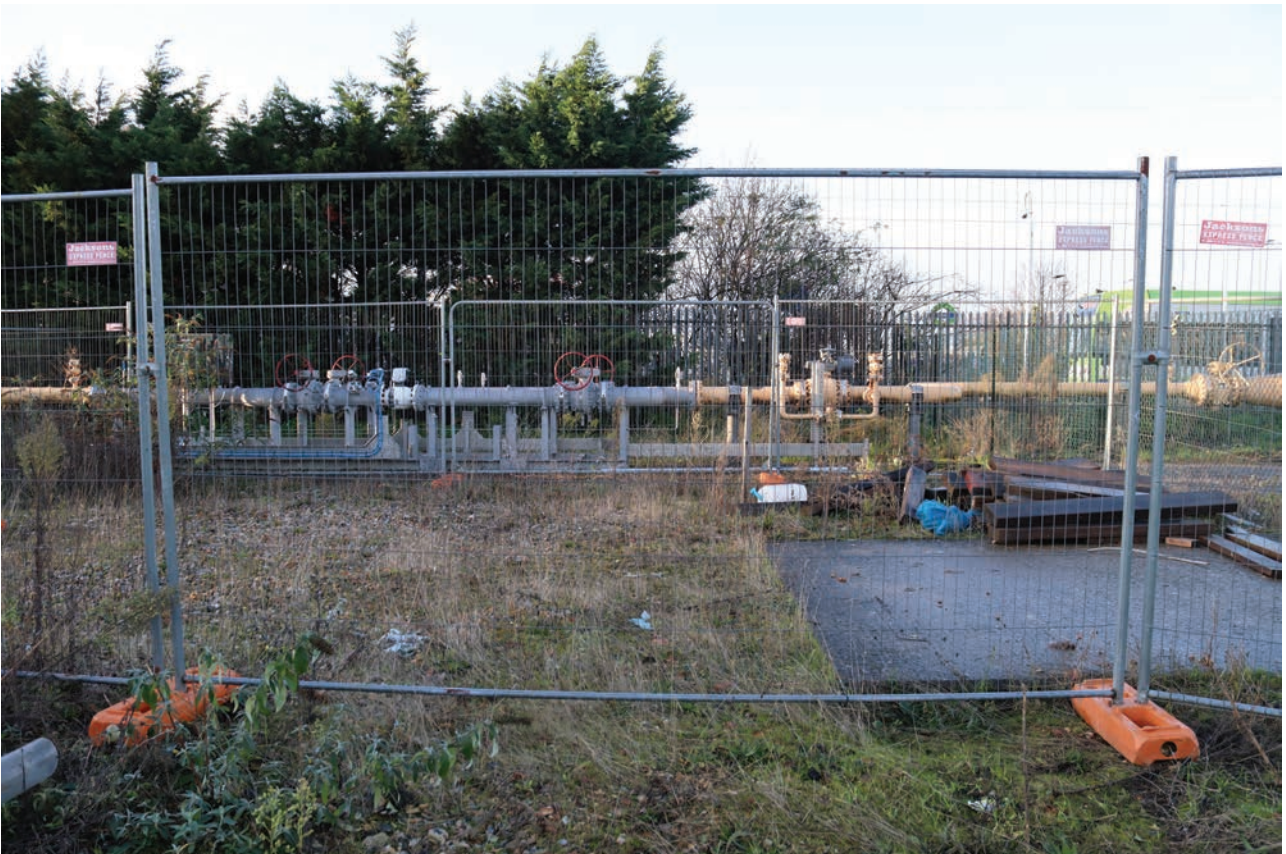
9.12.2 On the south-west boundary of the site there is a large area of above-ground pipework (Plate 198). There is also a short length of wide above-ground pipework to the south of structure 4 (Plate 199). During the Phase I survey, some below-ground pipework was also exposed to the south of this area in advance of replacement (Plates 200 & 201). It connects to pipework outside the boundary of the survey that was also being replaced (Plate 202). There was a long length of above-ground pipework in this same area outside the survey boundary (Plate 203).

Plate 198: Pipework, general view of above ground pipework on the south-west boundary of the site, from the north-east

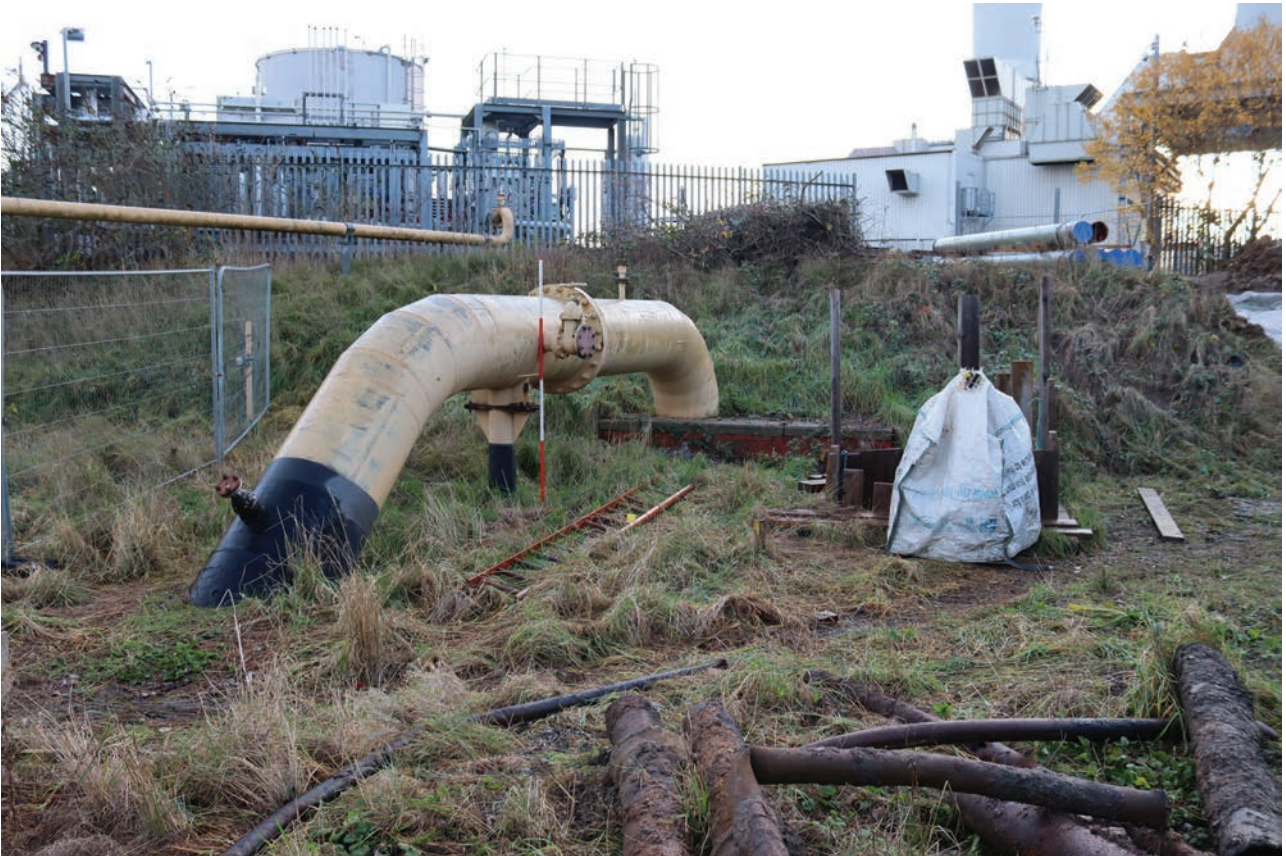
Plate 199: Pipework, detail view of above ground pipework to the south of structure 4, from the WNW

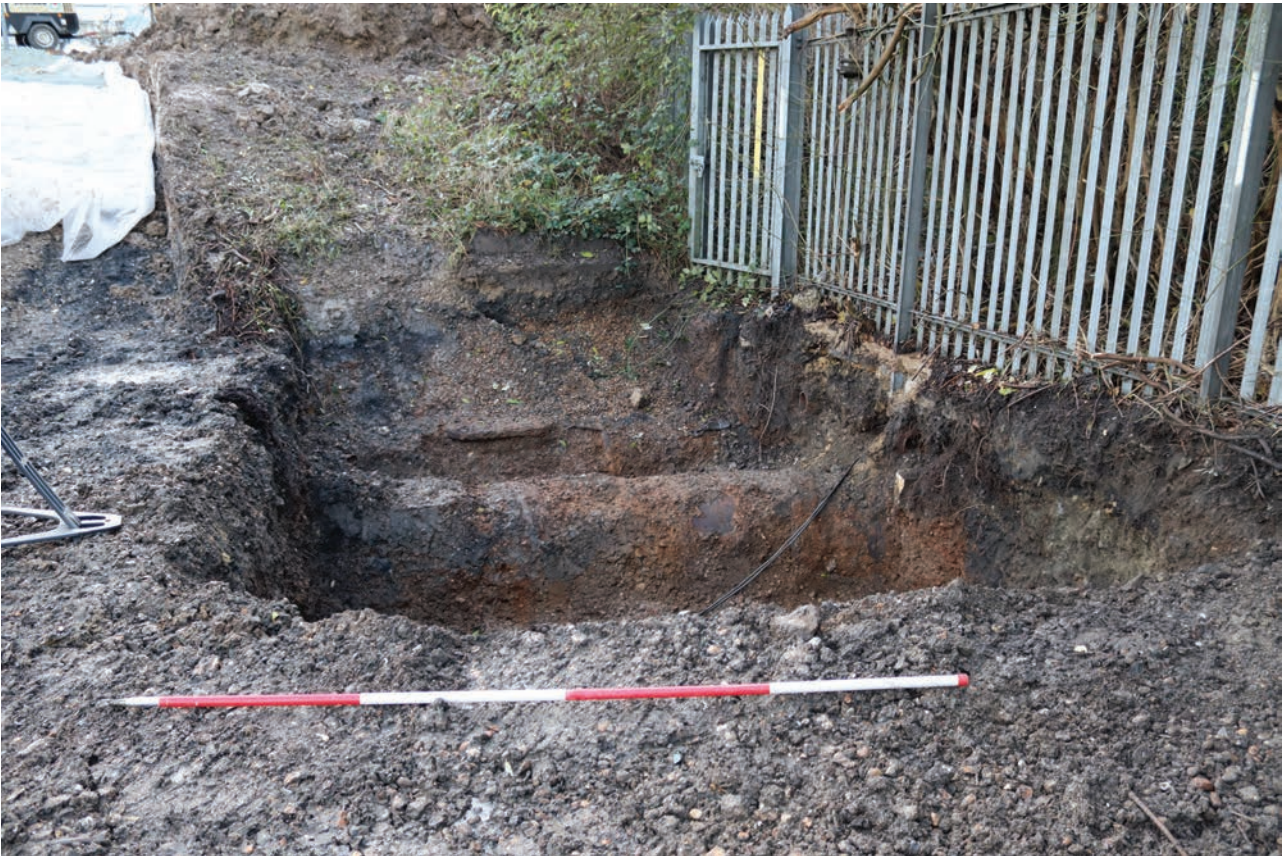
Plate 201: Pipework, section of below ground pipework being replaced during the survey works, from the north-west

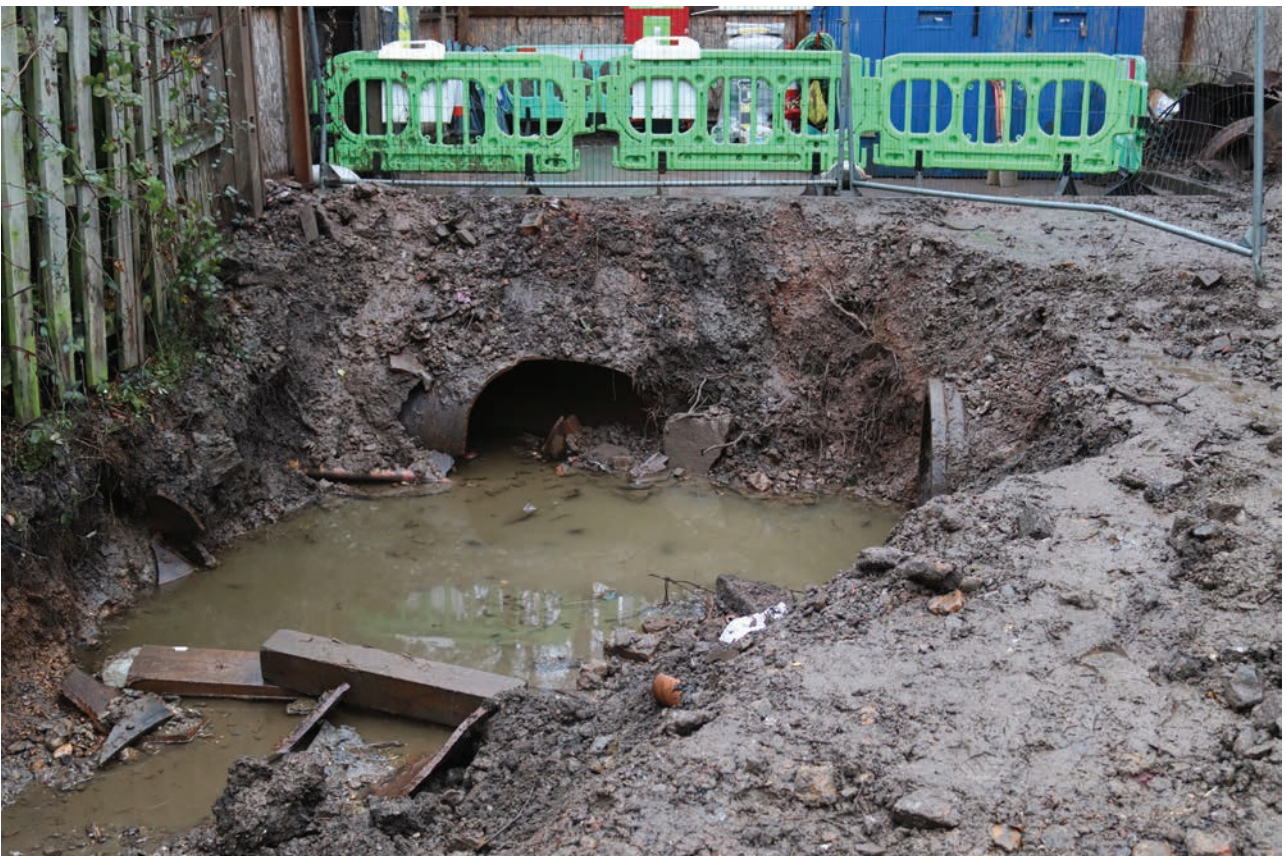
Plate 202: Pipework, section of below ground pipework being replaced outside the survey boundary, from the south-east

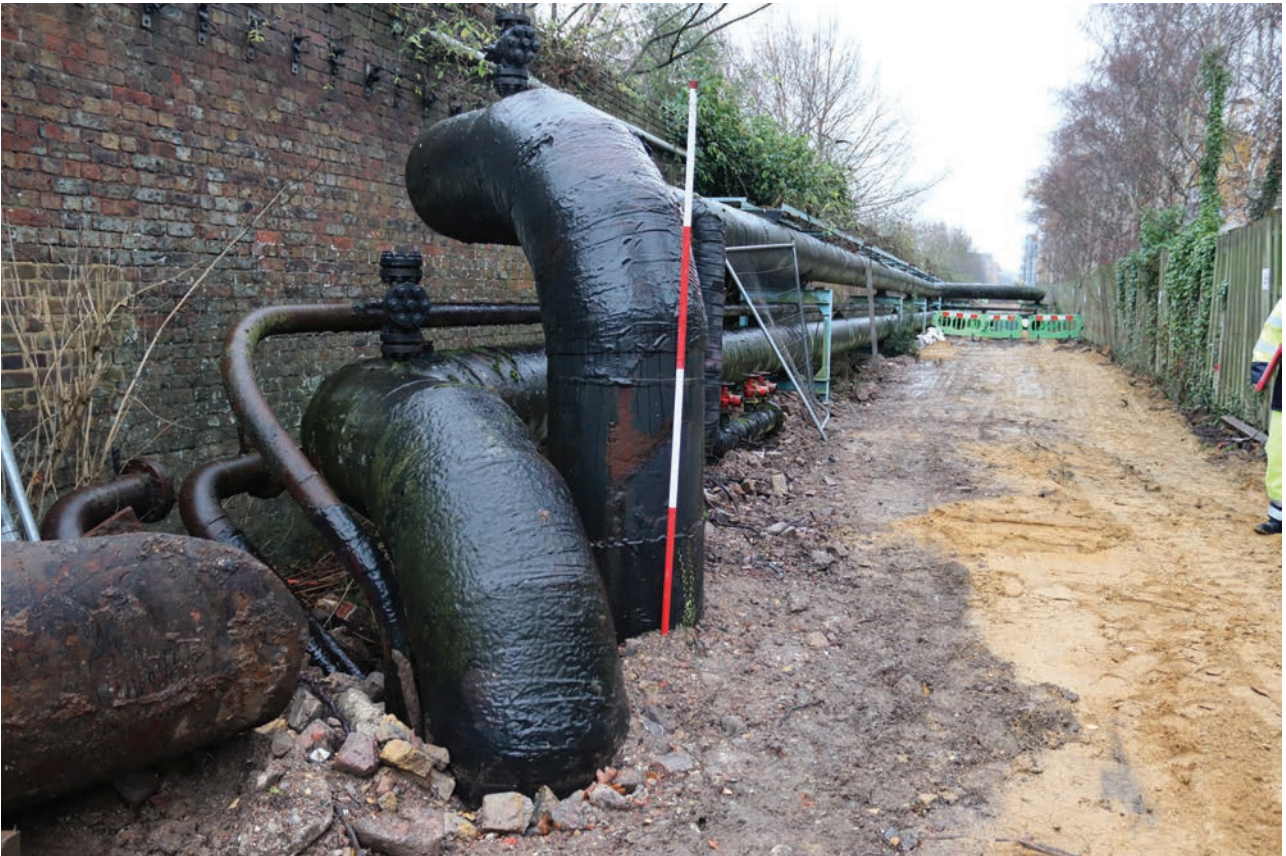
Plate 203: Pipework, general view of above ground pipework to the south of the site boundary, from the north-west

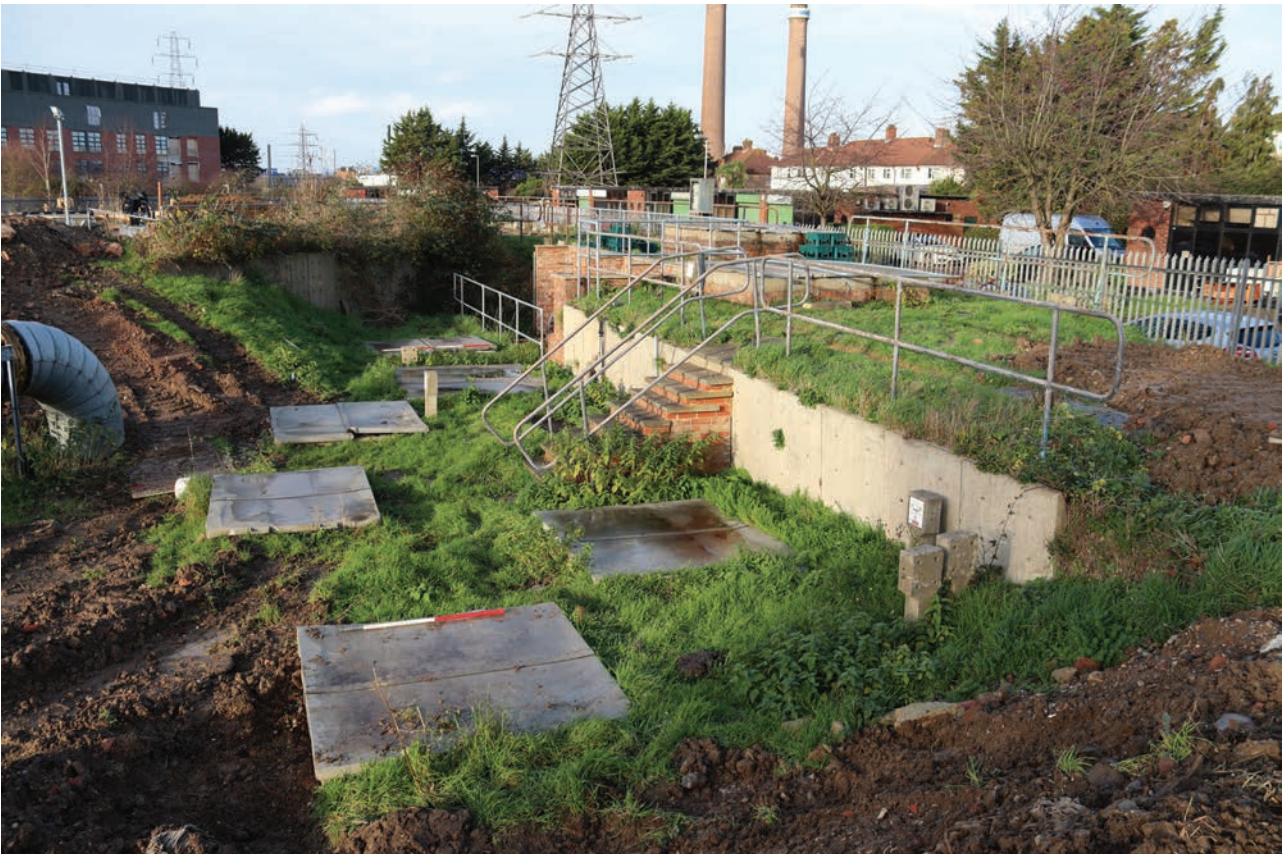
9.13.1 Two areas of valve pits exist on the site, one in the west corner and one in the centre of the north side. There are ten valve pits in the north of the site which are split over two levels (Plate 204). The pits of the higher levels have pipework emerging from the ground that has now been blanked along with a larger section of pipe which are all housed in a brick-walled area (Plate 205). The remains of a previous pit which has been filled in at the higher level are just visible (Plate 206). The pits are either brick or concrete-walled with access ladders built into the walls (Plate 207). A variety of valve types are present on the pipework including Cameron ball valves (Plate 208). Several sections of pipework have been blanked (Plate 209). The pits all have steel rain covers and contain only one pipe section, except for one on the south-east boundary which has two crossing sections of pipe (Plates 210 & 211).

Plate 204: Valve pits, general view of north side double level valve pit area, from the ESE

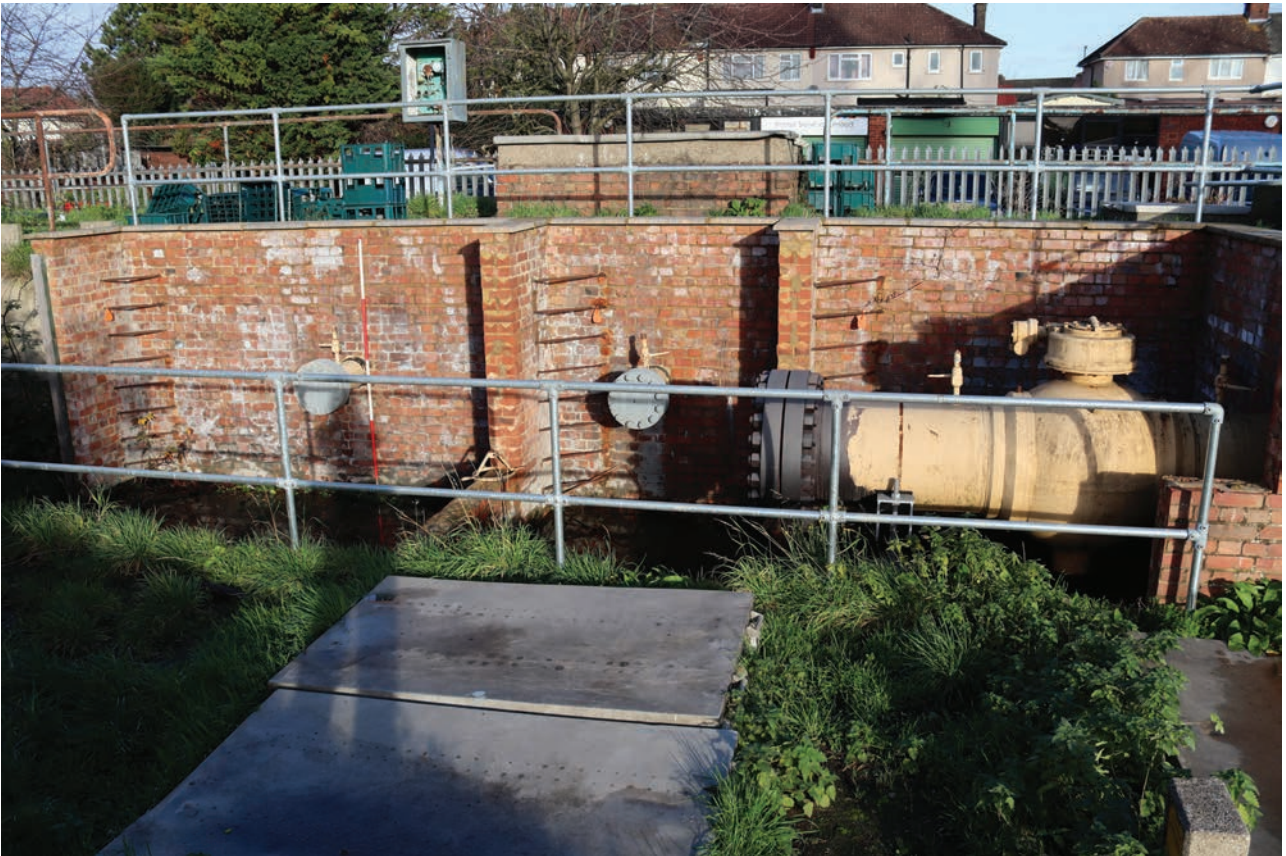
Plate 205: Valve pits, detail view of blanked pipework from the higher level valve pits, from the east

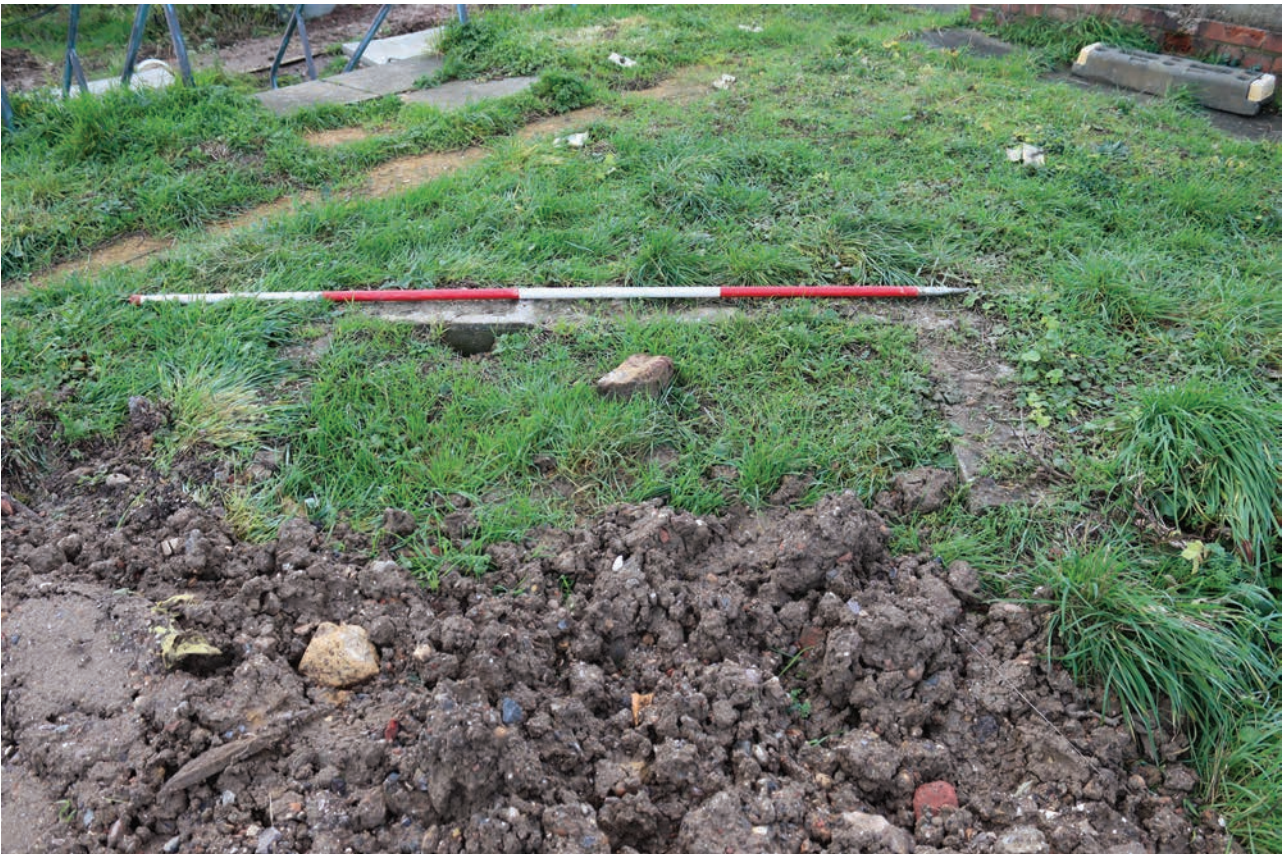
Plate 206: Valve pits, detail view of previously filled in pit, from the ENE
