Gasholders Nos 4 & 5, Factory Lane, Croydon, London: Historic Building Recording Final Report

*AOC Project No: 23686_V
3rd August 2021*

On Behalf of:	SGN 2 Woodstock Road Yarnton OX5 1NY
National Grid Reference (NGR):	Gasholder No 4: TQ 31212 65907 Gasholder No 5: TQ 31169 65975
AOC Project No:	23686_V
OASIS No:	411878
Prepared by:	Diana Sproat Gemma Hudson
Illustration by:	Gemma Hudson Jamie Humble Sam O'Leary
Date of Fieldwork:	16th – 18th December 2020 (Phase I) 5th May & 7th July 2021 (Phase II)
Date of Report:	3rd August 2021

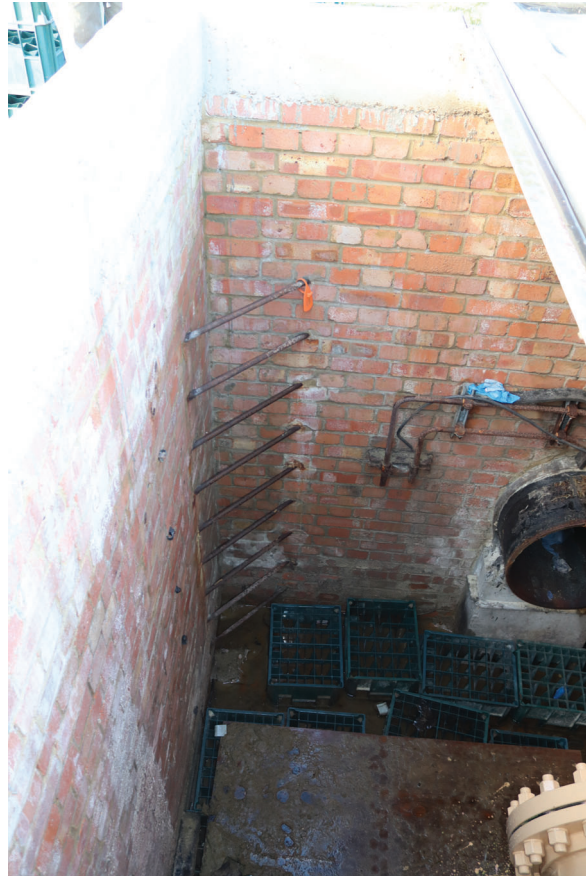
Plate 207: Valve pits, detail view of brick walled pit with access ladder, from the ESE

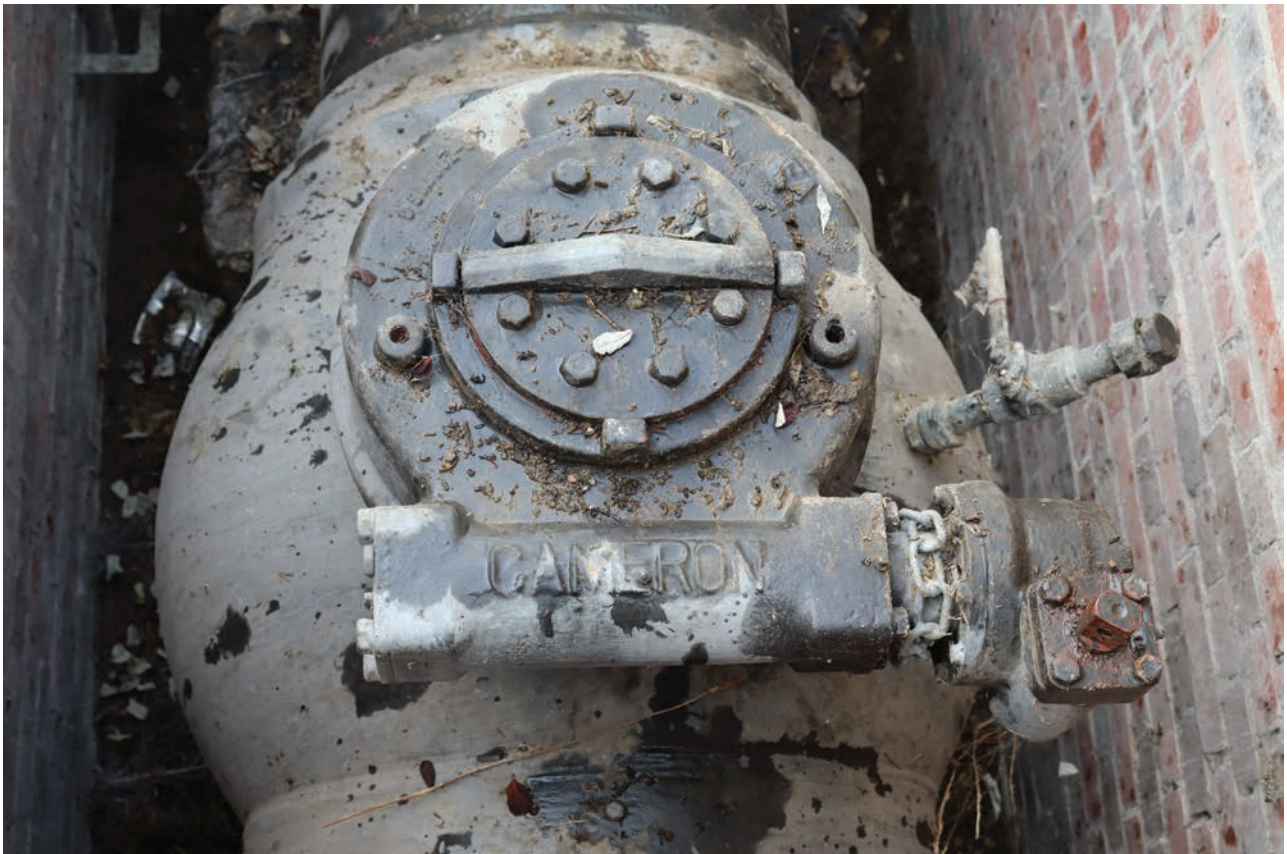
Plate 208: Valve pits, detail view of Cameron ball valve, from the north-east

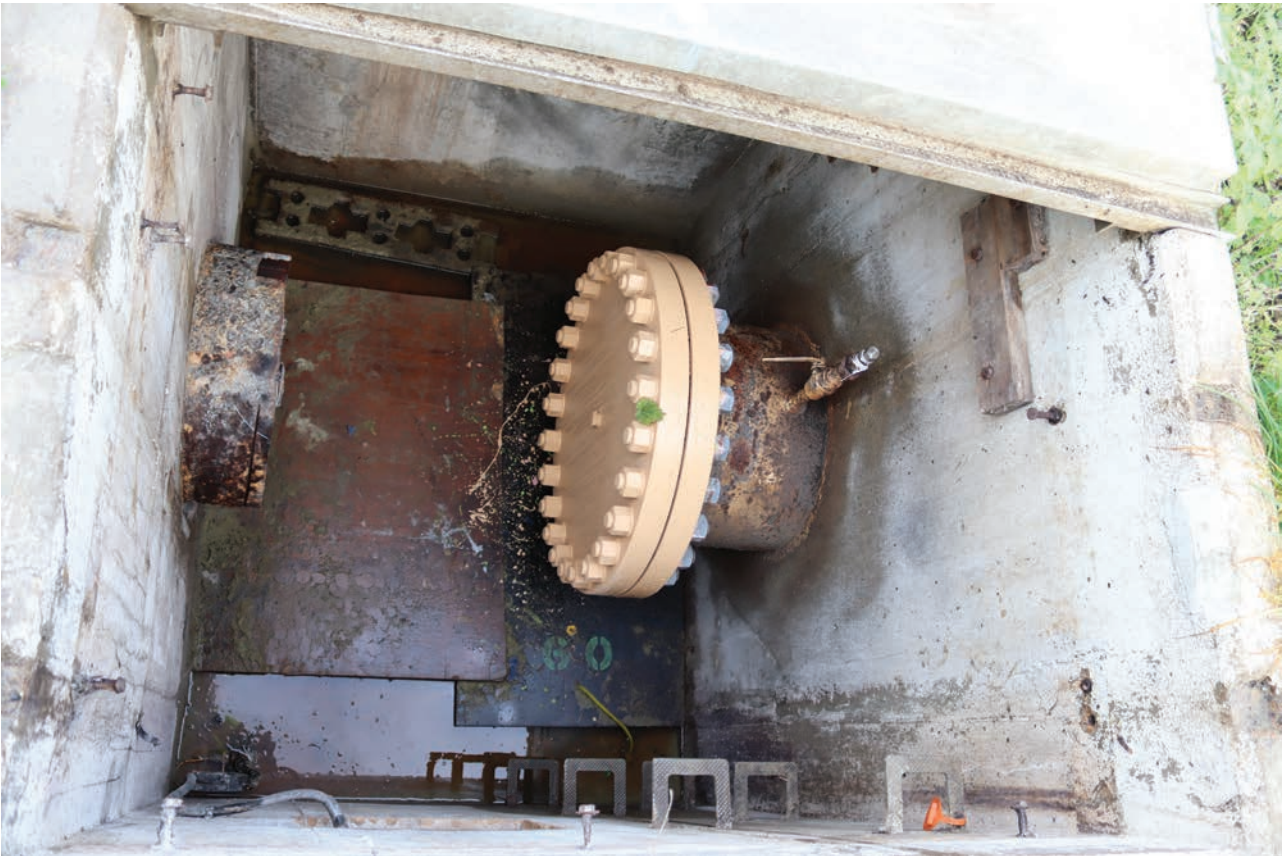
Plate 209: Valve pits, detail view of blanked pipe, from the WNW

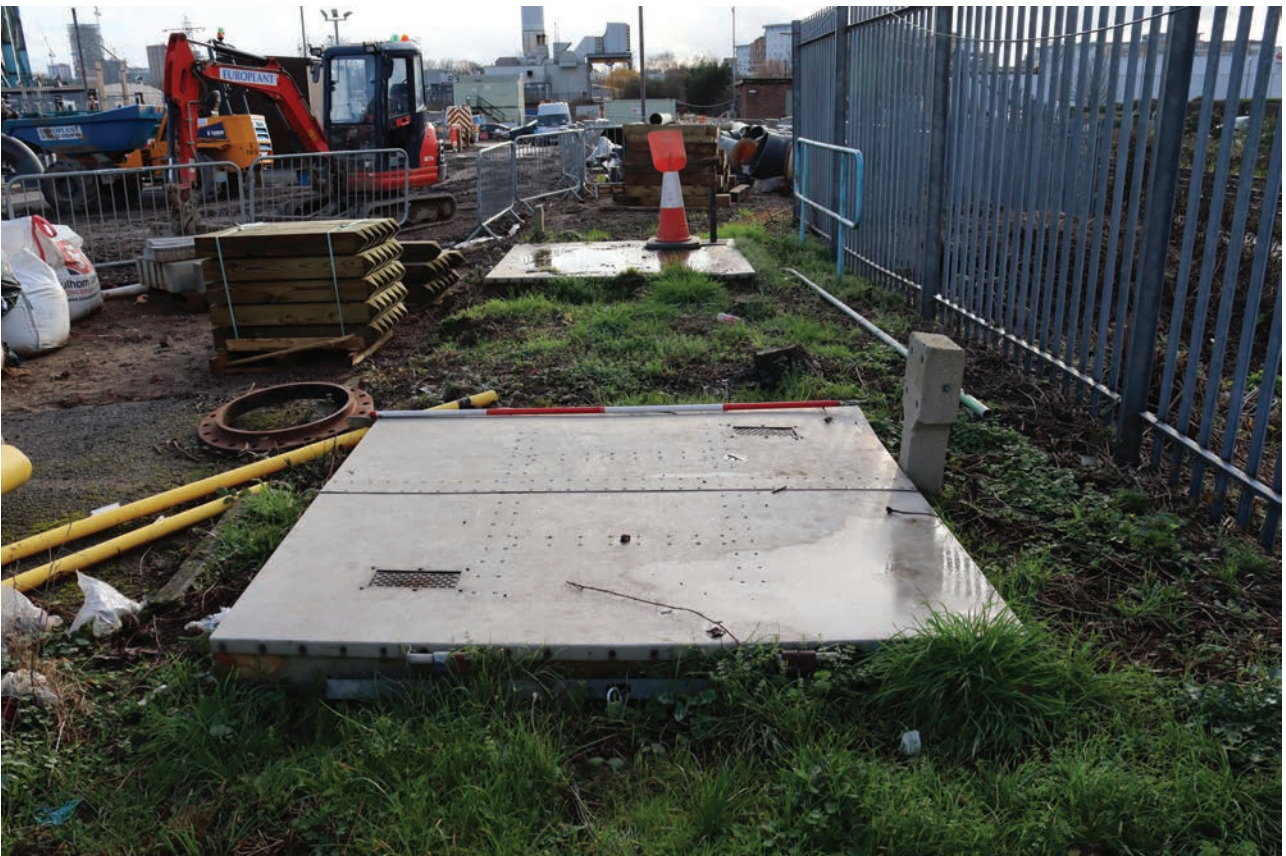
9.13.1 Two areas of valve pits exist on the site, one in the west corner and one in the centre of the north side. There are ten valve pits in the north of the site which are split over two levels (Plate 204). The pits of the higher levels have pipework emerging from the ground that has now been blanked along with a larger section of pipe which are all housed in a brick-walled area (Plate 205). The remains of a previous pit which has been filled in at the higher level are just visible (Plate 206). The pits are either brick or concrete-walled with access ladders built into the walls (Plate 207). A variety of valve types are present on the pipework including Cameron ball valves (Plate 208). Several sections of pipework have been blanked (Plate 209). The pits all have steel rain covers and contain only one pipe section, except for one on the south-east boundary which has two crossing sections of pipe (Plates 210 & 211).

Plate 210: Valve pits, detail view of steel rain covers, from the north-west

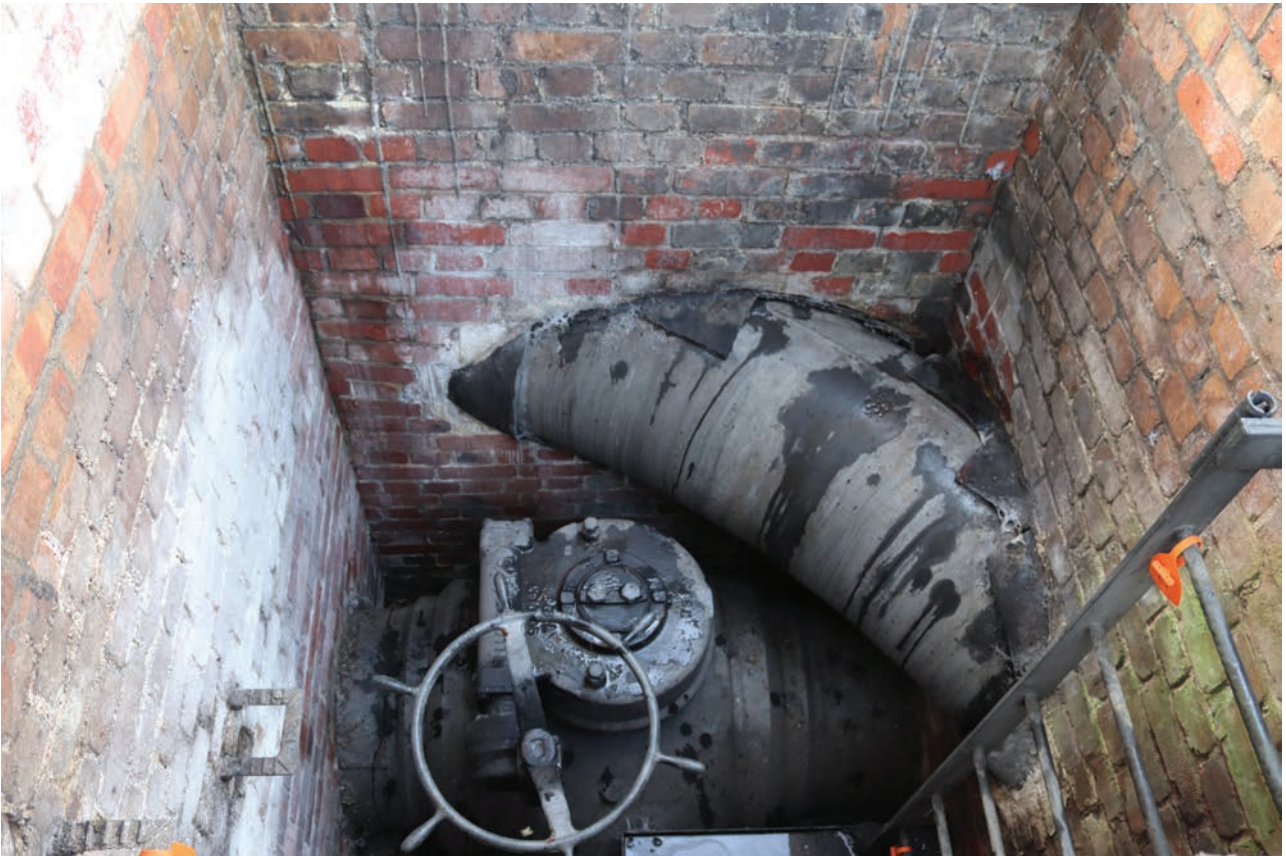
Plate 211: Valve pits, detail view of pits with two pipes, from the north-west

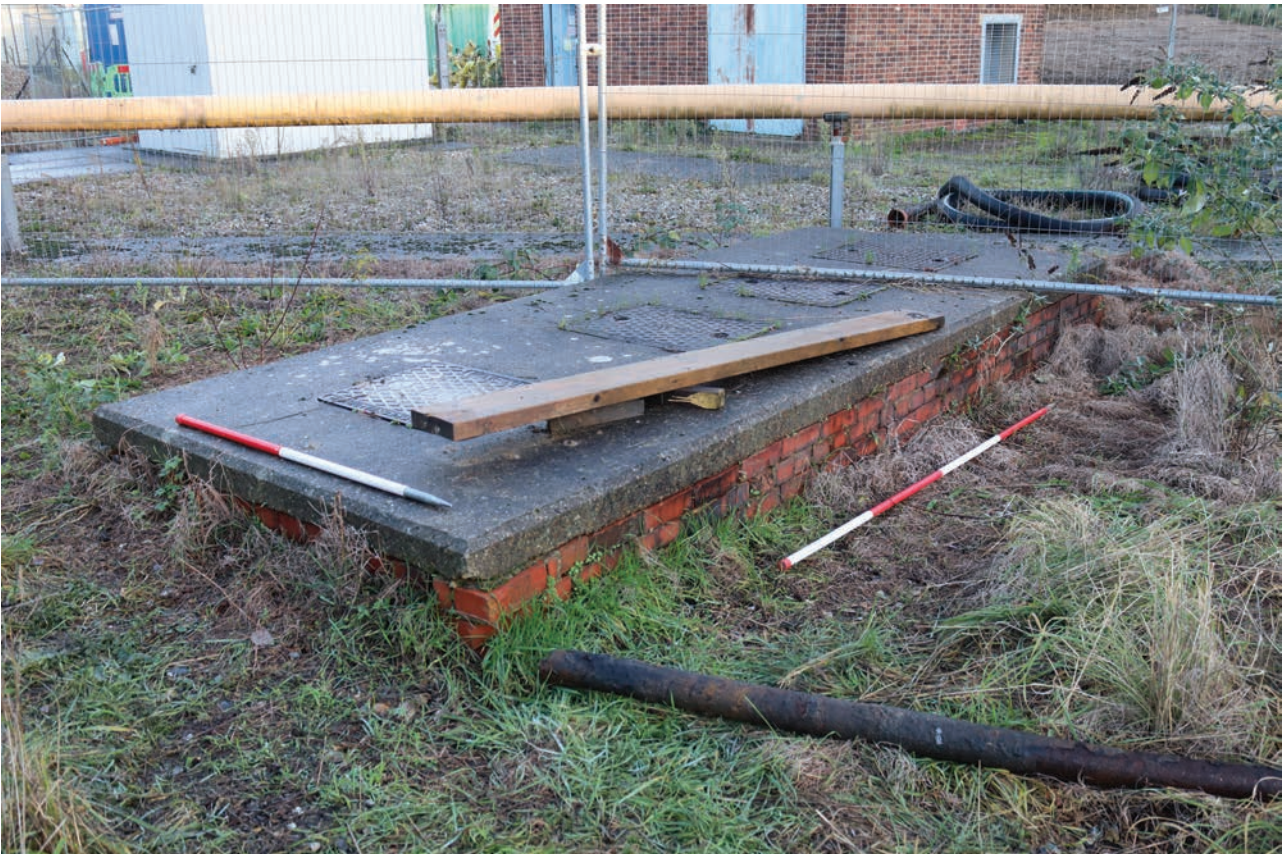
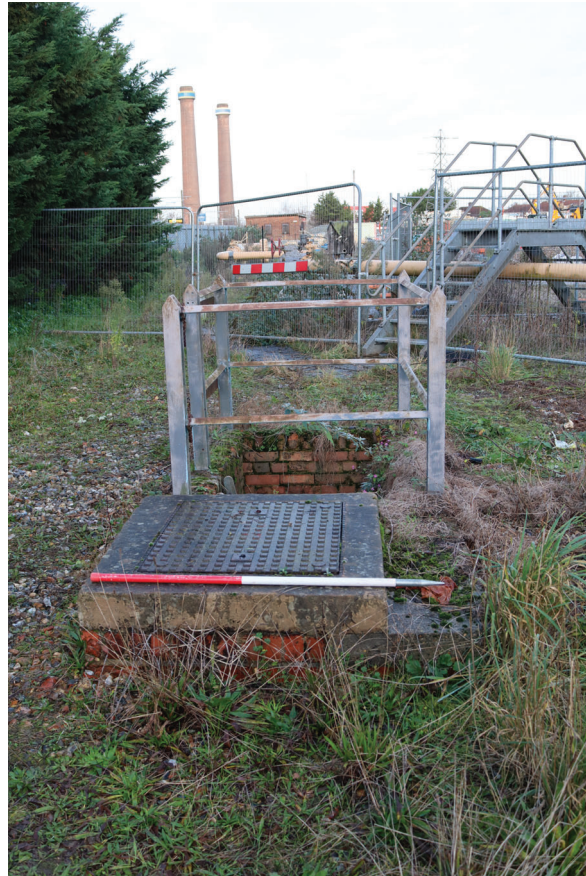
9.14.1 In the south of the site there is an interceptor tank and a holder discharge sample point (Plates 212–214). This interceptor tank may have been for Gasholder No 5 as there is not one close to the holder itself. The

Plate 212: Interceptor tank, general view, from the south-east

Plate 213: Interceptor tank, general view, from the south-east

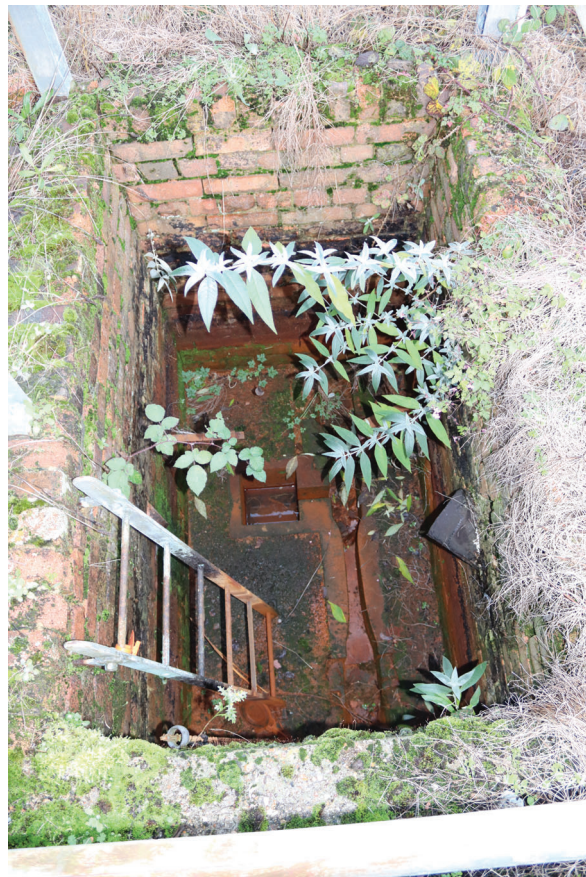
Plate 214: Interceptor tank, detail view, from the south-east
