Aldi Stores, Airdrie: Data Structure Report

Watching brief and Evaluation Data Structure Report

On Behalf of:	Oliver and Rob Architects Pitreavie Drive Dunfermline KY11 8UH
National Grid Reference (NGR):	NT 3821 7424
AOC Project No:	20876
Prepared by:	Erlend Hindmarch
Illustration by:	James Knowles
Date of Fieldwork:	May 2008
Date of Report:	June 2008

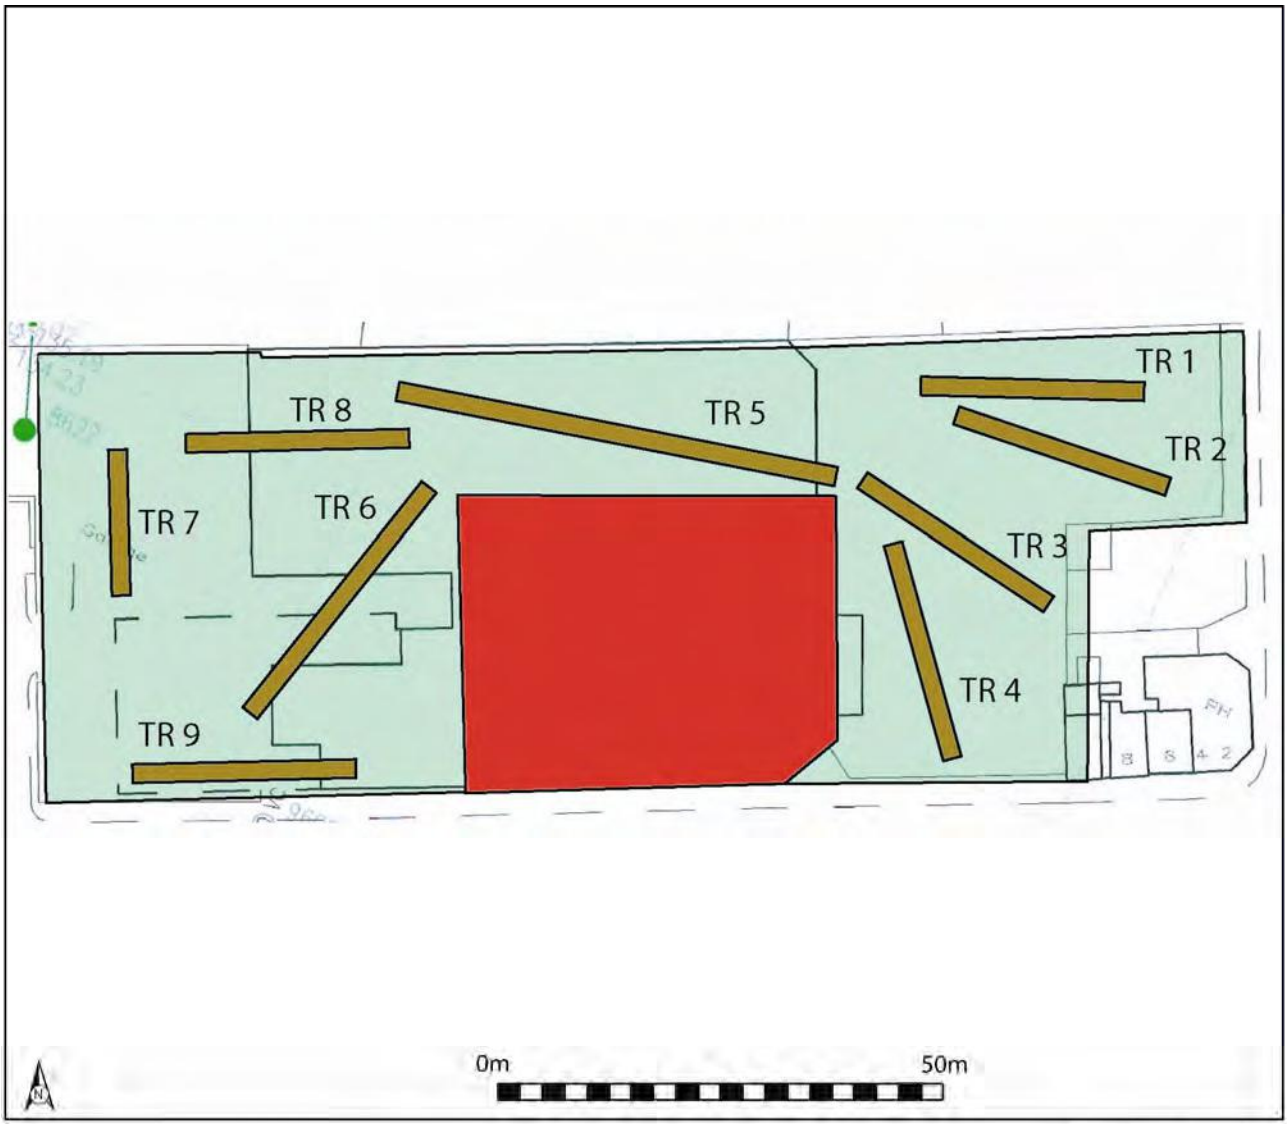
Figure 2 :Trench Plan Location

4.2.1 The evaluation trenches (Figure 2) were excavated following removal of the concrete slab / tarmac using a 360° type excavator fitted with a toothless ditching bucket under the direct supervision of an experienced field archaeologist. Excavation of the trenches was carried out in shallow spits down to the first significant archaeological horizon or natural subsoil. All significant features were cleaned and fully defined to enable a full written, drawn and photographic record to be taken.

4.2.2 Due to the presence of modern standing remains it was only possible to excavate a total of nine trenches totalling 500 m². Following discussions with WoSAS it was decided that given the results of the evaluation so far completed, it was not necessary to dig the final two trenches whose positions were in areas subject to considerable disturbance by prior building works.

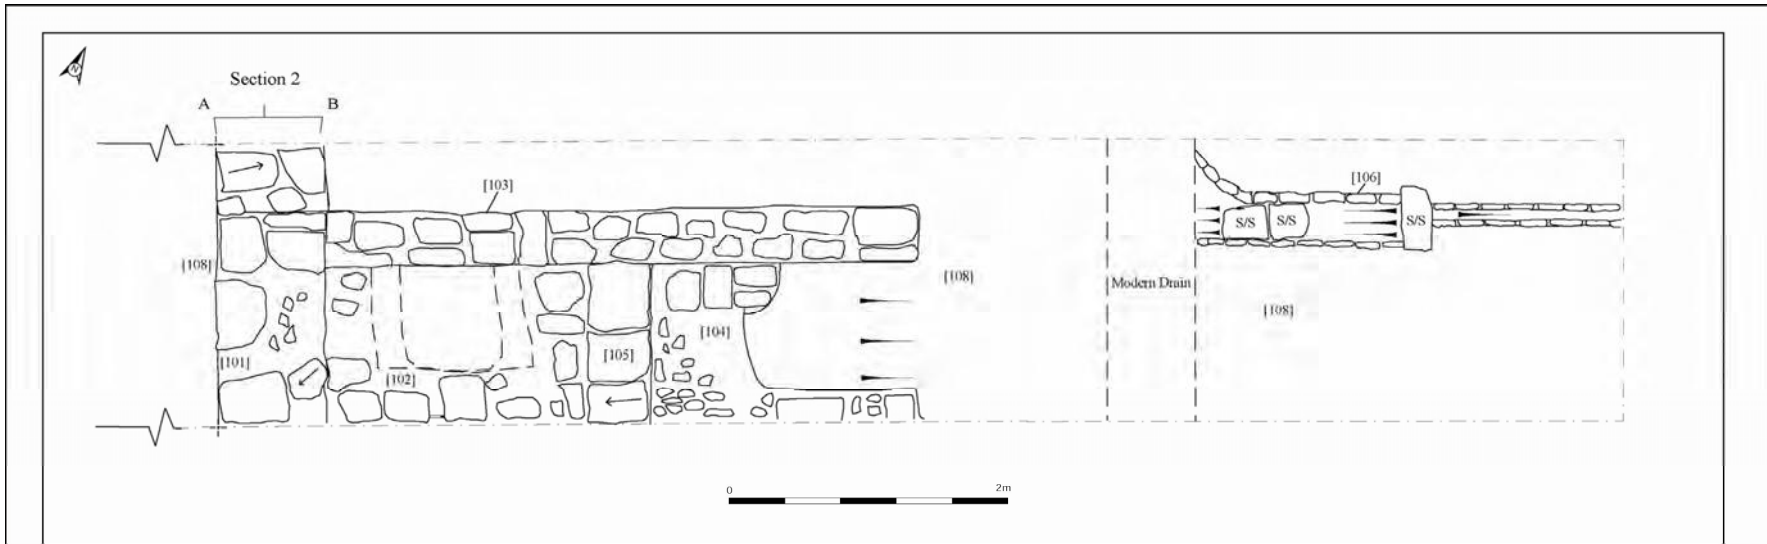
Figure 3 Showing Plan of Trench 1

5.3.1 Directly below the madeground and cutting the natural drift geology at a depth of 137.3 m OD were a number of stone-built features (Figures 3 and 4; Plate 1). These comprised stone walls (101), (103) and (105) and associated stone surfaces (102) and (104). All these features appeared to be contemporary. The walls were constructed from unworked sandstone blocks surviving to one course high and bonded with a light brown sandy mortar. Floor surface (102) bounded by walls (101), (103) and (105) was constructed from large sandstone blocks laid into the natural subsoil with no apparent bonding material, while floor remains (104) had a more cobbled appearance.

5.3.2 In addition to the features outlined above a stone-lined drain was exposed at the eastern end of the trench. This drain, aligned east to west, appeared to be constructed in order to allow drainage from the east to west where it appeared to turn to the north and where it was also truncated by a modern drain. The remains of a stone-flagged base and stone capping stones remained.

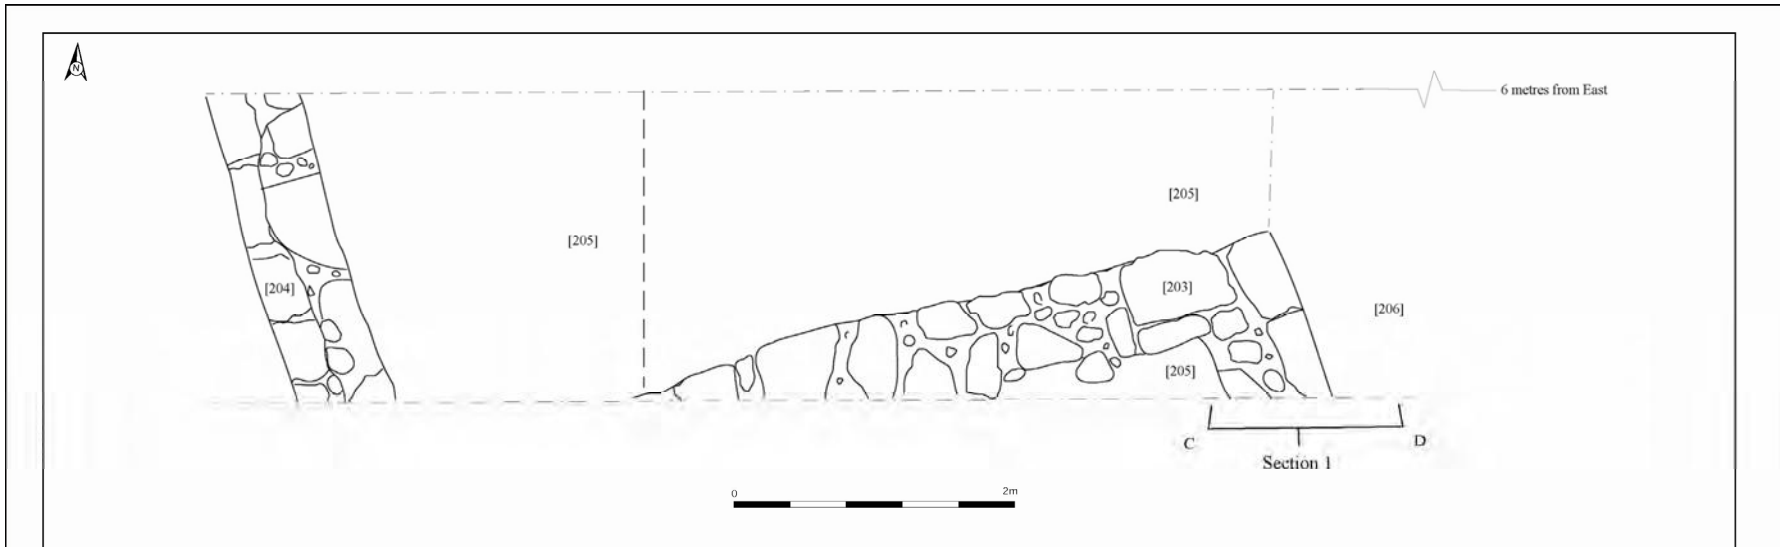
Figure 5 Showing Plan of Trench 2

5.5.1 Two stone-built walls (203) and (204) were sealed by madeground (Figures 5 and 6; Plate 2) and were of similar construction to the walls seen in Trench 1. Wall (204) is likely to be a continuation of Wall (101) unearthed in Trench 1. The eastern extent of Wall (203) turned 90° to the south and it is possible that it represents the north-east corner of a building. In addition, it is likely that at its western extent wall (203) joins wall (204) beyond the southern edge of the evaluation trench.

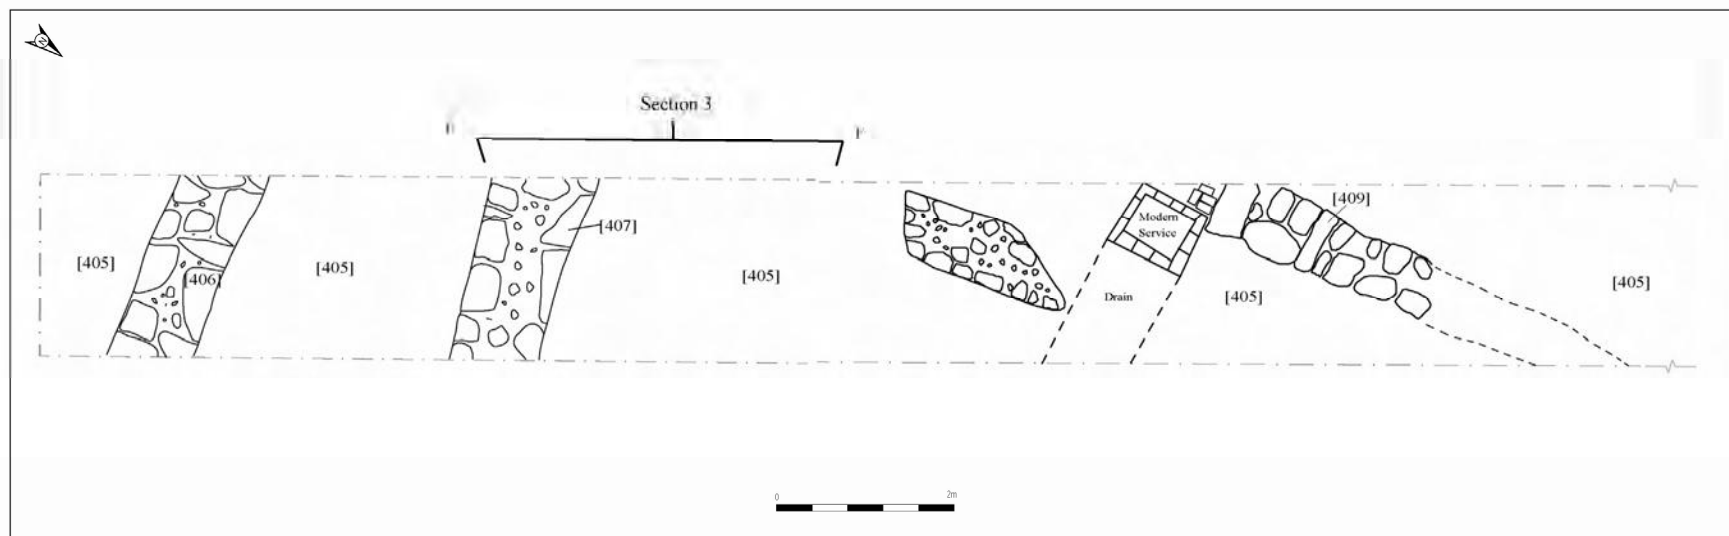
Figure 7 Showing Plan of Trench 4

5.6 Four walls (406), (407), (408) and (409) were located below madeground (Figures 7 and 8: Plate 3). These walls were of similar construction to the walls in the other trenches and formed two sets of parallel walls. Firstly, walls (406) and (407) were located toward the southern edge of the trench, aligned approximately east to west and separated by a distance of 2.5 m. The second set of walls, (408) and (409) were aligned at 90° to the first two walls. Although on the same alignment as each other, these two walls were not seen in a parallel context due to truncation caused by a modern drain. If these two walls were once side by side then they would be separated by 1 m.

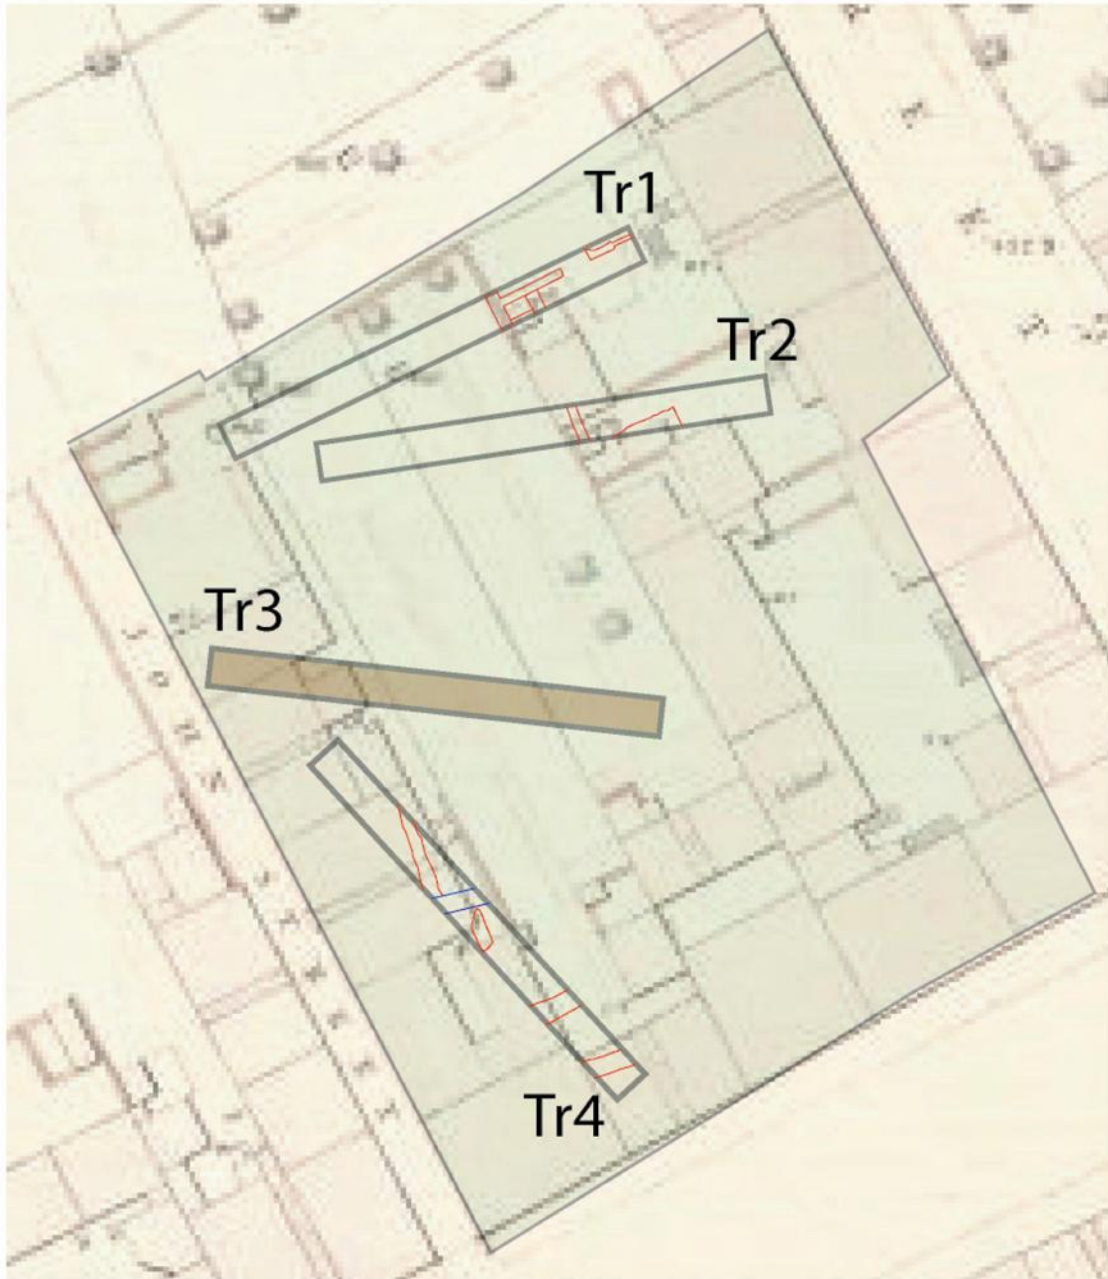
Figure 9: Showing Trench Plan with Features Overlaying the 1855 OS Map

- 6.1 It is clear from the evaluation that the vast majority of the site has undergone severe truncation. Building remains were only seen in the eastern portion of the site and these remains can be seen to correspond with buildings seen on Woods map of 1846 and the 1st Edition OS map of 1858 given the variations in mapping accuracies (Figure 9). Given that most modern disturbance is located below the modern concrete slab it is unlikely that further remains will exist below the presently upstanding building remains.
