239-241 High Street, Preston Evaluation Data Structure Report

239-241 High Street, Prestonpans Evaluation Data Structure Report

On Behalf of:	Oliver and Rob Architects Pitreavie Drive Dunfermline KY11 8UH
National Grid Reference (NGR):	NT 3821 7424
AOC Project No:	20876
Prepared by:	Erlend Hindmarch
Illustration by:	Douglas Park
Date of Fieldwork:	26/03/2008
Date of Report:	31/03/2008

This report documents the results of an archaeological evaluation and historic building assessment carried out prior to development at 239-241 High Street, Prestonpans, East Lothian. The remains of two sandstone built walls were found during the evaluation together with a deep waster pit containing a large amount of ceramic fragments and kiln furniture. A single upstanding wall forming part of the southern boundary to the site, possibly the remains of a Victorian washhouse, was subject to a historic building assessment.

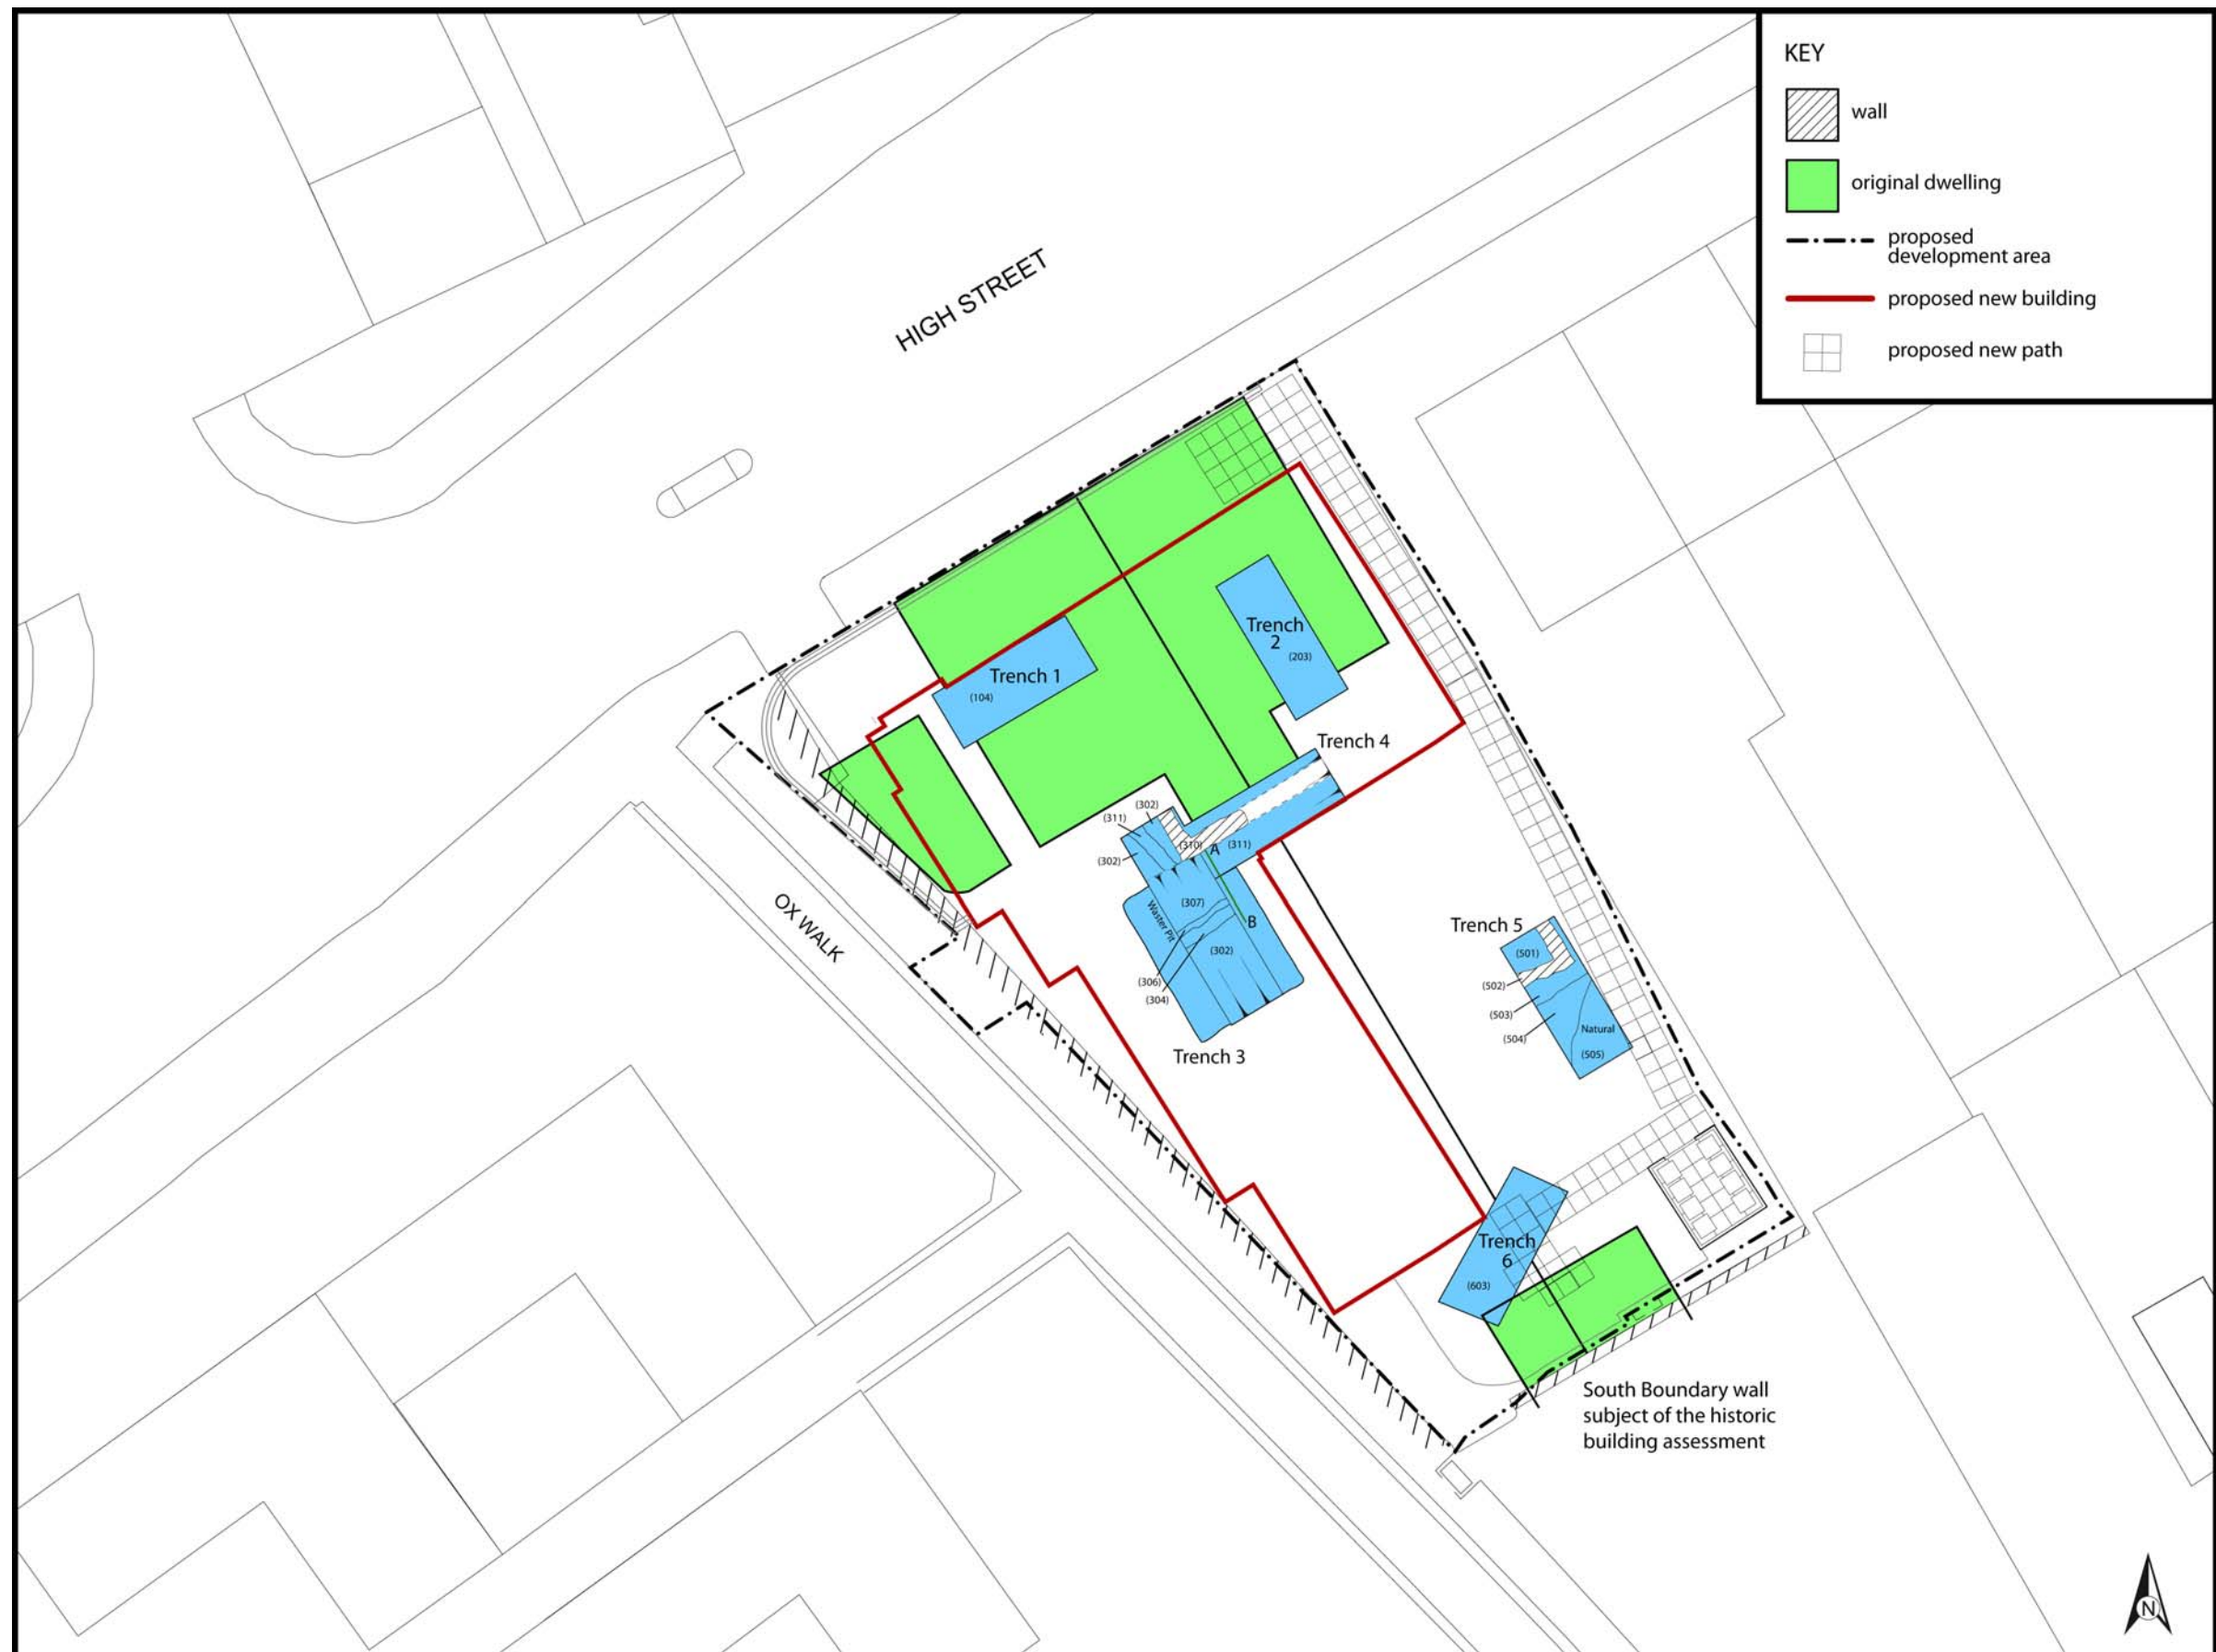
Figure 3: Trench Location

5. Results (Figure 3)

5.2.1 All the trenches were sealed by black clay silt topsoil up to 0.15 m in depth, except Trench 6 where this deposit reached a depth of 0.5 m. Underlying the topsoil in Trenches 1 and 2 was a layer of demolition material, (102) and (202), respectively. This material comprised sandstone and brick rubble varying in depth from 0.35 m in Trench 1 to 0.6 m in Trench 2. This layer is likely to relate to the demolition of sanding buildings in 2000 (Engl 2000). Beneath the demolition layer in Trench 1 was a buried soil (103) of compact mid brown sandy clay 0.15 m in depth which lay directly above the natural sand. A similar deposit (602), 0.2 m thick, lay below the topsoil in Trench 6. Both these buried soils which remain undated. The demolition material in Trench 2 lay directly above the natural sand.

- 6.1 It is not clear if the wall (310) exposed in Trenches 3 and 4 is the basement remains of the building demolished in 2000. This section of wall does correlate precisely with the footprint of the former building (Figure 3); but the watching brief carried out during the demolition (Engl 2000) states that the removed foundations had only a depth of 0.4 m and sat directly on a dark humic earth. The depth of wall (310) is in excess of 0.8 m and no deep walls or basements are mentioned within the watching brief report. Apart from the depth of the former foundations being different to wall (310), the physical appearance seems however to be similar; both being constructed from sandstone blocks bonded with a lime mortar. If (310) is part of the former building the remains may represent a small basement area confined to the back of the property. The watching brief report also mentions that despite the foundations being constructed from sandstone the upper structure was constructed from brick (Engl 2000). This may indicate that the foundations were reused and were originally part of an older structure.

- 7.1.3 Figure 3 illustrates the footprint of the proposed building as overlying waster pit (309) and wall (310). However cognizance should be taken of the proposed formation depths of the new building and whether these impact on the archaeology. It is anticipated that the local authority archaeologist will require information on both these formation depths and the feasibility of construction on '*hard spots*' like buried walls or '*soft spots*' created by archaeological fills of negative features like waster pit (309).

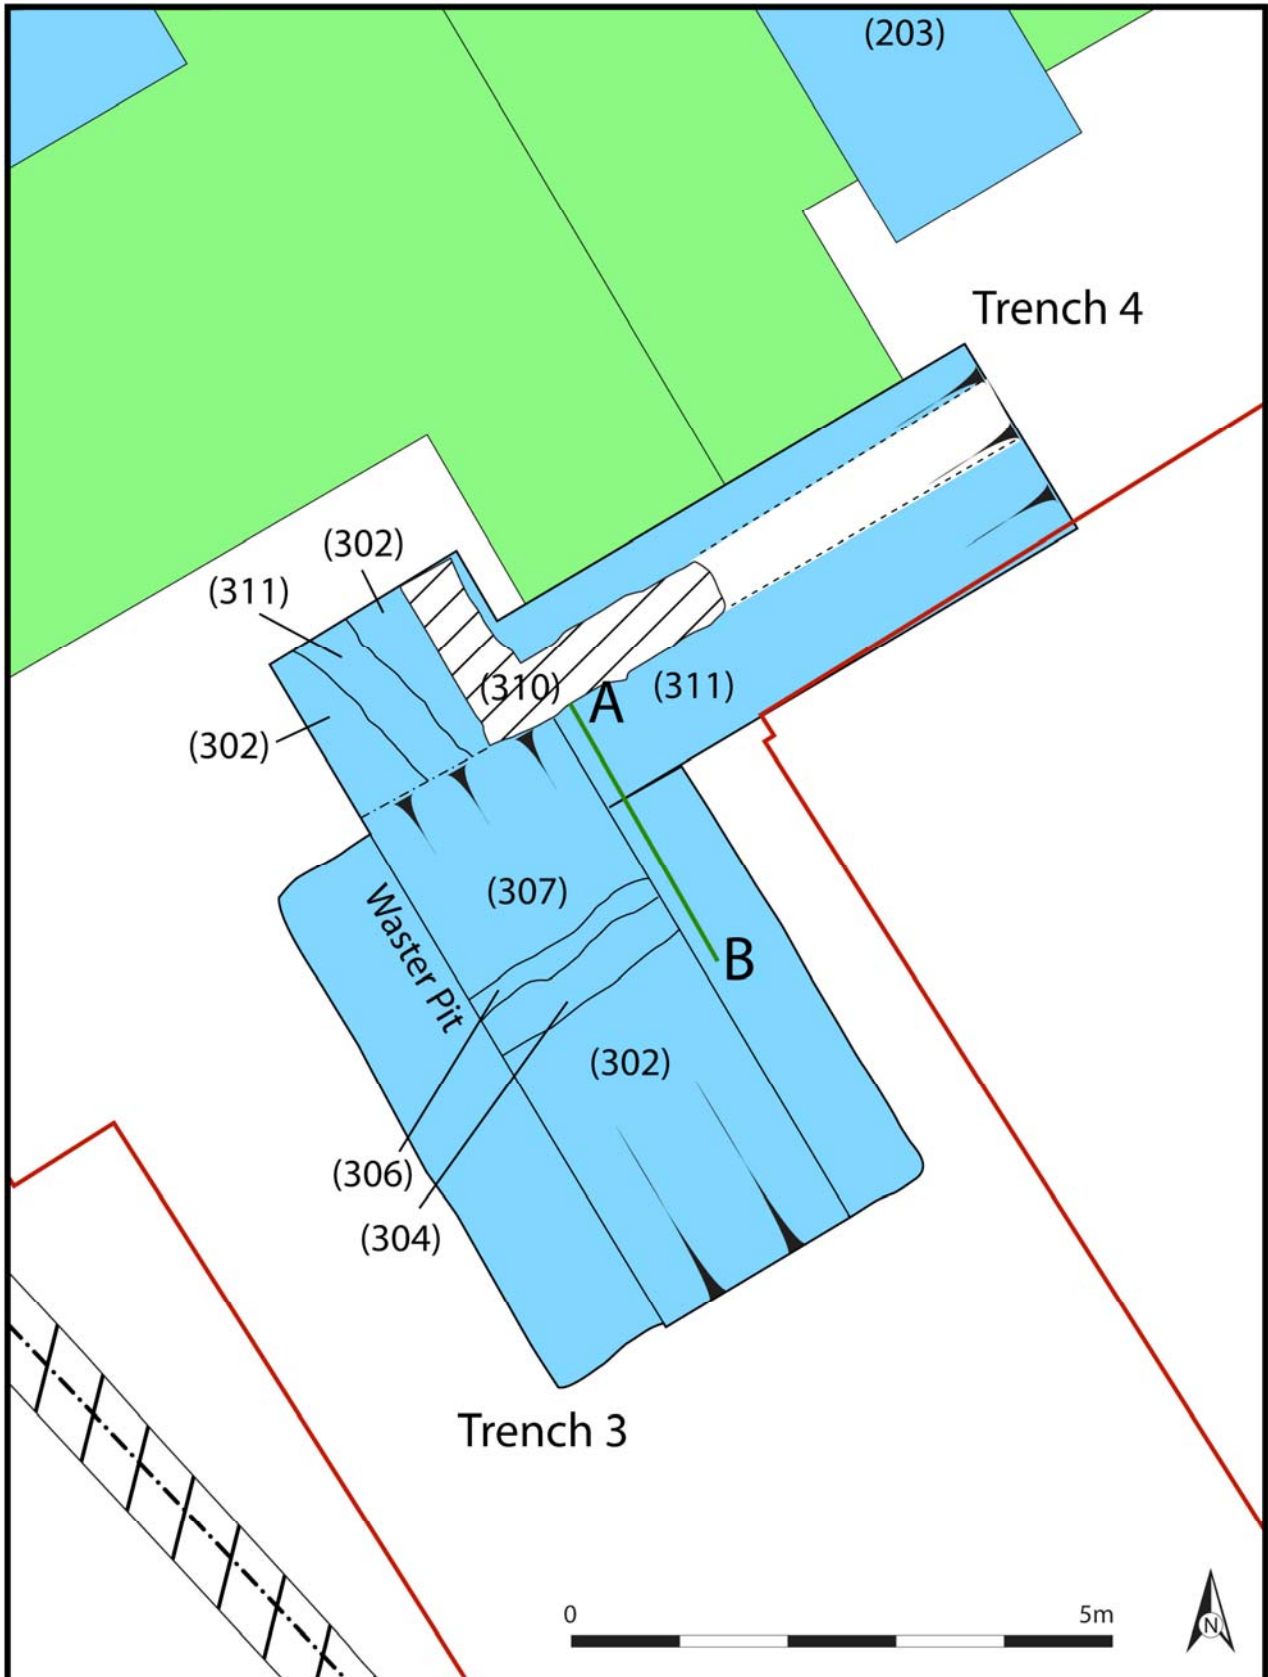
Figure 4: Detail of trenches 3 and 4

5.3 Trenches 3 and 4 (Figures 4 and 5; Plate 1)

5.3.1 Directly below topsoil in Trench 3 lay the remains of a sandstone wall (310). The exposed section of wall extended for a distance of 1.5 m from the northern end of the trench before turning through 90° toward the east into Trench 4. The remains continued in this direction for a distance of 2.5 m before becoming fragmented. Despite this fragmentation it was still possible to see that the wall extending through the whole length of this trench, approximately 5 m. These wall remains had a depth of over 0.8 m and were constructed from roughly worked sandstone blocks bonded with a lime-based mortar. The width of the wall was 0.45 m and no construction cut was seen. Directly on the southern side of the wall in Trench 3 and continuing through into Trench 4 was a drain (311/312) which was aligned east to west along the face of the wall. A spur of this drain was seen to run along the western side of the north-south extent of wall (310). This drain had in turn cut a deposit of loose mid brown clay silt with frequent ash and cinders (302). This deposit was the largest and final fill of large pit (309) and contained large quantities of pottery fragments dominated by stoneware ginger beer type bottles.

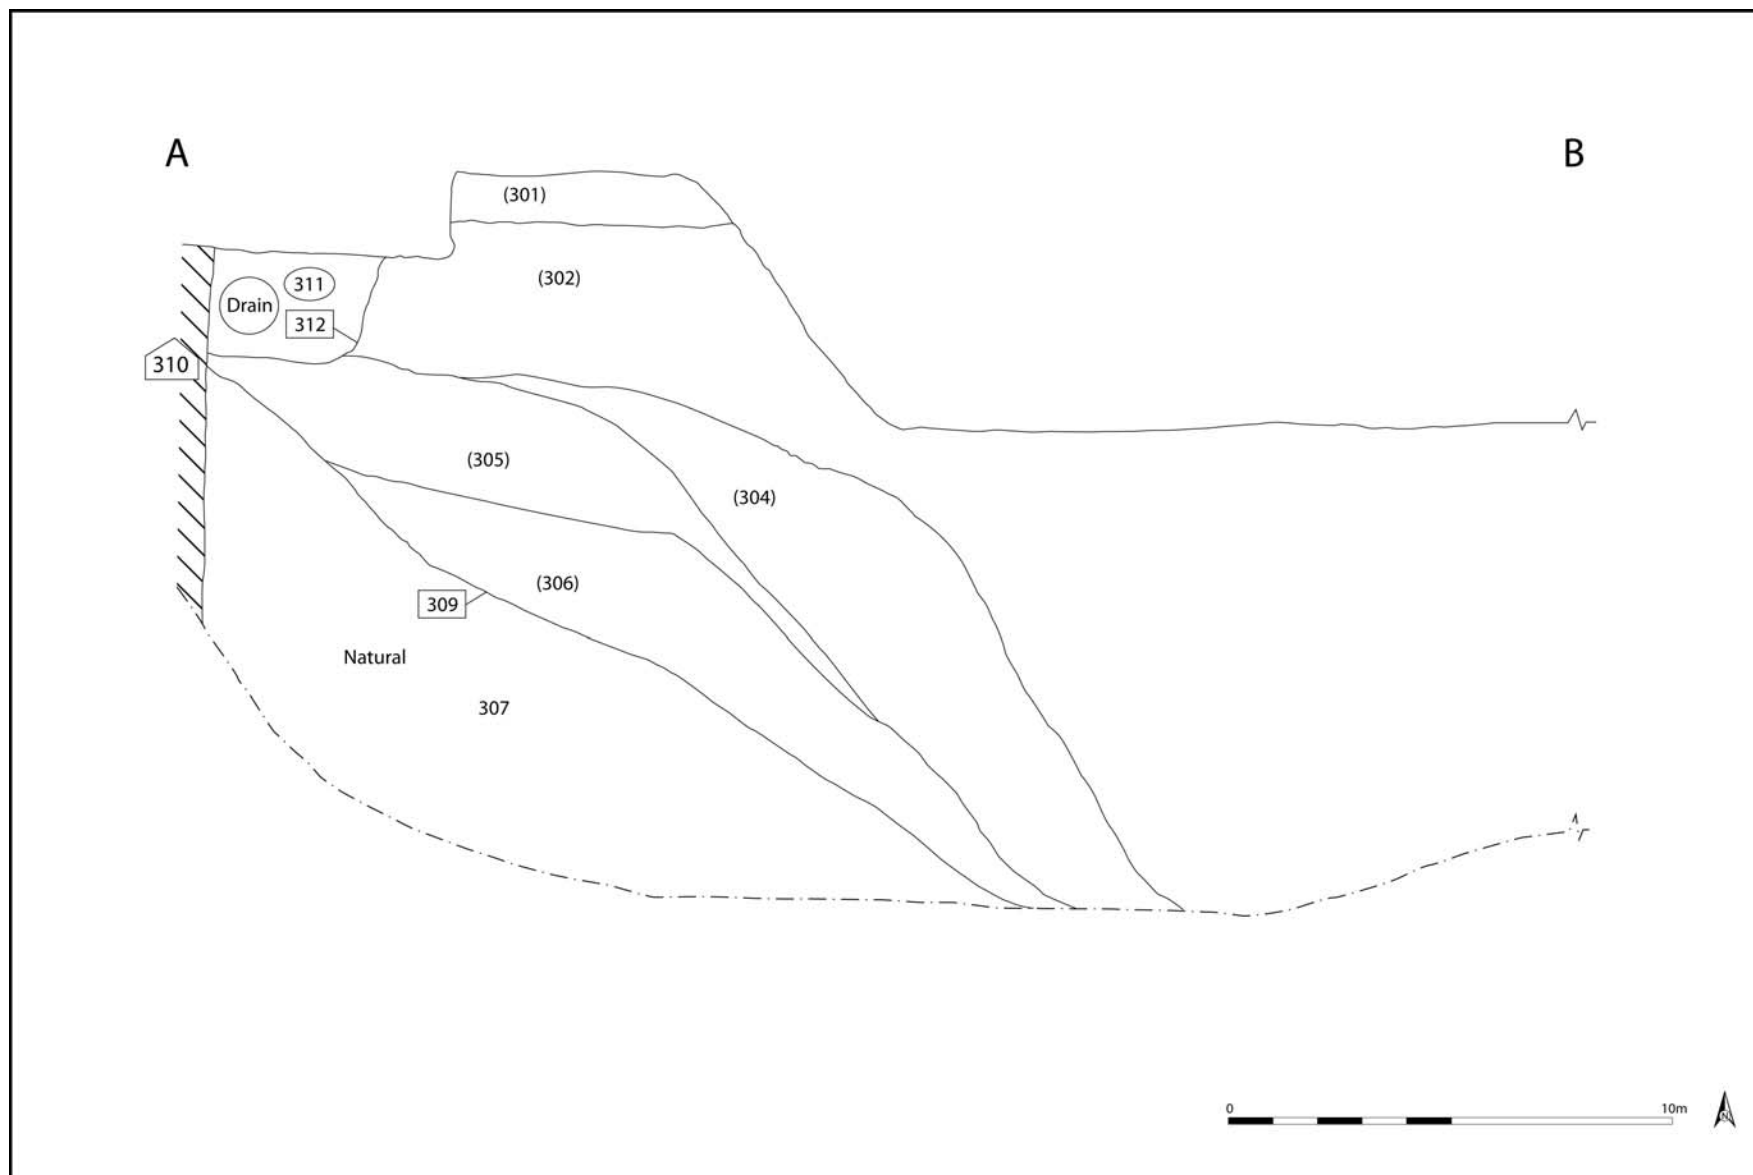
Figure 5: West facing section of trench 3, showing waster pit (309) and related fills.

5.3.2 Deposit (302) overlay a tip of crushed, moderately compacted red sandstone (304) which in turn overlay a black tip of fine ash and cinders (305). Sealed by fill (305) of the pit (309) was a coarse mix of ash and cinders (306) which contained considerable quantities of large kiln furniture fragments. This deposit was seen to fill the base of the pit (309).

5.3.3 Only the northern edge of the pit was seen. This cut the natural sand at a depth of 0.4 m below the present ground surface and extended downward at roughly 45° to a depth of 1.7 m which was the limit of excavation. Despite stepping the sides of the trench it was not possible to find the full depth

of the pit due to the unstable character of the trench sections; but it was clear that the pit extended below this limit.

- 6.2 The concentration of ceramic finds and the nature of the fills of pit (309) suggest a waster pit and may be derived from the former Belfield Pottery, which was situated directly opposite the evaluation site. During redevelopment work in 2000 (NMRS NT37SE 141) at the pottery site a quantity of ceramic fragments were found. Although the finds retained from this evaluation have not as yet been closely examined the assemblages seem similar with the majority of finds from both sites being large stoneware bottles. In addition fragments of *Rockingham glazed teapots with a bamboo moulding design were also recovered. This type of ceramic design (registered in 1872) is typical of that produced at the Belfield pottery.* The Belfield Pottery was in production from the mid 1830's and continued until the 20th century (Dalglish et al, 1990).

- 6.3 The relationship between the waster pit (309) and the wall (310) is not clear. The cut for the pit as originating on a contemporary surface was not seen. The upper pit fills simply butted up on the southern side of wall (309). It may be that the pit was dug directly against the wall making the pit the later feature, alternatively the wall may be cutting through the pit making the wall the later feature. Unfortunately, no construction trench for the wall was seen.

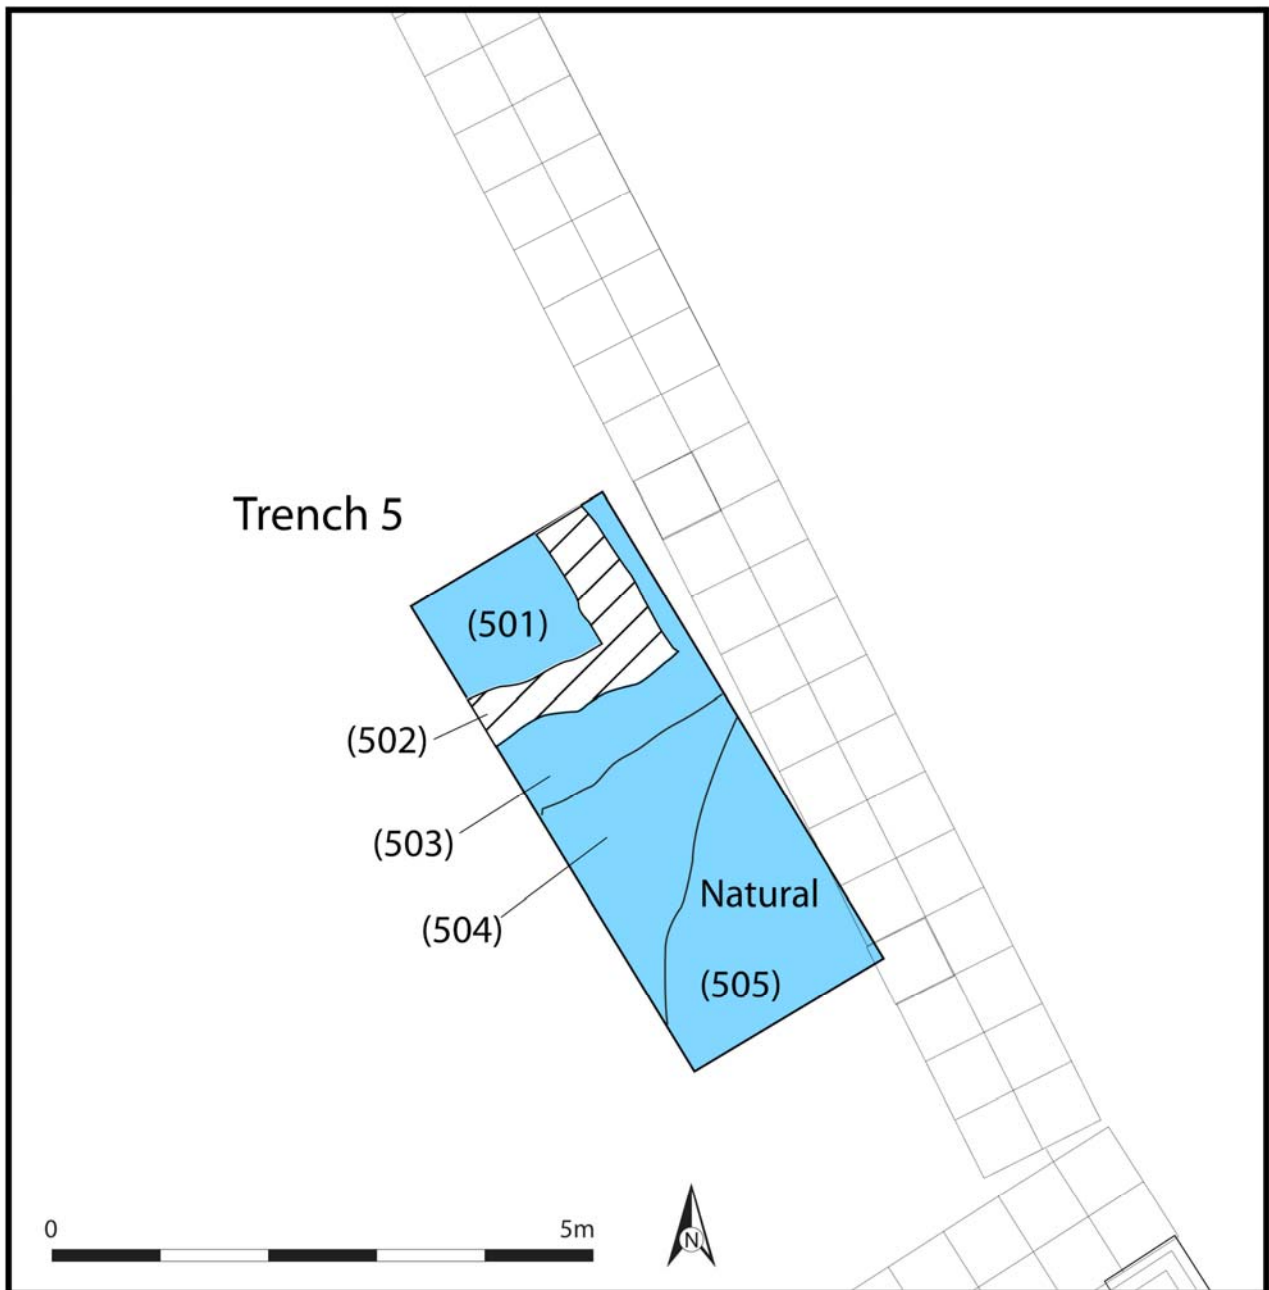
Figure 6: Detail of trench 5

5.4 Trench 5 (Figure 6)

- 5.4.1 Trench 5 was sealed by a 0.15 deposit of topsoil. Directly below this at the northern end of the trench were the remains of a mortared sandstone wall (502). This wall was seen to extend southwards from the northern edge of the trench for a distance of 1.5 m, before turning 90° toward the west and crossing the width of the trench. Butting up to the wall was a layer of compacted crushed sandstone (503) similar to (304) in Trench 3. This deposit appeared to be in excess of 0.3 m in depth. Overlying this deposit was a dark brown silt containing frequent ash and cinders (304), similar to (302) seen in Trench 3. The natural geology was seen at the southern end of the trench below (504).

- 6.3 The extent of the waster pit (309) is not yet clearly defined. Only the northern edge was traced in Trench 3, but it is possible that this large pit may extend into Trench 5 as indicated by the similar deposits (302) / (504) and (304) / (503) which butt up against the southern edge of a second sandstone wall (502). No structures appear on any maps that reflect this structure and it may be that these remains represent a pre-recent structure.

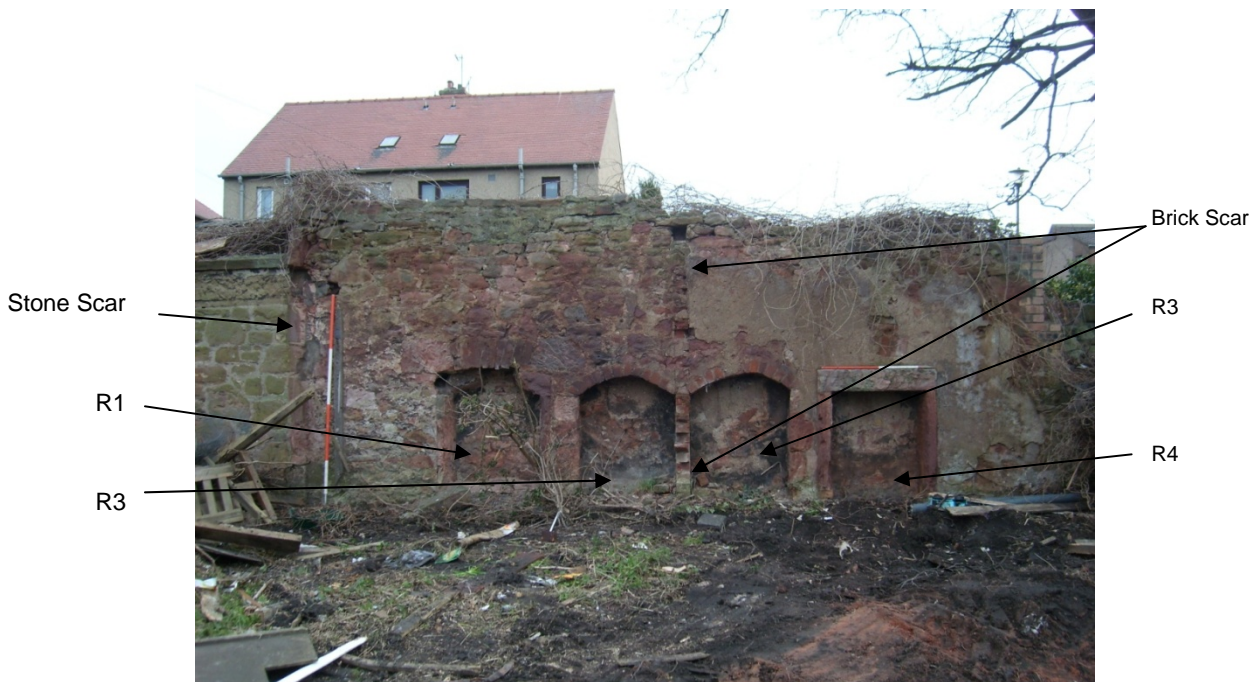
Plate 2: General shot of southern boundary wall, from the north

- 5.5.1 The southern end of the site was bounded by a large sandstone wall which stretched across almost the complete width of the site for a distance of 11 m. East of a point 3.9 m from the eastern edge of the wall, the wall has a height of 2 m and had a green sheen due to lichen growth suggesting long term exposure to the elements. West of this point the wall has a height of 2.5 m and is seen to have a different construction with no lichen growth. Although both sections are constructed from roughly worked, and slightly rounded sandstones, laid in a random un-coursed bonding pattern the eastern portion's stones are larger and more regular. However both parts of the wall appear to be tied together. At a point of 3.9 m from the east, scaring suggests a stone-built wall extended northwards from the main wall. Due the presence of a large tree root it was not possible to tell if any remains of this wall survived as a sub-surface feature. The wall was bonded with a lime-based mortar.

- 7.2.1 Should the development programme require alteration to this area of the southern boundary wall further limited historic building recording may be required by East Lothian Council as advised by Ms Simpson.

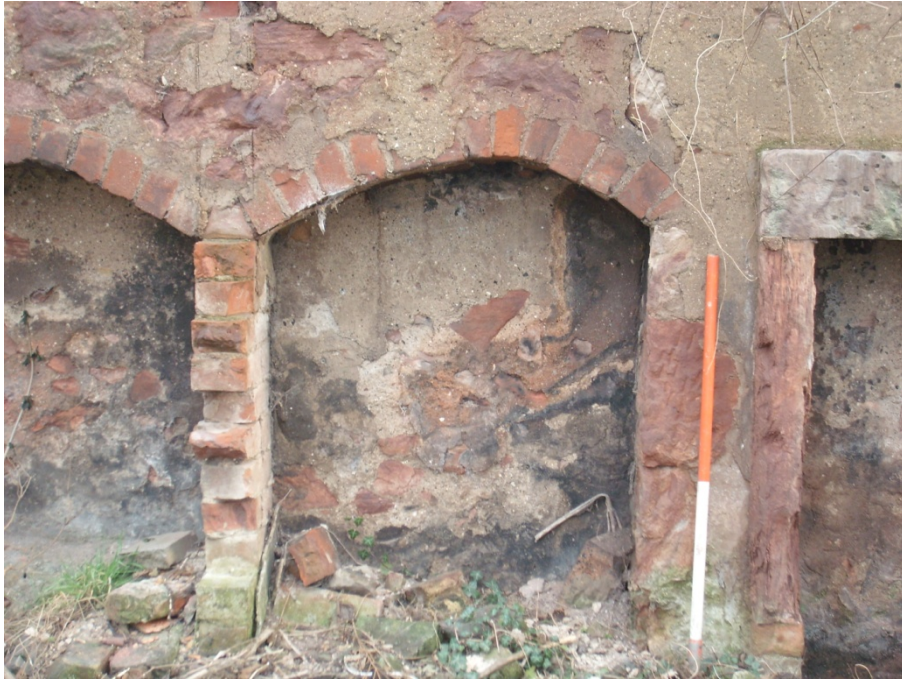
Plate 3: General shot of R3, from North

- 5.5.2 At 7.3 m from the eastern end the remains of a brick dividing wall were visible. This dividing wall stood to a height of 2 m above the present ground surface and was one brick width thick with bricks laid in a stretcher bonding pattern and bonded with lime mortar. Either side of the brick dividing wall were two recesses or alcoves built in to the main wall (R1-4), each pair mirroring the other. The outer two (R1 and R4) were lined on each side by thin upright sandstone slabs and capped by large sandstone lintels. Above the lintel was a single line of brick set into the wall as upright stretchers. The inner pair (R2 and R3) differed in that they had no lining stones and were capped by an arch of bricks laid as headers. All the alcoves had a height of 1.1 m and a width of 0.9 m recessed by 0.26 m. In addition each alcove had patches of blackening, although no scorching was apparent or evidence of flues. The base of R4 was lined with bricks which extended beyond the face of the wall. West of the dividing wall traces of a lime mortar render remained. Evaluation Trench 6 dug close to the face of the wall found no evidence of any structure which may survive as a sub-surface feature. The western extent of the wall had been repaired with modern brick.

- 6.5 The symmetry of the recesses seen in the southern boundary wall indicate that the structure (Figure 3) was divided into two with the same processes were carried out each side of the brick dividing wall. At present it is not known what these activities were or how they relate to the two different designs of recess.
