Aldi Stores, Airdrie: Data Structure Report

Aldi Stores, Airdrie

Watching brief and Evaluation Data Structure Report

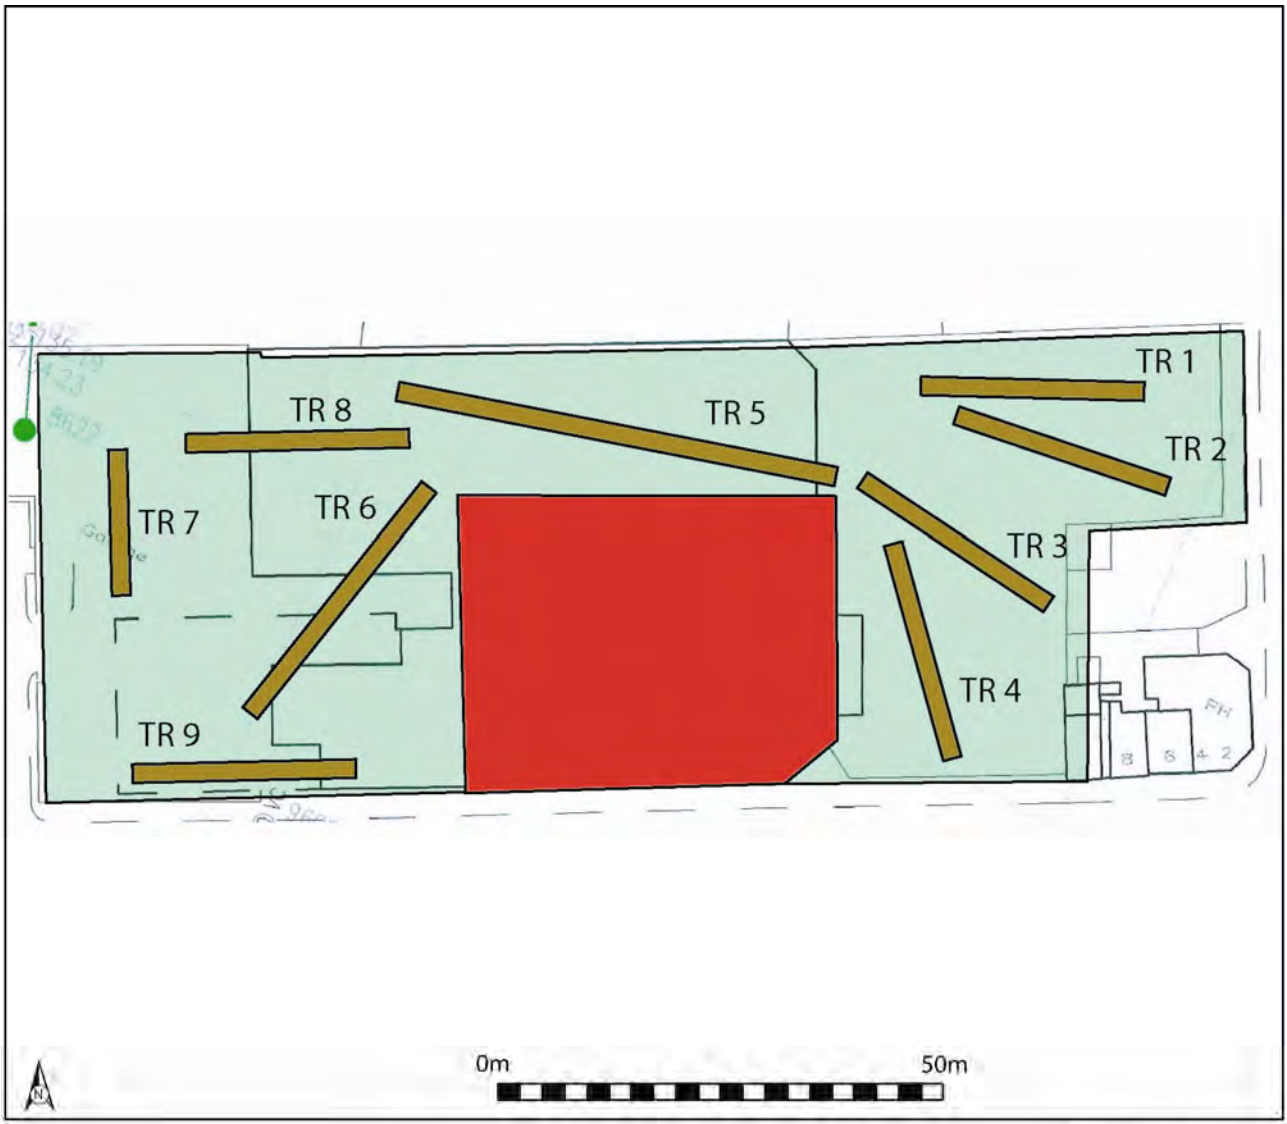
Figure 2 :Trench Plan Location

4.2.1 The evaluation trenches (Figure 2) were excavated following removal of the concrete slab / tarmac using a 360° type excavator fitted with a toothless ditching bucket under the direct supervision of an experienced field archaeologist. Excavation of the trenches was carried out in shallow spits down to the first significant archaeological horizon or natural subsoil. All significant features were cleaned and fully defined to enable a full written, drawn and photographic record to be taken.

4.2.2 Due to the presence of modern standing remains it was only possible to excavate a total of nine trenches totalling 500 m². Following discussions with WoSAS it was decided that given the results of the evaluation so far completed, it was not necessary to dig the final two trenches whose positions were in areas subject to considerable disturbance by prior building works.

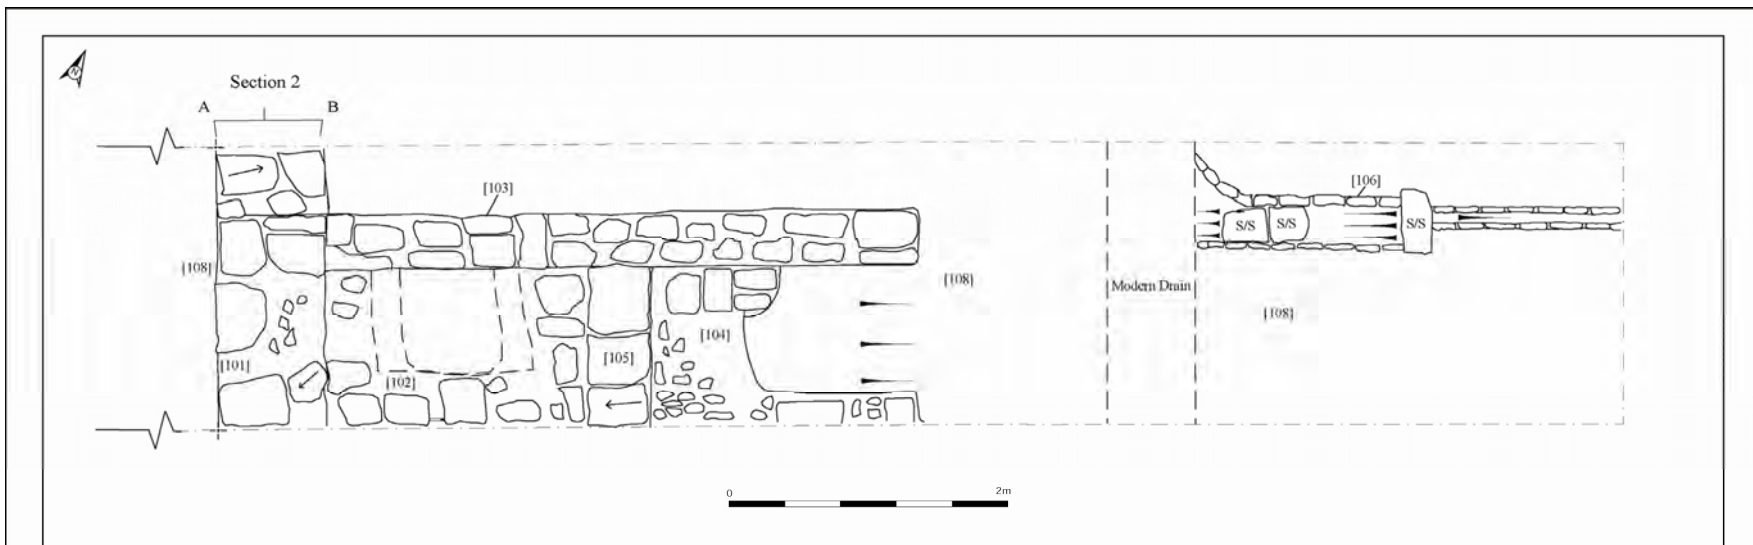
Figure 3 Showing Plan of Trench 1

5.3.1 Directly below the madeground and cutting the natural drift geology at a depth of 137.3 m OD were a number of stone-built features (Figures 3 and 4; Plate 1). These comprised stone walls (101), (103) and (105) and associated stone surfaces (102) and (104). All these features appeared to be contemporary. The walls were constructed from unworked sandstone blocks surviving to one course high and bonded with a light brown sandy mortar. Floor surface (102) bounded by walls (101), (103) and (105) was constructed from large sandstone blocks laid into the natural subsoil with no apparent bonding material, while floor remains (104) had a more cobbled appearance.

5.3.2 In addition to the features outlined above a stone-lined drain was exposed at the eastern end of the trench. This drain, aligned east to west, appeared to be constructed in order to allow drainage from the east to west where it appeared to turn to the north and where it was also truncated by a modern drain. The remains of a stone-flagged base and stone capping stones remained.

(101)	Wall foundation	Sandstone wall aligned NW/SE and constructed from unworked stone blocks which measure 0.3 m x 0.4 m by 0.1 m. with traces of a yellow sandy mortar. Only one course remains. Wall butts Wall (103) and surface (102) and cuts the natural clay (108).				111	108	204	2.0	0.65		0.1

(102)	Stone Surface	Stone surface built from unworked sandstone blocks. Stones are set into the natural clay (108) and the floor is bounded by walls (101), (103) and (105). Stone size up to 0.3 m by 0.4 m by 0.1 m.				111	108		1.7	1.0	0.1

(103)	Wall foundation	Sandstone wall aligned NE/SW and constructed from unworked sandstone blocks which measure up to 0.3 m by 0.3 m by 0.1 m and are bonded by a light brown sandy mortar. The remains butt up to wall (101) to the SW and continue for a distance of 3.7 m towards the NE where the remains end. It may be that these remains continued further toward the NE and have some connection with drain (106) but have been removed during recent activity.				111	108		3.7	0.4		0.1

(104)	Stone surface	Cobbled surface comprising sandstone cobbles. Surface is bounded by walls (105) and (103) to the west and north but appears truncated to the east. Cobbles are laid on to the natural clay (108).	111	108		1.7	1.0		0.05

(105)	Wall foundation	Sandstone wall remains aligned NW/SE and constructed from unworked blocks measuring up to 0.4 m by 0.4 m by 0.15 m. Wall is possible bonded with a light brown sandy mortar and butts up to wall (103) and stone surface (104).	111	108		1.0	0.4		0.15

(106)	Drain	Stone built drain aligned NE/SW consisting of small upright stones forming the sides of the drain with remnants of a sandstone flagged base and one capping stone remaining. The drain has been truncated by a modern drain which crosses the trench from NW/SE at which point the drain appears to turn toward the NW.	111	108		2.7	3.5	0.08

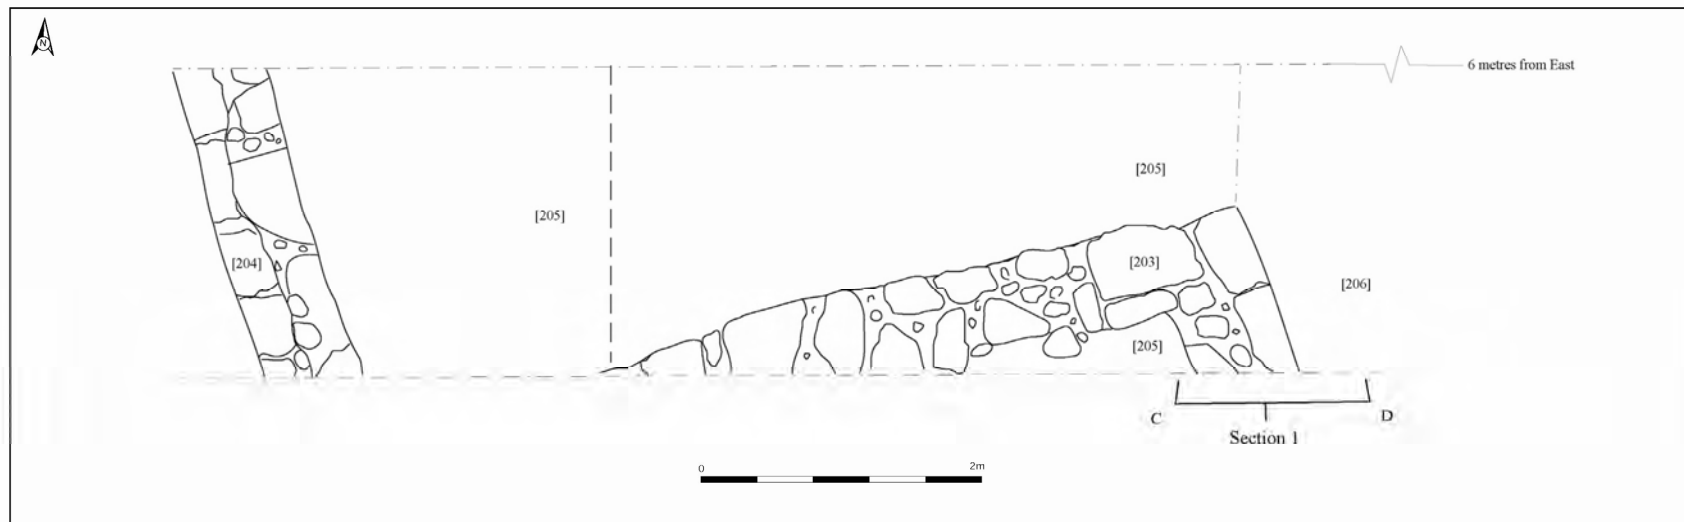
Figure 5 Showing Plan of Trench 2

5.5.1 Two stone-built walls (203) and (204) were sealed by madeground (Figures 5 and 6; Plate 2) and were of similar construction to the walls seen in Trench 1. Wall (204) is likely to be a continuation of Wall (101) unearthed in Trench 1. The eastern extent of Wall (203) turned 90° to the south and it is possible that it represents the north-east corner of a building. In addition, it is likely that at its western extent wall (203) joins wall (204) beyond the southern edge of the evaluation trench.

(201)	Made ground	Type 1 hard core. Fills whole trench				202	107			0.15	
(202)	Made ground	Red blaze. Fills whole trench			201	208	109			0.1	
(203)	Wall foundation	Sandstone wall remains constructed from unworked sandstone blocks measuring up to 0.55 m by 0.3 m by 0.15 m. Only one course survives seen cutting the natural clay 205. Wall aligned NE/SW with return seen at NE end. Not clear if remains are clay bonded or have a light brown sandy mortar. May be return of wall (204)			207	205		5.0	0.6		0.15

(204)	Wall foundation	Sandstone wall remains constructed from unworked sandstone blocks measuring up to 0.5 m by 0.3 m by 0.15 m. Only two courses survive the lower course of which is seen to cut the natural clay 205. Wall aligned NW/SE. May be continuation of wall (101) in trench 1. Not clear if remains are clay bonded or have a light brown			207	205	101	2.0	0.6		0.3

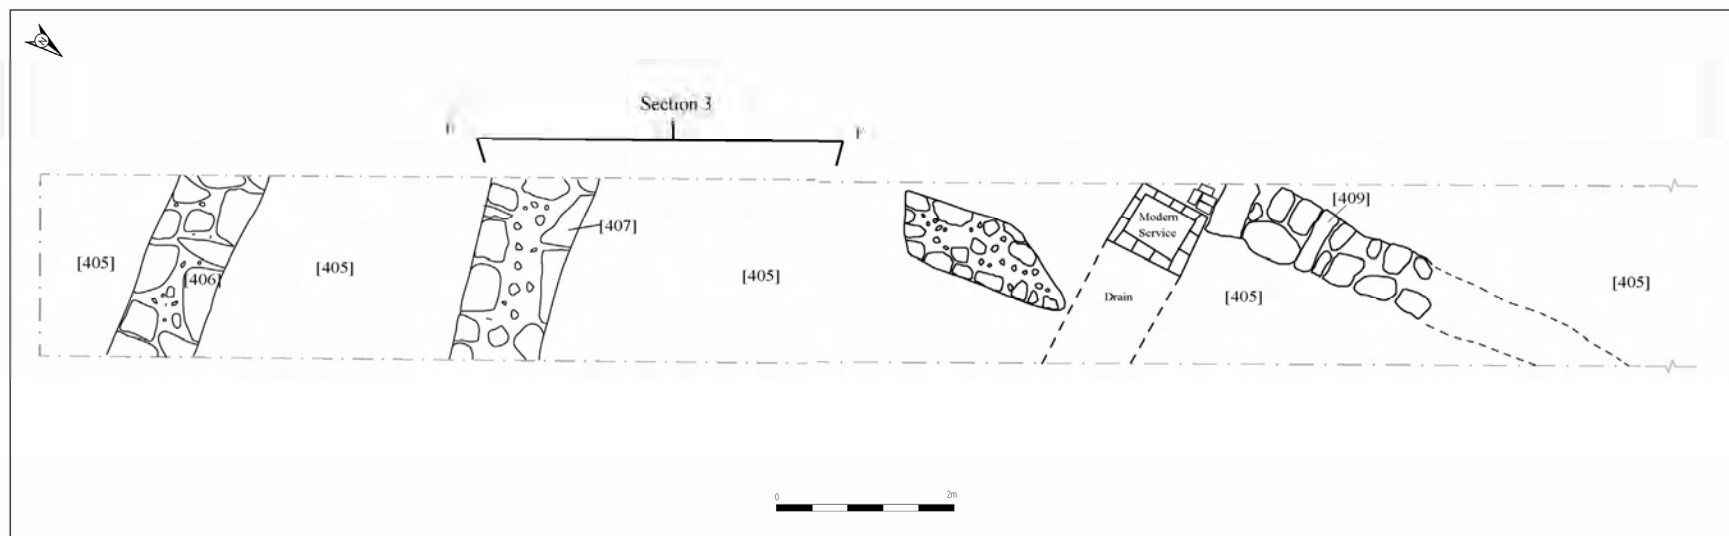
Figure 7 Showing Plan of Trench 4

5.6 Four walls (406), (407), (408) and (409) were located below madeground (Figures 7 and 8: Plate 3). These walls were of similar construction to the walls in the other trenches and formed two sets of parallel walls. Firstly, walls (406) and (407) were located toward the southern edge of the trench, aligned approximately east to west and separated by a distance of 2.5 m. The second set of walls, (408) and (409) were aligned at 90° to the first two walls. Although on the same alignment as each other, these two walls were not seen in a parallel context due to truncation caused by a modern drain. If these two walls were once side by side then they would be separated by 1 m.

(405)	Natural clay		406 407 408 409						
(406)	Wall foundation	Sandstone wall remains constructed from unworked sandstone blocks measuring up to 0.5 m by 0.3 m by 0.1 m. Only one course survives, which is seen to cut the natural clay (407). Wall aligned NE/SW. May be associated with parallel wall (407). Possible light brown sandy mortar seen	404	405		2.0	0.8		0.1

(407)	Wall foundation	Sandstone wall remains constructed from unworked sandstone blocks measuring up to 0.35 m by 0.3 m by 0.1 m. Only one course survives, which is seen to cut the natural clay (405). Wall aligned NE/SW. May be associated with parallel wall (406) although wall has a mortared rubble fill. Possible light brown sandy mortar seen	404	405		2.0	0.8		0.2

(408)	Wall foundation	Sandstone wall remains constructed from unworked sandstone blocks measuring up to 0.25 m by 0.2 m by 0.07 m. Only one course survives, which is seen to cut the natural clay (405) and has a light brown sandy mortar. Wall aligned NNW/SSE. May be associated with parallel wall (409). Wall is truncated by modern drain at NNW end.	404	405		2.3	0.7		0.07
(409)	Wall foundation	Sandstone wall remains constructed from unworked sandstone blocks measuring up to 0.5 m by 0.4 m by 0.1 m. Only one course survives, which is seen to cut the natural clay (405) and has a light brown sandy mortar. Wall aligned NNW/SSE and may be associated with parallel wall (408). Wall is truncated by modern drain at SSE end.	404	405		3.1	0.8		0.1

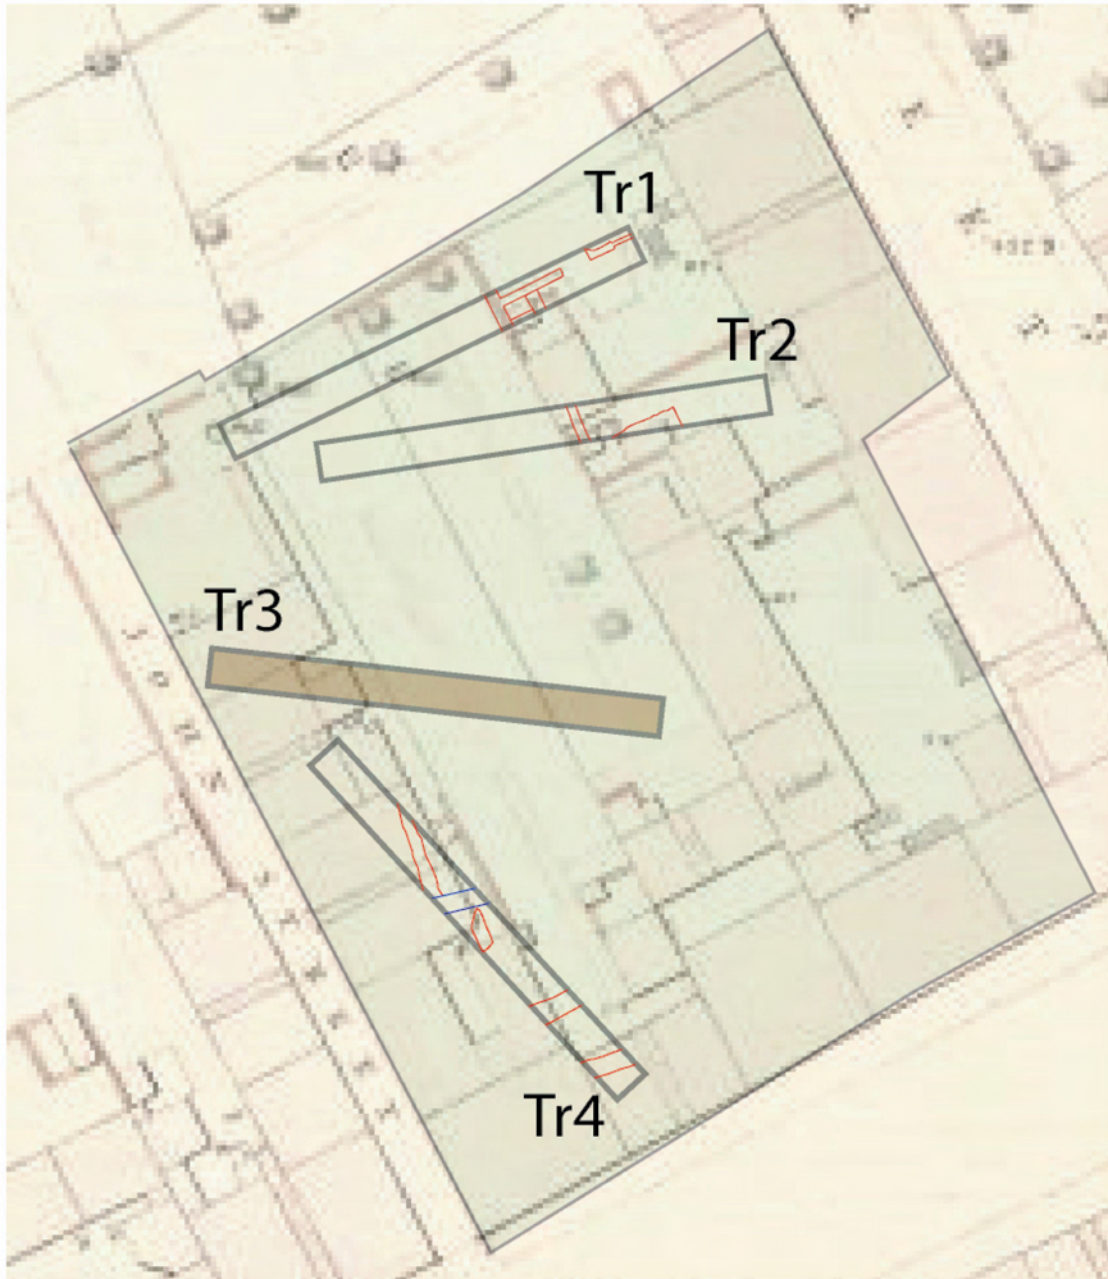
Figure 9: Showing Trench Plan with Features Overlaying the 1855 OS Map

- 6.1 It is clear from the evaluation that the vast majority of the site has undergone severe truncation. Building remains were only seen in the eastern portion of the site and these remains can be seen to correspond with buildings seen on Woods map of 1846 and the 1st Edition OS map of 1858 given the variations in mapping accuracies (Figure 9). Given that most modern disturbance is located below the modern concrete slab it is unlikely that further remains will exist below the presently upstanding building remains.
