Harps Farm Stables, Bedlar's Green, Great Hallingbury Essex Historic Building Record

Planning Application Numbers: UTT/0483/08/FUL and UTT/0484/08/LB

AOC Project no: 30275

Historic Building Record

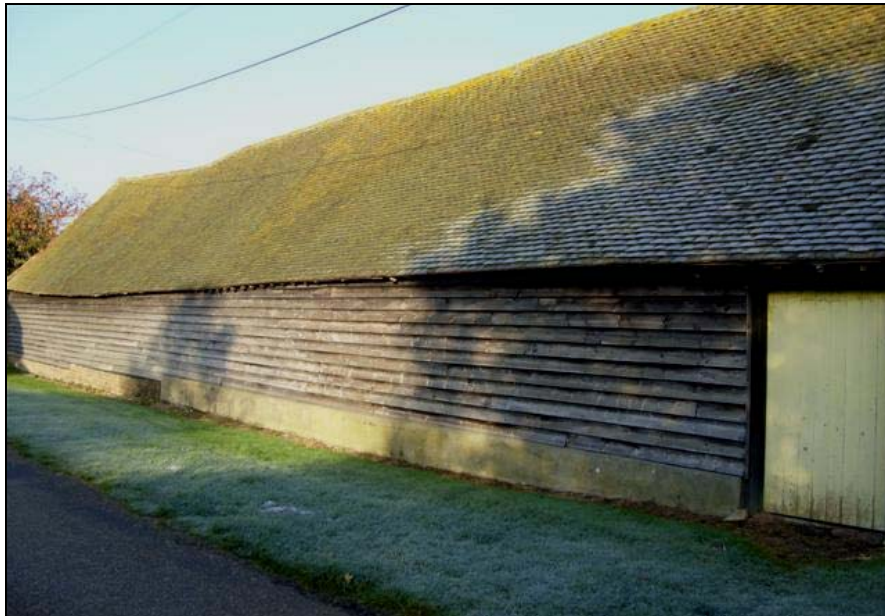
Plate 1, south side of southern block

3.2.1 The southern block of the stable range appears to be the earliest part of the stable complex. This is shown by the presence of former exterior gable-ends no longer relevant to the current form, as well as alterations to the roof. The eastern and western ends of this part of the stables are built outside of and against the core of the block. The whole of the southern range is suffering lateral loading; the tops of the walls are moving outwards and westwards. This may be the part of the farmstead described in the sales document as 'Range of three Loose-boxes and Harness-room'. The initial build is timber framed set upon low brick walls.

3.2.2 This building has brick dwarf walls standing three courses high above the internal enclosed area. The size of the bricks indicates date of 1700-1800, measuring 228mm by 107mm by 60mm (9" by 4¼" by 2⅜"). The mortar used is a lime mortar, quite sandy and coarse, with notable 2mm gravel inclusions and the walls are 0.34m thick. The end footings are not standing, later additions to each end of the building having necessitated their removal. The core of the southern block measures 19.8m east-west and 5.6m north-south. The ground walls are topped by a sill beam laid close to the outer edge of the ground walls.

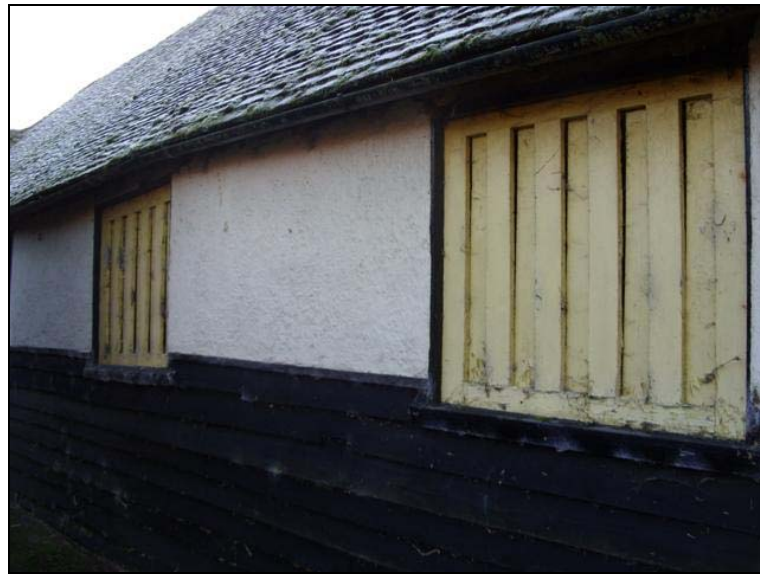
Plate 2: Rendered and boarded north wall

3.2.3 Posts and studs rise from this sill beam, the posts providing the principal supports for a wall plate above, the studs forming the body of the wall. The south-facing wall is entirely clad with timber boarding. The north wall is clad with boarding on the lower half, the lowest board overlapping the ground wall whereas the upper half has lath and render covering the frame. Three layers of this

exterior plaster are apparent, each finer than that beneath. Internally, all walls appear to have been fully boarded to wall-plate level, although this was randomly missing in several locations.

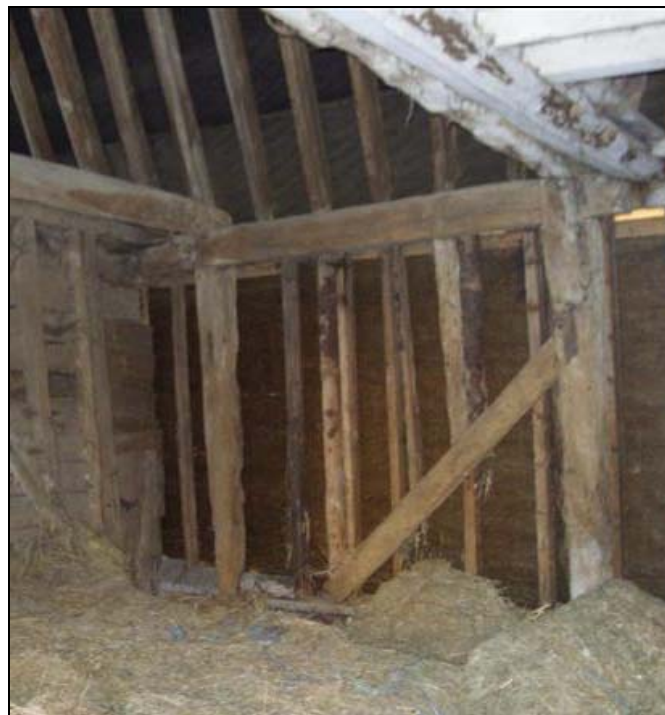
Plate 3, sample of south wall framing, Room 7

- 3.2.4 The major posts are typically 0.20m (8 inches) square in profile, and many showed signs of re-use from previous buildings, with mortises, empty peg-holes and lap-housings apparent (see 3.3 below). The wall-plates that form the base for the roof were typically 0.25m (10 inches) square in profile. Lateral stability is given by nine tie-beams, these span the building, and some show evidence of re-use. Two tie-beams at the centre of the building are just 0.80m apart. They both have additional iron straps affixing them to the wall-plates.

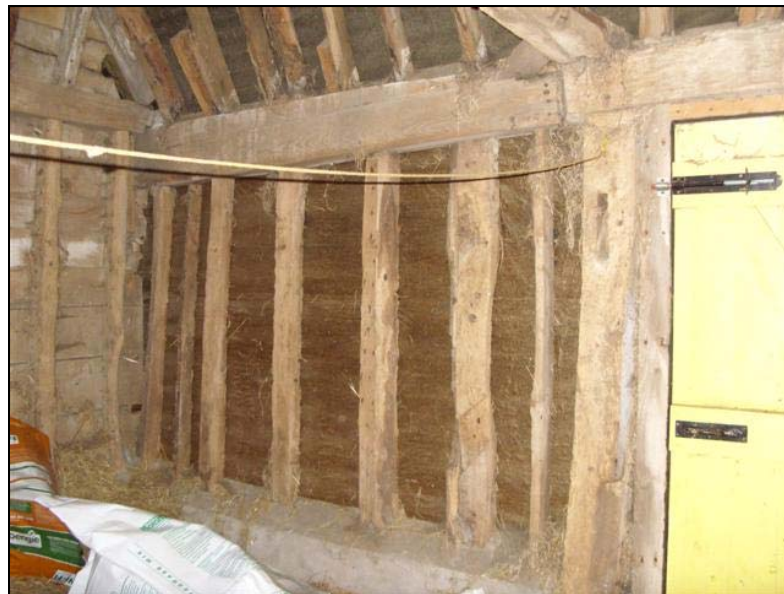
Plate 4, wall framing, Room 6

- 3.2.5 The east wall of the core of the building is largely intact, and is built in several sections: the ground floor wall is a series of studs, between the floor and the first tie-beam, the central stud supported by angled struts that are primary bracing. The other posts are irregular studs. There is a doorway to the north and a small narrow room partitioned next to it, almost a lobby. The door is boarded and hangs on two hinges. The wall above the tie-beam has studs to an upper collar. A third row of studs rise from the collar to the roofline. The wall is fully boarded on its eastern face to ridge level, not at all in its western (internal) side.

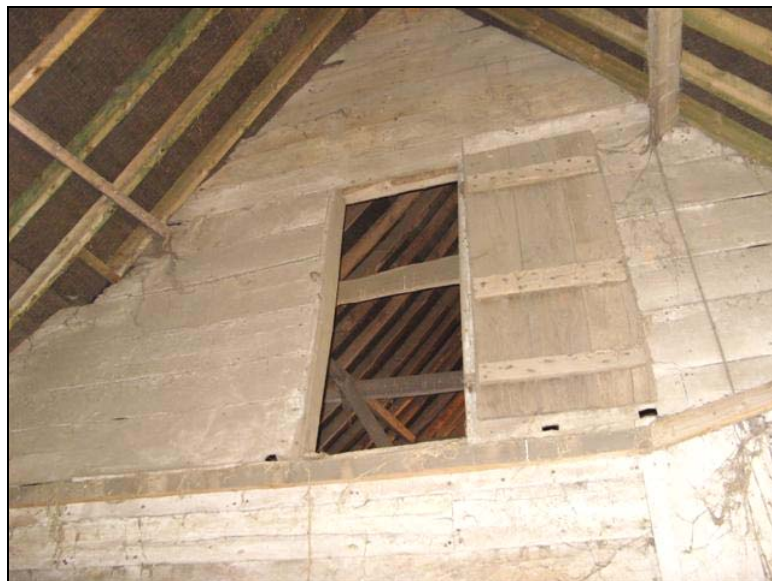
Plate 5: Gable end of early phase.

- 3.2.6 The partition is formed of studs with boards attached between the end tie-beam and the second tie-beam. This little partitioned area is the only area of the core building that has a boarded ceiling. Four joists run north-south from the partition wall to the north wall, and a row of planks are laid on this, an area of upper flooring 1.6m north south and 2.3m east-west. There was no jointing evidence in any timbers to prove that this had a larger extent, but the door in the centre of the gable

end must have been accessible. Possibly, the floor joists were simply pinned atop the tie-beams rather than being jointed in. The top of the doorway is level with the upper collar.

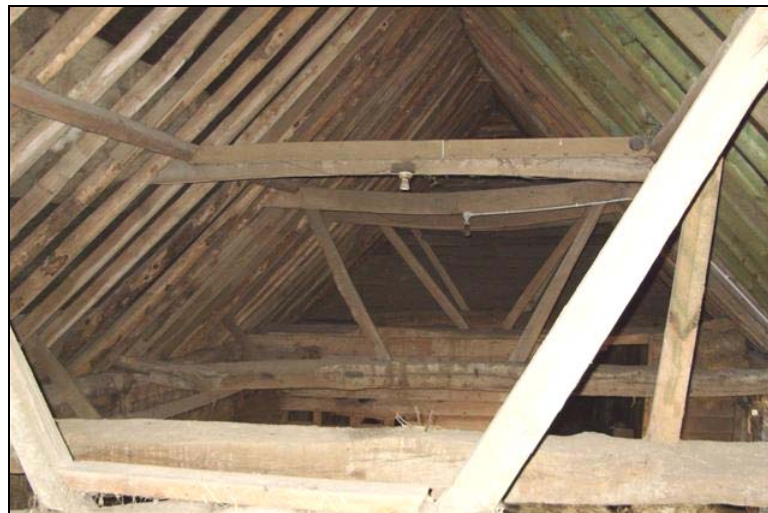
Plate 6: Roof detail

- 3.2.8 The roof is a clasped purlin roof with a ridge plate at the top. The purlins and ridge beam are supported primarily by the timber end gables of the building, and the common rafters lie atop this, fixed to the wall plates at their base and extending to form eaves, and laid on the outside of the purlins. Many of the rafters are quite narrow quartered conversions of small straight timbers, frequently with the bark still upon them. The purlins, which run the entire 19.8m length of the building, are not single timbers, but are box-quartered beams that are jointed in sections with scarf joints. Above each tie-beam is a collar beam that clasps the purlins, and is nailed in position; there are no principal rafters that are forming a major truss. The collar beams are supported by angled struts from the tie-beams. There are no wind-braces or struts that would have given the roof lateral stability.

- 3.2.9 The entire roof, rafters as well as end-walls, is sloping at 74°. This suggests that the thin rafters are contemporary with, or at least collapsed with the main movement of the roof westwards. The roof has been lined with roofing felt, indicating a phase of later 20th century repair. The roof is tiled and the ridges are sealed with ridge tiles.

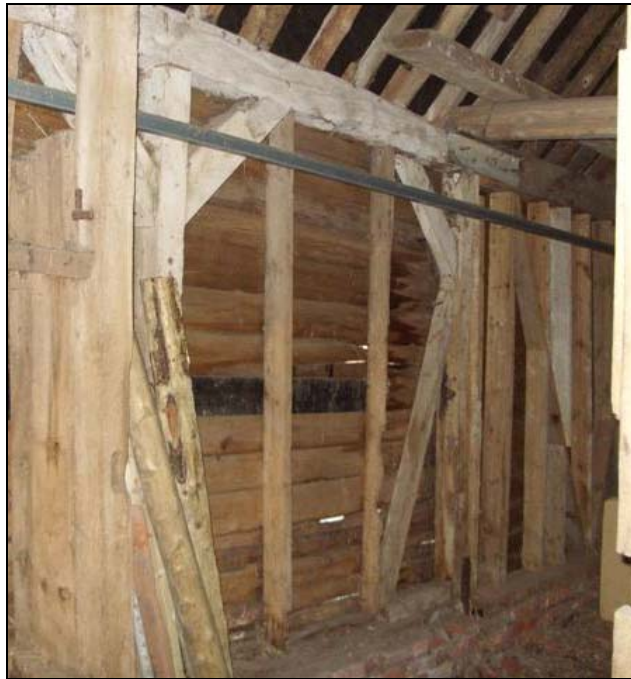
Plate 7: Framing of western extension

- 3.3.4 The western end of the south block has been extended by 11.5m (Rooms 8/9). The entirety is founded on a low ground wall, and has a structure based on posts rising from a sill beam and wall plates above. Frequent vertical studs are set between the major beams. The timberwork in this section of the block is of a notably different style using thinner timbers. All but one of the main posts are freshly cut box-quartered timbers, and only one shows signs of re-use. The principal posts also have supporting struts at the top towards the wall-plates. The wall plates too are of inferior quality, being short sections of squared timbers laid end-to end, and showing little regularity. The entirety of the block is boarded: the north face where visible, the west end and the south side. This is a contrast to the primary structure of the build, which is part-rendered.

- 3.3.6 Five further tie-beams add stability to the structure, including that at the west wall at the end of room 9. The roof structure at the west end shows evidence of alteration and repair. All the common rafters of the roof show the lean westwards apparent in the rest of the building, showing that the roof has moved after the construction of the western extension. However, the hip at the northern end is structurally sound, the rafters rising straight from the baseplates, and the sloping common rafters cut to accommodate this new end. This may indicate that the entire western roof has been rebuilt. Extra supports have been added to the wall-plates at the western end. An iron bracket has been inserted in the southwest corner, and there is a large iron bar spanning the corner, pulling the west and south walls together.

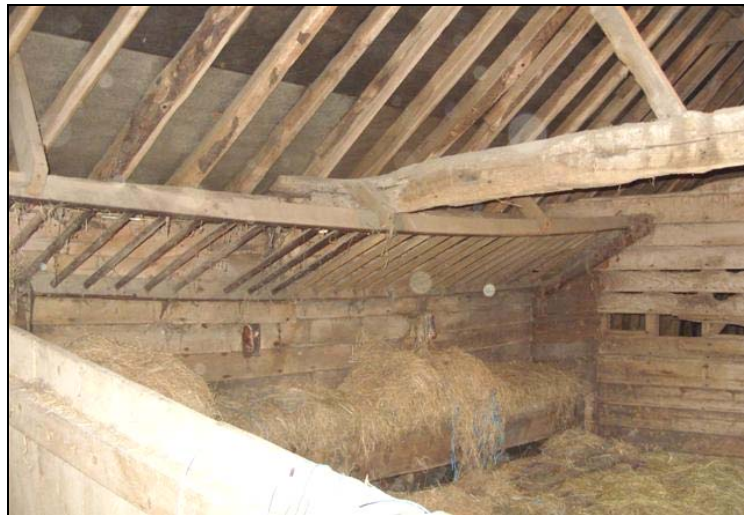
Plate 8: Room 7 manger and hay rack.

- 3.5.2 Set against the south wall of room 7 are mangers made of planks, supported on posts. The top of the mangers are 1.20m above floor level, supported by posts in front. These mangers are for soft feed. Higher up on the walls, in Rooms 5 and 7, are hay racks, which could be grazed from, providing a contrast and roughage to the softer feed below. These confirm that the block was used for keeping animals. The compartments apparent in Room 7 may indicate a degree of tethering. Boarding the inside of this building would help prevent damage to the walls from kicks.

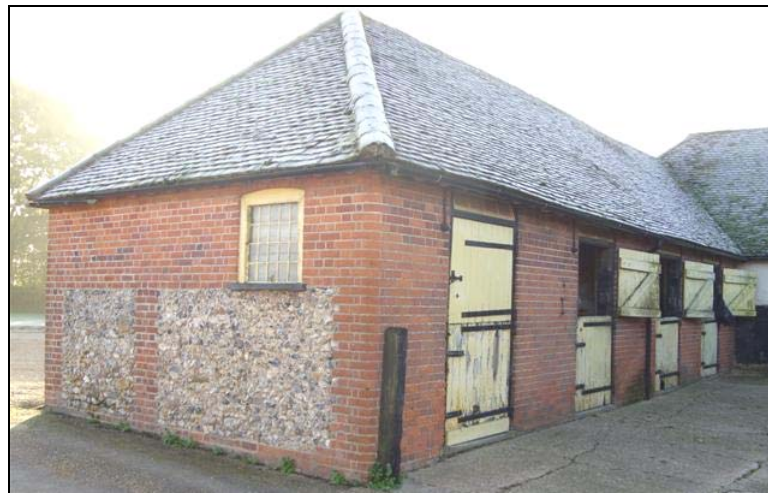
Plate 9: Eastern stable block

- 3.6.1 The Eastern Block is built of brick with flint panelling on its eastern face and northern end. Four stable doors open on the western side. The block is a single build, and measures 13.22m north-south and 5.30m east west. It is single storey. The principal construction material is brick, each brick 230 by 104 by 64mm, and laid in English Bond, bonded with very coarse lime-rich mortar with high sand and gravel content. Each exterior wall is 1½ bricks thick. The eastern side has four flint panels, each half the height of the walls and each beneath a high level four-paned window. The flint panels add no structural support and are a walling type common in flint areas.

- 3.6.2 Two flint panels are present in the north wall. The north wall also has a window, a fixed window with an arched lintel, wooden sill and split into 20 panes. This window had been blocked on the inside by several short planks.

- 3.6.3 The four doors on the western face of the building are each stable doors, split into two sections, each section with its own fixing. Each part of the doors hinge open on two hinges. The lower parts of the doors have bolts to secure them, the upper doors have latches. Each door leads to an individual stable, large enough for two horses. This may be the area of 'carhorse stabling for eight' as described in the 1923 auction document.

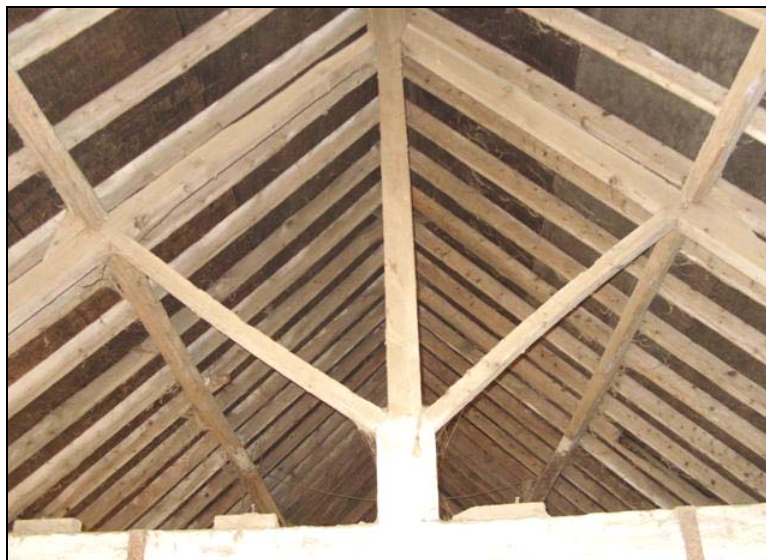
Plate 10: Stable King Post roof

- 3.6.6 The roof of the eastern block is hipped, and abuts the southern range, proving its later date. The valley formed by the change in angle is unflushed. The southern wall of the range is timber, and is boarded to ridge height. The roof is supported by a pair of king-post trusses with braces from the base of the king-post to the purlin locations, which are laid onto the principal rafters. A back purlin is also used at the northern hipped end (profile 2). The principal rafters rise from the tie-beams and the common rafters are set in mortices of the wall-plates, across the purlins and meeting at a central ridge piece that runs the axis of the building. At the mid point of the block, where a brick wall separates rooms 2 and 3 from each other, two struts have been added to help keep the roof level in the absence of a proper truss. The rafters and trusses are notably clean, and all exhibit saw marks rather than axe-marks or similar. This may be an indication that the roof is a modern replacement. None of the timbers have evidence for previous use. No trenails or iron nails were apparent in the roof assembly, suggesting the king-post trusses are made of unpegged mortis and tenon joints. The only fixings apparent are a pair of iron straps bolting the partition between rooms 1 and 2 to the tie beam of the truss. The roof is tiled and the ridges are sealed with half-round ridge tiles.

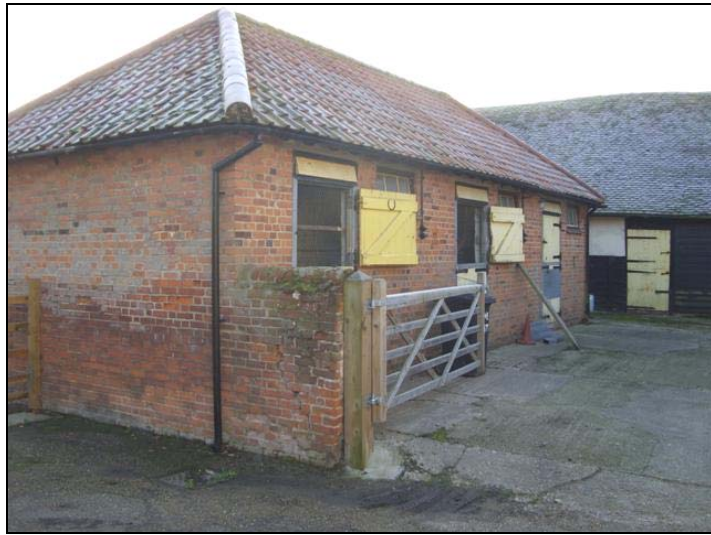
Plate 11, Western central block

- 3.8.2 The hollow in front of the stables is sealed with concrete, and two additional building blocks have been raised on cast concrete foundations. These are built in the same style as the stable blocks, single storey gable ended brick buildings with pitched roofs and stable doors. The westernmost of the two blocks contains rooms. Two are used for domestic fowl, the rest are empty. Cockerels are in one compartment, guinea-fowl in the other. The block has concrete window lintels, the roof is a hipped purlin roof with flat interlocking tiles. It is built of similar style to the main structure, and does not detract from the group. A low wall with metal gate runs between this block and the western arm of the building. The brickwork is bonded into this building but abuts the main structure, showing it to be contemporary with these 20th century additions.

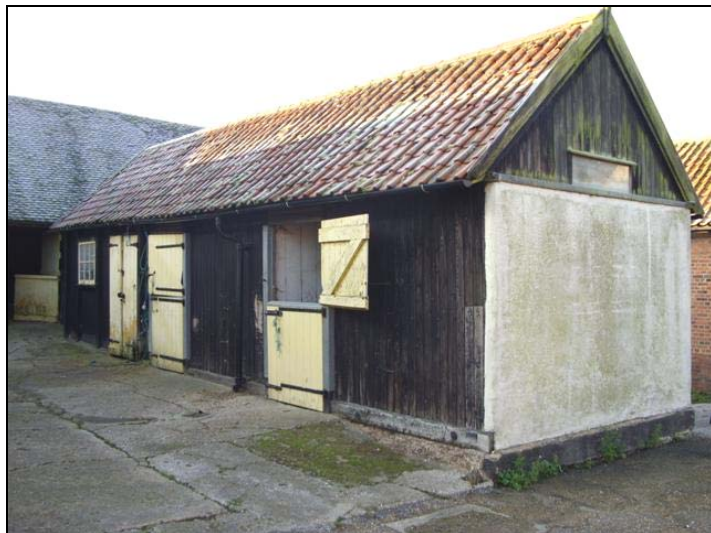
Plate 12: Eastern central block

- 3.8.3 The easternmost building is clad in boards, and has a pitched tiled roof with gable ends. The doors are in the eastern side. There are two stable doors leading to individual areas that may have been used as stables. The floors are concrete. To the south is a room used as an office, and is accessed through a pair of doors.

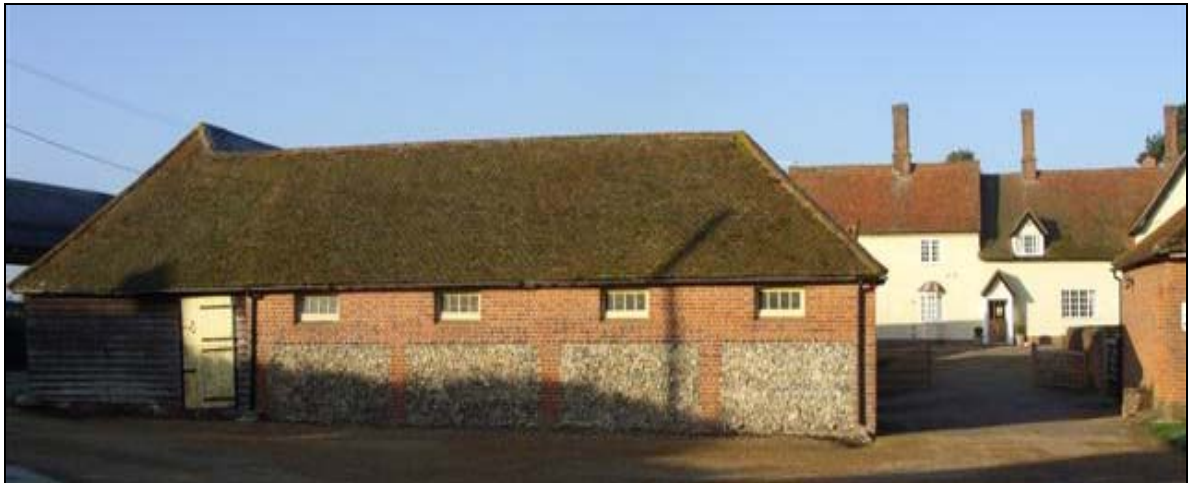
Plate 13: Harps Farm, stables in the foreground.

- 4.1 The core, earliest part of the stable block is the central part of the southern range, a timber framed loose-box built atop low ground walls with gabled ends and a boarded exterior. The north wall is half-rendered, and this may be the original finish. The original east wall was boarded from the ground to the apex of the gable and is still extant within later extensions. A ground-floor entrance in the east wall still exists. A door at eaves level indicates that there had been an upper floor more extensive than that currently present. It is tempting to describe the upper floor as a hay-loft. There is a building shown on Chapman and Andres' plan of the area (1777), but of such a scale and lack of detail make this somewhat unclear.

- 4.7 The group of stables and loose boxes that form the building under discussion lie on the south side of a courtyarded farm complex that may owe more to gradual evolution than a sudden influx of enthusiasm associated with fashion or the Model Farm Movement. The oldest building on the site is the early 15th century Hall House, still used as the principal dwelling on the site. This is presumably the dwelling of John-atte-Harpe, resident in 1420. The north side of the complex is dominated by the large 16th century barn, whose size is testament to the quantity of land farmed as well as the quantity of crops produced. The eastern side of the courtyard is formed by an open shed and one arm of the Stable, with access to the main house between. The south side is delineated by the Loose-box, and the rest of the farm complex is bound by a 2m high stone wall. The shed and stable block are later structures than the house and barn, but it seems probable that the earliest section is of 18th century date, since it predates the eastern row of stables that are shown on the Tithe Map.
