Castlehill Road, Wishaw: Data Structure Report

On Behalf of:	Dawn Homes 220 West George Street Glasgow
National Grid Reference (NGR):	NS 7947 5333
AOC Project No:	20995
Prepared by:	Alan Hunter Blair
Illustration by:	Alan Hunter Blair
Date of Fieldwork:	May 2008
Date of Report:	May 2008

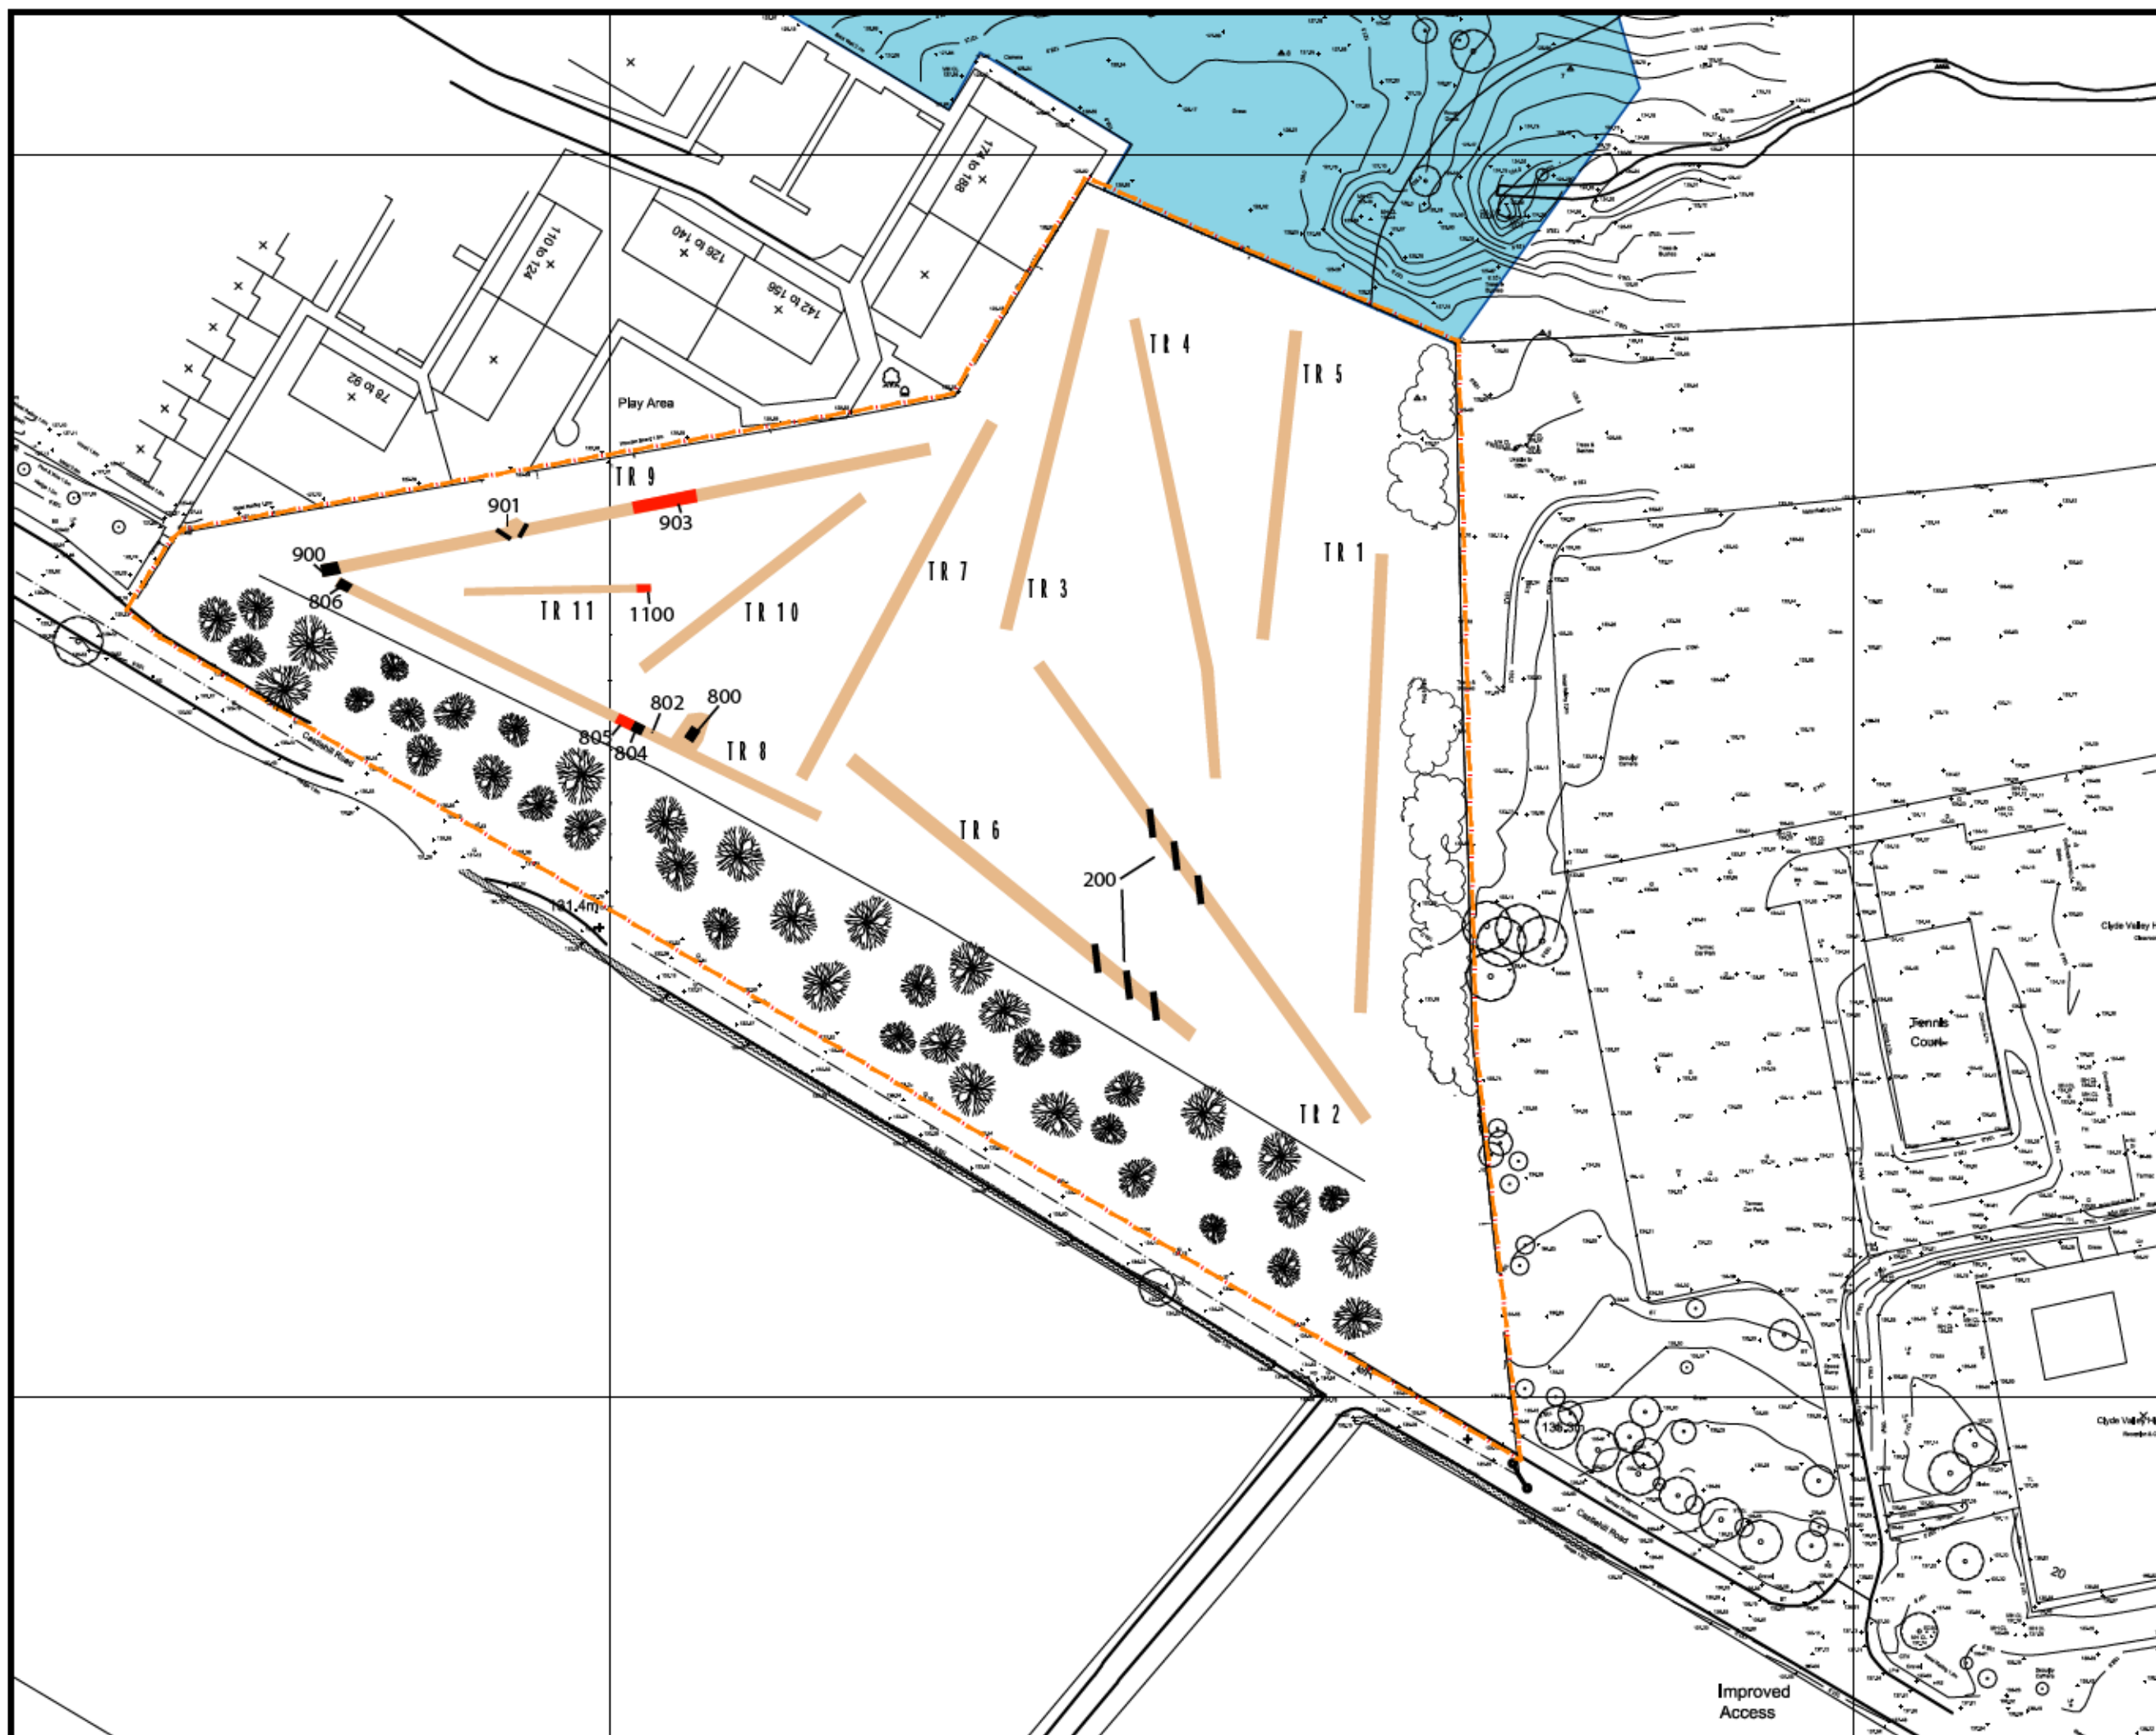
Figure 2: Location of features within the evaluation trenches

- evaluation trench
- proposed development area
- area in development not subject to evaluation

- 5.1 The following text should be read in conjunction with the fuller trench descriptions in Appendix 1 and context descriptions given in Appendix 2, the trench locations are shown on Figure 2.

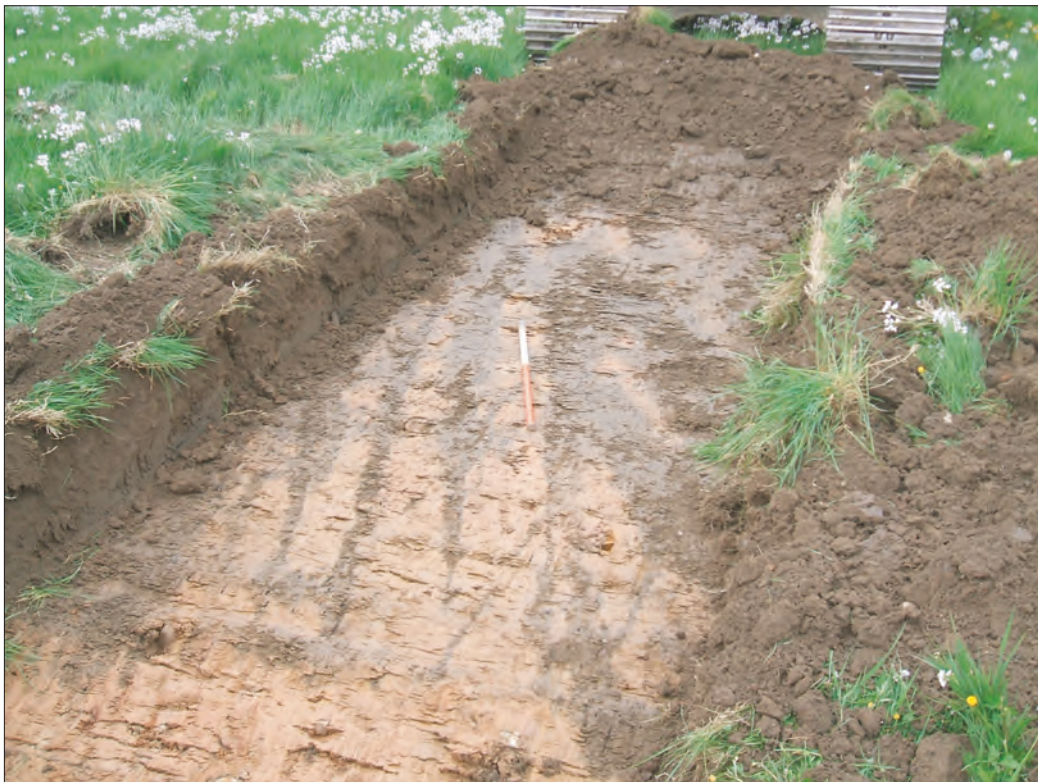
Plate 2: General view of modern plough marks evident in most trenches

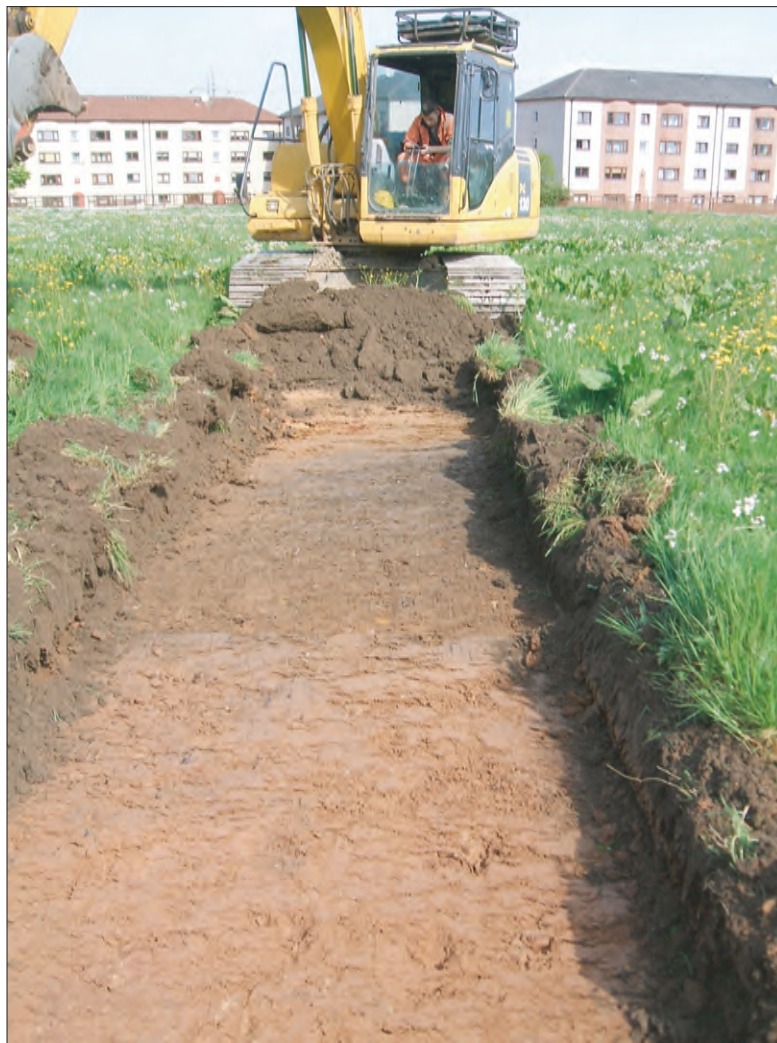
Plate 3: General view of broad rigg cultivation remnant in Trench 2 from the south-east

- 5.3 Rigg and furrow remnants were encountered in Trenches 2 and 6 [200] (Figure 2, Plate 3). Broad shallow furrows were visible cutting the natural clay up to a depth of 0.12 m these measured up to 3 m wide and were spaced approximately 6 m apart. The furrows were filled with a dark brown sandy clay [201] with frequent inclusions of small coal fragments, modern ceramic and occasional clay pipe stems and bowls.

- 6.1 The features recorded during the evaluation are believed to be relatively recent in date. The furrows of the broad rig and furrow cultivation remnants contained modern ceramic. Broad rig systems are found extensively around abandoned townships and farmsteads, most of them probably relating to the final stages of cultivation prior to abandonment in the early 19th century (Halliday 2001, 15).

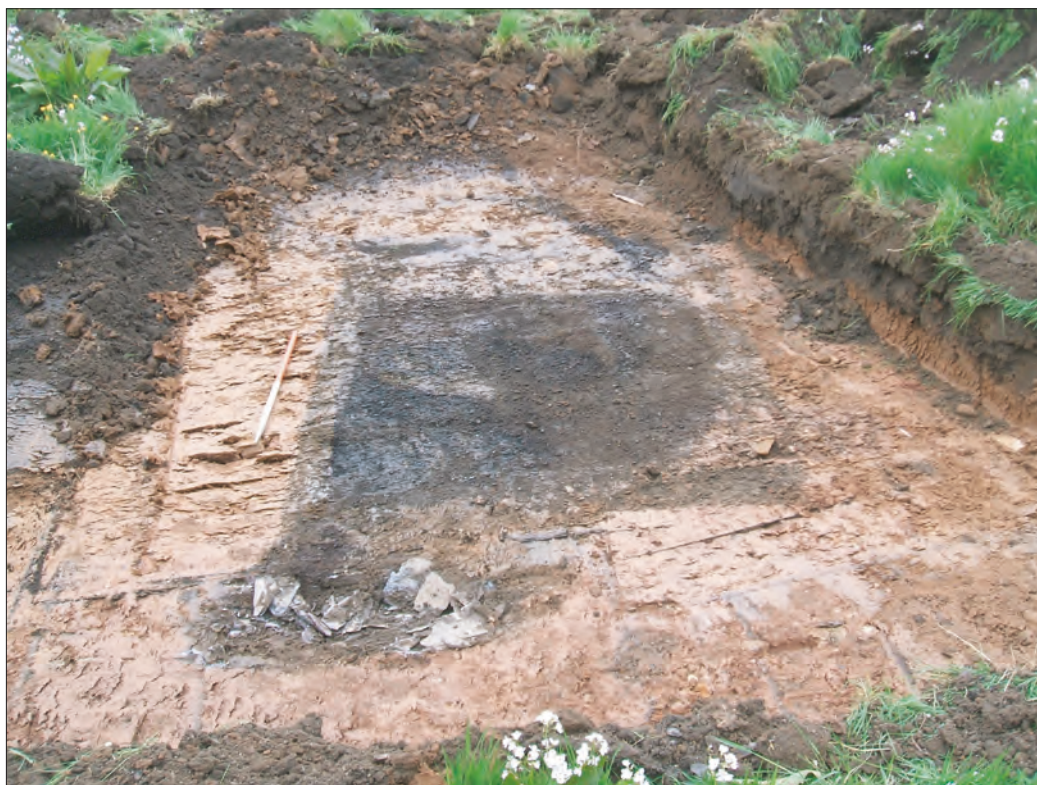
Plate 4: General view of pit 800 in Trench 2 from the south

- 5.4 A large pit [800] was recorded in Trench 8 (Figure 2, Plate 4) aligned roughly north to south. It measured 3 m long by 1.9 m wide had generally regular square-cut edges and appeared to have been dug by a machine. The fill of the pit [801] contained re-deposited natural clay with frequent inclusions of roof slate and tarmac fragments, coal, plastic and wire and other modern detritus. To the west of this feature a small pit [802] (Figure 2, Plate 5), containing a small animal burial, was located adjacent to the remnants of a crude brick-founded hard-standing [804] (Figure 2, Plate 6), built from bricks stamped "NELLFIELD", "***** WISHAW" and "COLTNESS". The western extent of the hard-stand was abutted by a compact layer of red blaes [805] (Figure 2, Plate 7). A spread of demolition debris [806] comprising bricks, concrete fragments, tarmac fragments and other modern detritus was visible at the western end of Trench 8.

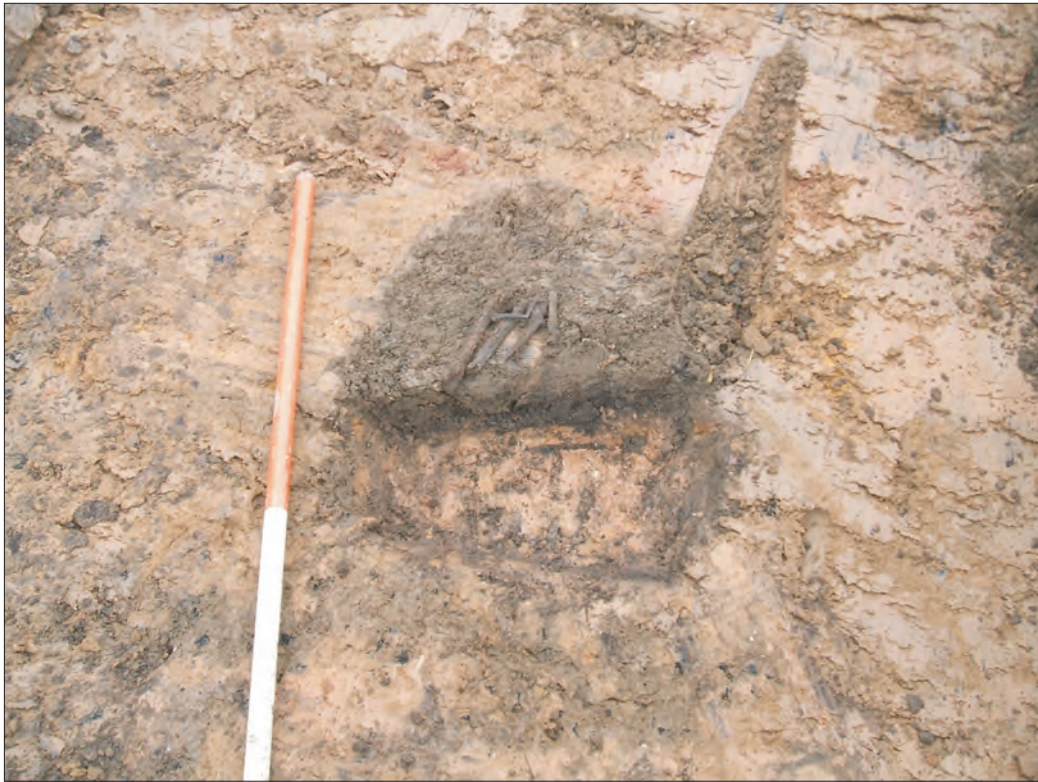
Plate 5: East-facing section through pit 802 in Trench 8

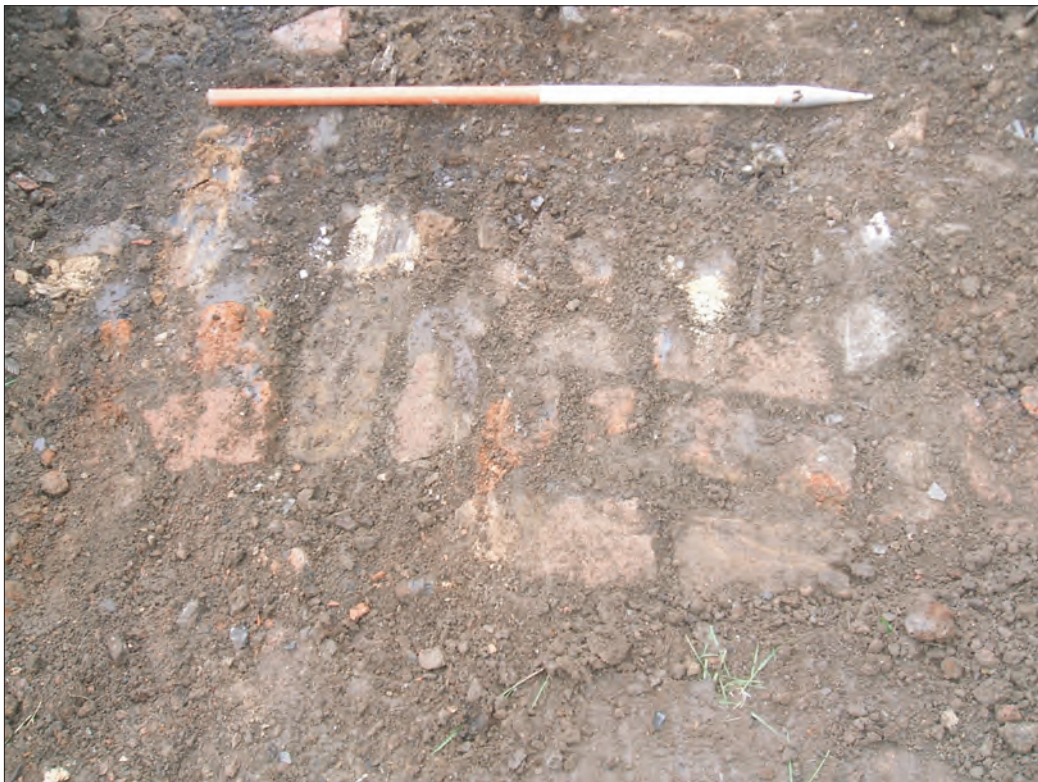
Plate 6: Detail of part of brick hard stand 804 in Trench 8 from the east

- 6.2 The brick-founded hard-stand, red blaes surfaces and small brick-built structure may represent the remnants of ruinous ancillary structures and trackways associated with either the Steelworks or Castlehill Colliery, as depicted on Bartholomew's map of the area published *circa* 1935 (Plate 11). These features may have been further truncated by modern ploughing and during the occupation of the eastern part of the site by a compound built during the refurbishment of the Gowkthrapple Heathfield Estate during the mid 1990s. The small pit containing the animal burial appeared modern and may have been that of a small dog.

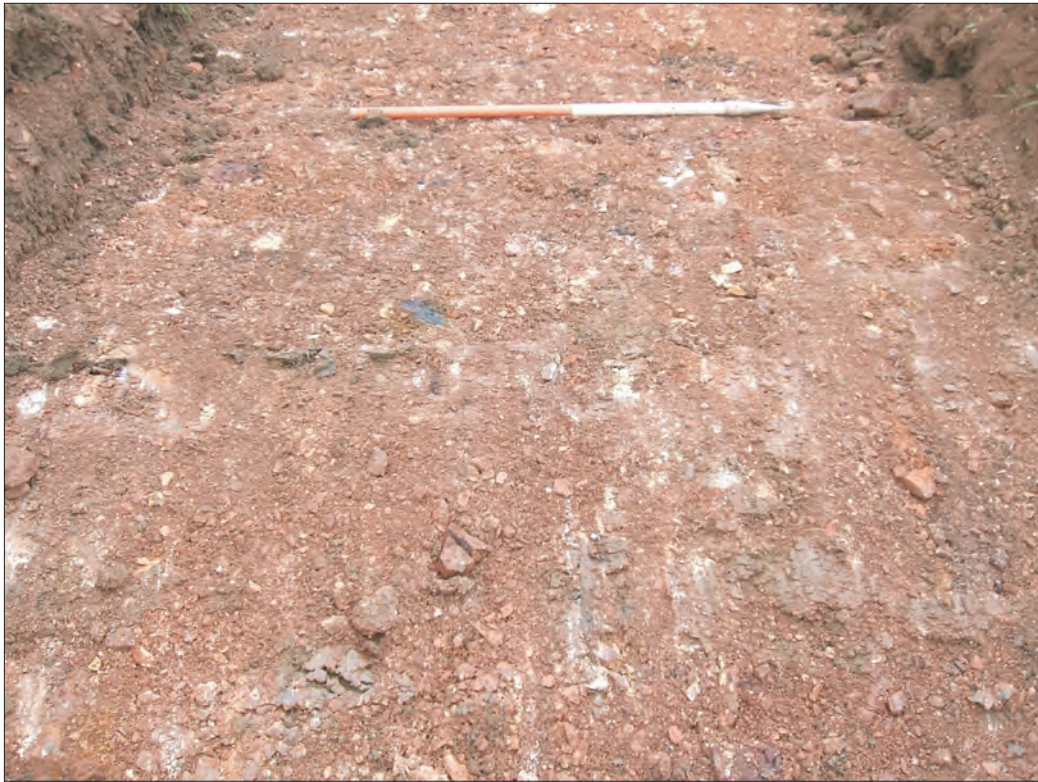
Plate 7: General view of red blaes surface 805 in Trench 8 from the east. Typical of blaes surfaces found elsewhere across the site.

805	Deposit: A layer of red blaes abutting the western extent of brick surface [804]. Measured 6 m long by 2 m wide (continued below trench edges to the north and south) by 0.22 m deep.	8
806	Deposit: A spread of demolition debris comprising bricks, brick fragments, concrete fragments, tarmac fragments, wood and other modern detritus. Measured 5 m long by 2 m wide (continued below trench edges to the north and south) x 0.25 m deep compacted into natural clay.	8
900	Deposit: A spread of demolition debris comprising brick, sandstone fragments,	9

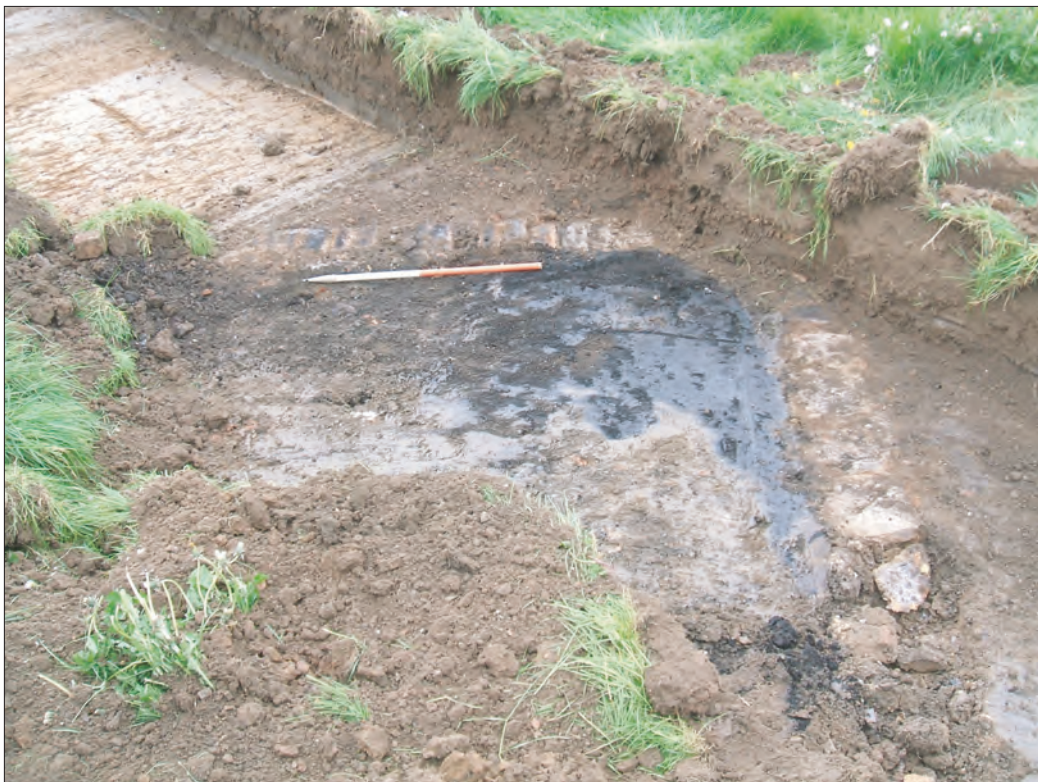
Plate 8: Brick structure 901 and coal dust deposit 902 in Trench 9, from the north-west

- 5.5 A further spread of demolition debris [900] was recorded at the eastern end of Trench 9; this may be a continuation of the material [806] recorded at the eastern end of Trench 8. Part of a small brick-built rectangular structure [901] (Figure 2, Plate 8) was recorded to the east of this deposit. The walls measured 3 m long by 0.26 m wide by 0.26 m deep and were built from poorly-fired brick a single course in width; bricks laid lengthways across the line of the wall and bonded by a cement mortar. The walls survived to two courses in height and

enclosed a deposit of very fine coal dust [902] which overlay natural clay. No evidence was found of a floor within the structure. A compacted deposit of red blaes [903] was recorded to the west of the brick structure this extended over a distance of 23 m.

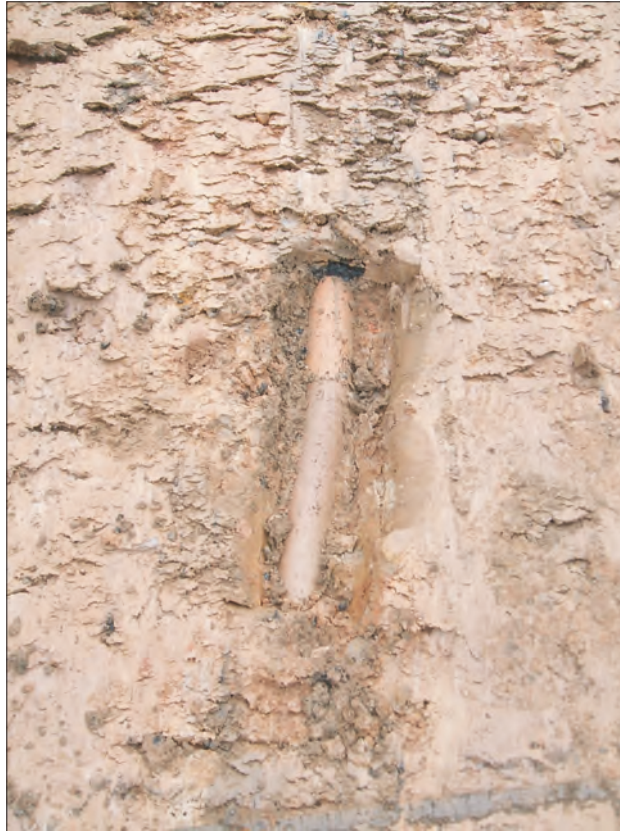
Plate 9: General view of tile drain in Trench 5 from the north

- 5.2 Tile drains were encountered in Trenches 1 and 5 (Plate 9). These were aligned NNE - SSW and were visible cut into the natural clay at the base of the trenches.

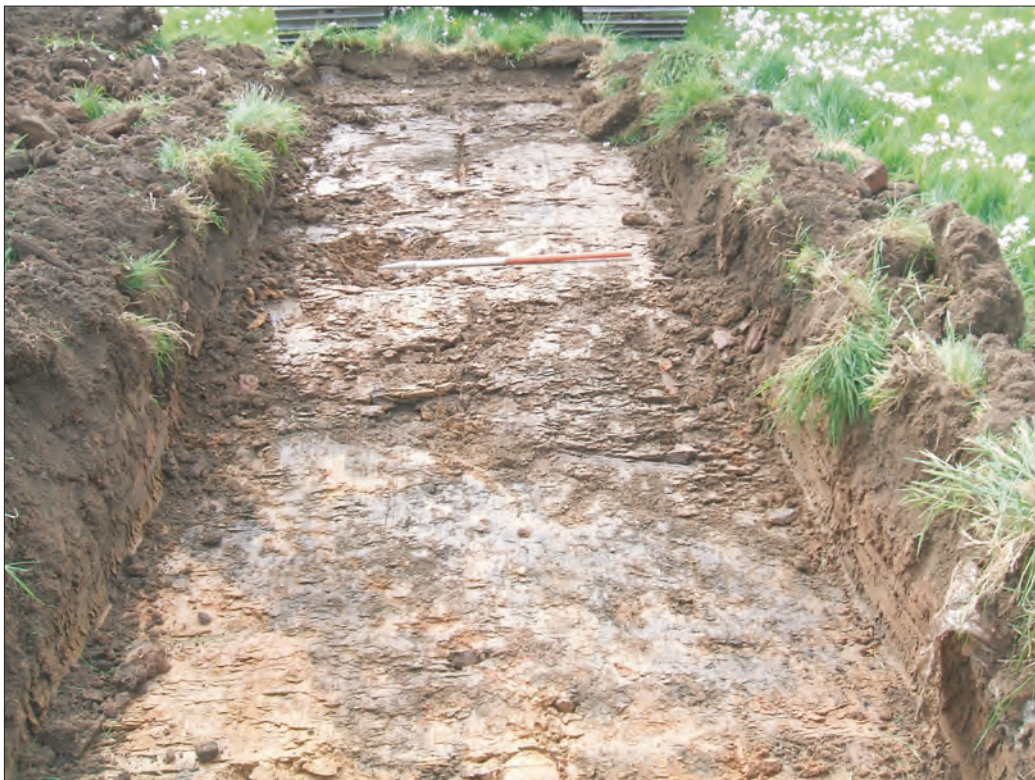
Plate 10: Made ground 1000 in Trench 10, from the north-east

- 5.6 Up to 0.35 m of madeground [1000] (Plate 10) was recorded in Trench 10 underlying re-deposited shallow topsoil 0.2 m deep. Brick, wood, concrete, rusty iron objects, plastic and other modern detritus, lying in re-deposited natural clay, overlay up to 0.1 m of subsoil which overlay the natural clay.
- 5.7 A further deposit of red blaes [1100] was recorded at the eastern end of Trench 11; this extended 5 m along the trench and measured 0.23 m in depth.

1000	Deposit: Made ground underlying re-deposited shallow topsoil 0.2 m deep. Brick fragments, wood, concrete, rusty iron objects, plastic and other modern detritus. Measured 30 m long by 2 m wide (continued under the trench edges to the north-west and south-east) by up to 0.35 m deep.	10
1100	Deposit: A layer of red blaes. Measured 5 m long by 2 m wide (continued under trench edges to the east, north and south) by 0.25 m deep	10

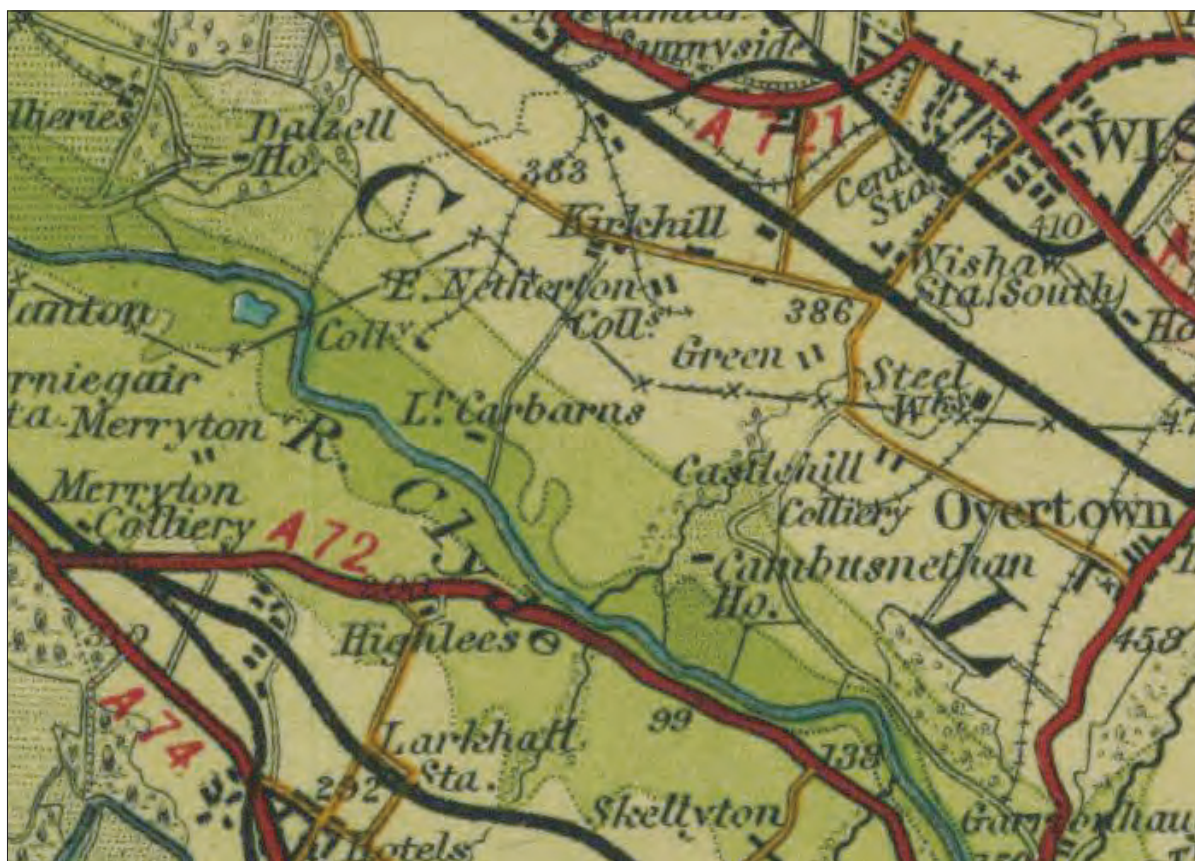
Plate 11: J G Bartholomew's map, published 1935 showing Castlehill Colliery and the steelworks in the vicinity of the development site
