# 4, Maids of Honour Row, The Green, Richmond, London Borough of Richmond-upon-Thames

## A Report following an Archaeological Watching Brief and Historic Building Record

AOC Project no: 7868

November 2008

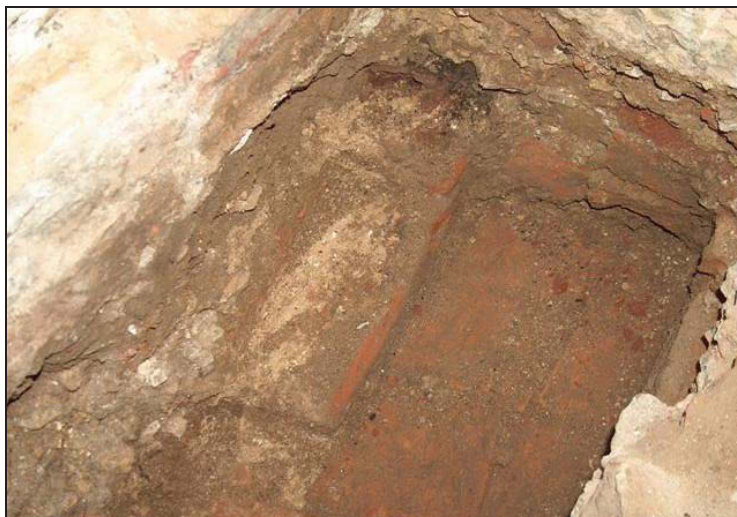
Plate 1: Drain, Trench 3

- 7.3.1 Trench 3 was located in the southwest corner of Room B1 of the basement, and was excavated to determine the depth of the walls of the basement. Within the trench was a short length of drain running north-south with an internal width of 0.24m. This had a base of ceramic peg-tiles (3/001) and sides of red brick (3/002), standing up to two courses high and bonded with pale brown lime mortar. The bricks were 60mm thick, and clearly of post-medieval date. The drain was considerably disturbed and incomplete. The remaining structure was filled with compact mid-brown sandy silt containing small brick fragments, and this was sealed by the lowest course of the basement wall. This lowest course was stepped out by 0.05m from the wall. The rest of the face of the wall was vertical, the basement 2.05m high. The extant floor of the basement at this location was concrete, although the rest of the room is tiled. There was no evidence in the trench for former floor materials.

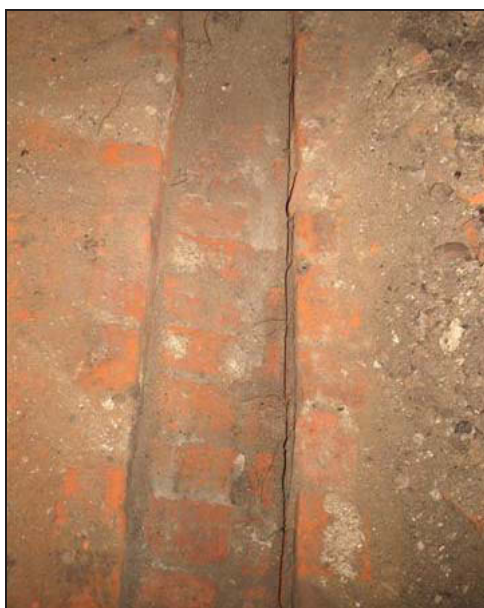
Plate 2: Drain, Trench 4

- 7.3.2 An area of concrete floor slab was raised in the eastern room, Room B7, and revealed a length of drain running east-west. This lay within a cut [4/003] into underlying yellowish brown silty sand with occasional gravel content (4/004). The drain (4/002) had a brick base and brick sides, the sides standing two courses high and truncated above. Most of the bricks were partial bricks, with few whole ones present. However, the dimensions of the complete bricks, of 220mm by 110mm by 60mm suggested a post-medieval date. The internal width of the drain was 0.24m and was filled with dark brown silty sand (4/001) that contained coal, charcoal, pebbles, and some fragments of animal bone, and owes more to deliberate infilling than the silty fill of an active drain. There was no hint of heat damage to the bricks, so the burnt material has no direct relationship to the function of the drain.

- 7.3.3 A 3.6m length of the drain was observed, continuing beyond the limit of the raised slab. The drain begins 0.9m from the eastern corner of the room. It had a beginning with a heavily mortared surface, which seems likely to be evidence for lost structural elements above. The archaeological record does not provide direct evidence to prove that this drain was fed by an internal feature.

- 7.3.4 On either side of the drain was a thin scatter of crushed brick rubble. This may have been a bedding or hardcore layer for a previous, now lost floor surface. The most recent surface was concrete: it lay upon the brick rubble and underlying yellowish brown silty sand (4/004).

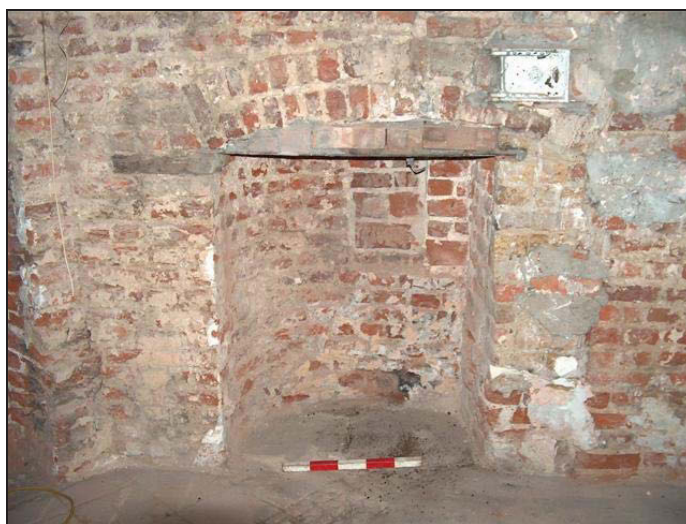
Plate 3: Fireplace, Room B1

- 7.3.8 Room B1 to the rear has a fireplace with an arched lintel originally formed of a shallow brick arch 1.24m wide and 1.31m high. This has been repaired by the insertion of a horizontal iron bar between the springing points of the fireplace, and bricks wedged between the bar and the arch. This has been insufficient to stop collapse: the bar itself is bending under the weight of the chimney stack above. The southern side of the fireplace has also been altered, narrowing the opening to 0.94m. A minor crack in the chimneystack has been repaired with mortar.

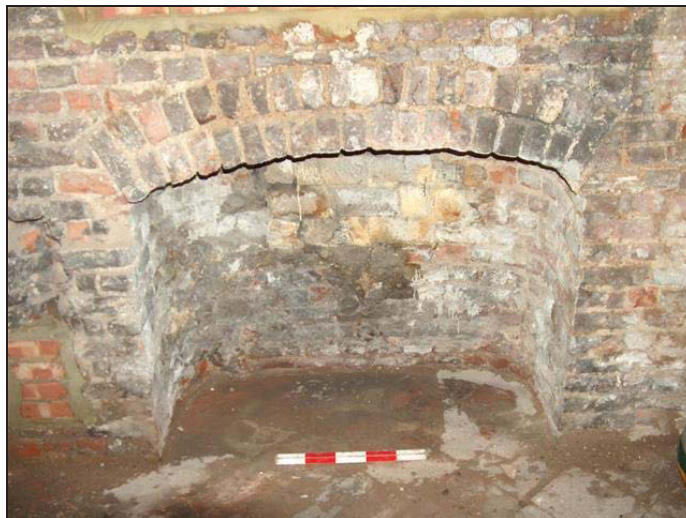
Plate 4: Fireplace, Room B5

- 7.3.9 Room B5, to the west (rear) has a tiled floor, the tiles are red and 0.25m (10 inches) square and laid square with the principal walls. A fireplace that had been boarded over was revealed in this room during removal of plaster: this was a small fireplace. No hearth was extant: the tiling continued into the fireplace. This was 1.31m wide and only 1.05m high, and has an arched lintel made from a double row of headers on edge. The fireplace may be a later rebuild or insertion. The bricks are

greyish red and measure 230mm x 100mm x 65mm, larger than those in the rest of the basement. The bonding material is firm, light greyish brown, fine sandy mortar
