# Cockenzie Old Parish Church, 44 High Street, Cockenzie, East Lothian: Historic Building Recording

*AOC 28186  
28th April 2025*

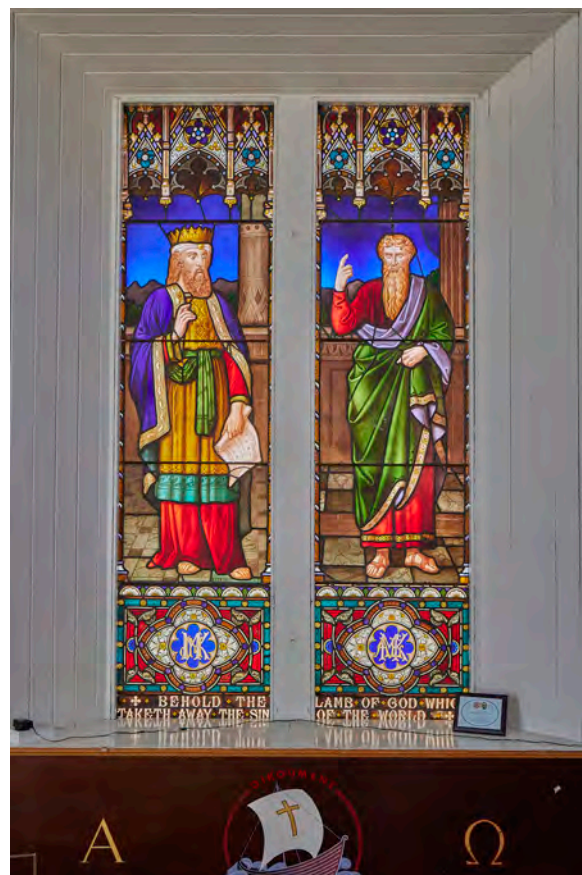
Plate 42: Cockenzie Old Parish Church Room 1, detail of the southern stained glass window in the west wall

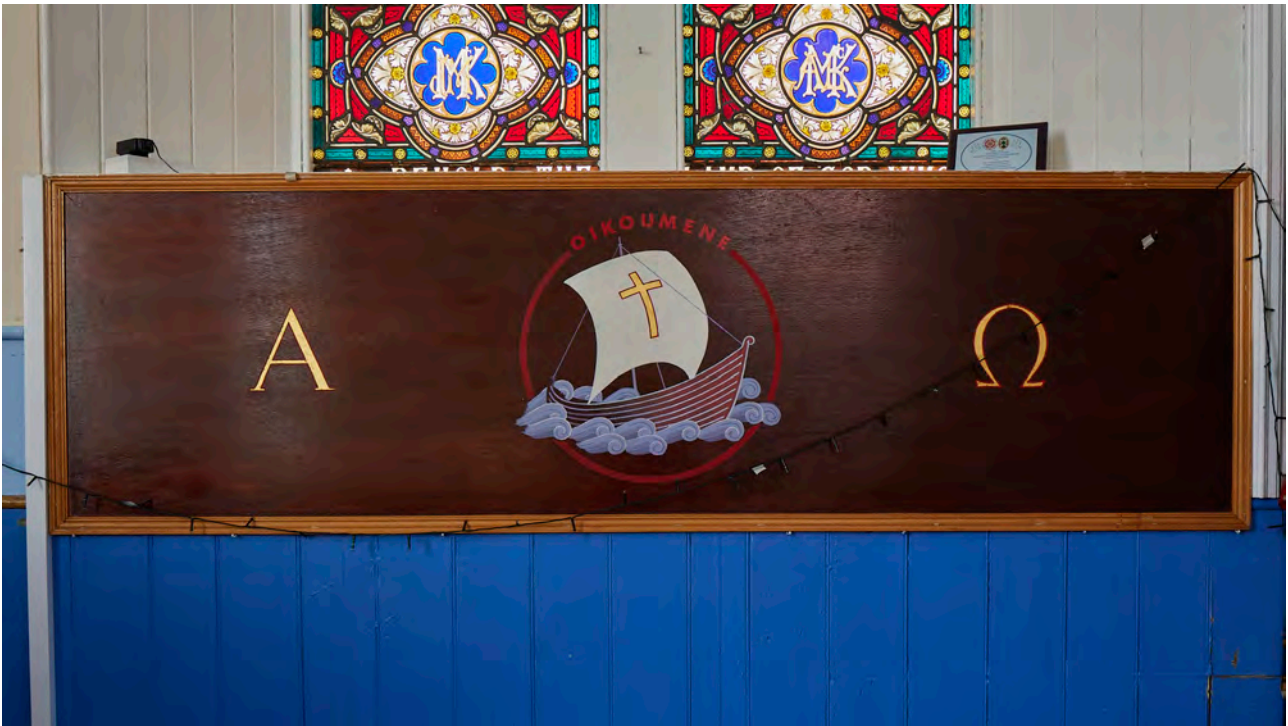
Plate 43: Cockenzie Old Parish Church Room 1, detail of timber panel and motif beneath the southern stained glass window in the west wall

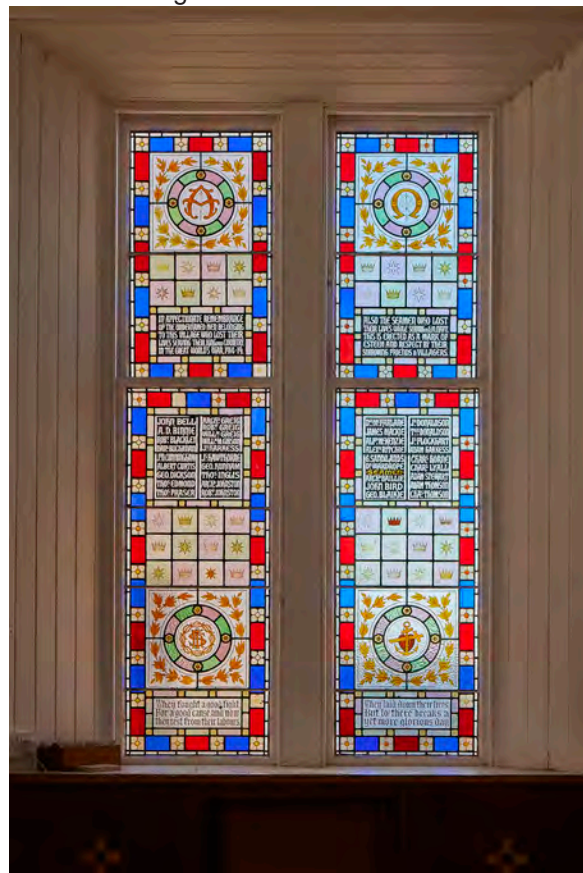
Plate 44: Cockenzie Old Parish Church Room 1, detail of northern stained glass window in the west wall

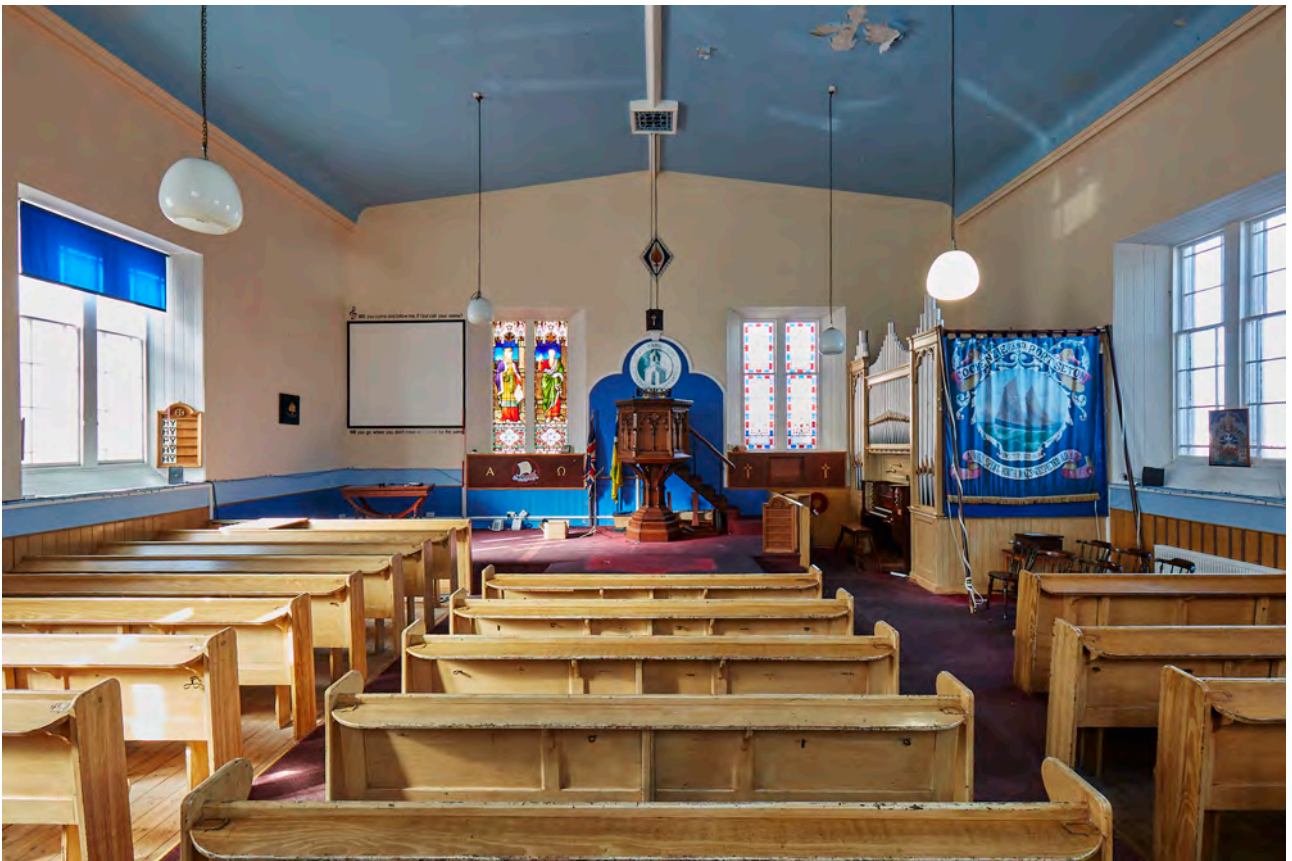
Plate 45: Cockenzie Old Parish Church Room 1, general view of the west wall
