# Land at Spa Road, Bermondsey London Borough of Southwark A Post-Excavation Assessment Report

AOC Project No: 30165

Site Code: SRQ 07

Date: May 2009

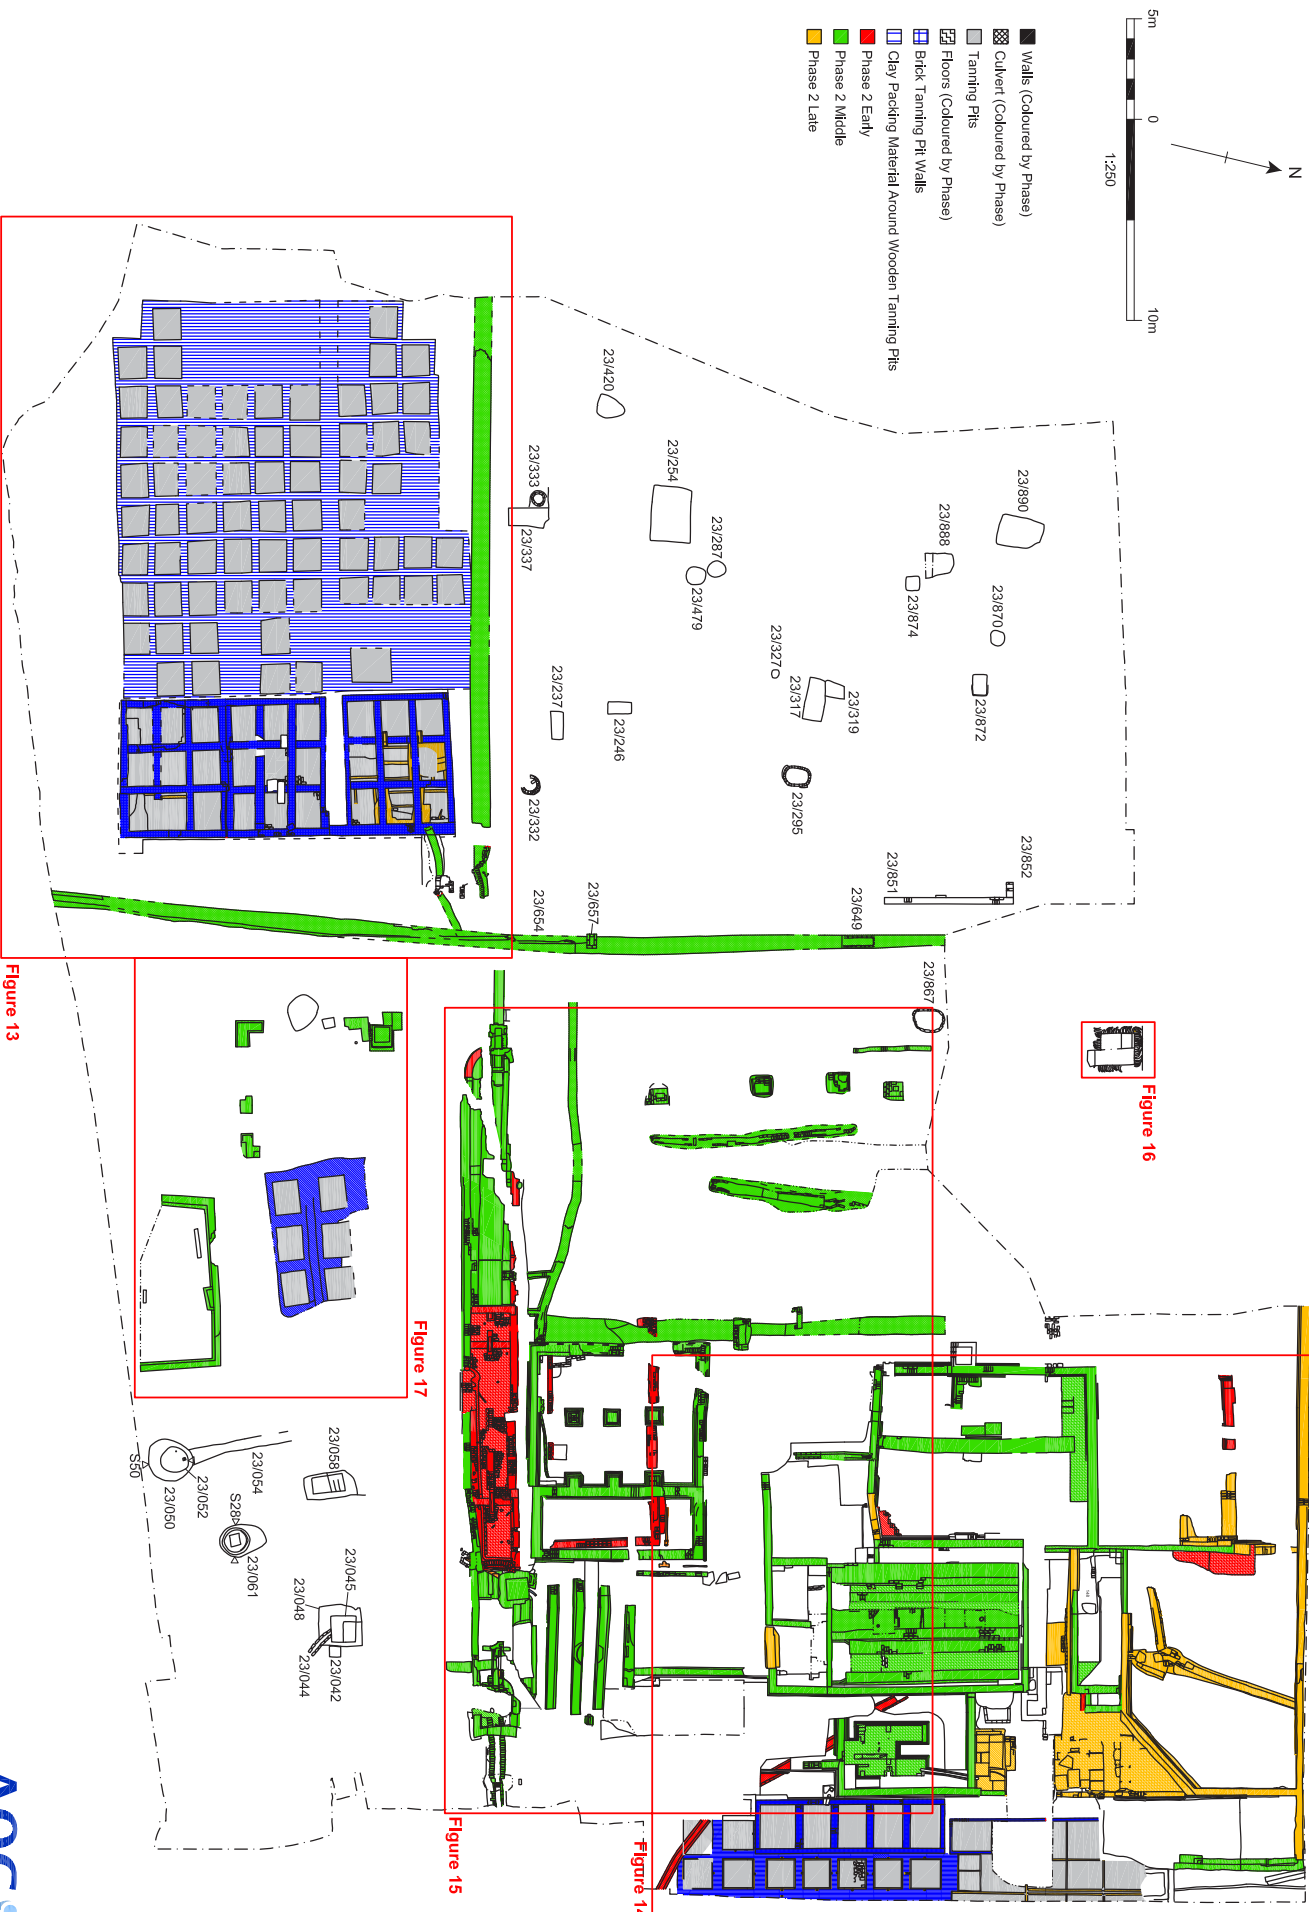
Figure 12: Period 4 Phase 2: Overview of Tannery Features

- 6.6.1 The tannery remains comprised an extensive range of square cut, wood lined tanning pits, closely set in a grid system across the south-western area of the site, three rectangular brick built structures internally divided to contain nine tanning pits, extensive buildings identified as air drying buildings, offices, store rooms, leather and skins warehouse, stables, a smithy and fleshing sheds, as well as an additional set of brick and wood lined tanning pits within the north and east of the site, numerous water and lime drainage systems, wells and various cut features, including a horn lined pit (Figure 12).

- 6.6.12 Samples were taken from much of the masonry dated to the tannery's occupation of the site, but no clear phasing of the structures could be confirmed from the results. A rudimentary phasing of the features has been created from the stratigraphic positions of the masonry remains (Figures 12, 13 and 14), yet from the cartographic depictions of the site it appears that all of the tannery structures were built prior to 1878.
