Rudchester Manor House and Barn, Rudchester Historic Building Report

Rudchester Manor House and Barn

Historic Building Report

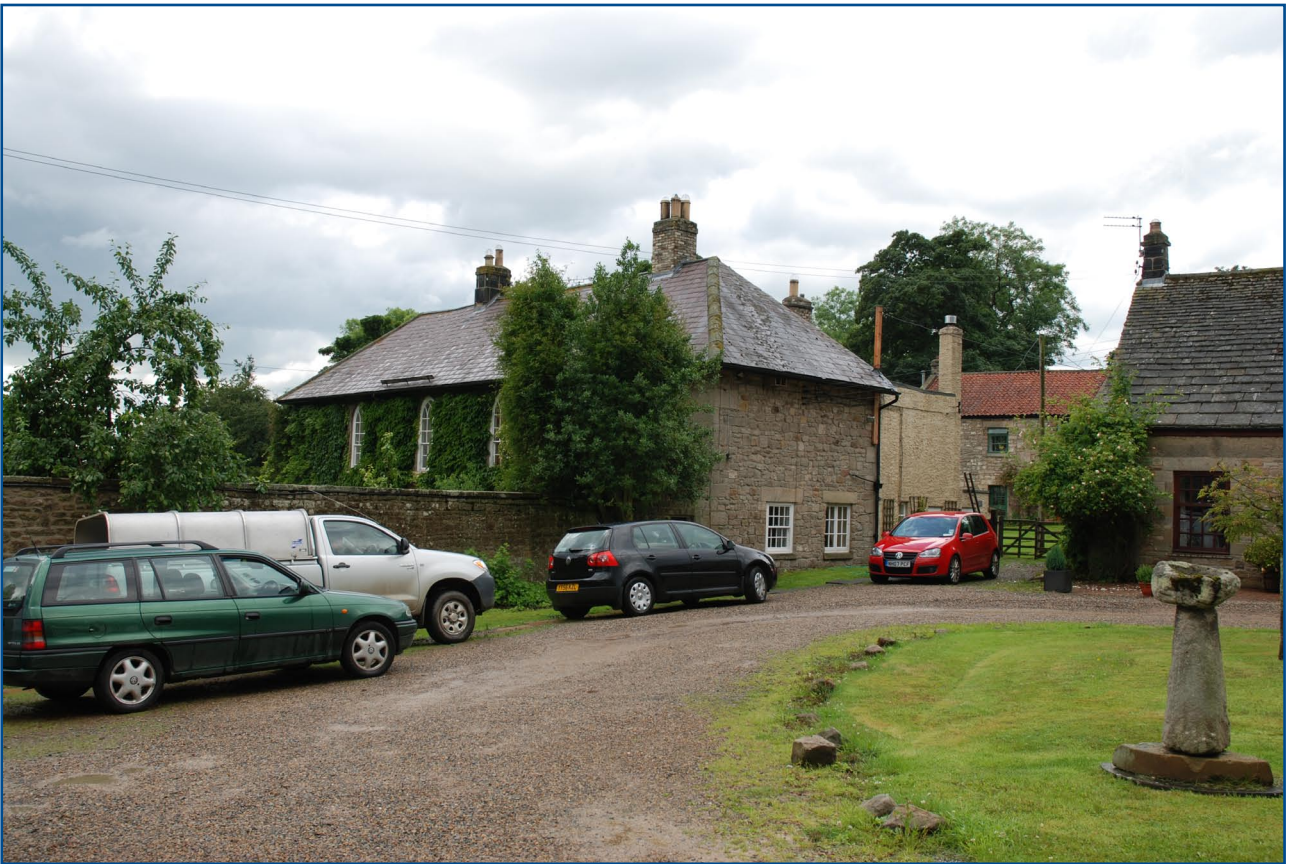
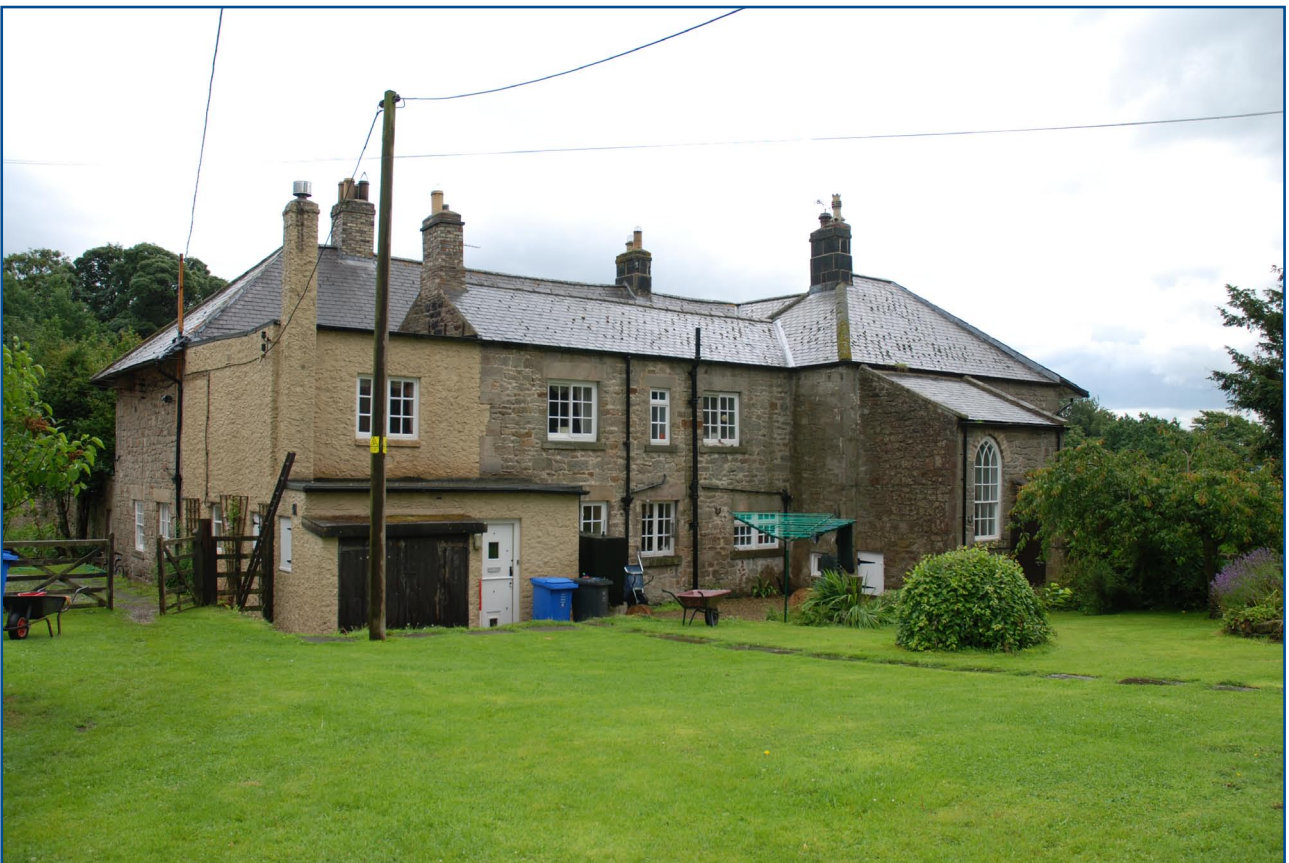
Plate 1: General of Rudchester Manor House from north-east

5.1.1 The Manor House is by far the largest and finest building within the township of Rudchester (**Plate 1 & 2**). It stands to the south-west corner of the hamlet with its rear (west) façade facing onto the second, western, courtyard and the front (east) façade faces onto a private walled garden which once included a drive providing direct access from the road.

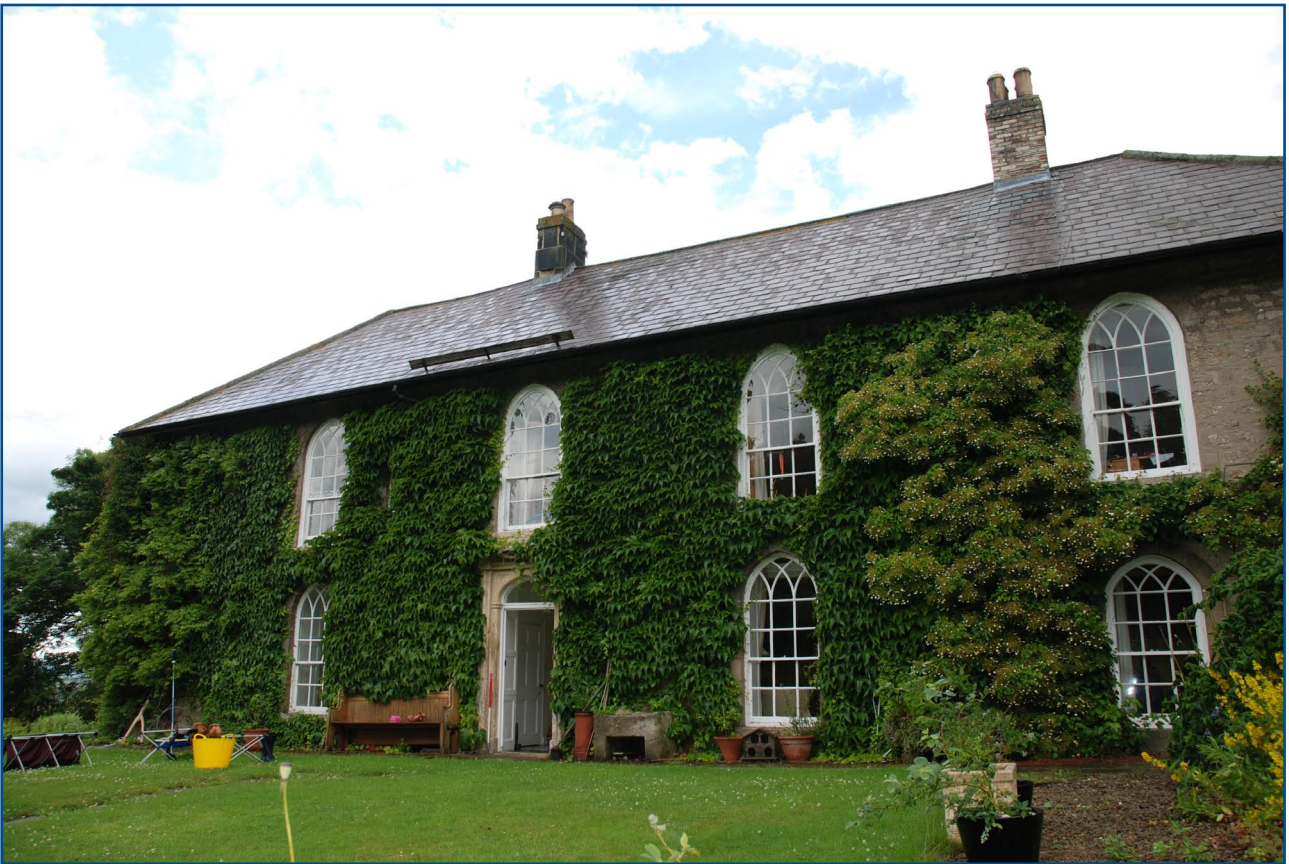
Plate 3: General view of east elevation of Manor House from north-east

The main façade (or east elevation) of the manor house is the most striking (**Plate 3**). It is largely covered with vegetation although a central doorway with dressed stone surround and segmental arched header is still visible together with flanking gothic sliding sash windows with intersecting glazing bars, at both ground and first floor level. There are two windows to the south of the doorway (at ground and first floor level) and four to the north. This is a result of the incorporation of the Pele tower to the south-east corner of the house. The window to the far north is smaller than the other windows possibly owing to a lower ceiling in the room at this side of the house.

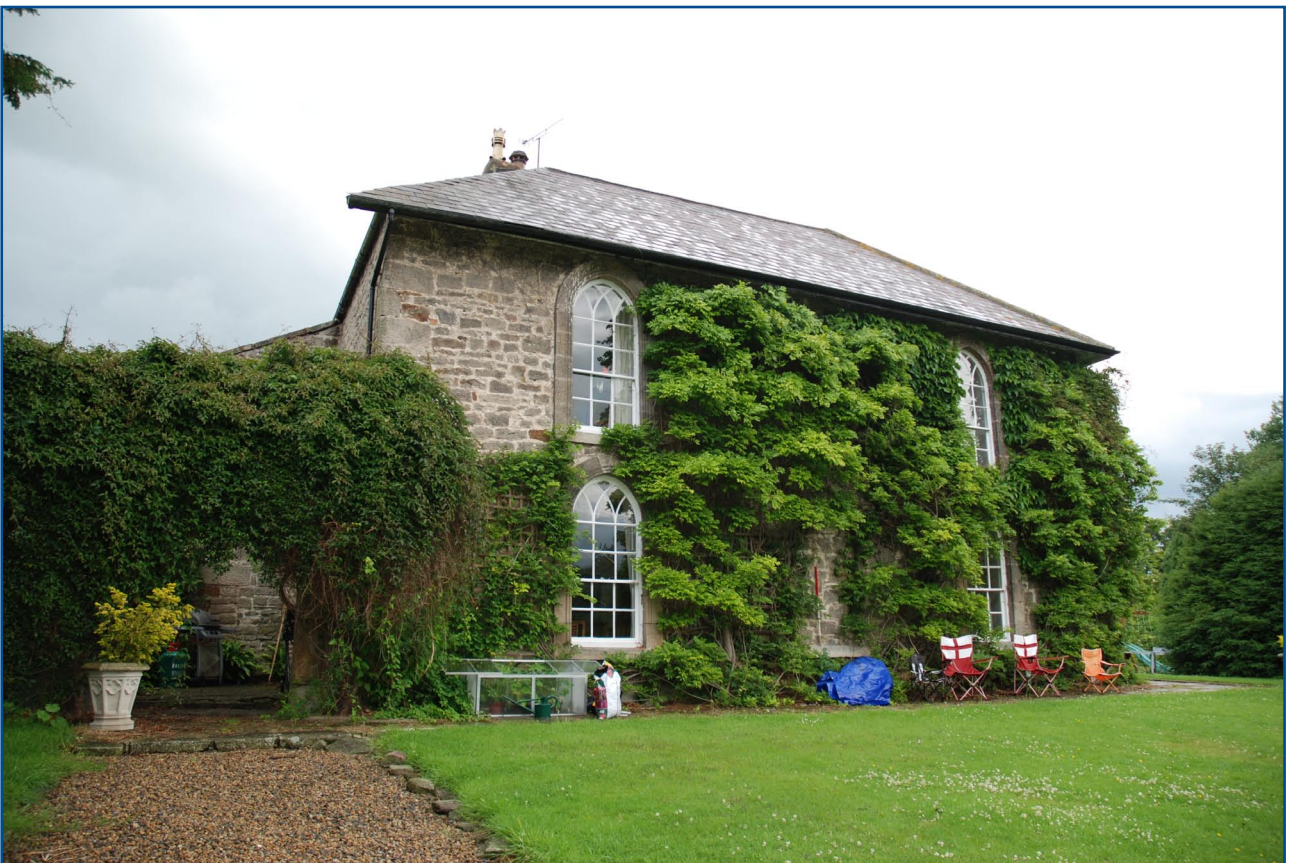
Plate 4: General view of south elevation of Manor House from south-west

Again the south elevation of the house is largely covered with vegetation although the design is discernible and is much the same as the main east façade (**Plate 4**). There are four windows, two to each floor, all containing gothic sliding sash windows with intersecting glazing bars and roll moulded dressed stone surrounds. At ground floor level there is a central blind window which provides balance to the elevation.

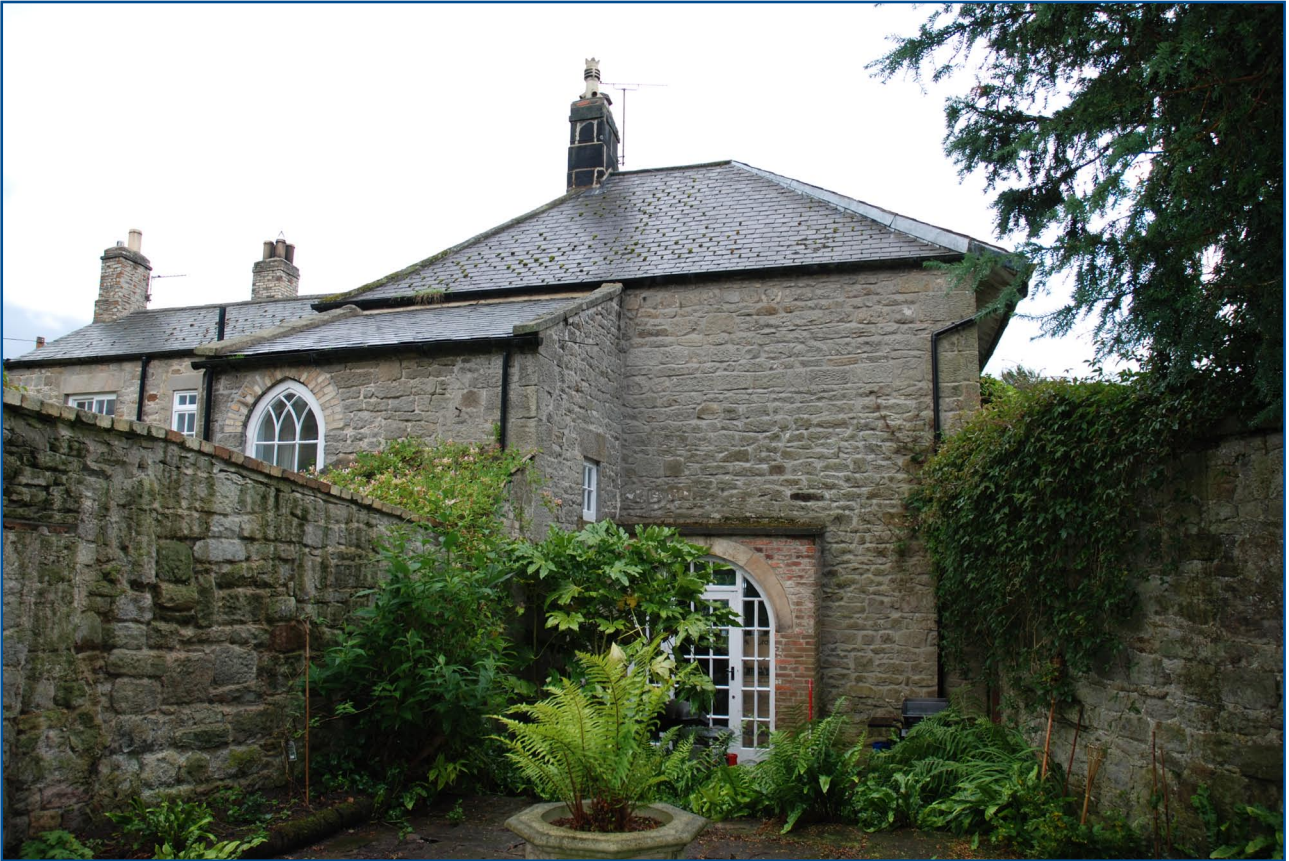
Plate 5: General view of south end of west elevation of Manor House from south-west

The rear or west elevation can be broken into different sections. To the south side of the elevation the house projects creating the L-shaped plan (**Plate 5**). The west elevation of this extension contains a small brick porch leading onto a small walled garden. To the north of the walled garden, on the same elevation, is a small single storey lean-to with slate roof and gothic sliding sash windows with intersecting glazing bars, although this example has a brick surround and appears to be a later insertion. The main west elevation is set back and it is clear that this elevation was not intended to be seen by the visitor in the 18th and 19th centuries (**Plate 6**). The elevation is constructed of roughly coursed, squared stone rubble with squared stone quoins to the south end and rendered to the north end (**Plate 7**). The rendered section of the elevation marks the extension which has now been demolished. There is a small single-storey outshot to the extension with double timber doors opening onto an external store and a modern stable door to the south of it.

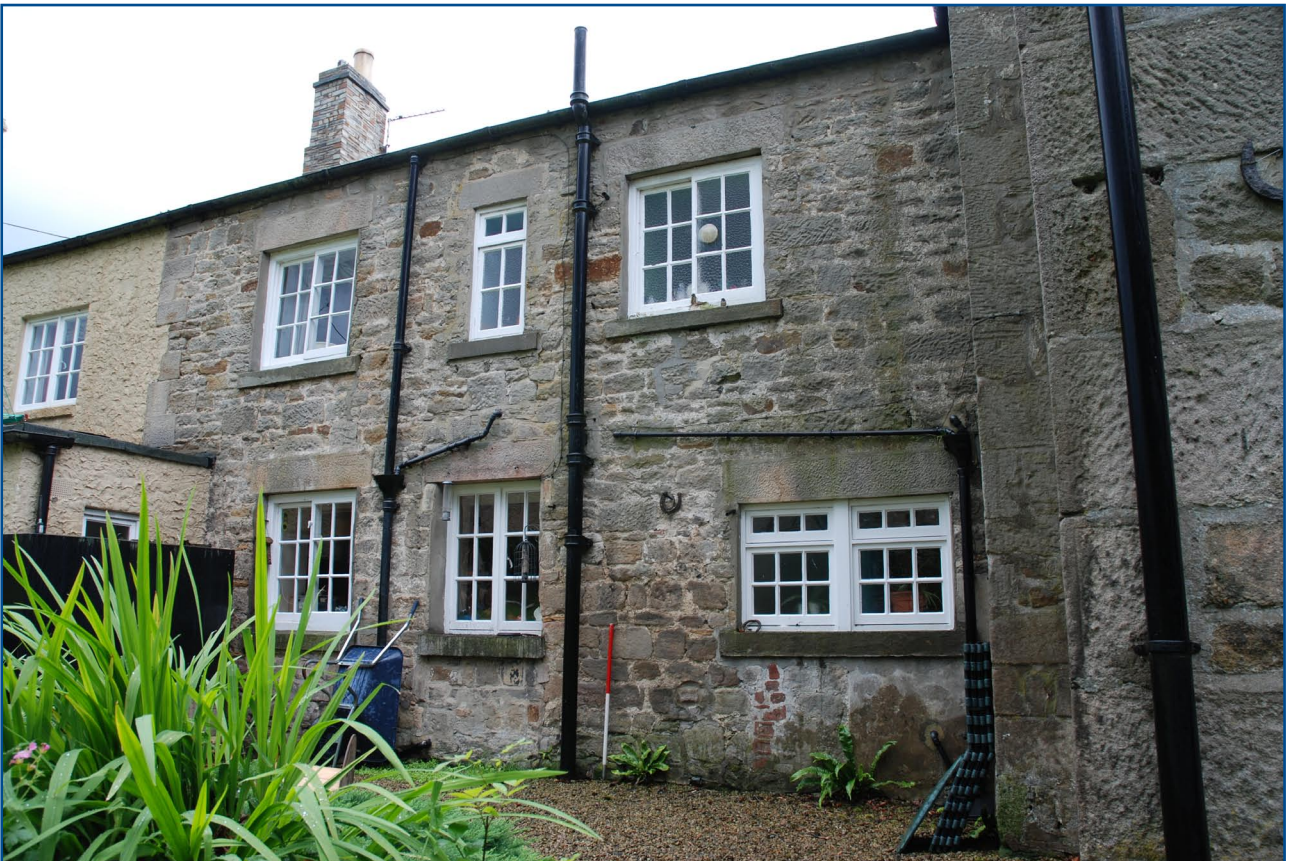
Plate 6: General view of centre of west elevation of Manor House from west

The main section of the west elevation contains four windows at first floor level (the northernmost within the extension that has been demolished) and three at ground floor level. All the windows have projecting stone sills and, with the exception of the first floor window in the extension to be demolished, dressed stone lintels. The first floor window within the extension contained a two-light, side hung, timber frame. The first floor window to the south of it and that to the far south at first floor level each have horizontal sliding sash frames (also known as Yorkshire sash windows). Between the two sliding sash windows is a narrow six-pane window with top opening panes. At ground floor level, the windows have three different designs. To the far north the window contains a horizontal sliding sash timber frame (or Yorkshire sash) whilst to the south of it is a side hung timber frame. To the far south is a two-light window with nine-panes to each light and top opening panes. The central window at ground floor level has been blocked underneath its sill which suggests it was a former doorway, probably the service entrance.

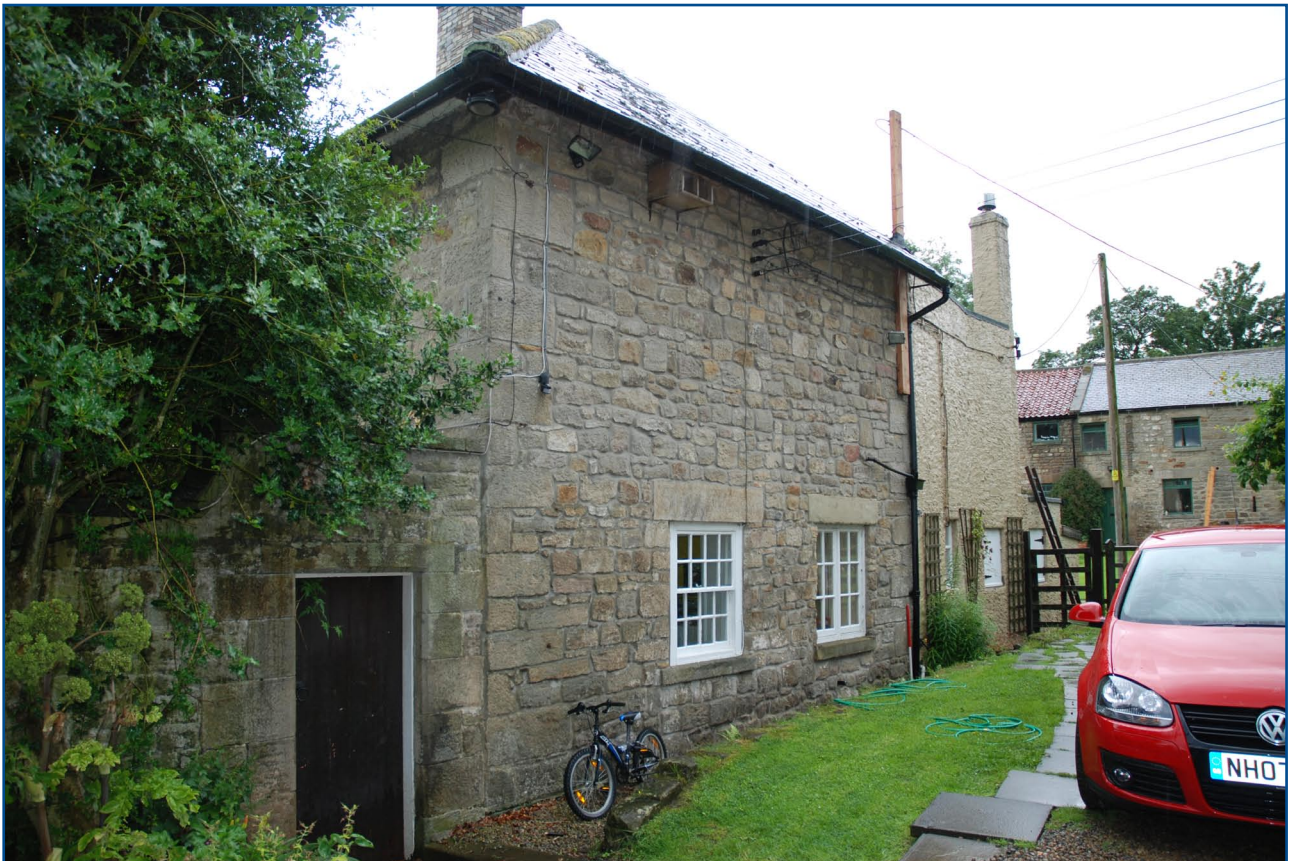
Plate 8: General view of north elevation of Manor House from north-east

The north elevation can be divided into two phases with the main manor house to the east side of the elevation and the rendered later extension to the west side of the elevation (**Plate 8**). The former is constructed of squared coursed sandstone with squared quoins to its edges, distinguishing it from the extension. This part of the elevation is punctuated by two windows each with dressed stone lintel and sill but with dissimilar frames. The window to the east contains a sixteen-pane sliding sash and the window beside it has a two-light window with side hung frames.

The extension to the west of the main house contained a single two-light fixed timber casement window and two openings to the west of it which contained timber plank doors. A tall chimney extended from the western edge of the extension.

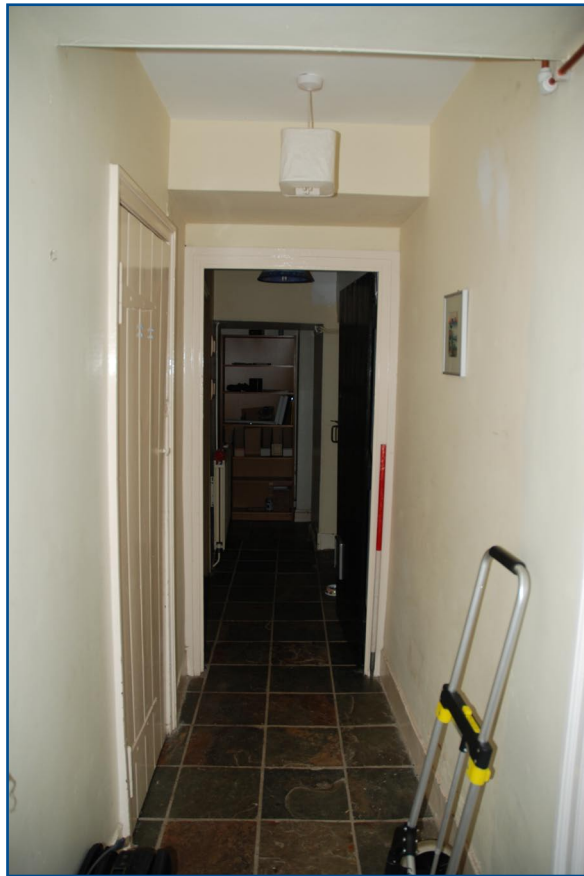
Plate 9: General view of Room 0.1 in Manor House extension from west

The most recent rear entrance into the manor house was through a modern split timber plank door set in the west elevation of the later extension. The doorway opened onto a long corridor which travelled east to the main rooms of the house (**Plate 9**). To the north side of the corridor were three doors to separate rooms and to the south side were two doors. The northernmost of these doorways led to a modern bathroom whilst the one to the south of it led to the modern kitchen (Room 0.11). The east end of the corridor opened onto Room 0.5, part of the 18th century manor house. The corridor had plastered and painted walls with a concrete floor to the west and tiled floor to the east.

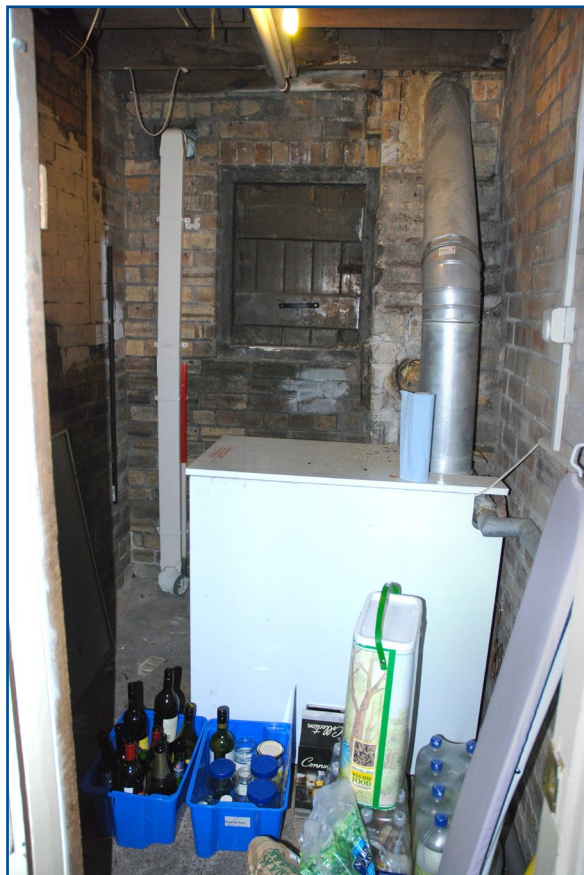
Plate 10: General view of Room 0.2 in Manor House extension from south

The small room to the west end of the later extension had pale, yellow brick walls and a concrete floor (**Plate 10**). To the north-east corner was a brick boiler with flue rising through the ceiling. In the north wall of the room was a square opening with a timber plank door over. To the opposite wall was a doorway with timber plank and battened door. This room was likely to have been the 'heating chamber' referred to in the 1936 sales particular.

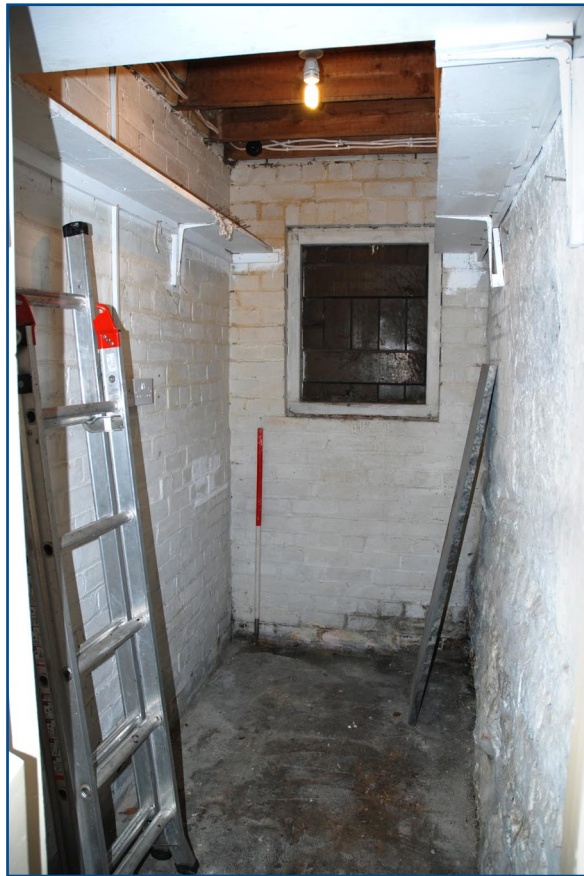
Plate 11: General view of Room 0.3 in Manor House extension from south

The central room of the later extension had painted brick walls to the south, west and north and a stone wall to the east, with a concrete floor (**Plate 11**). There was a timber plank and battened door in the south wall and a small opening, also with timber plank door, in the north wall. There was an opening in the east wall which was blocked with brick complete with a roughly dressed stone surround (**Plate 12**). During the demolition of this section it was discovered the surround was constructed of regular stone blocks and was blocked with pale, yellow bricks matching those used in the construction of Rooms 0.1 and 0.2 suggesting it was blocked in the early 20th century. Large stone quoins were also removed from the south edge of the wall and these probably formed the jamb of a former doorway. This room was probably the stick or coal house mentioned in the 1936 sales particular.

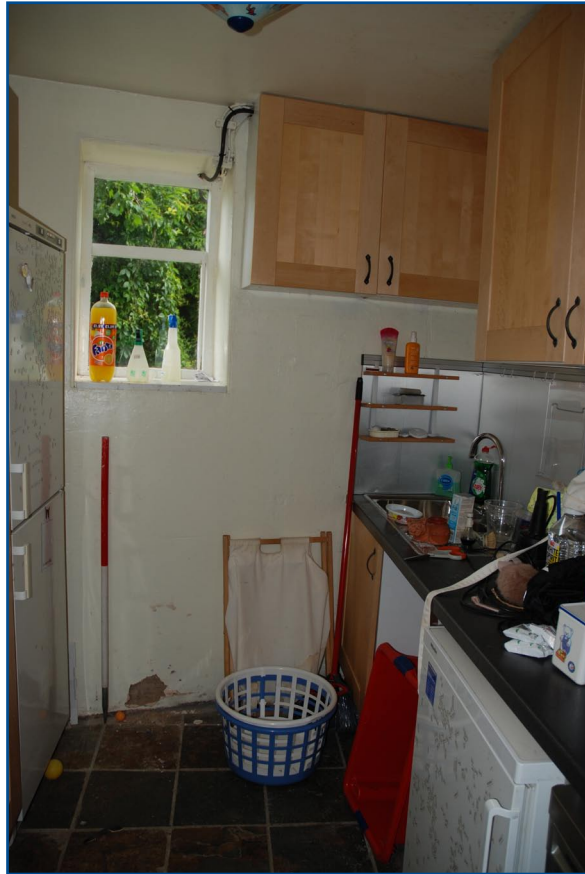
Plate 13: General view of Room 0.4 in Manor House extension from south

Unlike the other rooms in the later extension, Room 0.4 had stone walls and was accessed from the main corridor through a four-panelled timber door in the south wall (**Plate 13**). In the opposite wall was a two-light late 20th century timber casement window. During demolition, a broken 20th century blue and white patterned plate and horse shoe were found in this part of the wall. Prior to demolition, this room was used as the utility room and was probably the pantry or scullery described in the 1936 sales particular.

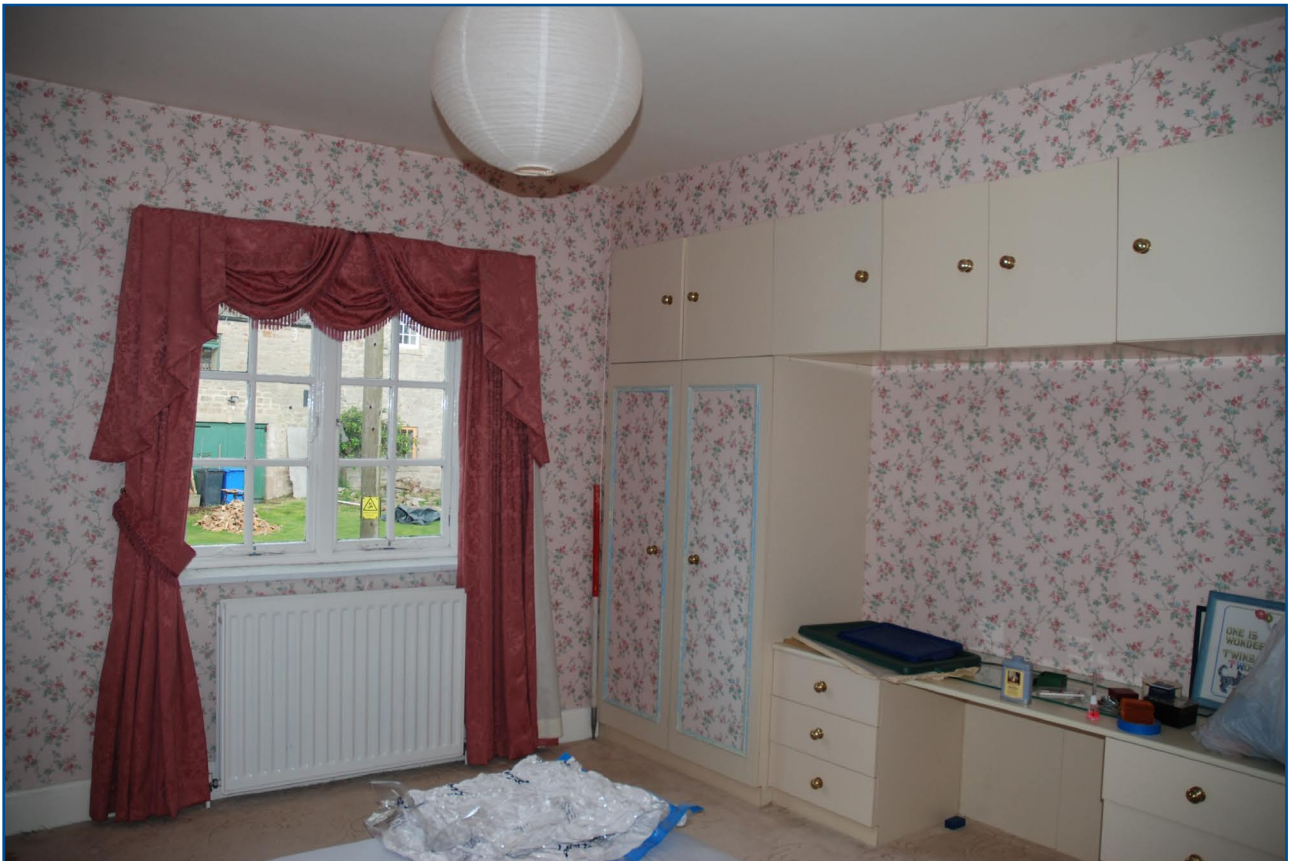
Plate 14: General view of Room 1.1 in Manor House extension from south-east

The majority of the later extension was single storey although there was a single first floor room above Room 0.4 which was constructed with brick walls, contrary to the ground which is stone built. Internally, the room was furnished as a late 20th century bedroom and was accessed directly from Room 1.9 through a four-panelled door (**Plate 14**). Late 20th century wardrobes lined the north wall and the room was lit by a single two-light window with six-panes to each light in the west wall. The room probably provided one of the maid's bedrooms described in the 1936 sales particular.

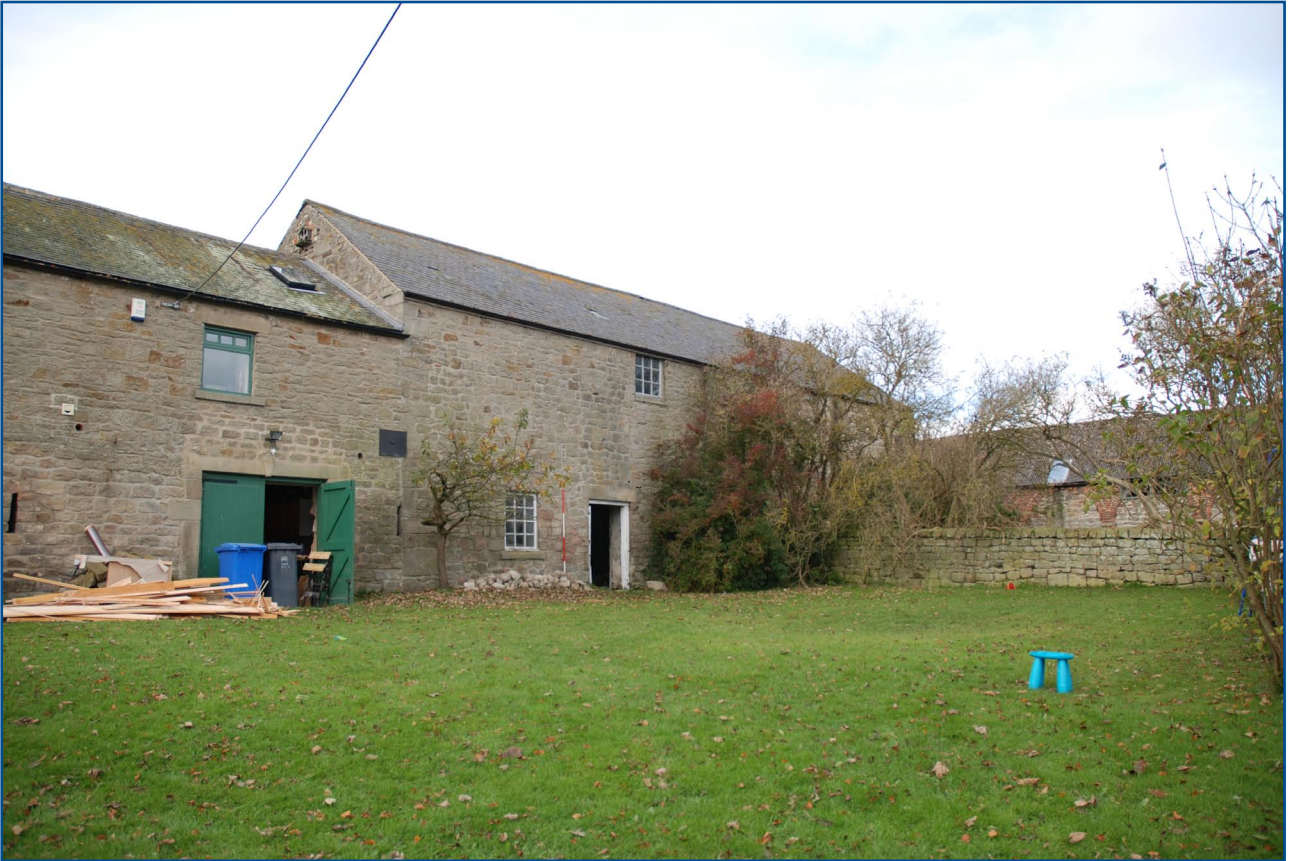
Plate 15: General view of barn from south-east

6.1.1 The barn stands to the north-west of Rudchester Manor and is located in the centre of a range of cottages and farm buildings that make up the western edge of the farmyard (**Plate 15 & 16**). To the north of the barn is a second two-storey barn which completes the range. This building is not included in the survey. To the south of the barn are further two-storey farm buildings which have been converted to cottages. These buildings are set lower than the barn and butt against it, suggesting they are of a later date.

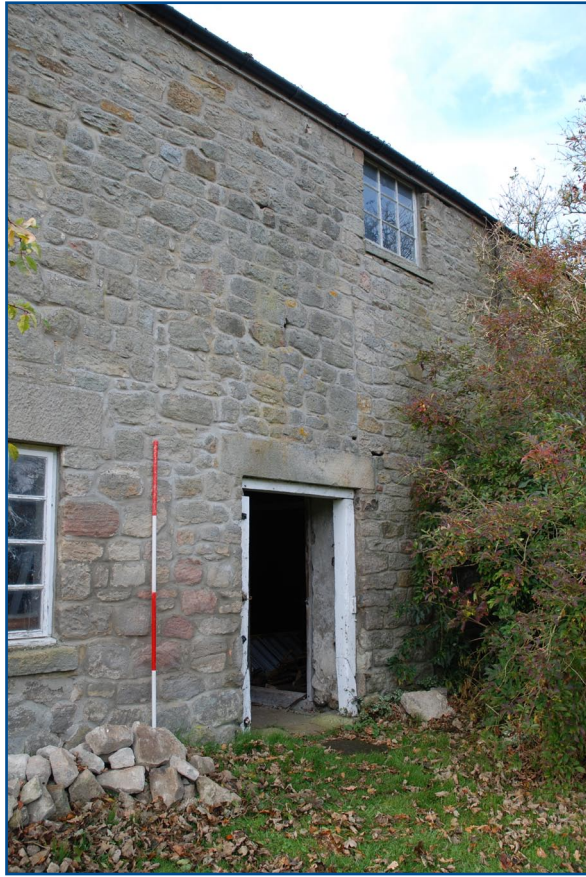
Plate 17: Detail of central door and edge of blocked door in east elevation of barn from east

The front east elevation faces onto the courtyard and towards the manor house. It is constructed of sandstone rubble with large stone quoins to its southern edge, separating it from the cottages in the south. The elevation has a central doorway at ground floor level with a dressed stone lintel and timber frame (**Plate 17**). To the north of the doorway is a clear phase break suggesting the barn was built in two distinct phases. Further to the north is the outline of a stone blocked doorway. To the south of the doorway is a fixed twelve-pane timber casement window with a projecting stone sill and stone lintel. At first floor level, above the doorway is a second nine-pane fixed timber casement window with projecting stone sill. The top of the window extends to the eaves of the roofline.

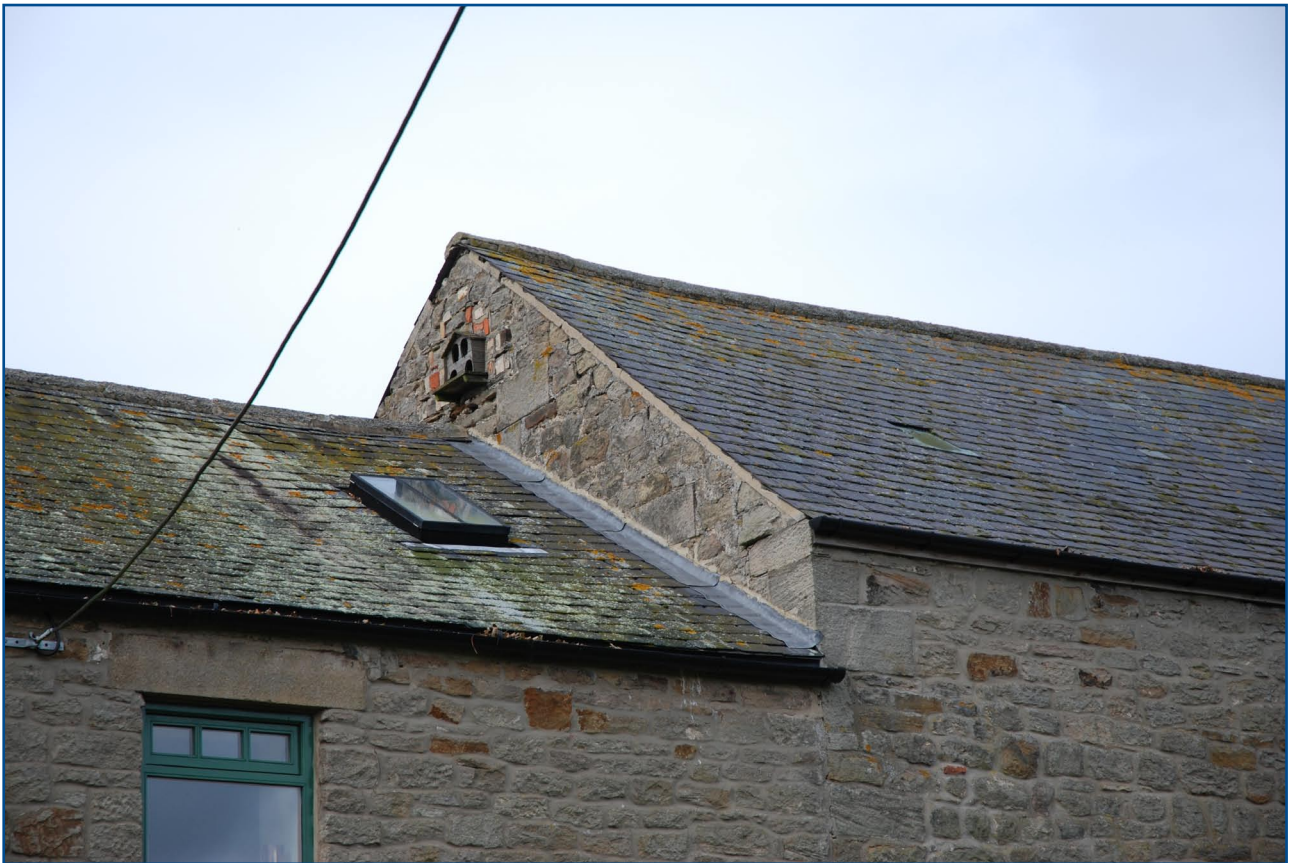
Plate 18: General view of south elevation of barn from south-east

Part of the south elevation is visible at the apex of the roof above the roofline of Stable Cottage which abuts the elevation (**Plate 18**). It is constructed of stone with some fragments of red brick. There are also some dressed stone blocks visible which relate to a former opening within the apex and the dressed stone lintel of one of the blocked first floor

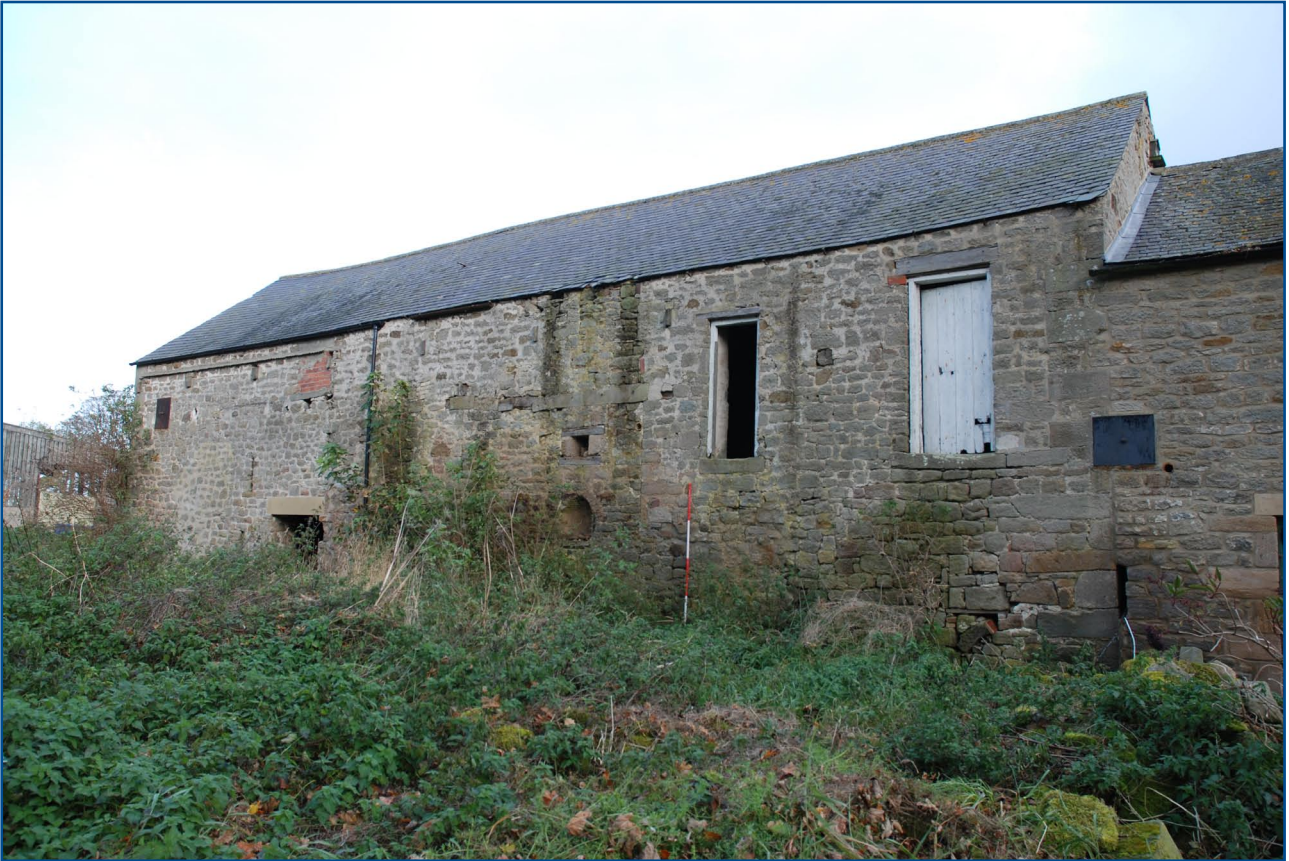
Plate 19: General view of west elevation of barn from south-west

The rear elevation of the barn is also constructed of sandstone rubble with stone quoins to its southern edge (**Plate 19**). There is a clear phase break in the centre of the barn with the south end of the barn belonging to a separate phase to the north end. At first floor level, there are two doorways with the southernmost being slightly smaller than its counterpart. Both doorways have timber frames and timber lintels. The southernmost door retains its timber plank door. Further to the north is a timber lintel belonging to the former cart entrance which has now been blocked with stone. Below the lintel is a square opening with timber lintel and timber sill and below the opening is a rounded recess.

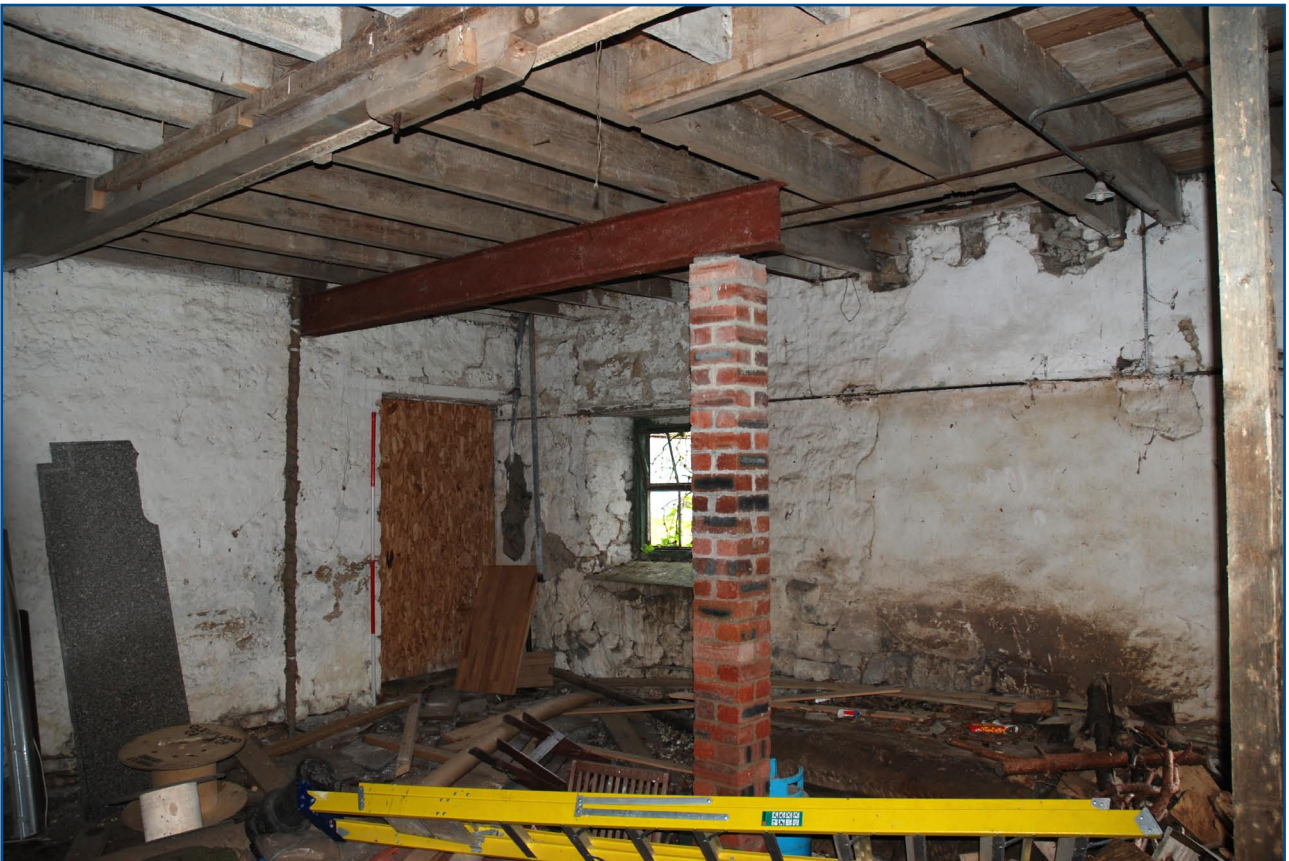
Plate 20: General view of ground floor of barn from south-west

The ground floor room of the barn has stone walls which are whitewashed with some plaster render, particularly to the south side of the room (**Plate 20**). The floor is divided east to west by a low step making the floor level in the north lower than that in the south. The floor to the south is concrete whilst to the north it is earth with some rubble and broken flags, presumably relating to the original threshing floor. The ceiling is timber but has been largely replaced, particularly in the south end of the barn and it is stepped as a result of the step at first floor level.

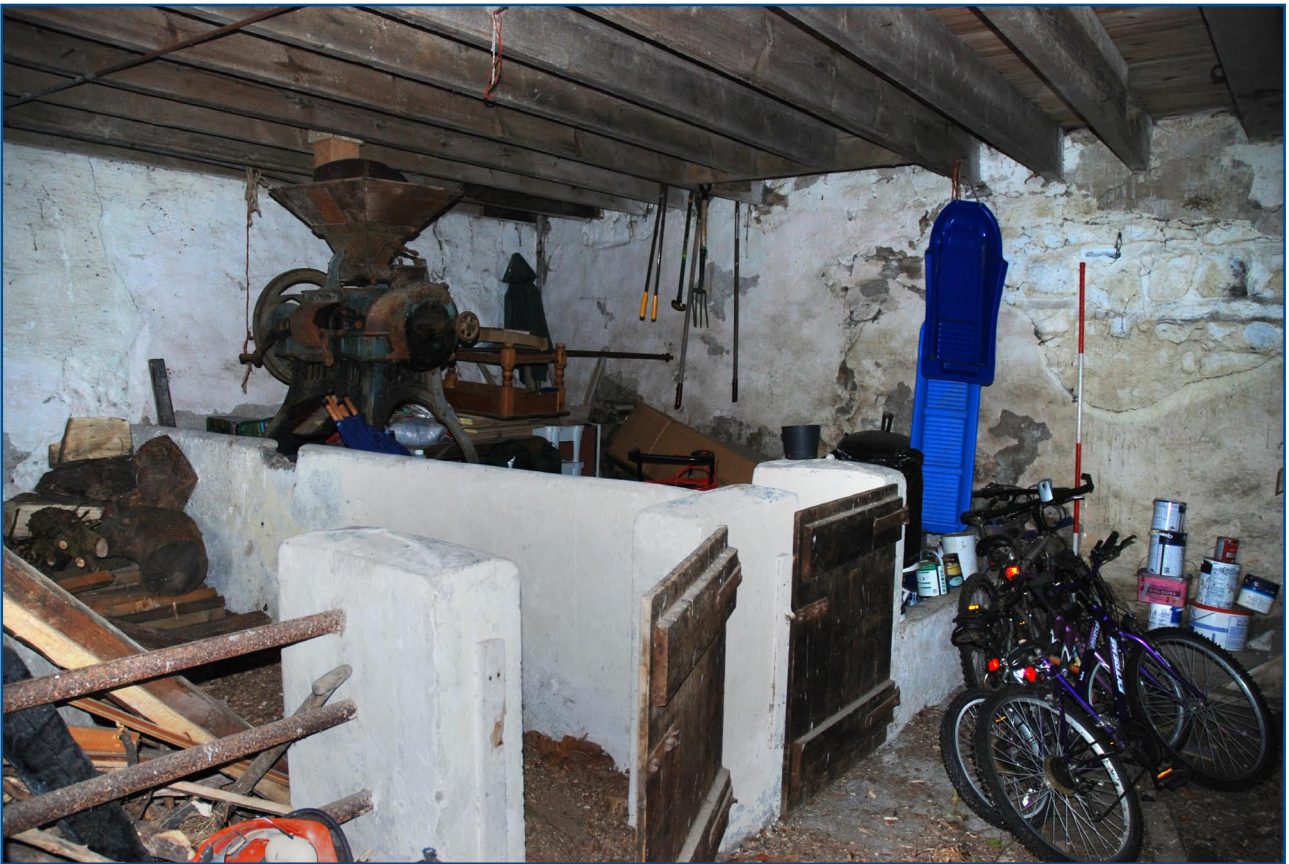
Plate 21: General view of ground floor of barn showing pens to south from north-east

To the south end of the barn are stone partitions which form two stalls with low timber plank battened doorways (**Plate 21**). In the western pen is a concrete block with a corn mixer upon it. The corn mixer was fed from the floor above via a timber hopper and a groove has

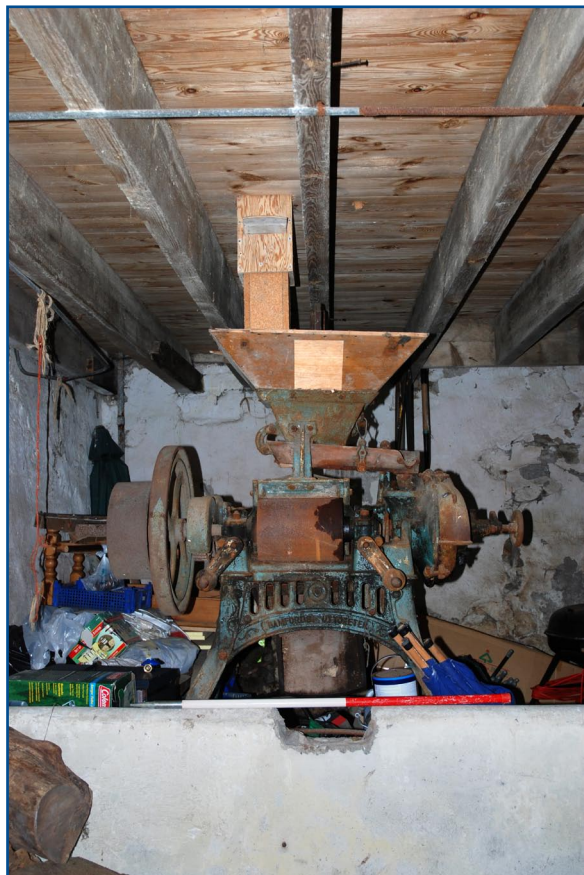
Plate 22: Detail of corn mixer to ground floor of barn from east

been cut in the partition between the stalls to allow the grain to collect in the eastern stall (**Plate 22**).

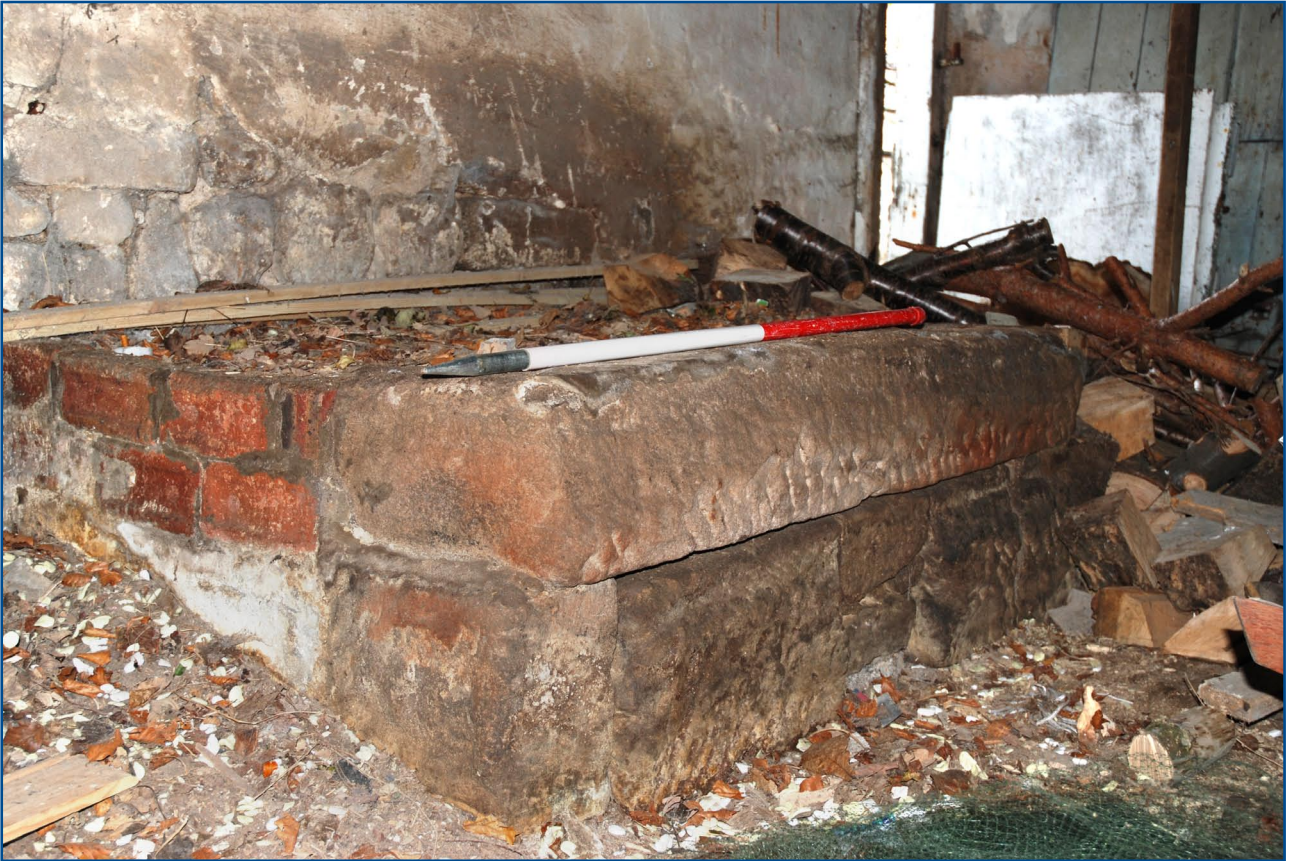
Plate 23: Detail of dressed stones to centre of east wall from north-west

To the north of the doorway, against the east wall, is a shelf for holding a former hopper. The circular shape of the hopper is shown in the cut in the ceiling above. The bench is constructed of large stone blocks and brick. The stone blocks contain tooling marks which suggest they are re-used, perhaps from the Roman remains found in the vicinity of the Manor (**Plate 23**).
