Rudchester Manor House and Barn, Rudchester Historic Building Report

Rudchester Manor House and Barn

Historic Building Report

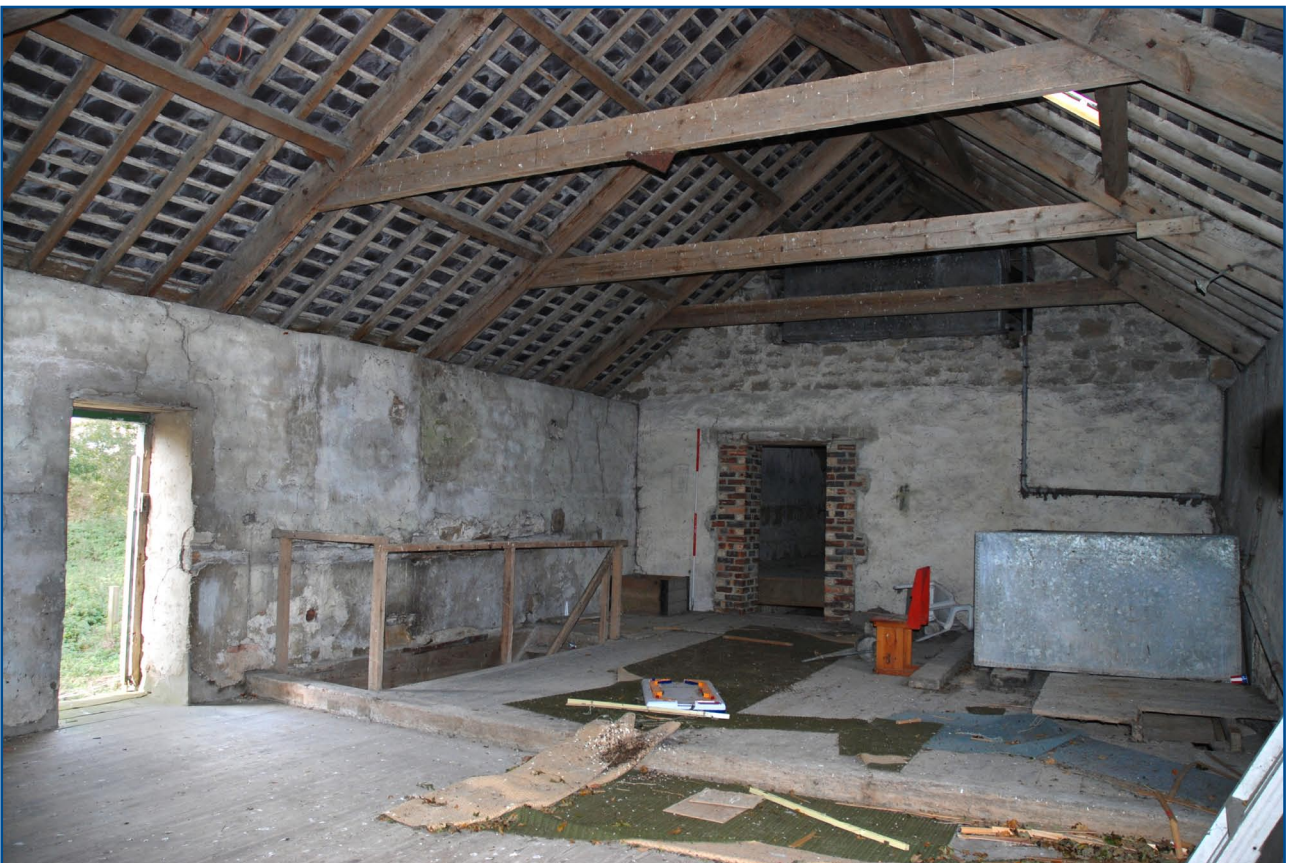
Plate 24: General view of first floor of barn from south-east

The first floor is reached via the timber staircase set against the west wall. As with the floor below, the room has whitewashed stone walls with the exception of the south wall which is red brick with render over (**Plate 24**). The room is open to the roof which is supported by timber A-frame trusses. The roof is slate with some small roof light windows to the east side.
