Former Ladywell Road Police Station, London Borough of Lewisham Historic Building Recording

AOC Project no: 30252

Date of Document: July 2009

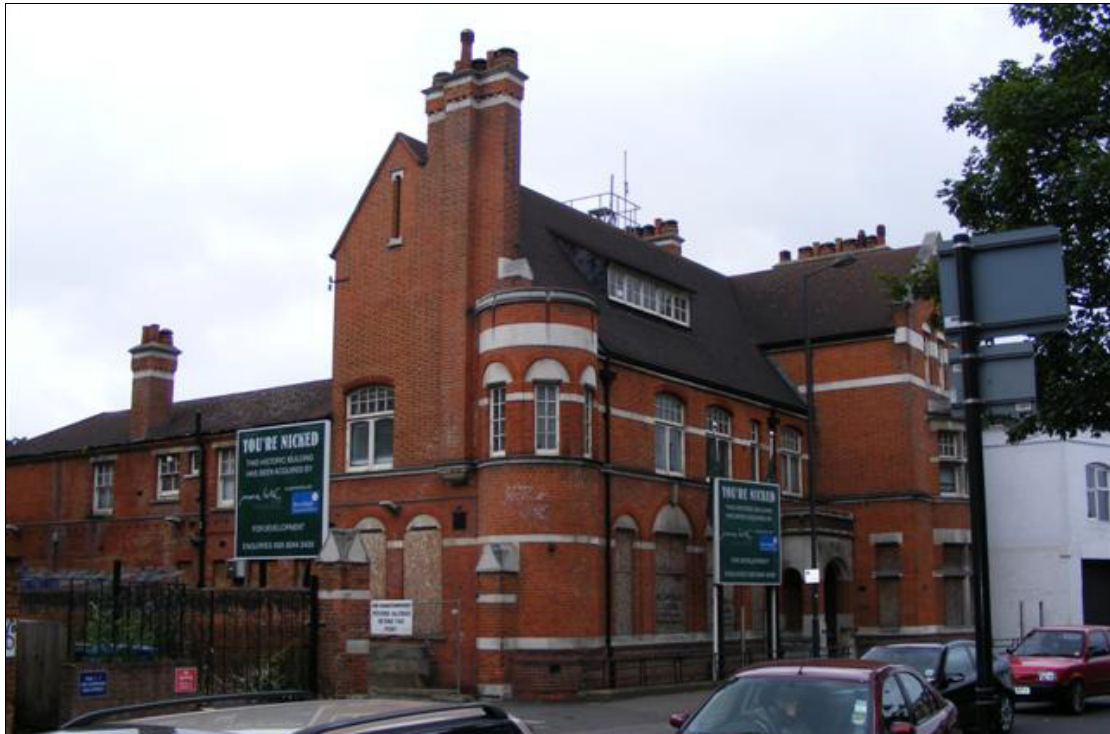
Plate 1: External view of Police Station looking southwest

- 3.1.1 Ladywell police station has a high frontage facing northeast onto Ladywell road. The building is mostly two-storey with an additional floor in the attic, which is lit at the front with as flat-roofed dormer. There is access to the rear of the property through a gated alleyway along the east side of the building, where a lower, two-storey range of room extends southwards. The external walls are of smooth red brick on a yellow stock core, with stone window dressings and a horizontal cornice at first-floor sill level. Stone bands also run horizontally, at mid-window level on the ground and first floors and a third at ground floor sill-level. The base of the walls project slightly, with curved mouldings.

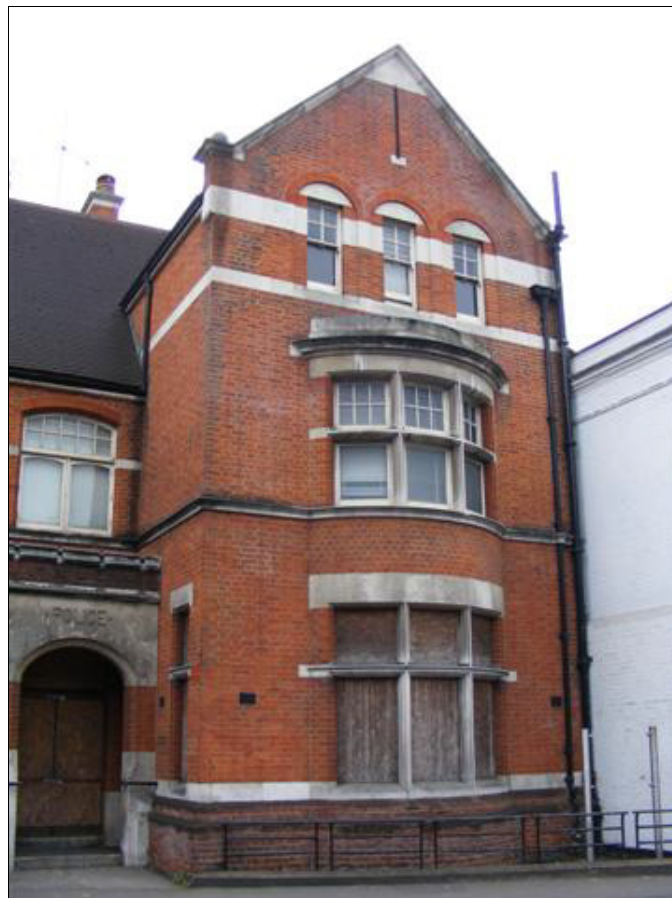
Plate 2: External view of western section and porch entrance looking south

- 3.1.3 Next to the bay, in the angle produced by the western section of the property is a small square entrance porch with a battlemented parapet and hollow-chamfered elliptical entrance arch. A second unglazed opening in the side of the porch has a similar arch, giving a Gothic look not apparent in the rest of the building.

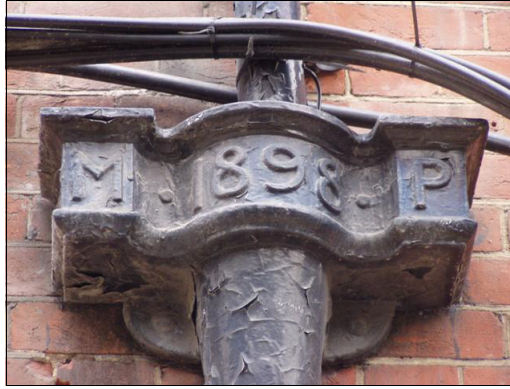
Plate 3: Detail of hopper, east side.

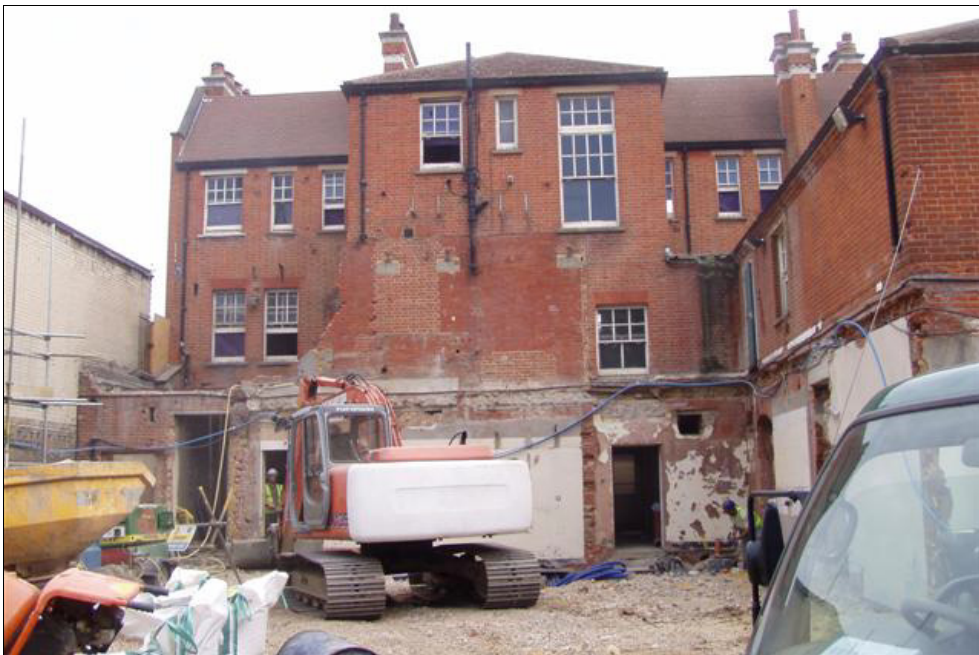
Plate 4: Rear view , 30-06-09, looking north

- 3.1.6 The rear of the building is visible across the open space from the churchyard, and is also faced with red brick, a quality not found on cheaper late 19th century properties, where only the roadside face uses the more expensive red bricks. Three storeys are apparent, the ridge of the roof not being central to the building, thus giving extra height. The ground floor rear wall has been much altered, and in some places absent. The first floor windows all have flat brick arches and the second floor, stone lintels. A very large window in the stairwell at the rear of the property is 3.16m tall.

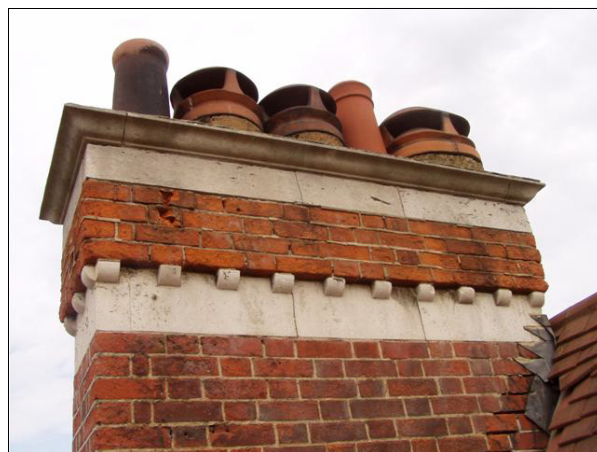
Plate 5: western chimney stack, detail.

- 3.1.8 The roof of the entire building is tiled, and four chimneystacks rise from the main building, each stone-corbelled brick stacks that rise significantly above roof level. A fifth chimney serves the southern range.

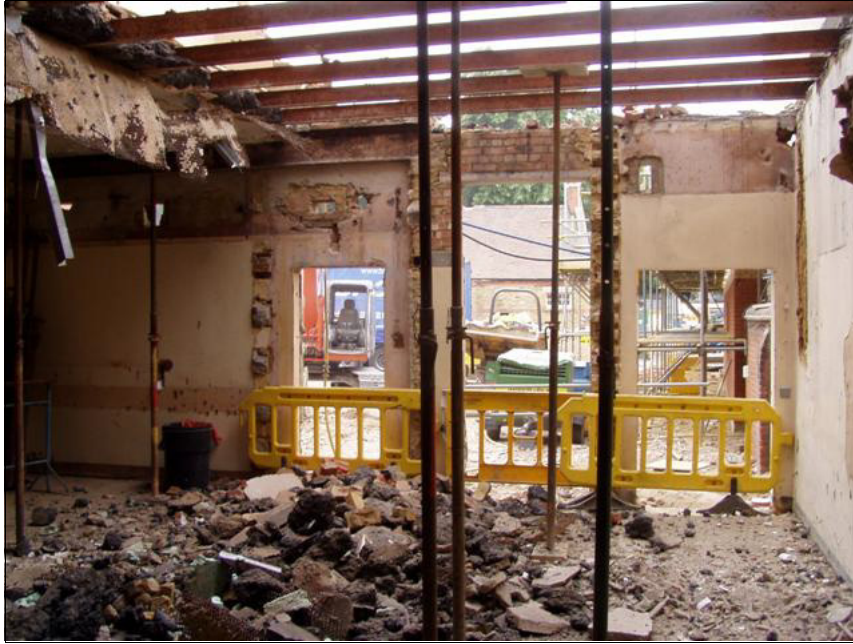
Plate 6: Ground floor Room G1 looking south

- 3.2.4 In the western part of the building is a second large room (**Room G1**). This spans the width of the building, from a rounded bay at the front to three vertical beams which support an extension to the first floor above at the rear. A double width of Iron girders supports the original first floor wall above. It is thought that much of the rear wall was removed to provide access to the range of buildings added in the rear of the site after the Second World War. A partition to the room 7.5m from the front was once present: a scar on the west wall and concrete floor was visible. The only original fittings in the room were the windows of the rounded bay, each consisting of a square pane above and two horizontal rectangular panes below. Most of the glass was frosted: possibly the original glass is the frosted glass, to give privacy to the occupants of the room from the nearby street front.

- 3.2.5 A blocked fireplace in the western end of this room leads to the chimneystack that rises at the western end of the building. There is a lack of associated features, neither hearth, mantel nor other fireplace furniture survived: this is probably more the result of conversion to alternative forms of heating rather than a recent loss. There is, however a decorative grill in the top of the stack.

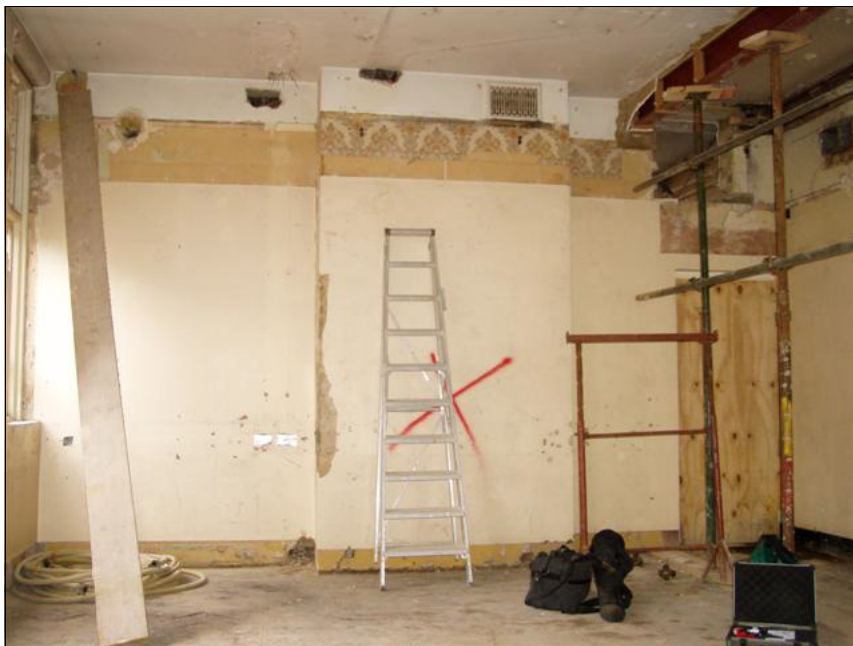
Plate 7: Ground Floor room G2 looking east

- 3.2.1 The ground floor has several entrances. The main public entrance lies beyond the battlemented porch, and currently has a roller door. This leads into a large room (**Room G2**), which provides access to the east to a room at the base of the tower (**Room G3**), rearwards towards the southern range (**Rooms G4, G6 and G7**) and the stairwell (**Room G5**), and westwards to another large room (**Room G1**). The ground floor rooms are all 3.40m high. No doors or moulding survived in this room at the time of recording, and access to the tower room unavailable. The windows in the front wall are all of a type, units of a rectangular frame with two fixed windows in the lower section, the upper with an arched top, and a four-part casement in the top. This basic shape forms two single unit windows and two double unit windows. This gives adequate light to the room. The central units had frosted glass. The internal reveals are rounded, in common with most original reveals in the building.

- 3.2.2 The room had been partitioned later in its existence, and steel Iron girders inserted to support the walls of the floor above. This suggests that there may have been internal partitions of a first phase of which no evidence remains except for their absence.

- 3.2.3 A chimneybreast rises in the eastern end of the room, of which there is no evidence for in the room above. Possibly, there may be a flue hidden in brickwork in Room G3, or between the floor and ceiling.

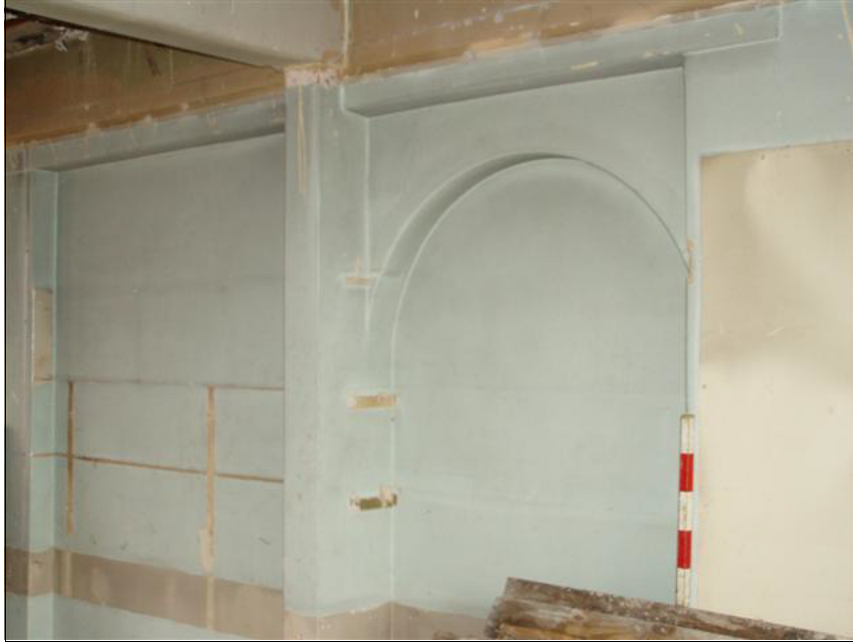
Plate 9: Room F1 arch between chimneybreasts, First Floor Room looking southwest

- 3.4.1 The largest room on the floor is in the western end of the building, and has a bay with three windows (**Room F1**). Each has a square pane at the bottom, a wide transom and a six-light casement window above. The frame has simple cylinder and block moulding. The windows in the rear wall are sash windows, the lower sash four lights, the upper sash six. The sashes weights are attached by chains rather than rope. The sashes also contain their original fittings of bowed handles on the upper sash and curved pieces on the lower. There are two blocked fireplaces in the west side of the room, which join above to a single stack. Between the fireplaces is a pair of alcoves with arched tops. These are strengthened by an Iron girder above, which is visible behind a plastered and painted surface. A partition in the centre of the room survives as a scar on the floorboards and the west wall. This terminates in the east at a doorway to Room F2, suggesting that at one time the doorway had been blocked, and this room must have had a door in the partition.

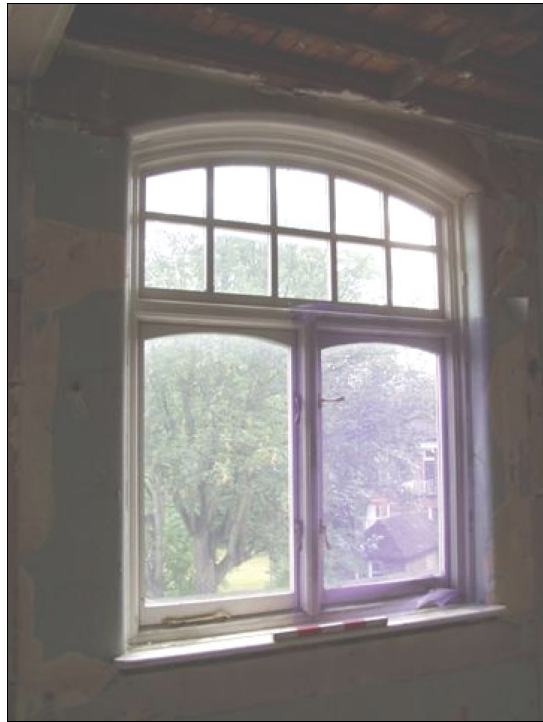
Plate 11: Front window, Room F3

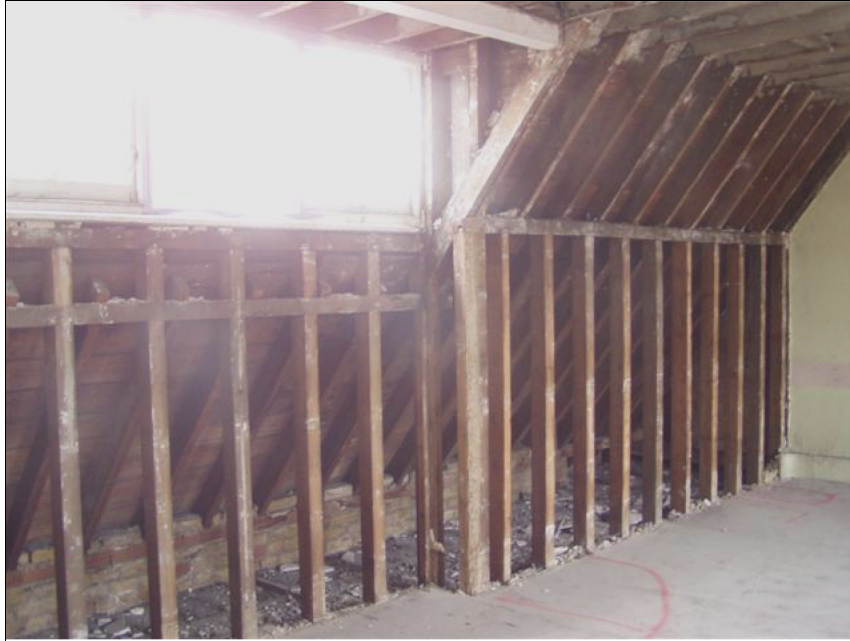
Plate 12: Second floor Room S3 looking northeast

- 3.4.2 The second main room on the second floor takes up the eastern end of the building (**Room S3**). The form of the room is governed by an off-centre east-west ridge: the principal rafters rise almost from floor level at the front of the building, but rise from wall plates at ceiling height at the rear. The room is then lit by a long flat-topped dormer at the front and regular sash windows at the rear. The dormer is set 1.05m south from the main wall, making a narrower room than that below. The dormer has five simple square casement windows in a row: each has four lights. The rear windows are four sash windows, each with a clear pane in the lower sash and four lights in the upper.

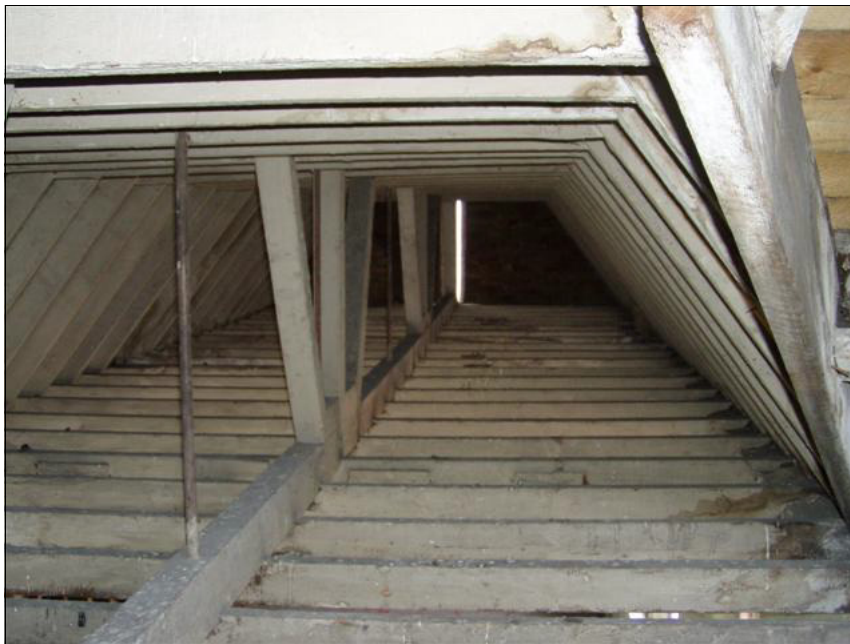
Plate 13: Roof assembly above room S3 looking east

- 3.4.4 The roofs of the main building are all of a basic construction, with no complex trusses or fixings. The main east-west roof of the building has two king post assemblies with struts: these support the ridge; the rest of the roof is a coupled rafter roof, pairs of rafters connected by a collar beam. The western gable projecting northwards is also a coupled rafter roof. The entire roof has 0.12m wide boards across the rafters, laid prior to the tiles.

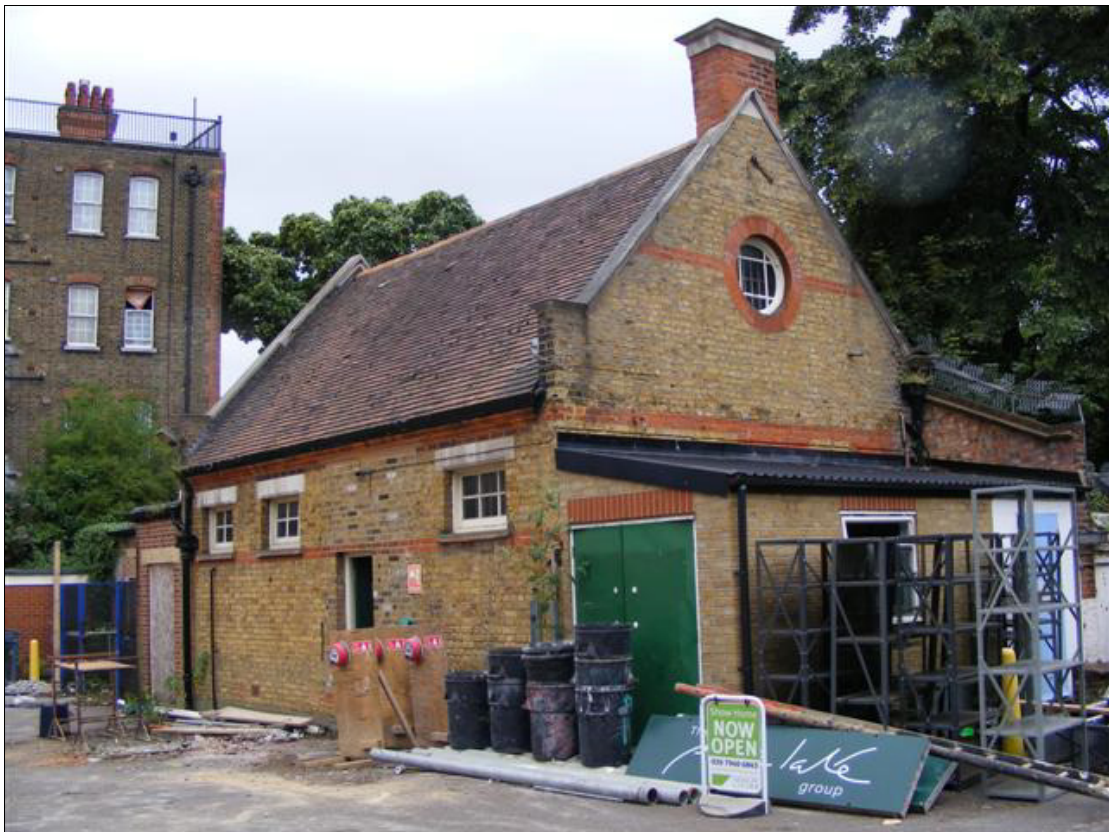
Plate 16: Rear building: cells?

- 3.6.1 To the rear of the police station land is a small yellow brick building oriented east-west with a decorative stringcourse of red brick and three small windows with stone lintels. There is a central doorway in the north face. This doorway is an addition to the original form, and may have replaced a fourth window, since there is an area of rebuild directly above the door. The roof is pitched, with a door in the east end and a circular window in the other. A short chimney rises in the west end of the building. The ground floor at the west end is obscured by a lean-to brick addition that has internal finishes that obscure the outer face of the brickwork, hiding evidence for blocked openings.

- 3.6.2 There is no evidence that the windows are the remnants of larger, stable doors. The internal reveals are rounded, and grills have been mounted against the windows. It seems likely that these small,

high-level windows with the grills barring access are the windows of cells. Internally, there are currently three rooms. The central area (**Room A2**) is an access corridor to Room A1 to the east. The corridor is an irregular shape. The internal walls are narrow, just 0.10m wide; this may be an indication that these walls represent a reorganisation of internal space.

- 4.5 The building at the rear was assumed, on initial assessment, to be a stable block for Police horses. However, upon inspection of its form and materials, it seems likely that it could have been used as temporary holding cells. The windows are small, and each of the small windows has a grill firmly secured. The small block could have been internally different to its current form: the corridor running towards the back of the building (A2) runs from a new opening. It is possible that this is in the location of a fourth window, giving four cells side by side. If the blocked doorway in Room A3 was the entrance, then a corridor could have run along the back of the building, accessing each cell.

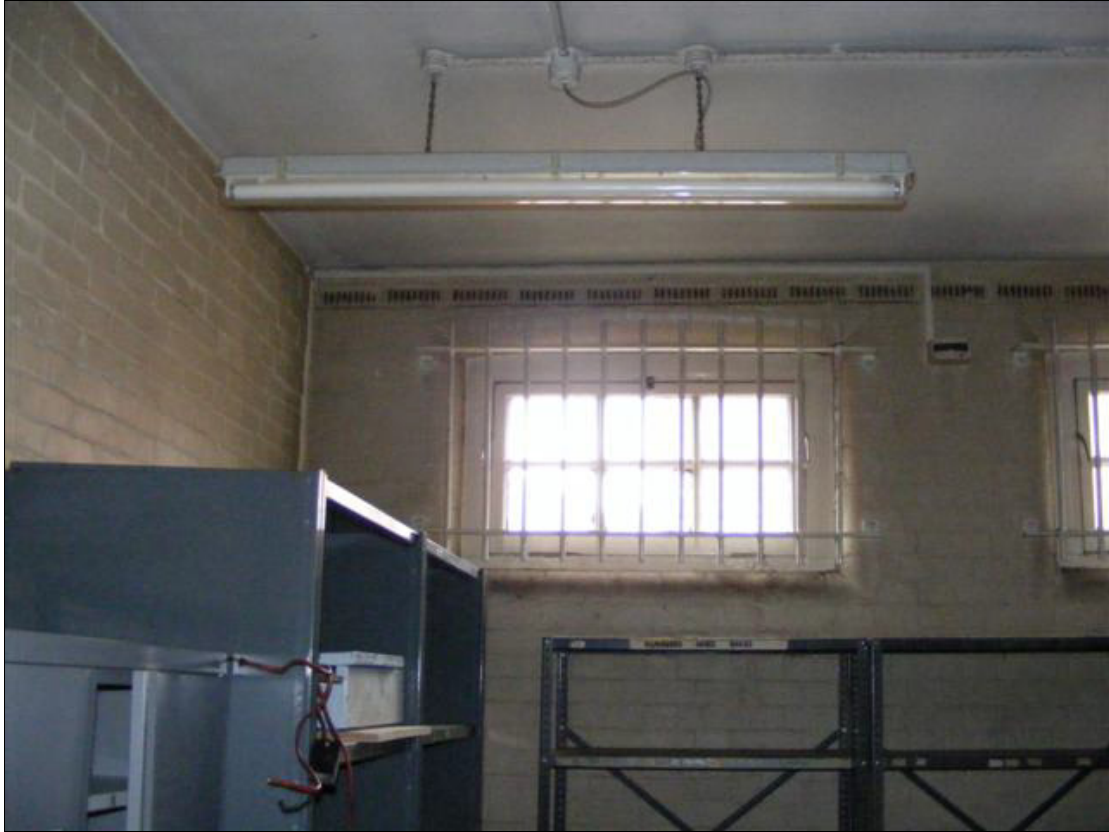
Plate 17: Room A1, including window grill

- 3.6.3 The room to the east (**Room A1**) has two of the barred windows. A central east-west steel beam supports the ceiling. No other features are present. The paint of the walls hides evidence for prior fixtures and fittings.

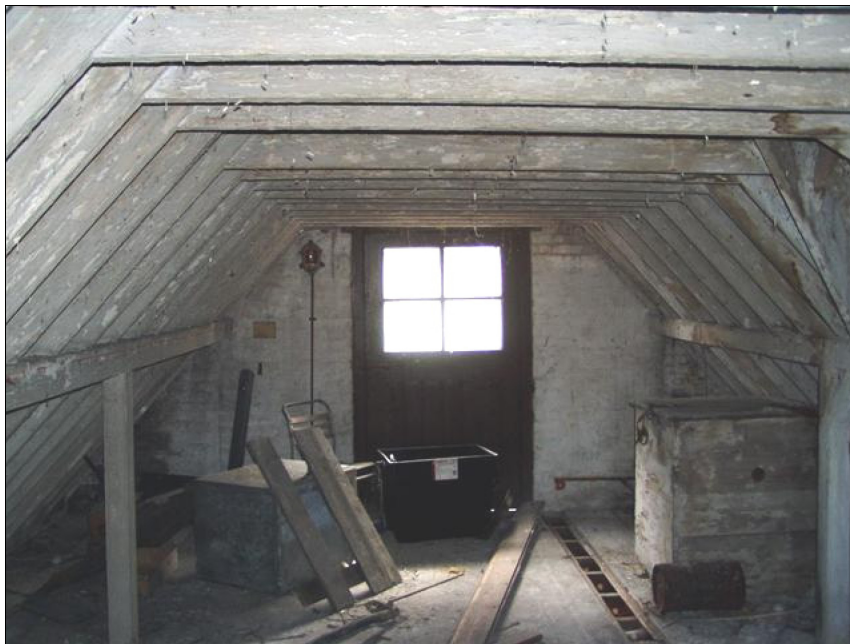
Plate 18: Loft of rear building, looking east

- 3.6.5 There is access to the loft from room A1. The access is via a vertical wooden ladder, which would have been in the corridor access to the small rooms. The trap in the ceiling opens to a single loft space with a door at the east end and a window at the west. Flues of a chimney rise into this room: there is no evidence for a fireplace on the ground floor, but equally no room for one in the loft. This may indicate that there had been some kind of office room or reception on the ground floor. The loft contains a lead tank and a wooden box with a small chute. It is tempting to ascribe the function of a hayloft to this room, but there is no proof that the ground floor was stables.

- 3.6.6 The roof of the building has a gable at each end and a third gable running south against the churchyard wall. Given the height of the churchyard wall, it is unlikely that the gable had any function other than giving headroom for entering the loft.
