Millhill Steading, Arbirlot

Historic Building Recording

Millhill Steading, Arbirlot, Angus Historic Building Recording Report

AOC Project No: 21150

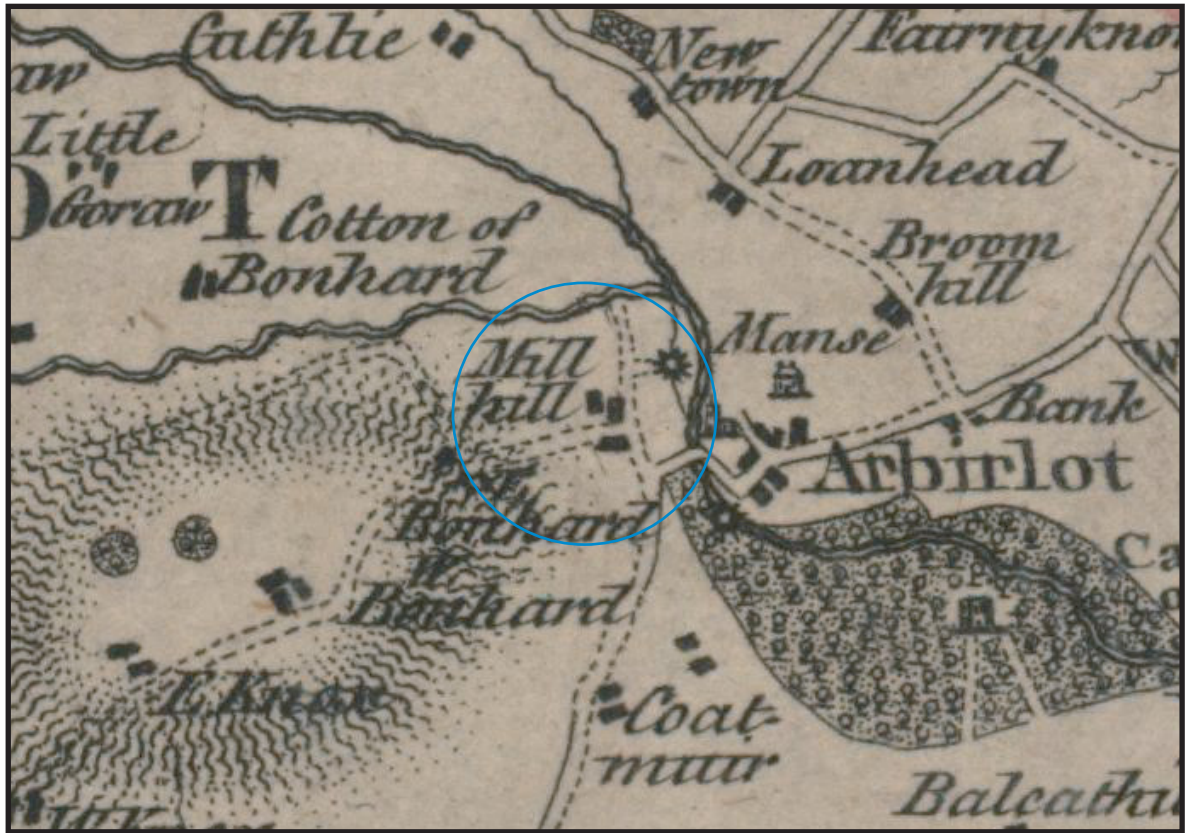
Figure 3: Extract from Ainslie's map, 1794

- 5.1 A settlement at Millhill has been recorded as far back as the late 18th century. John Ainslie's map of 1794 identifies a settlement called Millhill, probably so named as it was located on a rise of ground to the west of an established water mill (**Figure 3**). Buildings can be identified although the map is too schematic to identify the layout of the steading buildings at this time.

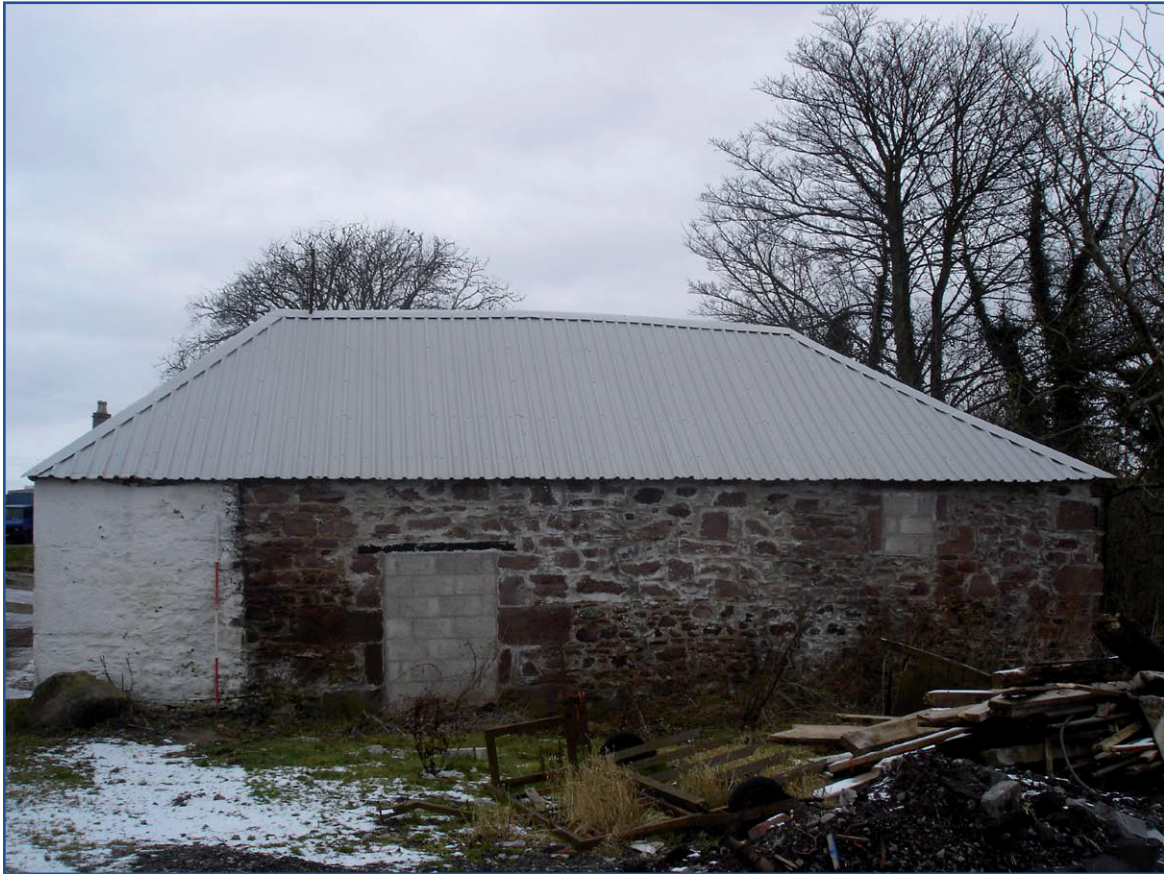
4.2.1 Located to the south of the steading range, this former cow barn is a two-by-one bay, two-storey barn constructed of stone rubble with a hipped modern corrugated steel roof. The south elevation consists of a two-bay elevation with a breeze-blocked door to the west and a smaller first floor window to the east. Both have a pronounced chisel-dressed surround (**Plate 1**). The west elevation is a plain gable with a large structural crack along the northern side (**Plate 2**). To the north elevation is access to the main cow stalls, through a plain timber plank stable door (**Plates 3 & 4**). To the east of this (west-facing) is a tall timber doorway leading to the first floor timber stair (**Plate 5**). To the rear (east) elevation of this barn, there appears to be a clear distinction between Buildings A and B, with a possible phase line denoted by the appearance of larger quoin stones between the buildings (**Plate 6**). There is also a small timber framed window with large pronounced chisel-dressed surround at ground floor level (**Plate 7**).

Plate 1: Building A, general view of south elevation

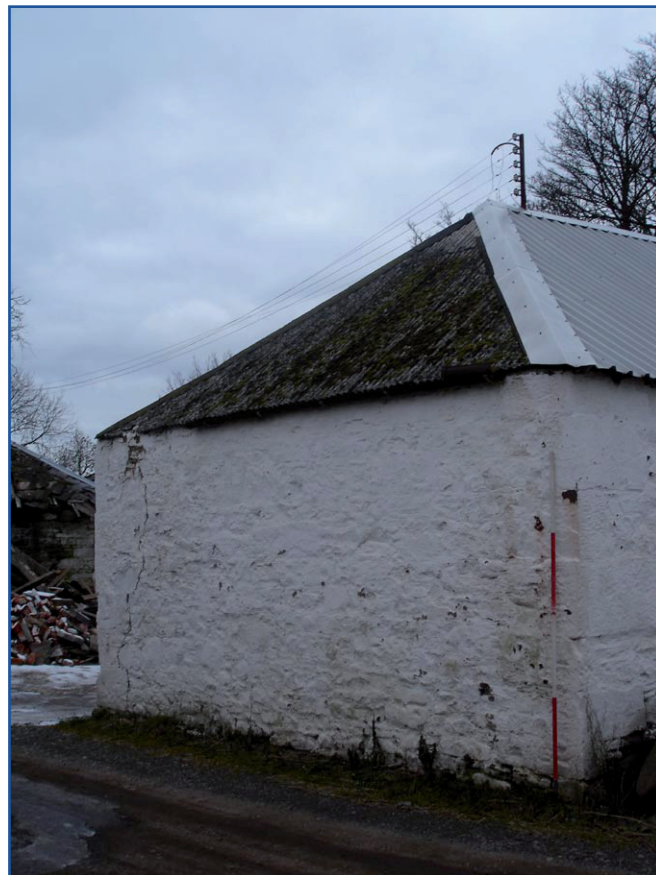
Plate 2: Building A, general view of west elevation

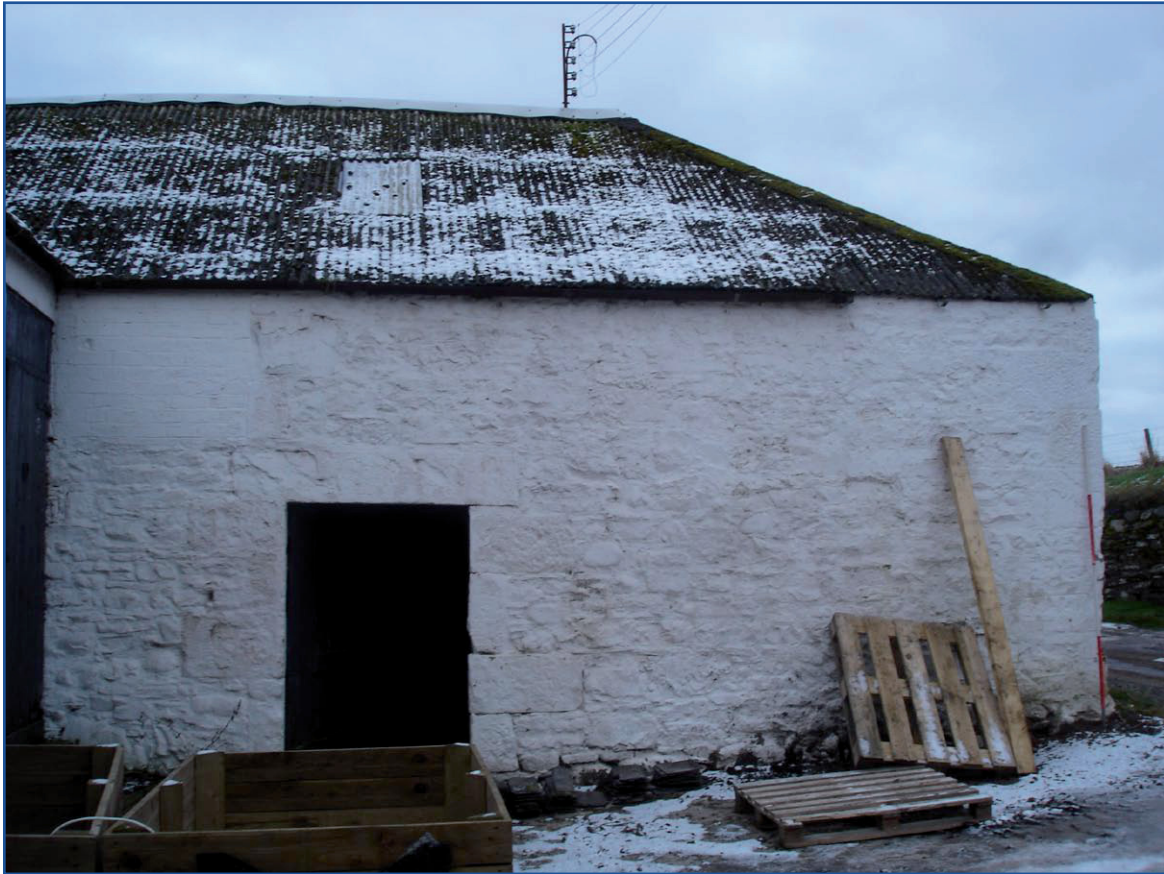
Plate 3: Building A, general view of north elevation

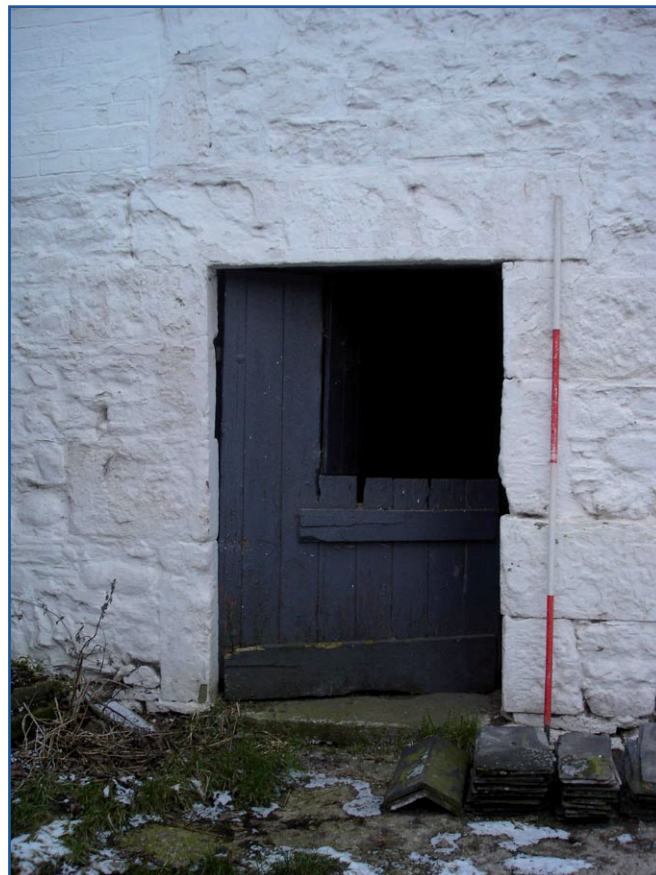
Plate 4: Building A, detail of door in north elevation

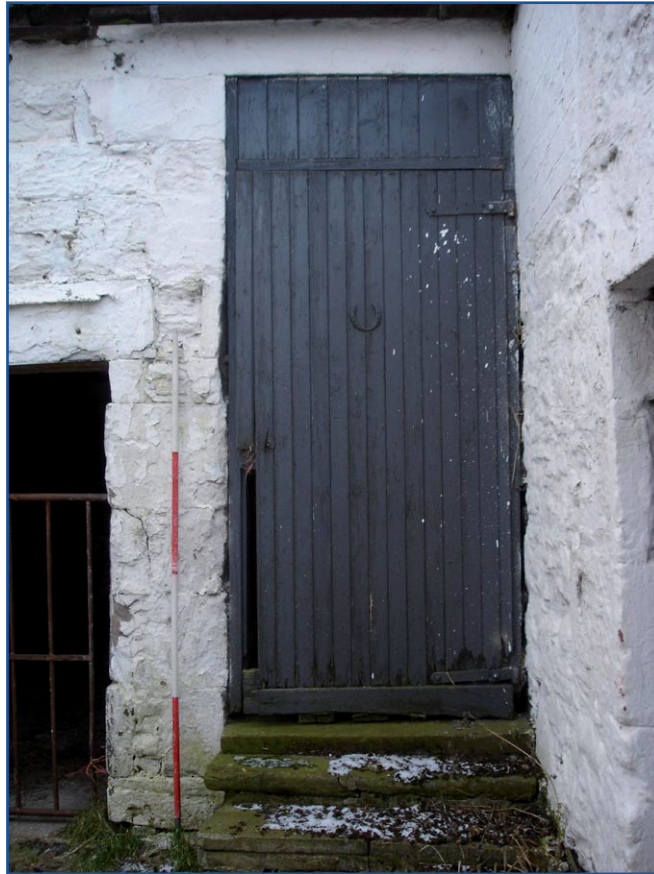
Plate 5: Building A, detail of west-facing door to first floor

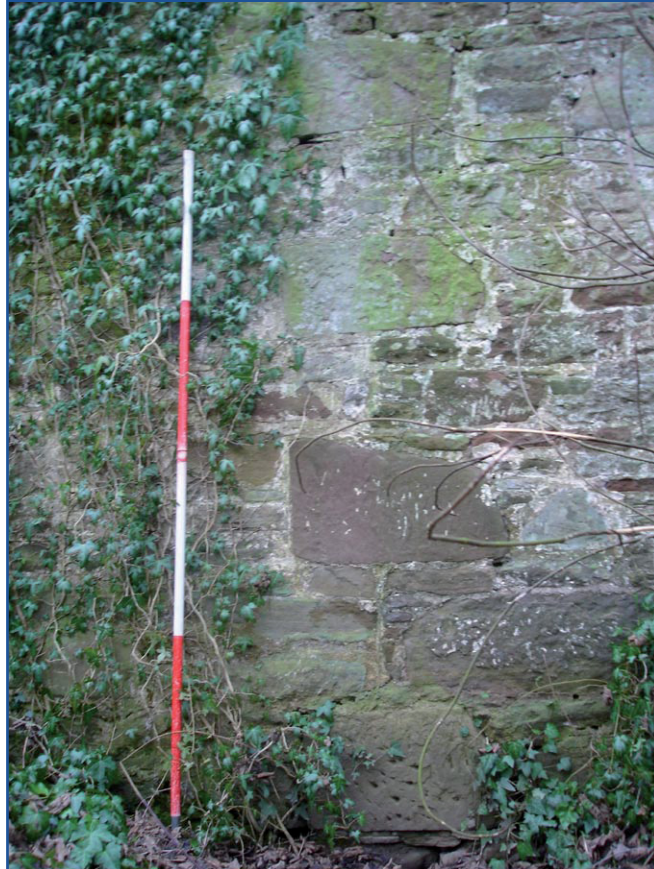
Plate 6: Buildings A & B, detail of phase line in east elevation

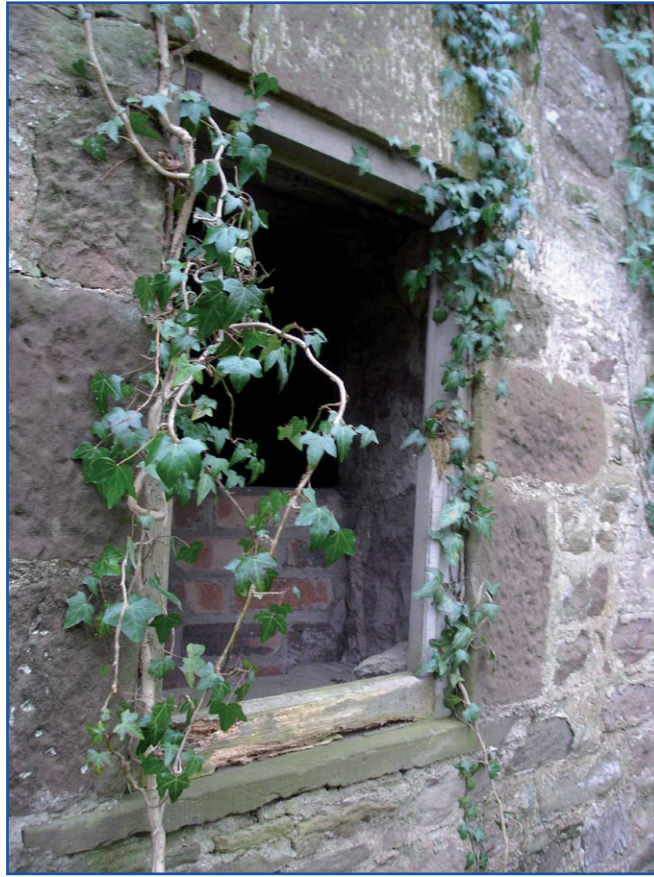
Plate 7: Building A, detail of window in east elevation

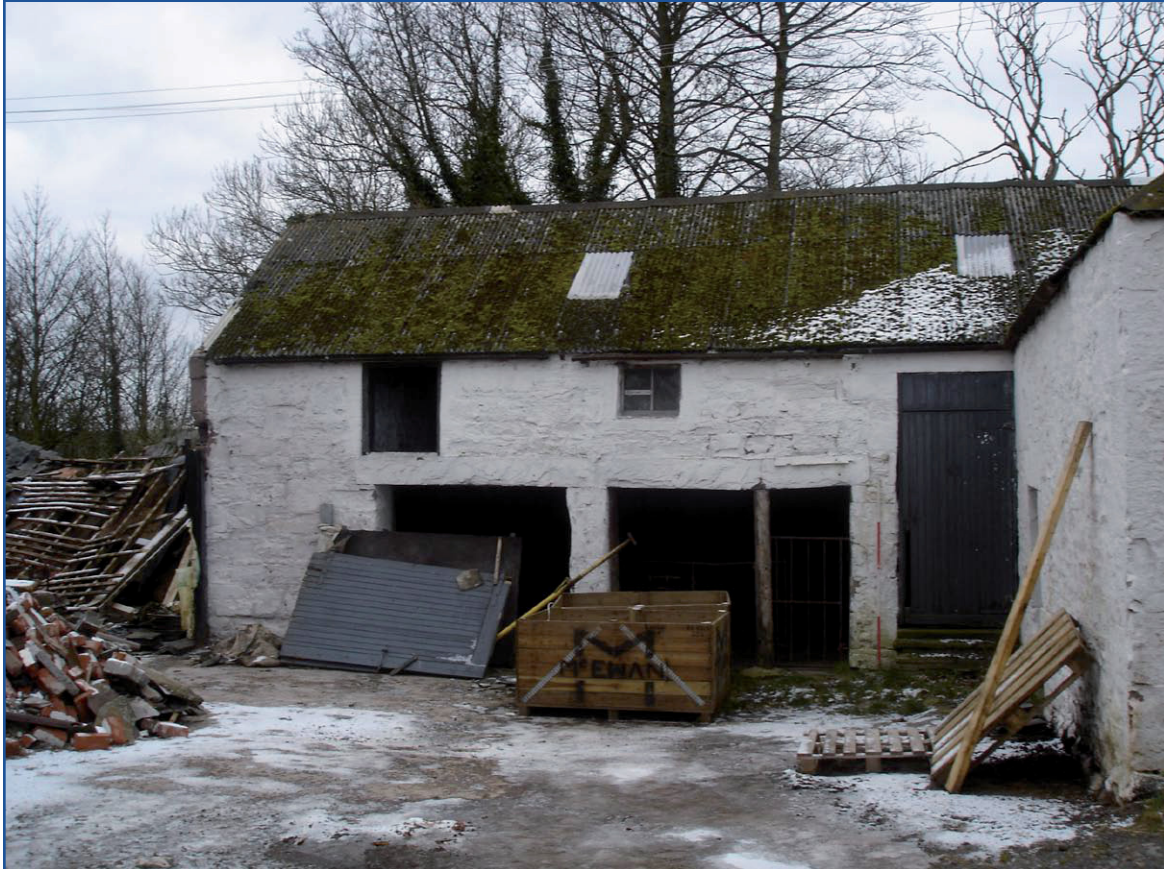
4.3.1 This building is abutted to the south by Building A and consists largely of a two bay barn, open to the front (west) (**Plate 8**). A large stone lintel is supported by a central timber column, another column being added to the southern side to support the area beneath another crack that has appeared. The stone lintel (and roof for the first floor) is further supported by a thin reinforced steel beam to the interior. To the first floor, are two windows? One is probably an insertion suggested by the brick blocking to the north. The second is a smaller window to the south. Originally obscured by Building C, the north elevation is a plain gable (**Plates 9 & 10**); although the appearance of some former roof lines indicates that the wall has undergone several phases of construction.. There is a much smaller stone rubble building of a smaller barn seen clearly in this wall, with a pitched roof. The larger more red sandstone build of Building B is then seen above this and the roof line of Building C (now demolished) can be identified towards the top of the gable. The wall itself is in a bad state of repair and bulges slightly to the centre. There is also a hole in the stonework which has been temporarily filled with stone and brick. Internally, the area is a former stables divided by a simple timber partition (**Plate 11**) with another timber column adding support to the north/south ceiling beams.

Plate 8: Building B, general view of west elevation

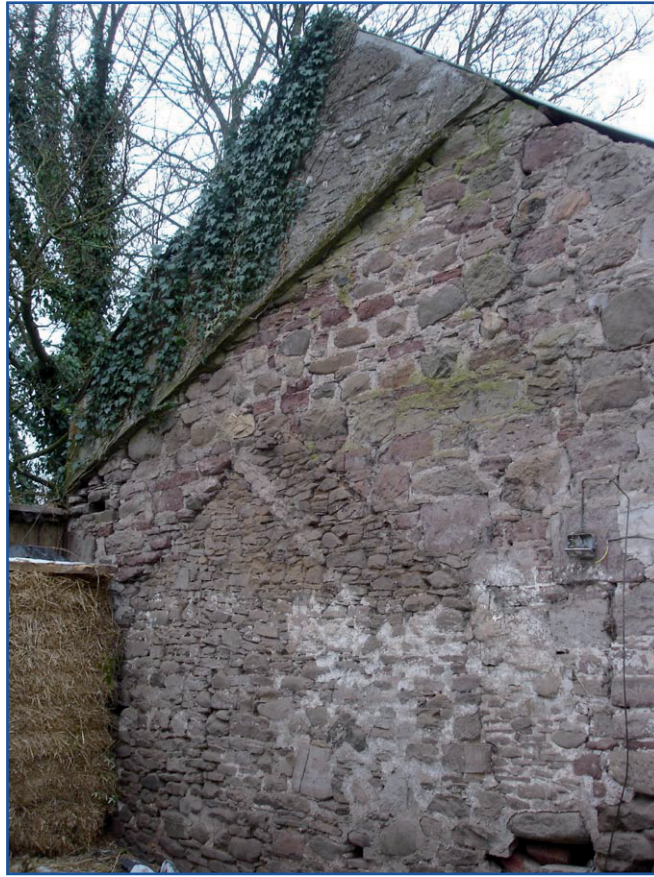
Plate 9: Building B, general view of north gable

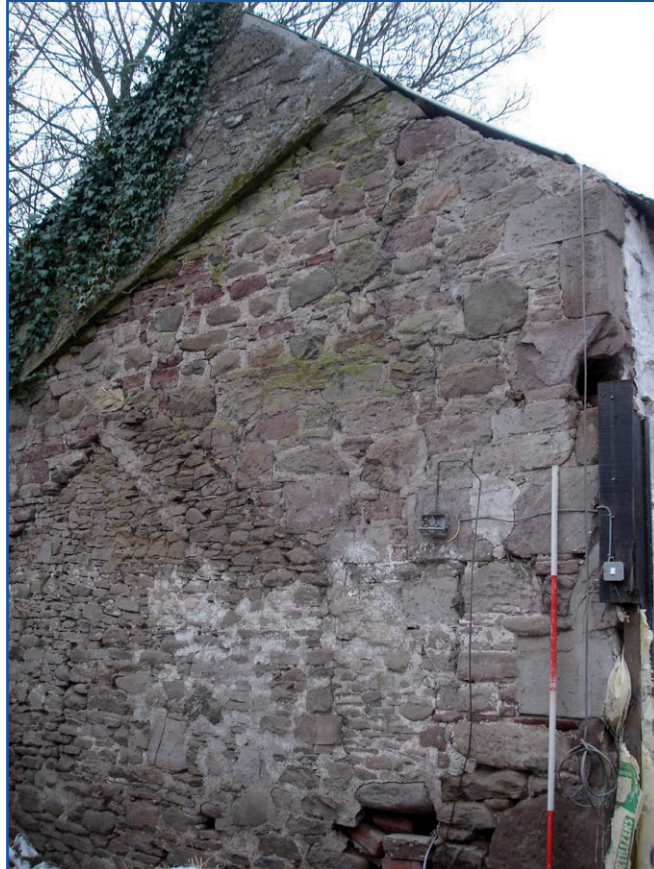
Plate 10: Building B, general view of north gable

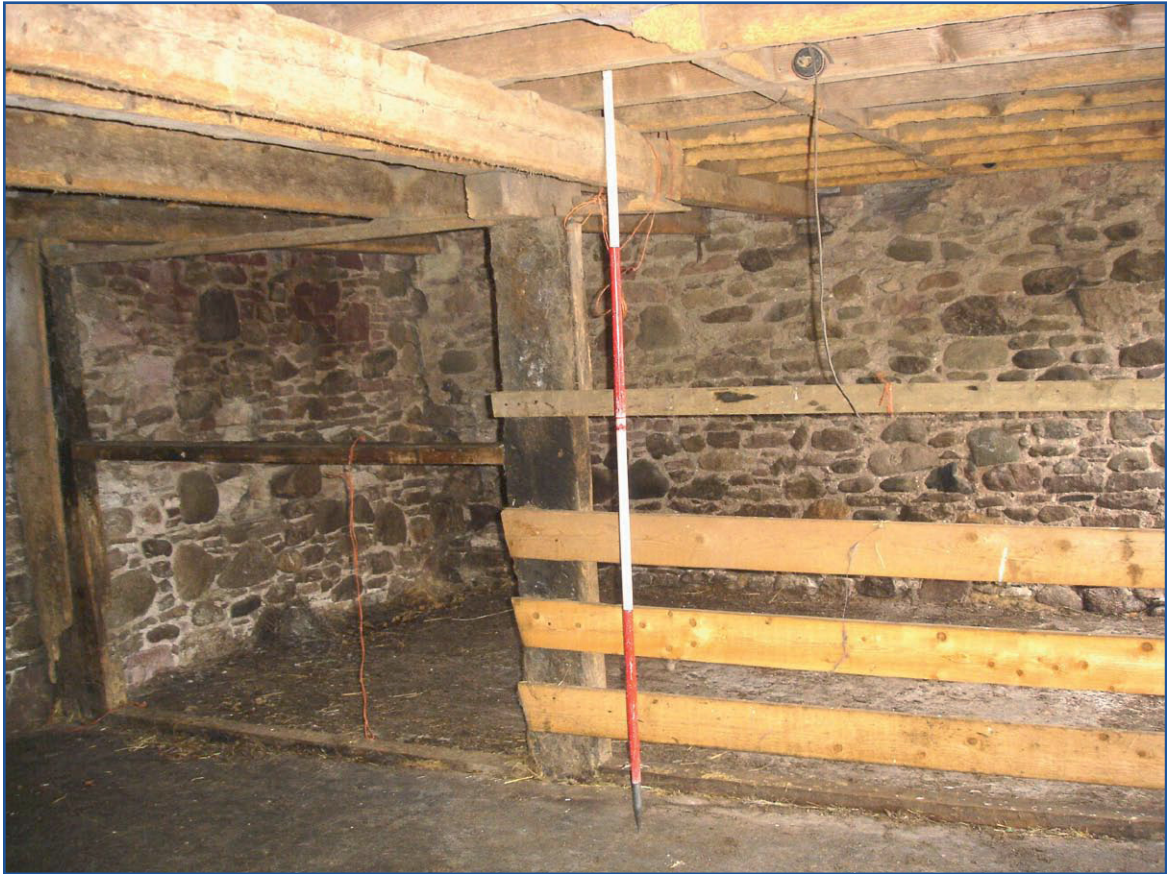
Plate 11: Building B, general view of interior from north-west

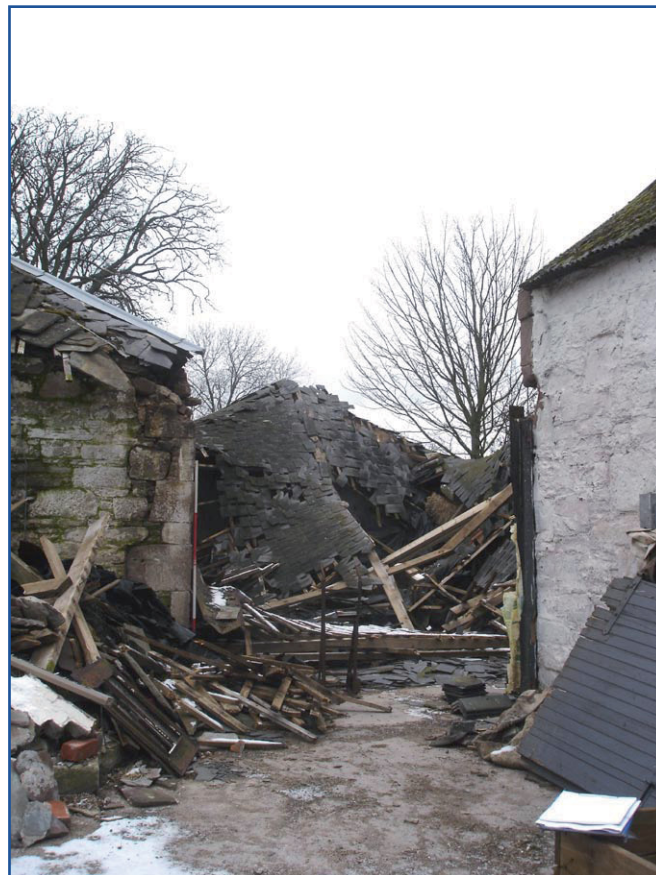
4.4.1 Building C had collapsed prior to the survey being undertaken and, as a result, little could be identified of the nature and extent of this barn. It is clear, however, that the building had a slate roof (**Plate 12**).

Plate 12: Building C, general view of collapsed building from the south-west

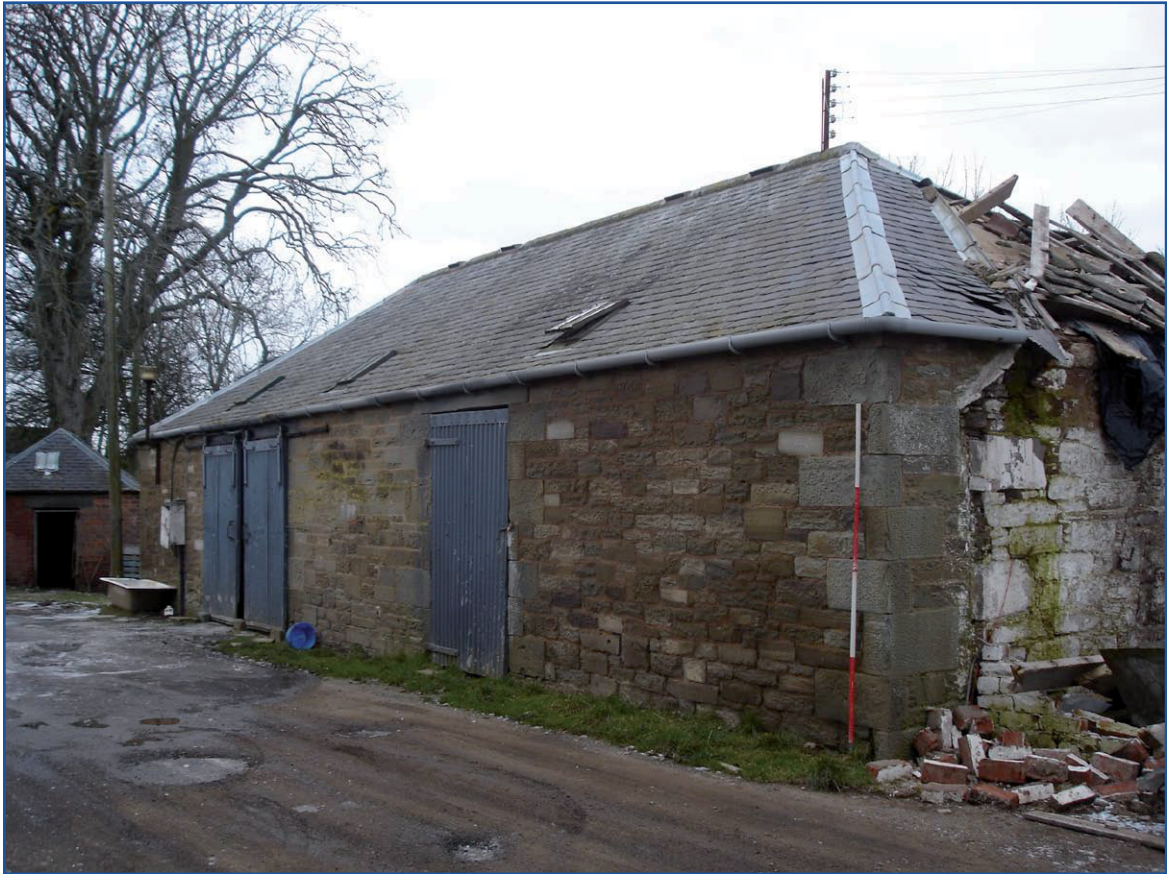
4.5.1 This barn is the most well preserved building in the steading range and is still currently being used as a stables and store. The main entry is through either door in the west elevation which is a coursed stone rubble construction with weathered, chisel-dressed quoins. There are two entrances – to the south, a corrugated-iron doorway and to the north a larger double sliding corrugated-iron door (**Plate 13**). The rear east elevation has been

Plate 13: Building D, general view of west elevation

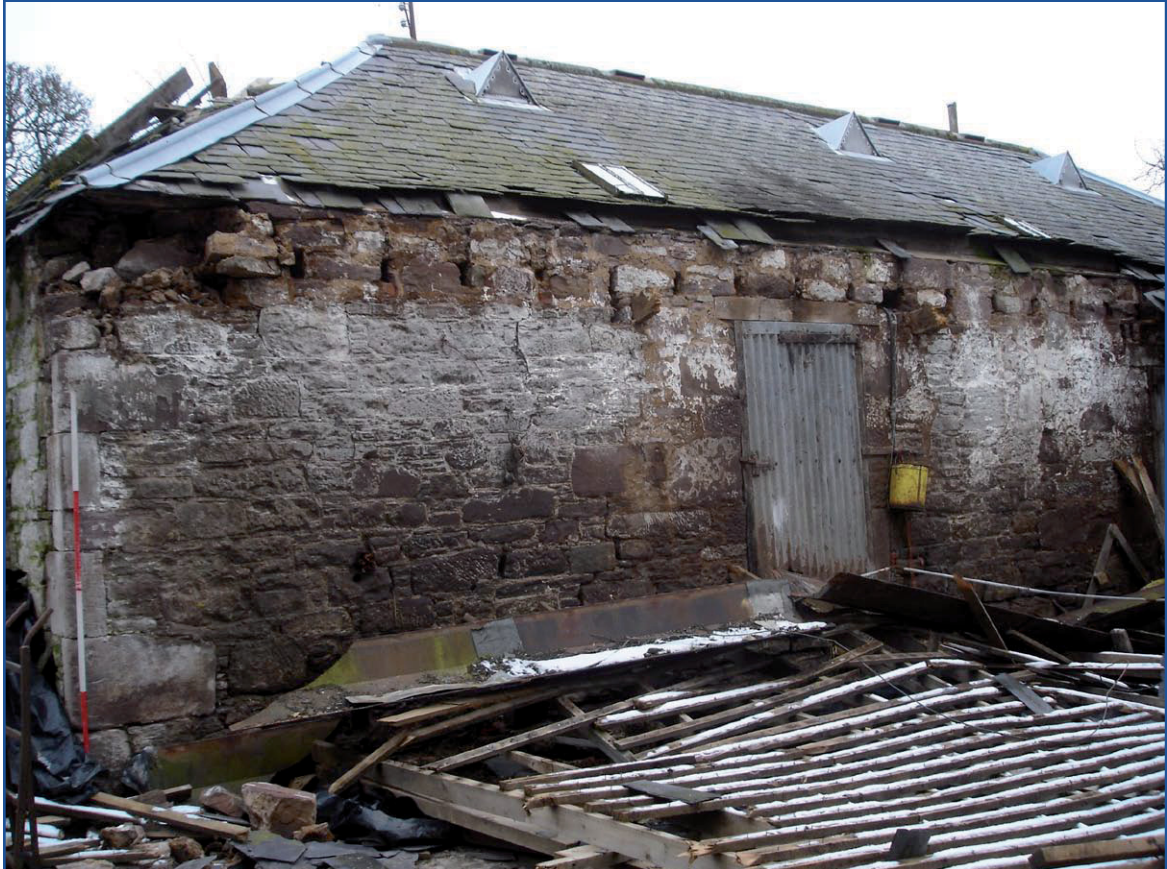
exposed after the collapse of Building C and is constructed of stone rubble with two corrugated iron doorways (**Plate 14**). The north elevation consists of plain gable end (**Plate 15**). The north elevation was a plain wall with the smaller remains of the north elevation of Building C behind (**Plate 16**).

Plate 14: Building D, general view of east elevation

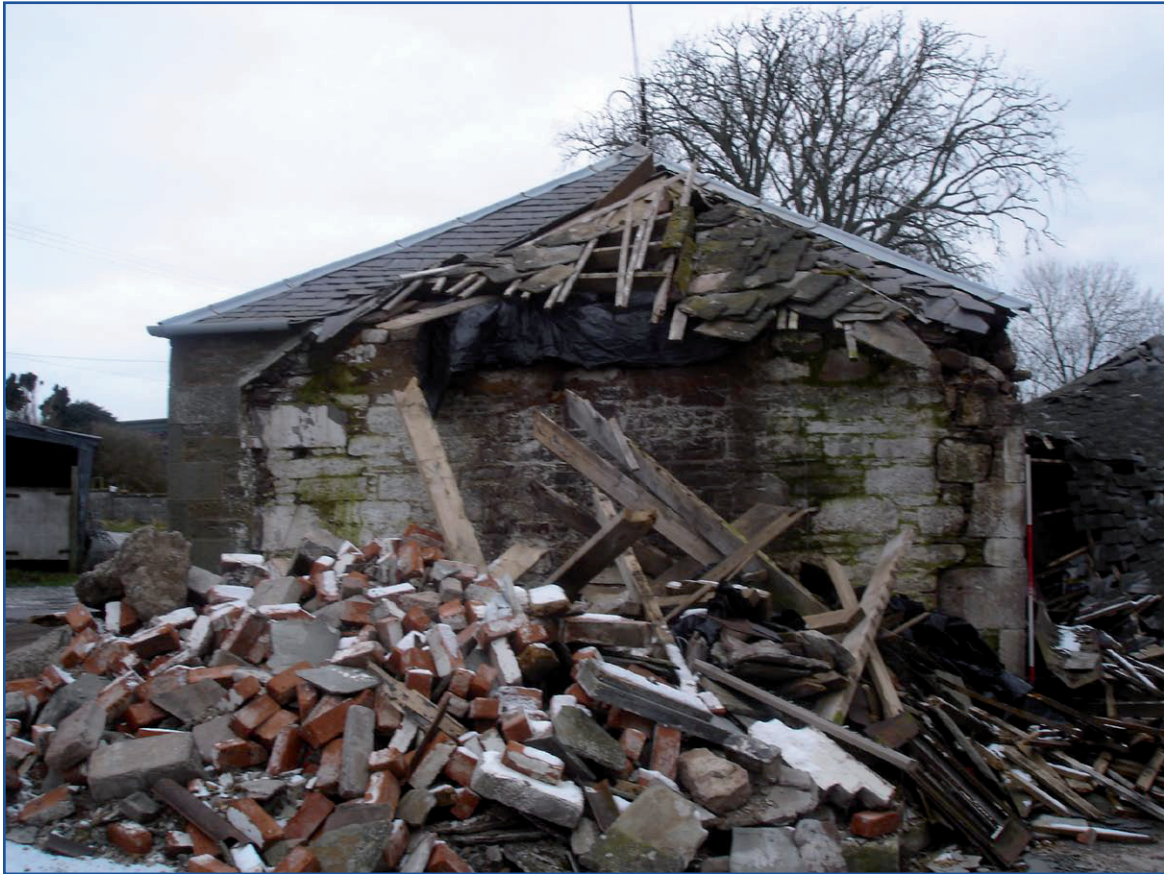
Plate 15: Building D, general view of the north elevation

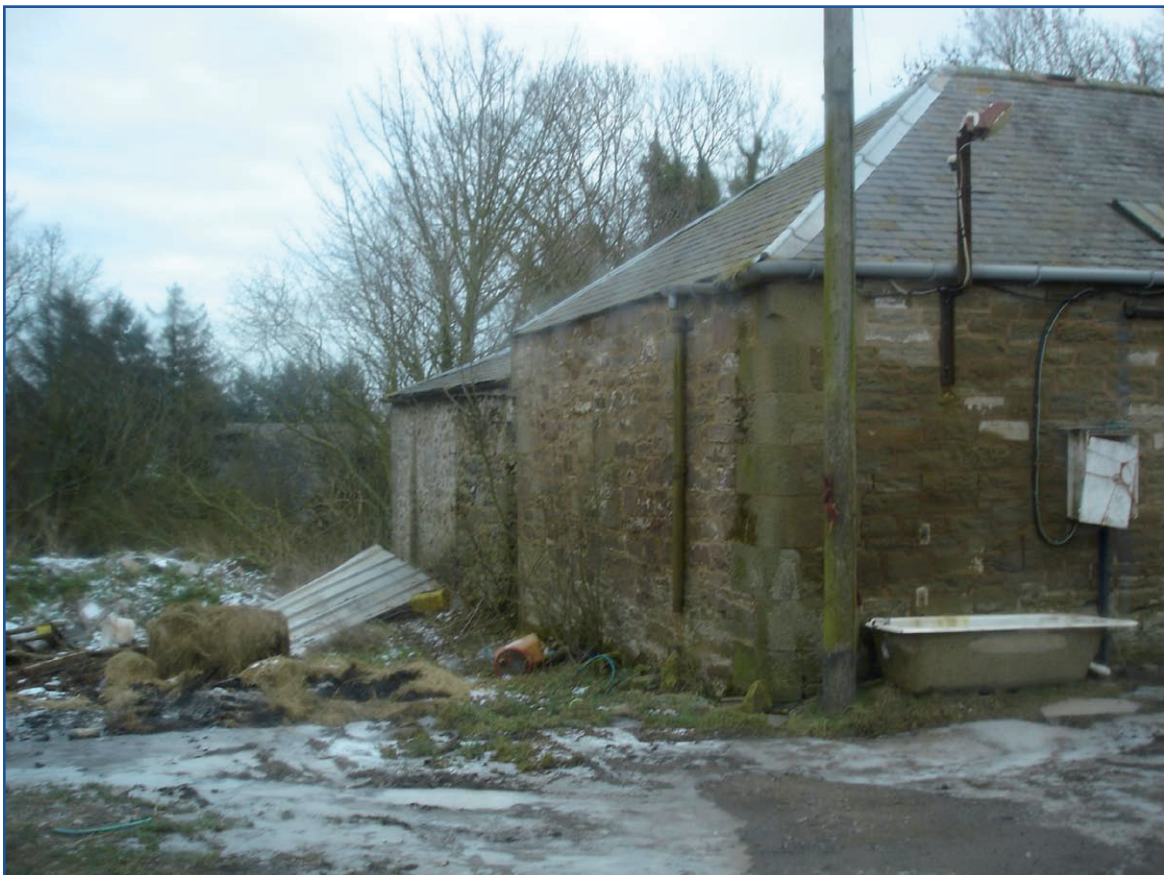
Plate 16: Building D, general view of north elevation

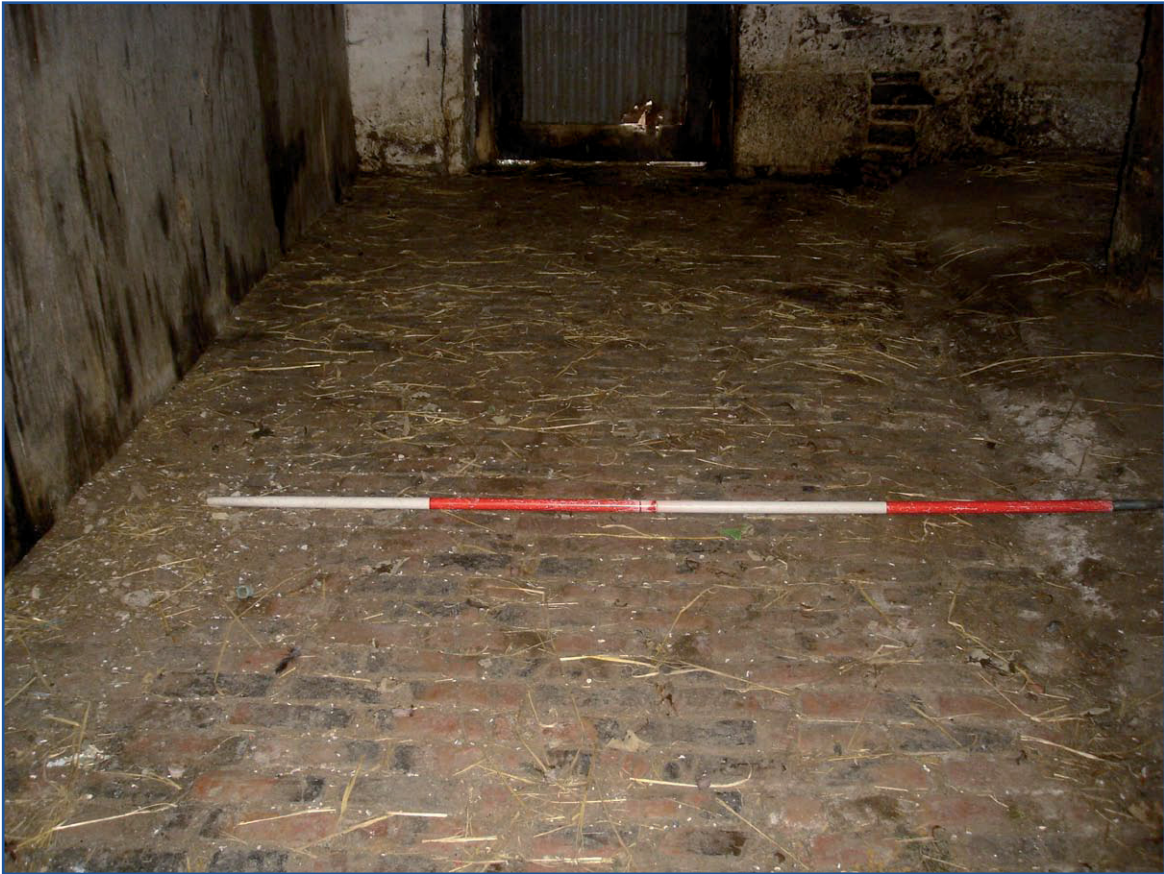
- 4.5.2 Internally, the stables are divided by a large timber partition and the southern room had a well preserved brick paved floor to the entranceway opposite a splayed window (**Plate 17**).

- 5.6 In terms of function, the buildings appear to have always been used as stables (Buildings B, C, D & F), a cart shed (Building G) and cow stalls (Buildings A & E) although some alternative uses have been employed (hay storage in Building F and Building G is now a garage). Building D displays a fine well-maintained brick paved floor suggesting this use has been continued throughout the 19th and 20th centuries.

Plate 17: Building D, detail of brick paving to the interior from the west

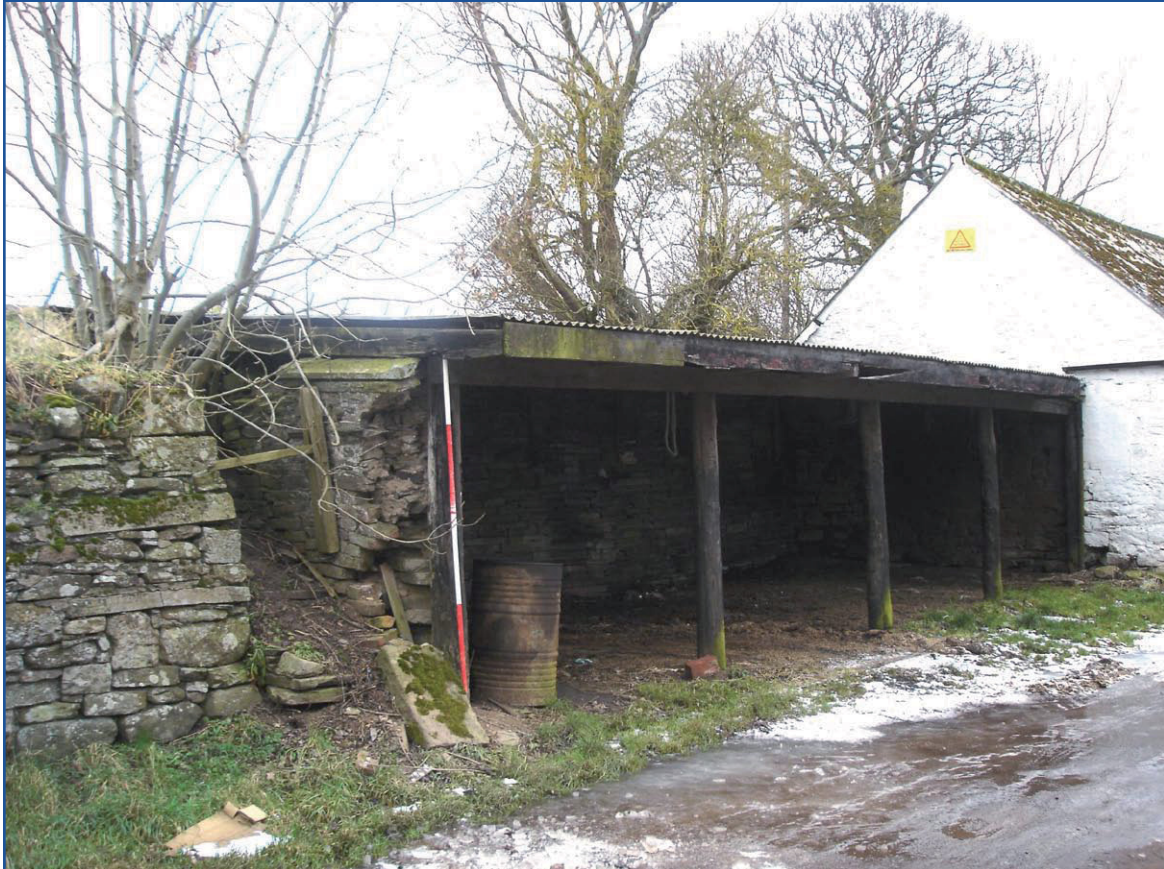
- 4.6.1 This small cow stall abuts Building F to the south and is constructed of dry stone against the bank to the west. It is open to the front (east) side with three timber columns supporting the roof beam. The roof itself is a lean-to with corrugated asbestos sheeting (**Plate 18**).

Plate 18: Building E, general view from the east

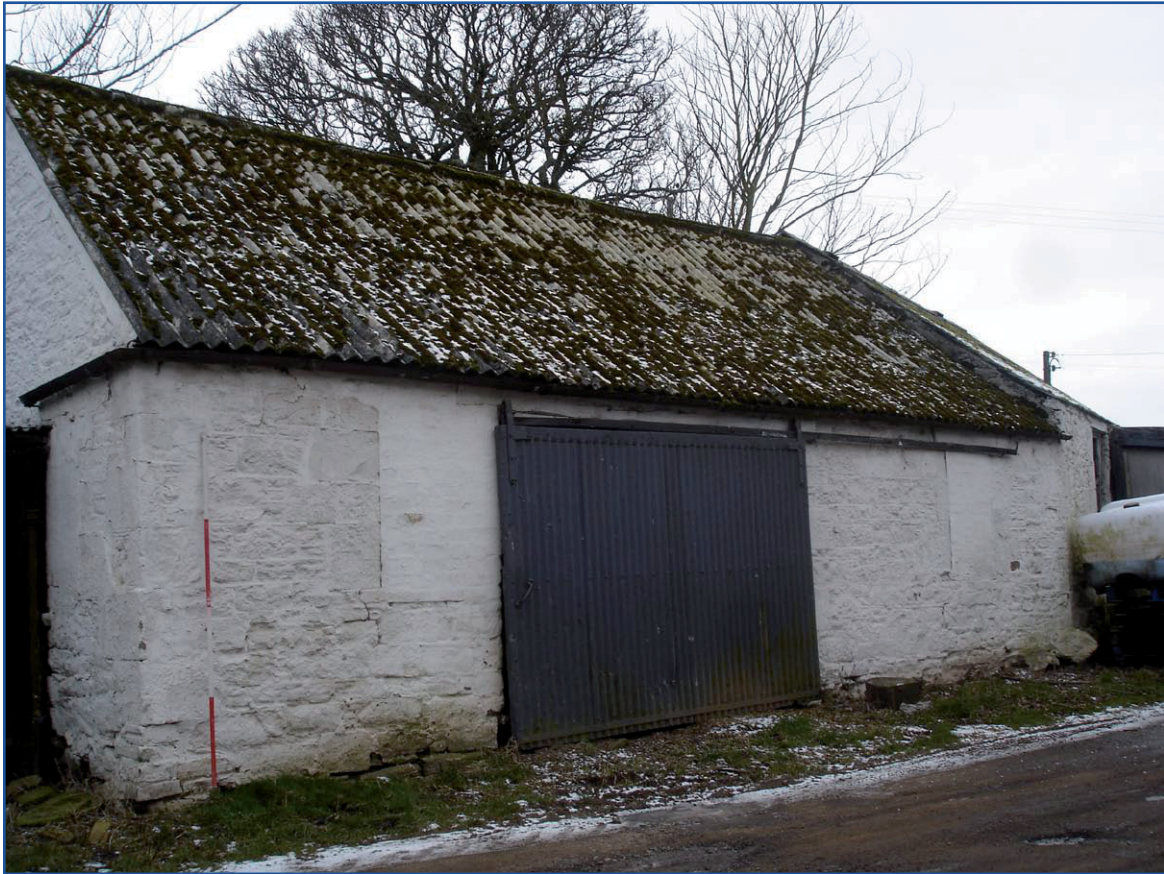
- 4.7.1 This barn is a single-storey three-by-one bay hay storage barn constructed of stone rubble, heavily whitewashed, with a pitched corrugated asbestos roof (**Plates 19**). The east elevation has an inserted large corrugated iron sliding door which has partially obscured one of the original windows to the south end. Both windows are now blocked. To the south, the building is abutted by Building E, and also features another bricked-up window. The north elevation is obscured by the abutment of the garage, or Building G (**Plate 20**).

Plate 19: Building F, general view of north-east elevation

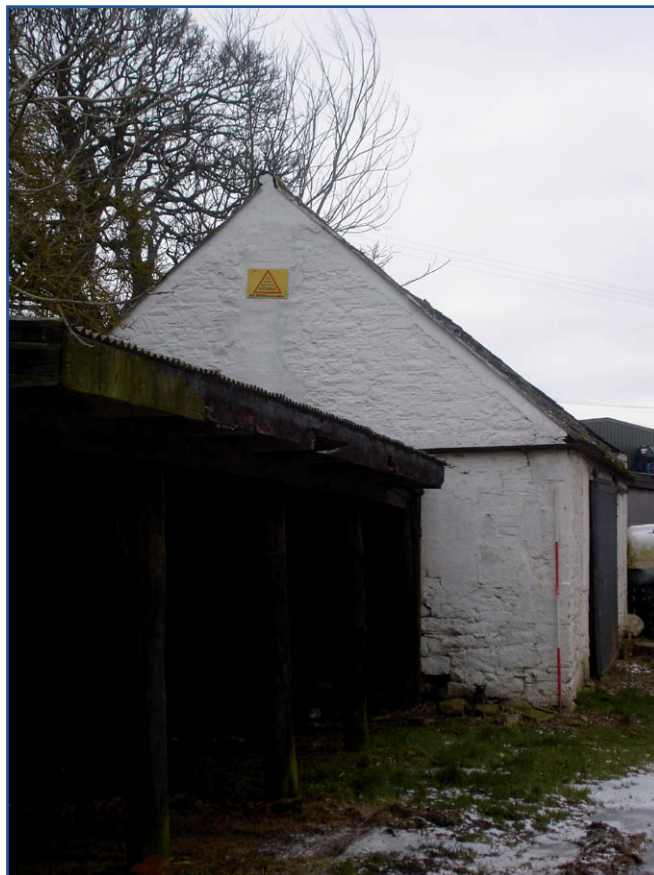
Plate 20: Building F, general view of south-east gable

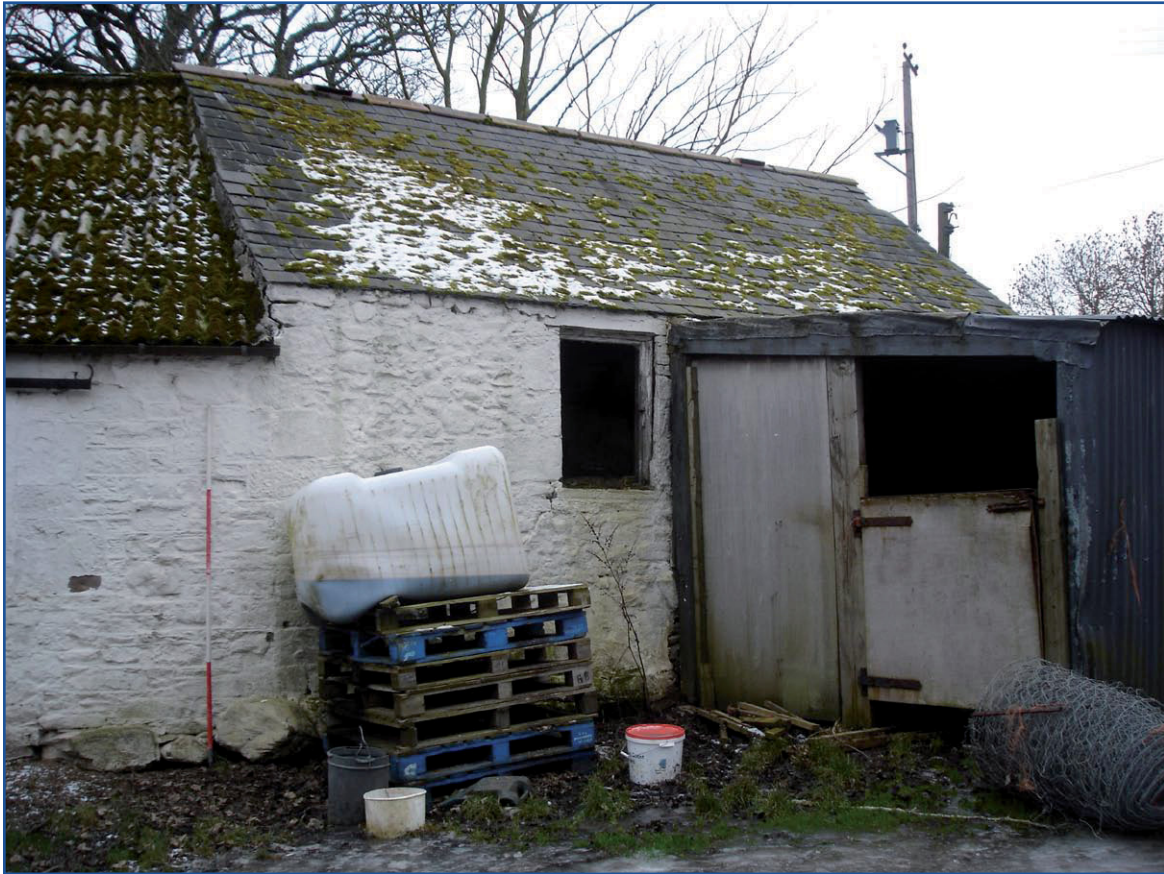
- 4.8.1 This small garage is a single-storey building, formerly used as a barn, constructed of stone rubble and abutting Building F to the south (**Plates 21 & 22**). It has a small lean-to to its north-east side.

Plate 21: Building G, general view from the east

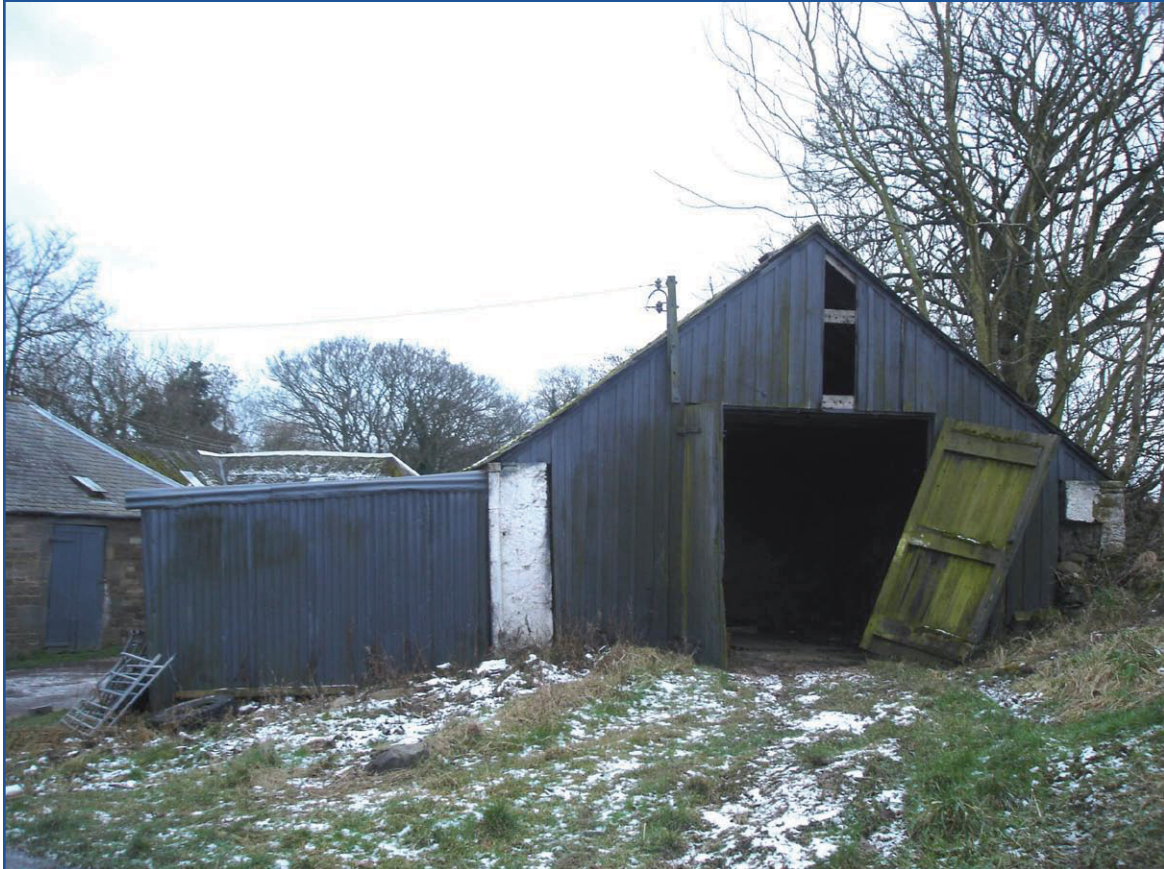
Plate 22: Building G, general view from the north
