# The Fortune Theatre Building, Bristol Cathedral Schools, Bristol Historic Building Record

AOC Project No: 30343

## Historic Building Record

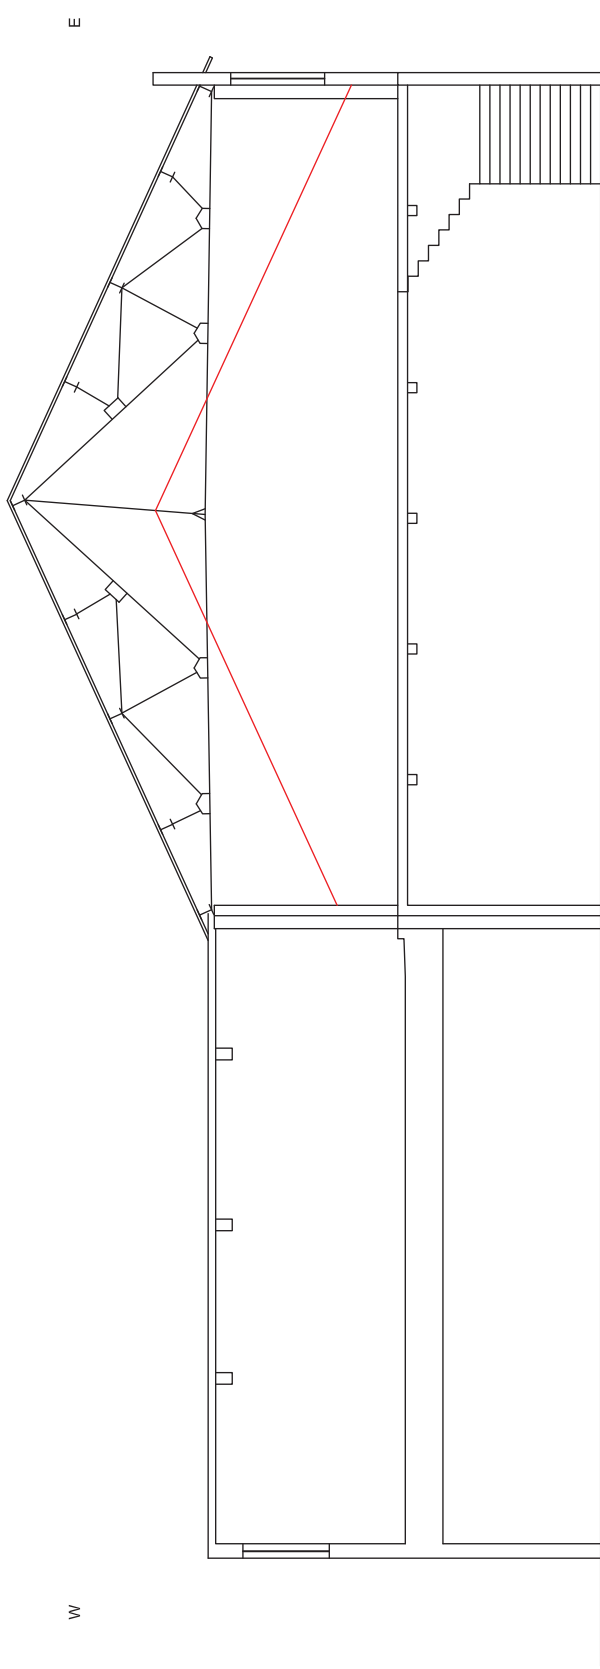
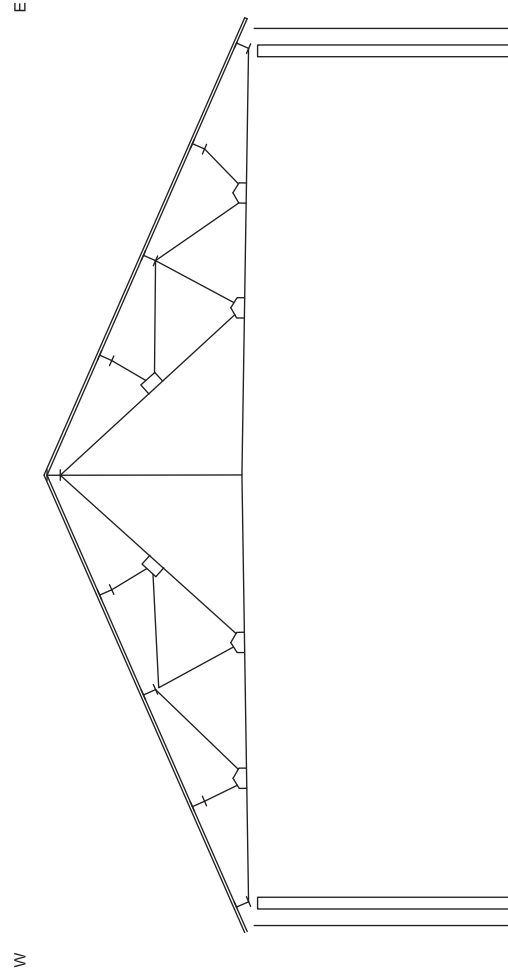
Figure 5: Building Profiles

— Roofline of Theatre/Warehouse

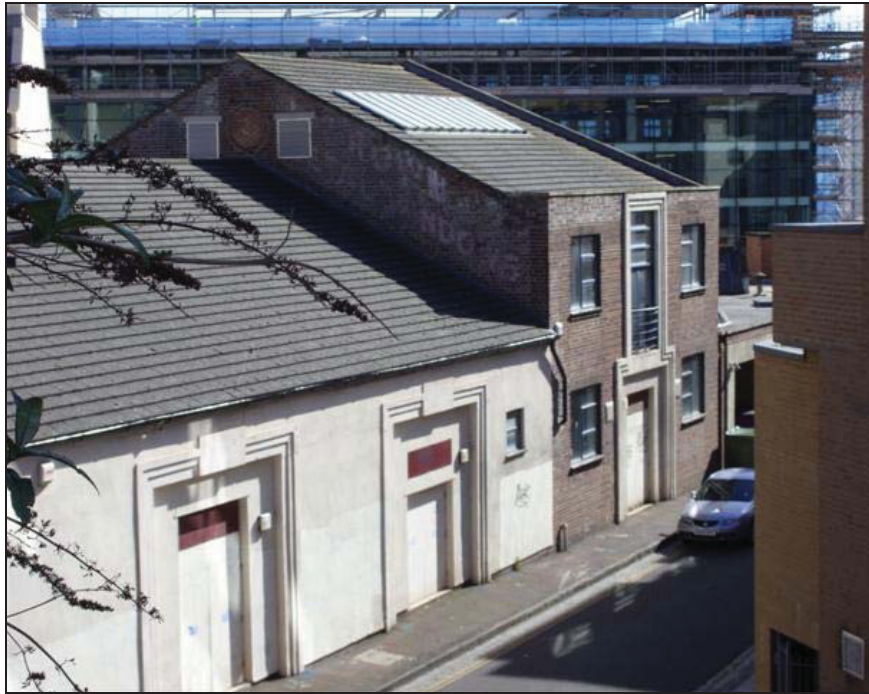
3.2.1 The west-facing elevation onto Lower Lamb Street is decorative with three entrances, and was clearly the public face of the building. One entrance leads into the office area and two into a warehouse-style building, now a theatre. The style suggests a 1930s or 1940s date. The entrances and decorative frontage suggests it was once more readily visible, not obscured by the housing on the west side of the street. Its decorative aspect now has limited, oblique viewing options. The presence of principal entrances on this side proves that this building's focus was the wider environs of Bristol, not the enclosed College Square to the east.

- 4.1.2 The main façade of the building was designed to be the west elevation fronting onto Lower Lamb Street. This is proved by the art-deco style entrances to the building. The advertisement for Rowe's metal Windows also suggest that this was the focus of activity. This focus was removed when the building became part of the Cathedral Schools. While not a great example of art-deco style, it is an example of good quality contemporary inter-war design motifs being used on a smaller, industrial building.

Plate 1: West elevation of Lower Lamb Street entrance

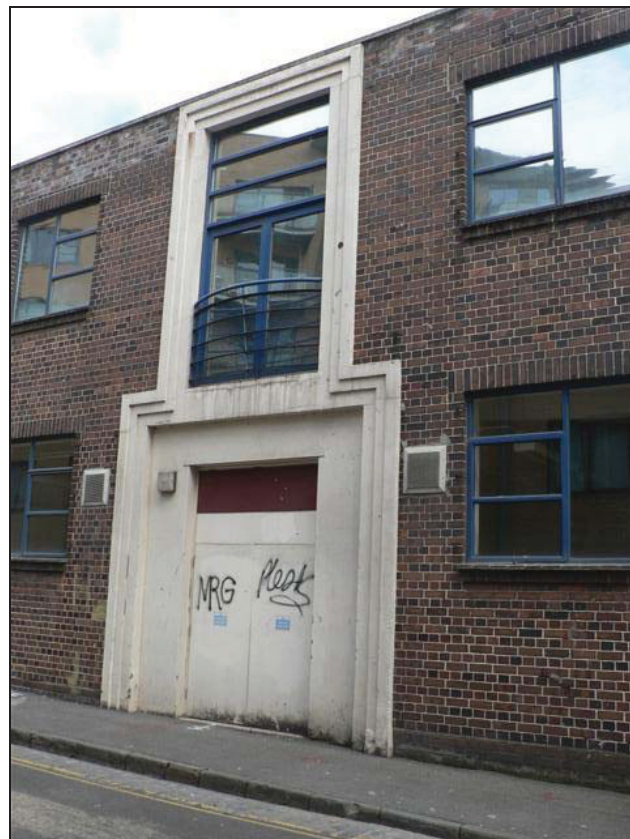
3.2.3 The office building has an Art Deco style entrance onto Lower Lamb Street with a moulded, rendered geometric surround that continues to eaves level with a balcony window at first floor level. There are windows on each floor either side of the central bay; the windows are metal framed casements and the windows have flat arches above. The sills are tiled, set upon a row of bricks set on edge. The bricks are fired dark reddish brown; each measures 226mm by 107mm by 76mm, and are laid in English bond. The wall of the office section is surmounted by a low parapet with stone coping above. The eaves of the roof of the warehouse section overlie the edges of that part.

Plate 2: Entrance to Office/ Art department, Lower Lamb Street

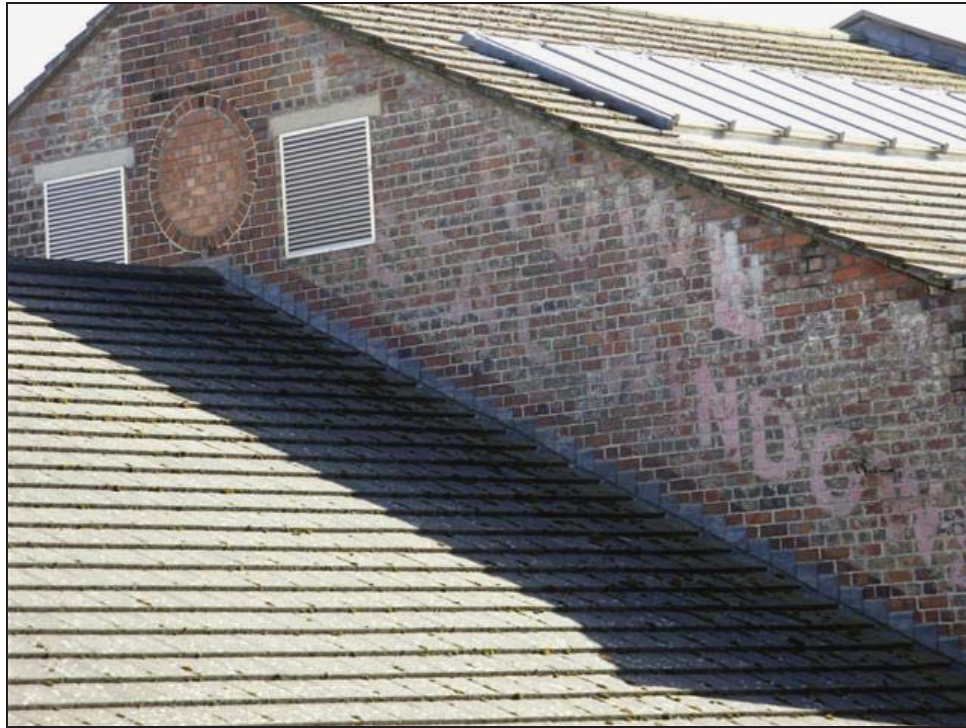
Plate 3: Rowe's Metal Windows and office roofline

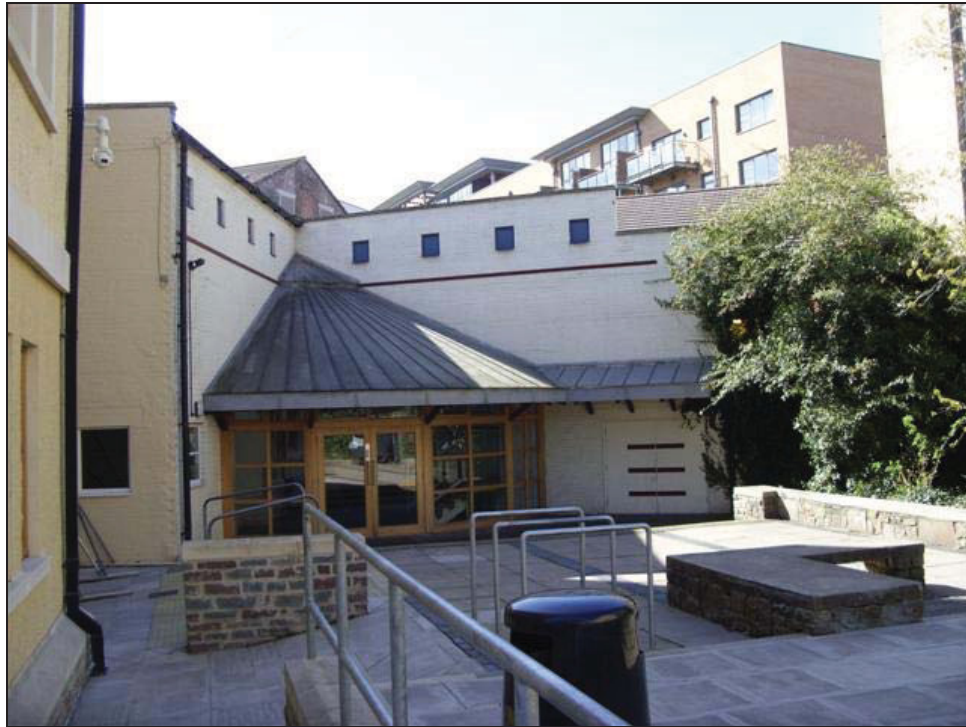
- 3.2.7 The eastern side of the building is in two parts: the warehouse part – now theatre – has two sets of double doors, and painted white. Part of the eastern wall rises above the eaves level of the theatre building by 13 courses, and contains four small rectangular windows that are blind. This may indicate that the theatre building has been lowered, or it may be no more than a screen wall added when an extension was added to the east. The roof of the warehouse is pitched, and tiled

Plate 4: View of east elevation.

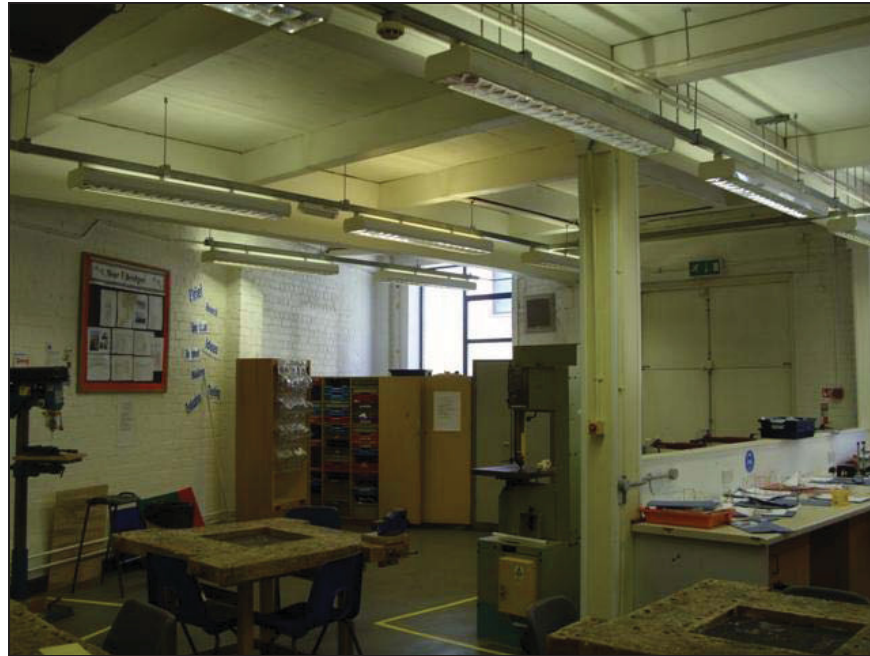
- 3.3.2 The floor of the Woodworking Room (**G1**) is covered with hard-wearing linoleum or vinyl, and the walls are painted magnolia. This floor covering and the paint serve to obscure any evidence of signage or function which may have survived from the use of the building prior to being a classroom. The room has all its fittings and fixtures intact for educational use: sinks are present along the north wall of the room, work benches at the west end and in the centre of the room, and machines for drilling and sawing are in the southwestern part of the room.

Plate 5: Ground Floor Room G1 looking southwest

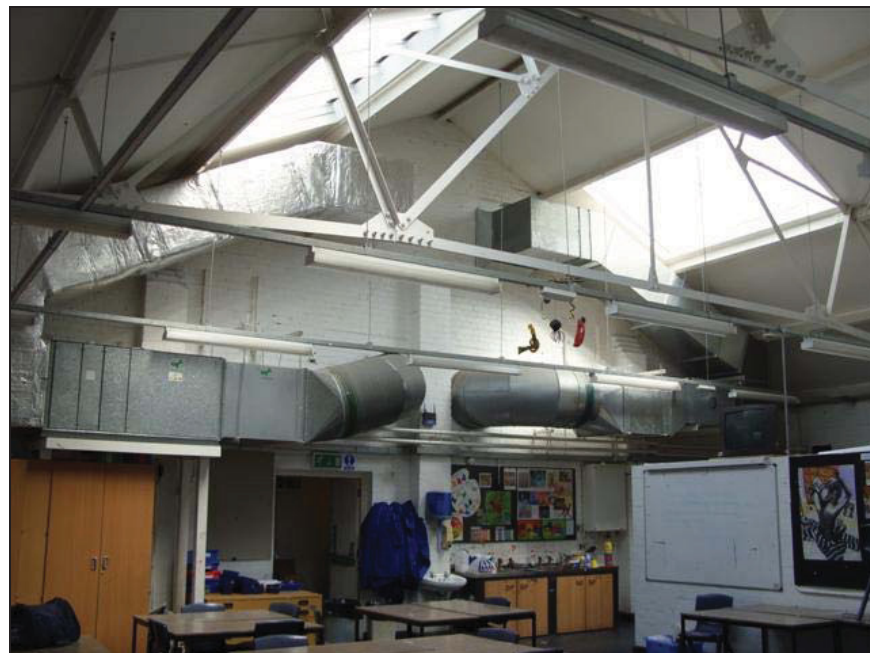
- 3.3.4 The second floor of this block can be accessed by a stairway to the northwest which is now the fire escape, from a landing leading up from the theatre foyer, and from the eastern extension, that has its own stairway. The main room is in use as an art classroom (**F1**), and was mostly accessible for recording. The three buttresses on the ground floor south side wall are also present in this room, rising to high level up the walls, where they terminate, the bricks stepping inwards, not continuing to the roofline. The central of these buttresses has an I-beam rising from its top, which appears to be an insertion or addition. This I-beam holds the ridge of the roof. The roof is supported by a pair of trusses running east-west, formed of latticed girders secured by bolted plates. Each truss supports I-beam purlins that hold the roof. Extra light is given to the room by a row of rooflights on both slopes of the pitch. There are three equidistant buttresses on the north side of this wedge-shaped room, these also terminate in stepped brickwork at their upper limit. The evidence on the outside of the building shows that the roof has been replaced, so each of the buttresses may have held previous supports for an earlier roof. Modern ventilation ducts run at eaves level and up to the outlets in the north wall.

Plate 6: First Floor Room F1 looking north

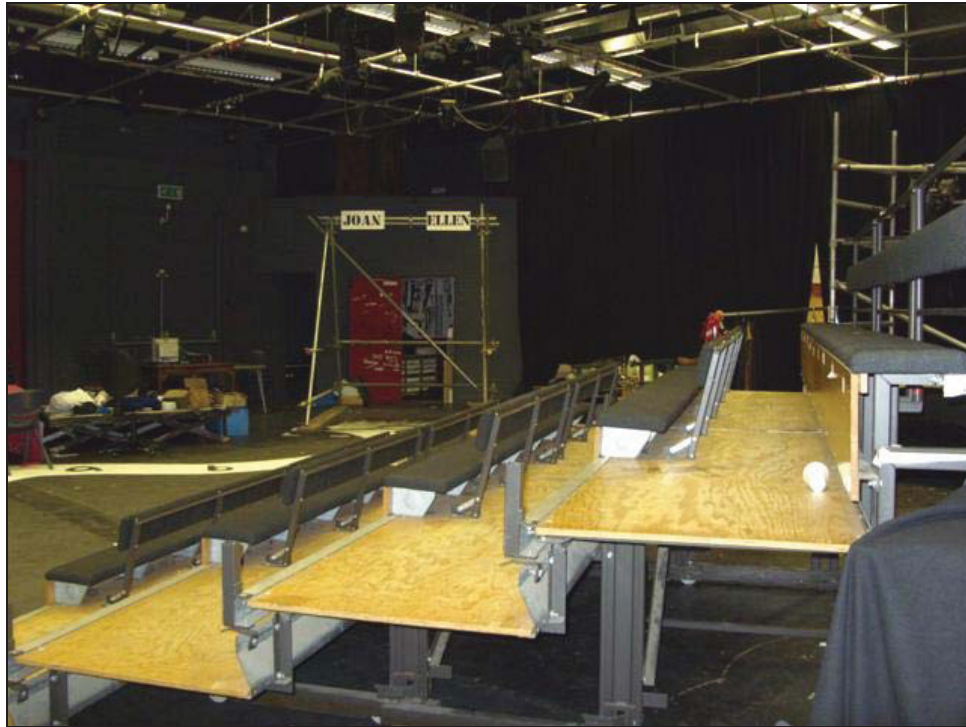
- 3.3.6 The northern part of the building is occupied by a single room (**G5**) with small internal partitions around the edges. This is in use as a theatre, and defined as 'Workshop' on the 1949 Ordnance Survey map. The theatre covers a space of 15m by 16.25m, the walls 4.60m high, and the apex of the pitched roof 8.14m above the floor. Each wall is brick with buttresses 0.48m wide projecting internally on all four walls, but those on the southern wall abut it, whereas the other three walls have buttresses built with the walls. The roof is supported by four trusses of latticed girders secured by bolted plates, identical to those forming the roof of the block to the south. There are two sets of double doors in the east side and one in the west. This latter opens onto Lower Lamb Street. The southern of the two eastern doors is the principal entrance to the theatre for the audience.

Plate 7: Theatre (Room G5) with seats and stage set, looking northwest

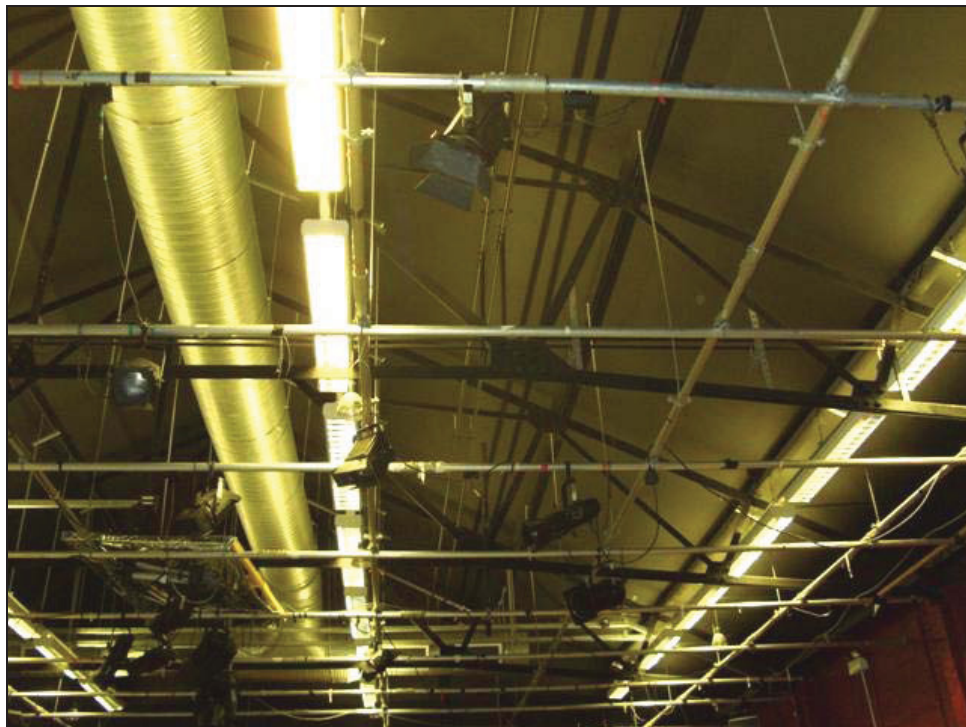
- 3.3.8 In the northwest corner of the room is another partition which encloses a props store, and has a ladder set into the wall. This provides access to a second balcony above the store.
- 3.3.9 At the time of recording, seating was located along the east wall of the theatre, and the theatre dressed for a production of a play about crime and punishment.
- 3.3.10 The walls of the theatre were covered in thick layers of paint, and there was no evidence for previous plant, machinery or other equipment that was present when this was in use as a workshop. Neither was there evidence for any locations for plant, the current decorative scheme obscuring potential changes in the brickwork. Theatre lights and ventilation are suspended and attached to the roof trusses.

- 4.1.4 The roof appears to have been replaced, or at the very least the roofline rebuilt. The inserted vertical girder on the south wall may be evidence of a full replacement. The form of the lattice struts is identical to the warehouse/ theatre, so the roofs may be assumed to be contemporary.

Plate 8: Theatre roof trusses

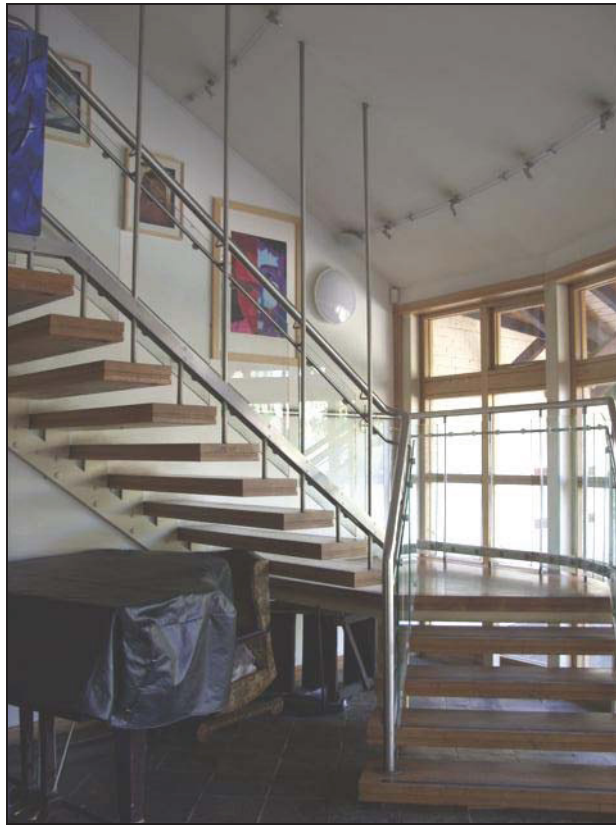
- 3.3.14 The stairs that rise from the foyer are largely within the circular 1999 extension, so seem likely to date from then. A beam across the corridor shows the line of the exterior wall of the extension, therefore the north wall must have been knocked through for access.

Plate 9: Stairs in Foyer

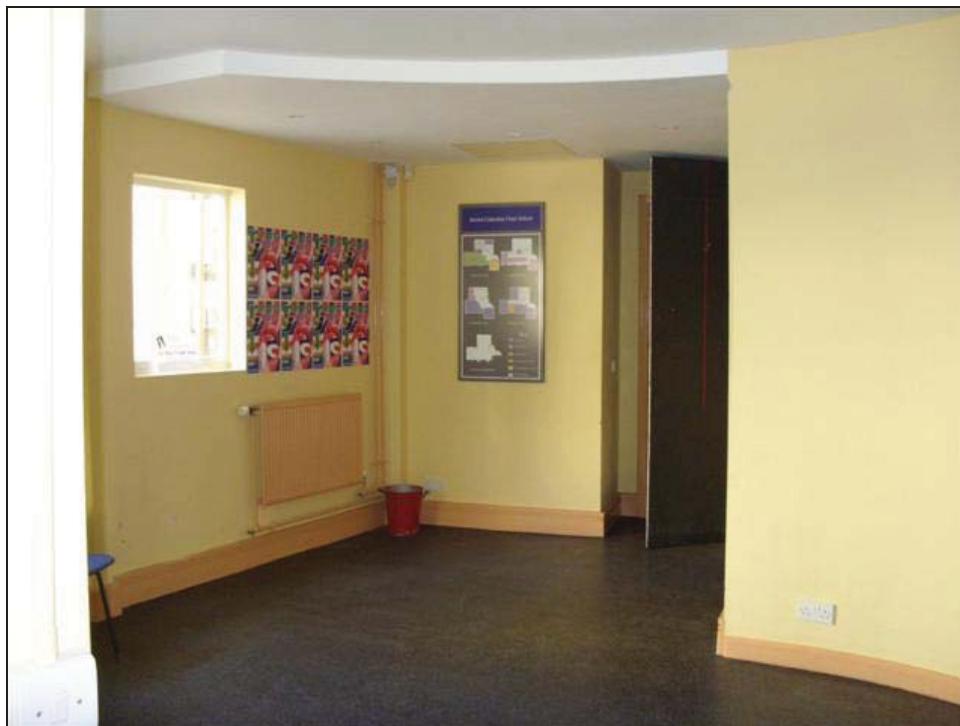
Plate 10: Foyer looking south
