THE ROSE GARDEN, ELTHAM PALACE, LONDON BOROUGH OF GREENWICH ARCHAEOLOGICAL EXCAVATION REPORT

AOC Project no: 30399

Site Code: EPL 09

Archaeological Excavation Report

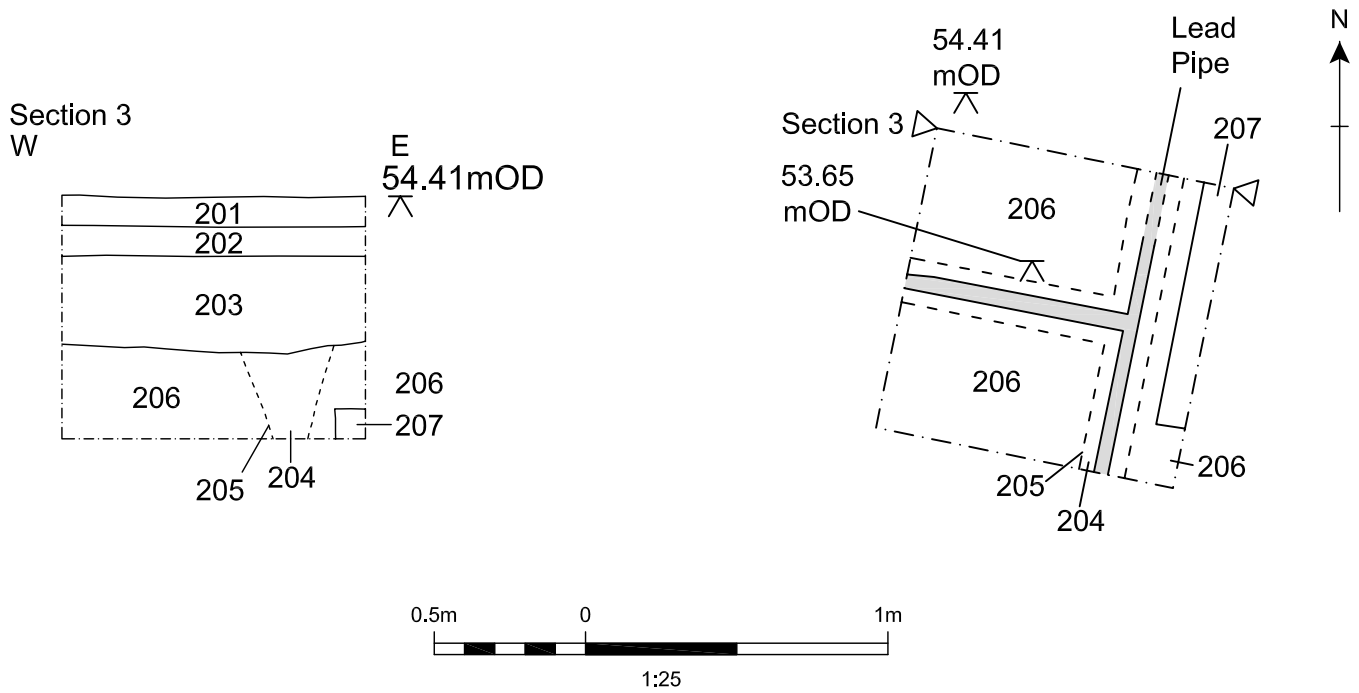
Figure 5: Trench 2: Plan and Section

■ Ceramic Pipe ■ Lead Pipe

6.2 Trench 2 (Figure 5)

- 6.2.2 The earliest feature observed in Trench 2 was a small linear patch of masonry [207] running parallel to the eastern side of the trench, at a height of 53.71m OD and measuring 0.80m long with a width of 0.10m. The masonry feature [207] appeared to be composed of a friable, yellowish grey, sandy mortar, containing CBM flecks and small stoney inclusions, bonded onto building stone of uncertain size. Due to the limited area uncovered, it was not possible to define the character or nature of masonry feature [207].

- 6.2.3 Overlying masonry [207] was a 0.30m+ thick made ground deposit consisting of firm, dark brownish grey, silty clay, with of CBM and mortar inclusions (206). Truncating made ground (206) was pipe trench [205] forming a T-shape in plan, mirroring the north-south/east-west alignment of the lead water pipe at the base of the cut. The pipe trench [205] generally had a V-shaped profile, and measured up to 0.3m in width. The junction of the lead water pipe was observed at the base of Trench 2 at a height of 53.65m OD. The backfill (204) of the pipe trench [205] was very similar in character to made ground (206), implying that the material excavated to create pipe trench [205] was used to backfill the trench once the lead pipe was laid. Finds retrieved from (204) included brick of 19th/20th century date and two sherds of blue and white transfer print ware dating to the late 19th/early 20th century.

- 6.2.4 Sealing pipe trench [205] was a 0.30m thick layer of firm, yellowish brown, clay (203), containing fragments of CBM. It is likely context (203) was purposely laid to level off the ground surface. A further deposit of dark grey, silty clay made ground (202), containing CBM fragments and measuring up to 0.10m thick, was present above layer (203). Above this was made ground (202) followed by (201) topsoil and turf no more than 0.10m thick.
