Loch Coille-Bharr Crannog

Condition Survey

AOC 21248
27th January 2009

On Behalf of:	Historic Scotland Longmore House Salisbury Place Edinburgh EH9 1SH
National Grid Reference (NGR):	NR 7789 8950
AOC Project No:	21248
Prepared by:	Graeme Cavers
Illustration by:	Graeme Cavers/Graeme Carruthers
Date of Fieldwork:	10th-12th January 2009
Date of Report:	27th January 2009

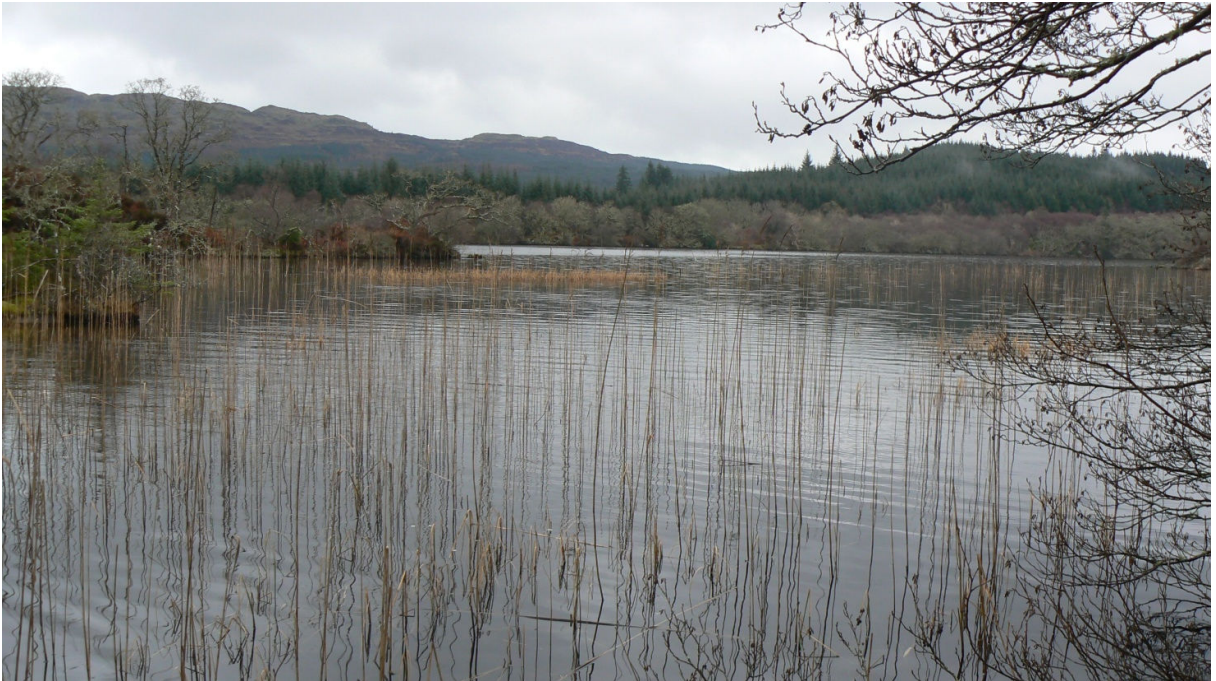
Plate 1: Location of the crannog, seen from the loch shore to the E. The site is located off the headland, beyond the reeds.

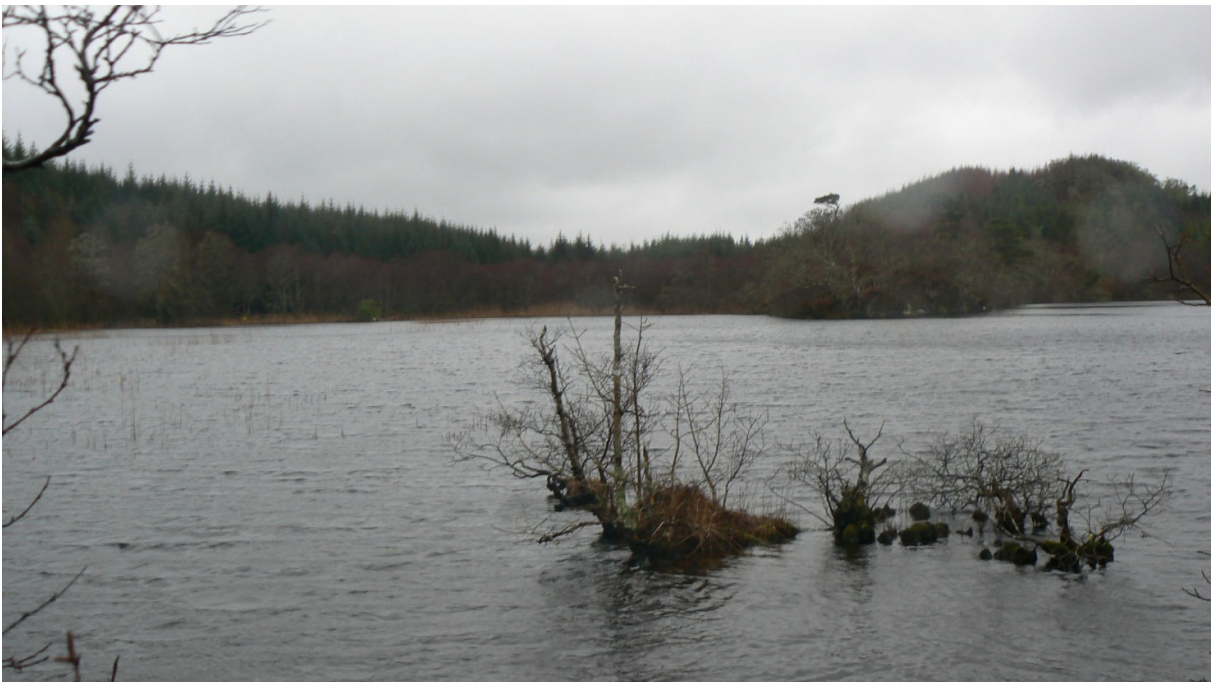
Plate 2: Location of the crannog, seen from the opposite headland, looking south.

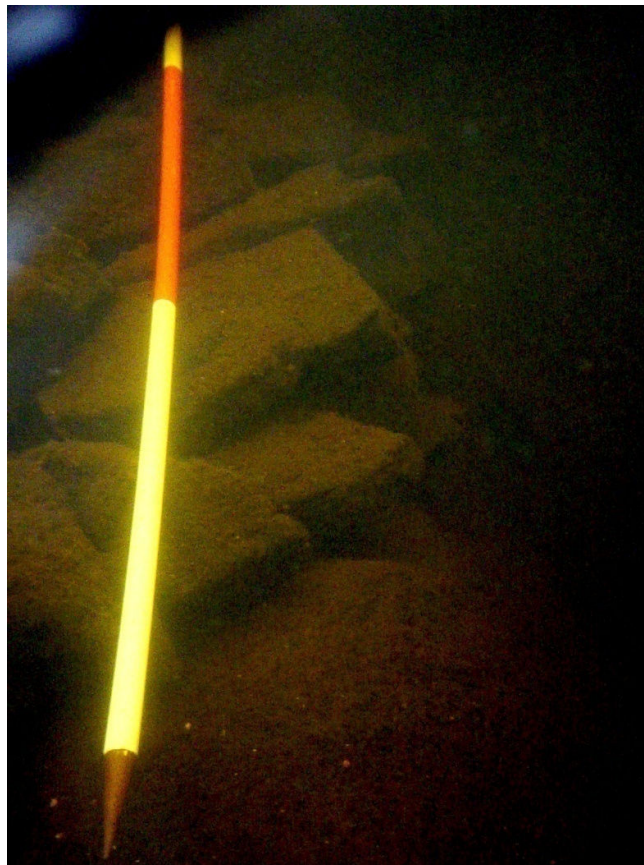
Plate 4: Revetment walling of elevation 1, from above.

- 4.1 The crannog itself is completely submerged, with no evidence of the site visible above water, and comprises a stone mound, roughly circular in plan and measuring 9m in diameter. The top of the mound was c.1.0m below the surface of the water at the time of survey. The site is visible as a mound of boulders, averaging 0.4-0.5m in diameter and, for the most part, showing no evidence of deliberate placement or construction. Around the edges of the site, however, the 'well-built walling' referred to by Mapleton is visible in two places (referred to as elevation 1, to the west, and elevation 2, to the south), on the shore side of the site, where it appears to act as a revetment, filling clefts in the bedrock, retaining the main boulder mound and creating a stable platform on the bedrock foundation. The walling is well made, standing to four courses, in the case of elevation 1, and five courses in the case of elevation 2. The boulders used to construct the revetment walls are well placed sub-angular stones averaging 0.3- 0.4m in diameter.

5. The crannog is generally well preserved. The survival of stone construction in submerged areas of a crannog site is unusual (see discussion below), and the quality of construction of the revetment walls at Loch Coille-Bharr goes some way to explaining their survival. Wave damage has been observed to be one of the fastest causes of erosion on crannog sites (Henderson et al 2004, 2006); located on the lee side of the site from the longest wave fetch direction, these wall faces are unlikely to be at risk of collapse.

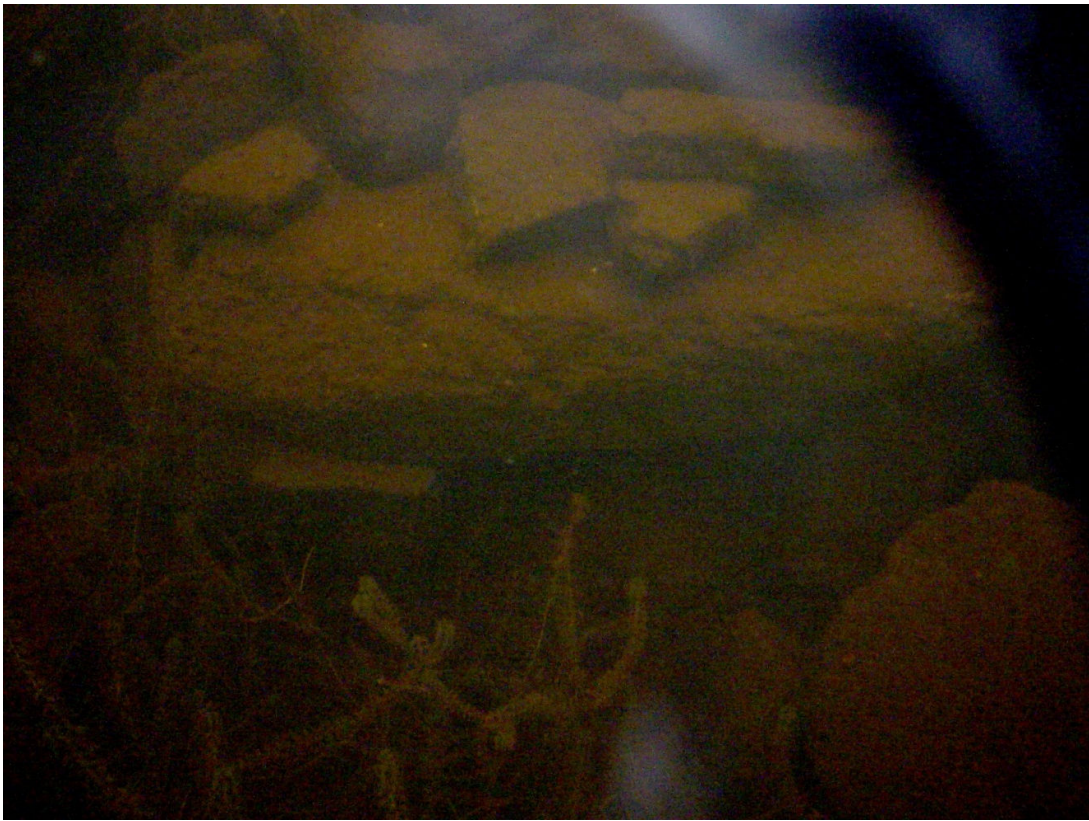
Plate 7: Large boulder near the edge of the mound, to the N.

- 4.2 The boulder mound is otherwise featureless, although around the edges of the site to the north and east several larger boulders may represent the ruinous remains of further retention walling. To the N area of the site, several large boulders have slipped down the sloping bedrock into deeper water, suggesting that portions of the site may have been lost to collapse. Although several large boulder were observed around the base of the bedrock reef while diving, there was no evidence of any further stone structure around the crannog itself; if this exists, it is buried by lake silts.

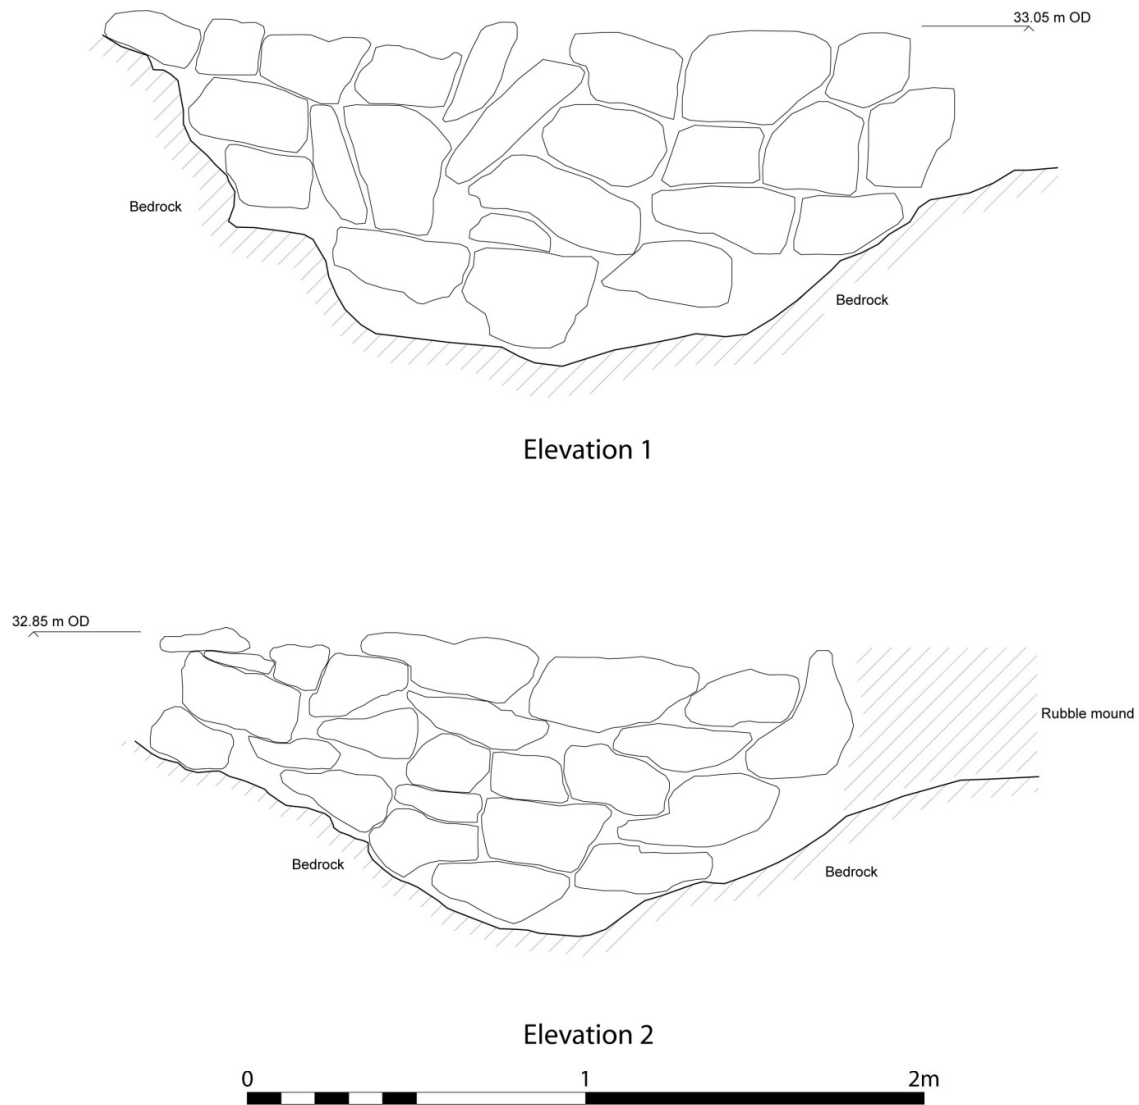
Figure 3: Elevations 1 and 2 showing the revetment walling.

3. The site and surrounding loch bed were inspected between the 10th and 12th January using SCUBA equipment. Photographs were taken using a digital camera in underwater housing and the wall faces were drawn onto drafting film by hand.
