## 1 NON TECHNICAL SUMMARY

- 1.1 This report presents the results of an archaeological Watching Brief and Excavation undertaken by AOC Archaeology Group on ground subject to redevelopment at 119-125 Marygate, Berwick-upon-Tweed, Northumberland. This work was commissioned by Bowcliffe LLP. The archaeological works were designed to satisfy the requirements of the local planning authority, as advised by Mr. Nick Best of the Northumberland County Council Conservation Team (NCCCT) and are in accordance with the principles inherent in PPG 16.

119-125 Marygate, Berwick-upon-Tweed:  
Archaeological Watching Brief and Excavation: Data Structure Report:

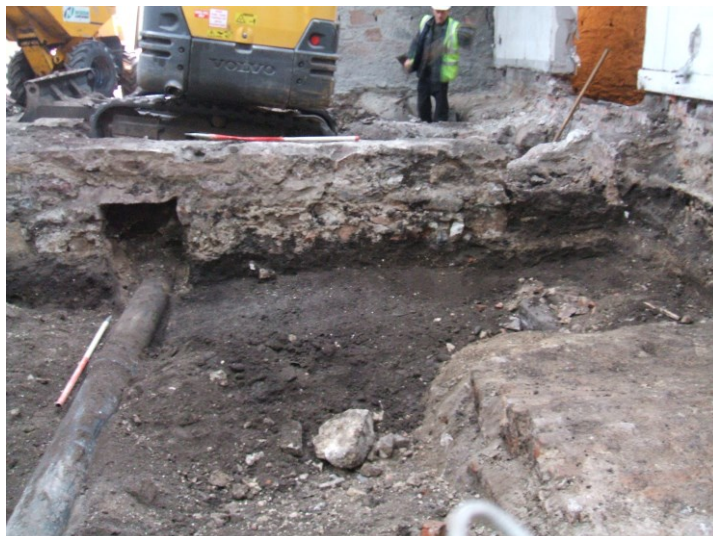
*View of wall (143) prior to removal: from north-east*

5.2.2 At the northwest end of *Area 1* between 16 m and 20 m from the northeast end of the area and directly below (100) at 10.9 m OD the remains of stone built structures were seen (fig. 3). These consisted of a single large wall (143) which ran from the southeast edge of the site across the width of *Area 1* for a distance of 5.8 m. At this point there was a gap in the wall of 0.7 m, possibly a doorway, before a short second section of wall (144) completed the full width of *area 1*. Both (143) and (144) were constructed from random courses of roughly finished mortared stone blocks. The wall remains stood to a height of 0.68 m with a width of 0.33 m. Wall (143) had been constructed directly over the central iron drain (fig. 4) suggesting a late date for the wall. Neither (143) nor (144) were seen to be tied into the existing walls of the present building. Associated with this wall were further stone built remains (145) and (146). This structure was situated on the southwest side of wall (143) and (144) on the northwest side of *area 1* (fig. 3) and possibly represented a small room. The remains were constructed in the same way as wall (143) and enclosed an area of 1.8 m by 2.2 m. As with the wall this structure was not tied into the existing buildings walls. Although other stone built structure of a possible similar date were seen in *Area 2* these features were not seen to extend into this area. No construction cut was seen for either of the walls but both were seen to be constructed above deposit (128) discussed below. Deposit (138) a thin compact layer of gravel is possibly the remains of an old yard surface associated with these late features. All the above features were demolished and removed.

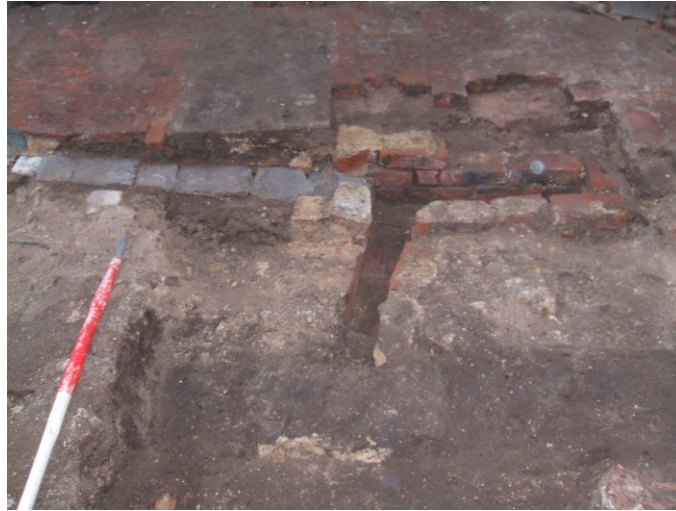
*Drain (126) following removal of slab (123a/b)*

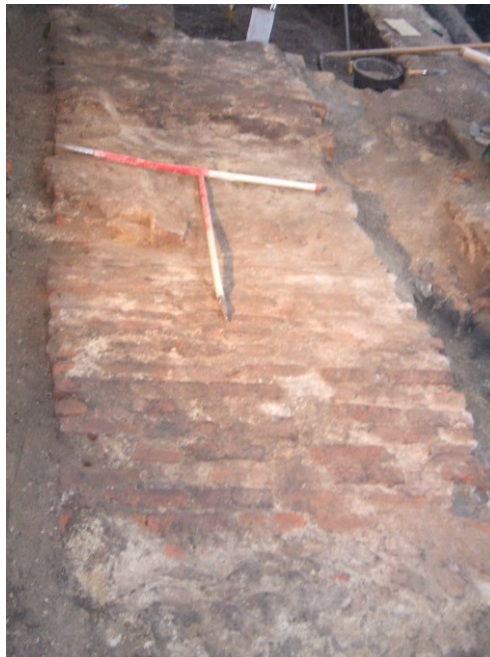
*View of upper surface of sprung roof (148): From SW*

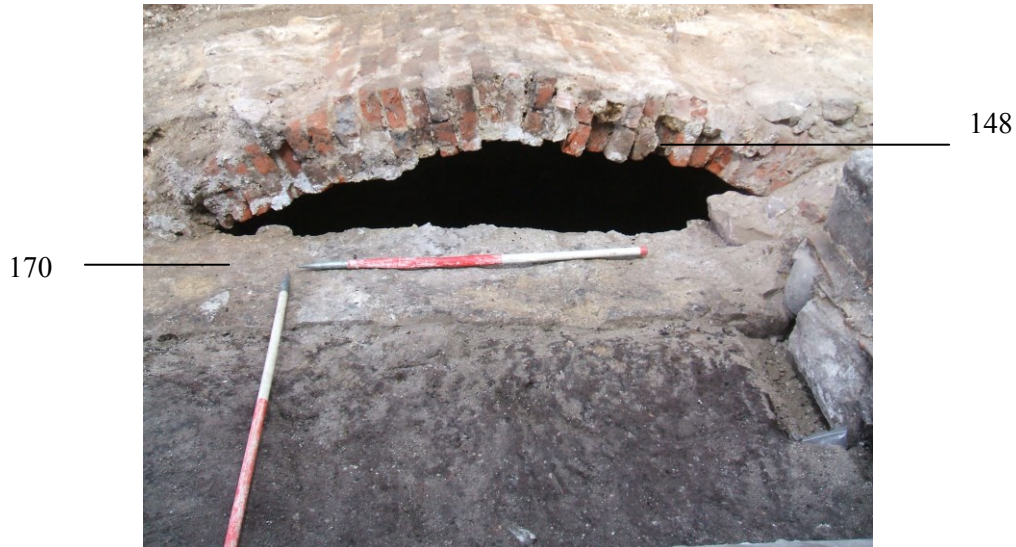
*View of SE edge of sprung roof (148): From SE*

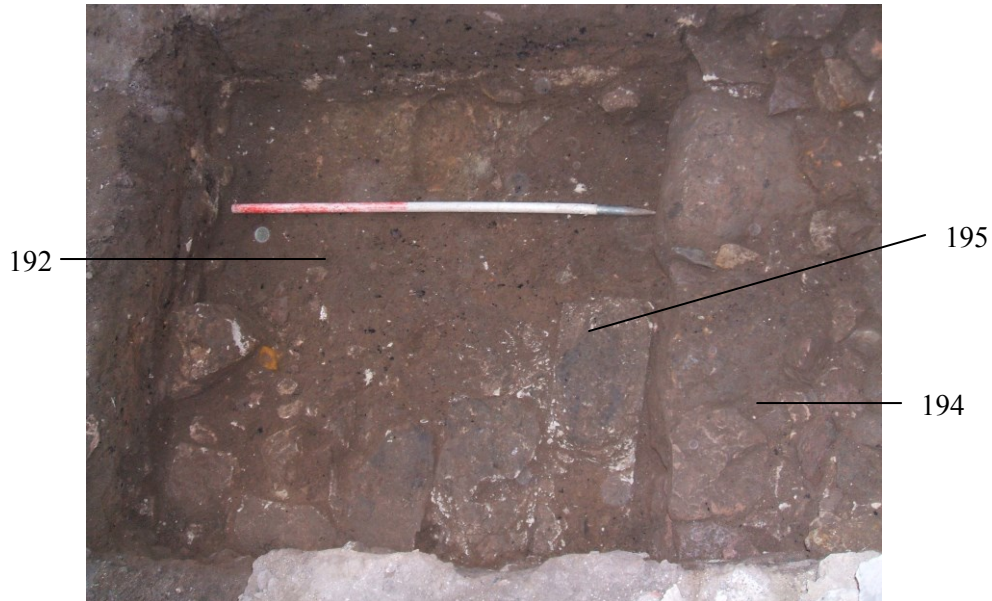
- 5.2.22 Pile cap 3 revealed the presence of an early wall (194) below the existing wall along the north-west side of *Area 1* (fig. 12). The remains were separated from the foundations of the modern wall by layers (179) and (151) a depth of 0.45 m. (fig. 16). The wall was constructed from large un-worked blocks measuring

0.25 m x 0.3 m x 0.4 m and small cobbles bonded with clay. Wall (194) was abutted by the remains of a flagged floor (195) buried below a deposit of loose friable orange brown clay silt at a depth of 25.62 m OD. Excavation did not continue below this depth. These remains were not detected else but the wall may be associated with other clay bonded walls seen in Area 3.

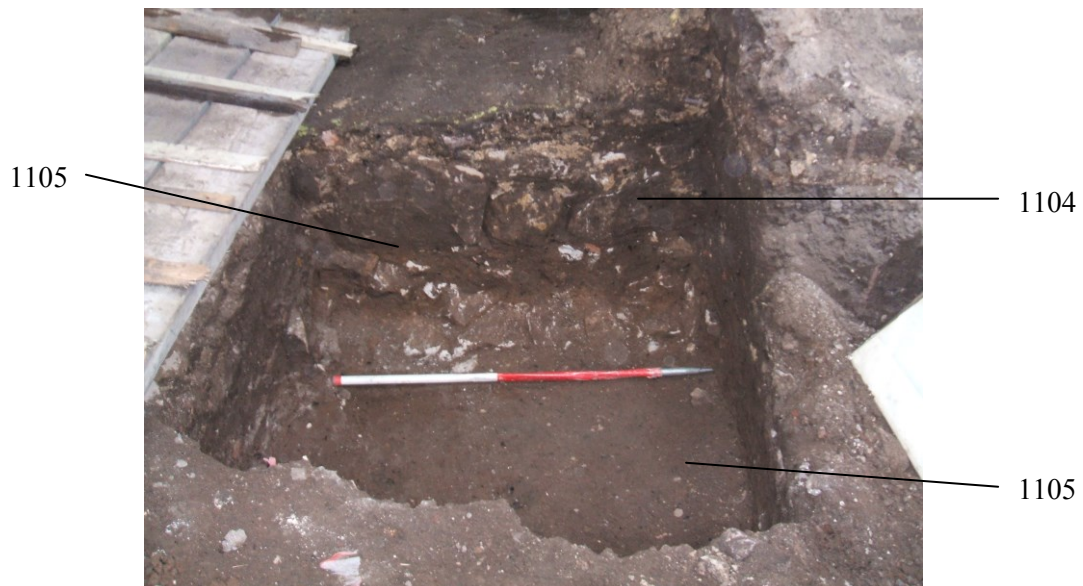
*Pile Cap 12: From South-East*

5.2.23 A further clay bonded wall (1104) was seen in pile cap 12 (fig.12) situated above a deposit of compact mid brown sandy silt (1113) which in turn lay over a compact layer of silt sand (1105) which filled the base of the pile cap (fig. 17).

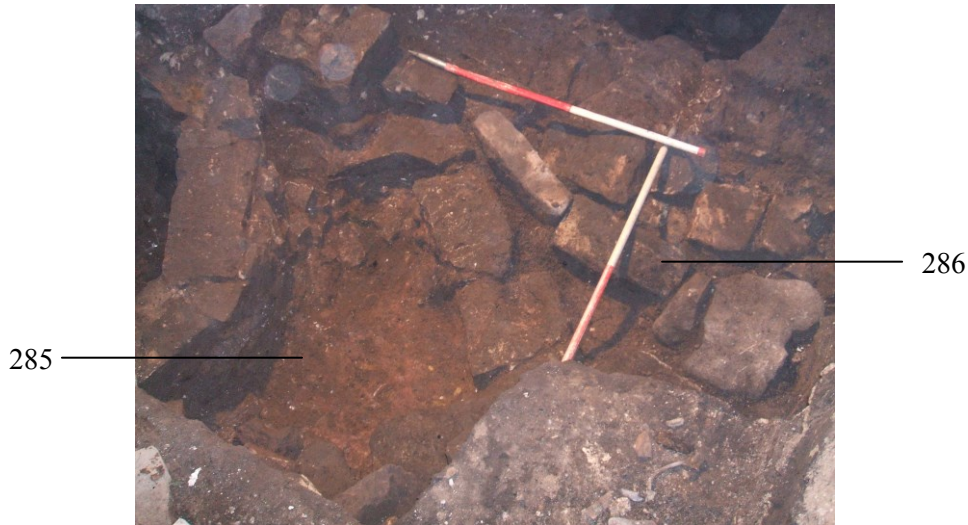
*Area to the north-west of oven/kiln (145) following removal of (260): From north*

- 5.3.7 The surface of (286) although outside the oven/kiln lay beneath a layer compact brown silty clay (260) with a depth of up to between 0.1 m and 0.4 m which in turn was overlain by a compact red clay (247) with frequent inclusions of angular stones and a depth of 0.2 m. It was clear that this area may have been subjected to stone robbing in the past and where flags were

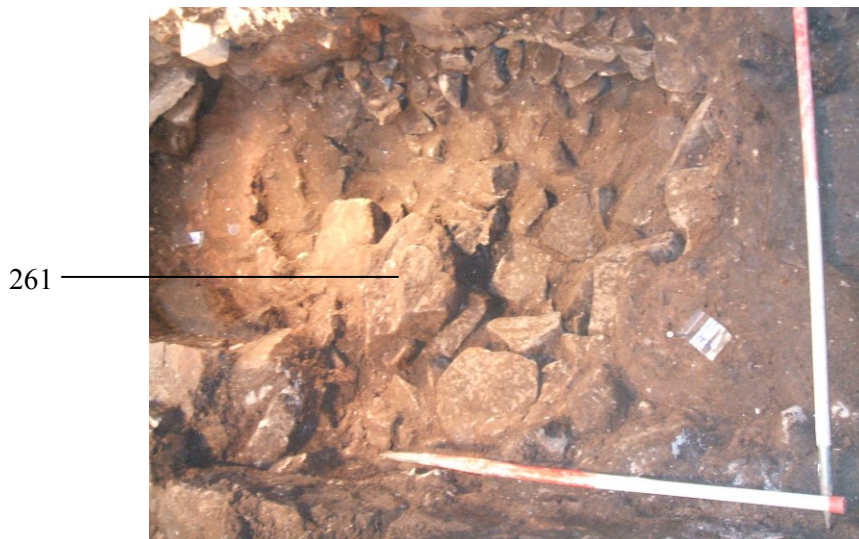
*Interior of oven/kiln (245) following removal (246): From south-east*

- 5.3.8 The stone slabs (246) within the oven were lifted. Beneath these slabs was a thin layer of compact black ashy silt (252) containing many charcoal flecks and had a depth of 0.02 m. Three further deposits were exposed beneath (252). These consisted of (264) a loosely compacted stony clay which was seen to overlie a deposit of loose stone rubble (261) which was also overlain by a red stony clay. These deposits were encountered at a depth of 25.9 m OD and no further excavation took place here. However the loose rubble nature of (261) may indicate the possible infilling of further archaeological structures. Post medieval pottery was recovered from this deposit. (Fig. 24).

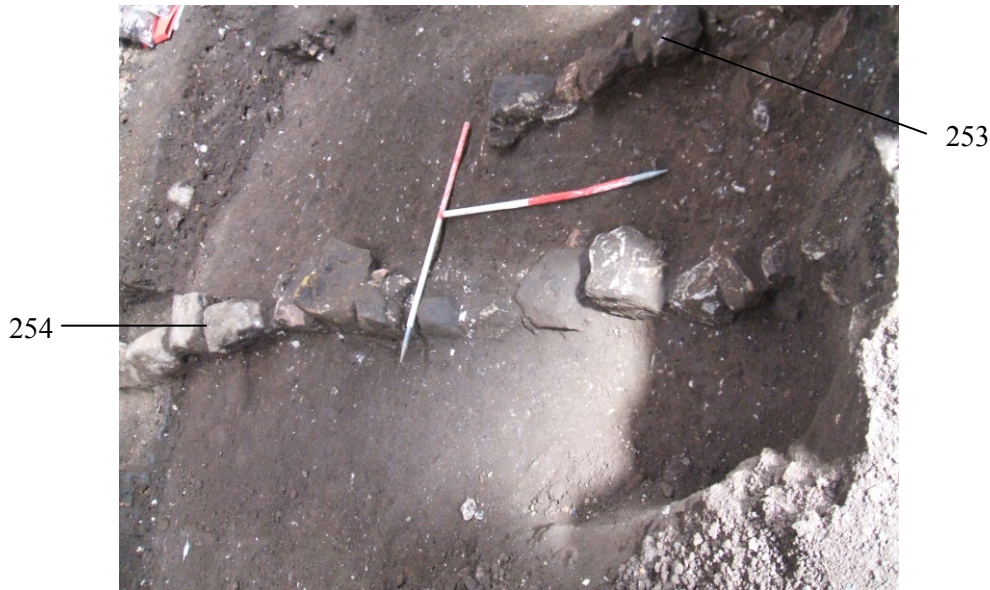
*Walls (253) and (254): From south*

- 5.3.13 At approximately 9 m from the north-east end of *Area 2* at the base of (228) and running across the width of the area were the remains of two parallel walls (253) and (254). Both were seen as single lines of unworked stone with only one courses remaining. No construction cut, bonding material or evidence of robbing was apparent for both walls which sat on midden deposit (259) below (228). Wall (254) ran for the full width of area 1 whereas wall (253) was only seen as partial remains extending from the south-east edge for 1.5 m. The function of these remains is not known at present. (Fig. 23).

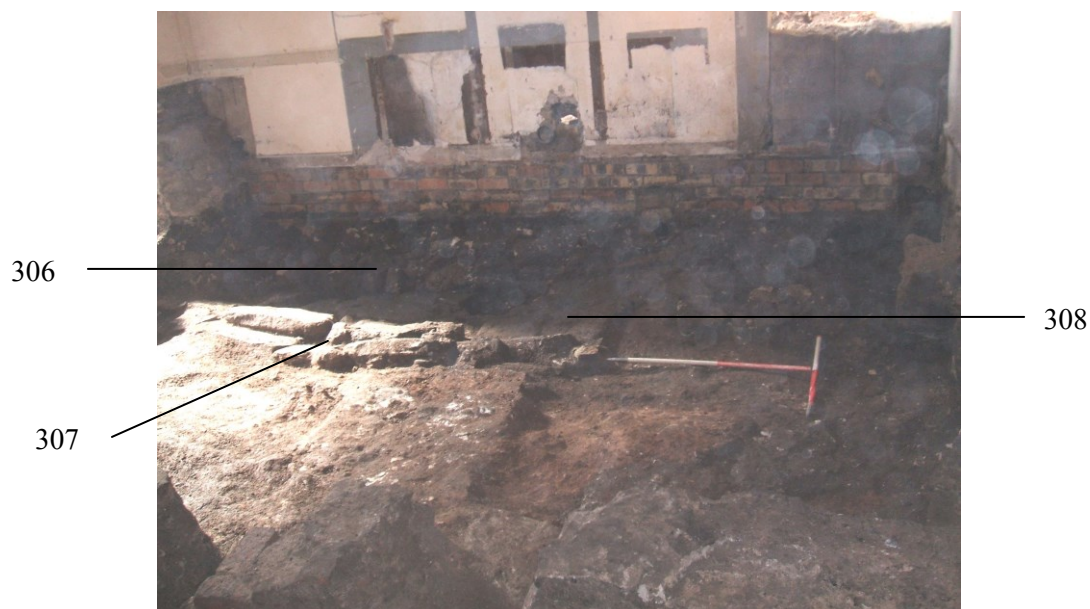
*Area 3: From north-east*

5.4.3 Following the removal of (304) significant remains were encountered in the form of a possible flagged floor (308), wall (307) and further patches of flagged floor (312). The wall (307) consisted of 2 layers displaced layers of large flat unworked stone with possible clay bonding apparent. The stones lay at an angle dipping toward the south-west suggesting collapse or deliberate
