Lochrin Basin, Tollcross, Edinburgh Excavation: Data Structure Report

Data Structure Report

AOC Project No: 20144

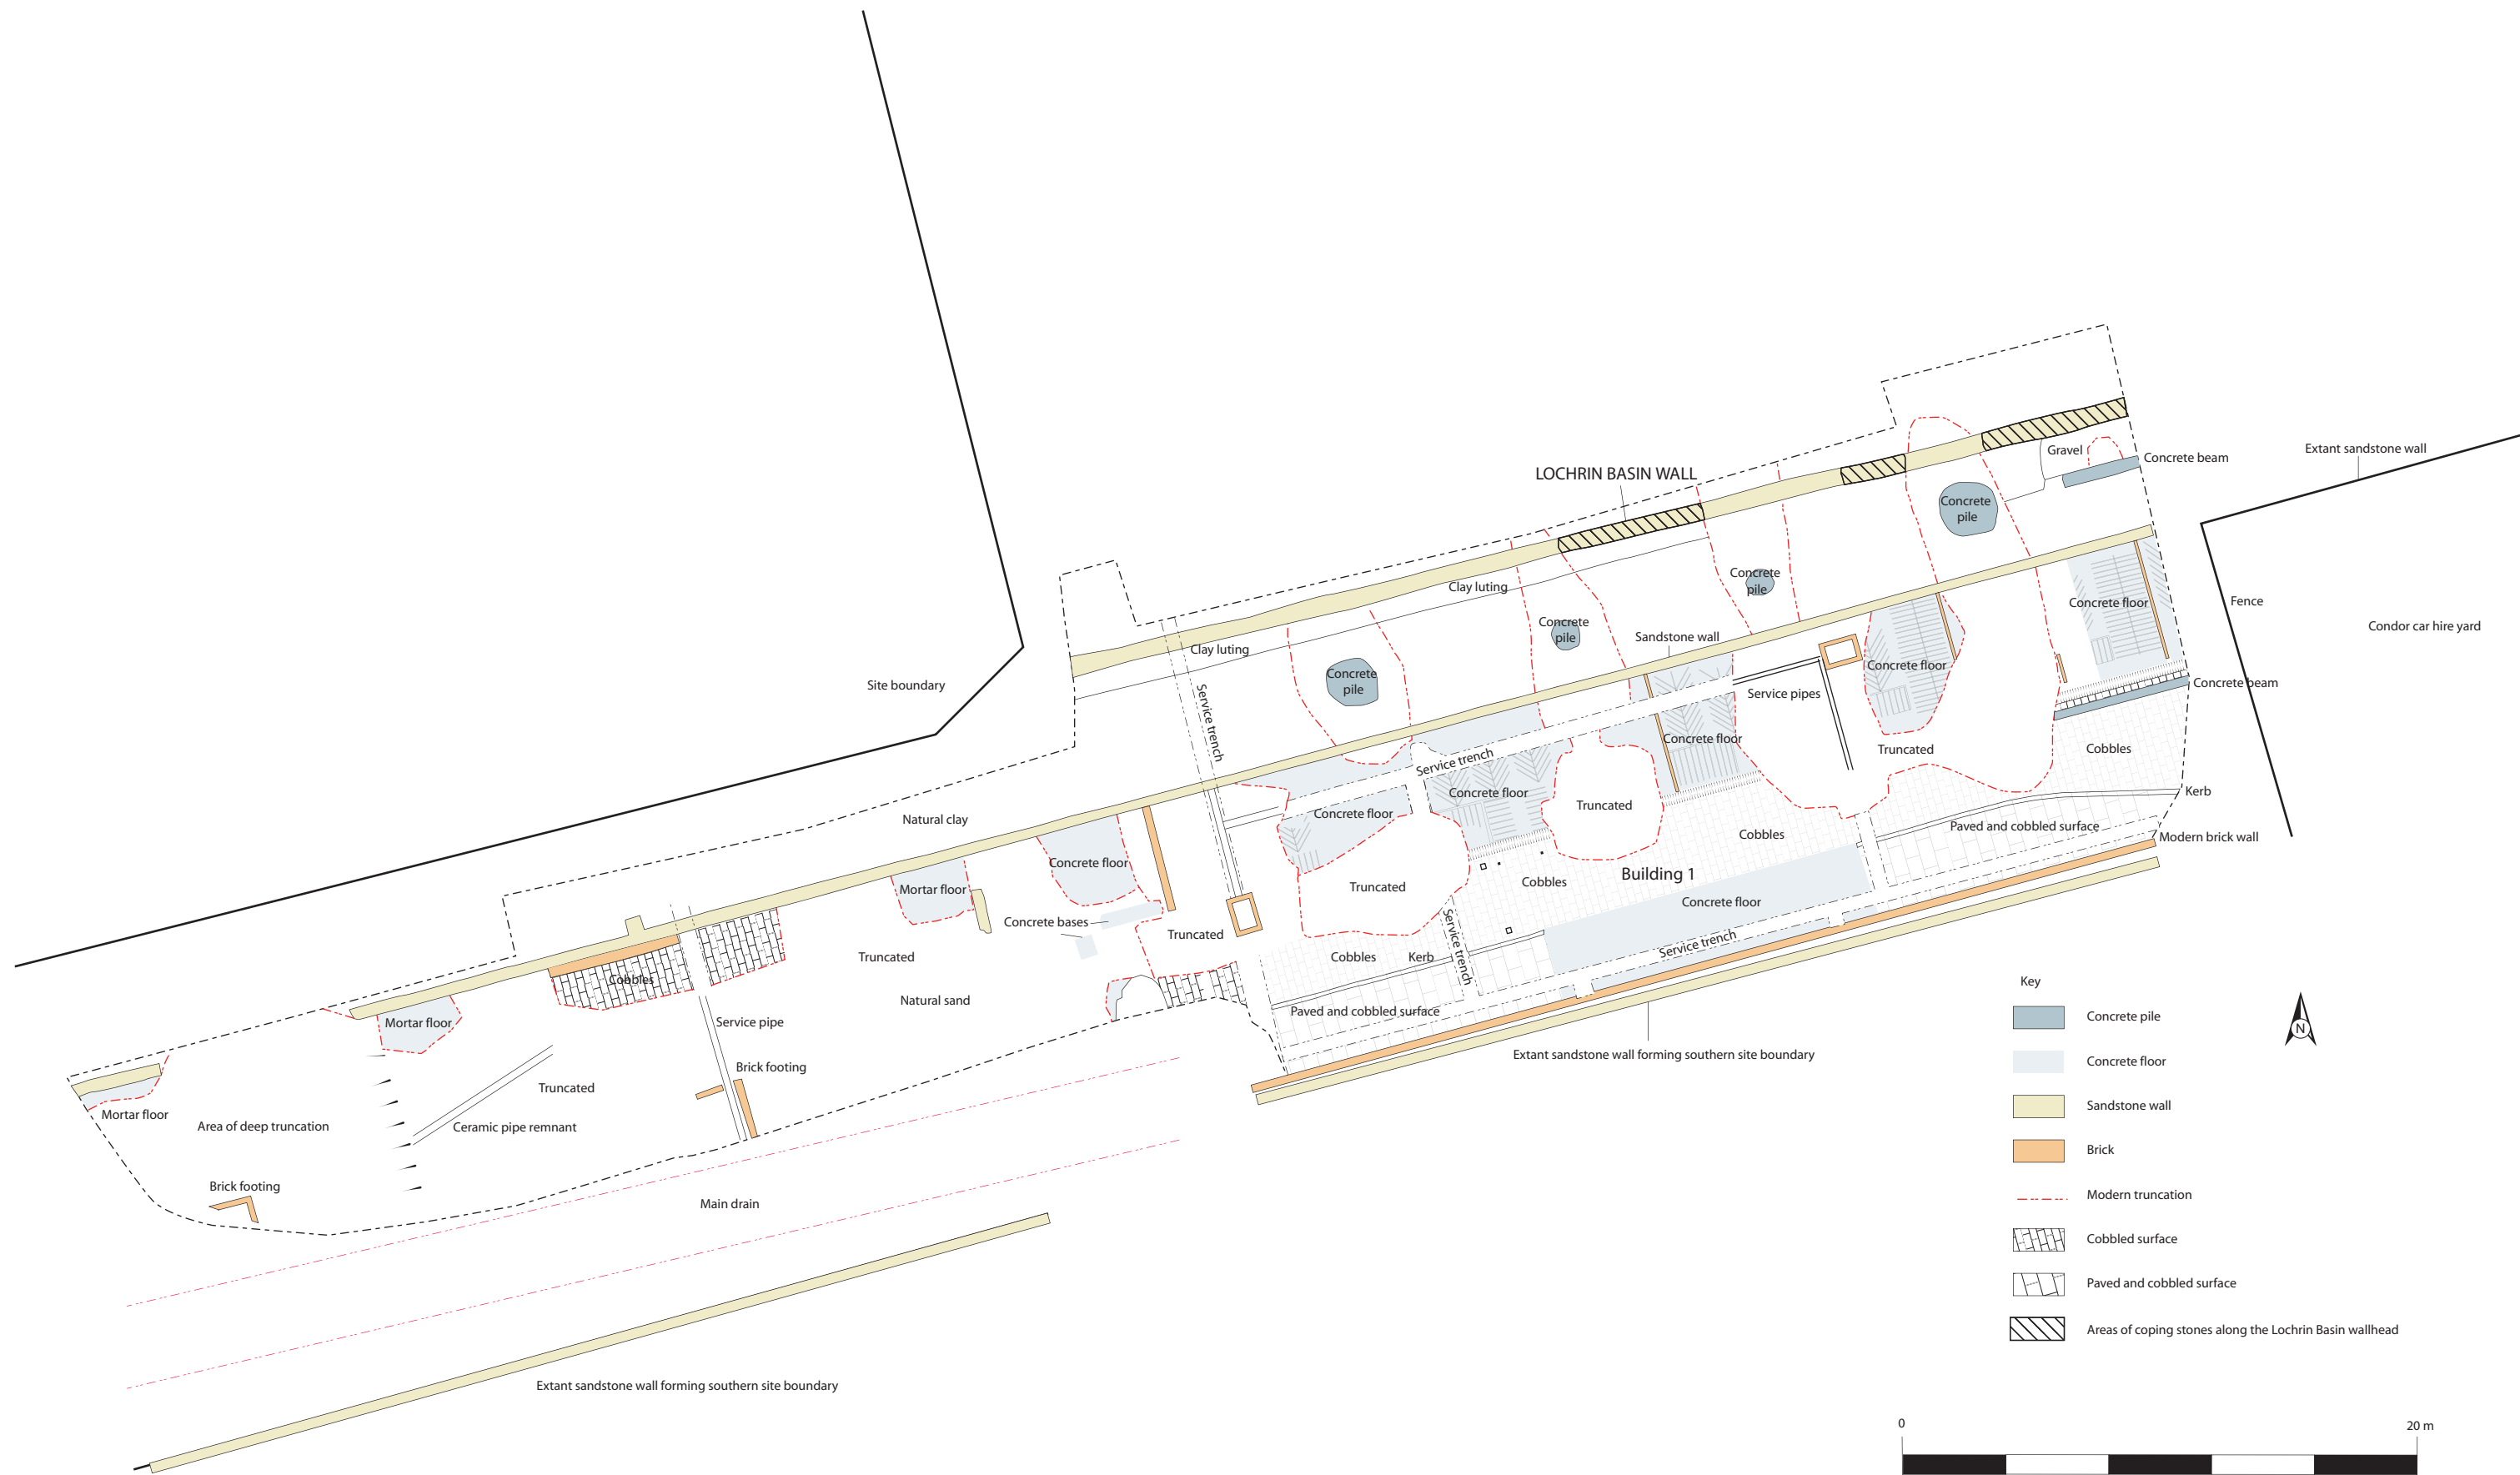
Figure 2: Plan showing location of principal features

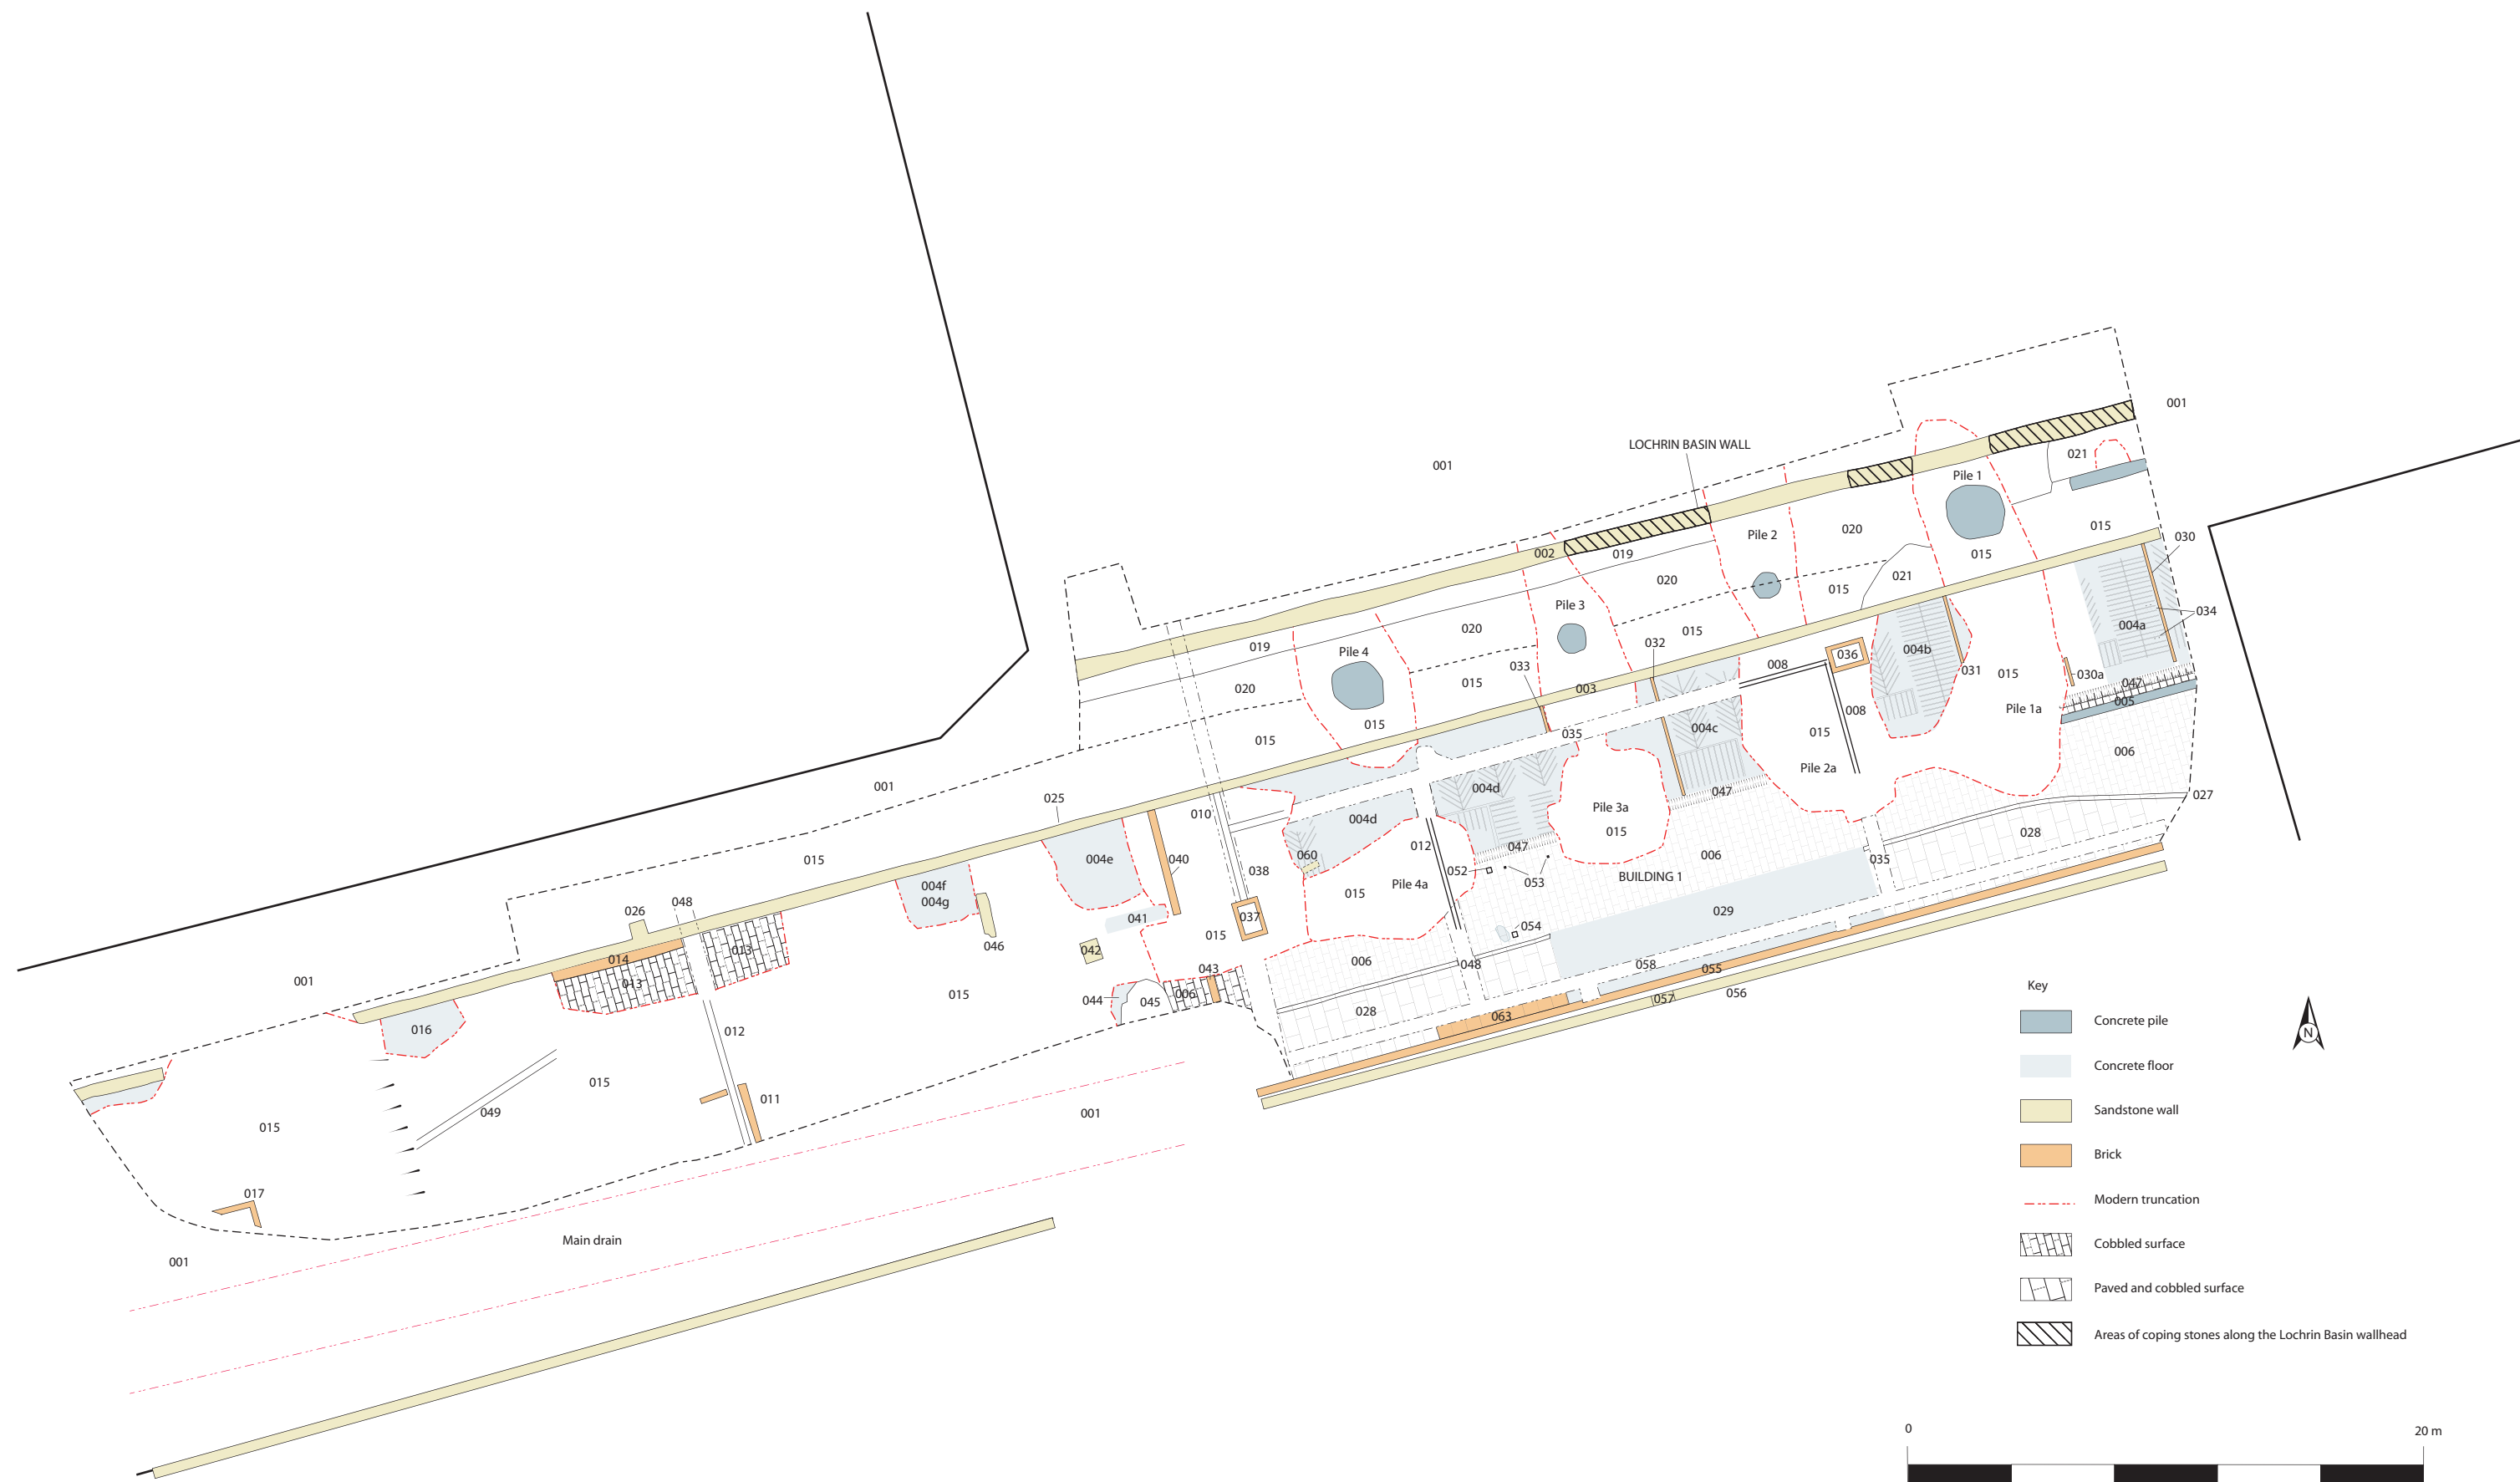
Figure 3: Plan showing location of Lochrin Basin wall and excavated features within Building 1

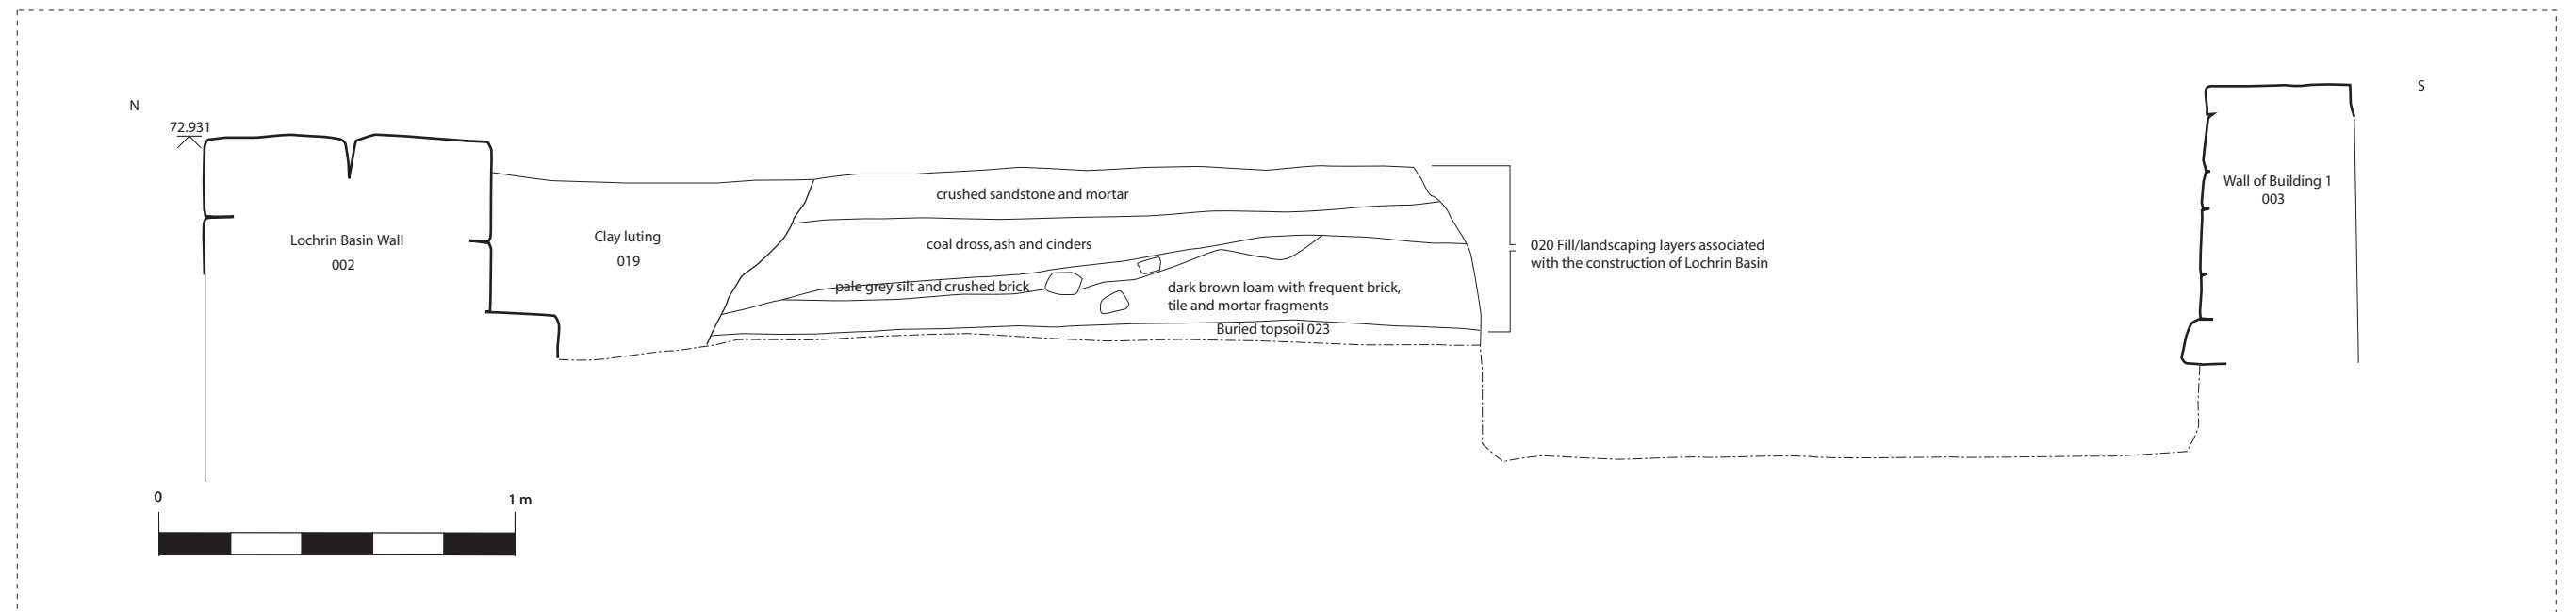
Figure 6: West facing section showing fill/landscaping deposits and clay luting south of wall 002

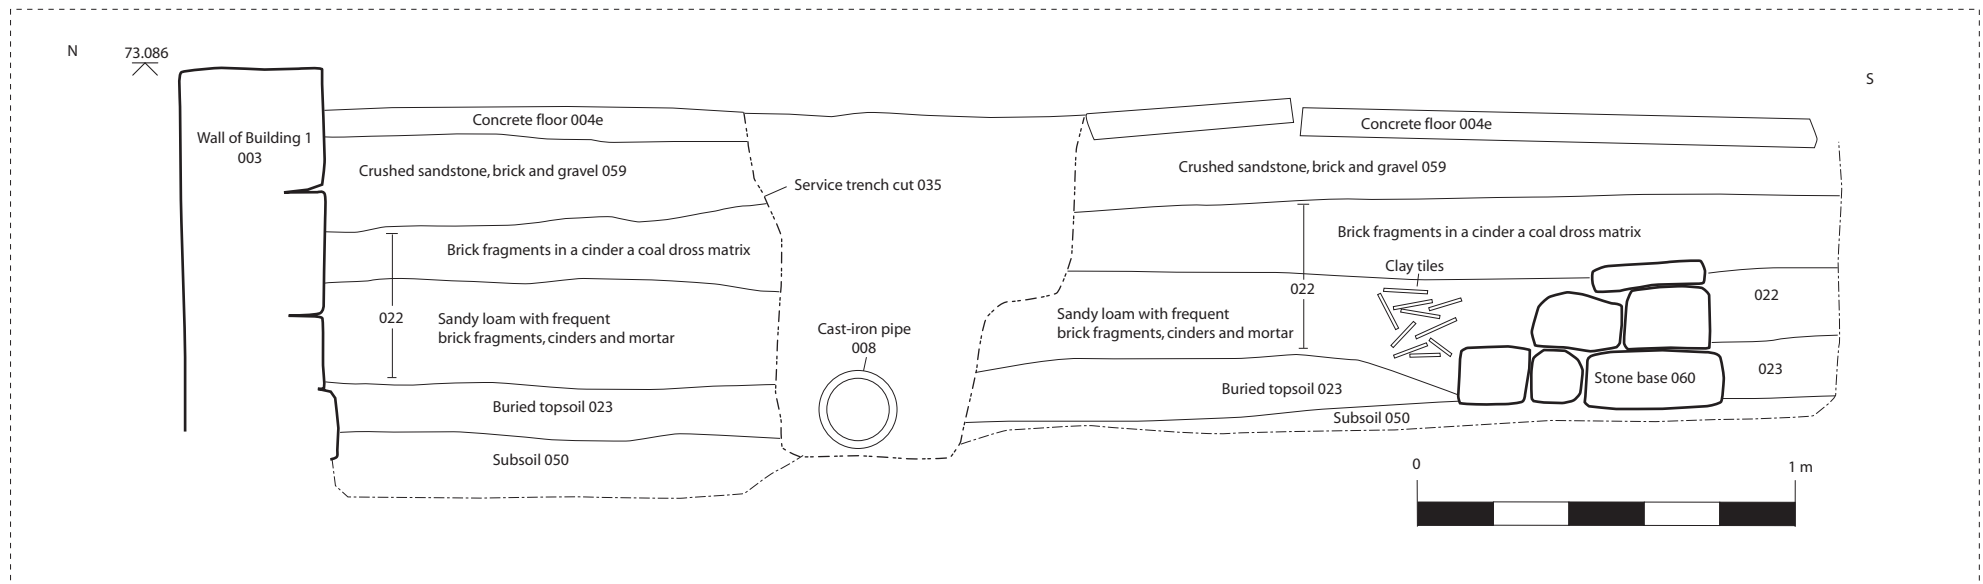
Figure 7: West facing section showing fill/landscaping deposits beneath concrete floor 004e, within Building 1 and stone base 060 south of wall 003

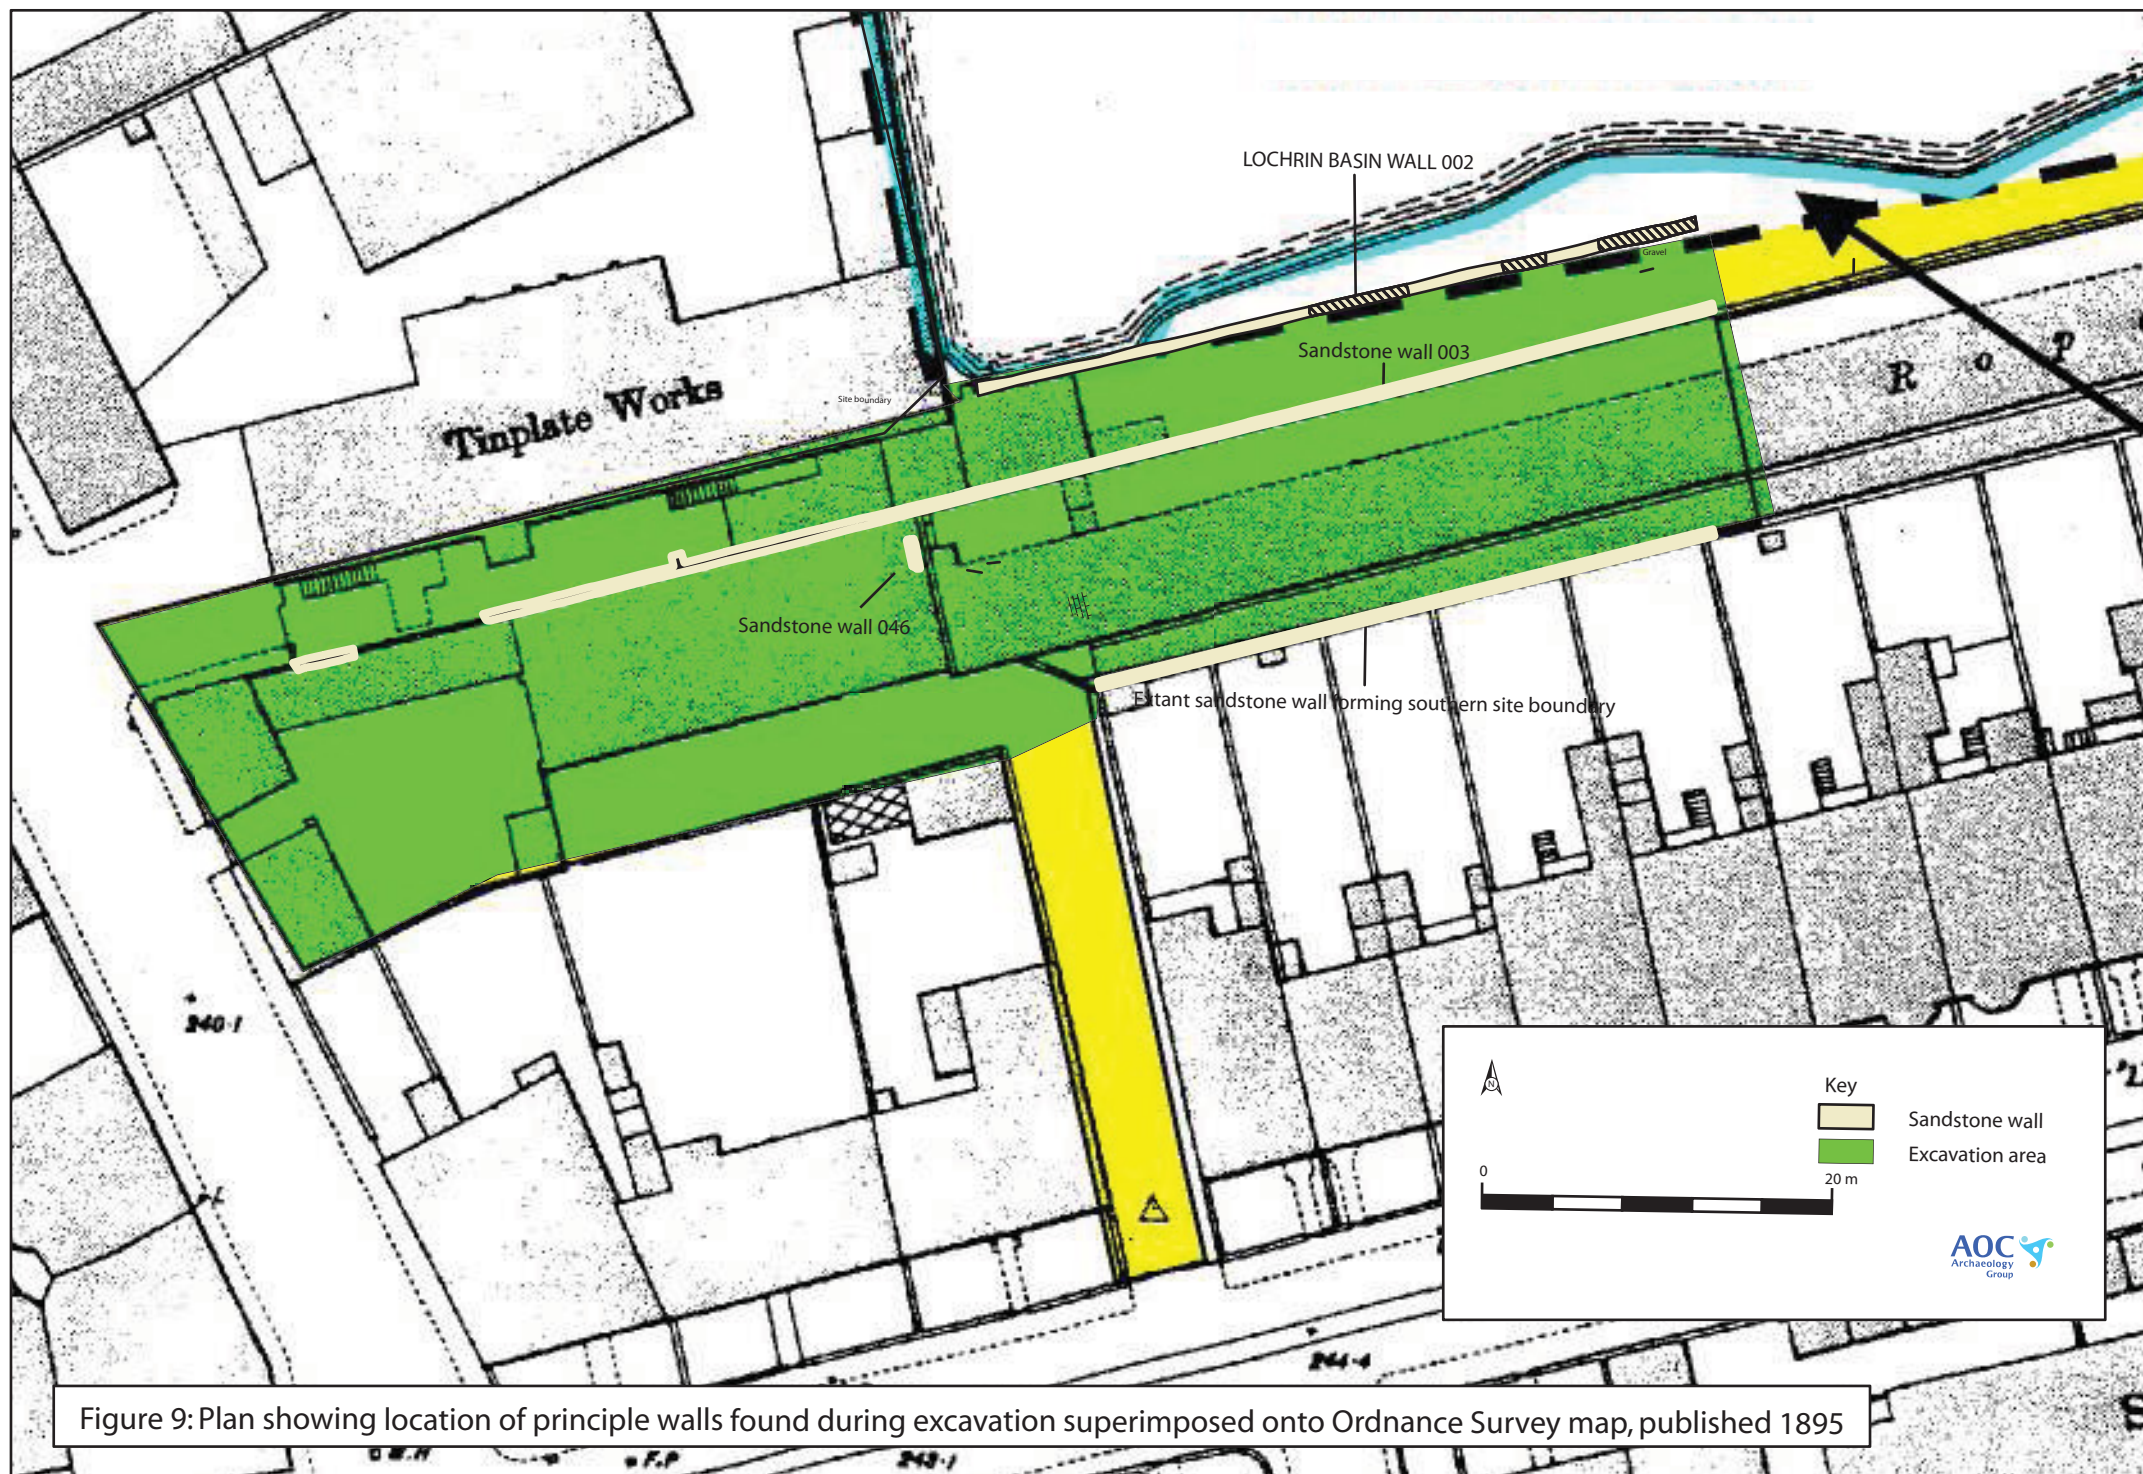
Figure 9: Plan showing location of principle walls found during excavation superimposed onto Ordnance Survey map, published 1895

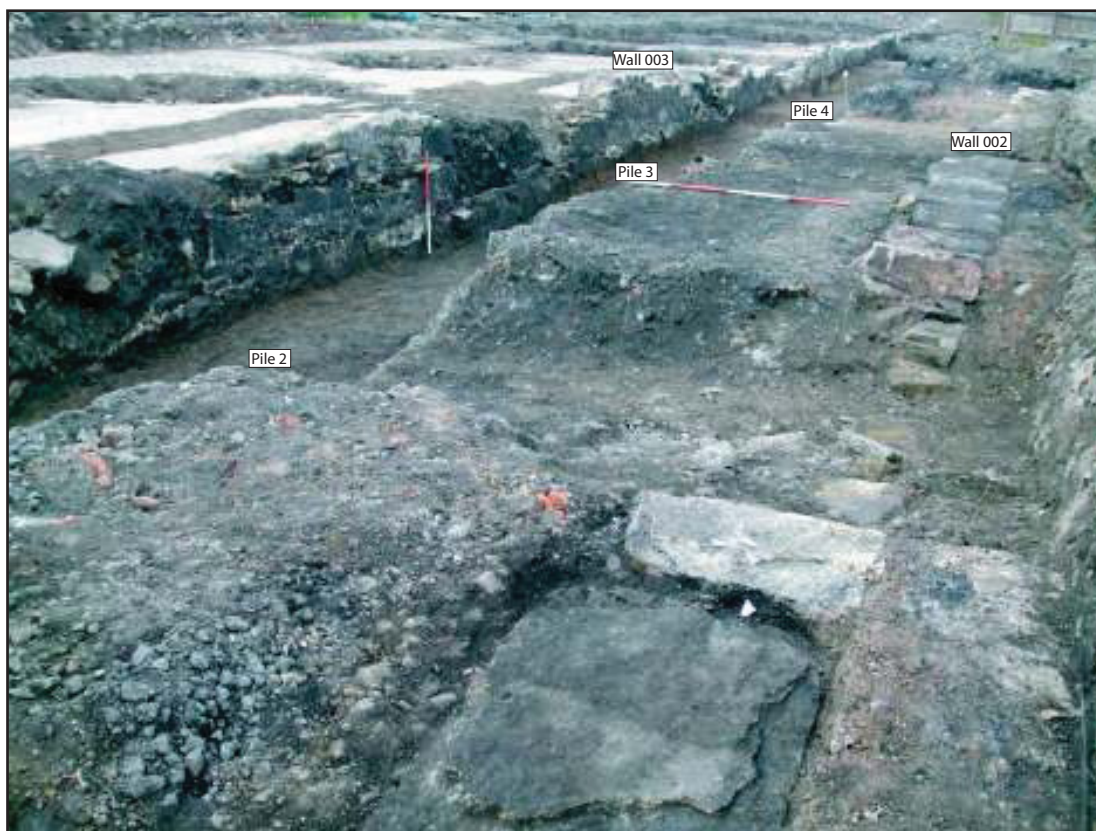
Plate 1: General view of Lochrin Basin wall 002 and north wall of Building 1 003, from the north east

- 6.2.1 Part of the southern limit of the Lochrin Basin wall [002] was recorded in the north-eastern part of the excavated area. The exposed section measured 42 m long by 0.7 m wide and was excavated over a short distance on its northern side (internal to the basin) to a maximum depth of 1 m. The wall was constructed from large, roughly dressed sandstone blocks, brought to course, with squared edges bonded by a lime mortar forming the outer faces. Contained within the wall faces was a mortar bound rubble core. Three sections of the wall survived to the wall head and still retained the original coping stones. These comprised large sandstone blocks with squared edges. The upper and front facing planes of these stones featured a chiselled broached finish with the upper leading edge of the stones finished with a round bevel. Occasional degraded metal fixings were visible on the upper surfaces of the coping stones. A band of clay luting [019] preventing water ingress was recorded abutting the southern side of the wall (Figure 18). Sections of the wall were adversely affected by the partial removal of a series of concrete piles, [Piles 1 - 4] associated with more recent occupation of the site.

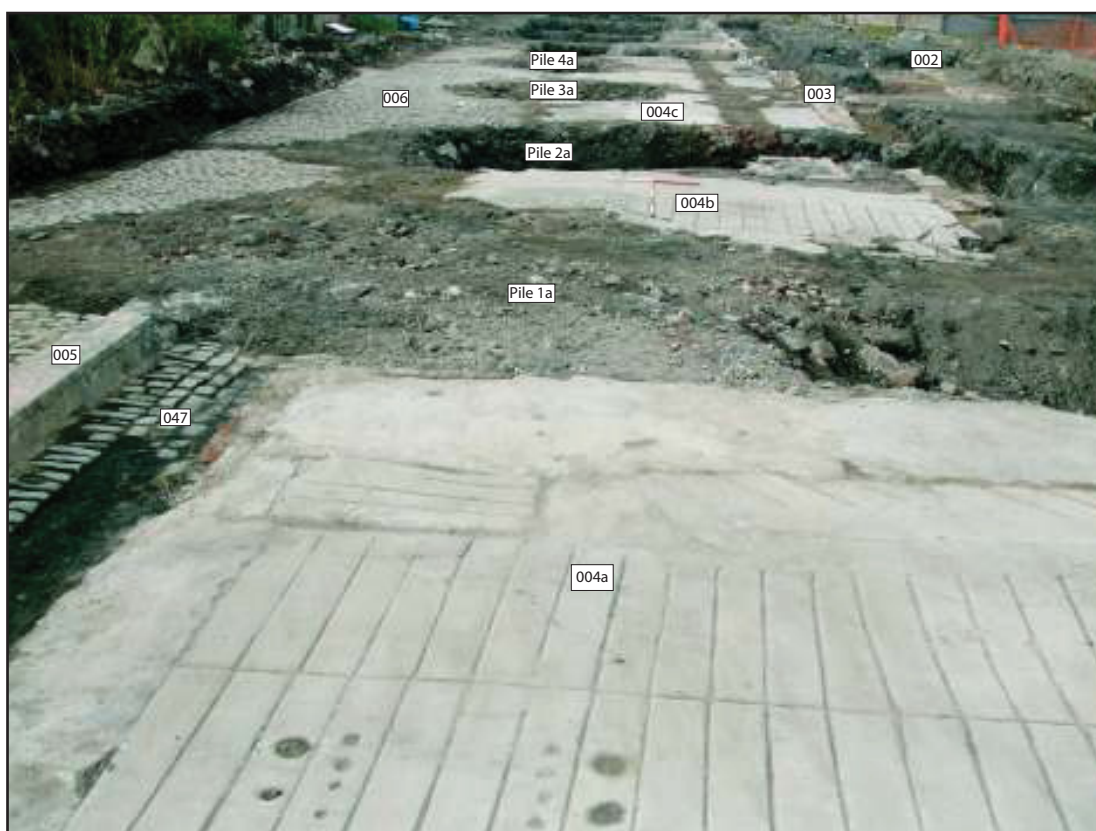
Plate 2: General view of floor surfaces within Building 1, showing truncation by modern piling and services associated with later occupancy of the site from the east

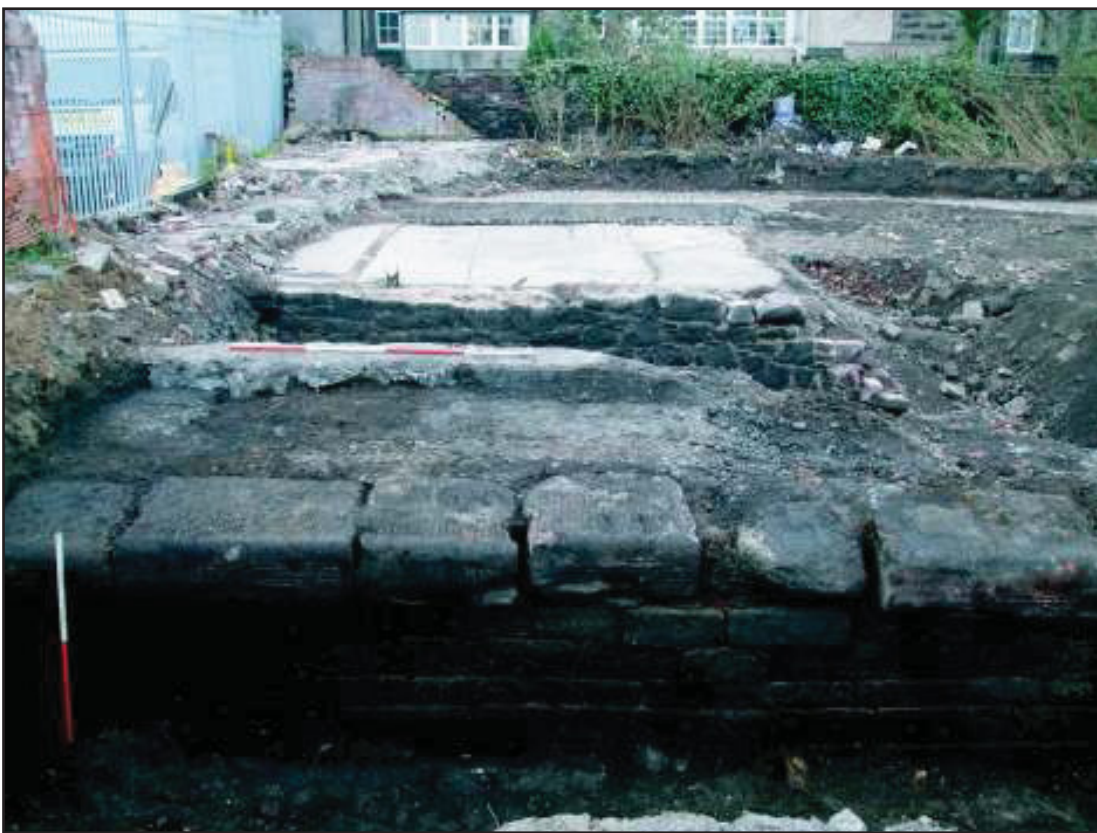
Plate 3: View of Lochrin basin wall 002, gravel surface 021 and the eastern end of Building 1, from the north

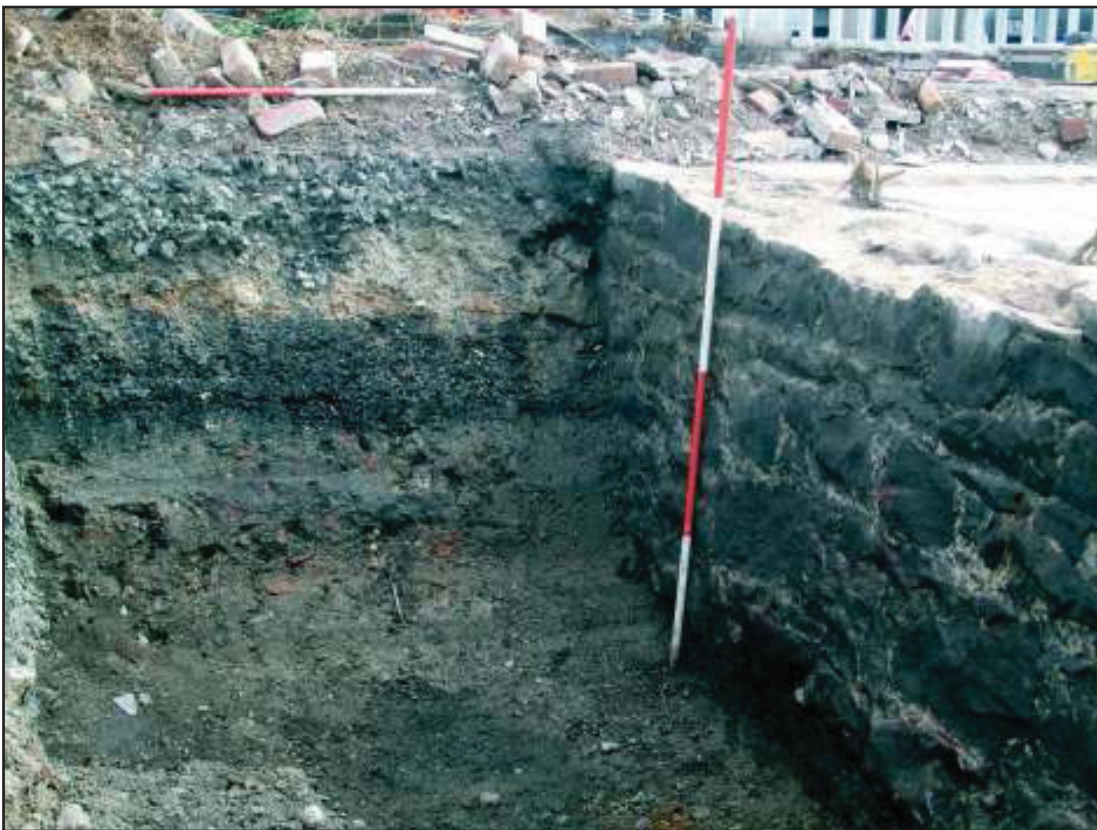
Plate 4: West facing section showing fill/landscaping layer 020 beneath type II gravel 021 which formed the original surface between Lochrin basin and Building 1

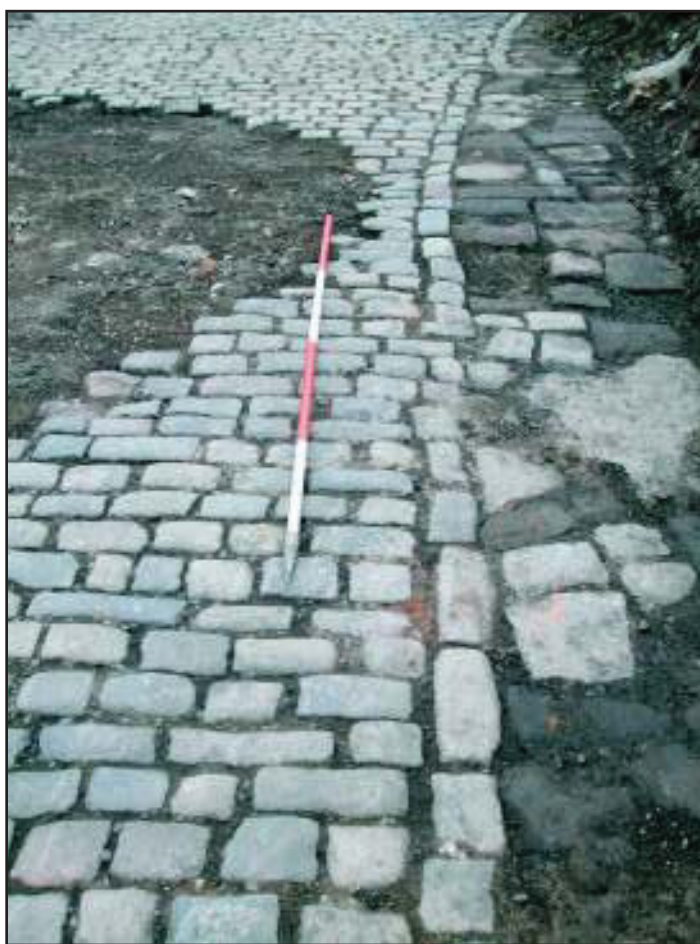
Plate 5: View of Cobbled surfaces 006, 028 and kerb 027, from the west

6.6.1 Two cobbled surfaces were found along the southern edge of the excavated area. These comprised of an area of regular whinstone cobbles set on edge [006] which incorporated a shallow gully drain [047] where it abutted concrete floors [004a]-[004e] to the north. The second cobbled surface [028] comprised a mixture of regular and irregular whinstone cobbles set on edge and large sandstone blocks set on bed; towards the western extent an area of red brick [063] was found making up the fabric of this surface. These two surfaces were divided by and both abutted a kerb of regular whinstone cobbles [027] laid lengthways

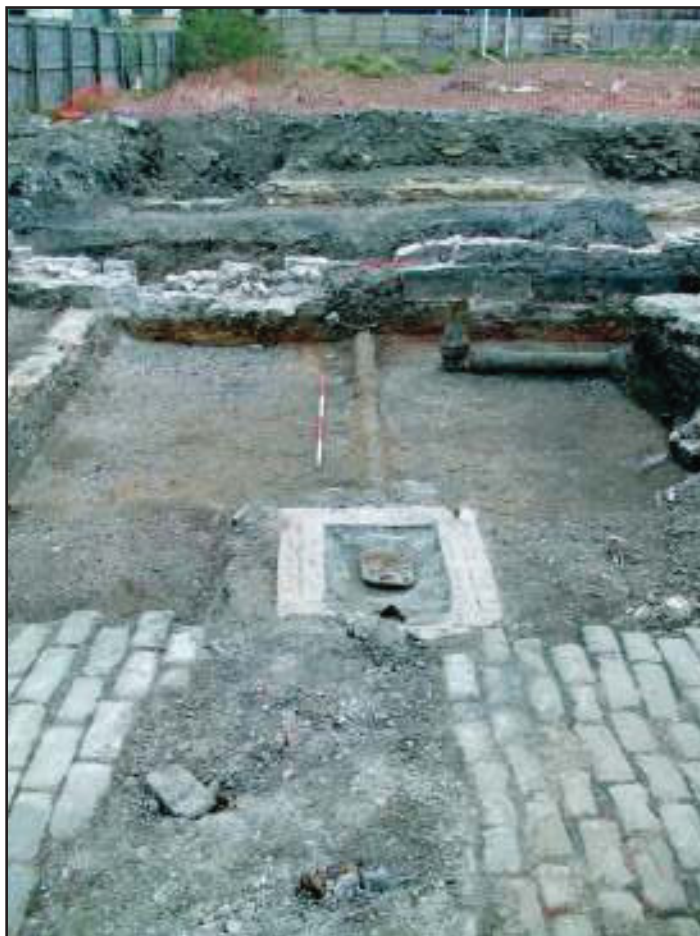
Plate 6: Manhole 037 and associated service duct 038 cutting
cobles 006, walls 002 and 003, from the south

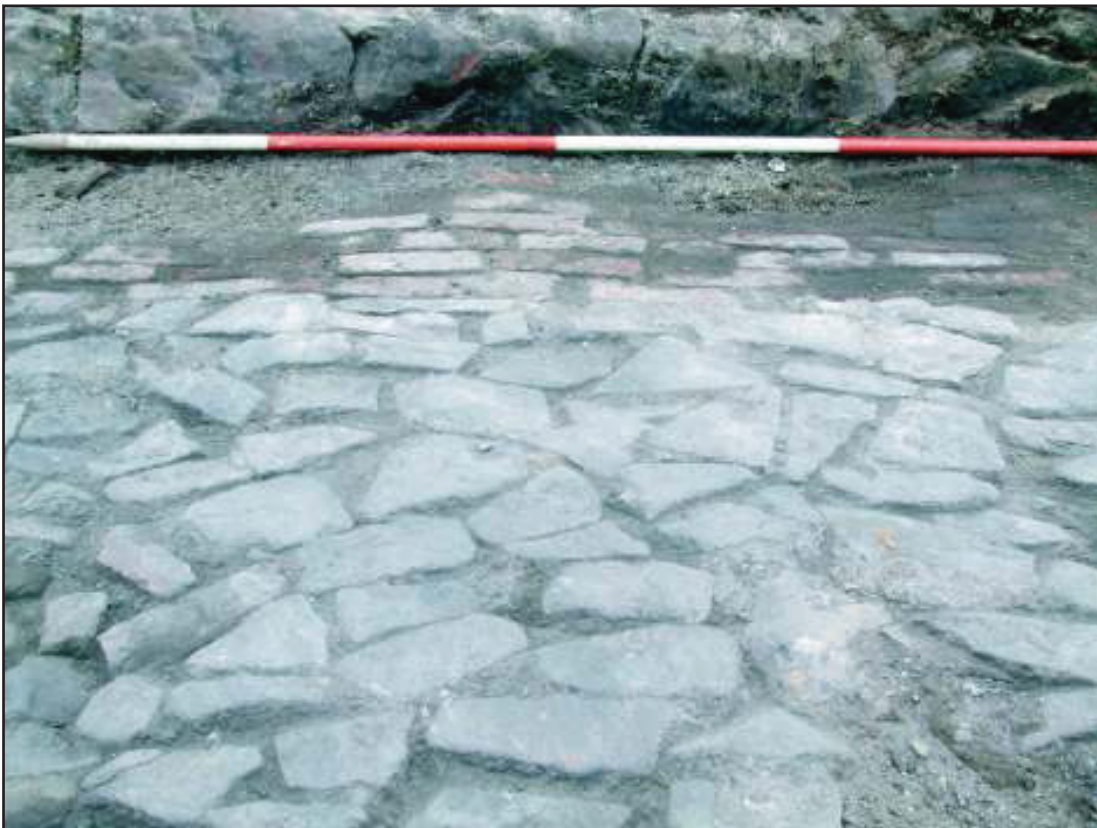
Plate 7: View of Cobbled surface 013 and brick surface 014 abutting the south side of wall 003 in Building 1

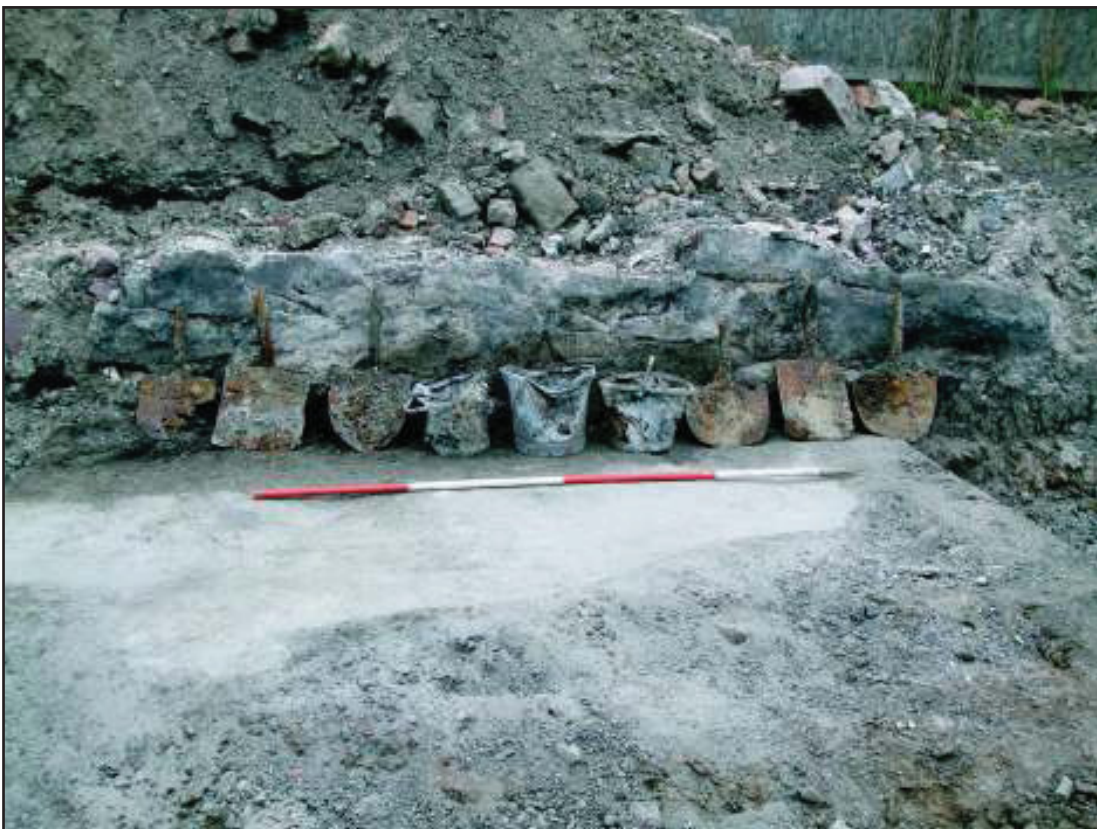
Plate 8: View of mortar floor 016 towards the west end of Building 1 abutting the south side of wall 003. An assortment of rusty shovels and buckets were found on top of the floor

- 6.7.1 Within a truncated sequence of two mortar floors, the first [004f] was found overlying a fill layer of cinders and ash [051] in turn overlying degraded mortar floor [004g]. These isolated surfaces abutted the south side of wall [003] and were located on an island of undisturbed ground between cobbles [013] to the west and concrete floor [004e] to the east. The lower of the two floors [004g] was found directly overlying a remnant of cobbled surface [061]. A further isolated, truncated remnant of a mortar floor was recorded towards the western end of the site. This again abutted the southern edge of wall [002]. An assortment of rusty buckets and shovels were found lying on the surface of this floor during excavation.

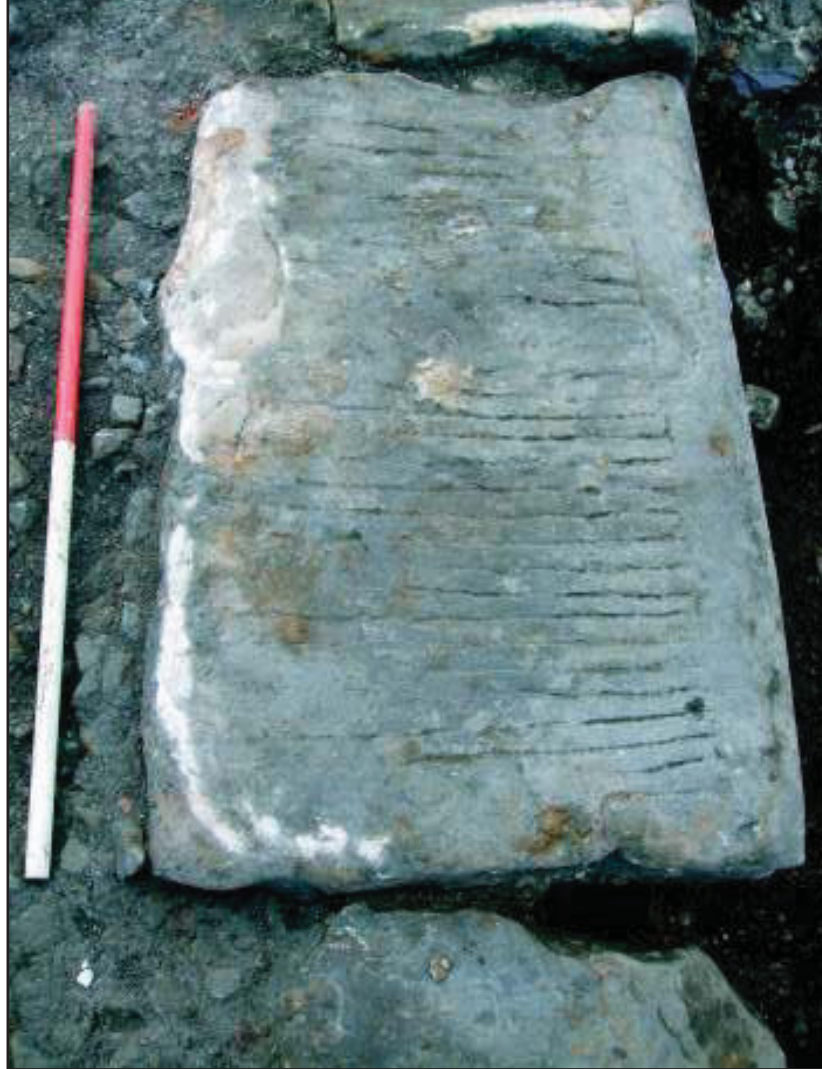
Plate 9: Detail of coping stone along the top of Lochrin Basin Wall 002 showing chiseled broach marks and rounded bevel along the leading upper edge.

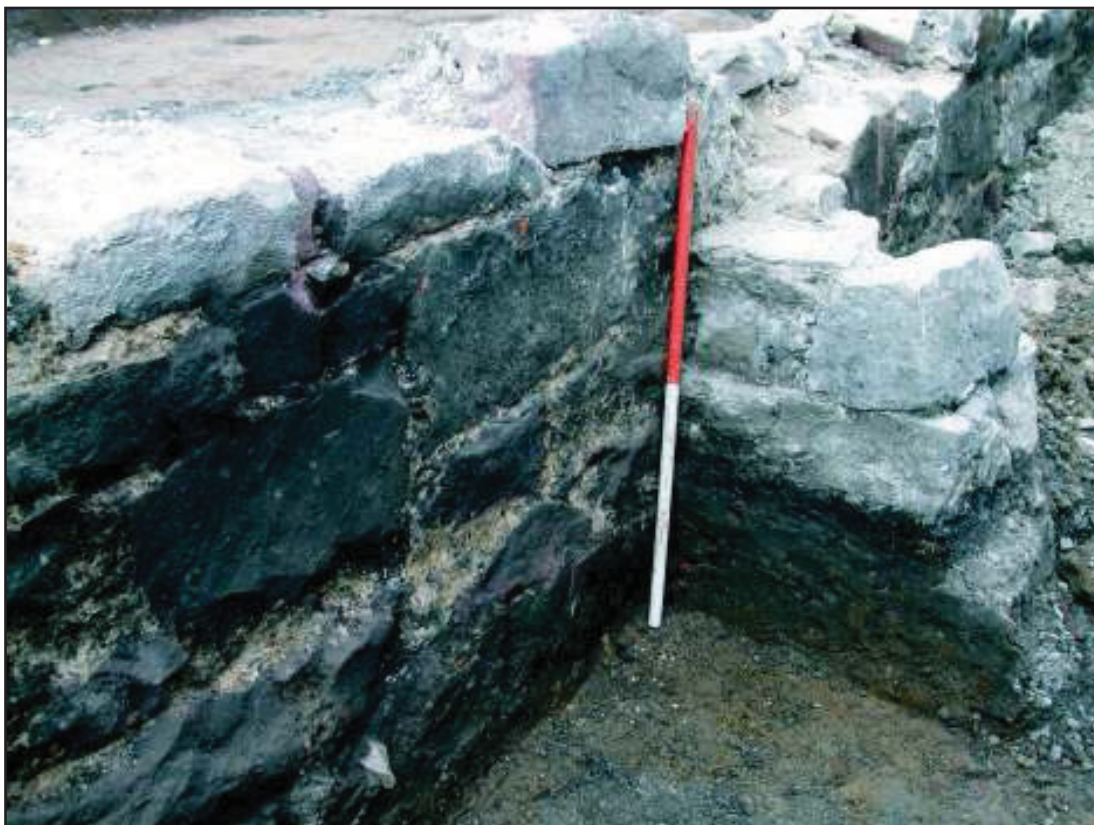
Plate 10: Buttress 026 abutting the north side of wall 003 from the north-east
