Lochrin Basin, Tollcross, Edinburgh Excavation: Data Structure Report

Data Structure Report

AOC Project No: 20144

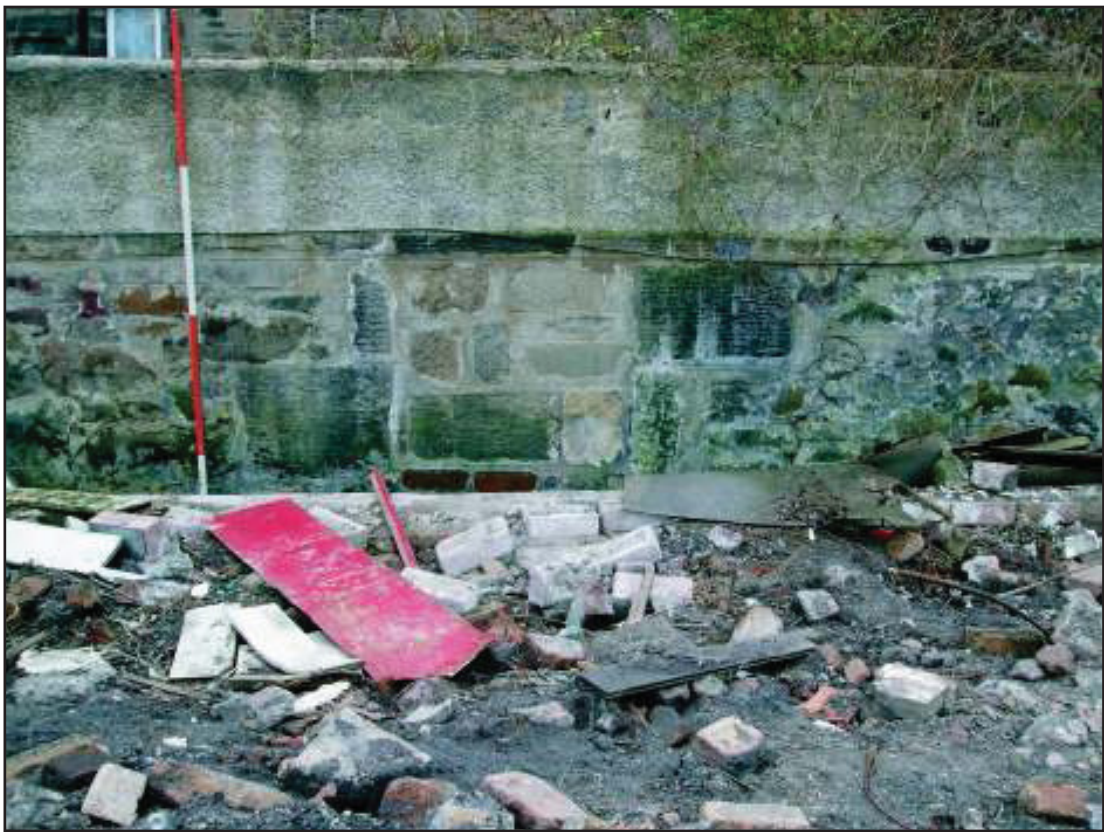
Plate 11: Detail of blocked opening 057 in external elevation wall 056

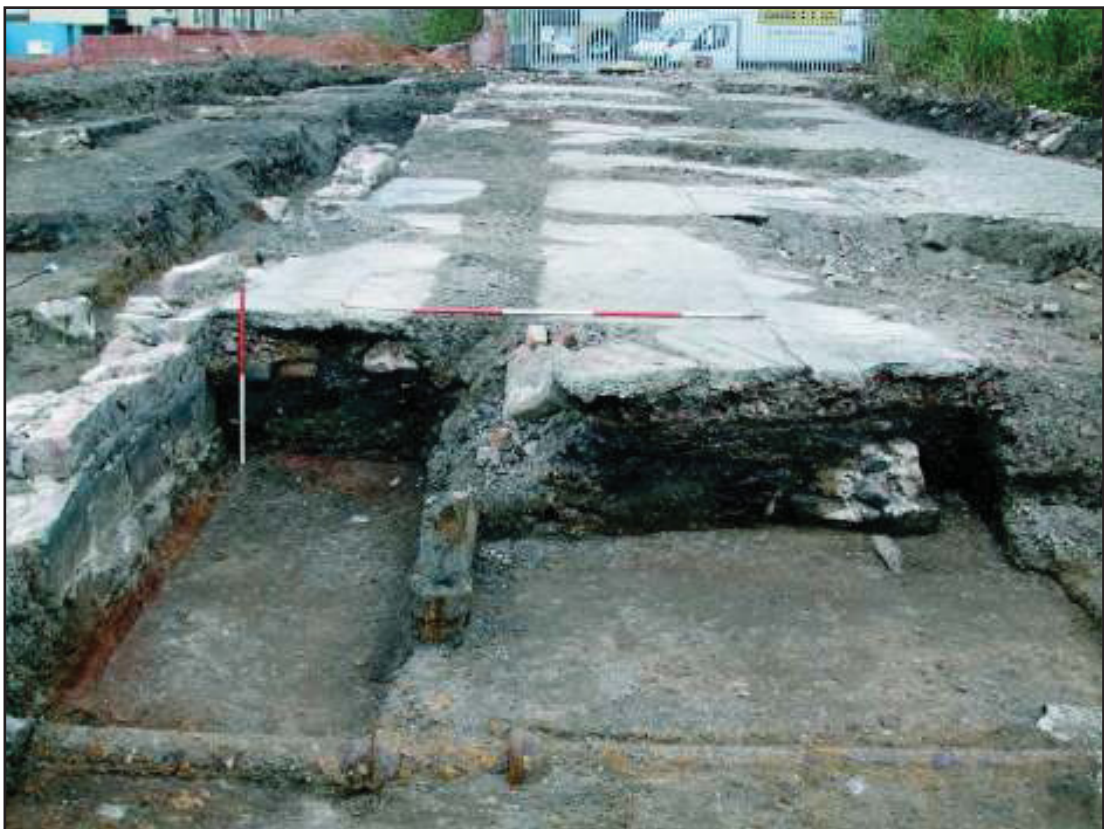
Plate 12: West facing section showing deposits below concrete floor 004d, stone founded base 060 and general truncation of site by services and grubbing out

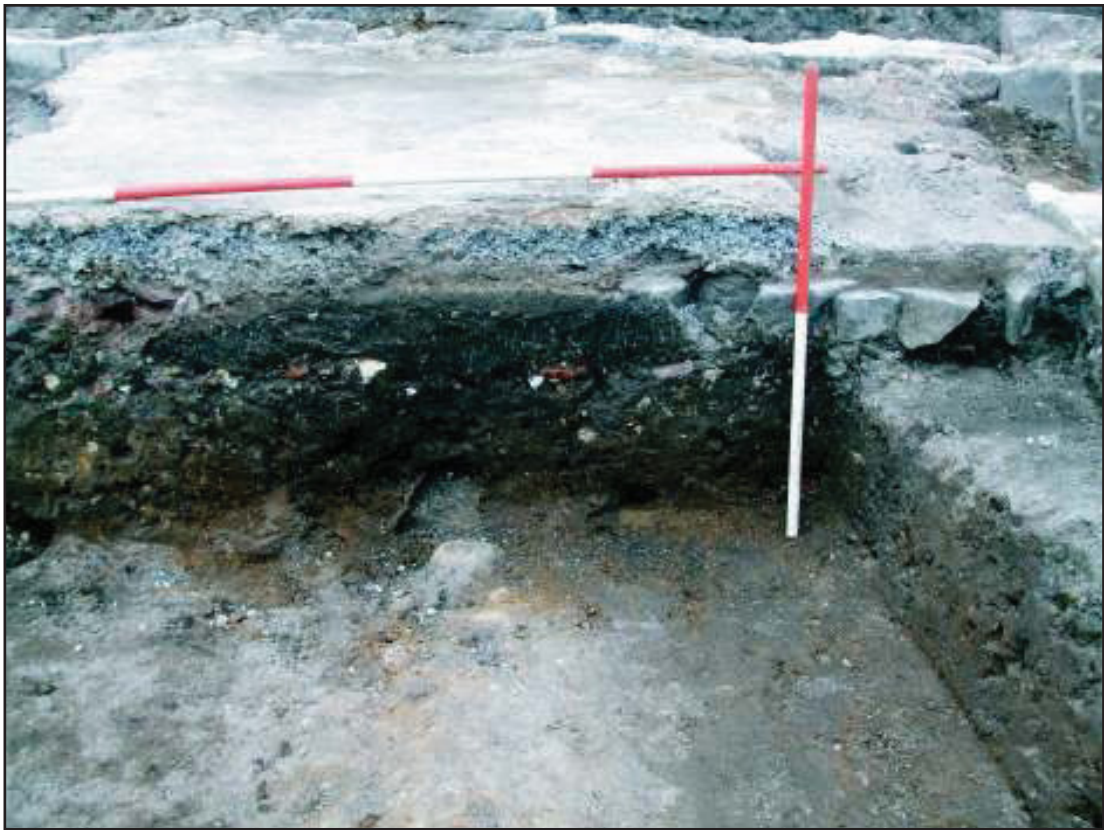
Plate 13: South facing section showing mortar floor 004f overlying mortar floor 004g overlying a possible continuation 061 of cobble surface 013 to the west.

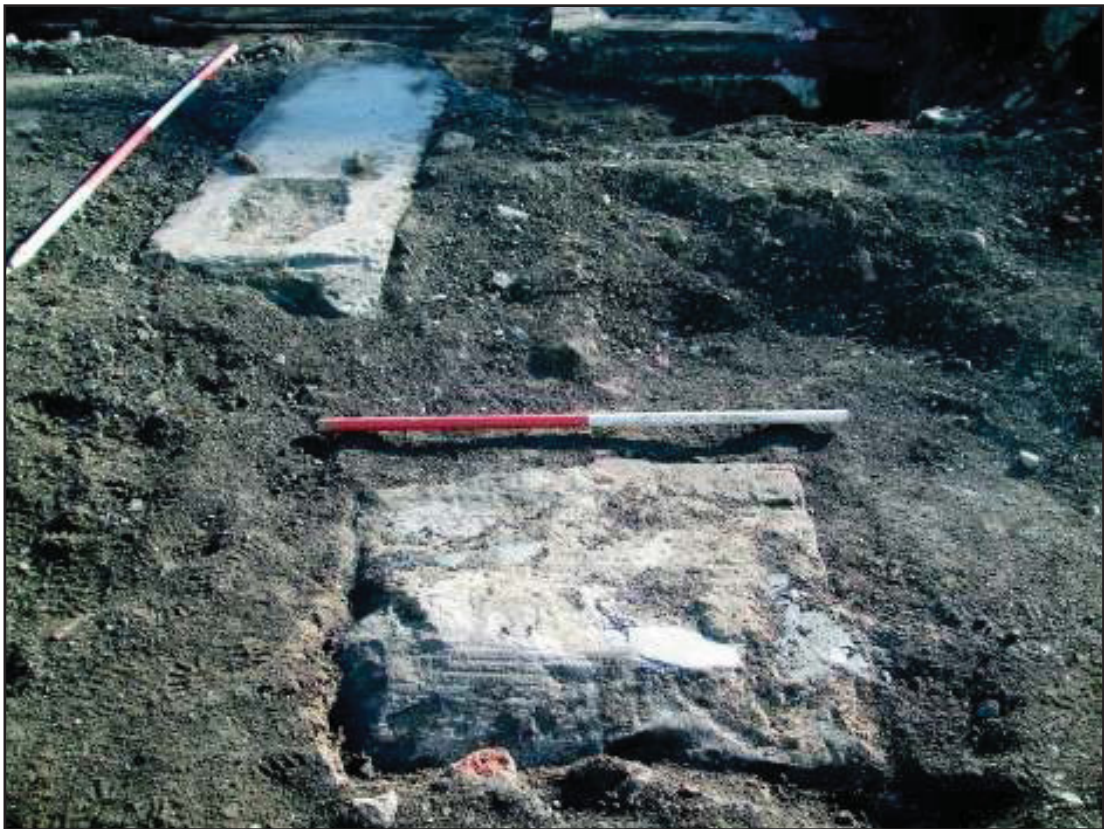
Plate 14: Concrete base 041 to rear and concrete base 042 in the foreground

- 6.8.1 Two concrete bases were recorded in close proximity to one another adjacent to part of the site disturbed by the insertion of a manhole and associated service pipe [037] and [010] respectively. Base [041] consisted of a rectangular structure with four metal bolts protruding vertically from its upper face. The second [042] consisted of a square structure but was devoid of any obvious fittings. Base [041] is likely to be associated with the site of plant within Building 1 but it remains unclear as to the function of base [042]. A mortar bonded sandstone founded structure [060] was visible in section beneath concrete floor [004d]. This appeared to pre-date Building 1. After recording and subsequent removal of the overlying concrete floor [004d] this feature was found to be diminutive, poorly constructed from small sandstone rubble and not to have any structural integrity. Its function remains unclear.

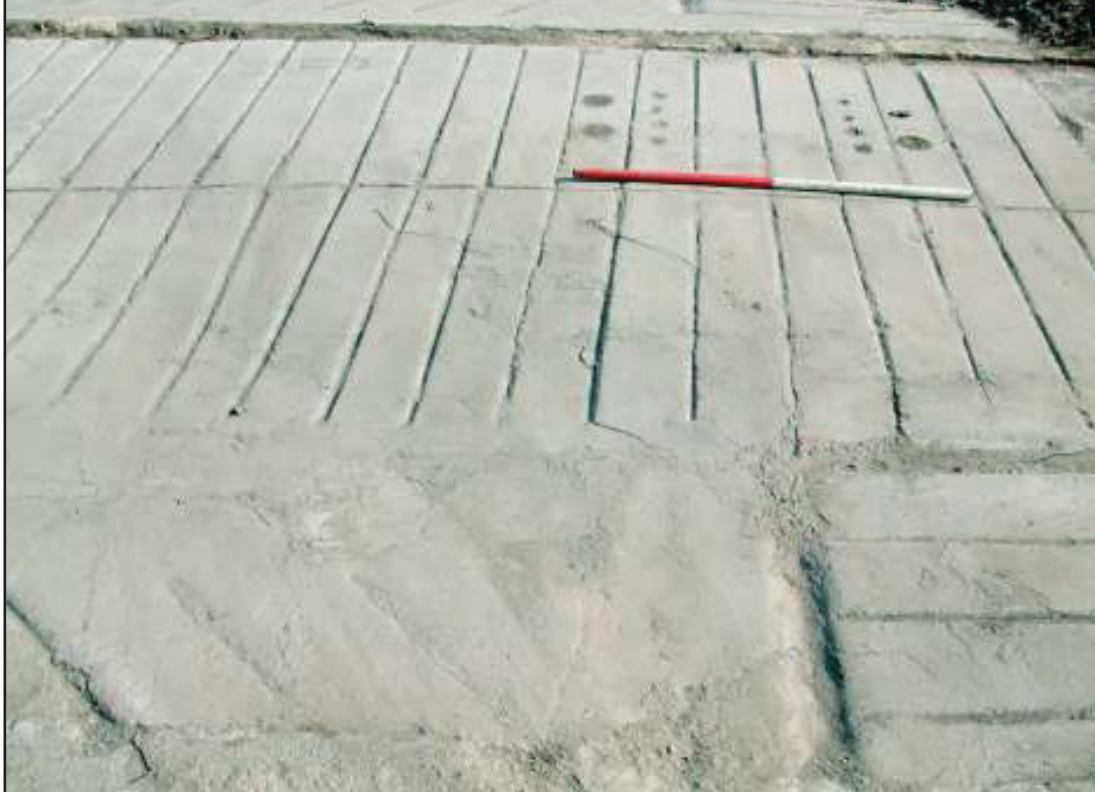
Plate 15: Concrete floor 004a showing plant base 034 and brick partition wall 030 visible towards the rear of frame

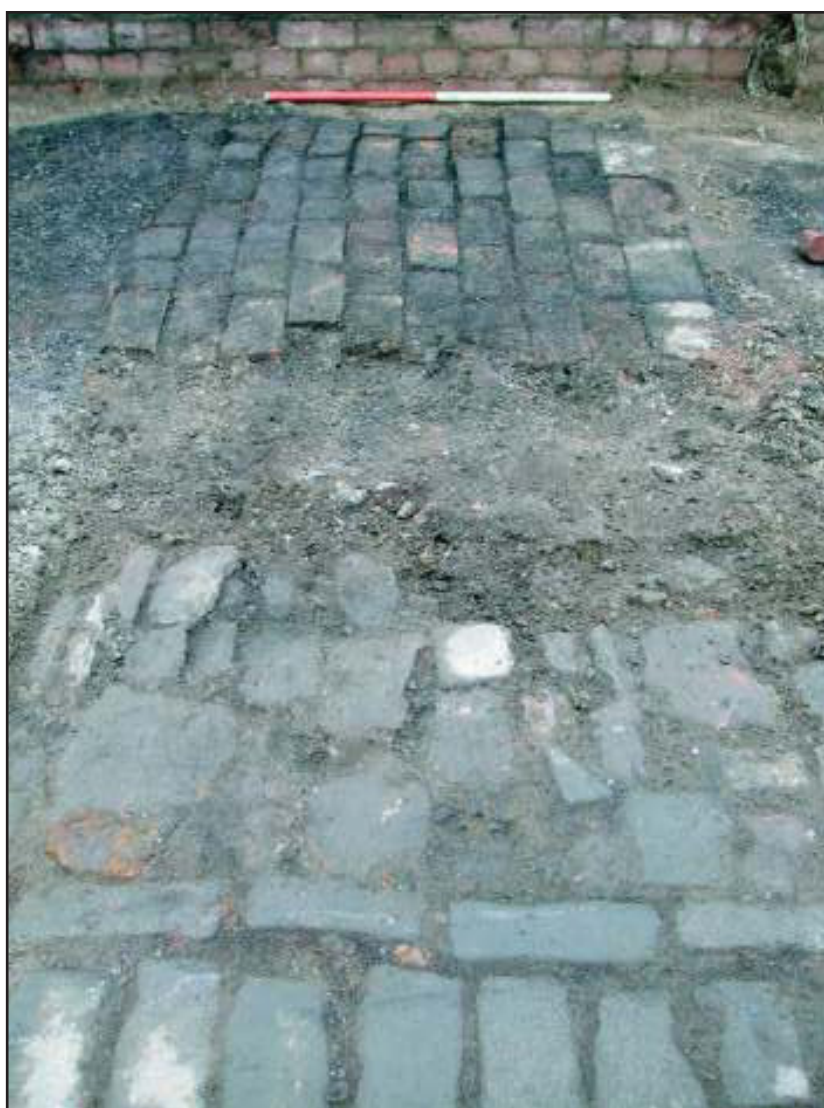
Plate 16: Brick element 063 of cobbled surface 028 from the north

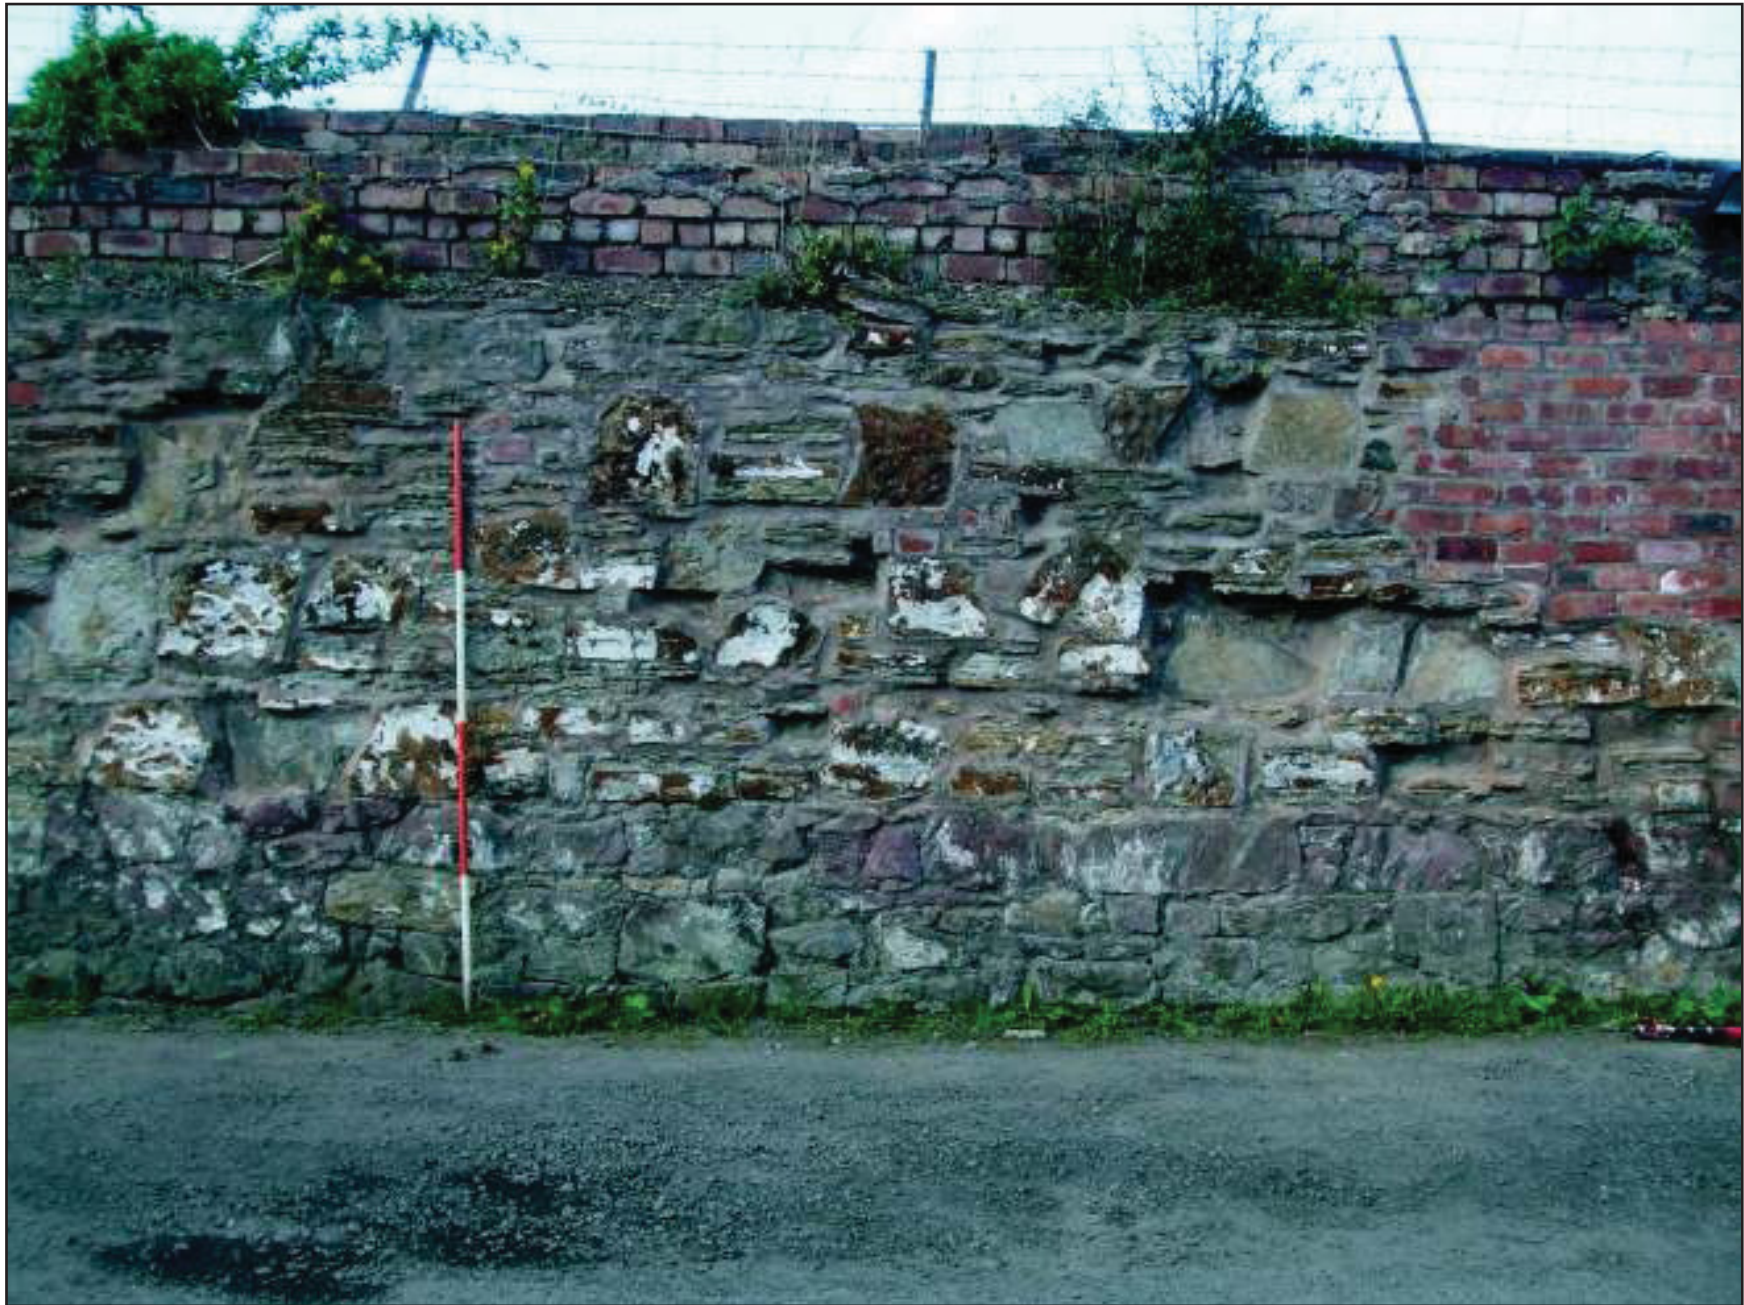
Plate 17: Extant section of wall 003 to east of the excavation area, the lower courses of red sandstone possibly forming an early 19th century property boundary. The wall above shows signs of additions in both brick and stone.
