# Beinn nan Oighrean: Watching Brief Report

April 2009

**AOC Project No:** 21132

## 1 NON TECHNICAL SUMMARY

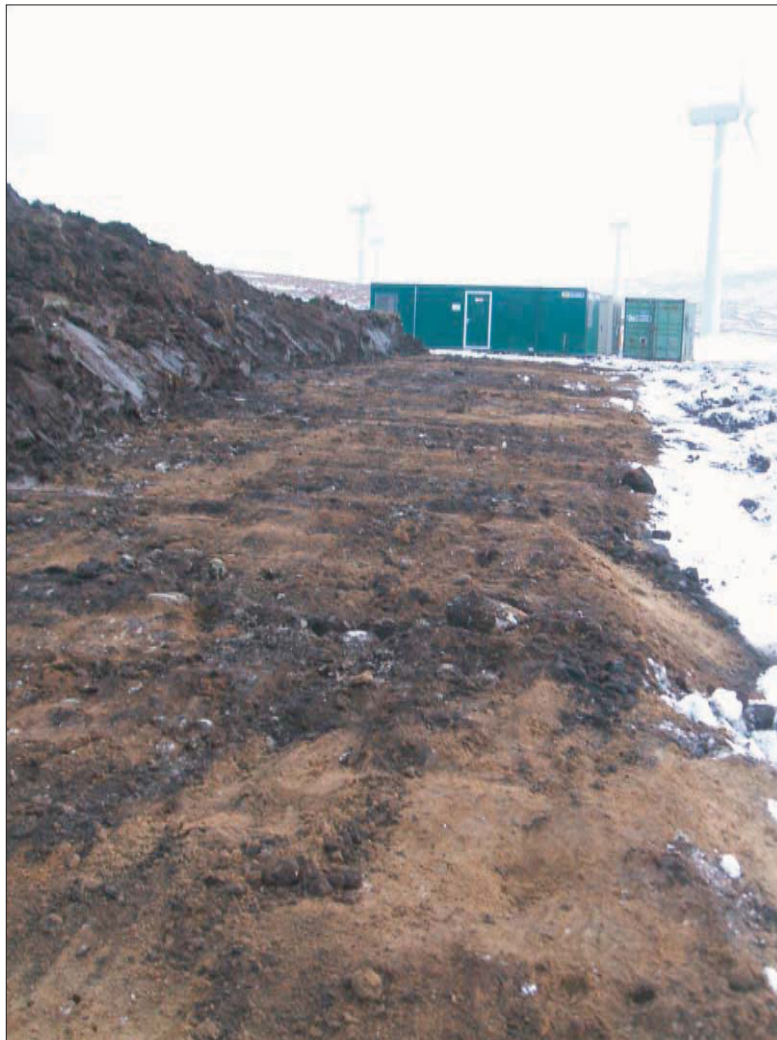
Plate 1: General view after peat stripping haul road and temporary lay down area, from the north

6.1.1 A corridor measuring 40 m long by 4 m wide linking the borrow-pit and the new access road immediately east of the hard standing for existing turbine 14 was stripped of peat up to 2 m in depth, this overlay stony sandy gravel. No archaeological features were seen.

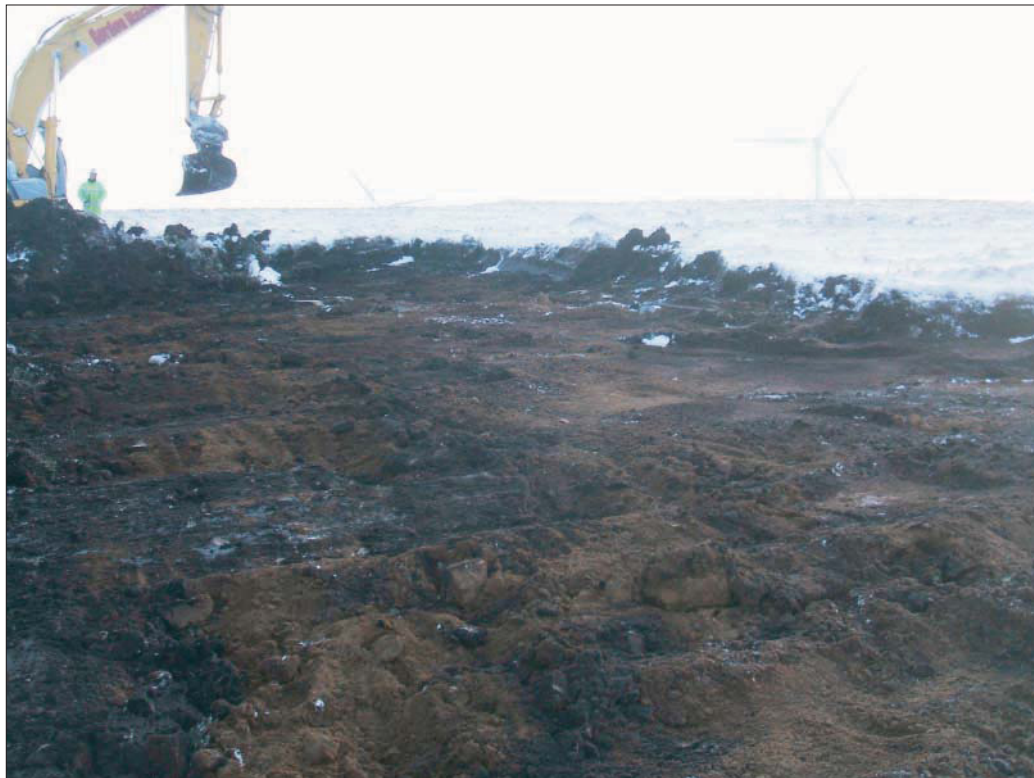
Plate 2: General view during peat stripping across borrow-pit, from the north-west

6.2.1 An area measuring 48 m wide by 65 m long was stripped of peat, this overlay stony sandy gravel. Approximately 0.6 m of peat was recorded at the northern limit of the borrow-pit, this reduced in depth to 0.25 m towards the southern extent of the borrow-pit. No archaeological features were seen.

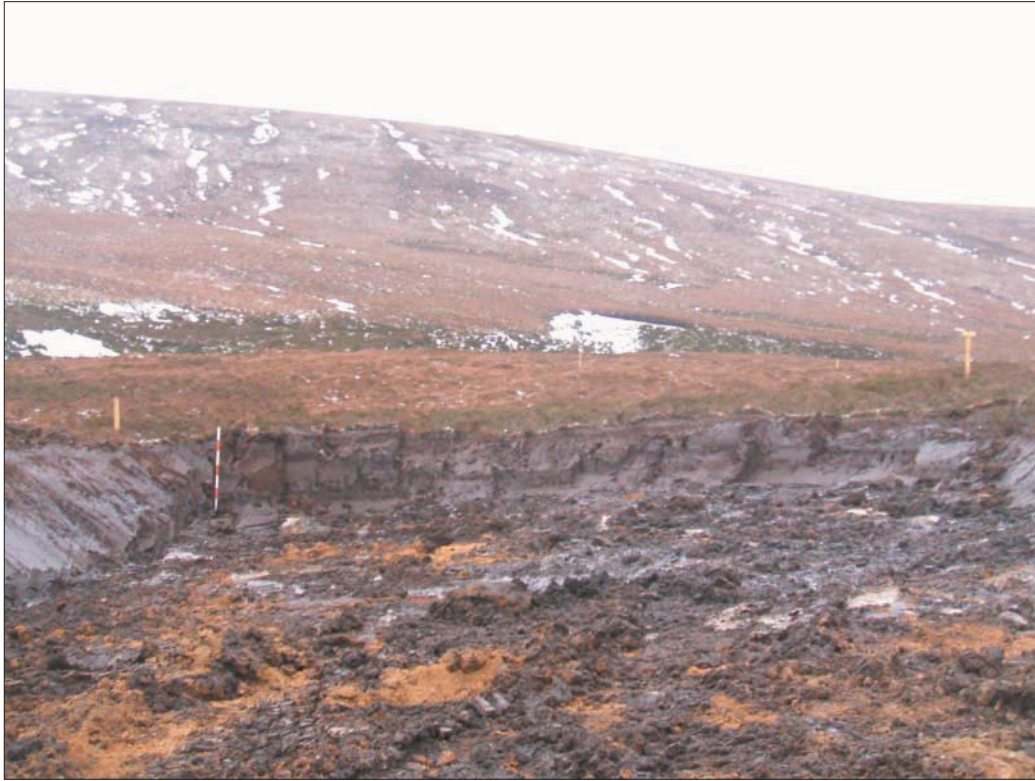
Plate 3: General view during peat stripping along the access road to turbine 1

6.3.1 Peat 0.4 m up to 2 m in depth was excavated along the course of the access road to the new turbine bases and associated hard standings. Iron pan up to 0.01 m in depth was frequently visible at the interface between the peat base and the till. Occasional widely dispersed Scots pine roots were visible within the basal 0.3 m of peat below 480 m OD. Occasional large boulders or glacial erratics were encountered lying within the peat just below the turf horizon (Plate 5). These were hand cleaned and inspected for rock art, none was seen. No archaeological features were visible across this part of the site.

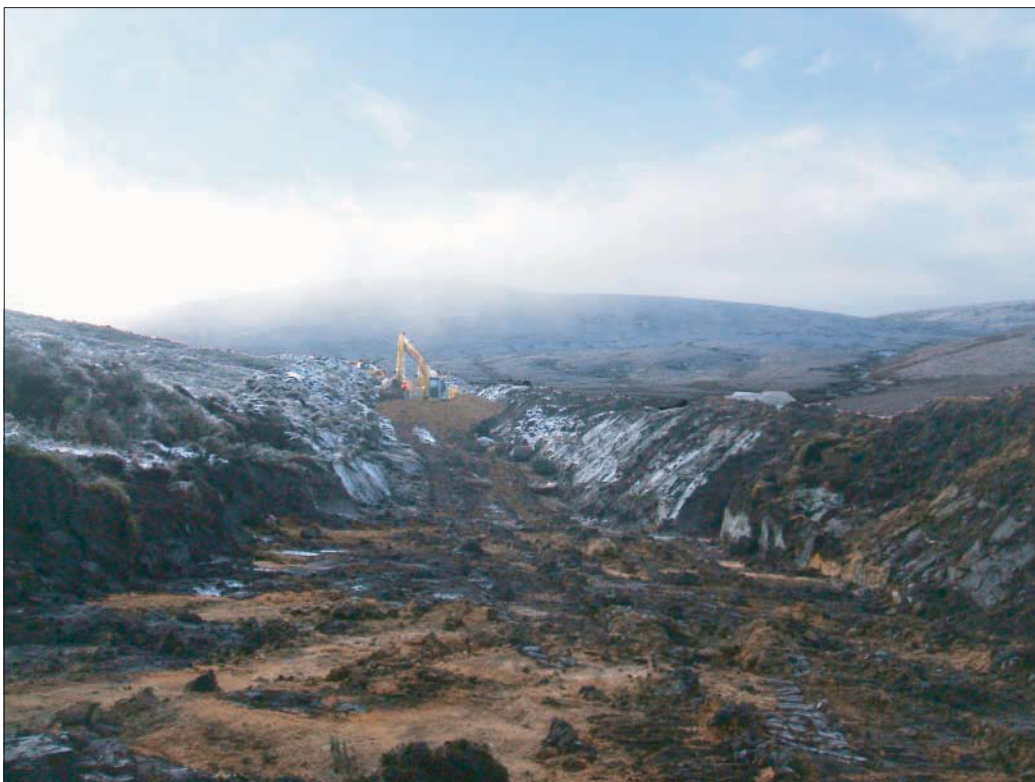
Plate 4: General view after peat stripping access road between turbines 1 and 2, from the north

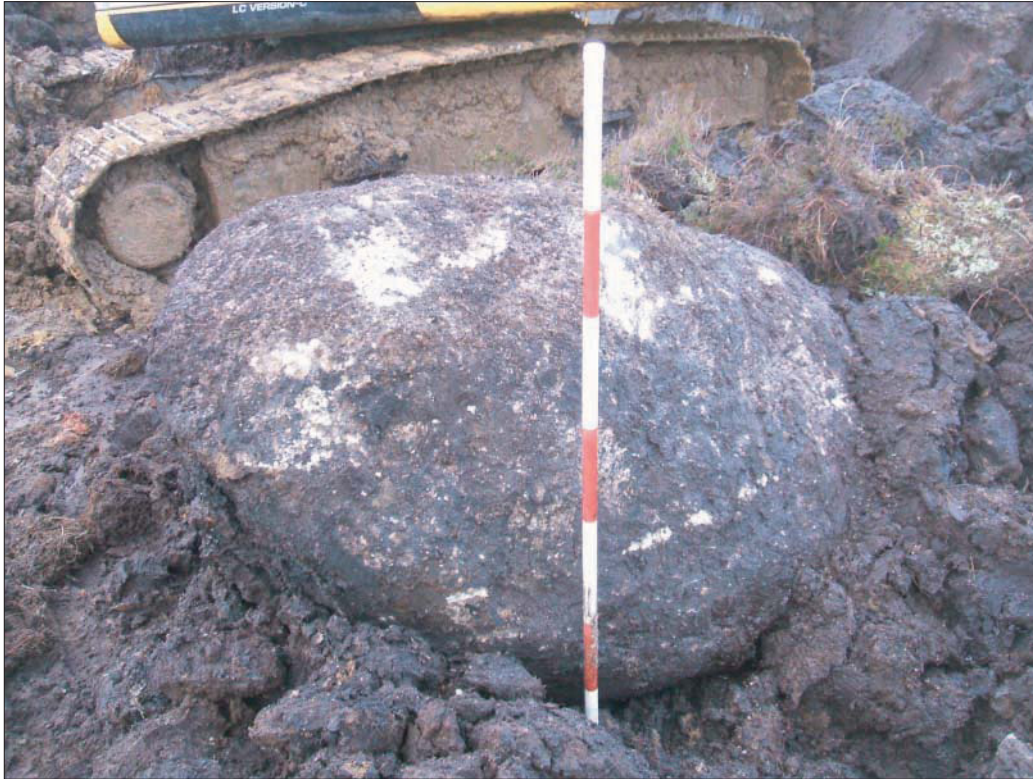
Plate 5: General view of typical glacial erratic encountered along parts of the access road to turbines 1 and 2

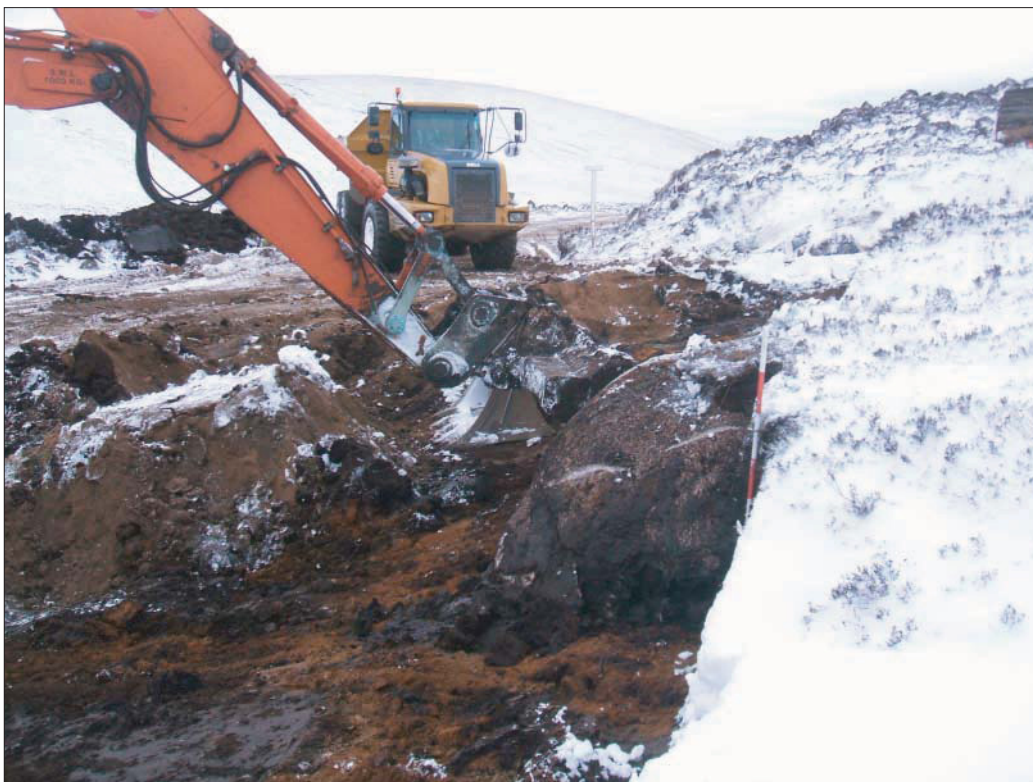
Plate 6: General view during peat stripping of the area and hard standing for turbine 1, A large glacial erratic is visible just below the turf horizon

6.4.1 Peat from 0.65 m up to 1.8 m in depth was excavated across the area of turbine base 1 and associated hard standing. Iron pan up to 0.01 m in depth was frequently visible at the interface between the peat base and the stony gravel till. Occasional widely dispersed Scots pine roots were visible within the basal 0.3 m of peat. A large glacial erratic was encountered just below the turf horizon no rock art was visible across its surface. No archaeological features were observed.

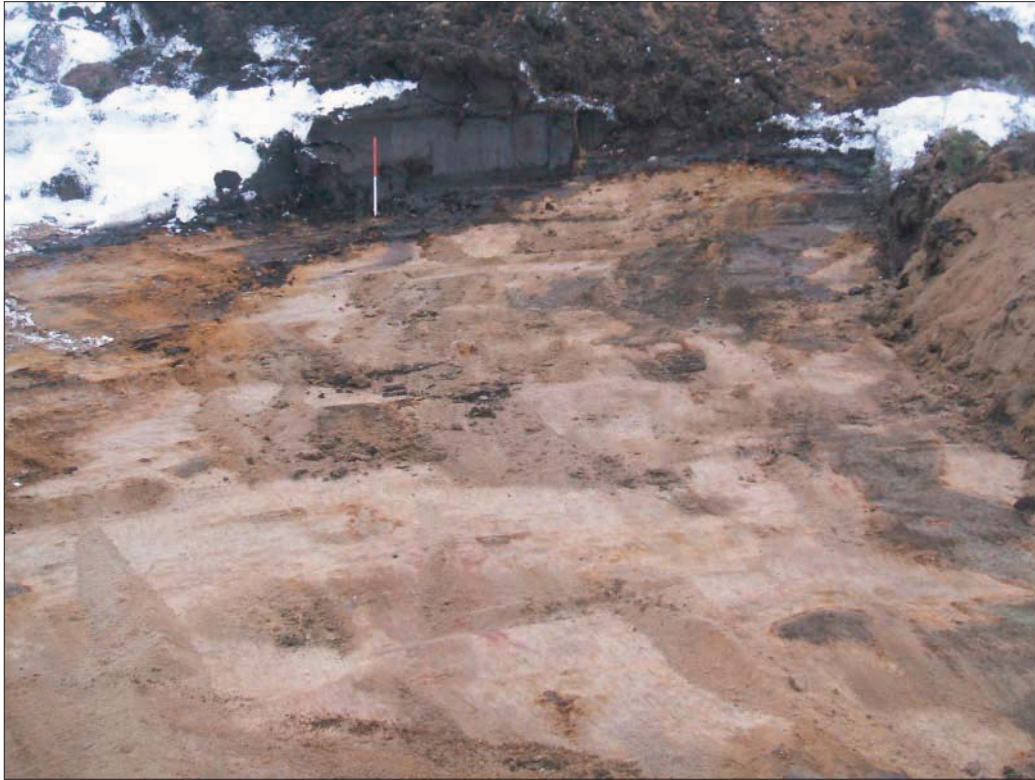
Plate 7: General view showing sandy gravel encountered around the base and area of hard standing for turbine 2

6.5.1 Peat 0.45 m up to 2.0 m in depth was excavated across the area of turbine base 2 and associated hard standing. Iron pan up to 0.01 m in depth was frequently visible at the interface between the peat base and the sandy gravel till. Occasional widely dispersed Scots pine roots were visible within the basal 0.3 m of peat. A small stone was found with circular abrasion marks lying among the heather towards the northern end of this area. This transpired to be a result of the borehole investigation work. No archaeological features were seen.

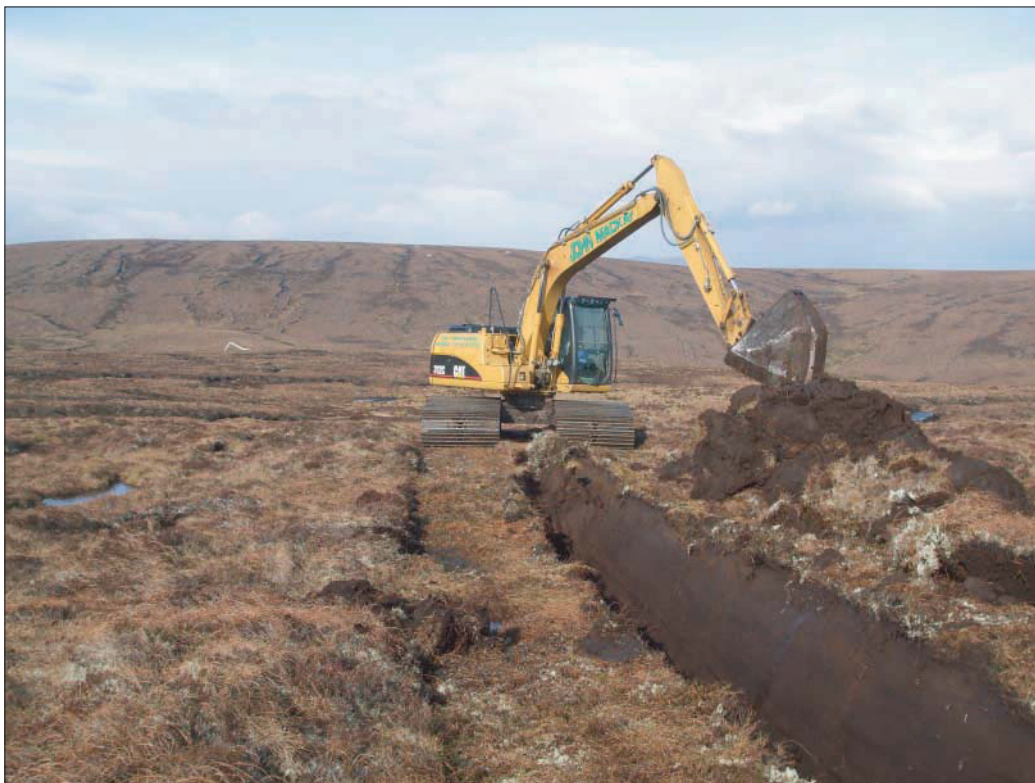
Plate 8: General view during excavation of cable trench, from the east

- 6.7.1 A trench aligned east to west and cut through peat up to 1.8 m deep was excavated from the site of the new sub-station to turbine 1. Here the trench turned north and continued to turbine 2. Very stony ground was encountered at a depth of 0.35 m around the area of turbine 1. A number of peat pipes (natural drainage features) were visible along parts of the trench no archaeological features were seen.
