Montrose Swimming Pool Watching Brief: Data Structure Report

Montrose Swimming Pool, Watching Brief

Data Structure Report

AOC Project No: 21343

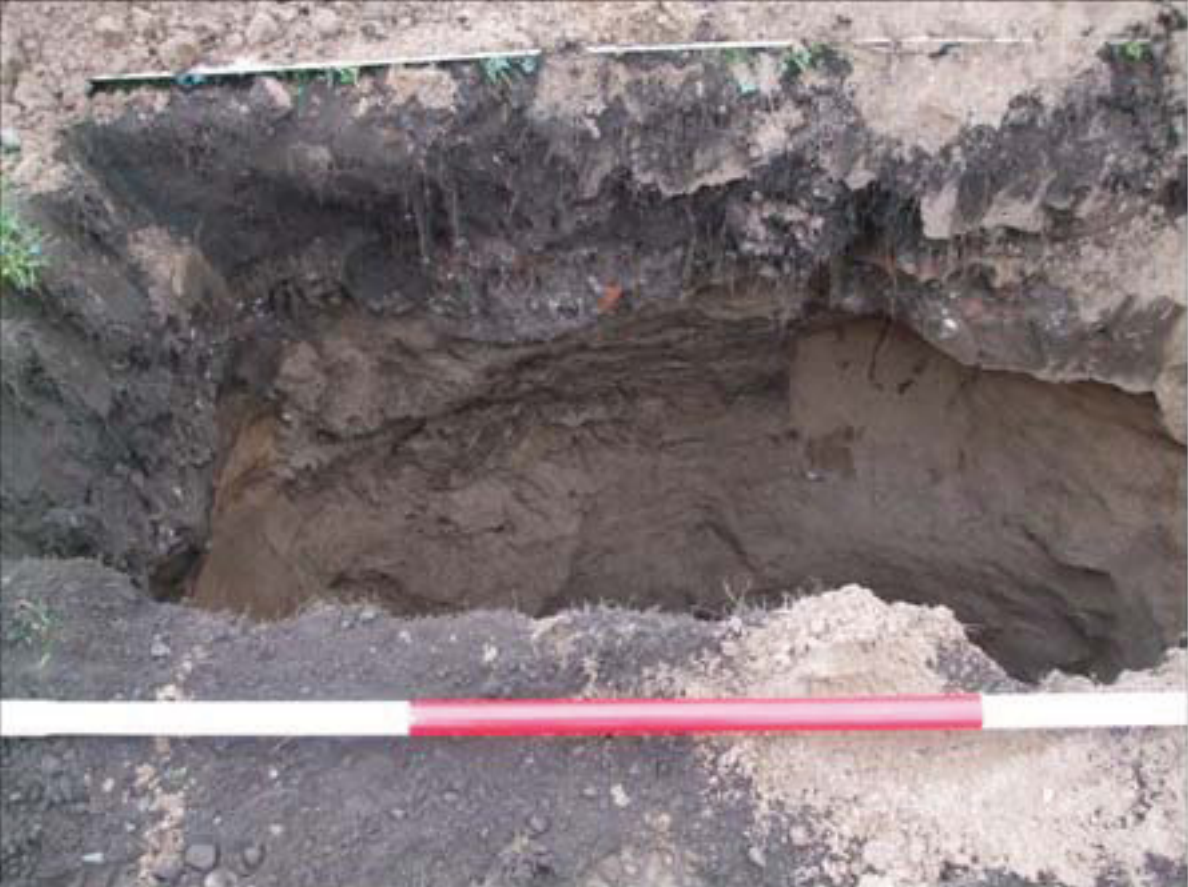
Plate 1: Cut 303 in the west facing section of TP 03

6.5.1 A rectangular trench measuring 2.6 m long x 0.6 m wide x 2.9 m deep, aligned N-S was cut through a layer of landscaping topsoil [300], this overlay a layer of demolition debris [301] comprising unfrogged brick and brick fragments in a degraded mortar matrix. This was found overlying clean pale brown natural sand [302]. A very steep sided, flat bottomed, U-shaped linear cut [303] aligned E-W was visible, cut into the natural sand at the north end of the trench. This measured 0.8 m wide, (excavated) and continued under the north trench edge, by 0.6 m deep. This was filled by pale brown sand with frequent, discontinuous horizontal lenses of brown silt [304].

- 7.2 The cut features unearthed in TP03 and TP06 cannot be assigned a period or function. The buried improved sand horizon which was evident across the entire site may be associated with agricultural use of the site prior to development.

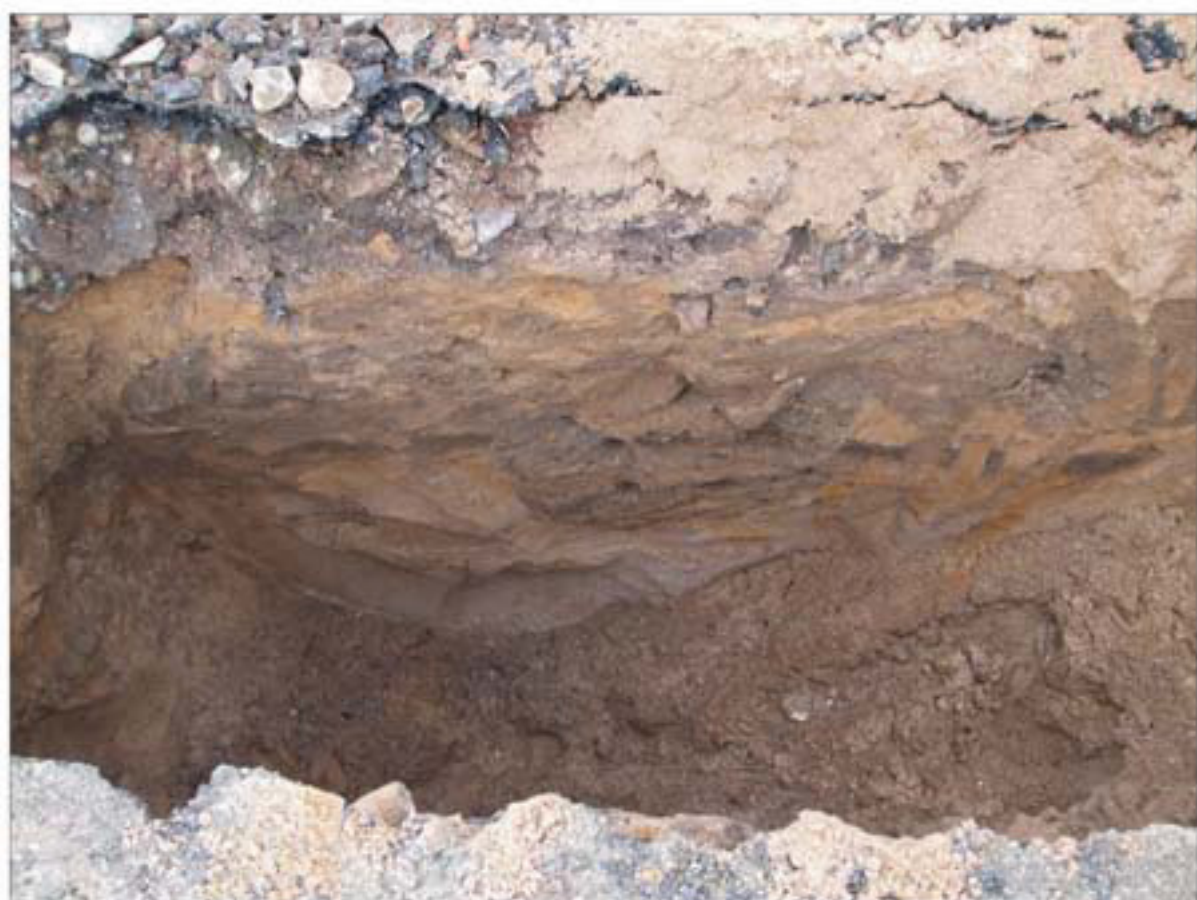
Plate 2: Cut 608 in the east facing section of TP 06

6.8.1 A rectangular trench measuring 2.6 m long x 0.6 m wide x 2 m deep, aligned N-S was cut through a layer of tarmac [600], this overlay a layer of gravel fill or leveling [601] which overlay a layer of rounded gravel in a dark brown silt [602] which probably formed a surface before the tarmac was laid. Below this a thin layer of clean sand [603] was visible overlying a layer of small to medium sized sandstone fragments in a degraded lime mortar matrix [604]. Beneath this natural sand [605] was encountered. The east facing section of this trench revealed a similar sequence of deposits although the crushed sandstone layer [604] was not visible. Below the clean sand deposit [603] a mottled brown orange sand [606] was recorded, at the base of this layer a discontinuous band of dark brown silt was visible [607] overlying natural sand. A rounded U-shaped cut [606] was visible cut into the natural sand in this section. It measured 0.5 m wide by 0.3 m deep. During further excavation of the test-pit this section edge collapsed and what remained of the feature had disappeared

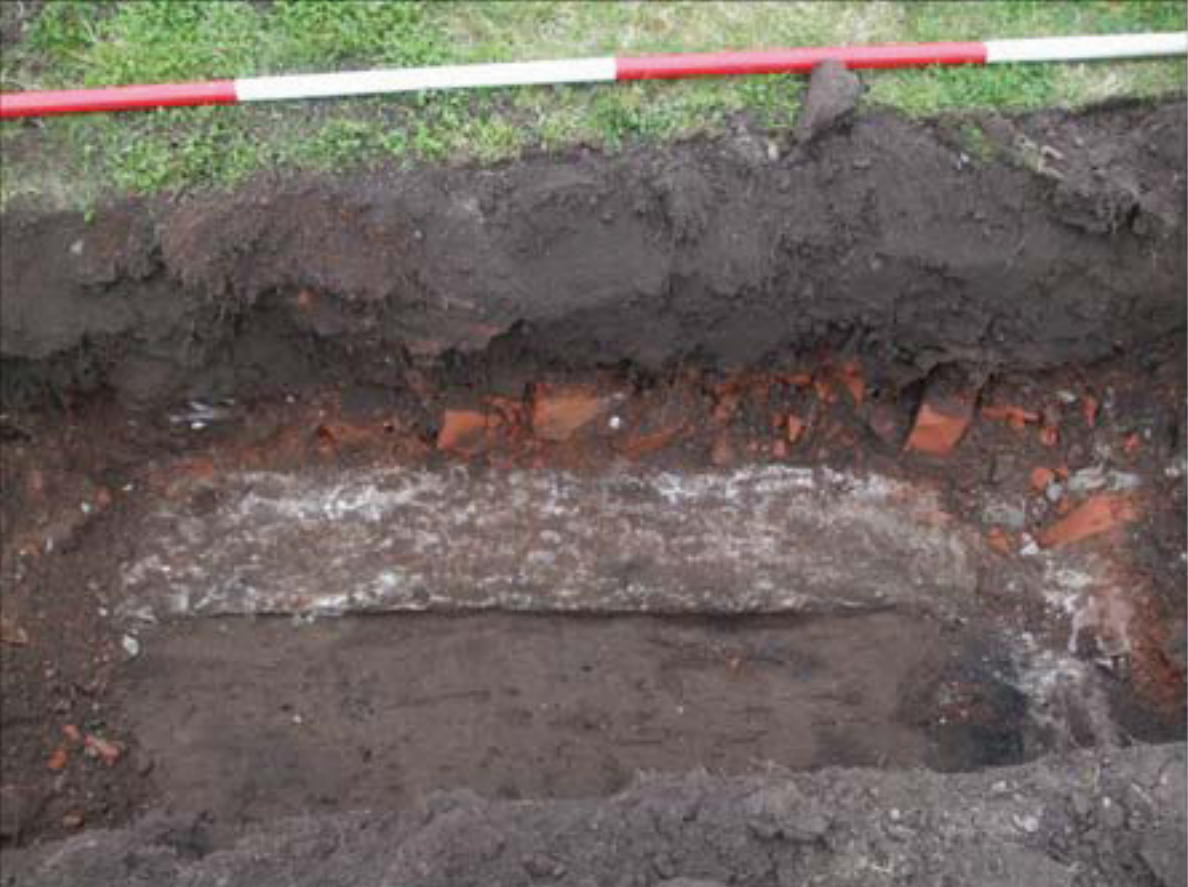
Plate 3: Brick wall remnant 401 and concrete foundation 402 in TP 04, from the east

6.6.1 A rectangular trench measuring 2.6 m long x 0.6 m wide x 2.7 m deep, aligned N-S was cut through a layer of landscaping topsoil [400]. This overlay a layer of brick [401] comprising unfrogged brick set on edge bound by a cement mortar. This was aligned N-S with an eastern return at the north end of the trench and found built off a concrete foundation [402] which projected into the trench beyond the base of the brick structure. This feature continued below the west and north trench edges. Below this a layer of brown, improved sand [403] was visible which overlay clean pale brown natural sand [404].

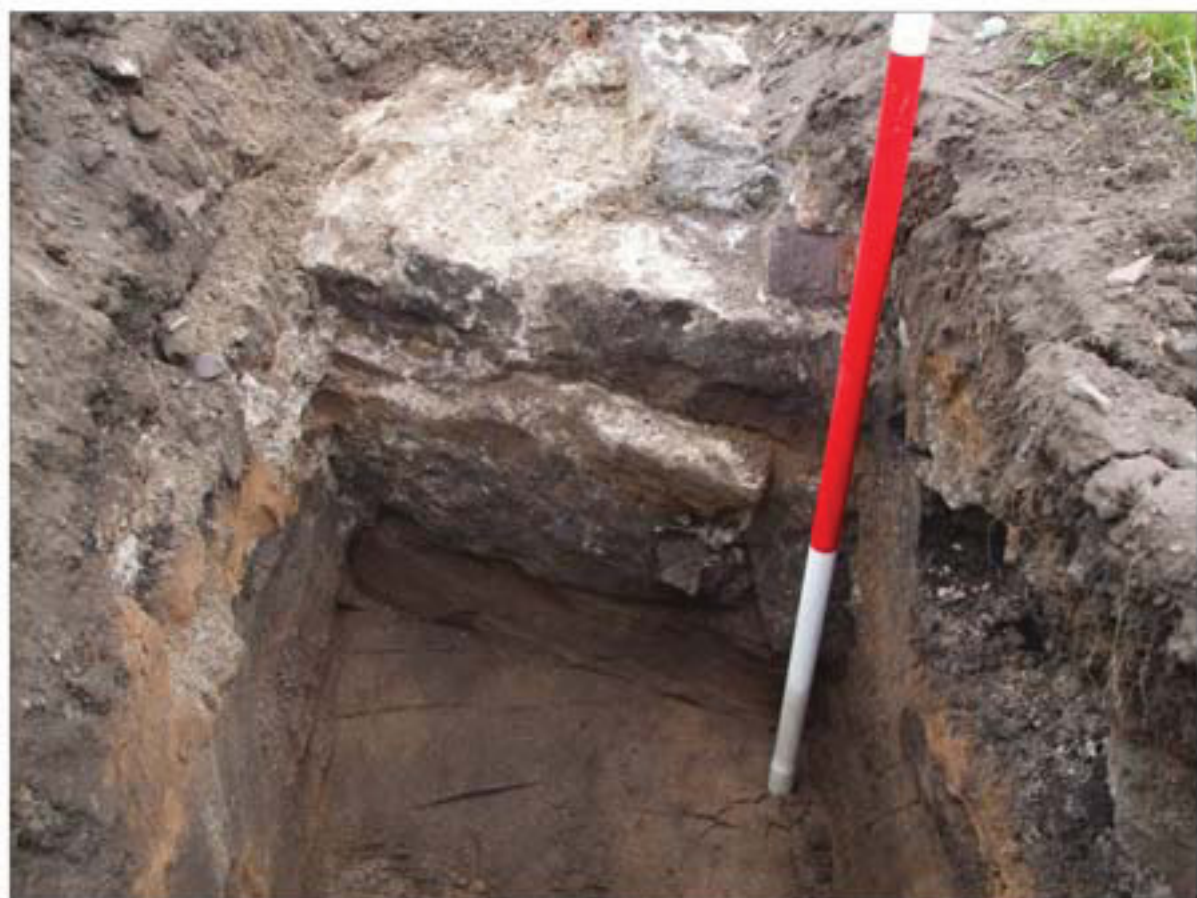
Plate 4: Sandstone wall 903 in TP 09, from the north

6.11.1 A rectangular trench measuring 2.4 m long x 0.6 m wide x 2.6 m deep, aligned N-S was cut through a layer of topsoil [900], this overlay a layer of brown improved sand [901] which lay directly over clean pale brown natural sand [902]. At the southern edge of the trench a wall [903] was found. This was built from red roughly dressed sandstone bound by a pale grey lime mortar, aligned northwest to southeast built off a foundation course which protruded 0.12 m below the base of the wall which including the found survived to three courses in height. The wall was partially obscured by the southern trench edge.

- 7.1 The watching brief determined that various elements of previous occupation of the site survived below a layer of landscaping material. Some of these features can be assigned interpretations with a degree of confidence. The sandstone wall uncovered in TP09 probably represents part of the building forming a railway siding associated with a timber yard depicted on the map of Forfarshire published in 1903. Similarly the cinder and mortar surfaces may be associated with buildings forming part of the timber yard from this period. The concrete and brick wall recorded in TP04 could also perhaps be attributed to structures depicted on this map, alternatively they may be associated with part of the Montrose Academy, depicted on the OS map published in 1991, which occupied part of the development site until as recently as 2000.

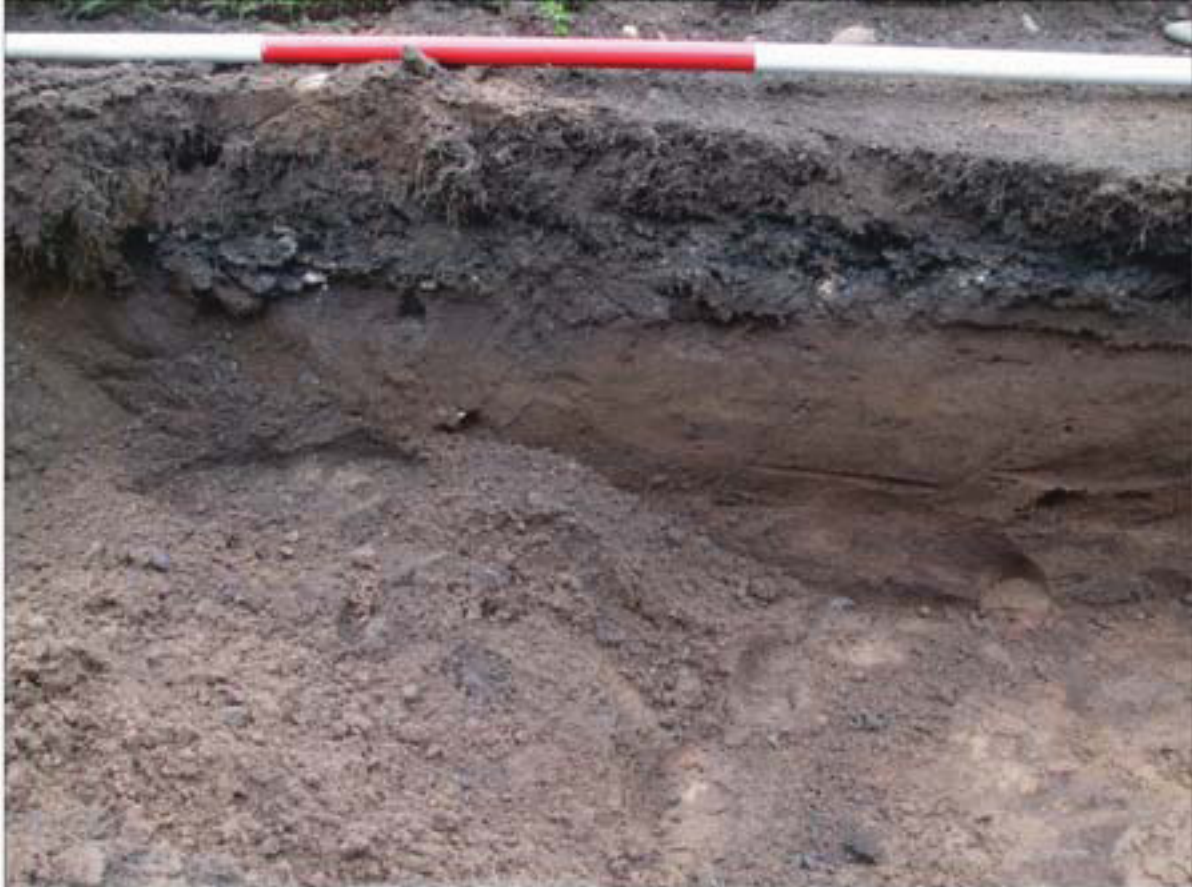
Plate 5: Landscaping deposit 500, cinder deposit 501 and improved sand 502 in TP 05

6.7.1 A rectangular trench measuring 2.6 m long x 0.6 m wide x 2.6 m deep, aligned N-S was cut through a layer of landscaping topsoil [500], this overlay a layer of compact cinders in an ashy matrix [501]. Below the cinders a layer of brown improved sand [502] was recorded, this lay directly over clean pale brown natural sand [503].

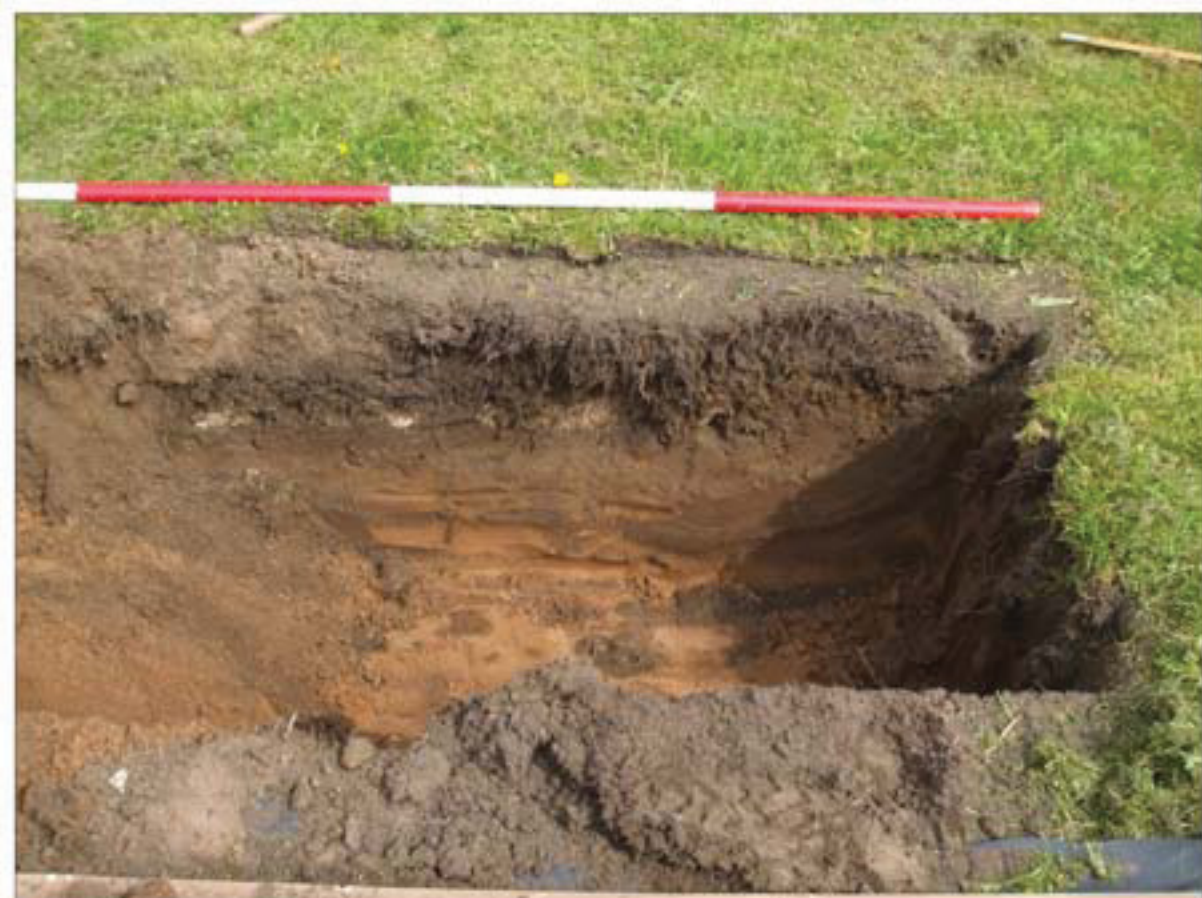
Plate 6: Landscaping deposit 800, mortar deposit 801 and improved sand 802 in TP 08

6.10.1 A rectangular trench measuring 2.6 m long x 0.6 m wide x 2.8 m deep, aligned N-S was cut through a layer of topsoil [800], this overlay a thin layer of degraded lime mortar [801]. Below this a layer of brown improved sand [802] was recorded, this lay directly over clean pale brown natural sand [803].
