Land between Brook Street and Raby Road, Neston, Cheshire A Post-Excavation Assessment Report

Planning Application Number: P/2008/101/NE/118

AOC Project No: 40018

Site Code: BKN 08

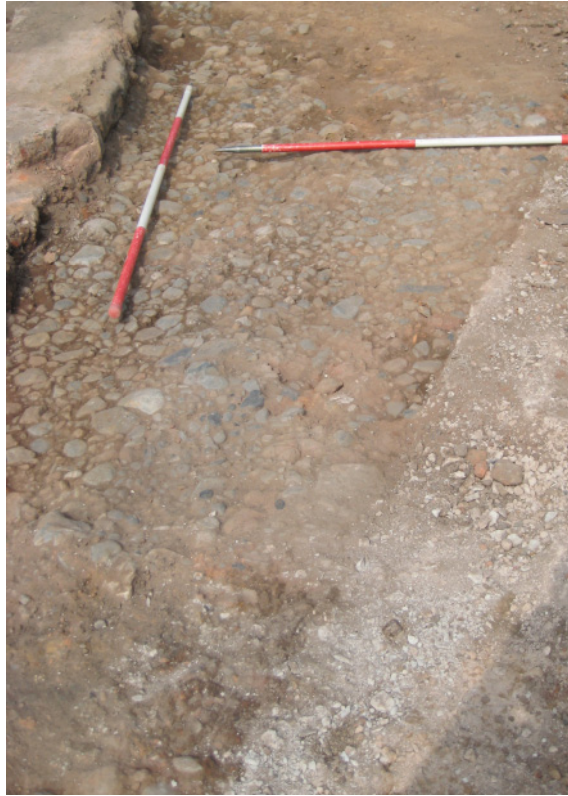
- 6.4.11 The southern terminus of ditch [696] was found adjacent to an extensive cobbled surface [660] which appeared to respect the ditch, suggesting that the features were contemporary and may have functioned co dependently (Figure7, Plate 1). A limited extent of the surface was found during the previous evaluation, recorded as [208]. In total, cobbled surface [660] / [208] measured 17.43m north to south and up to 4.67m east to west. The surface extended on a northwest – southeast orientation at a height of between 30.99m AOD and 31.59m AOD, across the centre of the site towards Brook Street to the south. The surface was 0.12m thick, comprised of a single layer of tightly-packed, water worn cobbles, pebbles and sandstone fragments of varying size that were generally smaller to the north and larger to the south. Within the eastern extent of the surface a single row of larger cobbles were arranged to form a curb, suggesting that the surface functioned as a drive rather than a yard.

Plate 1. Cobbled Path [660]

6.4.12 The components of the surface were held within a mid greyish clayey silt packing material. A sherd of iron rich glazed 17th-18th century pottery was recovered from the packing surrounding the cobbles asserting the early date of the surface. However, this was further emphasised by a 0.10m deep layer of dark brown, firm, silty clay (668) that overlaid both the upper fill (694) / (670) of ditch [696] and cobble floor [660]. The silting deposit contained 193 sherds of pottery, most of which contained an iron rich glaze, although olive green, mottled, clear, salt and tin glazed sherds were also recovered. Examples of German imports were found within the assemblage and fragments of medieval Ewloe and Brown glazed pottery were also recovered. This deposit was overlain by a 0.13m thick spread of reddish brown sand (583) at a height of 31.24m, which in turn was overlaid by a 0.07m thick deposit of dark grey, silty clay (667) at a height of 31.11m AOD. Both of the overlying deposits similarly contained substantial amounts of 17th-18th century pottery.

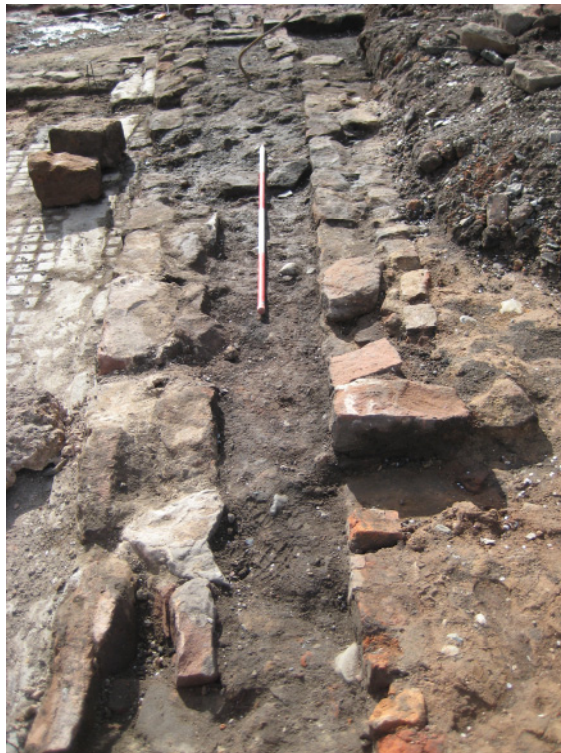
- 6.4.17 To the north of stone wall [549], on a similar alignment, but set to the east of the wall was brick lined drainage gully [538] (Plate 2). It was 3.60m long and comprised two short parallel walls [539] constructed from a single course of hand made, soft fired red bricks (240mm x 110mm x 80mm) held in header coursing by a mid brown sandy mortar. The wall reached 32.49m AOD. The brick walls lined a cut that was 0.60m wide and 0.36m deep, with vertical sides and a flat base [538]. The feature contained a silting deposit of mid dark brown, silty sand, with occasional mortar, CBM and stone fragments (540), which did not contain any datable evidence. To the south of the gully it appears that the drainage system would have continued against wall [549], perhaps ceasing at the aforementioned protruding stones of the wall, but like to the north, gully [538] was truncated by later Victorian drainage measures.

Plate 2. Early stone wall [549] and contemporary brick lined drainage gully [538] truncated by later Victorian wall [520]

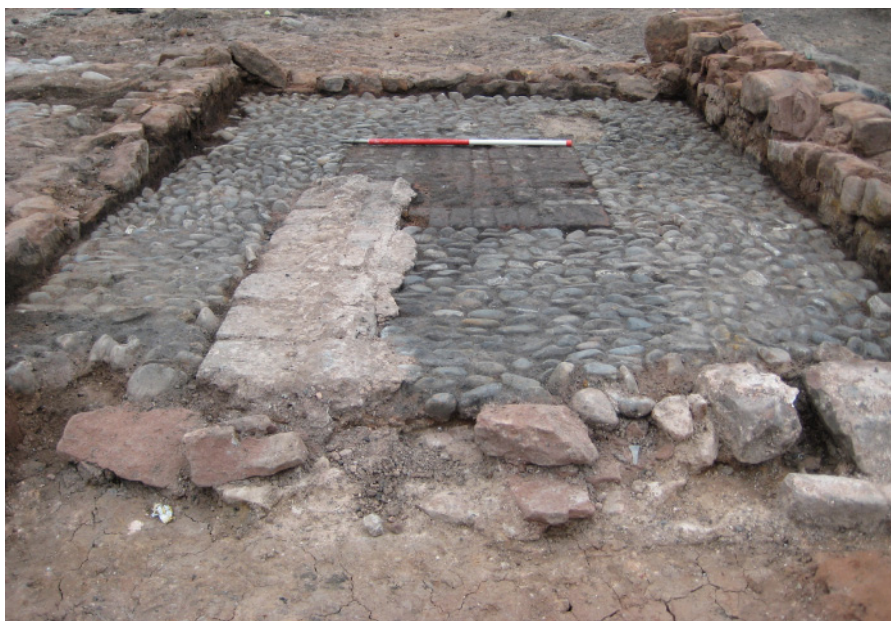
- 6.5.6 An enclosed yard was found within the southeast of the site. It comprised a tightly packed cobbled surface [559], measuring 3.51m by 2.76m and at a height of 31.42m AOD, was found set around a central brick pad [560], measuring 1.17m by 1.00m at a height of 31.41m AOD, constructed from hand made, soft fired bricks, each measuring 235mm x 110mm x 80mm. Similar bricks have been found from 17th and 18th century sites within the area (Appendix G), but the truncation of earlier, 17th century curvilinear ditches [663], [664] and [665] by the enclosed cobbled yard accordingly dates it to the later end of the dating range.

- 6.5.7 Cobbled surface [559] was set within the confines of an enclosing stone built wall [558], which bound the floor to the north, east and west. The wall was constructed from red sandstone sub rectangular blocks that varied in size between 180mm x 170mm x 90mm and 620mm x 300mm x 170mm. The wall was bonded by a reddish yellow, friable sandy mortar, in irregular coursing two blocks wide and up to four blocks high (31.81m AOD) (Figure 12, Plate 3). Both wall [558] and cobbles [559] were truncated by a modern toilet to the south.

Plate 3. Enclosed cobbled yard within the southeast of the site

- 6.5.9 The function of the enclosed yard is not obvious from its form. It certainly formed an enclosed yard, but it is unknown if it was an external or internal feature. The brick pad set within the centre of the cobbles could have functioned as a the base for machinery, suggesting that it was a workshop, but no metal pins or supports were found within the pad, so it is more likely that it functioned as an external yard. Its perpendicular location with nearby Brook Street further suggests that it would have been a yard situated to the rear of a building fronting onto the road. The extensive truncation caused by the 20th century toilet block to the south has destroyed the remains of any such building associated with the yard and accordingly made the identification of the structure difficult.

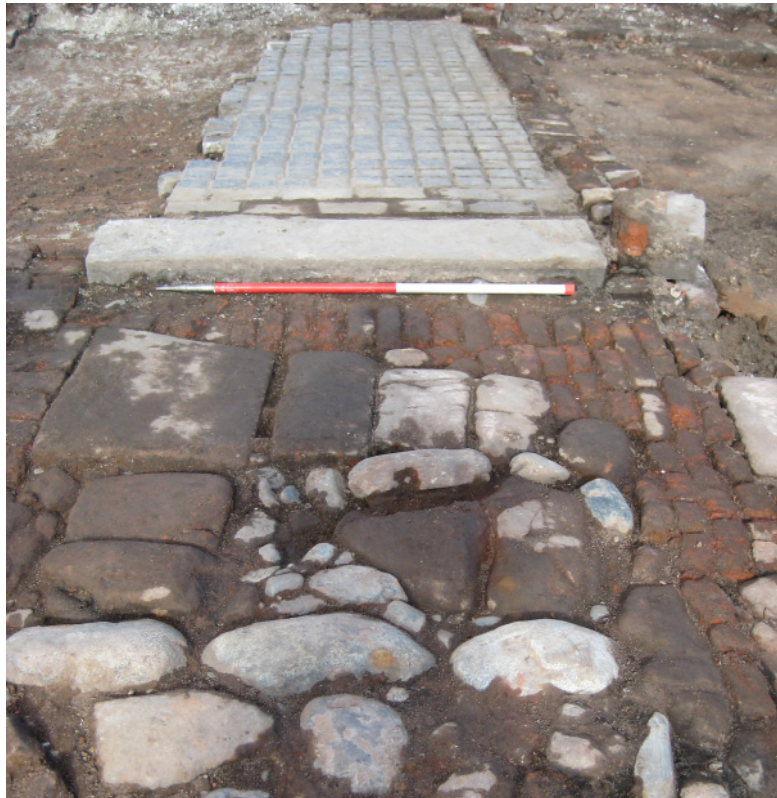
- 6.6.12 Large stone block [587] was located within the south-western facing wall, at a height of 31.97m AOD in the southern corner of the room. It was clearly inserted in between the exterior walls at the time of their construction to form a threshold for the structure. It comprised a single stone that was 1.47m long and 0.30m wide. To the southwest of the stone a sandstone, cobble and brick surface [588] ran from the building towards contemporary farmhouse, Building 2, where a heavily truncated fragment of it was revealed [602] close to the eastern extent of the building. Surface [588]/[602] was constructed directly on top of the natural clay drift material (509) and 17th century cobbled floor [660], at a surface height of between 31.70m and 31.89m AOD.

Plate 5. Floor [588] to the southwest of Building 3

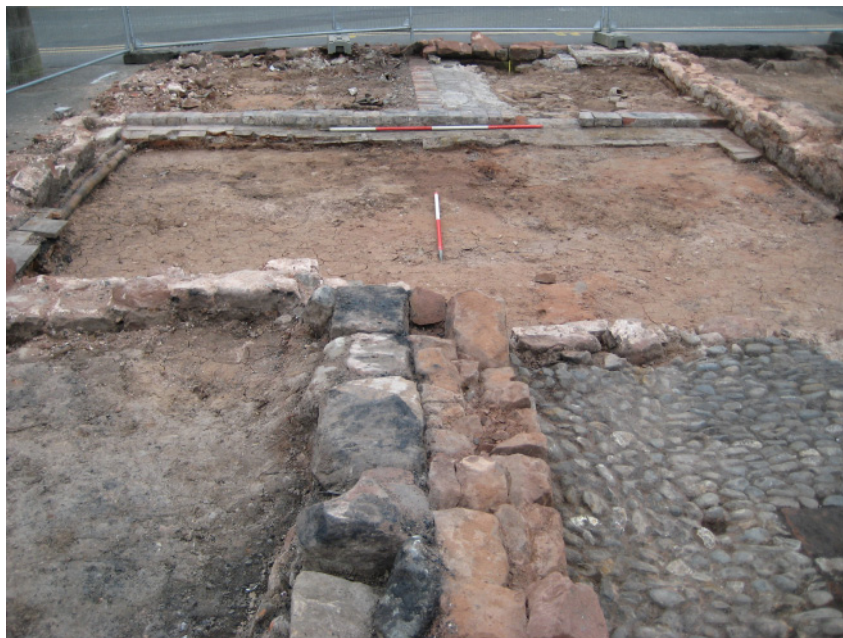
- 6.8.3 The most significant 20th century remains were found in the form of Building 4; a stone built toilet block, fronting onto Brook Street within the southeast corner of the site. The structure measured 7.60m north to south and 6.60m east to west, externally composed of an outer stone built wall [526] and [568], which incorporated red sandstone blocks varying in size from 180mm x 180mm x 80mm to 500mm x 200mm x 120mm, held in place by a pale white limey mortar. The walls were found between a height of 31.34m and 31.67m AOD. The structure was internally divided into three rooms by east-west orientated brick wall [564] and north-south orientated brick wall [556]. Both walls were constructed from hard fired red bricks (230 x 110 x 80mm) within a grey concrete rich mortar, at a height of 31.36m AOD. The two smaller southern rooms contained a concrete floor [566] overlying a layer of re-deposited natural (567) and the larger northern room a ceramic tile floor [568] at a level of 31.32mAOD constructed onto the natural clay drift (509).

Plate 6. Building 4 truncating an earlier enclosed yard to the north

- 6.8.4 The toilet block heavily truncated an earlier building to the north (Building 4) and earlier field drains [569] and [571]. The exterior stone walls appeared to be joined to the existing car park stone wall, which was knocked down at the time of construction. The cartographic evidence used for this
