King's Park Road and Roundabout, Evaluation Data Structure Report

AOC 21251
January 2008

King's Park Road and Roundabout Evaluation

Data Structure Report

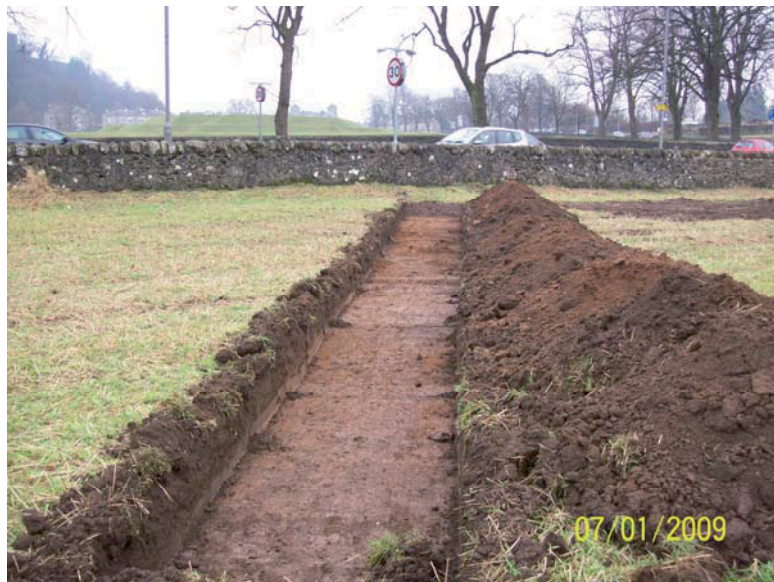
Plate 1: General view of Trench 12

- 4.1.4 Twelve trenches were excavated across the site at various lengths and orientations (Figure 2). Trenches 1, 2, 4, 5 and 12 were excavated across the top of the plateau; Trenches 3, 6, 7 and 11 across the slope and Trenches 8, 9 and 10 in the flat area to the west of the development area. The trenches were generally excavated through between 0.20-0.40 m of topsoil, overlying the natural orange sands and gravel (Plate 1).

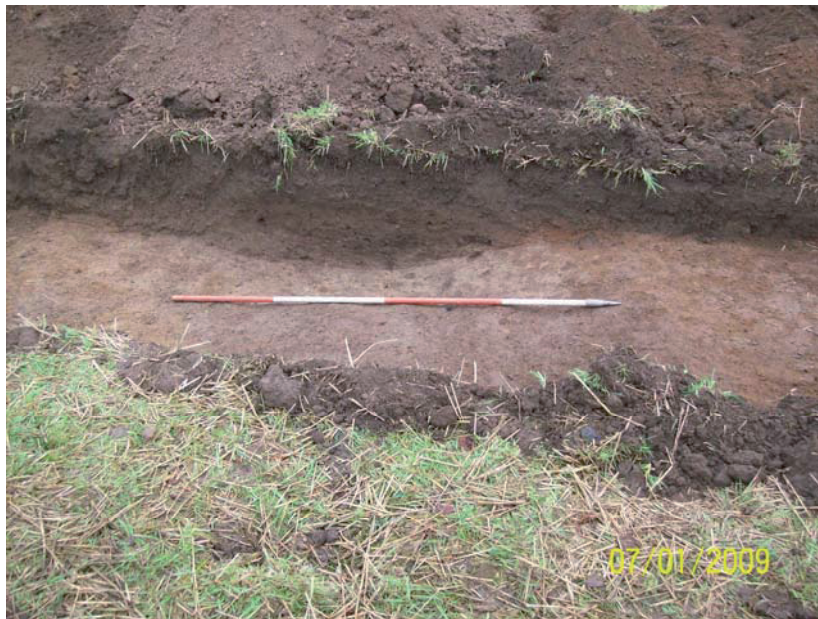
Plate 2: West facing section through Ditch [201]

- 4.1.5 A north-west to south-east aligned ditch [201] was identified and excavated within Trench 2 (Plate 2). The ditch was linear in plan, with shallow sides sloping in to a flat base. The ditch, measuring approximately 3 m in width by up to 0.35 m in depth, was filled by two deposits [202] and [203]. A single piece of white ceramic was identified from the base of the fill [202].

- 4.1.7 Two the features identified in Trenches 2 and 4 lie on the same approximate alignment as each other and the north-western edge of the Queen's Knot (Figure 2). Although truncated, it seems likely that the two features [201] and [401] form the fragmentary remains of the designed landscape. Unfortunately no other remains of the Queen's Knot were identified in either Trench 2 or 4 or any of the other excavated trenches.

- 5.3 Under normal circumstances the identified features could be preserved *in situ*, and remain unexcavated, under either an area of garden or parkland. However, as the proposed development will have a severe impact across the evaluation area, the features need to be *preserved by record* through excavation and subsequent post-excavation analyses/publication where applicable. This can be achieved under a phase of watching brief.
