Dalvuie Farm, North Connel: Watching Brief Report

National Grid Reference (NGR): NM 9207 3659

AOC Project No: 21331

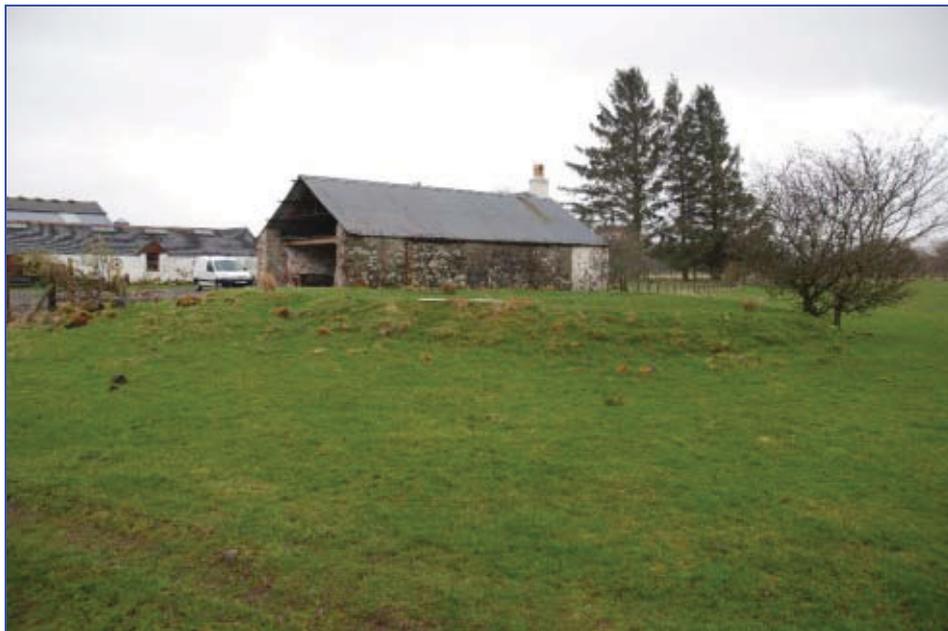
Plate 1: General view of the horse circle from the north-west

- 4.2.3 The circle itself stands between 0.5 m and 1.0 m in height above the ground and is now covered in grass, although the large sub-rounded stones of its foundations were still visible (Plates 1 & 2). It measured approximately 16.20 m (north/south) by 12 m (east/west) and the depression of the horse circle within the mound – where the horse would have effectively walked – was still visible, much wider on the southern side. There was a small depression on the north side (Plate 3), 0.80 m in width, and another depression adjacent to the barn, also 0.80 m in width.

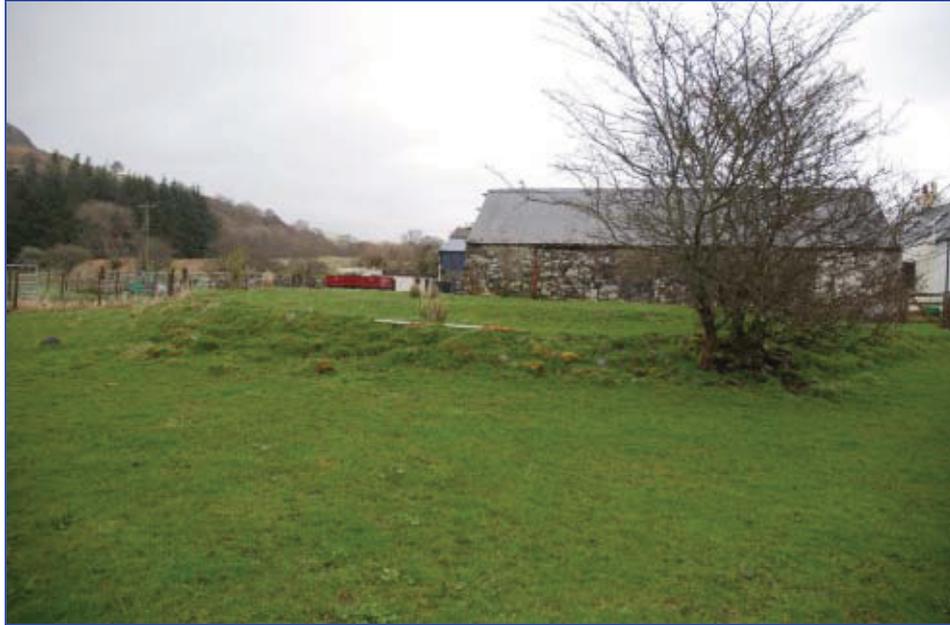
Plate 2: General view of the horse circle from the west

4.2.2 The horse circle is located to the north-west of the main house, adjacent to a three by one bay single storey barn, which is almost certainly associated with the circle. It is possible that there was once a chute or mechanism in which the horse would have powered machinery within the barn. However, there was no evidence within the barn of former machinery, all openings on the western side adjacent to the circle having been blocked.

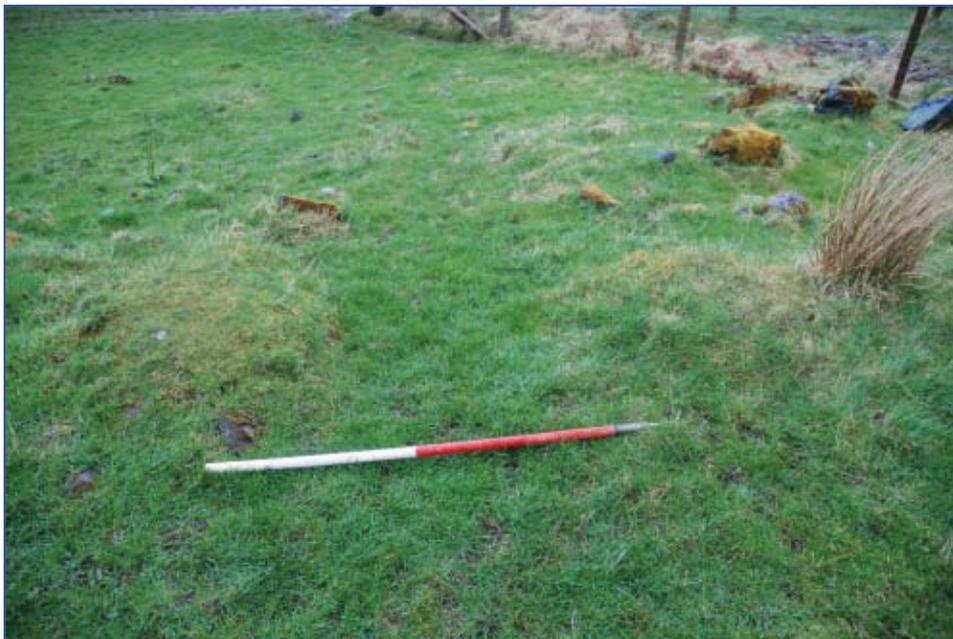
Plate 3: Detail of the small depression on the north side of the horse circle from the south

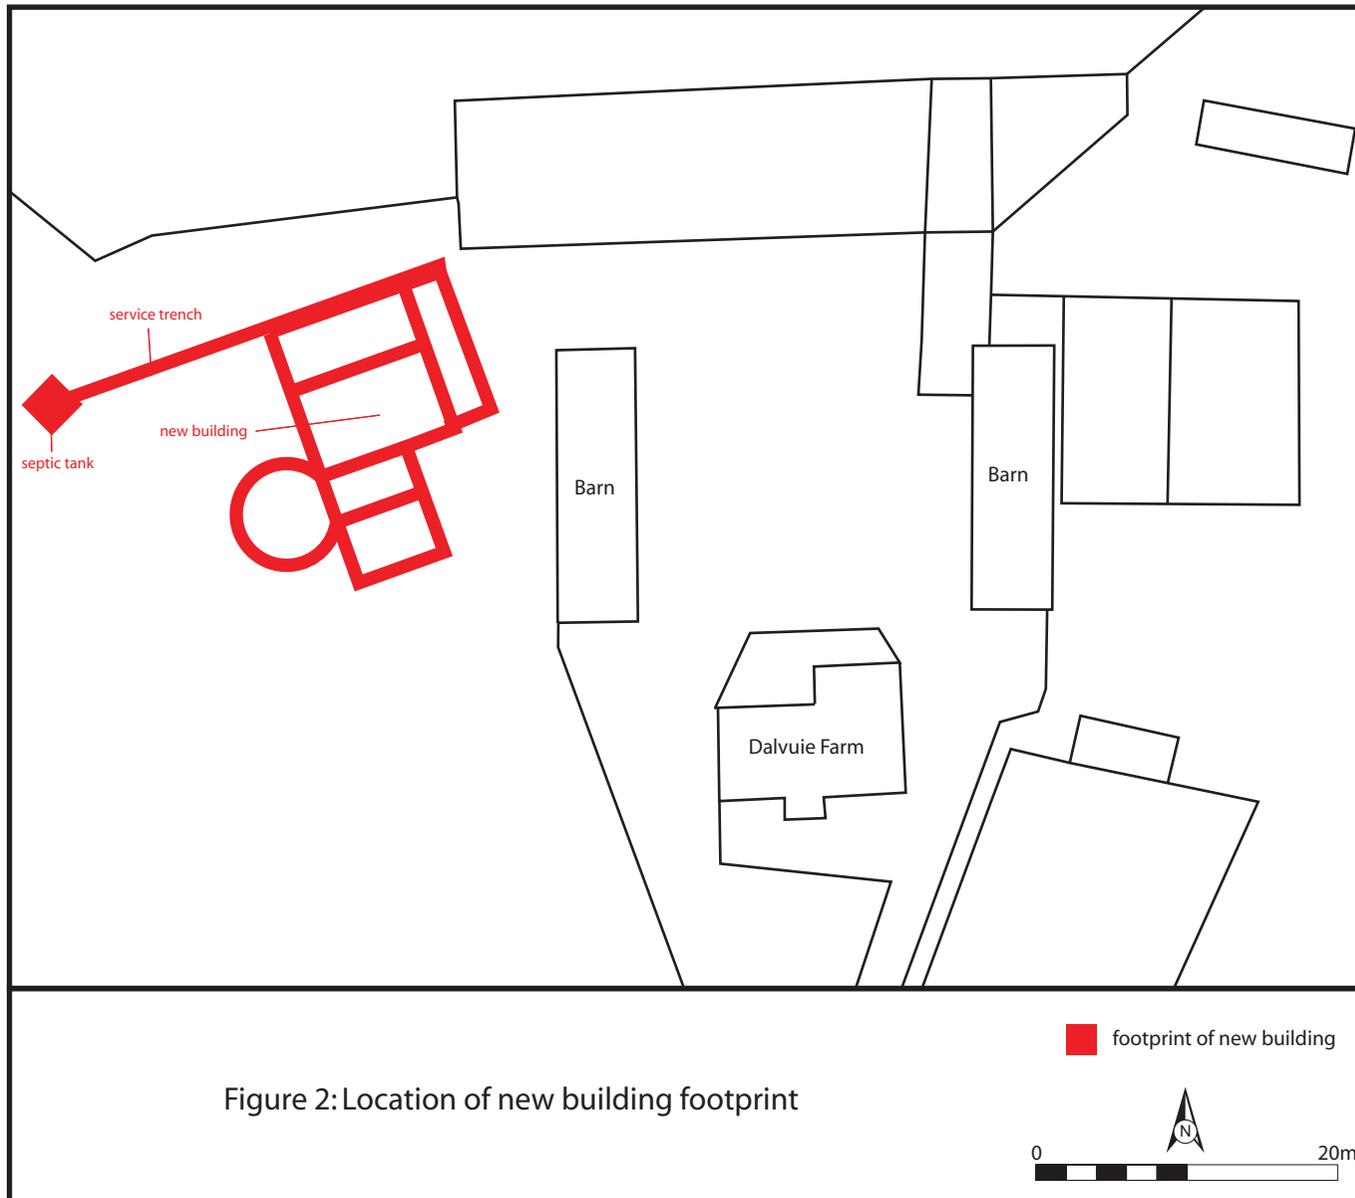
- 4.3.1 The watching brief covered all ground breaking works that occurred within the proposed house plot and included topsoil stripping and excavations for services/foundations (Figure 2).
- 4.3.2 The site was covered in a thin, patchy topsoil between 0.05 - 0.10 m in depth. The subsoil comprised loose gravel.
- 4.3.3 Neither features nor artefacts of archaeological significance were encountered during the watching brief.
