# Parliament House Gas Main, Edinburgh: Watching Brief Report

AOC 21299  
5<sup>th</sup> April 2009

## Parliament House Gas Main, Edinburgh

### Watching Brief Report

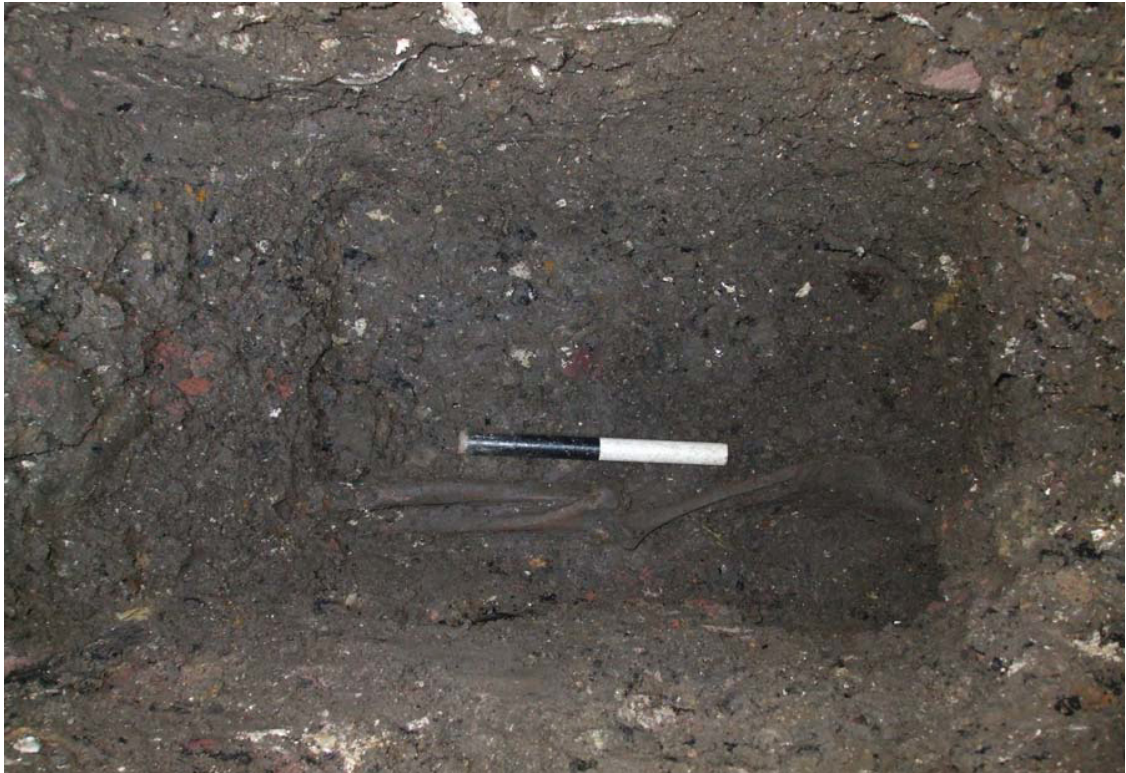
- 4.2.3 *Burial [113] (Plate 1)*  
Burial [113] consisted of an extended inhumation, presumed lying on its back, orientated on an E/W alignment with the head to the east (a Christian burial with the head to the east is unusual by not unknown). The remains visible included the upper and lower arm bones and shoulder of the right-hand side of skeleton. It is liable that foundations [103] at western end of trench were responsible for some of the truncation to the skeleton.

Plate 1      View of burial [113] *in situ* from South

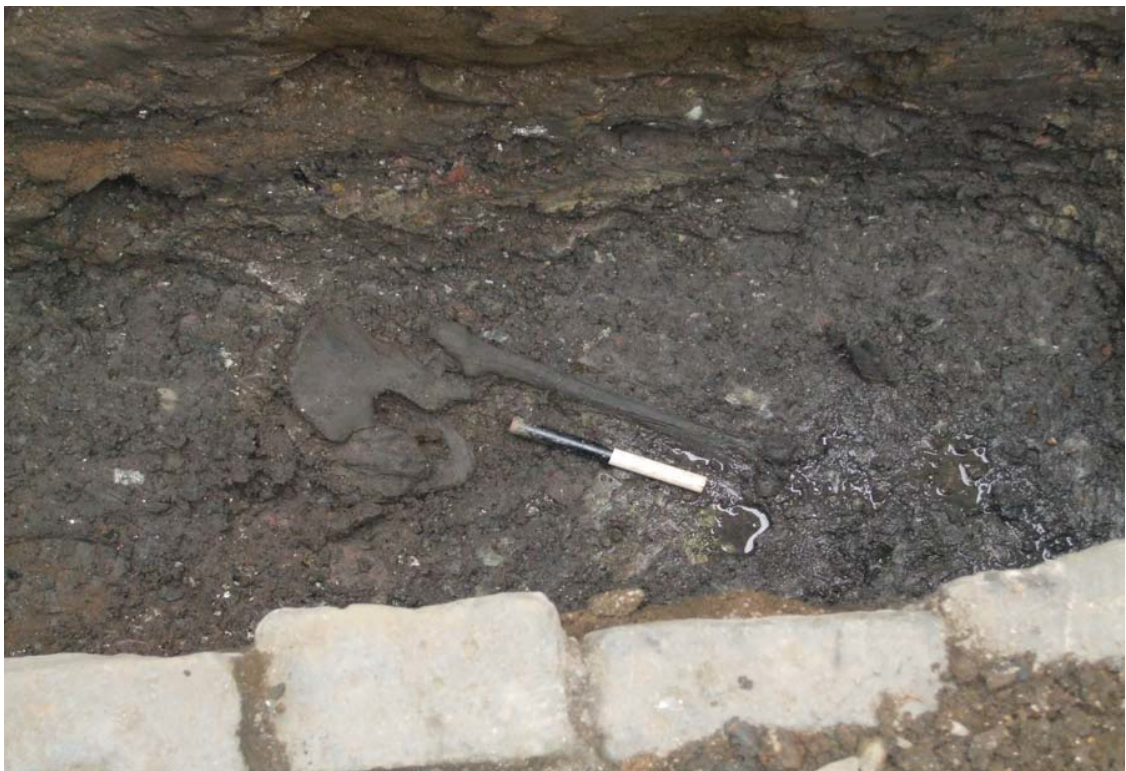
- 4.2.4 *Burial [114] (Plate 2)*  
Burial [114] consisted of a truncated extended inhumation, lying on its back and orientated in an E/W alignment with the head to the west. The remains visible included the left-hand side of the pelvis and left femur. Truncation, potentially due to service trench [109], appears to have removed the lower limbs. Additionally the right femur and side of pelvis as well as both hands and forearms would all be expected to be visible within trench suggesting they too have been lost to truncation. The remaining upper part of body and skull may survive beyond trench limits.

Plate 2      View of burial [114] *in situ* from South

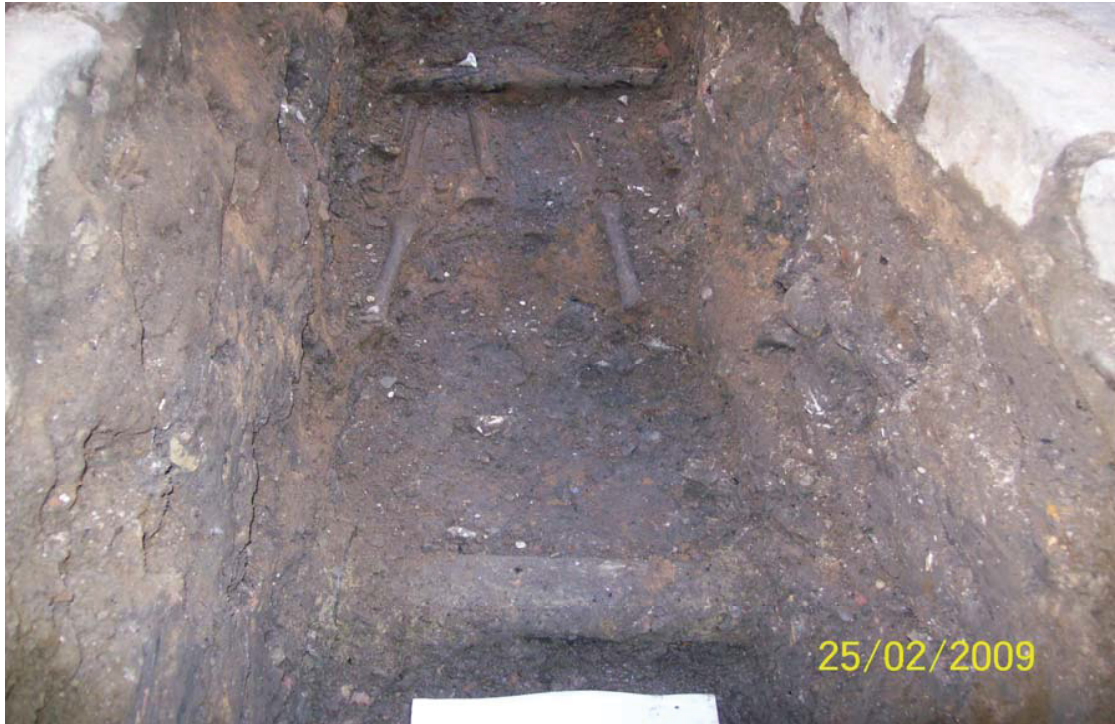
- 4.2.5 *Burials [115] and [116] (Plate 3)*  
Burials [115] and [116] lay side by side and both have suffered similar levels of truncation. The service trench to the west [109] has removed the much of the body from the pelvis to the head in both instances. The remains visible of [115] include the left femur and left and right lower leg bones,

whilst in case of [116] the left femur and left leg bone (tibia?) survive. Service [111] cuts across the ankles and feet of both burials though they may survive underneath the service pipe [112].

Plate 3 View of burial [115] & [116] *in situ* from West

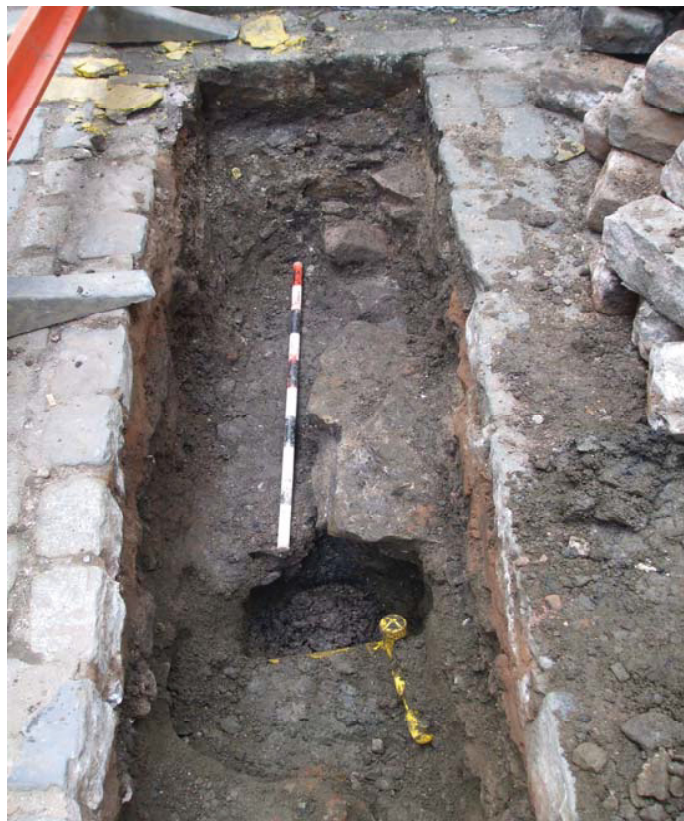
- 4.3.4 At the western end of Trench 2 at a depth of between 0.4 m and 0.7 m were four large pieces of roughly hewn sandstone [117] which may have been the basal course or foundation to a wall (Plate 4). The stones extended from the northern section of the trench with only approximately 0.3 m protruding into the trench. The wall may have been aligned E/W and appeared unmortared; after superficial cleaning the stones were left *in situ*.

Plate 4 View of possible sandstone wall [117] from East
