**AN ARCHAEOLOGICAL ASSESSMENT
OF
THE TOWER OF ST MARYS CHURCH,
HAREFIELD**

JANUARY 2005

By: AOC ARCHAEOLOGY GROUP

Client: St Marys Church, Harefield

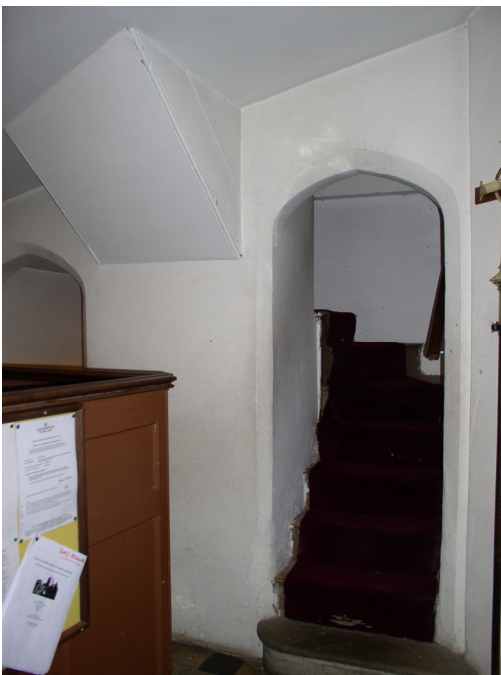
Plate 2: East arch of the tower showing blocking and inserted staircase (looking west)

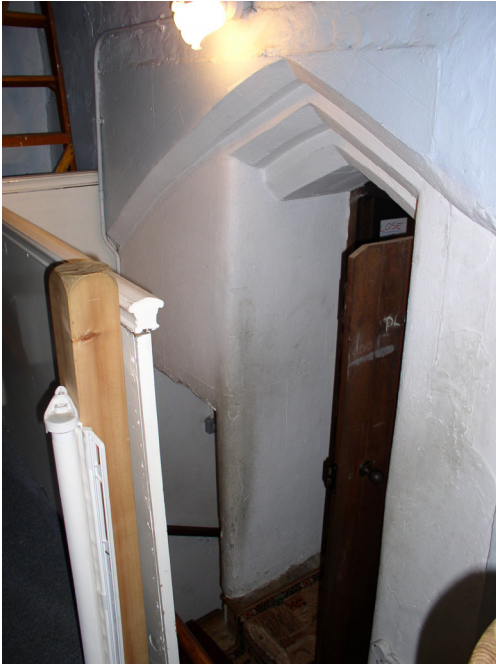
Plate 3: East arch of the tower showing blocking (looking east)

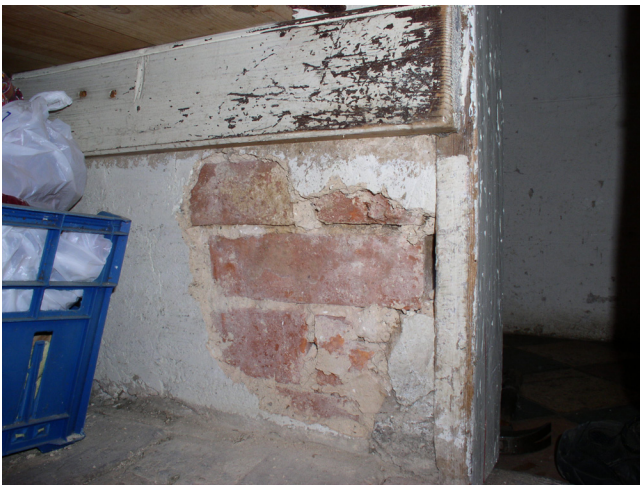
- 2.3 The cupboard under the stairs within the east arch appeared to be built as part of one structure with the stairs and main blocking of the arch. The cupboards walls and floor were constructed of the same brick type and one of these was temporarily removed and examined. The bricks measured 211mm x 99mm x 62mm and were light red and hand made with no frog (Plate 4). The bricks in the wall were bonded with white lime mortar and the bricks of the floor were unbonded, held in place by dust and dirt between the bricks.

Plate 4: Brickwork revealed within the cupboard inserted into the east arch of the tower (looking south)

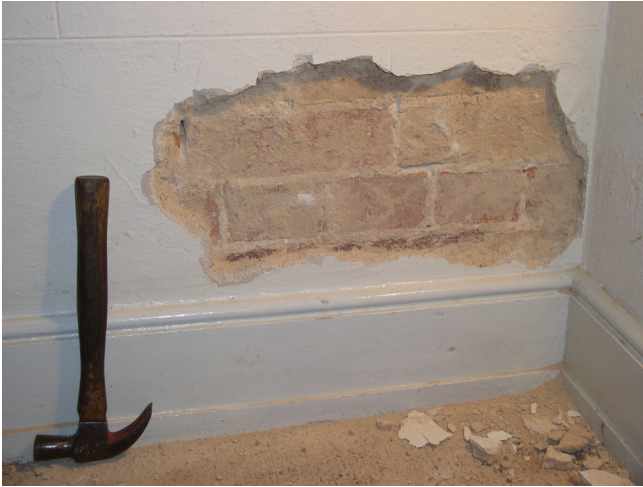
- 2.5 The bricks within the south arch blocking were of the same type as those within the east arch blocking and insertions. A slightly larger area of brickwork was exposed here, which revealed that the bricks were laid in English bond, alternating rows of headers and stretchers (Plate 5). These bricks were bonded with white lime mortar and the structure was covered with a thin skim of light yellow brown plaster with frequent small grit animal hair inclusions. This was in turn covered by a thin skim of harder, white plaster with no hair inclusions that had been finished with lines inscribed in the surface to give the appearance of ashlar block masonry and painted.

Plate 5: Brickwork revealed within south arch of the tower (looking south)

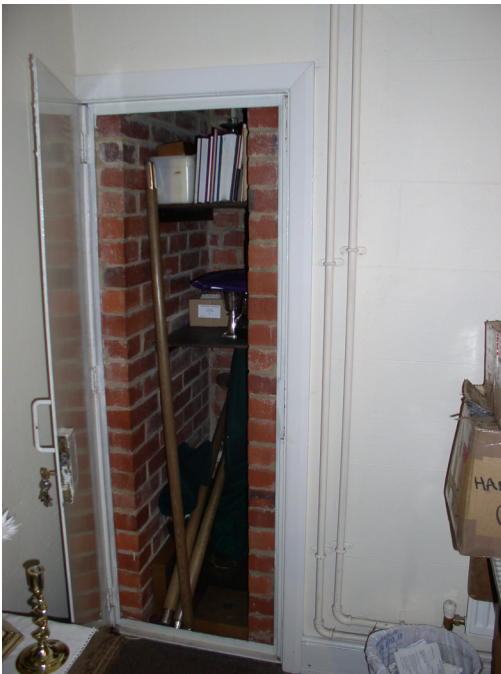
- 2.6 A safe had been inserted into the blocking structure at the north end of the vestry. This was built of fletton bricks and was unrendered (Plate 6).

Plate 6: 20th century safe within the east arch of the tower (looking east)
