The Chequers Inn, 149, Ealing Road London Borough of Brent An Archaeological Investigation Report

Planning Application Number 09/3013

AOC Project No: 30710

Site Code: EIG 10

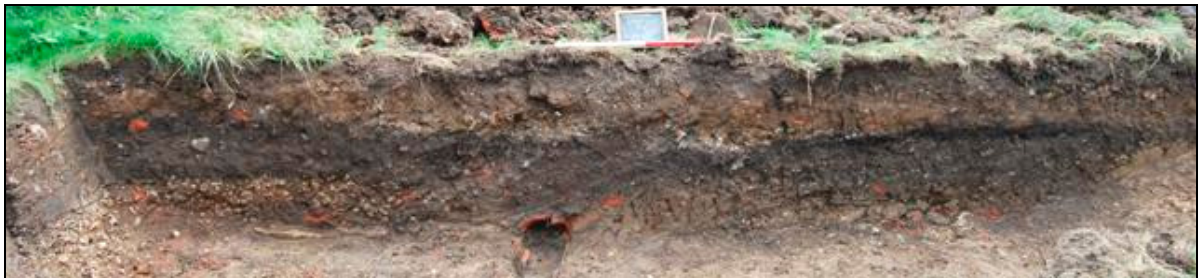
- 6.8 The earliest feature in the trench was the western edge of the same large cut seen in Trench 1 [219]. This showed a gradual break of slope, a shallow angle of slope, dropping to a rounded base. The width of the cut was 6.5m, up to 0.70m deep, and continued beyond the limits of excavation. The primary fill was brownish yellow silty clay (218) which contained occasional gravel, brick and tile and pottery fragments indicating an 18th century date or later. This was sealed by a compact layer of gravel with occasional brick and tile fragments (217). This lay roughly level, and lensed out 2.5m east of the edge of the cut. This suggests that it may be a layer used to consolidate soft ground. The main body of fill above this was up to 0.48m deep (216) and was dark brown sandy silty clay, containing fragments of porcelain, china and clay pipe.

- 6.9 The edge of the large feature was cut by a pit [207], circular in plan, over 1.20m deep, with a brick-lined soakaway established inside [206]. The soakaway had a domed top with a square opening. The bricks measured 235mm by 112mm by 65mm, and indicated a 19th century date. The soakaway was investigated to a depth of 1.2m, and became very wet. The soakaway was backfilled with soft wet blackish brown silty sandy clay (208) that contained glass bottles, porcelain and building material that indicated a probable early 20th century date. A subsidiary cut [212] to the south of the soakaway is thought to be associated with it. This was 1.2m wide, 0.70m deep, and filled with dark yellowish brown sandy silt (211). This was contiguous with the soakaway cut, so may be a working space for its construction. No pipe was in this subsidiary cut, so it is not a pipe trench. A glazed ceramic pipe entering the soakaway from the north is probably a continuation of the drain seen in Trench 1. A thin layer of black, organic silty clay (213) over the top of the fill (211) may indicate that this feature was a soft spot in the property after being filled, and was damp.

Plate 1: Section through Cut Feature 219.

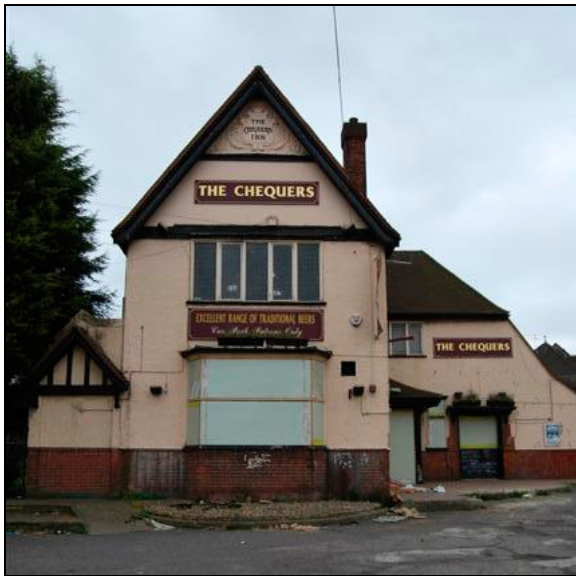
- 7.1 The Chequers Inn stands on a high point of 38mOD, and, its principal aspect faces northwards, attracting traffic southwards along Ealing Road. The large gable end clearly states the identity of the Inn. The building has two floors and a cellar, and has external walls of brick, much of which is pebble-dashed; the windows are mostly lead-glazed with rectangular panes and there are tiled and flat roofs. There are two bars within the inn, a lounge bar in the northeast and a public bar to the west. Each bar is served with toilet facilities. A kitchen lies to the rear. The stair to the cellar and to the first floor rises in the centre of the property. The first floor has living areas. A small brick building to the south has a pitched roof and doors that suggest a carriage-house, stable, or garage. The northern end of the Inn is currently a tarmac parking space with cobbles beneath, while to the east and south is the beer garden. At the time of recording, the site had been enclosed with protective hoarding, and all ground floor openings boarded up.

Plate 2: northern aspect, the Chequers Inn Plate 3: detail under northern gable

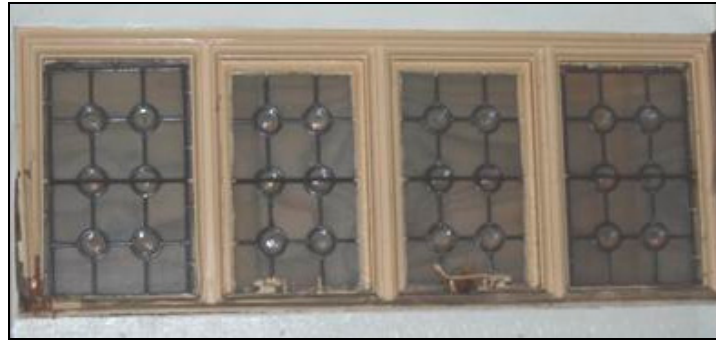
bars is a single storey porch providing the main entrance to the northeast bar. This is constructed of wooden posts and brick. The entrance is through the north, the western side has an interesting group of windows.

Plate 4: Porch windows

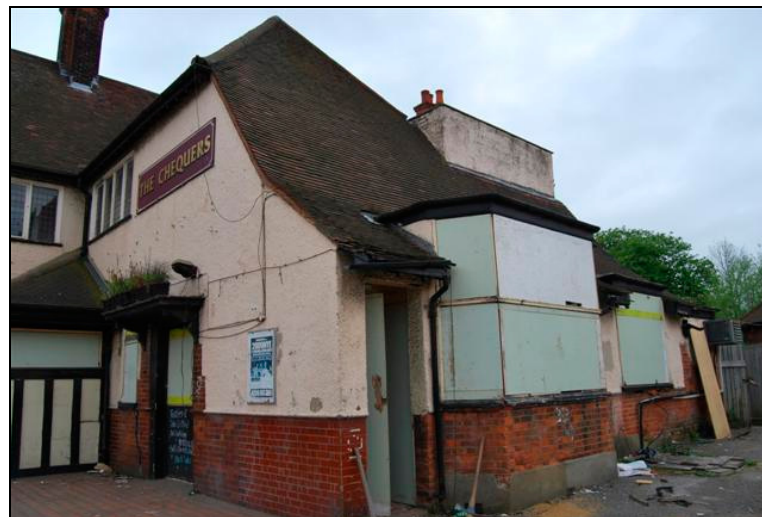
7.5 The west wall of the public bar has a bay window, of same style as the northern bay. A second window lies south of this. At the south end of this side, a small extension is part of a toilet suite. The entrance to the western bar is in this wall, the door is part glazed with six lights, and there is a short porch entrance. An outer metal door is a modern security door. A pair of cellar hatch doors is the delivery point for barrels.

Plate 5: western bar, external looking southeast

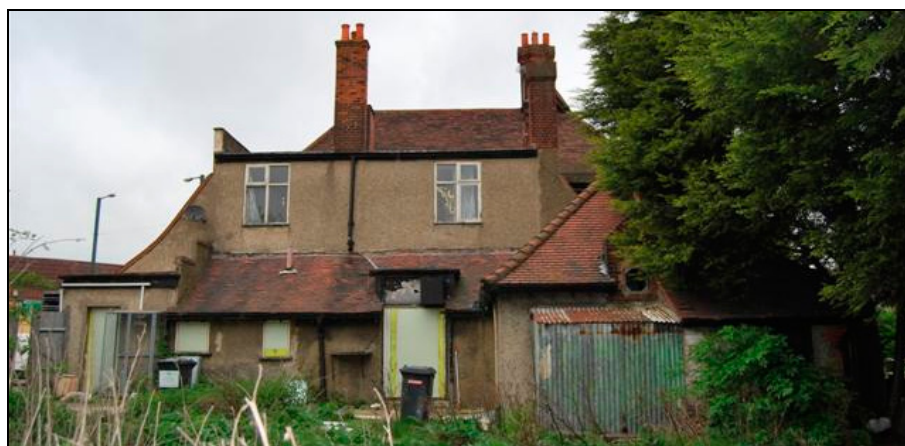
Plate 6: Rear view

7.6 At the rear of the property, the south elevation is all pebble-dashed, except for the windows. Two casements on the first floor lie below a flat roof, and the ground floor has two windows and two doors with a lean-to roof above.

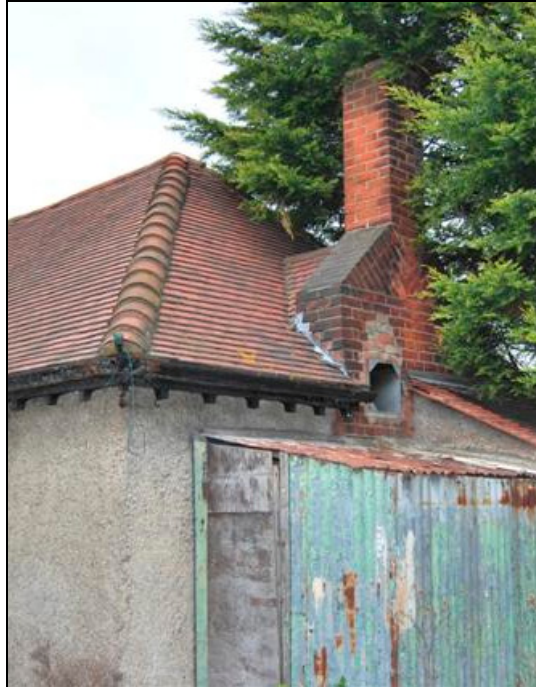
- 7.7 A single storey building attached to the main structure houses the kitchen (**G10**). This has a hipped roof, and is accessed from inside the main Inn, as well as a pair of doors in its west wall. Two extensions lie against the south wall, both with lean-to roofs: one is brick, the other corrugated iron. The kitchen's best feature is a chimney in the south wall whose form suggests a 19th century date, but may be 20th century.

Plate 7: Kitchen chimney

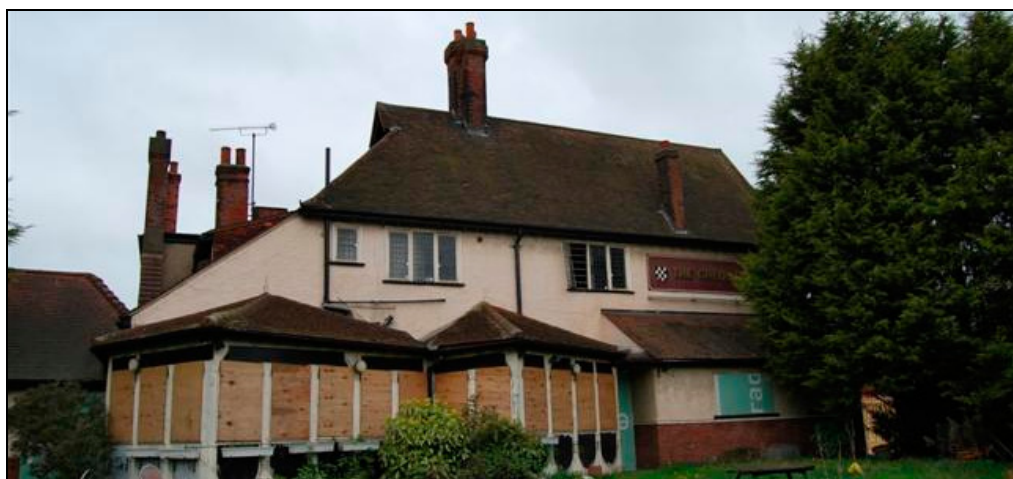
- 7.8 The eastern wall has been largely removed a ground floor level following the addition of a pair of polygonal extensions of modern date. An earlier extension to the north houses a toilet and washroom with a lean to roof that is bonded in to the main structure and therefore later. At first floor level, a large sign advertising 'The Chequers' with a chequerboard shield motif is located towards the front of the building, and there are three windows: two are three-light casements, the other is a small casement lighting a small lavatory. All of these have leaded windows with square panes.

Plate 7: east side of Inn

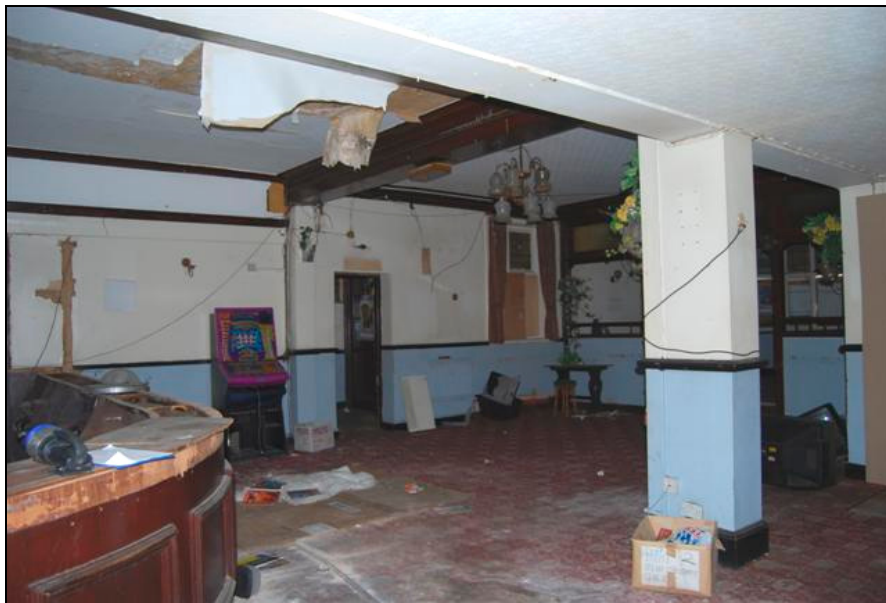
Plate 9: Lounge bar looking northeast

- 7.13 The lounge bar is open plan and can be accessed by customers from the small porch at the front of the building, or through a door from the garden area. There is no direct access between the two bars: a wooden panelled partition divides the two areas, and is of a style consistent with an early 20th century date, thus an original fitting of the 1903 phase. The whole bar has a wide skirting board with a roll moulding above and a dado rail: painted blue below, cream above. Thus, the internal finishes

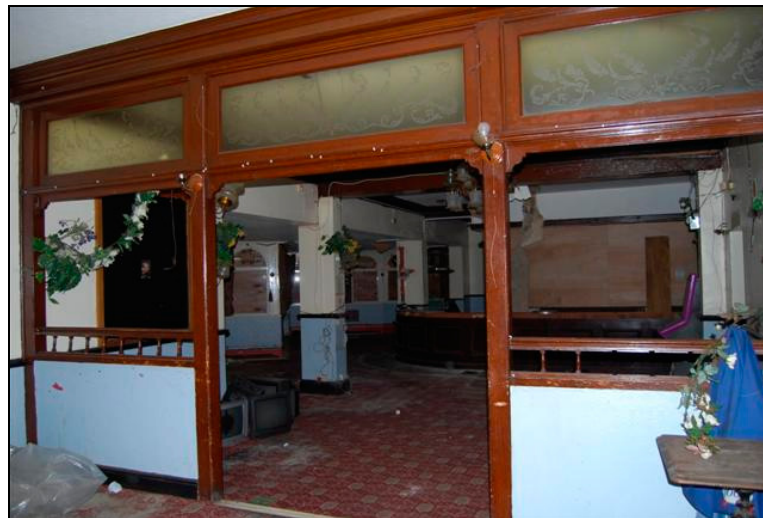
- 7.16 North of here, two steps up give access to a room including the front bay (**G13**). An imprint on the carpet indicates that this recently had a pool table. The wooden partition dividing this from the room to the south appears to be of modern date.

Plate 10: Partition of G13 looking southeast

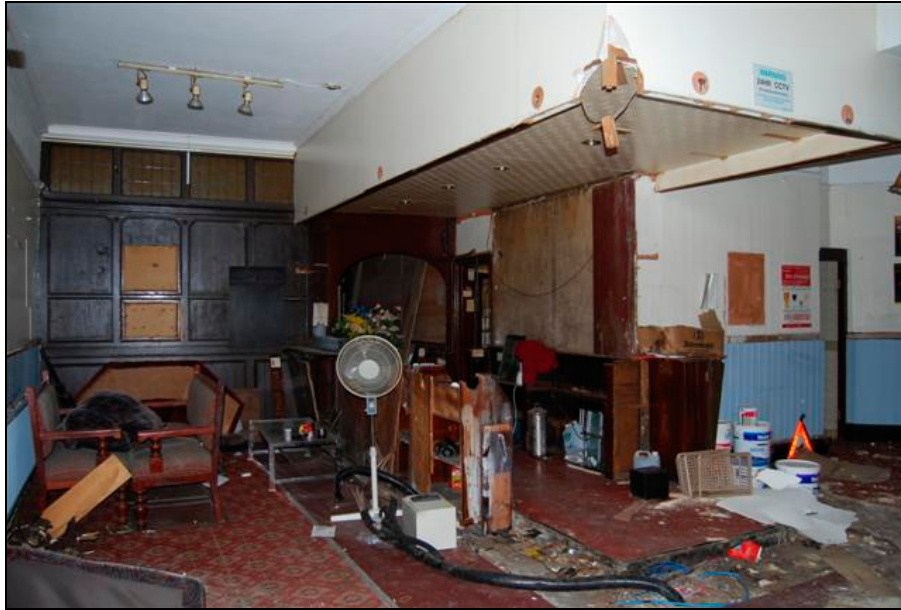
- 7.18 The public bar, accessed from the west, has beams in the ceiling supporting walls above, and these may represent a significant alteration to the west wall of the property. The beams lie directly above some walls of the basement, and therefore may indicate part of the form of the inn before the substantial rebuild of 1903. The beams also suggest that the north and south walls may be part of this older phase. The skirting and dado rail are of a style with those in the Lounge bar, so it is likely that all internal finishes date to the 1903 rebuild. Access to the cellar is behind the counter in this bar. The counter itself is a lightweight wooden frame with wooden panels. Pipes from the beer cellar (Room B4) rise behind the counter.

Plate 11: Public Bar with wooden partition and serving counter

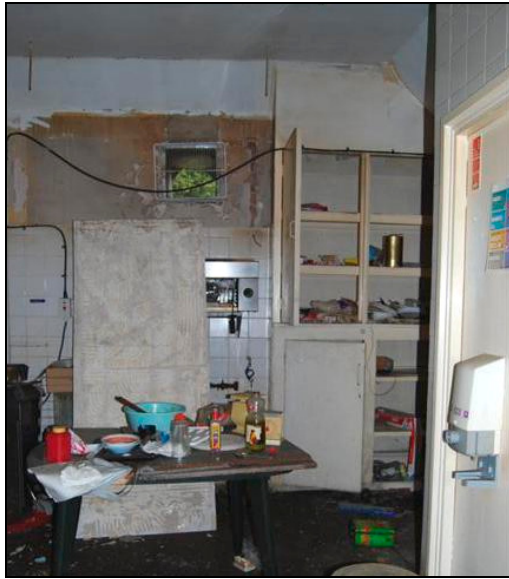
- 7.21 The kitchen block has a small store in the north (**G9**) and the cooking area to the rear (**G10**). Food items that remain in the rooms are evidence for the inn's most recent ownership and part-use as a restaurant specialising in curries. The kitchen block, with its hipped roof, is single storey, and notably lacking in ornament, being very functional. There is daylight provided by windows in the east wall to both rooms: the windows are wooden framed and the windows have no decorative features, being simple casements. The kitchen has its main range along the east wall, but originally must have had its cooking area at the south end, where a chimneystack rises. The fireplace for this stack is blocked, and an extractor fan cut through the chimney. The south wall has been cut for a doorway into a more modern brick extension, used as a store.

Plate 12: Room G10

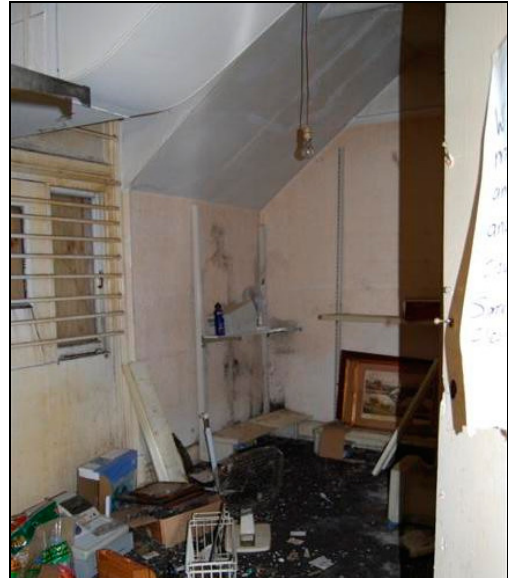
- 7.22 The corridor (**G11**) behind the public bars leads to the fire exit to the south which can also be accessed through the kitchen. To the west of the corridor is a large irregular room, its shape determined by the presence of the ladies lavatories on its north side, behind a partition wall. The room is lit by a large window in the south wall, with wooden casements. These rear windows contrast sharply with the windows in the north, east and west faces, which are high quality, whereas these are cheaper.

Plate 13: Room G11

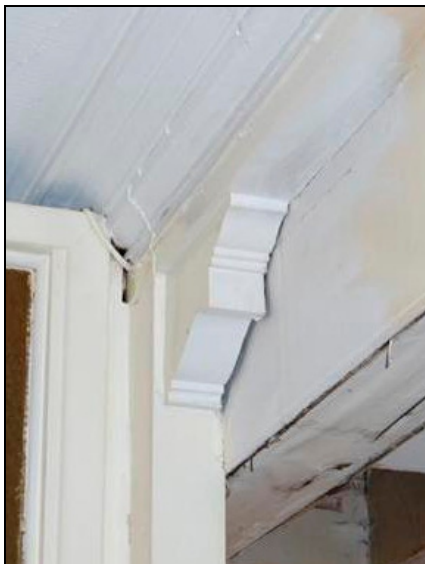
- 7.24 The first floor (Figure 9) is accessed up a single flight of stairs that open onto a landing running east-west (F5), and the landing also runs north to the front of the building (F11). The landing is edged against the stairwell with a banister of square-profile posts and a curved rail. Principal posts of the banister rise to the ceiling, where they support an east-west joist with the use of semi-ornate brackets.

Plate 14: Semi-ornate brackets in the landing.

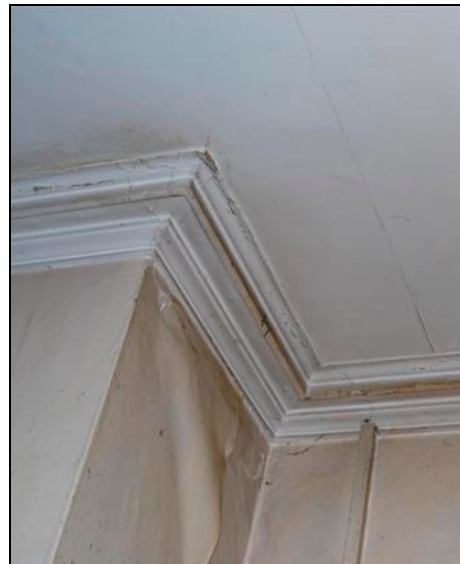
Plate 15: Typical moulding of first floor

- 7.25 The internal finishes across the whole of the first floor are alike; ceiling mouldings have sharp, squared profiles, doorframes have a succession of roll moulding and a square stop, and picture rails are of a simple form. The north, east and west windows also have a common form; well-glazed panels typically 9 by 5 units in casements. The identical form of all fittings suggests that the whole of

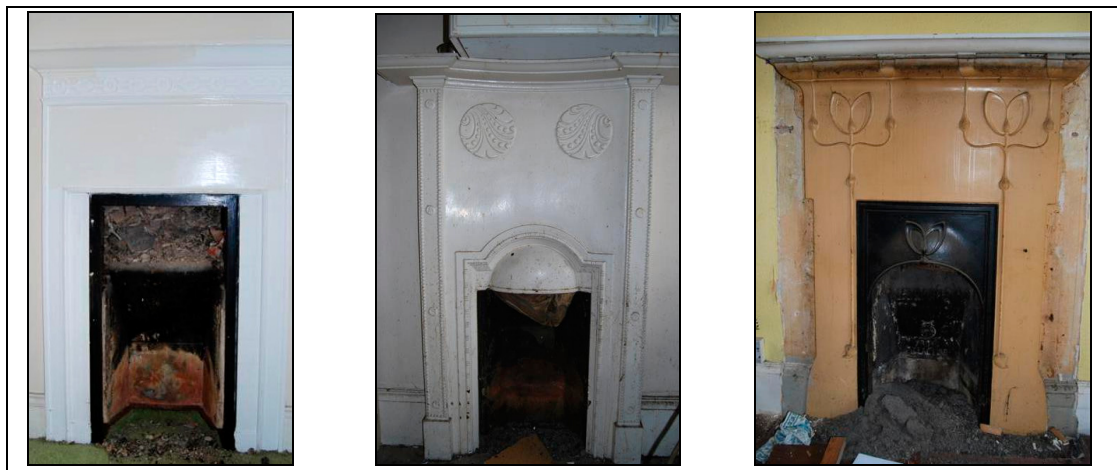
- 7.30 Room F9 is light, and shows the same mouldings as the rest of the floor. The fireplace survives in this room, the mantelpiece having a tulip design. This room was most recently a sitting room for the self-contained flat.

Plate 16: Fireplaces in Rooms F1, F8 and F9 (left to right)

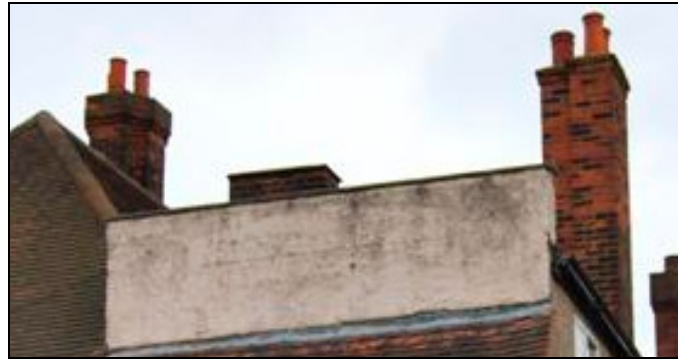
- 7.32 The roof is tiled, varied pitched or hipped, as described in the section on the exterior. The chimneys are all brick, topped with pale brown ceramic pots. There are two main styles of chimney, multi-flue and simpler. One multi-flue chimney rises between Rooms F8 and F9, no stack left on the ground floor, and has four pots, showing two missing flues. The second has three pots, and rises at the rear of Rooms F1 and F2. The other chimneys are straight, and plain, and generally finish below ridge level.

Plate 17: multi-flue chimneys

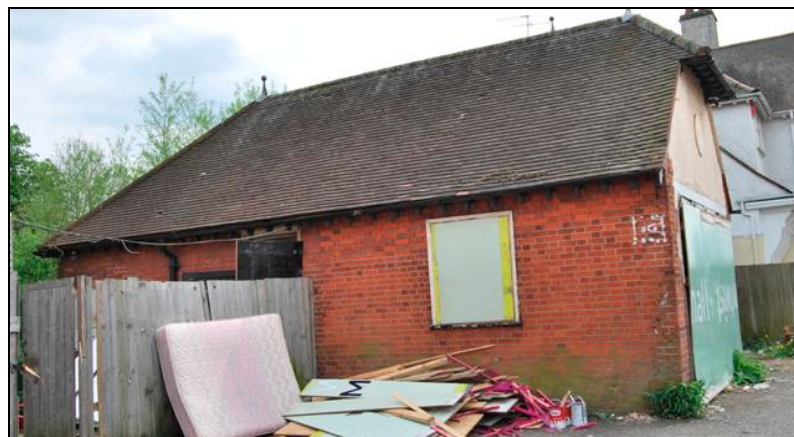
- 7.35 The rear room is accessed through a stable door, and has a window in the eastern wall. The concrete of the floor was worn in this room, showing manufactured cobbles of 20th century date. The ceiling joists run north-south and have angled supports between, typical of the late 19th or early 20th century. A hatch in the ceiling was not accessible, but the loft is clearly boarded, and there is a small window in the front wall. It is tempting to consider this as a hay loft.

- 7.36 The function of this building as a stable is assumed by the stable door, perhaps carts held in the front room. If this were a stable, it was probably soon converted to a garage in the early 20th century.

Plate 18: Stable Block
