Nunholm Road, Dumfries, Archaeological Evaluation:

Data Structure Report

AOC 21151

May 2009

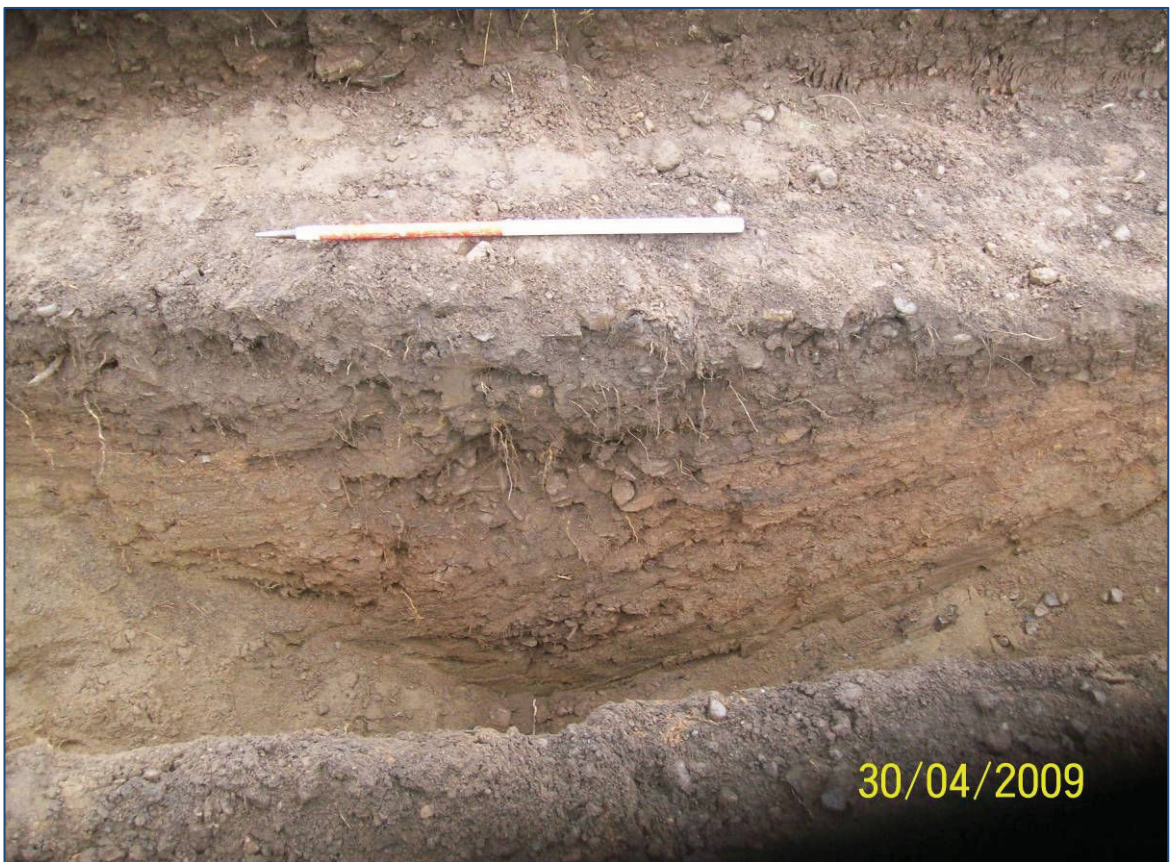
- 4.2.2.1 Trench 1 revealed two linear features, [101] and [103]. Feature [101] appears to be a large enclosure ditch which is aligned south to north and appears to curve around to the west. A one metre wide slot was excavated through this, revealing a steeply sided concave cut with a slightly rounded base. Within the trench the feature was visible for 2.4 m with a width of 5.32 m and a maximum depth of 1.52 m. The feature was filled by two deposits (102) and (105). The upper fill (102) consisted of dark brown sandy silt with occasional small sub-rounded stones which became more frequent towards its base. This in turn overlay the primary fill (105) which consisted of pale brown gravel sand. This deposit also contained occasional, large sub-rounded cobbles especially towards the base and occasional flecks of charcoal. The feature was also observed in Trenches 2, 3 and 4.

Plate 1: West facing section of enclosure ditch [101]

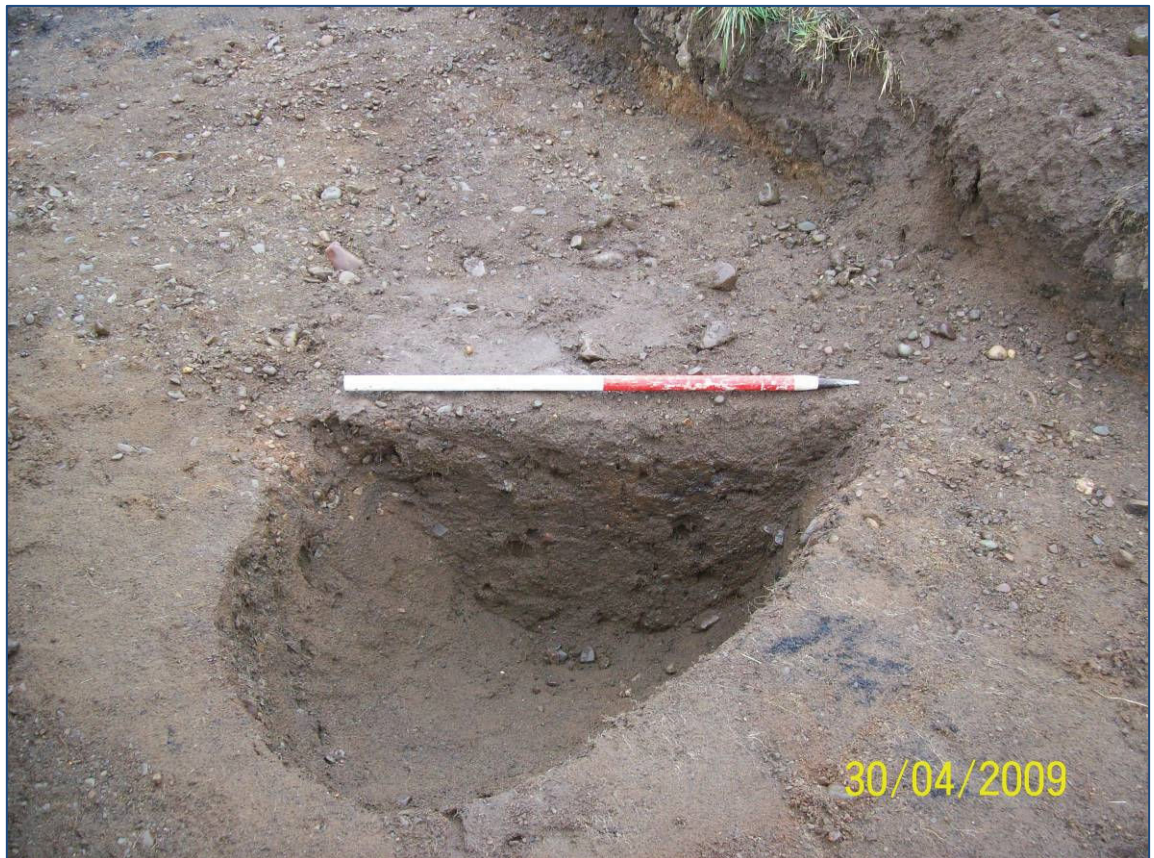
- 4.2.3.1 This trench contained five features including a sub-circular pit feature [203], a post-hole [205], a cobble spread [207] and the recurring boundary ditch from Trench 1 [201]. This feature was not excavated but had a similar visible length and width and a similar fill (202). The pit feature [203] had steep gradually sloping sides and a slightly rounded base. It had a length of 2.60 m and a width of 1.10 m. The feature was 0.51 m in depth, and was filled by a single deposit (204), a dark brown silty sand which produced occasional flecks of charcoal and a single body sherd of black glazed ceramic. Feature [205] was a truncated oval feature with steep sides and a rounded base. The feature was 0.46 m in length, 0.36 m in width and 0.16 m in depth. The fill (206) was very similar to (204).

Plate 2: South-west facing section of pit [203]

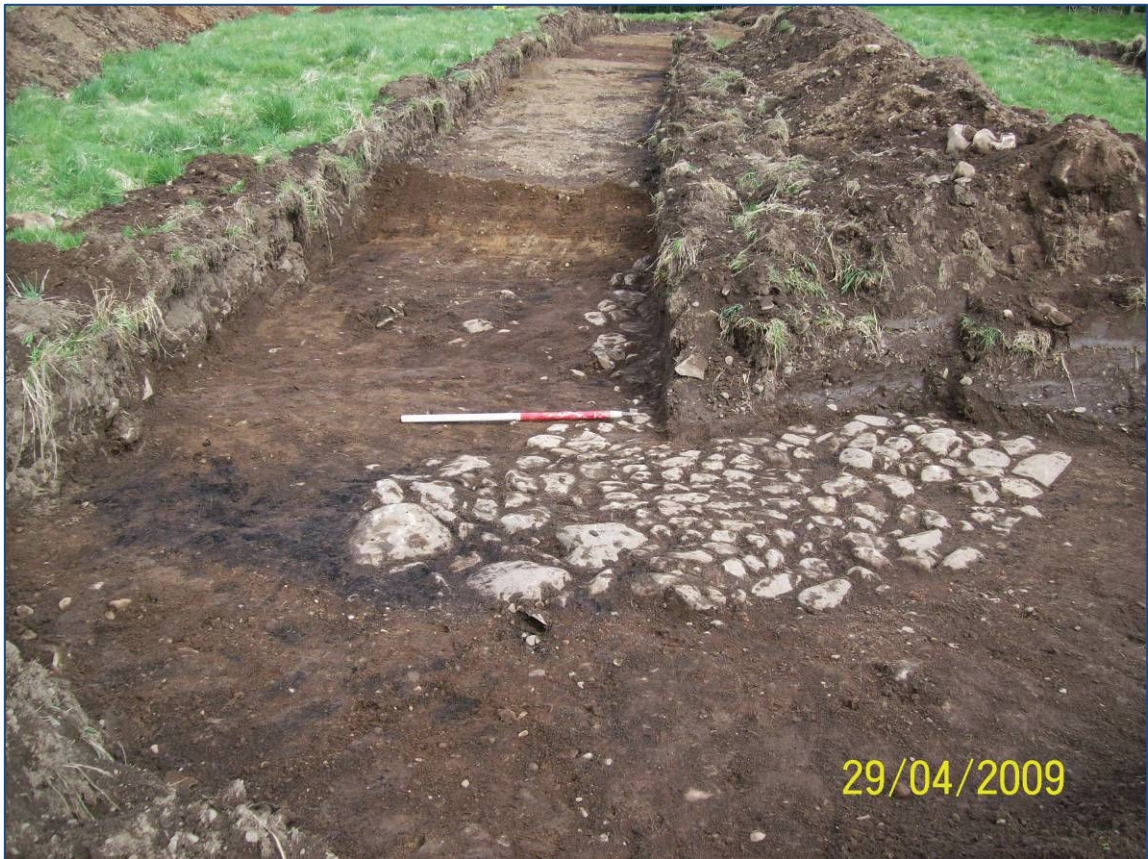
- 4.2.3.2 An area of cobbles [207] was revealed at the south-east end of Trench 2. This was irregular in shape and possibly truncated with variously shaped cobbles possibly overlying the pit [208] although this was not proven during the evaluation as [207] was not excavated. The cobbled area was approximately 4.9 m in length with a width of 2.25 m. Pit [208] was 3.7 m in visible length and 2.4 m in width. It had a fill (209) of pale brown silty sand. A thin patch of black silty sand with possible charcoal (210) appeared to overlie the cobbles [207] in its south-west corner.

Plate 3: Cobbled area [207] with possible pit [208] and layer (210) from SW

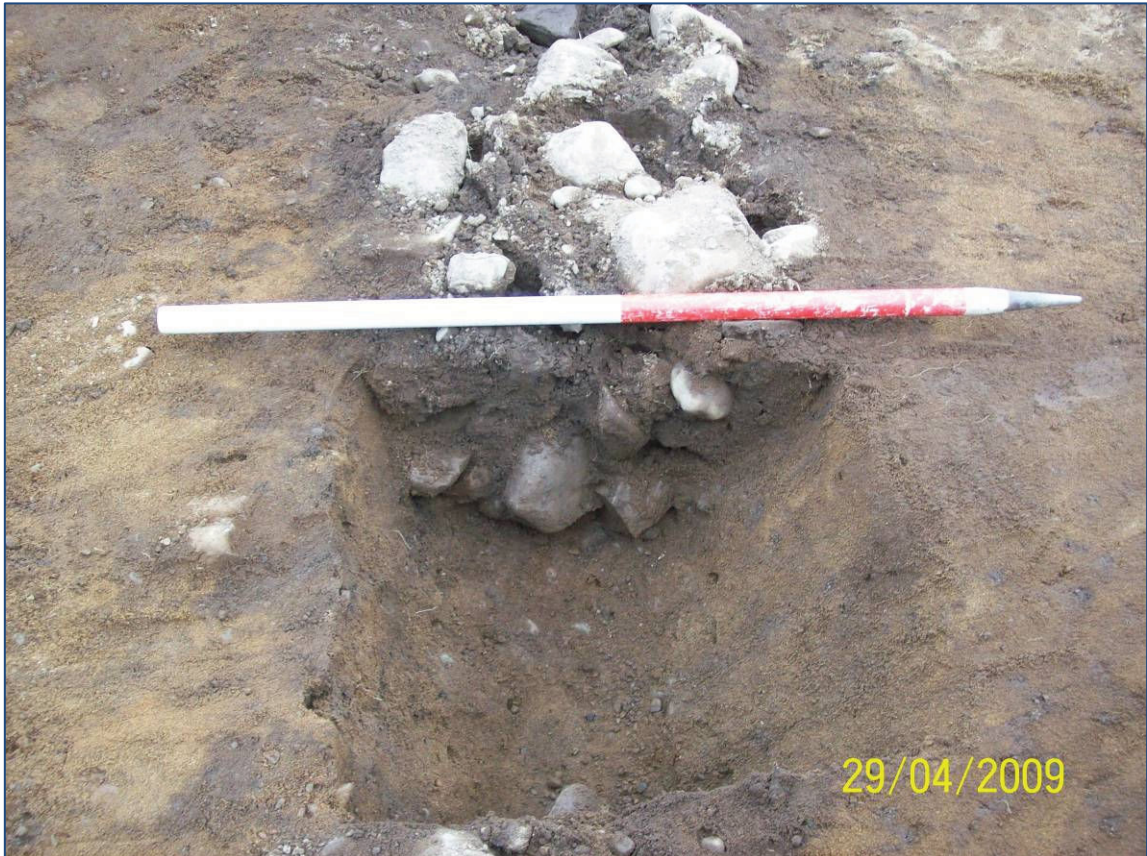
Plate 5: South facing section of ring gully [307]

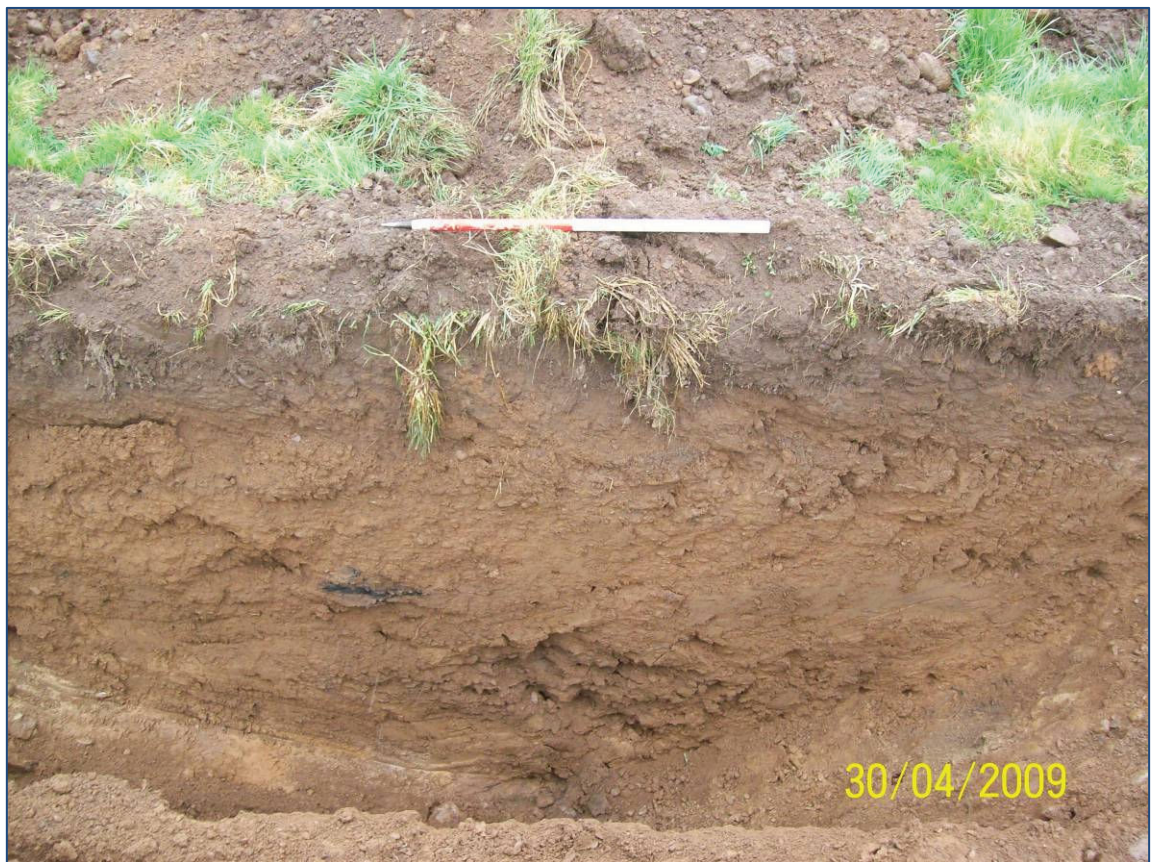
- 4.2.5.1 Trench 4 appeared to show the same linear feature observed in Trenches 1, 2 and 3. It is roughly V shaped and has sharp, steep, slightly irregular sides and a slightly rounded base. The feature has a visible length of 2.80 m, a width of 6.42 m and a depth of 2.04 m from the top of the top-soil. A one metre wide slot was excavated by machine. The feature was filled by (402), a light orange sandy silt with a lens of charcoal towards the middle of the deposit. This fill had a maximum depth of 1.24 m and extended across the width of the feature. Underlying (402) was a more compact and friable sandy silt (409). This was 0.42 m in depth and had a width of 3.20 m. A second linear feature [403] was aligned north-east to south-west across the trench. This feature had shallow concave sides and a generally flat irregular base. The feature had a visible length of 2.0 m, a width of 1.35 m and a depth of 0.26 m. The single fill of this feature (404) was a grey brown sandy silt with occasional small to medium sub-rounded stones and fragments of charcoal.

Plate 6: South-west facing section of ditch [401]

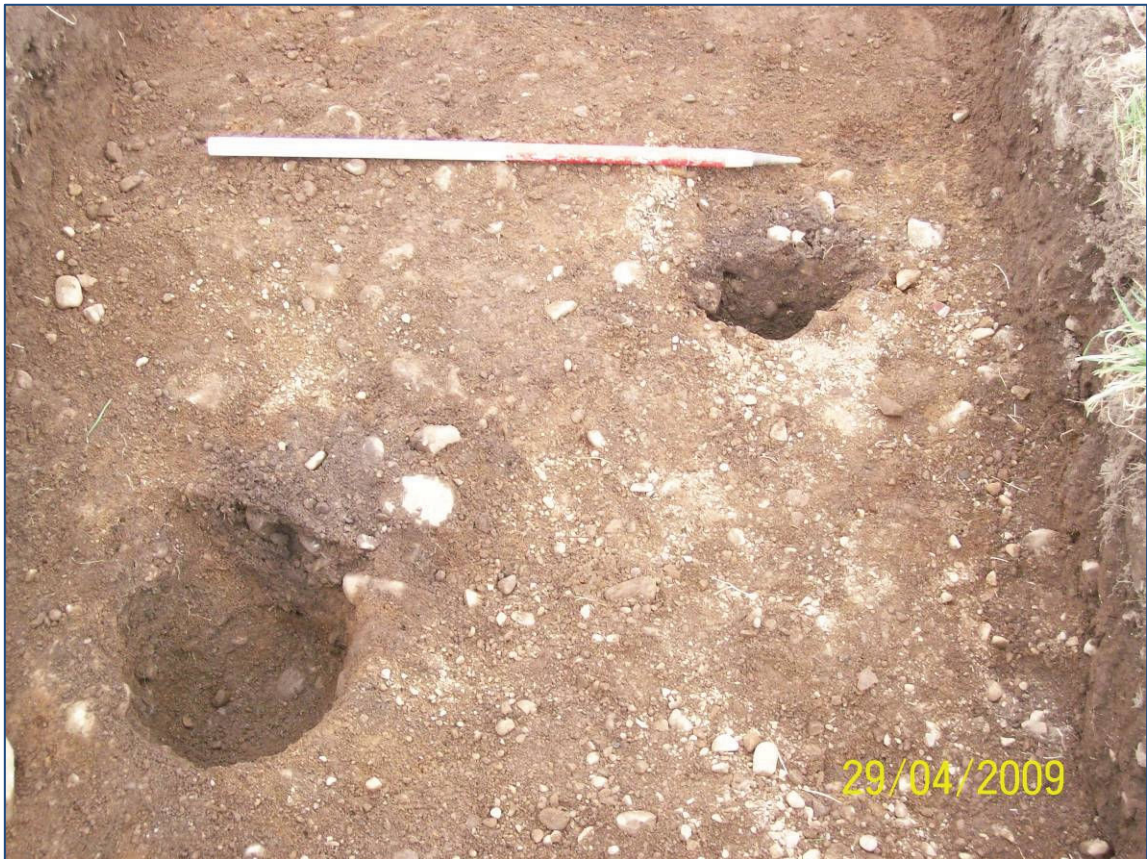
- 4.2.5.2 Two post-hole features [405] and [407] were revealed within Trench 4. Feature [405] was circular in plan with steep concave sides and a gently rounded base. It had a diameter of 0.30 m and a depth of 0.19 m. feature [407] was more oval in plan with a length of 0.67 m, a width of 0.33 m and a depth of 0.32 m. Its sides were steep and concave and a rounded base. Both post-holes were filled with a friable silty gravel (406-408) with frequent large sub-rounded stones pressed against the edge of feature [407] which are probable packers.

Plate 7: Postholes [405] and [407] from SE
