# St Cuthbert's Street, Catrine, Ayrshire

## Watching Brief Report

AOC 21417

28<sup>th</sup> July 2009

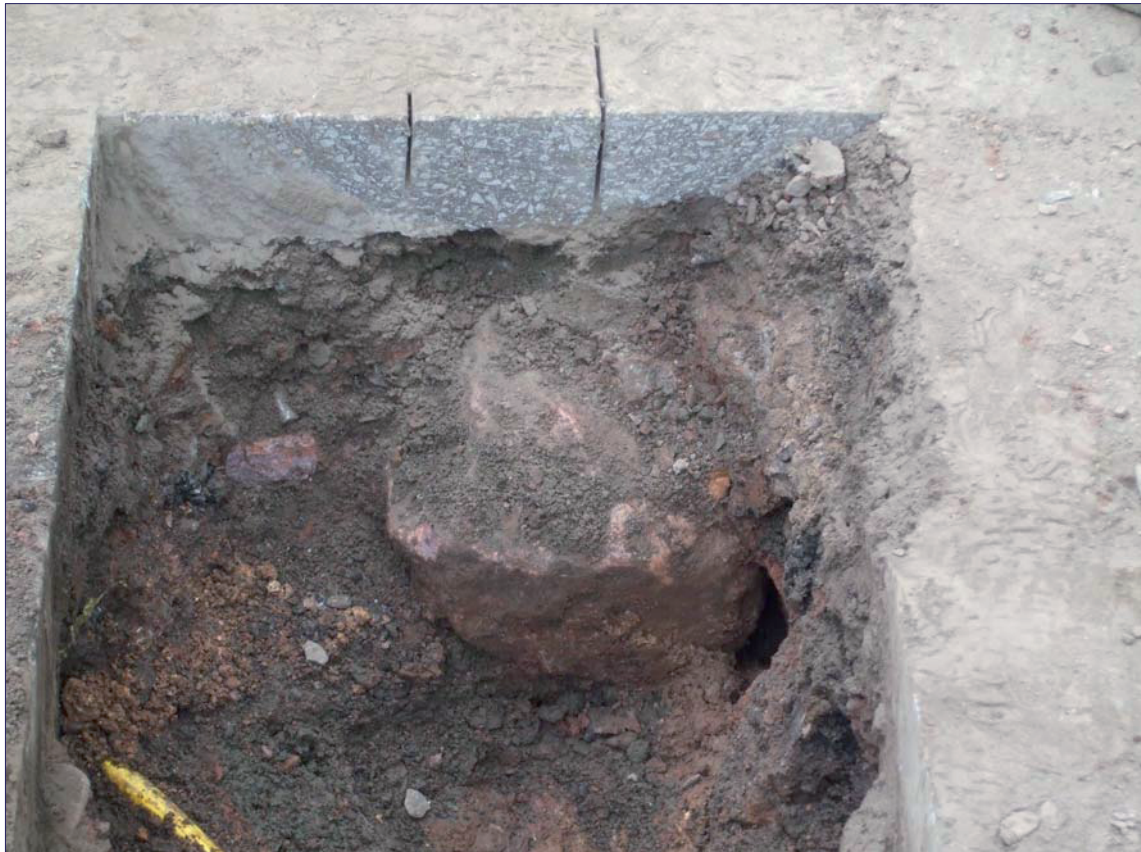
- 4.1 The ground breaking works were excavated between Monday 6<sup>th</sup> and Thursday 16<sup>th</sup> July 2009 in variable weather conditions. Archaeological visibility was good throughout.
- 4.2 Trial pit 1 measured 1.3 m long and 0.5 m wide with a maximum depth of 0.5 m at which point the existing gas main was located. Trial pit 2 measured 1.4 m long and 0.5 m wide with a maximum depth of 0.6 m where the gas main was identified. Both trial pits showed approximately 0.1 m of tarmac road surface overlying made ground of dark grey and black ashy material with frequent fragments of sandstone and brick rubble. At the western limit of Trial pit 2 a red sandstone block was observed within the section which appeared to be an *in situ* block of the lade. A void directly below this block clearly showed the existing gas main running through the lade (Plate 1).

**Plate 1: Sandstone block, forming part of the covered lade, with void below**

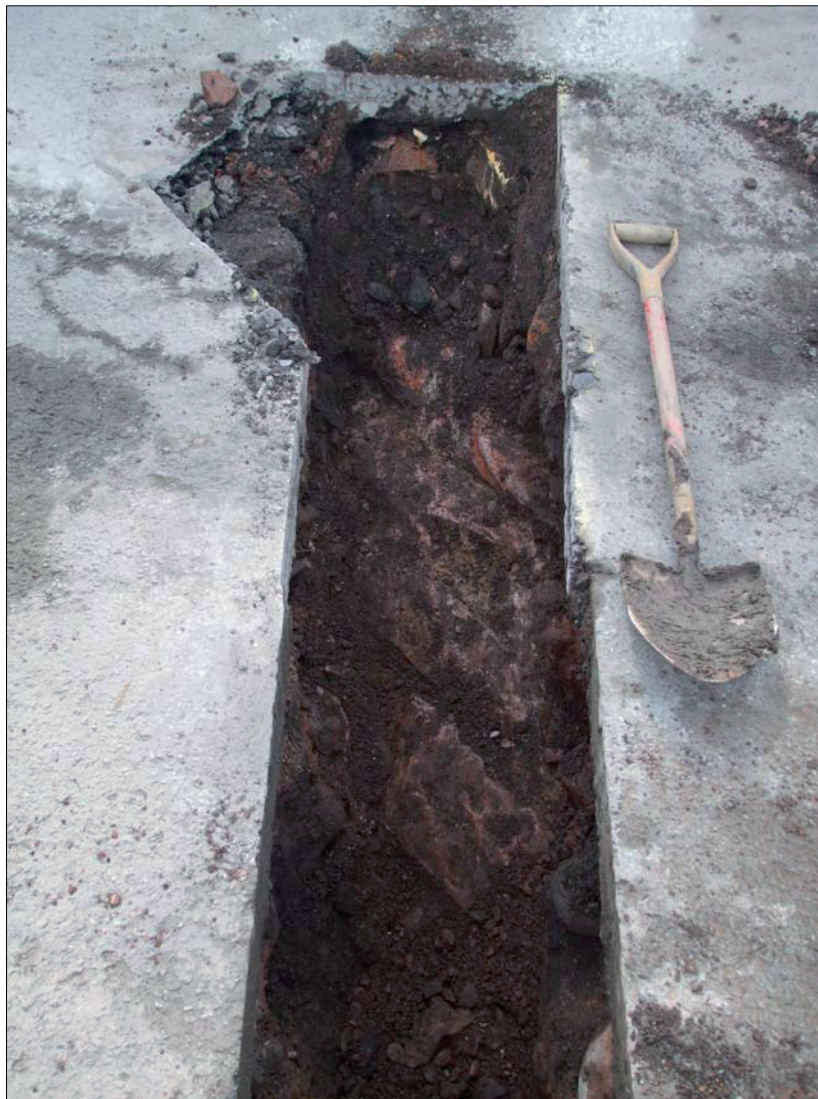
- 4.4 Trench 3 was excavated from the mid point of Trench 1 along an E/W alignment for approximately 3 m (Figure 2). It was 0.45 m wide and a maximum of 0.9 m deep. This trench revealed 0.1 m of tarmac road surface overlying 0.6 m of rough red sandstone rubble and yellow brick fragments in a matrix of dark grey sandy material with frequent small to medium rounded and sub-rounded stones. This in turn overlay around 0.20 m of mid red brown sandy clay natural subsoil. At the west end of the trench several long sandstone blocks were observed, sloping to the north-west and bonded with a coarse light yellow mortar (Plate 2). These blocks appeared to be *in situ* however they were located well away from the predicted line of the covered lade and while they may relate to the structure it is unlikely that they form part of the lade. In order to avoid damage to this area the junction with Trench 5 was diverted to the north-east (Figure 2).

**Plate 2: Mortar bonded sandstone blocks in Trench 3**

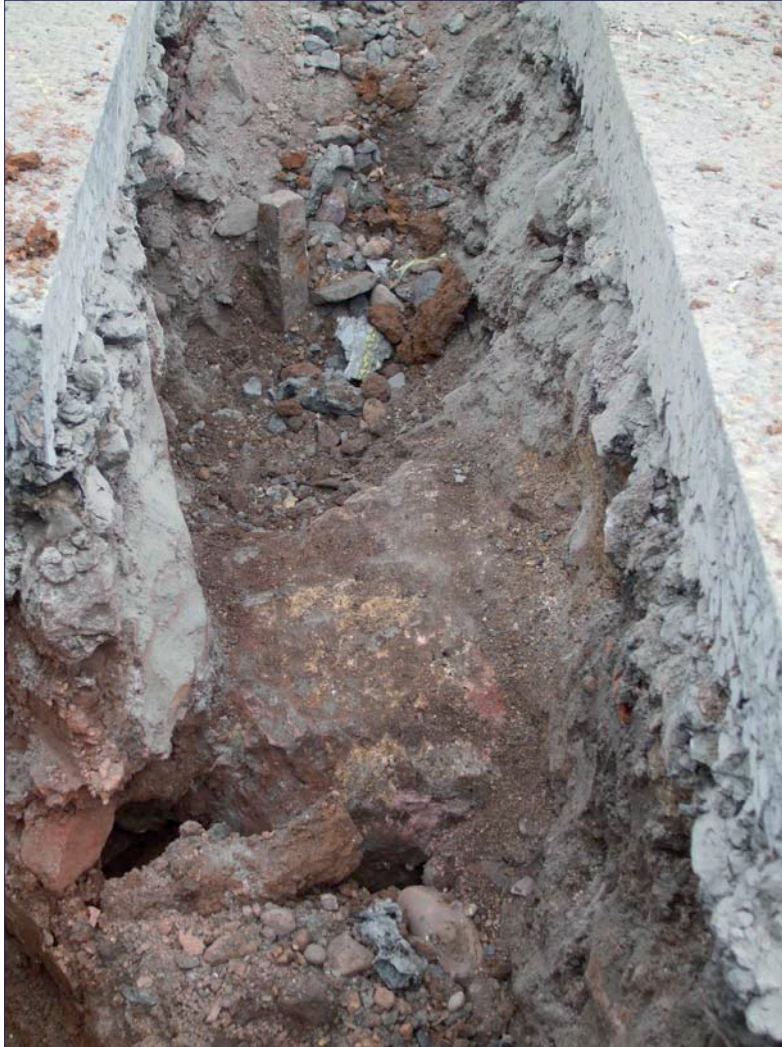
- 4.5 Trench 4 was excavated from mid way along Trench 2 (Figure 2). It was begun on an E/W alignment for a length of c.1.4 m; however at this point several roughly squared blocks of red sandstone bonded with light creamy mortar with an iron bar encased in the centre were encountered (Plate 3). Although this was some way from the predicted line of the covered lade the blocks seem likely to be a structure related to the lade. The trench was, therefore, diverted to the north-east to avoid this

structure. The trench thus ran 2.2 m to the north-east before turning to run E/W for 1.25 m, avoiding the sandstone structure and revealing 0.1 m of tarmac road surface, overlying 0.5 m of hardcore and brick rubble. This in turn overlay firm mid red brown sandy clay natural subsoil. A large reinforced concrete post which was clearly not related to the lade was removed from the west end of Trench 4 close to the junction with Trench 5; this post appears to be related to the modern road construction.

**Plate 3: Mortar bonded sandstone blocks with iron bar in background**
