# Pittendreich Care Home, Lasswade: Evaluation Data Structure Report

AOC 21352  
August 2009

## Pittendreich Care Home, Lasswade Evaluation Data Structure Report

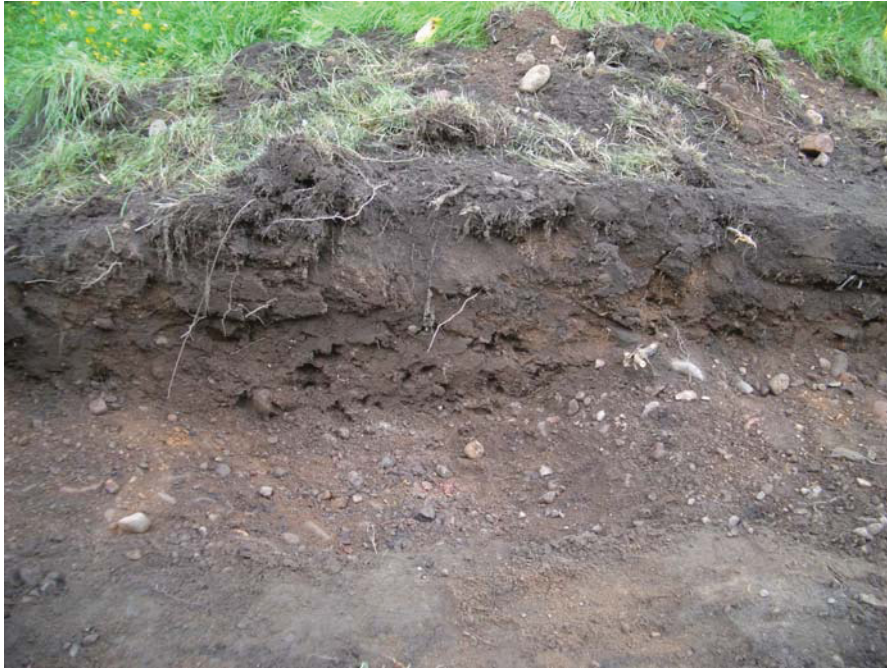
*Plate 1: Trench 6, Ridge and ditch [603]*

A low ridge exists as a surface anomaly at the south-western extent of Area B, aligned north-west to south-east, at right angles to Trench 6 (Figure 6). The full extents of this ridge are unknown as it ran into heavily overgrown ground either side of the trench. Excavation of this trench showed the ridge to be formed by topsoil (601) with depth of 0.4 m overlying the fill (602) of a shallow ditch [603]. This fill consisted of mid brown sandy silt containing frequent small stones with depth of 0.1 m rising to 0.2 m in the centre. The ditch itself had angled sides and a flat base and was seen to cut the underlying natural drift (610) with a width of 1.1 m (Plate 1; Figure 7). No dateable artefacts were recovered from this fill.

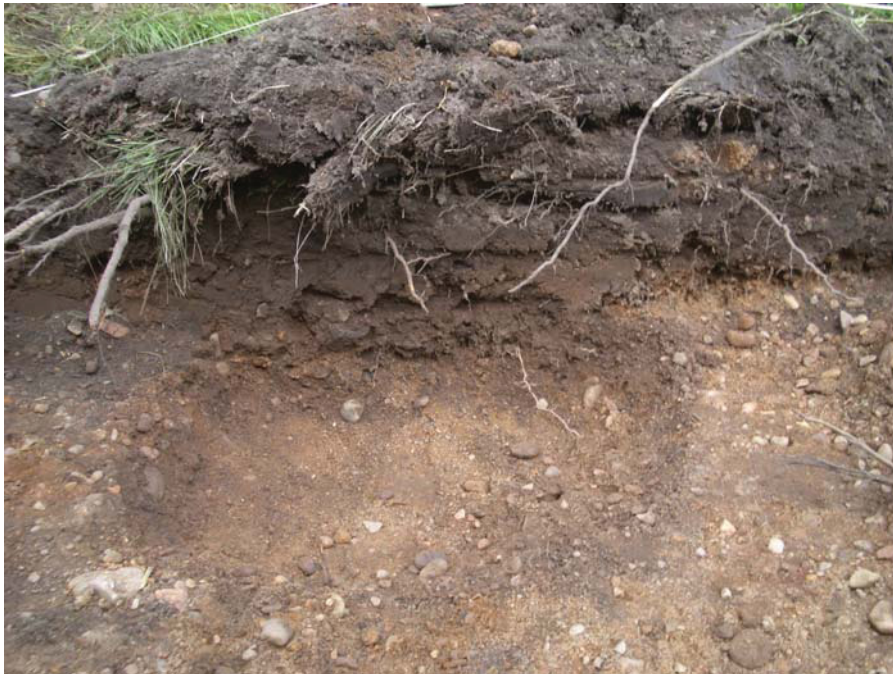
*Plate 2: Trench 6, Pit [605]*

At a distance of 13 m from the south-west end of the trench and extending from the northern trench section was a sub-circular pit like feature [605] with concave sides and a flat base (Plate 2; Figures 6 and 9). The diameter of this shallow pit was 0.9 m with a depth of 0.12 m. It cut the underlying drift geology (610) and was filled by orange brown silty sand (604) which contained frequent small stones, but no dating evidence.

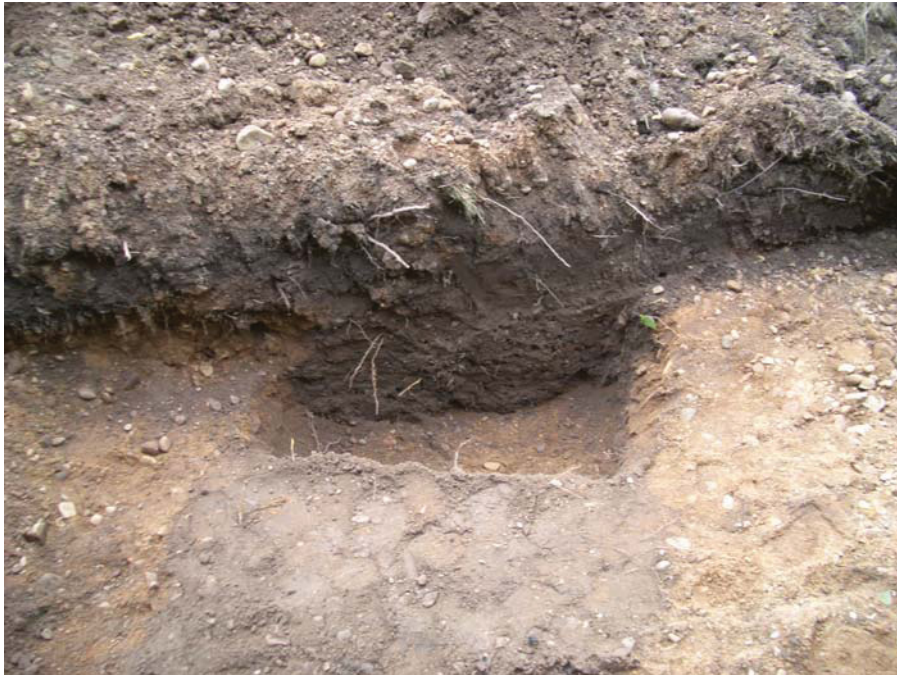
*Plate 3; Trench 6, Pit/Ditch terminus [607]*

Extending from the south-eastern section at a distance of 14 m from the trench's south-west end was a rectangular shaped cut [607] in the surface of the natural geology (Figure 6). This feature, aligned north to south, had steep sides 0.45 m deep with a width of 1.1 m. It is not clear if this feature is the remains of a pit or ditch terminus. It was filled by a mid brown sandy silt (606)

containing frequent small stones (Plate 3; Figure 9) and a single small fragment of 19<sup>th</sup>/20<sup>th</sup> century pottery, which may be intrusive.

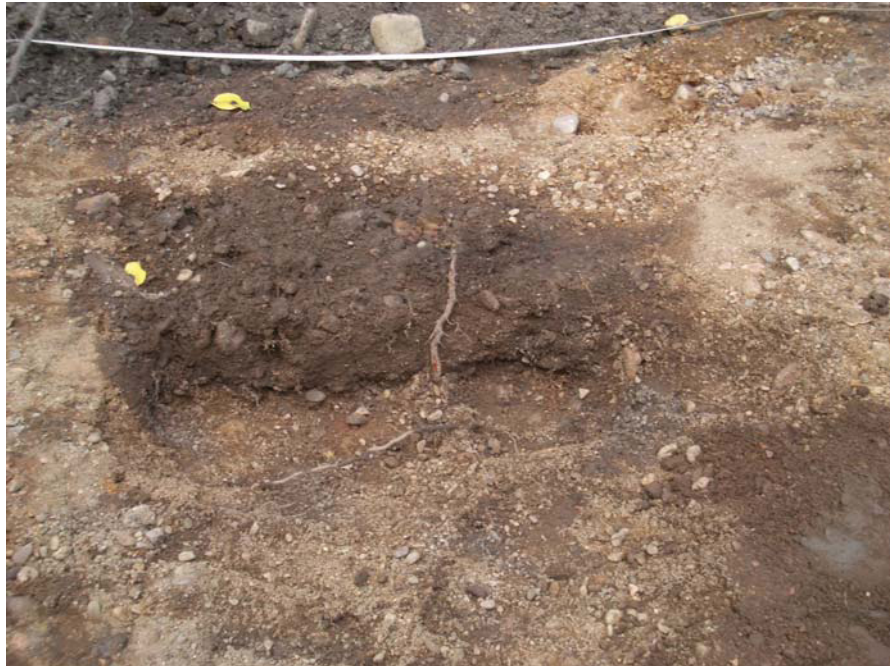
*Plate 4; Trench 6, Pit [609]*

A second circular pit [609] was located at a distance of 24 m from the south-western end of the trench (Figure 6). Again this feature was shallow being only 0.1 m in depth with a diameter of 0.6 m. Unlike other circular pit (605) this feature had a slightly concave base (Plate 4; Figure 10). The fill of this pit consisted of a mid brown sandy silt (608) containing frequent small stones, but no diagnostic dating material.

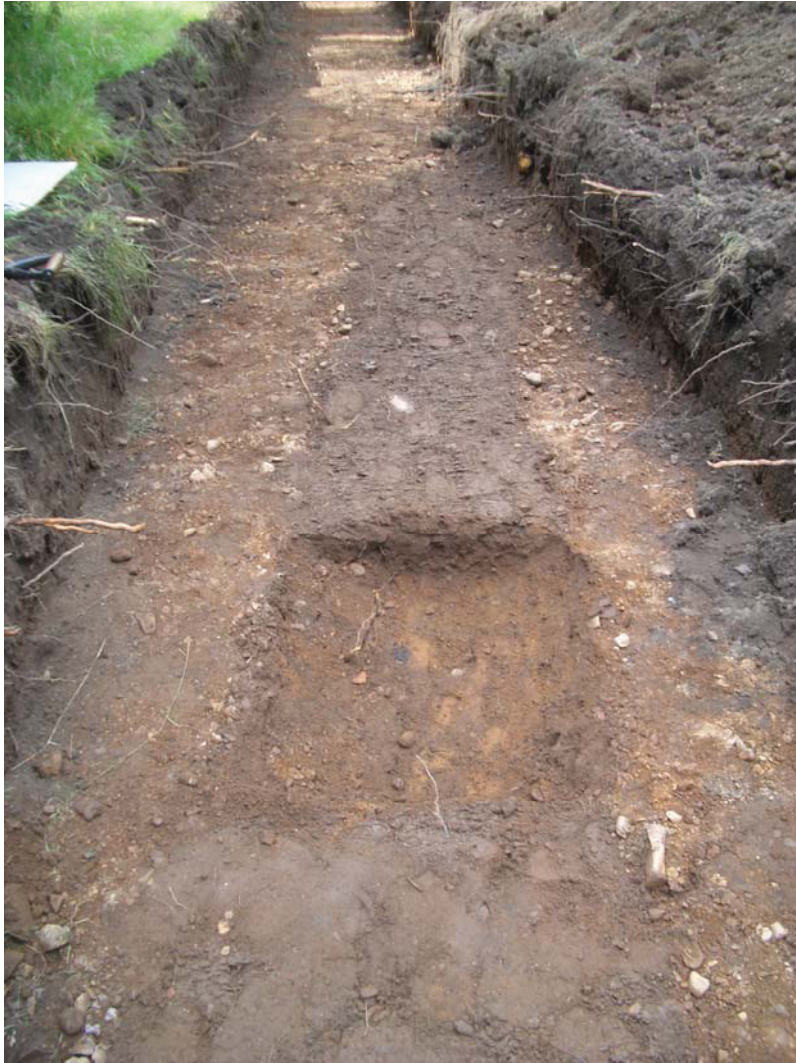
Plate 5: Trench 7, Ditch [704]

This trench differed from the other trenches in this area in that below the topsoil (701) it contained a subsoil (702) similar to that seen in Area A which had a depth of between 0.1 m at its western end deepening to 0.2 m toward the east. Only one feature existed within this trench in the form of ditch [704] aligned east to west with an exposed length of 13 m (Figure 6). A section excavated through the ditch showed it to have curved sides and base, 0.8 m wide by 0.2 m deep (Plate 5; Figure 11). This ditch also appears to bend to ward the north-west at its southern end toward Trench 6 but no trace of any continuation could be seen within Trench 6. The date and function of this ditch which was sealed by subsoil (702) are unknown.

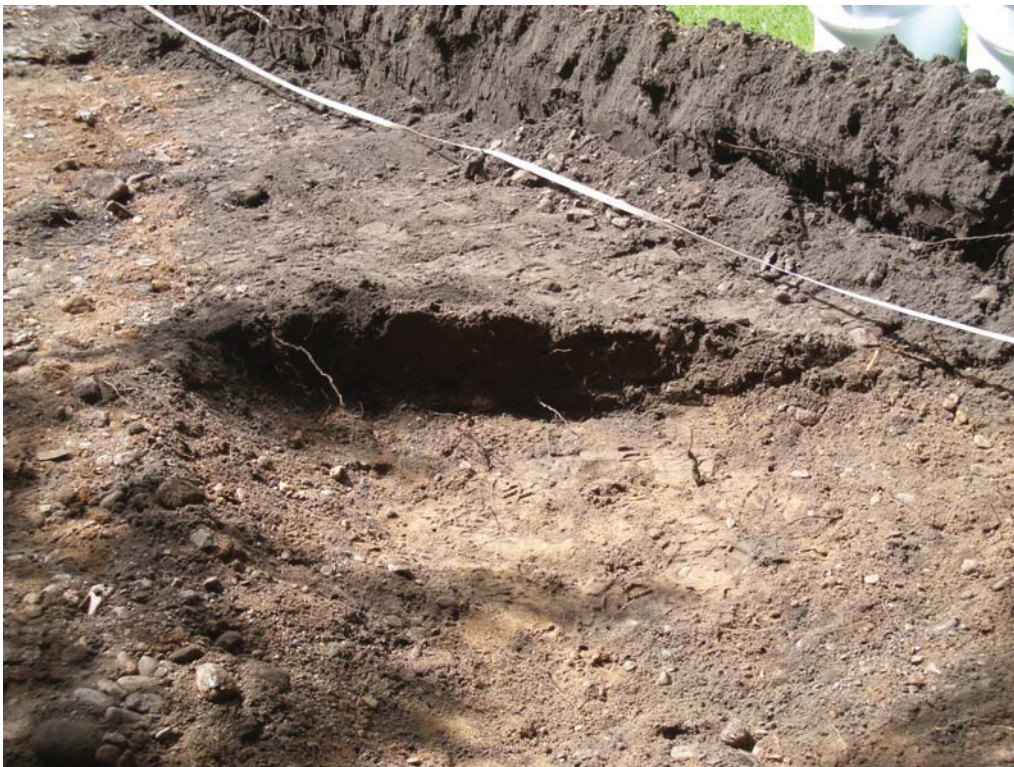
*Plate 6: Trench 10, Ditch [1003]*

- 4.9.1 The terminus of a shallow ditch [1003] was located at the north-eastern end of Trench 10 aligned on an east west axis (Figure 12). The exposed remains were sealed below topsoil (1001) and ran for a distance of 3 m before disappearing into the trench section. However a dark spread of soil partially crossing Trench 9 may show that it extended for at least a further 9 m (Figure 12). A section dug through the ditch at the terminus showed that it had gently sloping sides with a flat base 0.9 m wide and 0.15 m deep. It was filled by orange brown silty sand (1002) which contained frequent small stones (Plate 7; Figure 13).

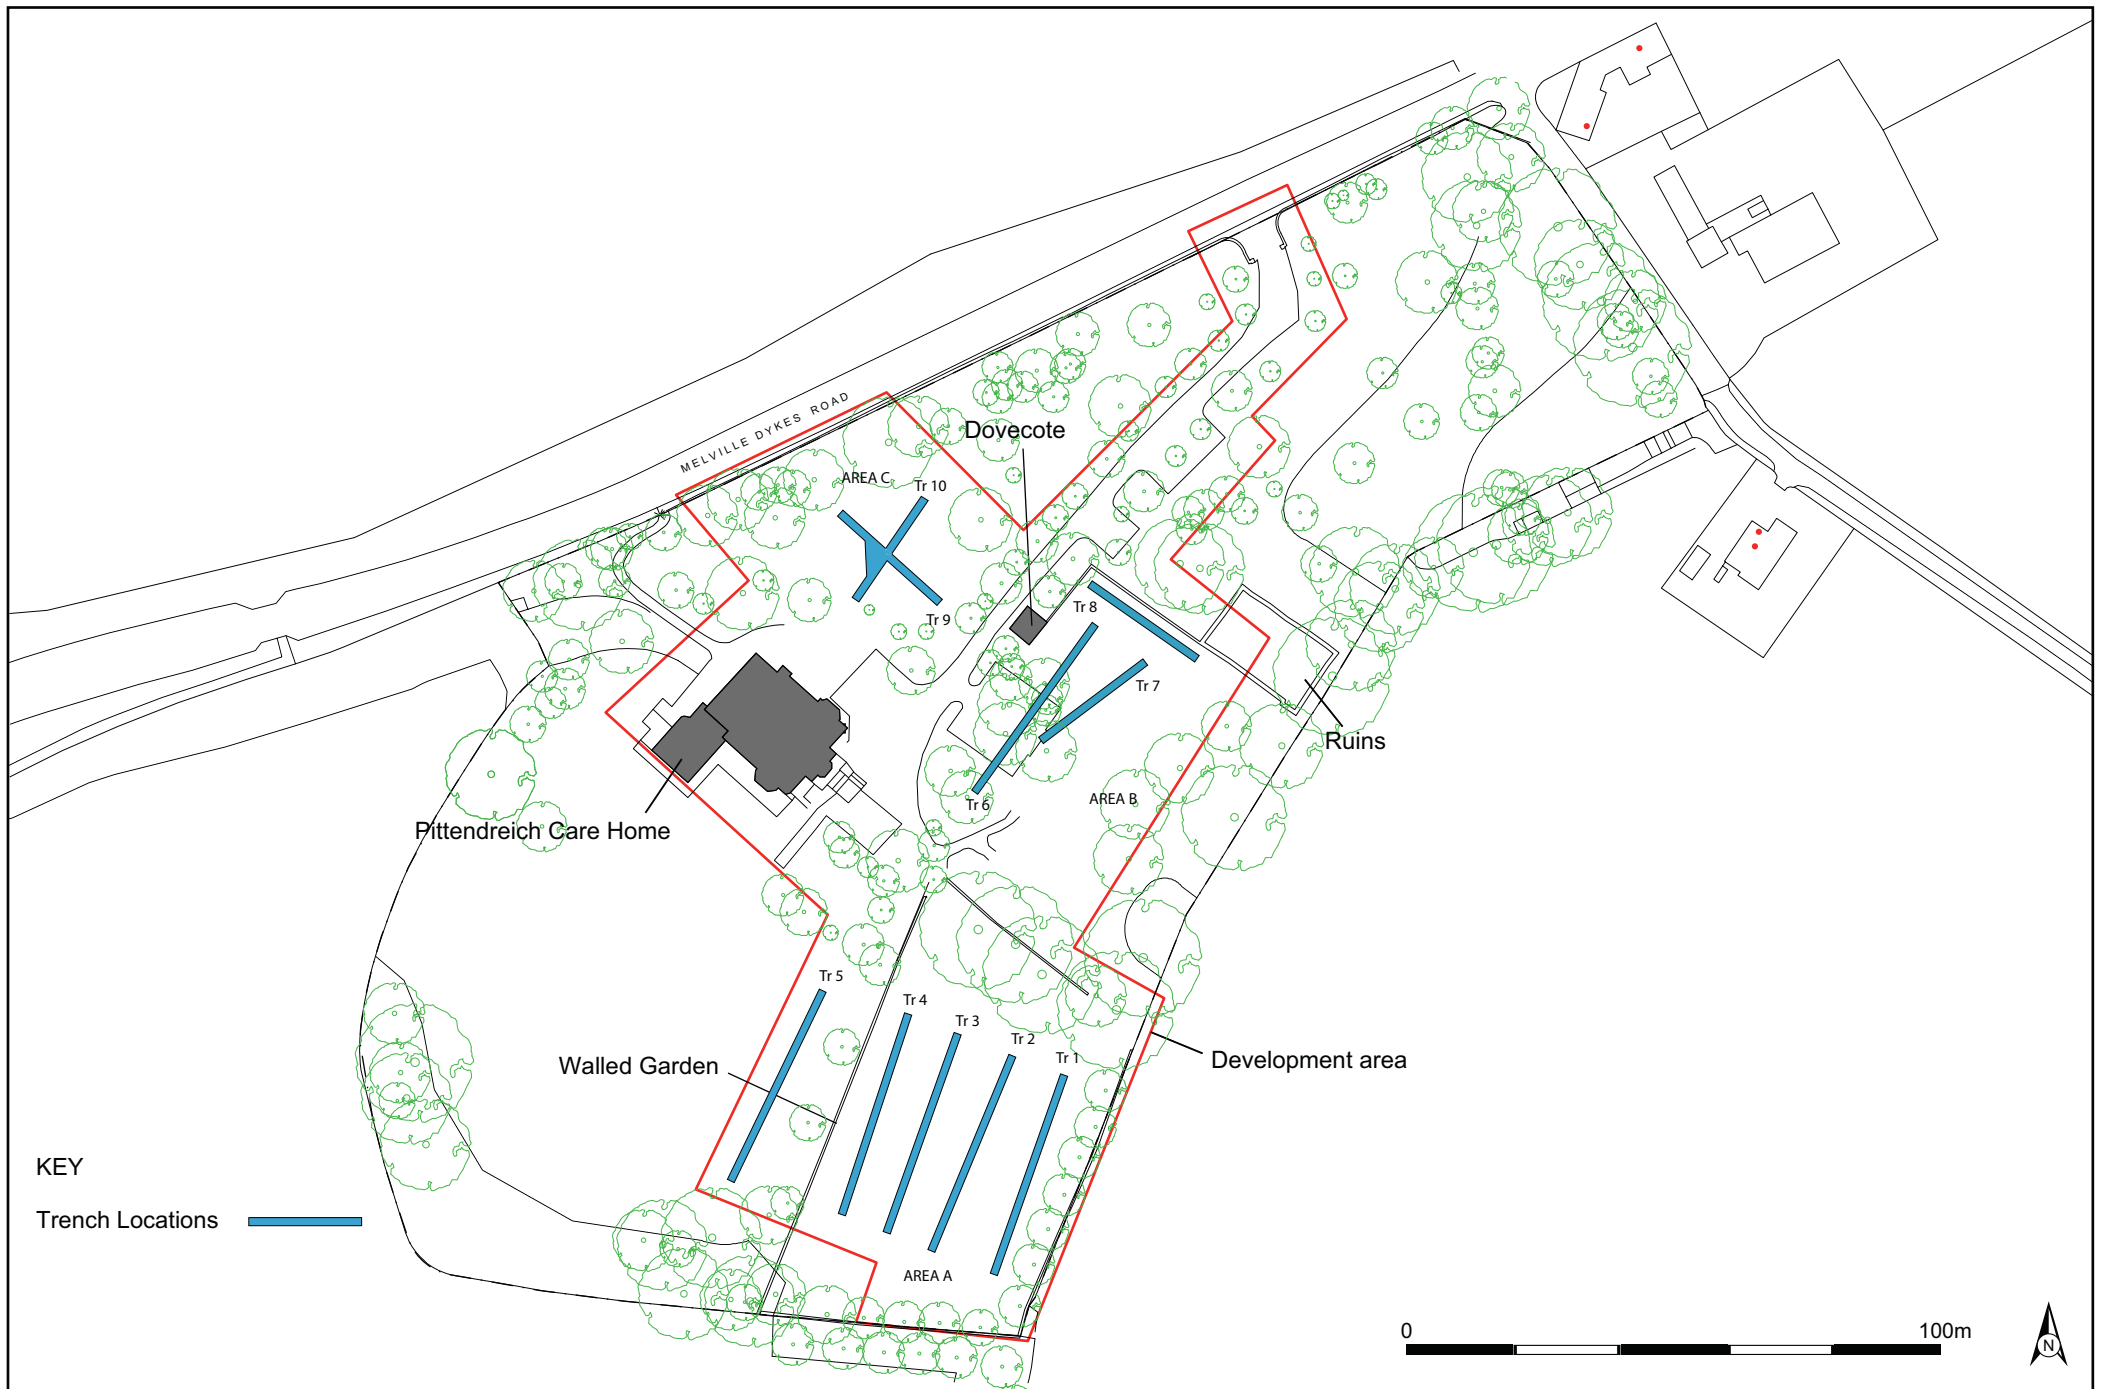
Figure 2: Trench location plan

3.1.1 A total of ten trenches were excavated in three discrete areas within the development area (Figure 2). Area one was located to the south-west of the main house within and immediately adjacent to the old walled garden. Area B to the east of the main house occupies an area of clear ground north-east of the walled garden and bounded to the north by upstanding walls. Area C was located in an area of lawn to the south-east of the main house.
