CARLTON ROAD, WORKSOP, NOTTINGHAMSHIRE: A POST-EXCAVATION ASSESSMENT REPORT

AOC Project No: 30809

Site Code: CNW10

Date: September 2011

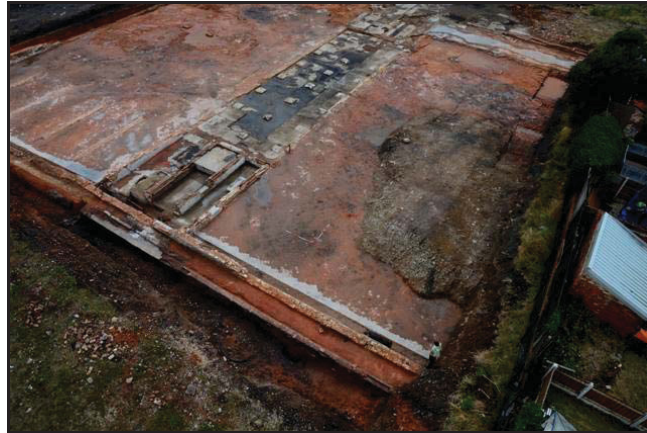
Plate A. Room 1 Looking Southeast

- 6.3.5 Room 1 was located in the west area of Trench 6 covering an area of 40.80m north-south by 16m east-west. To the north Room 1 was defined by external wall [645] which was cut into natural sand (738) (Figure 4 and Plate A). The wall was aligned east-west extending for a distance of 24.50m to be incorporated into the construction of Rooms 2, 3 and 4., The wall was rerecorded as having a maximum width of 0.50m. To the west, wall [645] extended beyond the limit of excavation, probably continuing for a distance of 1.50m before encountering the site's western boundary wall. On inspection the western boundary wall, which forms the rear wall of the residential properties fronting onto Carlton Road, incorporates lower courses which appear to be constructed in the same fashion as wall [645] and may represent the return line of the wall. Wall [645] was constructed from roughly dressed sandstone blocks bonded together to form regular courses using a pinkish brown, soft, sandy mortar. The sandstone blocks used had a maximum size of 400mm by 230mm by 230mm. The interior southern face of the wall had been plastered and subsequently whitewashed. Wall [645] survived to a height of 45.84m AOD.

- 6.3.6 The eastern limited of Room 1 was originally defined by a consist series of segmented internal wall sections on a north-south alignment [636], [704], [744], [745], [746], [750], [751], [752], [753] and [754]. The wall segments varied in length between 0.25m and 3.80m, with a consistent width of 0.50m. Each wall section was constructed in the same manner using both red and yellow handmade un-frogged bricks measuring 230mm by 110mm by 70mm, bonded using a form, pink, sandy mortar. This type of brick was manufactured between the late 18th and 19th centuries. Bullnosed bricks had been incorporated into the corners of each wall section. The most northerly wall section [746] had been keyed into east-west aligned wall [645]. The four most northern wall sections [636], [744], [745] and [746] were the best preserved, surviving to a height of eight courses at 45.72m AOD, revealing the western face of the wall had at once been whitewashed. The remaining wall sections only survived to floor level. The openings created by the wall sections varied in width between 0.70m to 2.30m.

- 6.3.8 The presence of internal structural features within Room 1 was limited to two limestone foundation pads [762] and [763] in the southern half of the room. Foundation pads [762] and [763] were trench cut into natural sand (738) and both were well dressed, cut to a shape measuring 0.70m by 0.70m in plan by at least 0.20m thick. The upper surfaces of the foundation pads were at 45.22m AOD.

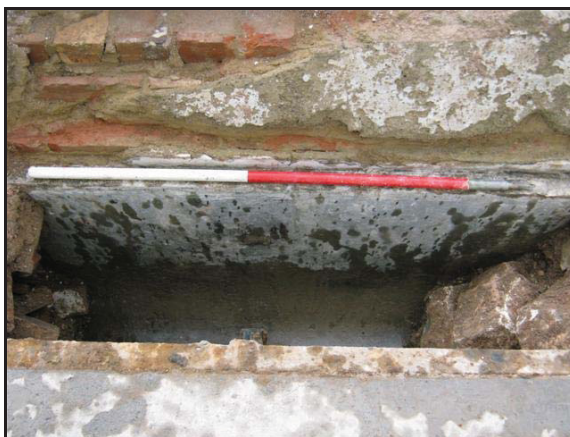
Plate B. View of Channel [739] Looking North

- 6.3.11 Another later addition to Room 1 was concrete drainage channel [739] which had been cut through floor (640) and ran the width of the room adjacent to wall [645], continuing on into Room 2 (Figure 3, Section 14, Figure 6, and Plate B). Channel [739] was 0.40m wide, vertically sided with a rounded base. The depth of the channel consistently increased in depth up to 0.70m creating a gentle gradient at base from east to west. Metal fittings for unknown attachments were present in the side walls of the drain, in addition to the presence of hinged grills attached to wall [645] which would have once acted as a cover for the drain (Plate B).

- 6.3.12 As part of the installation of channel [739] a 0.55m high rendered red brick chamfer [749] was built occupying the area between wall [645] and channel [739]. The chamfer abutted wall [645] and ran the full width of the room.

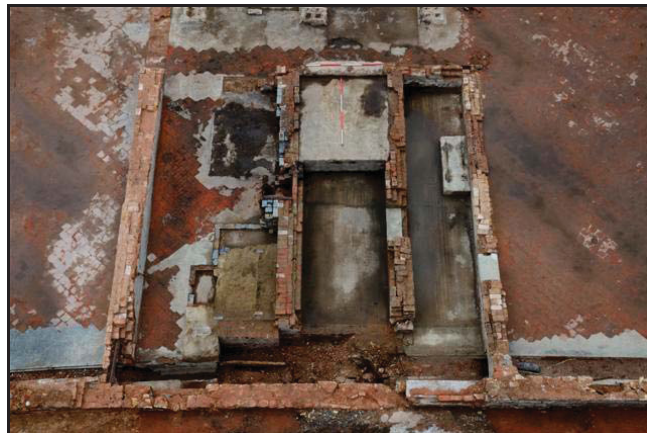
Plate C. View of Rooms 2, 3 and 4 Looking South

- 6.3.15 Room 2 was located centrally at the northern end of the building, with Room 1 lying immediately to the west (Figure 6 and Plate C). The room measured 7.50m by 2.50m in plan. To the north Room 2 was defined by the eastern extent of wall [645], while to the west Room 2 was defined by two distinct elements. The first element was the four segmented wall sections [636], [744], [745] and [746] dividing Room 2 from Room 1. The openings between the wall sections had subsequently been blocked by three short lengths of brick work [637], [638] and [639]. These three sections of blocking brickwork varied in length between 1.10m and 1.65m dependent on the width of the opening, with a consistent width of 0.40m. The red bricks used in their construction were double-frogged measuring c. 225mm by 115mm by 75mm, manufactured between the late 19th to 20th centuries. Some of the bricks were stamped 'WILKINSON ELLAND'. The bricks bonded using a firm pale grey, cementious mortar in an English bond. Of interest was the incorporation of a simple squared opening 0.40m wide at the base of wall [639] to allow channel [739] to pass between Room 1 and Room 2. This is in addition to the 0.70m wide doorway included into brickwork [638], initially raised above floor level by two courses, and subsequently raised again by the height of another two courses by a flush stone block. All brickwork had been whitewashed.

- 6.3.16 Wall [647] formed the eastern limit of the room measuring 6.60m in length by 0.50m wide. The red bricks incorporated into the wall were 230mm by 110mm by 70mm, bonded by a hard, mid grey, cement mortar in an English bond pattern. These bricks were stamped 'COCKING DONCASTER' and were made between the late 19th and 20th century. Mid way along its length, wall [647] incorporated a raised doorway 0.90m wide. The doorway had been constructed three brick courses above floor level and had been lined by concrete slabs 90mm thick. The western face of the wall had been plastered and whitewashed.

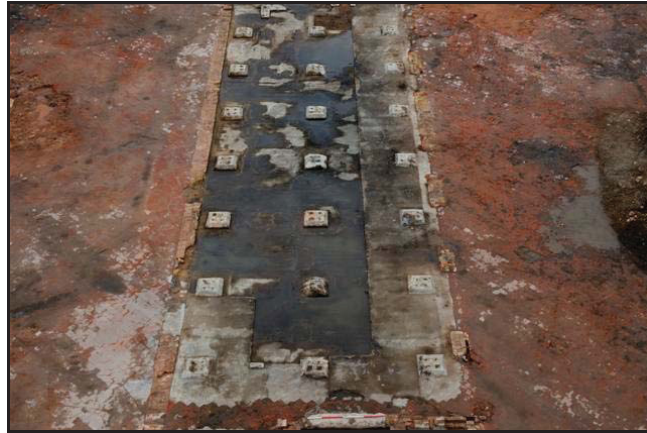
Plate D. View of Room 5 Looking South

- 6.3.34 Room 5 was a north-south orientated room, bordered by Room 1 to the west and Rooms 2, 3 and 4 to the north (Figures 4 and 5, Plate D). The room was 31.50m long by 7.50m wide. The northern boundary of the room was defined by wall [643], while the western extent of the room was defined by wall segments [704], [707], [750], [751], [752], [753] and [754] (Figure 4). Wall [650] designates the eastern extent of Room 5, and incorporates a doorway, approximately 0.80m wide, between Room 5 and Room 8 in the northern half of the room. Due to the poor survival of wall [650] in this area it is unclear if the doorway is an original feature or a later alteration. The southern limits of Room 5 are defined by walls [674] and [676] associated with Room 6.

- 6.3.35 Arranged at regular intervals within Room 5, forming a grid pattern were 24 concrete stanchion bases [703]. Each stanchion base was separated by a distance of 2.30m from each of its neighbours. The stanchion bases themselves were 0.75m square, with a height of 0.15m and chamfered sides. Set into the top of each stanchion were four iron bolts set in a square pattern 0.25m apart. Associated with the stanchion bases in the southern half of Room 5 were three low concrete platforms. The largest was concrete platform [670] which covered an area 4.55m north-south by 0.95m east-west set 50mm above floor level. To the northeast of concrete platform [670] were two L-shaped concrete platforms [811] and [812] set at approximately the same height. Both platforms [811] and [812] were 1.20m long east-west, by 1m north-south and 0.50m wide. Platform [811] was the only platform of the three to exhibit markings on the upper surface, which consisted of a 0.15m shallow straight edged groove running centrally through the platform.

- 6.3.36 Concrete floor (664), including southern section (672), extended across the full area of Room 5. The concrete floor at been laid at a height of 45.30m AOD, although in the northern and western area of the room a 40mm step had been incorporated into the floor, raising the floor level in these areas so that floor level through into Rooms 1 and 8 were the same. To the south of Room 5 limited repairs using concrete (679), brick (678) and (680), and stone flags (677) had been made to floor (664) (Figure 7).

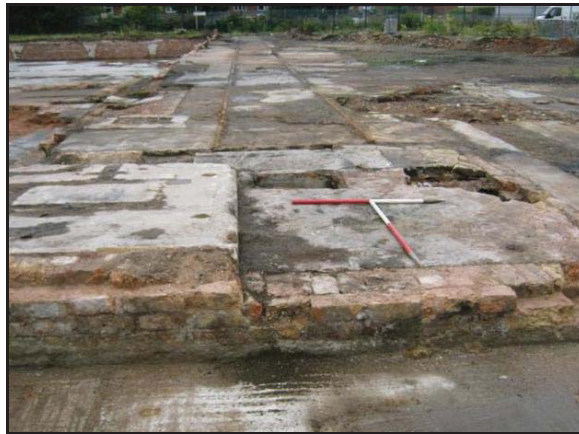
Plate E. View of Room 6 Looking South

- 6.3.40 Room 6, located at the southern end of Room 5, measured 4m east-west by 3.20m north-south, and was defined to the east by wall [650] (Figure 7, Plate E). Northern wall [676] abutted earlier wall [650], while wall [674] formed the western side of Room 6. The lack of any substantial foundations to the southern side of Room 6 indicates that the room was open to the exterior. Wall [676] was 4.25m in length by 0.40m and survived to a height of four courses above the floor level of Room 5 at 45.49m AOD. Red and yellow bricks measuring 220mm by 120mm by 70mm were used to construct the wall, and were bonded using a hard, pinkish lime mortar. Wall [674] was 2.60m in length and narrower at 0.25m wide.

- 6.3.41 Part of the southern boundary of Room 6 was defined by a brick lined channel [687]. The channel was 2.40m in length, by 0.10m wide, by 0.10m deep, the function of which may be related to the instillation of buffers at the end of railway tracks (695).
- 6.3.42 In the northeast corner of the room a substantial concrete block [690], designed to act as an engine bed, had been installed abutting wall [650] and [676]. Engine bed [690] measured 1.90m by 1.70m in plan and was raised 0.10m above floor level to a height of 45.73m AOD. A series of angular grooves and metal fixings were incorporated into the upper surface of machine bed [690] to assist in the attachment of plant (Plate F).

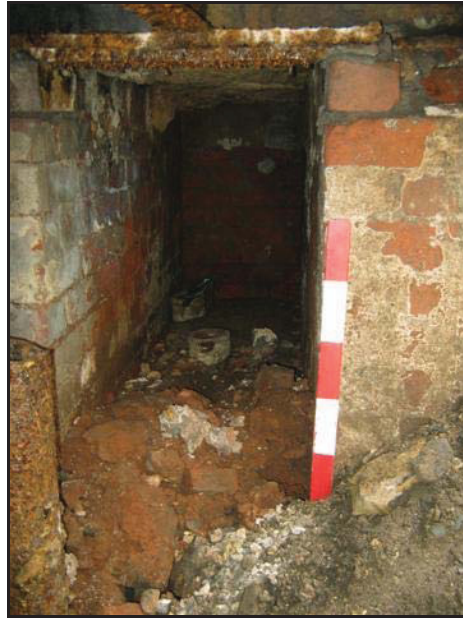
Plate G. View of Tunnel within Chamber

- 6.3.44 Dominating the northwest corner of Room 6 was a covered chamber, measuring 2m square by 0.80m deep. It was defined by the extension below ground level of walls [674] and [676] to the west and north respectively, and wall [813] to the east and wall [814] to the south (not illustrated). All four walls were of the same construction. The interior of the chamber contained several features of interest, most notably an east-west brick-lined tunnel travelling from the northeast corner of the chamber (Plate G). The tunnel was 0.50m wide and extended to the full height of the chamber. Where the tunnel led in unclear. Mechanical fittings were also present attached to wall [676] in the form of toothed cog wheels (Plate H). Two metal water pipes (682) and (683) were attached to wall [674]. Prior to the chamber being covered a 0.20m thick metal beam (681) was inserted into walls [674] and [813], with short lengths of corrugated metal sheets (684) lining the upper edges. Resting on beam (681) and corrugated sheets (684) was a 0.10m thick concrete slab (675), measuring 2.20m by 2m in plan, which capped the chamber (Plate I). In the southeast corner of the capping slab (675) a rectangular inspection hatch (685) had been incorporated into its manufacture, measuring 0.70m by 0.50m in size. It is likely the hatch would have incorporated an inspection cover or grate. It is thought a second, similar, inspection hatch would have once been present to the southwest corner of capping slab (675), but that corner has been removed by later truncation.

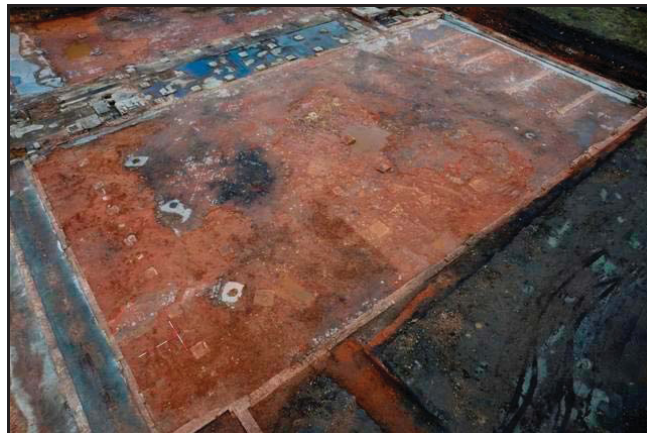
Plate J. View of Room 8 Looking Northwest

6.3.52 Room 8 occupied the northeast area of the maltkiln building complex, representing the single largest room covering an area of 41.50m north-south by 22m east-west (Figure 4, Plate J). Wall [650] formed the western boundary of Room 8, dividing it from Rooms 4, 5 and 6, part of which had been white washed. The northern limit of the room was formed by wall [651] which abutted wall [645] to the west. Wall [651] represents the continuation of the northern external wall of the maltkiln complex, although its alignment slightly different by a couple of degrees to the northeast to the established east-west alignment associated with the rest of the complex. The wall was 0.50m thick and made from red bricks measuring 230mm by 110mm by 70mm in an English bond style, held together by a hard, pink, sandy mortar. The southern internal face was plastered and subsequently white washed. Wall [651] survived to a height of 45.67m AOD. The eastern wall of Room 8 was primarily represented by wall [662] which ran for a distance of 38.50m north-south and was 0.65m wide. Wall [662] was constructed using double-frogged bricks measuring c 228mm x 110mm x 70mm made between the late 19th and 20th century, stamped with 'COCKING DONCASTER'. The wall survived to a similar height as wall [651]. Wall [720], which divided Room 8 from Room 9 in the southeast corner, was 3m in length by 0.40m wide, and bonded into east-west wall [718]. Later truncation had removed its relationship with wall [662], although it was associated with the same phase of building as the same materials, construction technique and surface treatments had been used. Southern wall [718] extended the full width of Room 8, with a maximum width of 0.40m, and bonded into walls [650] and [718] at each end. The same materials and construction method had been employed as observed elsewhere in Room 8, although later truncation had reduced wall [718] to floor level.

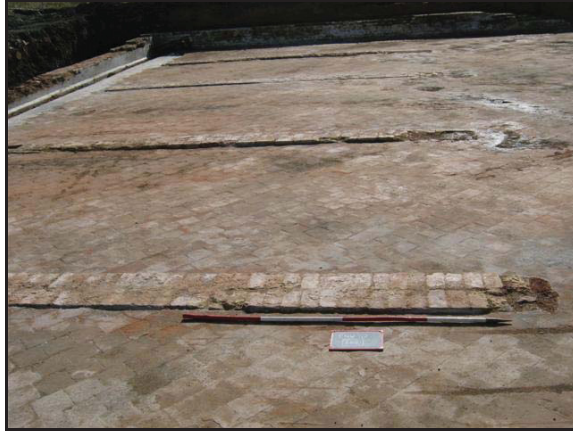
Plate K. View of Walls [663], [664], [665] and [666] Looking East

6.3.53 At the northern end of Room 8 free standing north-south orientated walls [663], [664], [665] and [666] had been constructed in order to divide this area of the room into five separate bays (Plate K). Each bay was 3.80m wide, except for the central bay which was larger at 4.80m wide. Each wall was 0.50m wide and varied in length between 6.70m and 7.50m. This variation in length was incrementally proportional in order to maintain a 1.30m gap to the irregularly aligned wall [651], yet extending out to the same limit within the room. Each wall had been built in the same way using both red and yellow bricks measuring 230mm by 110mm by 80mm, bonded using a hard, pink, sandy mortar. Bullnosed bricks had been used at each corner. Each wall had been truncated to floor level.

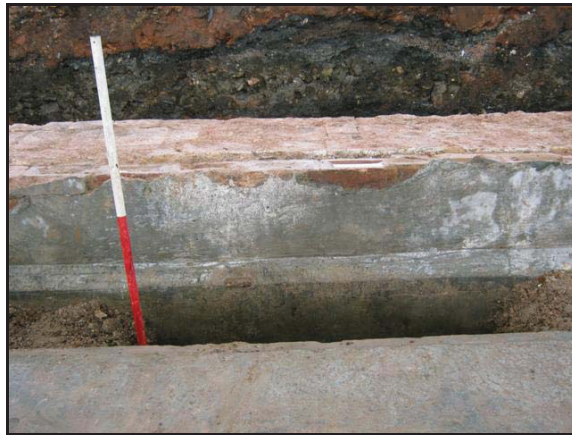
Plate L. View of Channel [743] Looking North

- 6.3.58 The main later feature in Room 8 was the construction of concrete channel [743] which ran adjacent to northern wall [651] the full width of Room 8 (Figure 3, Section 13, Figure 5 and Plate L). Channel [743] was of the same size and design as channel [739] in Room 1. The base of channel [743] incorporated a very shallow gradient descending from west to east, draining into small rectangular chamber in the northeast corner of the room. Positioned over the chamber was a large metal frame inserted into wall [651] and [662].

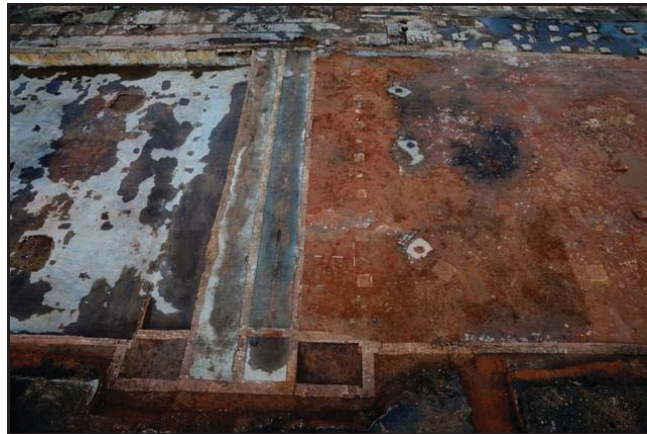
Plate M. View of Rooms 9, 10, 11 and 12 Looking West

- 6.3.62 Room 9 was located to the southeast corner of Room 8, measuring 2.60m by 1.80m in plan (Figure 4, Plate M). The room was bounded by wall [720] to the west, the eastern end of wall [718] to the south, wall [692] to the east and wall [721] to the north. In total, wall [692] was 11m north-south and 0.50m wide. Wall [721] was 1.80m long and a similar width to wall [692]. Walls [692] and [721] were built in the same style as the adjacent walls and survived to floor level. On the western side of the room wall [720] an addition brick facing [727] consisting of red brick measuring 230mm by 110mm by 80mm bonded using a hard, pink, sandy mortar. Abutting brick facing [727] was the remains of partially truncated floor surface made from firm, brownish red sand (728) which survived to a height of 45.25m AOD.

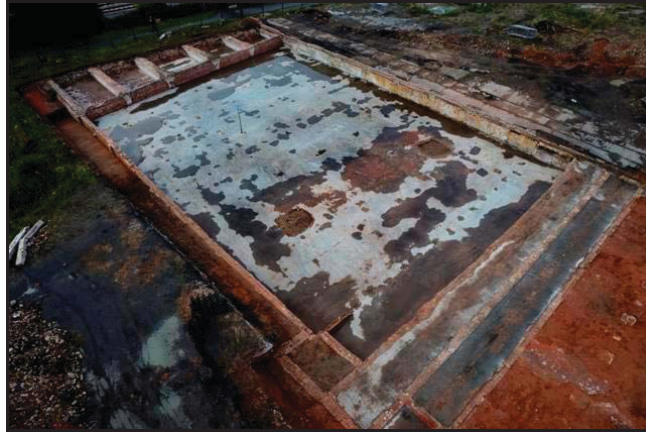
Plate N. View of Room 13 Looking Southwest

- 6.3.72 To the south of Room 11 was located Room 13 which covered an area 32.50m by 22m (Figure 4, Plate N). The northern limit of Room 13 was formed by wall [617], with the eastern limit defined by wall [691] and [629], to the west by wall [607] and to the south by the northern extent of walls [619], [620], [621], [622] associated with Rooms 14, 15, 16, 17 and 18. Wall [691] defined the initial 3m extent of the eastern boundary before the wall doglegged and continued to run north-south in the form of wall [629]. Wall [629] was 29.50m in length by 0.40m wide and was constructed using both red and yellow handmade un-

frogged bricks measuring c.230mm by 120mm by 75mm and bonded using a hard, pinkish, sandy mortar. This type of brick was manufactured between the late 18th and 19th century. The internal face of the wall had been plaster and whitewashed. Wall [629] survived to a height of 1.05m allowing an English bond pattern to be identified.

- 6.3.74 Internally, Room 13 was covered by what is presumed to be a later concrete floor surface (630), laid at a height of 43.87m AOD (Figure 5). This floor level was substantially lower than the rest of the floor levels within the building. Across floor (630) there was a regular grid pattern of circular scars, 0.10m in diameter, set at intervals of 3.50m. These appeared to relate to the former positions of columns for supporting the ceiling. At the northern end of the room this pattern varied as there was a row of column scars set at intervals of 1.50m, which defined a 3m corridor. Floor (630) was laid at a uniform height of 43.87m AOD. Two modern square geotechnical test pits cut through the central area of the floor.

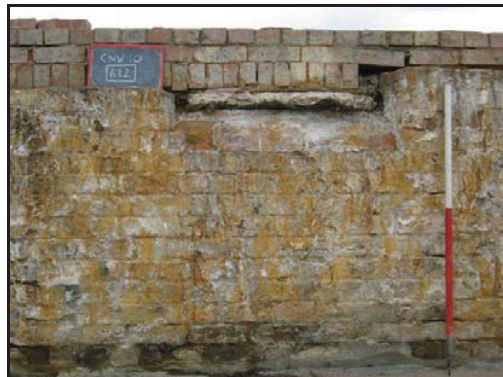
Plate O. View of Opening [612] Looking West

6.3.73 Wall [607] was 32.50m in length and approximately 0.40m thick, constructed using the same type of bricks used in wall [629]. The internal face of the wall had been plastered and whitewashed. Wall [607] survived to a height of 1.20m allowing the remains of multiple openings to be identified in the wall. The bases of eight openings [608], [609], [610], [611], [612], [613], [614] and [615] were set at regular 3m intervals along the walls (Plate O). The openings survived to a height of 0.20m to 0.30m demonstrating that the openings were 0.95m wide framed by bullnosed bricks with tiles set at 45° at the base of the opening. In plan, the openings extended a further 0.45m to the west of wall [607]. The design of the openings suggests they were the bases of chutes, and/or, windows, facilitating the delivery of materials into the buildings, as well providing air and light. At the northern end of wall a larger opening [616] was present with a width of 2.50m (Figure 3, Section 11, Plate P). The base of the opening was set five courses above the floor level and had been lined with sandstone slabs. Opening [616] extended for a further 1m to the west at ground level. The size and design of opening [616] indicates it once related to a large doorway to allow access into Room 13. A short wooden set of stairs probably linked the base of the opening with the floor level.

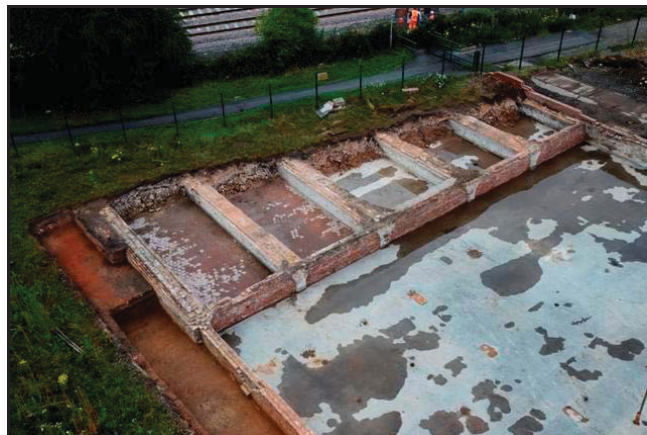
Plate Q. View of Rooms 14, 15, 16, 17 and 18 Looking Southwest

- 6.3.78 Rooms 14, 15, 16, 17 and 18 were of identical construction located at the southern end of Room 13, forming a row of five vaulted chambers (Figure 4, Plate Q). Rooms 14, 15, 17 and 18 were 4m wide, whereas central Room 16 was slightly wider at 4.70m. The full length of the rooms could not be determined as they continued beyond the southern limit of excavation, although it is known that they were in excess of 10m long.

- 6.3.79 North-south orientated walls [618], [619], [620], [621], [622] and [623] were all of the same construction, using unfrogged handmade red bricks measuring c.230mm by 120mm by 75mm which were made between the late 18th and 19th century. The bricks were bonded using a hard, pink, sandy mortar. The walls were 0.50m wide, with the vault spring starting at approximately 0.40m above floor level. The observed lengths of the walls extended between 4.50m and 10m. Walls [618] and [623] representing the two furthest extents of the vaulted chambers were recording as abutting walls [607] and [629] respectively. All walls had been plastered and subsequently whitewashed.

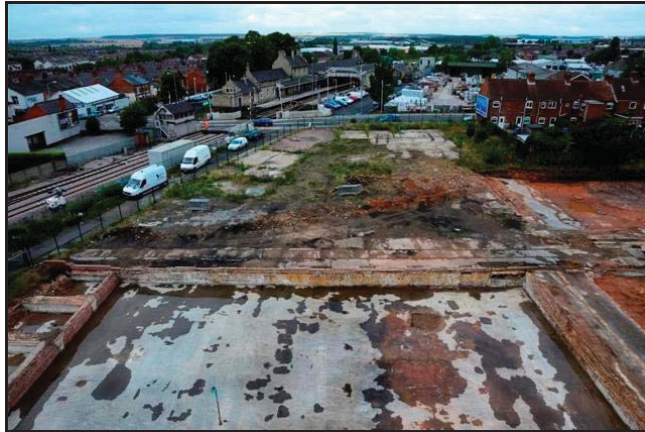
Plate R. View Railway Tracks (695) and (696) Looking West

- 6.3.91 To the west of Room 13 two sets of steel railway tracks were identified. The earliest set of tracks (696) were curvilinear travelling from the west to the south, covering a distance of 25m before terminating adjacent to later tracks (695) (Figures 4 and 5, Plate R). The width between tracks (696) was 1.42m. The later set of linear tracks (695) ran north-south for a distance of 48m, continuing beyond the southern boundary of the site (Figure 5). The

northern extent of the tracks was defined by the southern limit of Room 6. Tracks (695) were the same gauge as tracks (696).

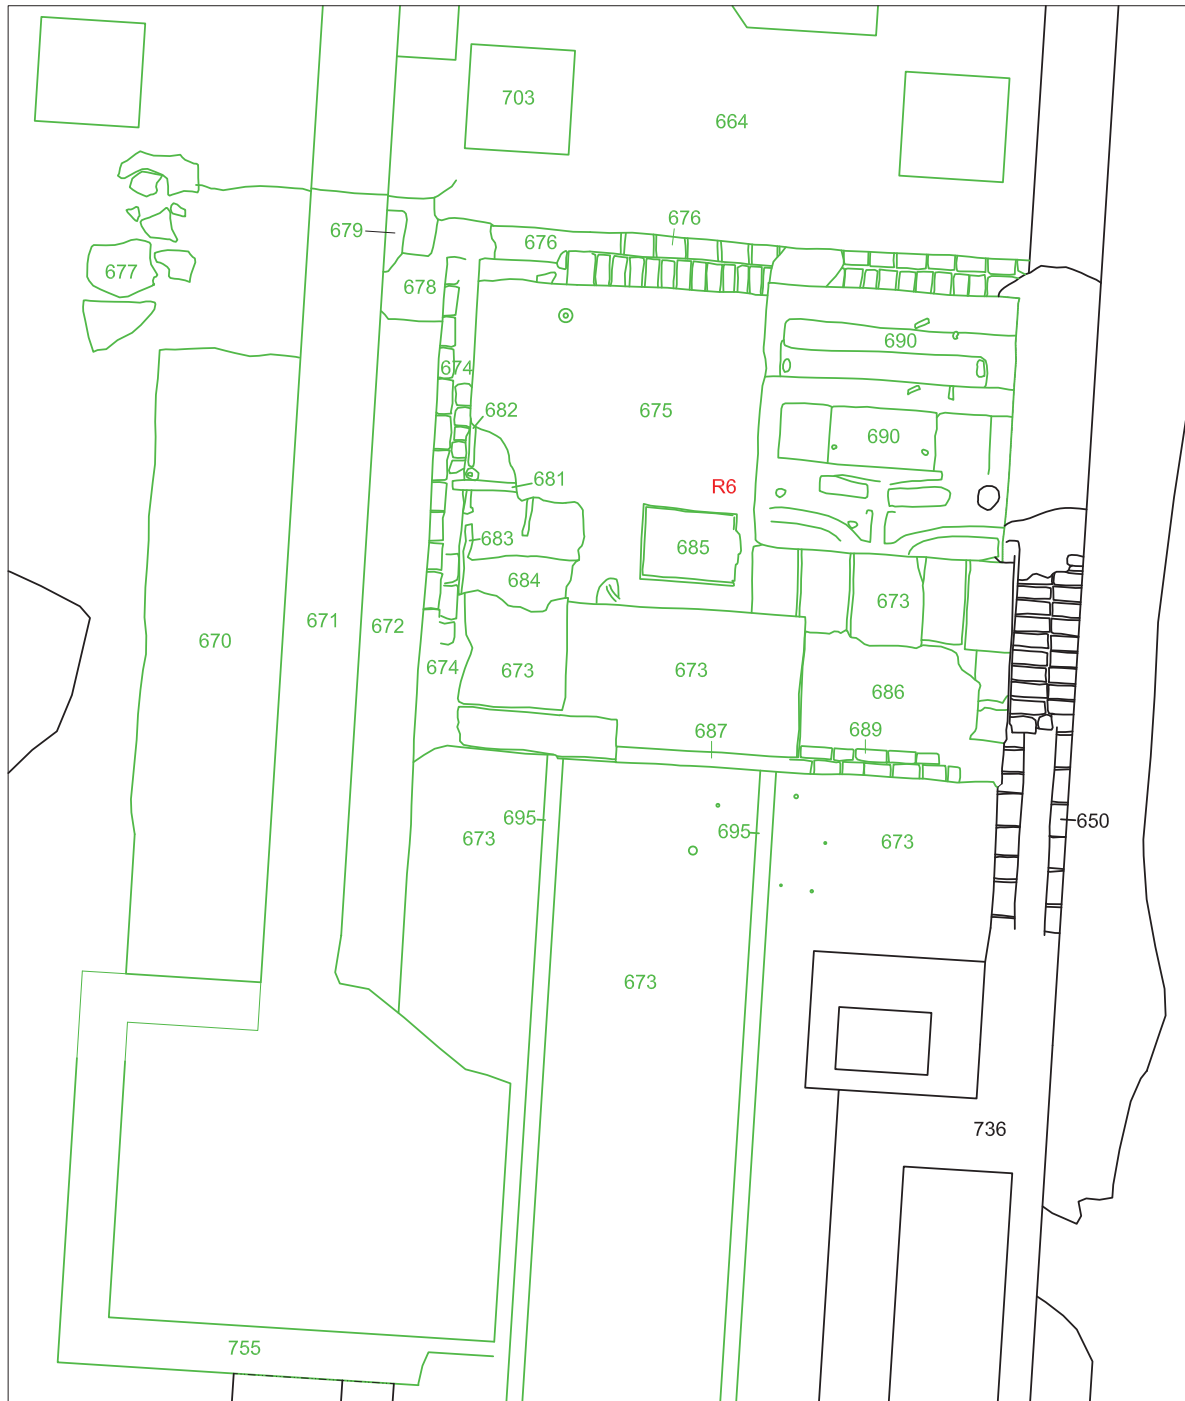
Figure 7: Period 3: Phase A and B Room 6

- Period 3 Phase B
- Period 3 Phase A
- R1 = Room Numbers

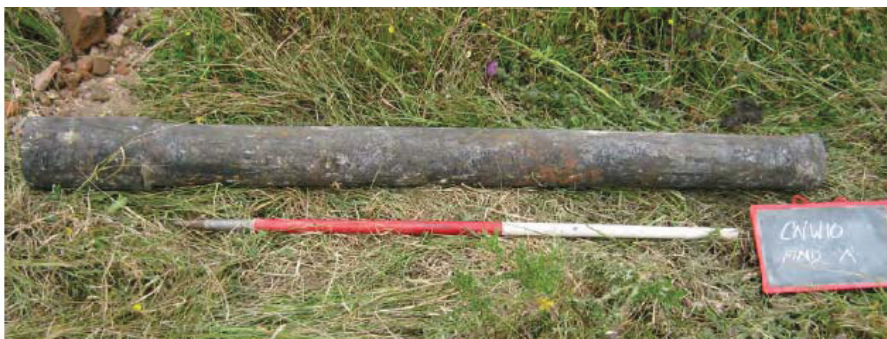
Figure 1: Find A

Flared stock end external diameter 157mm internal diameter 122mm.

Untapered end. External diameter 127mm internal diameter 84mm. (see Figure One)

The object should be inspected for casting/foundry marks and recorded.

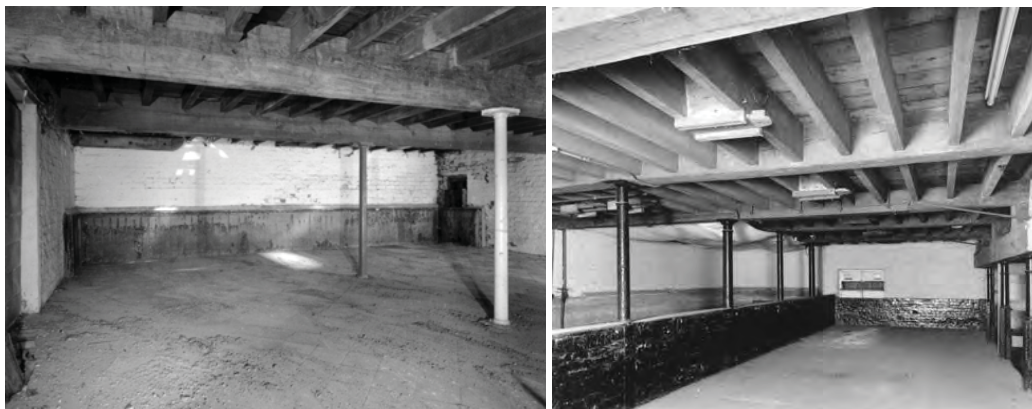
Figure 2 Two examples of cast iron column props used in malting. 2b shows varied heights to be expected.

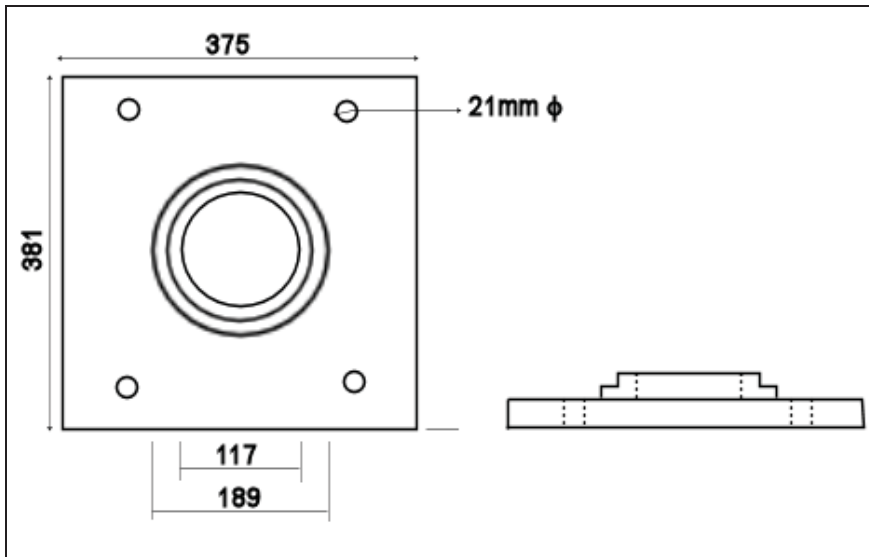
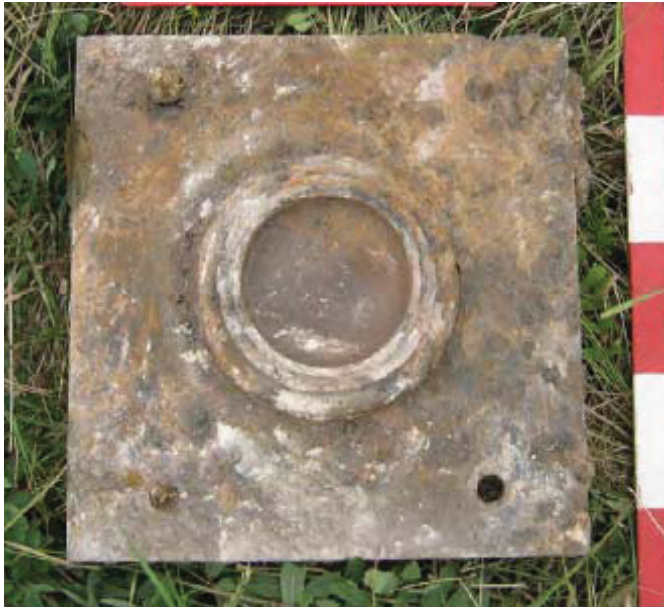
A square metal plate with a central circular boss. The plate has fitting holes located at each corner. The plate measures 375x381mm and is 16mm thick (see Figures 3 and 4).

Figure 3 Projection of Find B. All dimensions in mm (Doonan)

Figure 4. Find B showing raised circular boss.

Find B most likely relates to architectural ironwork. It is probable that it is used in conjunction with the a column prop such as that described under Find A. It serves to centre the prop and assist in fitting it to other structural members (see above). Figure 5 shows the detail of how props and plates were used in conjunction.

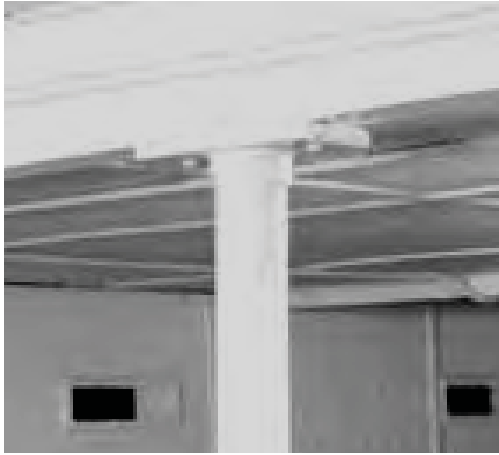
Figure 5. Column prop and securing plate in situ (after Patrick 2004)

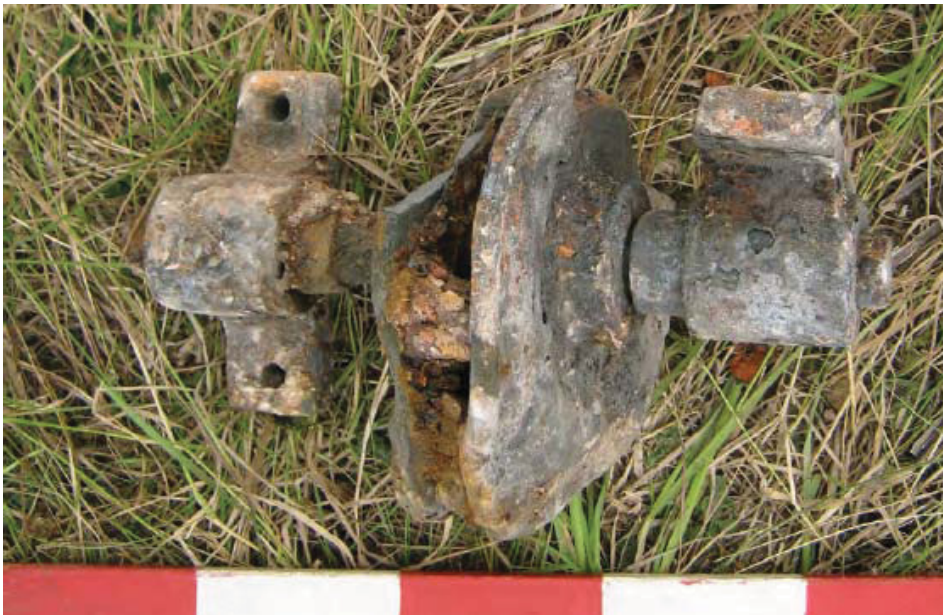
Bearing, shaft and pulley assembly. Shaft length 330mm. Bearing housing length 165mm, Pulley diameter (complete) 260mm (see Figure 6). This composite artefact would have been used in conjunction with a driven belts. The shaft (diameter unspecified) is contained in two bearing housing which include fixing holes. This would have been a stationary assembly most likely fitted to a flat surface.

Figure 6. Bearing, shaft and pulley assembly. Note fixing holes in bearing housing.

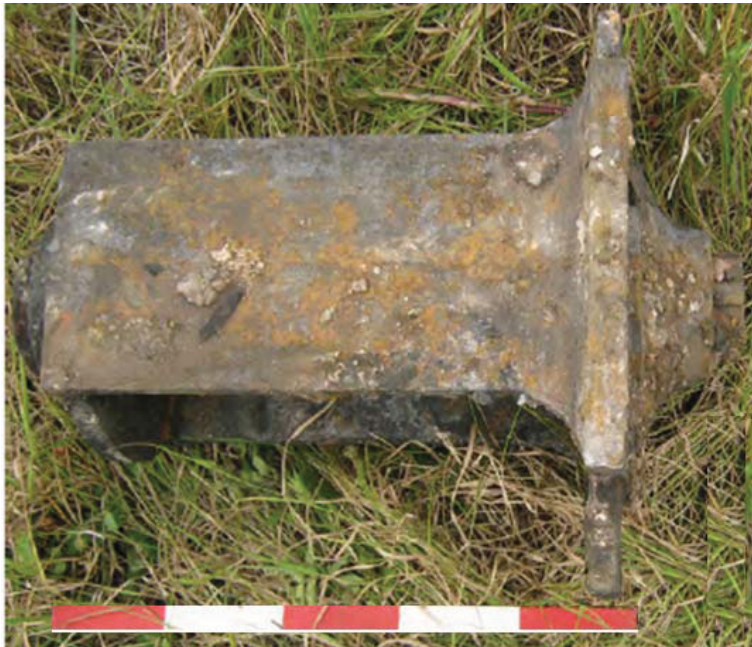
Cast Iron Fitting. Find D most likely derives from an architectural feature and may have been used in conjunction with features such as those detailed above (Figure 7).

Figure 7: A component of architectural ironwork.

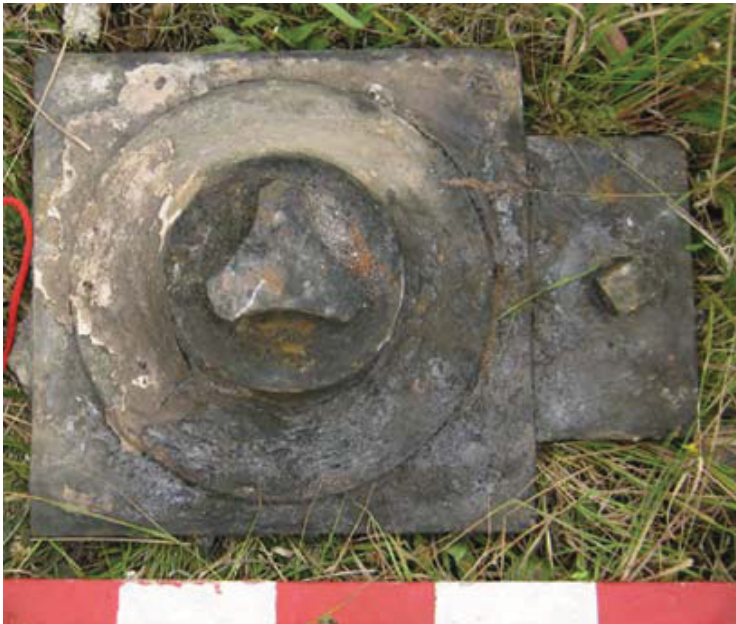
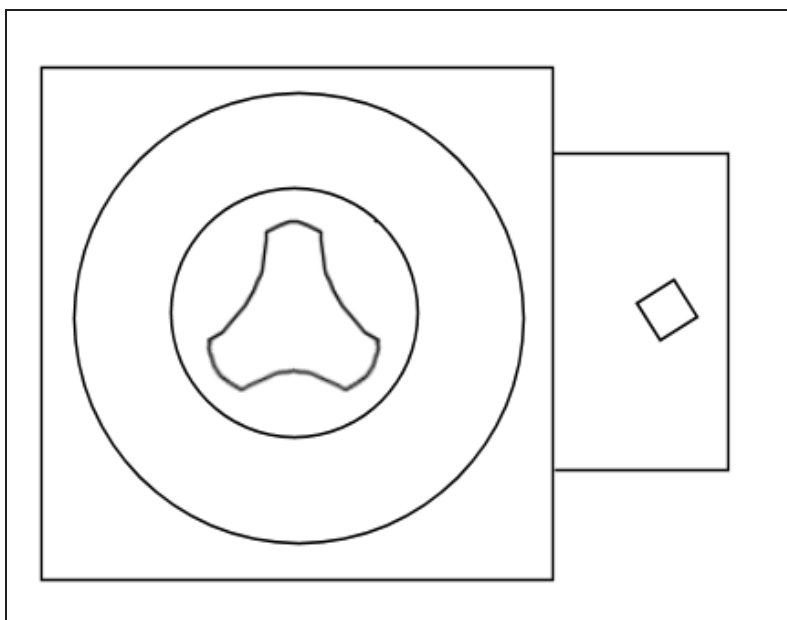
Metal Plate measuring 230mm square with peripheral flange and square section boss (see figures 9 and 10).

Figure 9 Find E showing detail of object.

Figure 10 Schematic of Find E (Doonan)

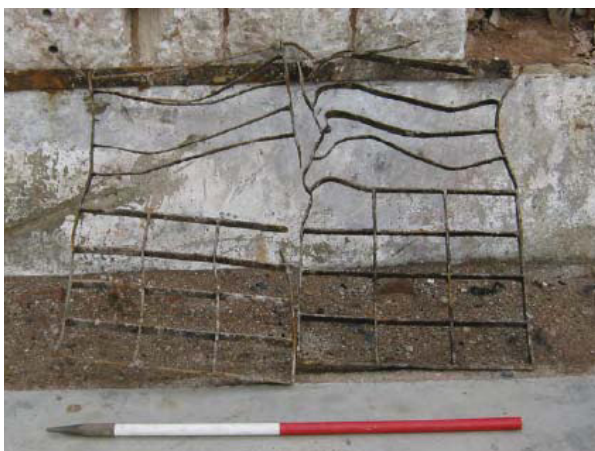
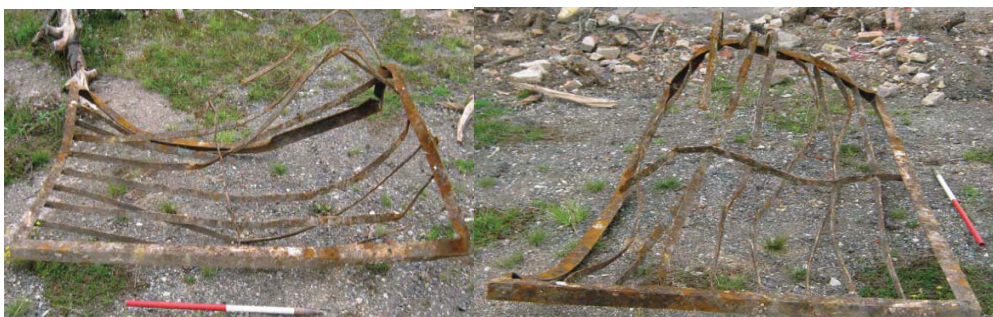
Grill A (See Figure 11) and Grill B (Figure 12) are both comprised of steel and have variable mesh dimensions. Grill B is recorded as being 1520x2440mm. Mesh spacing is 150mm with a central strut at 1220mm. No dimensions are supplied for Grill A.

Figure 11 Grill A showing variable mesh size

Figure 12 Grill B, note difference to Grill A

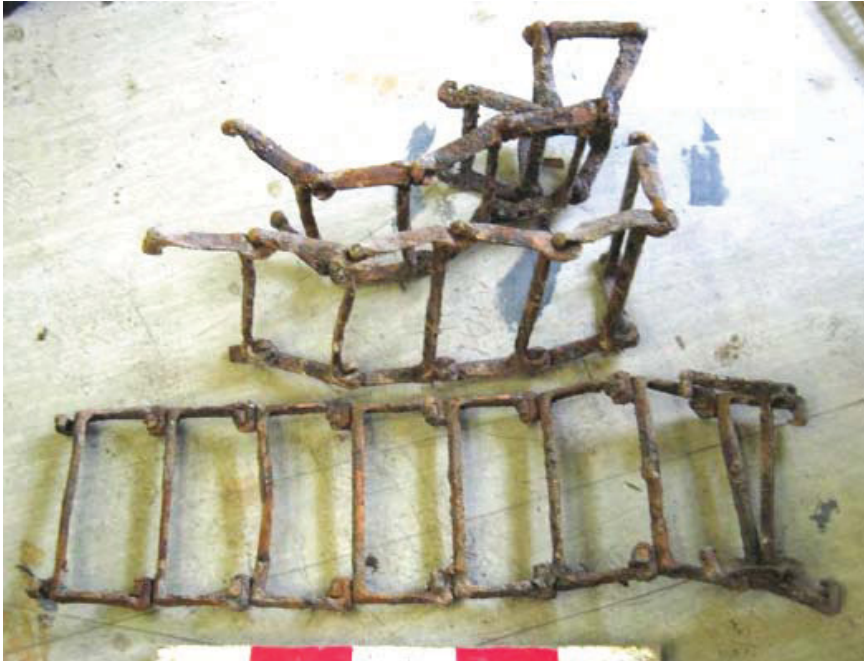
Three sections of flexible ladder link conveyor. The conveyor width is 230mm with each section measuring approximately 110mm. The dimensions for the recovered sections are 0.8m x 0.23m (x2) and 0.60m and 0.23m.

Figure 13 Sections of the ladder link conveyor.

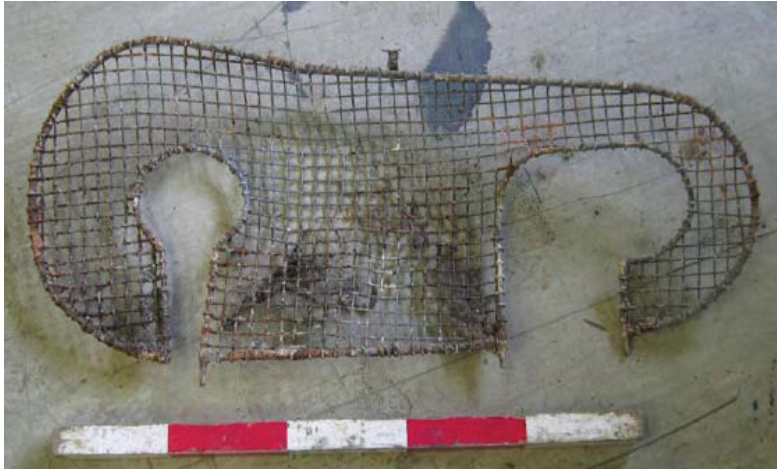
Fabricated 1cm mesh fitting with cut-outs. Measurements 0.65m x 0.28m.

Figure 14: Belt guard from motor or compressor

This object is a fitted mesh belt guard designed to prevent the entanglement of operators and materials with driven flexible belts. Such guards are regularly seen on compressors or drive motor assemblies (see Figure 15). It is most likely that this guard was part of a motor used in the transfer of grain materials (see above)

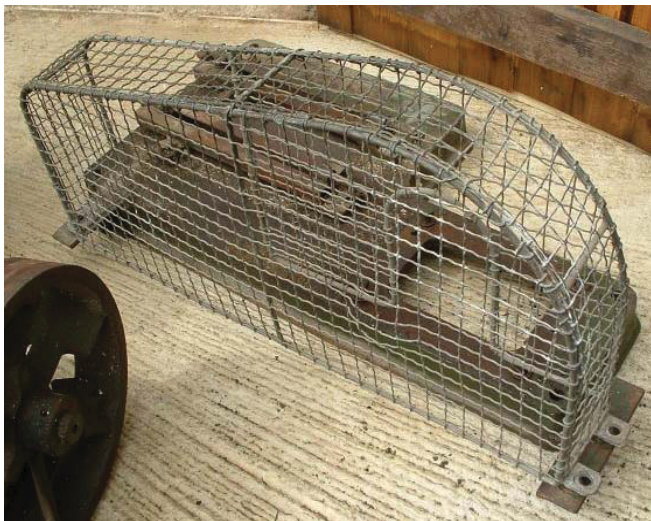
Figure 15; Example of a drive motor belt guard.
