Poplar Drive, Kingsbridge, Devon: Archaeological Desk-Based Assessment

Project No: 30693 March 2010

On Behalf of:	ISG Pearce / Tesco Stores Ltd.	
National Grid Reference (NGR):	SX 733 443	
AOC Project No:	30693	
Prepared by:	Nick Carter	
Illustration by:	Chloe Smith & Jonathan Moller	
Approved by:	Melissa Melikian	
Date of Report:	March 2010	
Report Stage:	FINAL

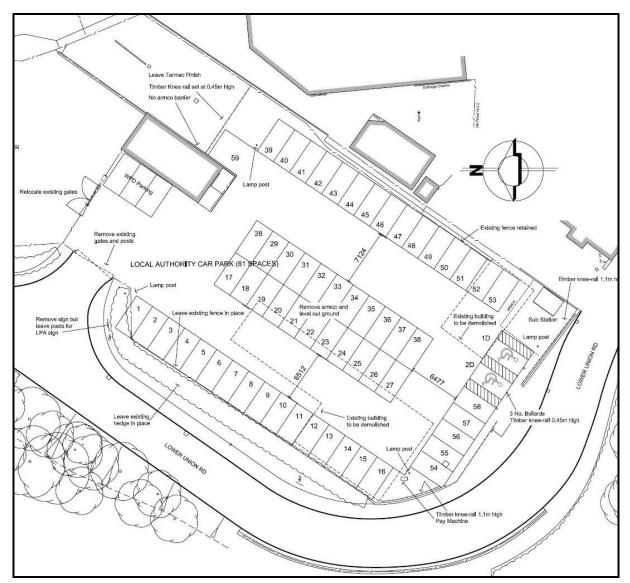
PLATE A: Proposed layout of car park in the detached portion of the proposed development site

- 1.2.7 Within the WPD depot site south, proposed works include demolition of two exiting buildings and conversion of this area into public car parking (Plate A, below).

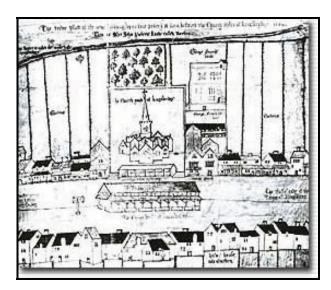
PLATE D: 'The trewe platt of the newe byldyng, upon fyve pyllers', a 1799 copy of original plan dated (Fox 1864)

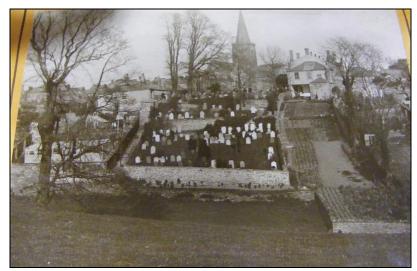
PLATE F: View looking eastwards across the southern half of the main proposed development site, sometime in the late 19th or early 20th century

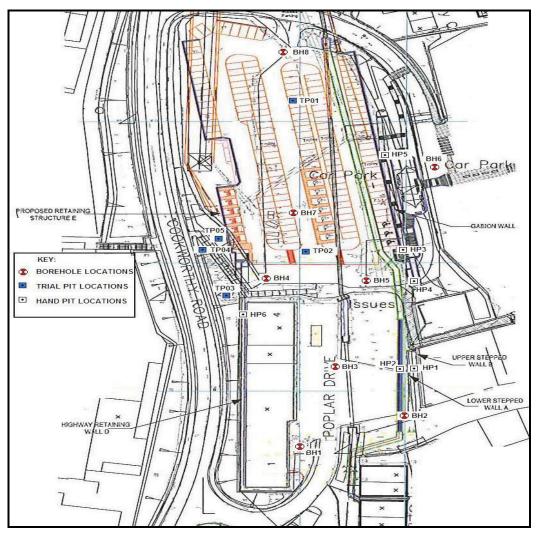
PLATE H: Location of geotechnical investigation holes in the main area of the proposed development site (WYG 2009)

- 6.2.1 On site geotechnical investigations were undertaken by WYG Environment in the main site area between 27th October and 3rd November 2008 and comprised six hand dug trial pits (HP1 to HP6) to investigate existing on-site retaining walls, five shallow hand dug trial pits (TP01 to TP05) in the northern half of the main site, eight rotary cored and window sampled boreholes (BH1 to BH8) and one subsequent trial trench excavated in January 2009 in the toe of the embankment on the west of the site (see location plan reproduced as Plate H).
- 6.2.2 The results of these investigations are detailed in Ground Conditions Assessment Report (WYG 2009) and are briefly summarised below. Relevant logs are displayed in Appendix C.

- 6.2.3 The on-site investigations encountered made ground in all boreholes and hand pits locations except for HP02, in the east of the southern half of the site and HP03, in the east of the central area of the site. TP03, TP04 and TP05 encountered a minimal deposit of topsoil, *c.* 0.20 -0.25mbgl (metres below ground level) overlying weathered meadfoot group bedrock (WYG 2009, 13).

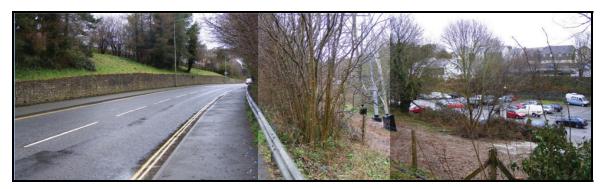
PLATE I: View looking northwards along Cookworthy Road and down to the northern area of the main site

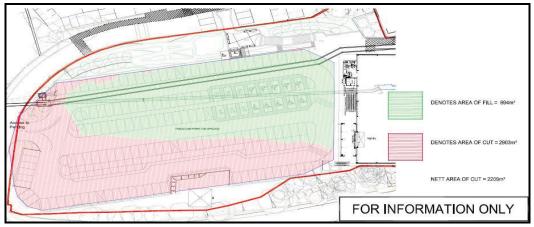
PLATE P: Basic areas of cut and fill in the area of the proposed Tesco store car park (WYG 2010)

- 8.2.12 Further impact will results form the reduction of levels in the west of the car park and cutting into the western embankment, the attenuation tank adjacent the east of the superstore and the realignment of the culvert along the east of the site. The culvert realignment will likely constitute the greatest potential impact, Medium to High Magnitude, being located close to or upon the course of the brook / stream which ran along the rear of the medieval / post-medieval burgage plots. The impact from cutting in the western embankment, the car park and from stores foundations will vary between Low and Medium magnitude depending upon the nature of made ground and fill material in these areas and the adopted foundation scheme.

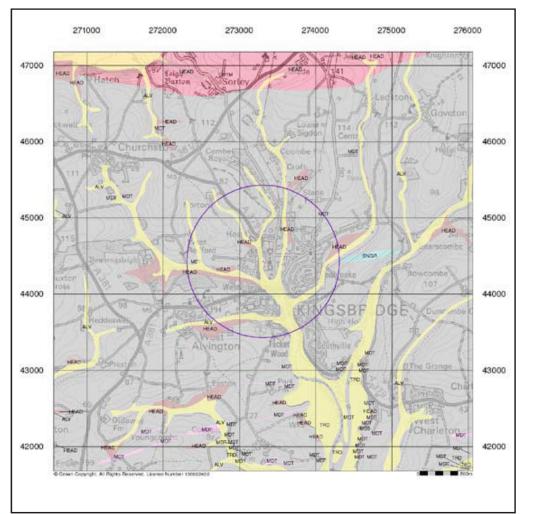
Figure 5: Geology Map

Map Colour	Lex Code	Rock Name	Rock Type	Min and Max Age
	ALV	Alluvium	Clay, Silt, Sand and Gravel	Flandrian - Flandrian
	TRD	Tidal River Or Creek Deposits	Clay and Silt	Flandrian - Flandrian
	HEAD	Head	Clay, Silt, Sand and Gravel	Quaternary - Quaternary
Map Colour	Lex Code	Rock Name	Rock Type	Min and Max Age
	MDT	Meadfoot Group	Basaltic-rock	Emsian - Praghian
	MDT	Meadfoot Group	Slate, Siltstone and Sandstone	Emsian - Praghian
	DRTM	Dartmouth Group	Slate, Siltstone and Sandstone	Praghian - Lochkovian
	BNGR	Beeson Grits Formation	Slate and Sandstone, Interbedded	Early Devonian - Early Devonian

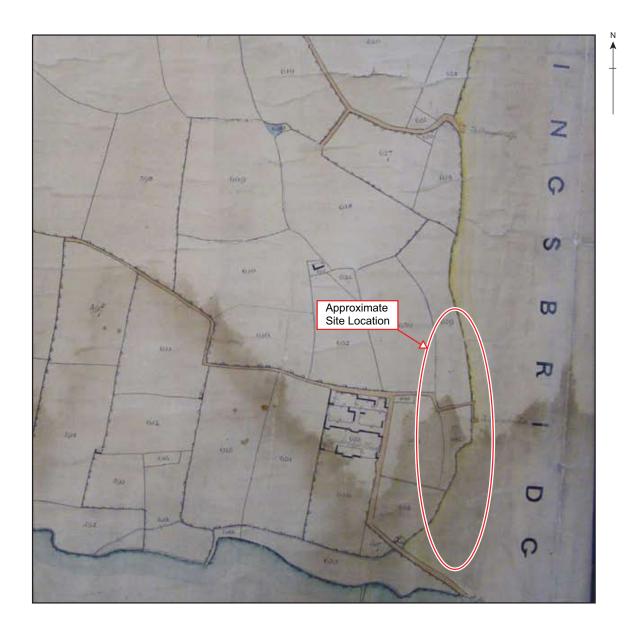
Figure 6:Churchstow Tithe Map, 1841.
(Devon Records Office)

- 6.1.2 The two earliest relevant sources are the Churchstow Tithe map of 1841 (Figure 6) and a Plan of the Parish of Kingsbridge, also dated 1841 (Figure 7). Tithe maps number each plot of land with the associated tithe apportionment listing the landowners and occupiers, the name, description, and state of cultivation and the size (measured in acres, roods and perches) of each numbered plot. Tithe maps are generally quite accurate in terms of the field patterns and approximate size of each plot shown and the relative size, shape and location of the buildings and other features; though the map is not drawn to scale and small structures and features are not necessarily always shown.

- 6.1.4 During the mid-19th century the majority of the proposed development site lay within the Parish of Churchstow, although well away to the south-east from the main focus of settlement activity in that parish. The approximate area of the site on the Churchstow Tithe Map can be ascertained through comparison with later Ordnance Survey mapping and through the position of the Kingsbridge Union Workhouse (AOC 72 Figure 4b), which is shown to the west of the site (Plot 633 Figure 6).

- 7.1.2 No previously identified features have been recorded within the area of the main site, however the following has been noted:
 - The present day footpath crossing the site follows the alignment of a lane shown on the Churchstow Tithe Map and Kingsbridge Parish Maps of 1841 (Figures 6 & 7). The alignment of this lane is likely to be of earlier origin and part of it is shown running alongside the Church on a 1799 copy of a town plan dated 1586 (Plate, though the central and western part of it, passing through the site, is of obvious modern construction.

- The late 19th century cartographic evidence shows three watercourses running north-south passing through the northern half of the site (Figure 6), one of which in the east of the site formed the original parish boundary of Kingsbridge and was one of the streams which flowed southwards to power the town's mills. The mapping suggests these watercourses were managed. The modern-day culverted stream may be the realigned boundary brook following development works in the late 20th century.
