# THE RAILWAY HOTEL, CONNAUGHT ROAD, SILVERTOWN, LONDON BOROUGH OF NEWHAM Historic Building Record

Planning Application Number: 07/02290/FUL  
National Grid Reference Number: TQ 4211 7911  
AOC Project no: 30817  
Site Code: RIH 10  
Date: September 2010

**The Railway Hotel, Connaught Road, Silverton**  
**London Borough of Newham**  
**Historic Building Record**

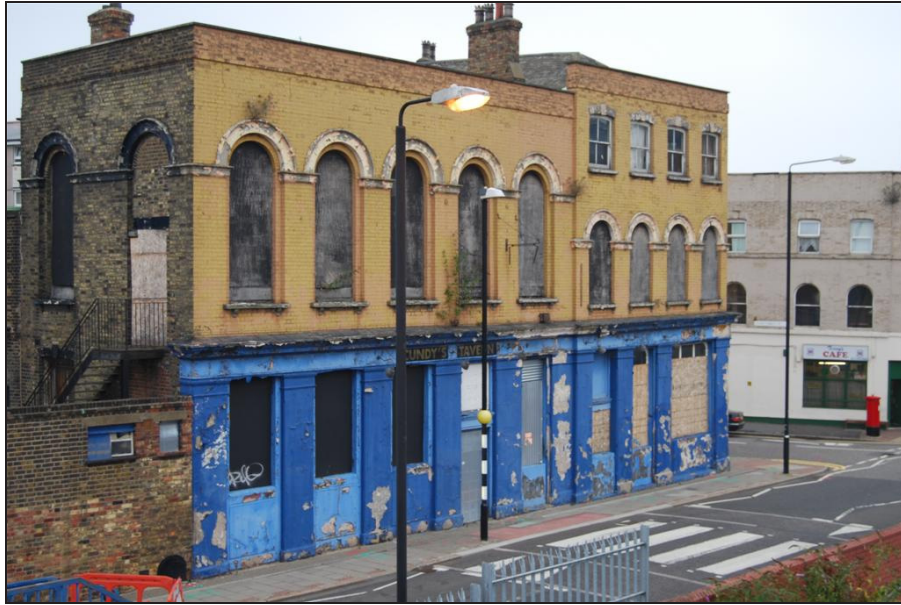
Plate 2: Elevation onto Connaught Road. Looking Northeast

- 6.4 The two faces of the Public House which front onto the main roads have decorative elements, whereas the west and north walls are purely of yellow stock brick. The east and south walls surround ground floor bars, and have a series of large rectangular windows 2.89m high lighting the main bar, and three large windows 2.52m high lighting the back bar. Square pilasters with Tuscan entablature at first floor level surround the windows, the architrave plain and continuing across the entire south and eastern walls. The pilasters are formed of render over brick, although the upper architrave and cornice are stone. One window in the south wall has been blocked to become a doorway and then reblocked, becoming a smaller window. A similar event has happened to a window in the east wall. The ground floor has been painted in two contrasting shades of blue.

Constance Street is a seven-bay structure, with symmetry on all floors. The first floor windows are tall, with stone arches springing from narrow Tuscan impostes and with stone sills, whereas the second floor windows have segmental arches with rusticated keystones. This scheme continues along the Connaught Road frontage for four bays.

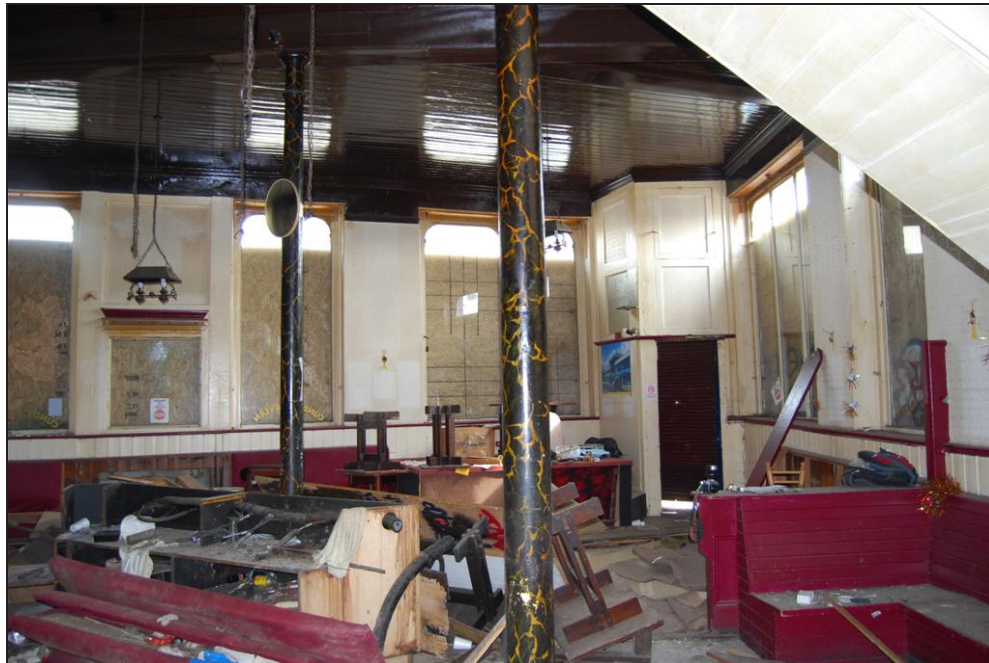
Plate 4: Main Bar Looking Southeast

- 6.8 The principal room on the ground floor is the main bar, being the focus and raison d'être for the building. The bar is an irregular L-shape in plan, part governed by the 78° angle between the two main streets. The main bar (**Room G1**) can be accessed from the corner or through a set of double doors on the eastern wall. A second door on the south wall is more specifically a door to the function room on the first floor, although there is access to the bar too. The room is lit by tall windows that span much of the height of the room. The windows are plain glass with mullions in the larger ones. No decorative etching or engraving was present.

- 6.9 One of the principal features of the building is the height of the room with the Main Bar: 4.56m from floor to ceiling. Only a few decorative mouldings survive, specifically a dado rail around the room and architrave at the ceiling that reflects the entablature of the exterior. The first floor is supported by large principal joists that are clad with timber panels. These complement polished and varnished wooden boards that clad the ceiling. The principal joists are supported on three iron columns, two of which rise from brick piers in the basement.

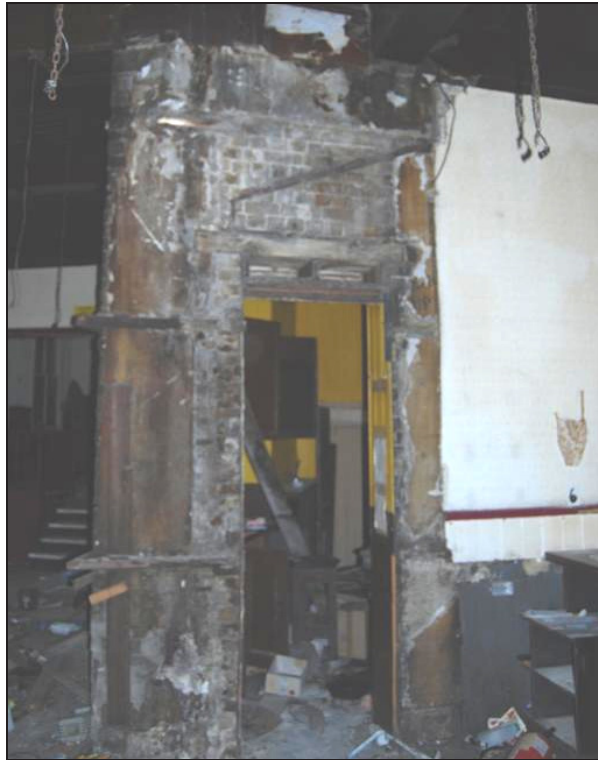
Plate 5: Stripped Area Behind Bar.

- 6.10 The serving counter of the bar faces east and south, opposite the corner doorway. This had been largely demolished at the time of recording. Behind the bar, the location of probable shelves, possible former mirrors and brass fittings had been stripped, exposing sooted, dusty yellow brick.

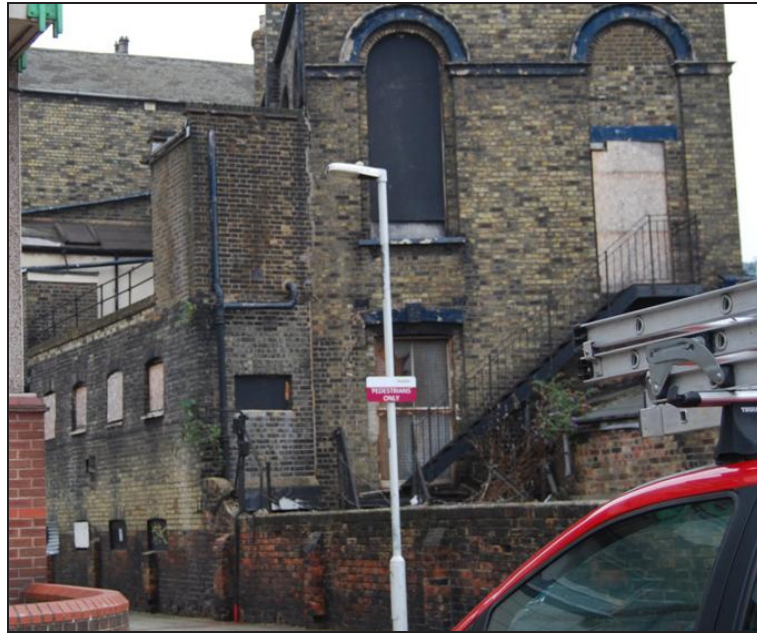
was an office-cum-store for the bar and has a flat roof above. A door in the western wall leads to the foot of the stairs, and a step down leads to a short passage (**Room G5**) with a door at its southern end leading down to the cellar and a door at its northern end to a covered area with the small yard in the west beyond it. This space (**Room G4**) is formed by the wall of the cellar and the outer wall supporting the middle floor above. Three windows light this covered passage. The external wall of this part shows two phases of build: the lower part is red brick, the upper half yellow brick, showing that the passage was covered and the middle level created as an addition.

Plate 6: External View of Western End of Building, with Rooms G4 and M1, Red Brickwork with Yellow Brick Above.

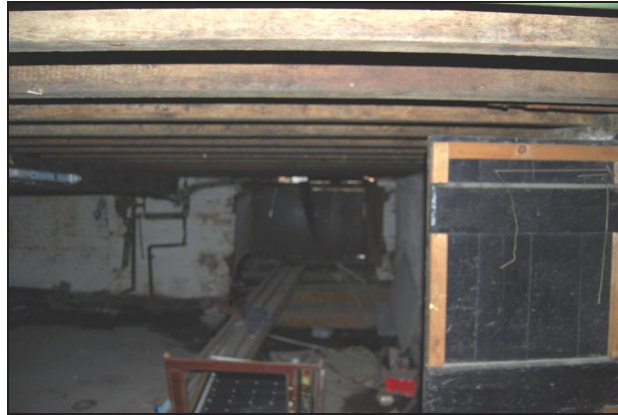
Plate 7: Room B1 Looking West to Barrel Hatch Doors

- 6.16 External access for rolling in and out the barrels is at street level: four steps also inset with wooden rails give access to this level, and may explain the height of the Back Bar, a necessary elevation of the floor level given the confined nature of the site. Two doors open inwards to allow access. These are now boarded up.

- 6.19 All pipes from the cellar have been cut and removed. A number of aluminium barrels were afloat in the eastern end. Discarded detritus and bags of rubbish also litter the room.

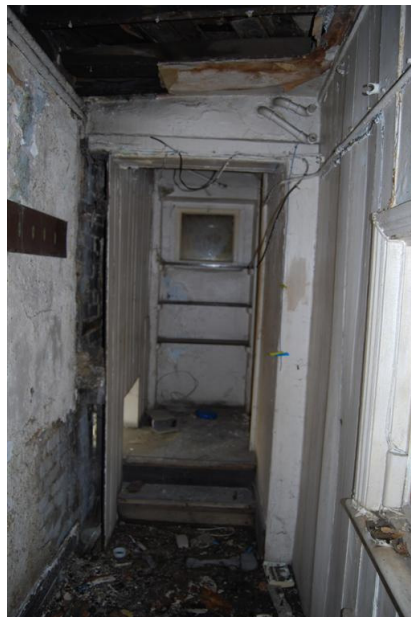
Plate 8: Landing M1, with Window to Main Bar

- 6.20 Above the basement store (**Room B4**) and the covered passage (**Room G4**) is a room used as a kitchen (**Room M2**). This is accessed off the long landing (**Room M1**) that rises from the ground floor. The kitchen has a fireplace in the south wall that feeds into a chimneystack rising up the north wall of the function room. The room is lit by a window in the end wall and three in the north wall, all small windows with segmental arches. A fourth window of this form on the north wall lights the landing. Two other windows on the landing are internal, and provide different functions. One window lights the central office area. The wall here is studwork with boards, and was clearly not an external wall. The other window overlooks one of the exotic dancing stages.

- 6.21 The stairs to the landing are lit by a skylight in the flat roof above.

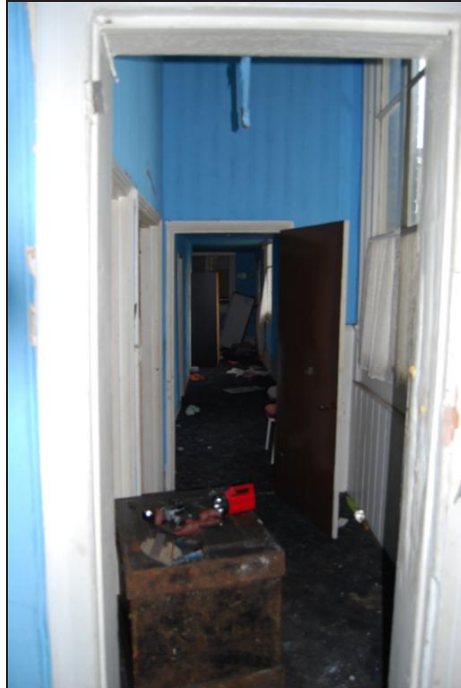
Plate 9: Partitions Obscure the Function Room

- 6.22 The first floor has a range of rooms on the eastern side, and the function room in the western end. The Function Room has been partitioned to form three bedrooms (**Rooms F9, F10 and F11**) and

one corridor (**Rooms F7 and F12**) leading to a fire escape. As well as the partitions, a ceiling has been inserted 3.85m above the floor, the original ceiling being 5.01m high. Access to these rooms was restricted by the presence of foetid odours and filth. However, this once large Function Room retains many original details. A chimneystack in the western wall marks the location of the fireplace, now blocked, and the room would have been lit by four windows on each side and two in the end wall, flanking the fireplace. One of these windows is now the fire escape, the window part bricked up and part converted to a door. The Function Room measured 10m by 6.5m. The architrave remains above the new ceiling, and a heavily painted ceiling rose still survives. The ceiling is clad in polished boards.

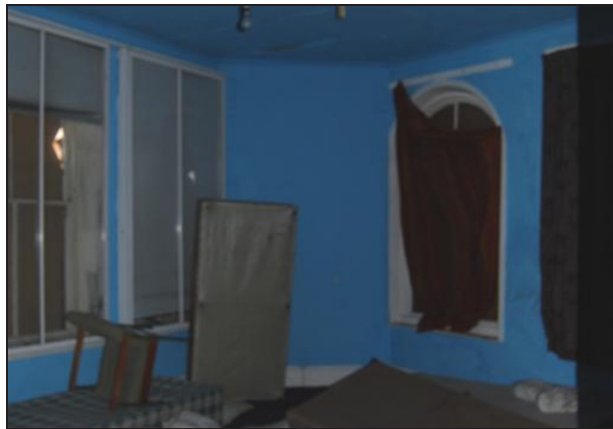
Plate 11: Room F2 Looking Southeast

- 6.24 Six rooms are present in the eastern part of the first floor, and their layout does not appear to have altered. All rooms lie off a north-south landing (**Room F1**), which is accessed from the northern staircase via the long middle landing, and all are bedrooms except for bathroom/ toilet at the northern end (**Room F5**). All rooms bar one are formed with single brick-width walls 0.12m wide. The other four rooms have or had fireplaces, some of which may have been quite decorative since they were removed fairly recently, marked by wall scars and loose rubble and debris. The corner room (**Room F2**) overlooking Connaught Road and Constance Street is the largest, and may be considered the Main Bedroom. There had been a fireplace in the angled corner wall, but this had been removed long since. This room (**Room F2**) is lit by two windows in the south wall and three in the eastern wall. A wide skirting board has roll moulding, and the window frames have slightly splayed reveals and triple roll moulding. The doorframe has a triple roll moulding on the inside, and plain mould in the hall. Most other bedrooms on this floor have these of mouldings, clearly all of a phase.

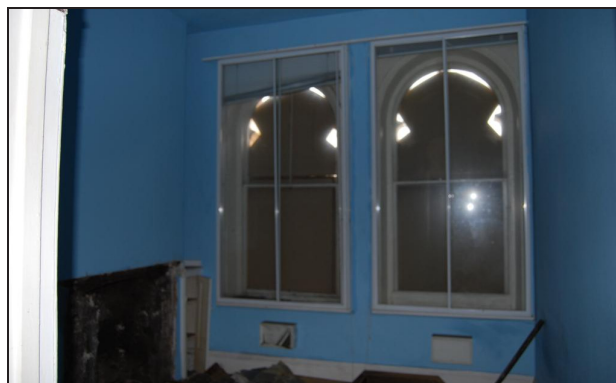
Plate 12: Room F3 looking northeast

- 6.25 The other three rooms are smaller. On the south side next to the main room is an irregular-shaped room (**Room F6**) with two windows and a blocked fireplace in the western wall. The two rear rooms, (**Rooms F3 and F4**) both have two windows and recently removed fireplaces. The rear Room (Room F4) has a differently moulded doorframe, plain on the exterior, a single roll mould on the interior. The wall of this room is 0.32m wide, probably a necessary function of supporting the stair to the second floor.

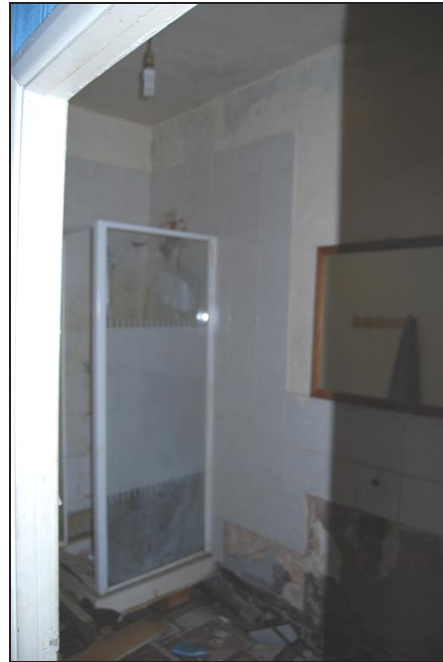
Plate 14: Bathroom S3 with Doorframe.

- 6.28 All of the rooms are bedrooms except for the bathroom (**Room S3**), a small room to the west of the landing. One room (**Room S9**) is open to the landing and may therefore be a general store or cloakroom for the second floor. All other rooms were heated, as proved by the presence of chimneystacks and removed fireplaces This proves that the layout is the primary build, with no

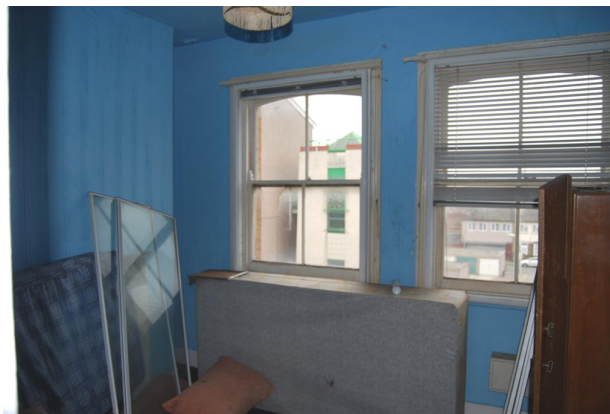
Plate 15: Room F5 Looking East

- 6.26 The bathroom is a small room at the north (**Room F5**), under the stairs to the second floor, and over the stairwell to this level. It contains a toilet in the west, a basin under the main window and a shower cubicle to the east.
