# THE SWAN INN, YATE SHOPPING CENTRE, STATION ROAD, YATE, SOUTH GLOUCESTERSHIRE

## Historic Building Record

AOC Project No: 30554

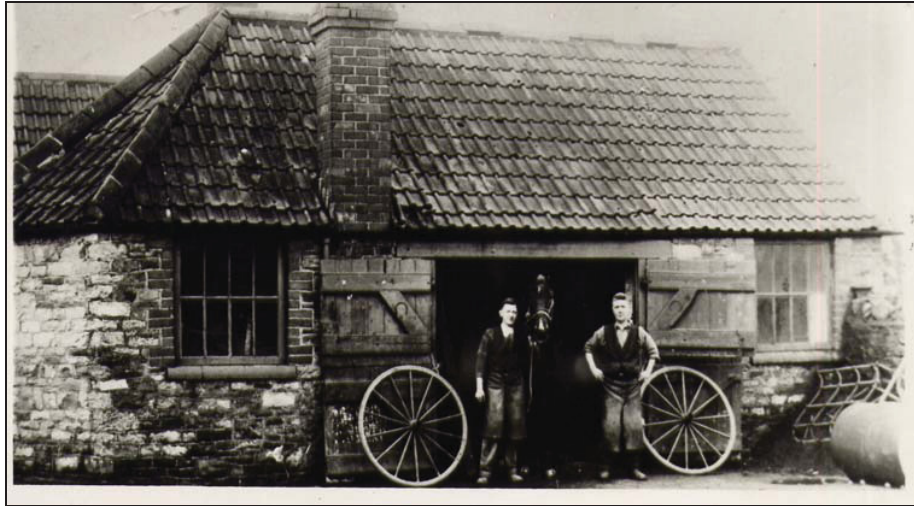
Plate 2: Denis Fletcher and Bill Wilkins outside the smithy

- 3.9 The smithing and farrier business was run independently from the Public House, two men in business there were Denis Fletcher and Bill Wilkins who were both Farriers and Blacksmiths. Their work included shoeing horses and ponies, repairing drag rakes, sharpening plough blades and repairing tools (Barry Fletcher pers.comm).

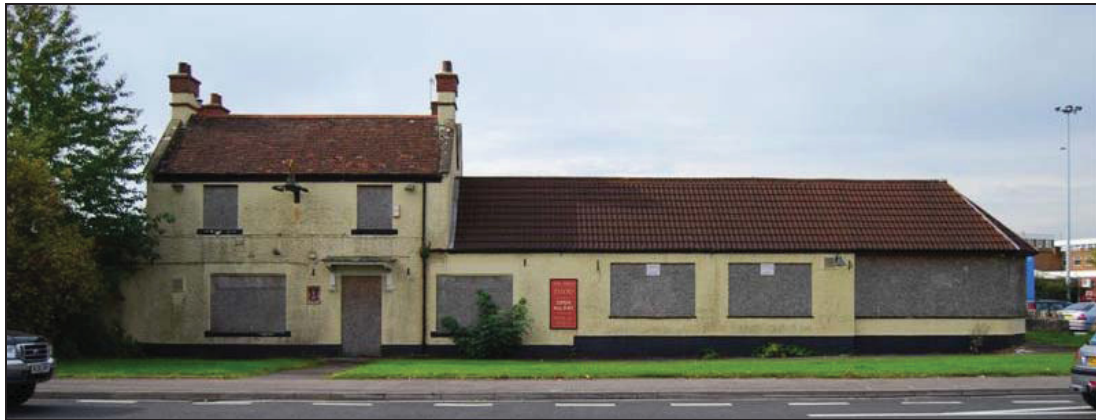
Plate 4: Northern Elevation, the Swan Inn

- 6.2 This Public House is surrounded on the south side by a low dry-stone wall, that encloses a beer garden. The principal entrances are from the north, off Station Road, and a second to the south. The northern face has some symmetrical elements. At the time of recording, all ground floor openings were boarded up and rain that enters through holes in the roof was beginning to cause structural damage.

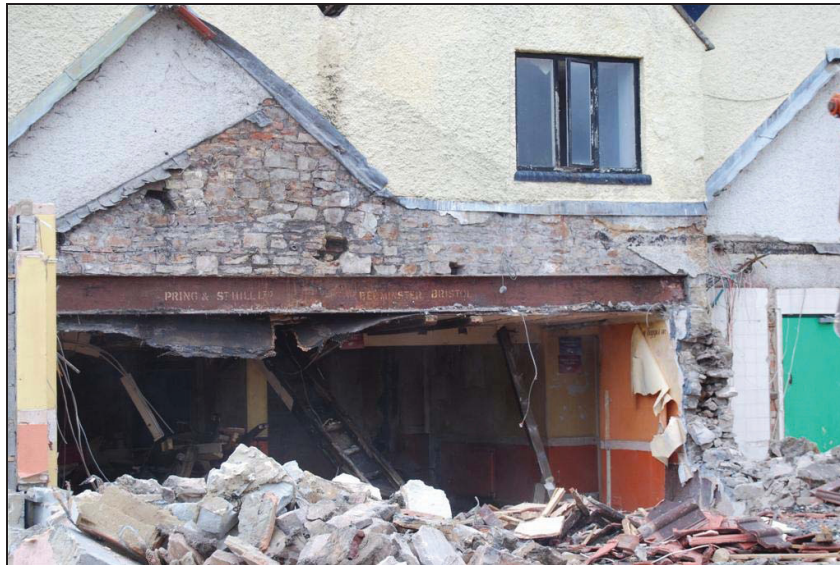
Plate 6: Roof scar behind extensions

- 6.4 The western ground floor part is represented by a short wall forming the edges of the Gents toilet, and the wall skirting the stairs to the upper new bar. The roof scar is visible behind the later extensions, showing a shallow pitch.

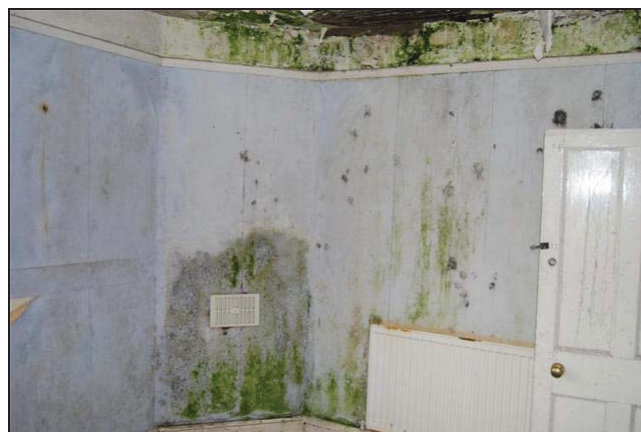
Plate 7: Room F6 looking North

- 6.5 The first floor has been less altered, and the external walls are 0.48m thick. The plan shows east-west symmetry, two rooms of identical shape lie to either side of a short north-south corridor (**Room F4**). The two southern rooms have three-light windows with a central casement window facing east and west. That to the east (**Room F6**) was most recently a bedroom, that to the west a kitchen (**Room F5**), the first floor being accommodation: now a self-contained flat. Corner set stone chimneystacks in these rooms are blocked. The flue from the western room joins a stone stack to the north.

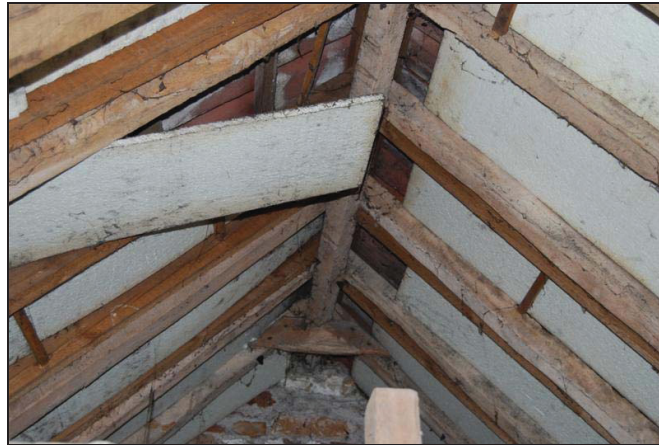
Plate 8: Roof Detail

- 6.8 The twin gables of this build are oriented east-west, the central valley supported on a wide internal wall. The roofs are both butt-purlin roofs, the purlins scarf assemblies with trenails. The southern roof has an added collar beam beneath the purlins that is nailed in place with hand-made nails, and is probably a repair or later strengthening.. Both roofs have a ridge piece and are clasped at the apex by a triangular piece. The principal trusses and rafters are mostly of historic date, with a few repairs. Visible saw marks on the timbers show their method of conversion: no other tool marks or carpenters marks were visible. The gables are topped with limestone slabs.

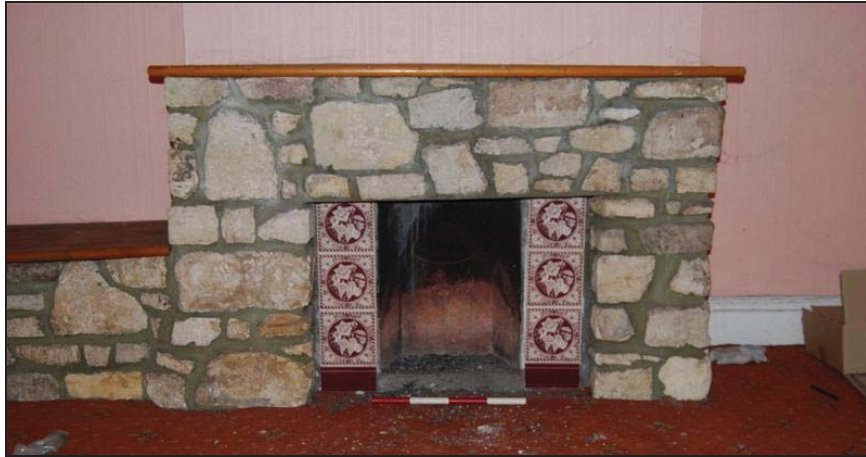
Plate 9: Fireplace, Room F3.

- 6.10 The stairs open onto a short landing (**Room F1**) that leads to a small bathroom (**Room F2**) and then a living room (**Room F3**). The top of the stairs and landing are lit by a narrow casement in the east wall, the bathroom by a top hung casement, and the living room by a three-part casement. A chimneystack rises in the west of the room, with a fireplace which is an irregular combination of modern and Victorian styles. The fireplace has a stone façade set with glazed Victorian tiles, and has an unbalanced appearance.

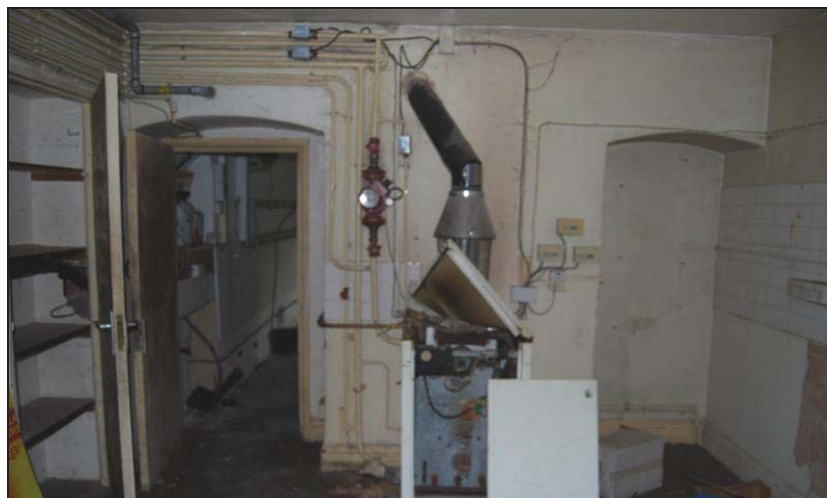
Plate 10: Room G9 looking North

- 6.13 A single storey brick extension across the eastern end of the Public House has a central chimneystack. The fireplace is now blocked, and has the flue from a boiler leading into it, and a pressure gauge. It originally faced south into one of the two new rooms (**Room G9**). A recess to one side of the chimneystack was probably for storage, while access to the other half of the new range is to the west (**Room G10**). The flue overflies the doorway and is joined to a Phase 1 chimneystack. The floors of both rooms are concrete. A doorway from the main bar may have been blocked when this was built, the precise phasing of the blocking could not be determined. The main access into Room G9 is from the stair hall (**Room G7**). This room may have been the kitchen for the occupants of the Inn, since the main access is from the stair hall rather than the bar.

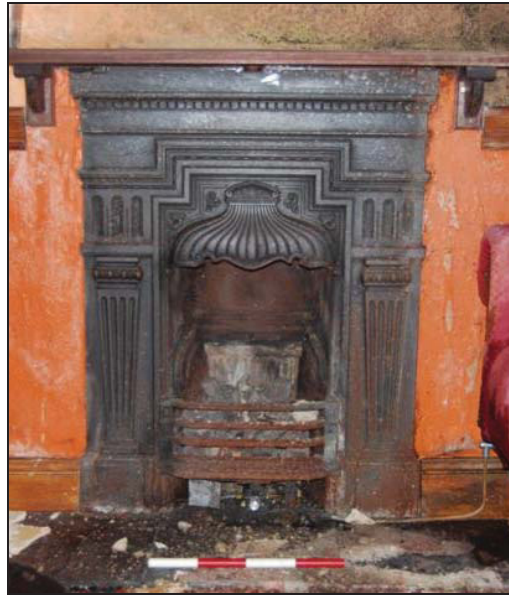
Plate 11: Romanesque fireplace, Room G5

- 6.15 The surviving ground floor chimney in the early phase has a later Victorian or Edwardian Romanesque fireplace, which may be an addition contemporary with this rebuild. The grate is flanked by fluted pilasters and a geometric entablature above.

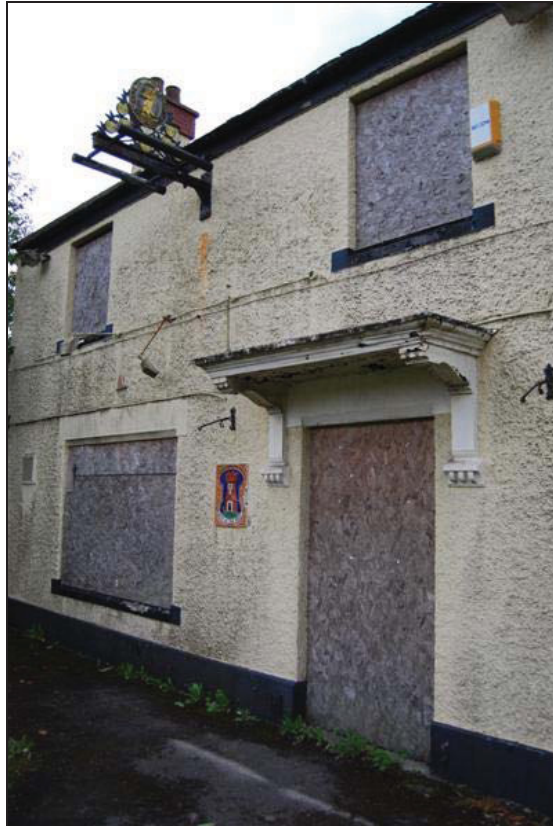
Plate 13: Detail of New Northern Wall and Entrance.

- 6.17 Mounted on the wall above the doorway is the bracket and hanging bar for the sign. The sign, presumably an image of a Swan is now in the keeping of the Yate Heritage Centre. Plate 13 shows the brewery's motif, a hind's head for Whitbread & Company.

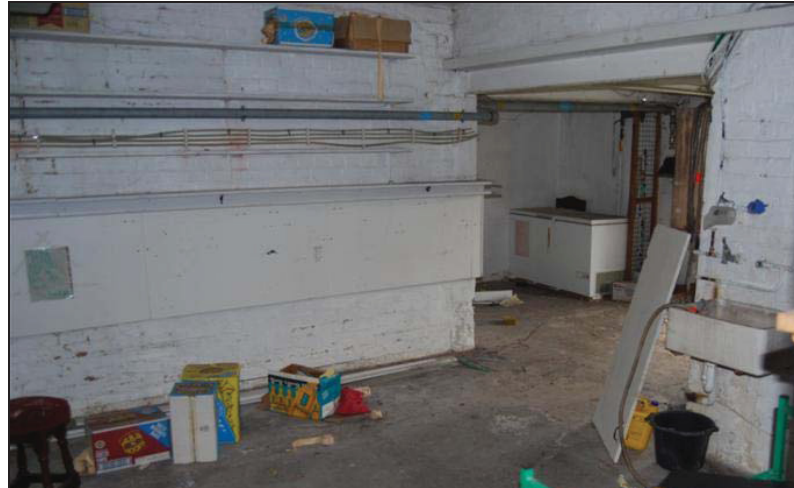
Plate 14: Barrel store (Room G10) looking Northwest

- 6.20 A third extension lies to the north of the kitchen and beer store, and forms a larger barrel store and another store room (**Room G12**). The extension of the barrel store (**Room G10**) has removed the end wall of the earlier phase. This is now spanned by an I-beam. The extensions are largely featureless, with most pumps supplying the bar having been removed, although some pipework remains. This barrel store is used instead of a cellar which typifies most purpose built Public Houses rather than this conversion.

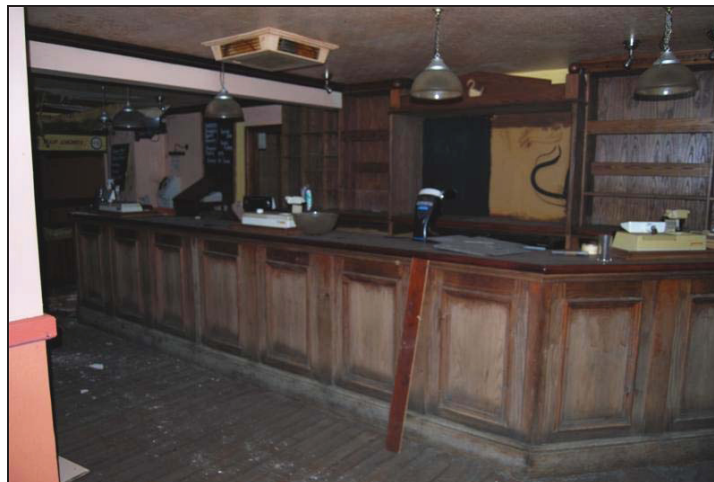
Plate 15: The New Bar, Room G6 looking Southeast

- 6.21 The bar was extended southwards with a brick and then wooden framed section. The brick section lies 0.80m higher than the original bar area, accessed up a pair of four-flight steps. The serving counter for drinks lies to the south of this new bar (**Room G6**), a wooden counter with shelving storage behind and remnant cash-tills. Two new large windows on the north wall give light to the room. To the rear of the bar lies a kitchen that has superseded that to the north (**Room G11**). The kitchen has one external door with the only natural light coming from a large skylight in the roof above.

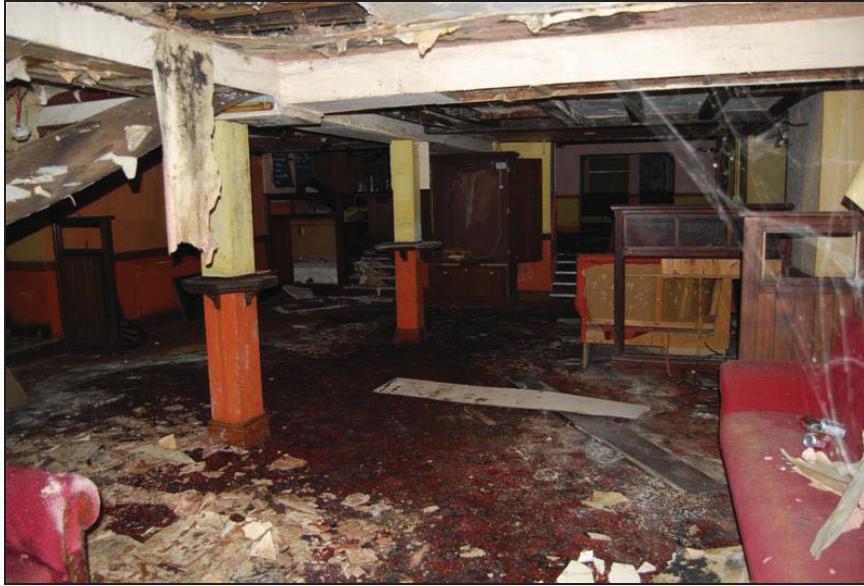
Plate 16 The Old Bar/ Phase 1 Remnant in its Latest Form.

- 7.8 The result of each phase of change has been to reduce the historic value of the old house, and the years of recent dereliction have also had some effect. Only one wall of the oldest section remains on the ground floor, with each successive extension to the bar removing the outside wall of the previous phase.

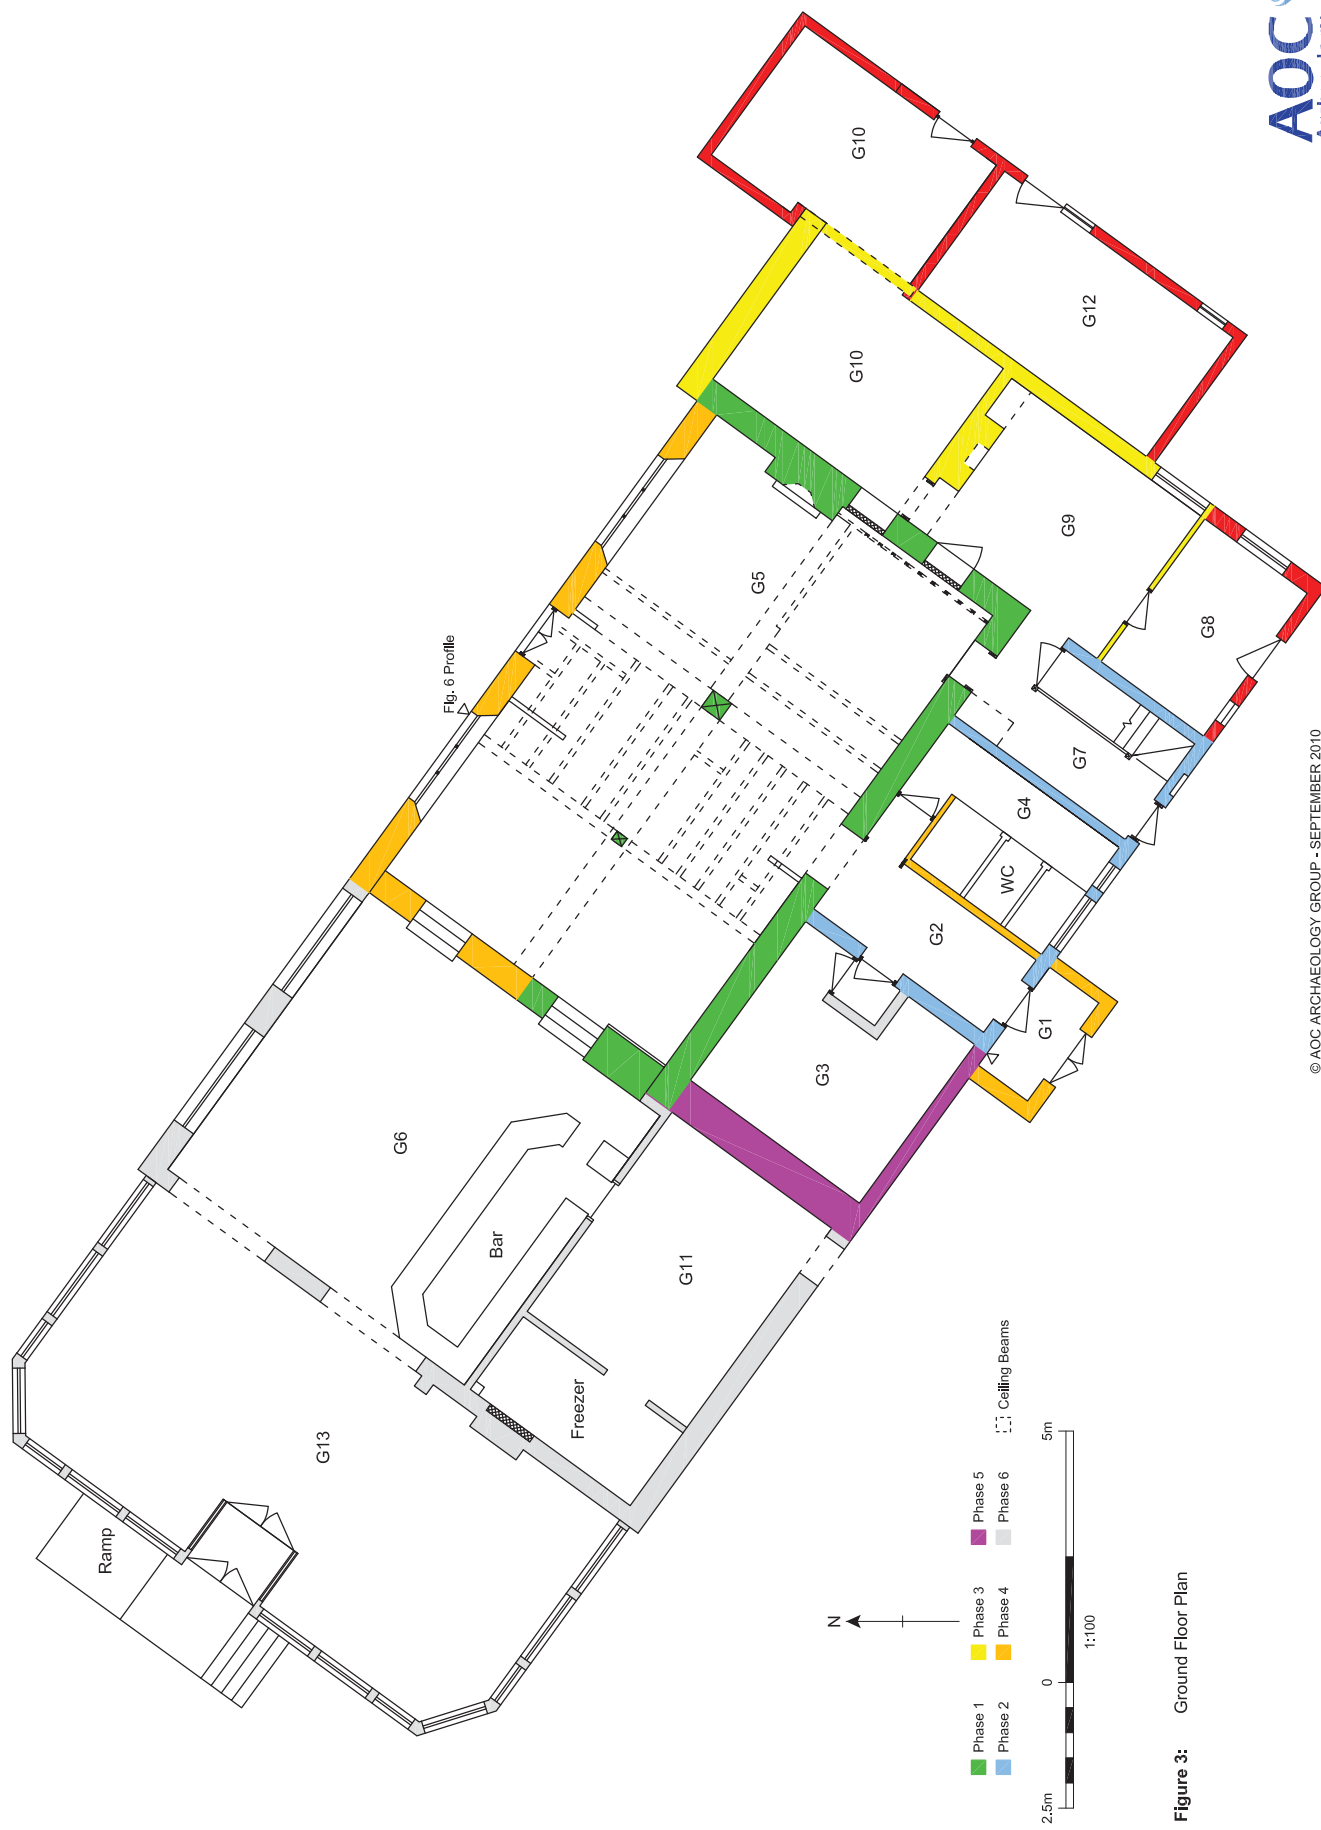
Figure 3: Ground Floor Plan

- 6.1 The Swan Inn stands 200m southwest of the river Frome as it meanders westwards towards Bristol. The Swan Inn is situated, and lies on the south side of Station Road, a principal route between Chipping Sodbury and Bristol. The building has a central two-storey core with three gable ends facing east and west, with a red tiled roof. A single storey extension lies to the west, and there are a series of extensions to the east. Much of the ground floor has been opened out to form a single bar area, with internal load bearing walls replaced by beams and posts.

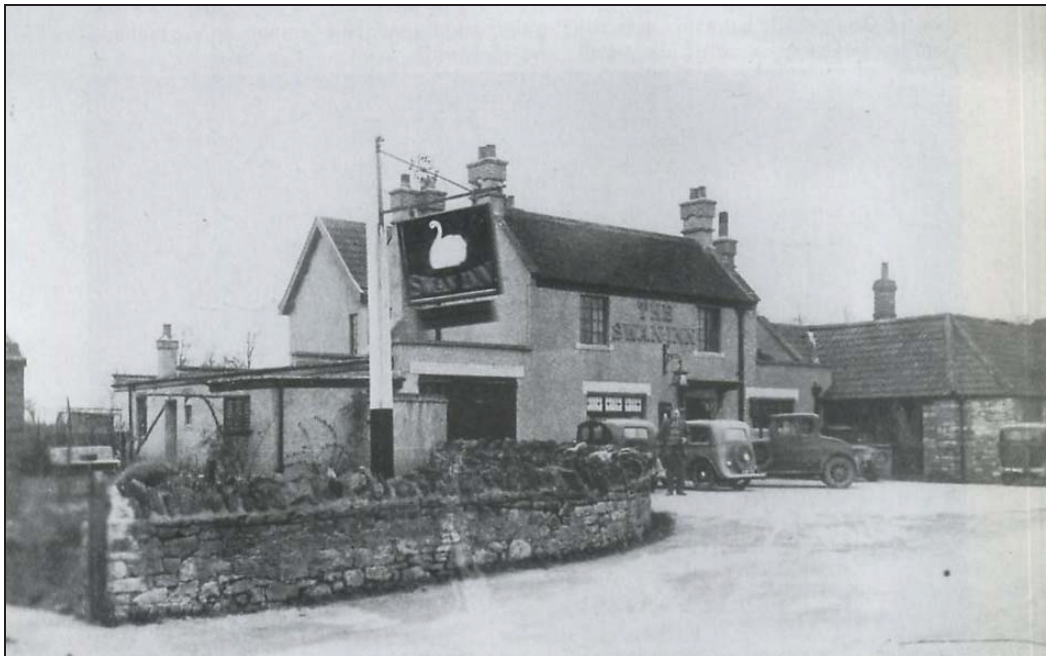
Plate 17: the Swan Inn, c.1935

I recall that on entering the pub from the street, the public bar was to the right, the lounge bar to the left. The photos I have sent are of the Swan, Yate as it was some where between 1910 – 20. The next photos are of the Swan with the forge along side it and the back yard gates to its back entrance for the landlord, some time early 1960's. The other is of my father Denis Fletcher on the left and Bill Wilkins on the right who were both Farriers and Blacksmiths. They shod horses and repaired some drag rakes that were towed behind tractors from local farms, sharpened plough blades, re-shaped Pickaxes to give them a good point, fitted new handles to those that were broken and also replaced shovel handles, but the main thing at that time was shoeing horses and ponies. In the 30's late 50's there were a lot of cart horses about as a lot were used to plough fields and some were used for milk & coal deliveries after WW2 due to the shortage of fuel. As time went on the use of horses became less so the need for farriers in a fixed location has died out and mostly now they are mobile. There is another photo of the Swan & Forge on page 9 of the book: IMAGES OF ENGLAND YATE compiled by the Yate District Oral history project. Barrie Fletcher, (Son of the Farrier Denis).
