Tate Britain, Tate Gallery, Millbank, City of Westminster; Report on a Historic Building and Archaeological Watching Brief

Planning Application: 10/0351/FULL, 10/02946/LBC, 10/02945/FULL

AOC Project No: 30855

Date: July 2013

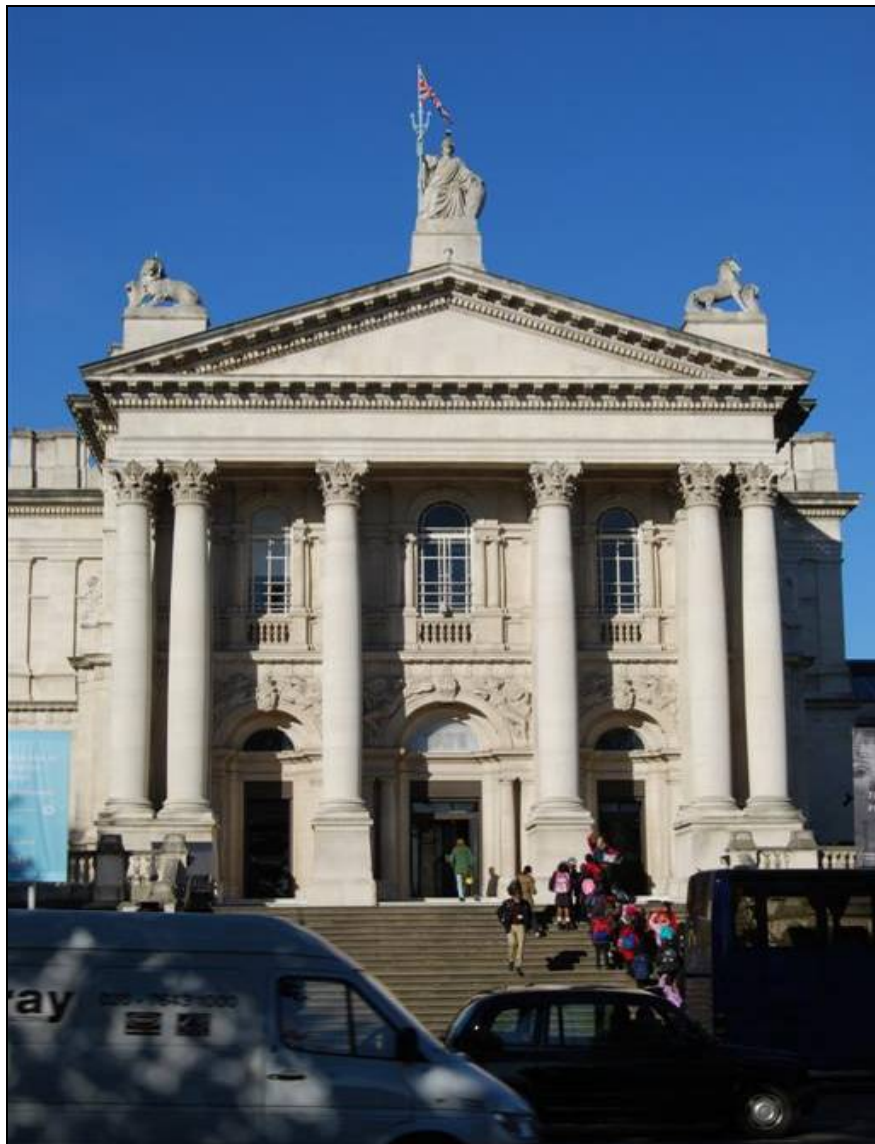
Plate 1: Main Entrance to the Tate Gallery

- 6.2.1 The main east entrance to the Tate (Plate 1) provides a magnificent frontage to the oldest parts of the building, and is more impressive than the ramped access to the basement on the south side. Two flights of Portland Stone steps lead up from street level to the principal floor level. Two paired and two single Corinthian columns rise from tall plinths; the pairs are on the outside corners of the entrance. The columns support an architrave and frieze, with dentil course above, all obeying the orders described by Vitruvius (15 BC). The frieze is surmounted by a pediment: a low pitched gable. At the peak of the gable as a stature of Britannia. On the south edge is a lion *sejant*, one paw raised upon a Royal Standard shield. On the north side is a unicorn, also *sejant*, again with the Royal Standard shield.

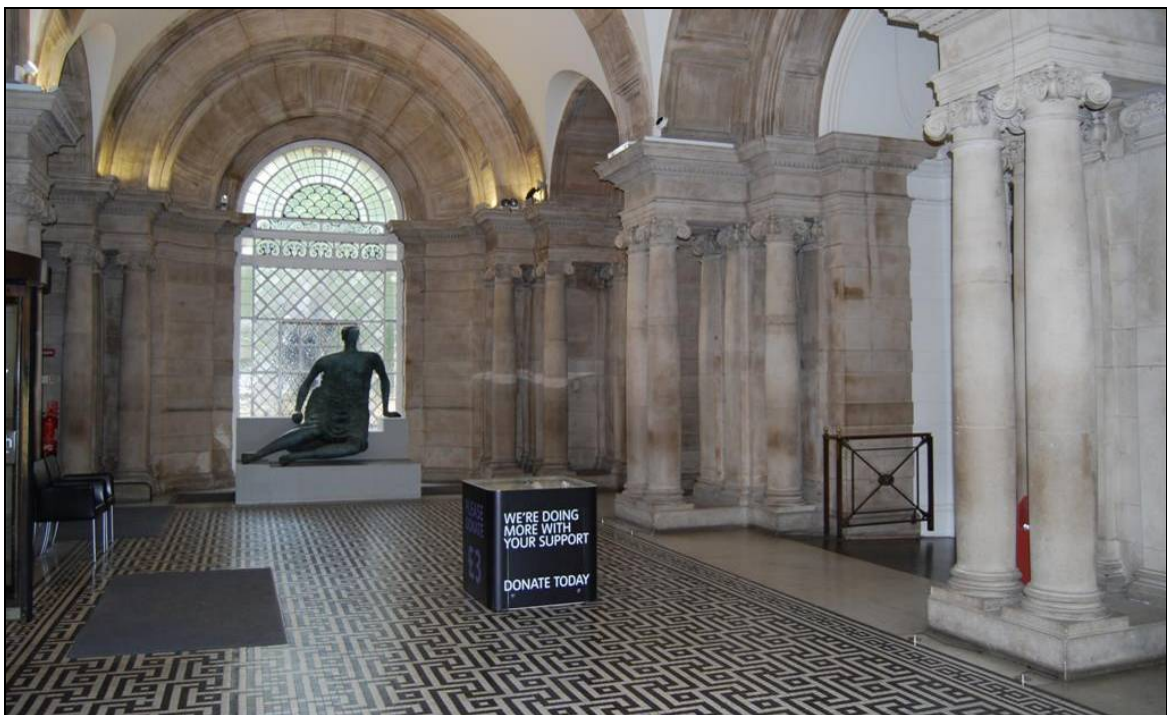
Plate 2: Geometric Mosaic and Portico, Looking North

6.2.7 The north window is an arched window, with a radiating fanlight in the upper register. The windows have rectangular glass forming a border, with square panes of opaque textured glass set at 45°. Between these and the arched fan are two friezes. The lower has a row of carnations, the upper a series of waves. The inner light of the fan is a semi-circle of scales, also evoking sea imagery. The south window is much plainer, and is a simple square frame with radiating spokes in the arch. The difference between the two may be the result of a repair, perhaps following blast damage in the Second World War.

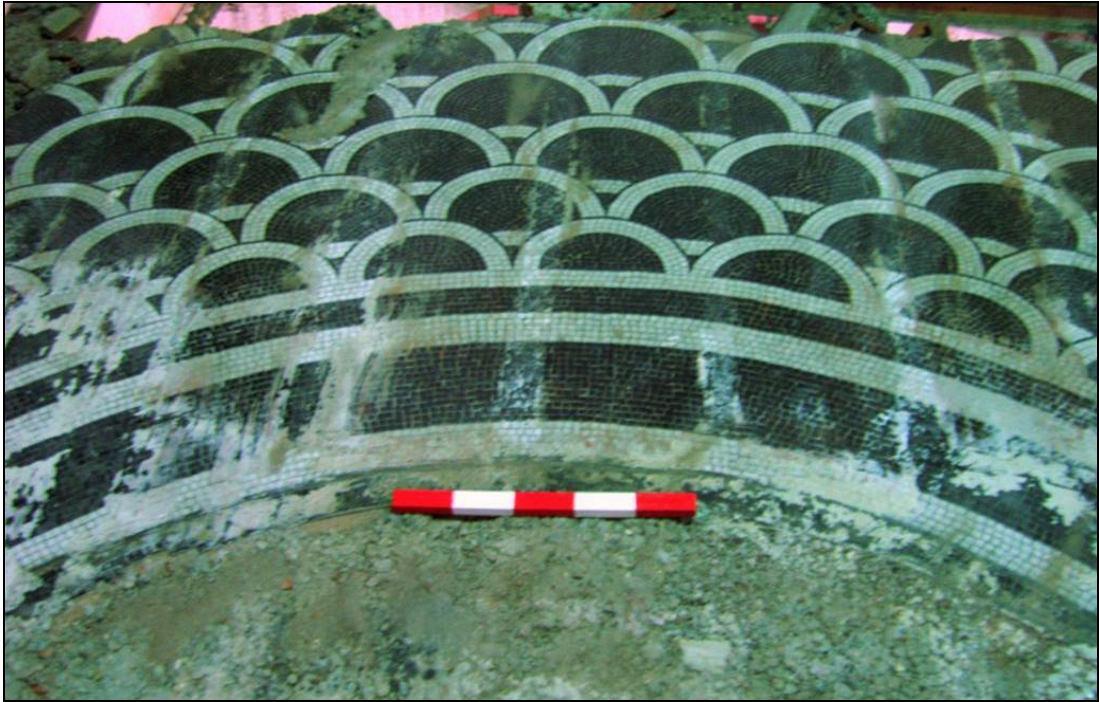
6.2.10 The floor of the rotunda as present in 2010 is formed of highly polished concrete terrazzo with thin strips of brass inlay giving the impression of polished marble. When this was removed as part of the reconfiguring works, this was seen to rest upon a floor of much different character. The floor was supported on a pair of principal steel girders running east-west, 4m apart, with eight subsidiary north-south girders at regular intervals between. This frame held a secondary layer of nine girders, also oriented north-south. Above this, a central circular slab of polished white marble of 1.84m diameter was laid, with a central, small drilled hole. Around this was a course of smooth Portland stone blocks that stood 0.12m higher. Beyond the blocks, a poured concrete floor sealed the girders, and was presumably shuttered during construction. The concrete was topped with a decorative mosaic floor (Plate 3). The inner pattern is a sequence of black and white concentric circles, with rows of small semi-circular patterns beyond, becoming larger towards the edge. The outer border is formed of blocks Portland stone, which skirt the room at the radius of the Roman Doric columns. The whole floor suggests that the central marble slab may have held a fountain or statuary with a shallow pool, and would have been a focus for the room, after entering through the portico. The modern floor was laid over hollow ceramic bricks, with the sunken marble centre filled with concrete. This was all broken out and discarded during the works.

Plate 3: Mosaic Floor of the Rotunda

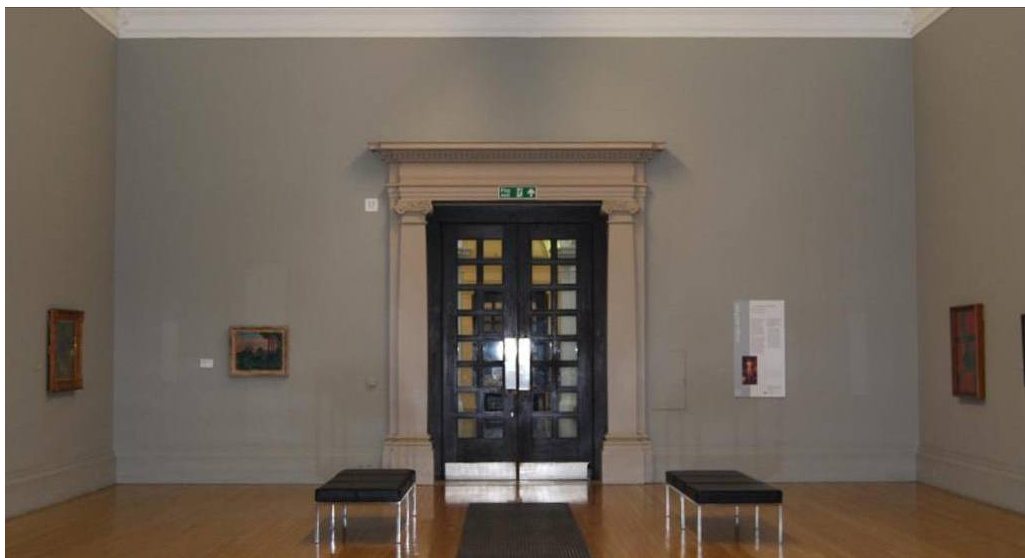
- 6.2.12 Four of the doors are of identical form (Type A), set in identical porticoes of Composite order (Plates 4 and 5). On the north side, the doorways lead into Rooms T8P.30 and T8P.33 (the shop and Gallery 33). On the south side of the Rotunda, these lead to Rooms T4P.1 and T4P.3 (Galleries 1 and 3). All these doorways are located in the first phase of the building from 1897, which includes the construction of the Rotunda.

Plate 4: Doorway Type A, Gallery 1 Looking North

6.2.13 The Composite pilasters of the porticoes comprise all the expected architectural elements: a plinth, base, shaft, capital and entablature. The plinth is 0.38m high, with the moulded base 0.24m wide above it. The shaft is square, plain and bulges slightly as it rises to 3.12m above floor level. The shaft is topped by a capital with volute and abacus, the architrave spans the doorway which is 2.20m wide, inset with a wooden frame from which a pair of double action doors hang. The architrave, frieze, dentil and cornice continue around the room. Above the entablature is a tall arch, reflecting the style of the rotunda.

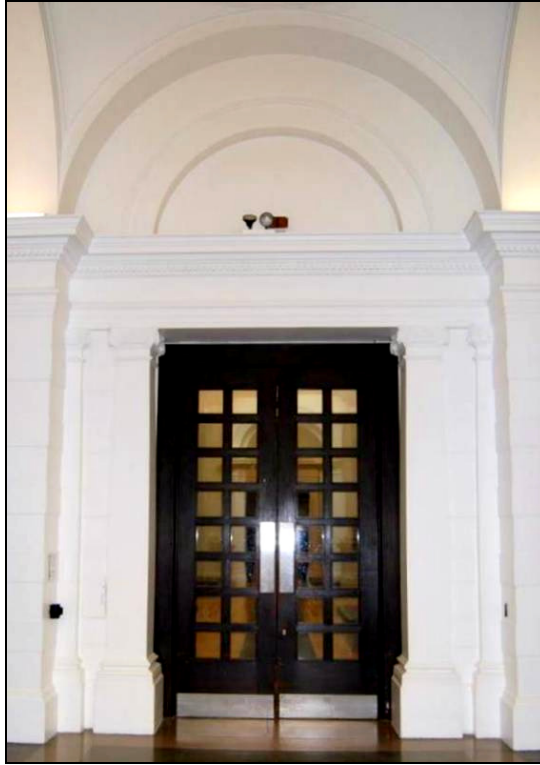
Plate 5: Door Type A to Gallery 1, Looking South

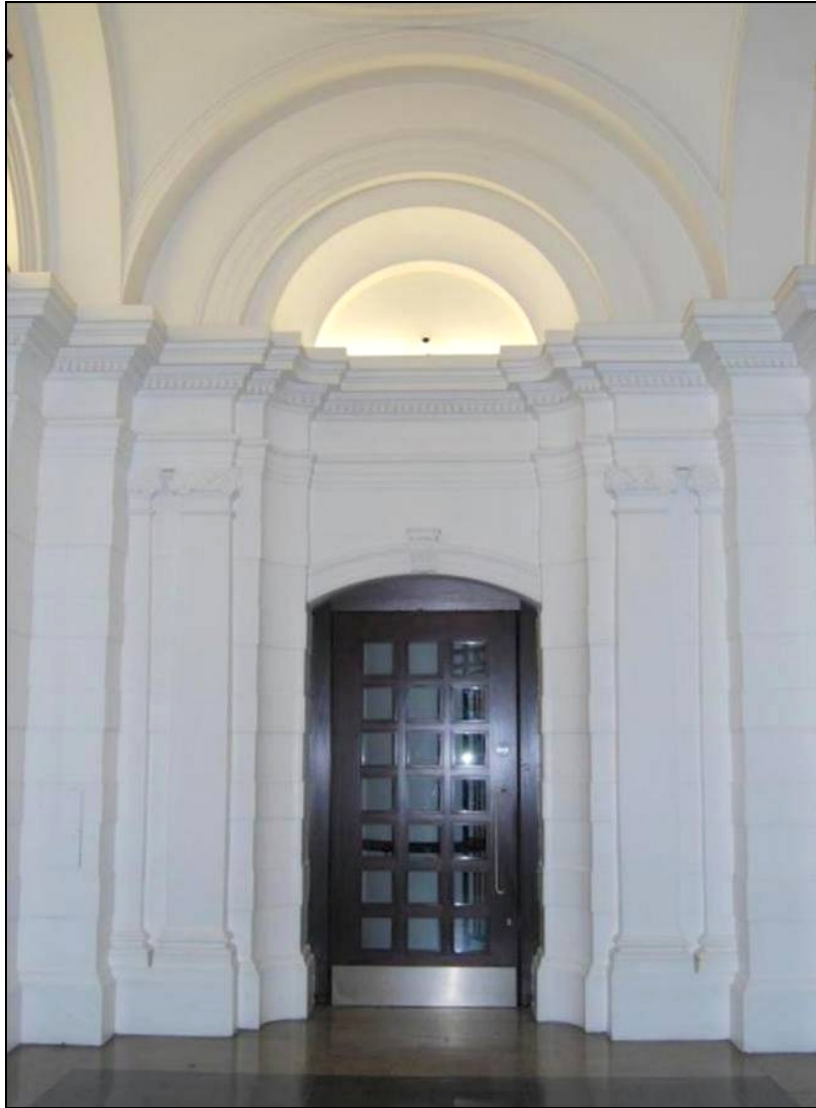
6.2.14 A winding staircase leads down to the lower level and up to the upper level of the Rotunda. Access to the staircase is from the north end of a passage between the Rotunda and the Portico (T1P.33). This door is at the end of a series of moulded Composite pilaster recesses, giving an illusion of distance (Plate 6). The composite pilasters are in the same style as the main doorways to the galleries. The door itself is a single door (Type B), opening northwards, hung on the western frame. The door has wooden stiles and a bottom and top rail. There is no lock rail, rather the door is panelled with three columns of seven square glass panes with wooden muntins between. Above the door, an inset arc has a keystone.

Plate 6: Door Type B to Spiral Staircase.

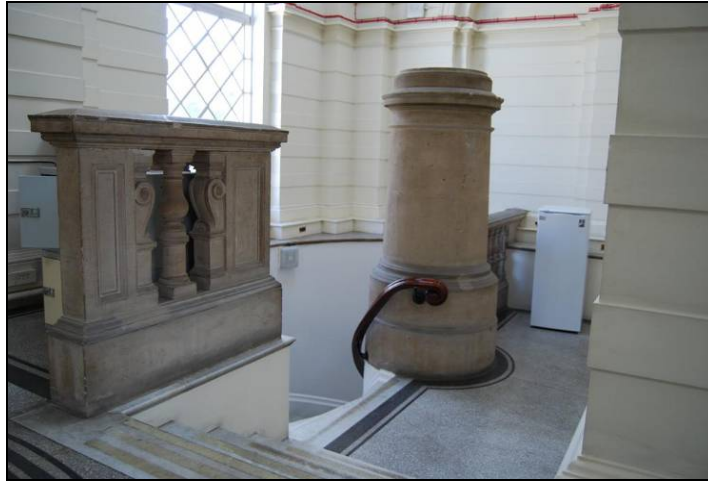
Plate 7: Newel Post and Masonry at top of Spiral Stair

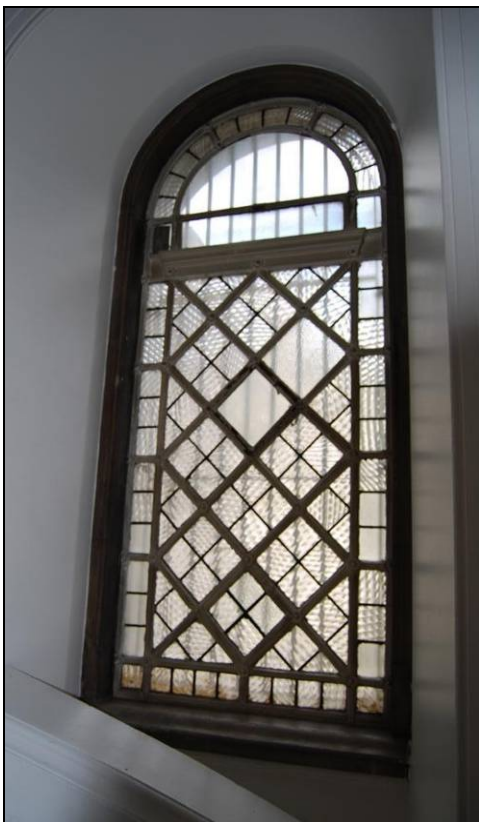
Plate 8: Lower window, Spiral Stairway

- 6.2.15 The staircase winds anti-clockwise to the upper floor. The stairs are polished stone, and the stair has a wide central newel (Plate 7). Light to the stair is given by one window half-way up, in the north face of the structure, and a second at the top (T1ST.1). The lower window is 1.08m wide and 2.60m high, with an arched top. It is inset in a straight-sided reveal, with a bead-mould surround rising from end-stops. The window uses textured glass to achieve opacity. The window has a series of small rectangular panels around the perimeter, with incised grooves set either horizontally, vertically, or on the diagonal. The central panel has diagonal set panels in lead-cames, with two hinged casements in the centre. The top panel within the arch is clear, and may represent a repair (Plate 8) (Figure 6).

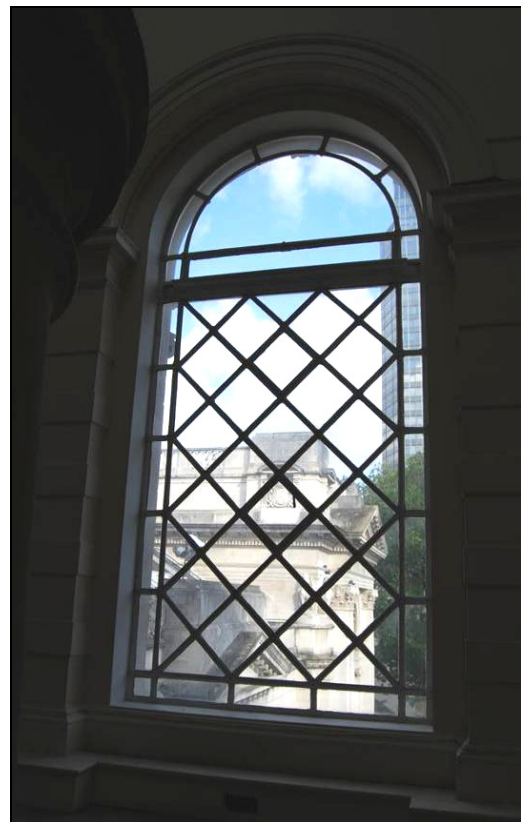
- 6.2.16 The window at the top of the stair is of similar form, but lacks the textured glass and is slightly larger (Plate 9). This may indicate that the glass was fully replaced, and may even represent blast damage from sustained during the Second World War. The top of the newel post is a notably large block of masonry. It has the form of a stunted column, with plinth and moulding near the top. Abutting it to the east is a short banister with stone blusters. To the west is a stone panel of neoclassical form: a plinth has a moulded base above, with two incised panels flanking a central baluster. The inner edges of the panels have scroll moulding.

Plate 9: Upper Window, Spiral Stairway

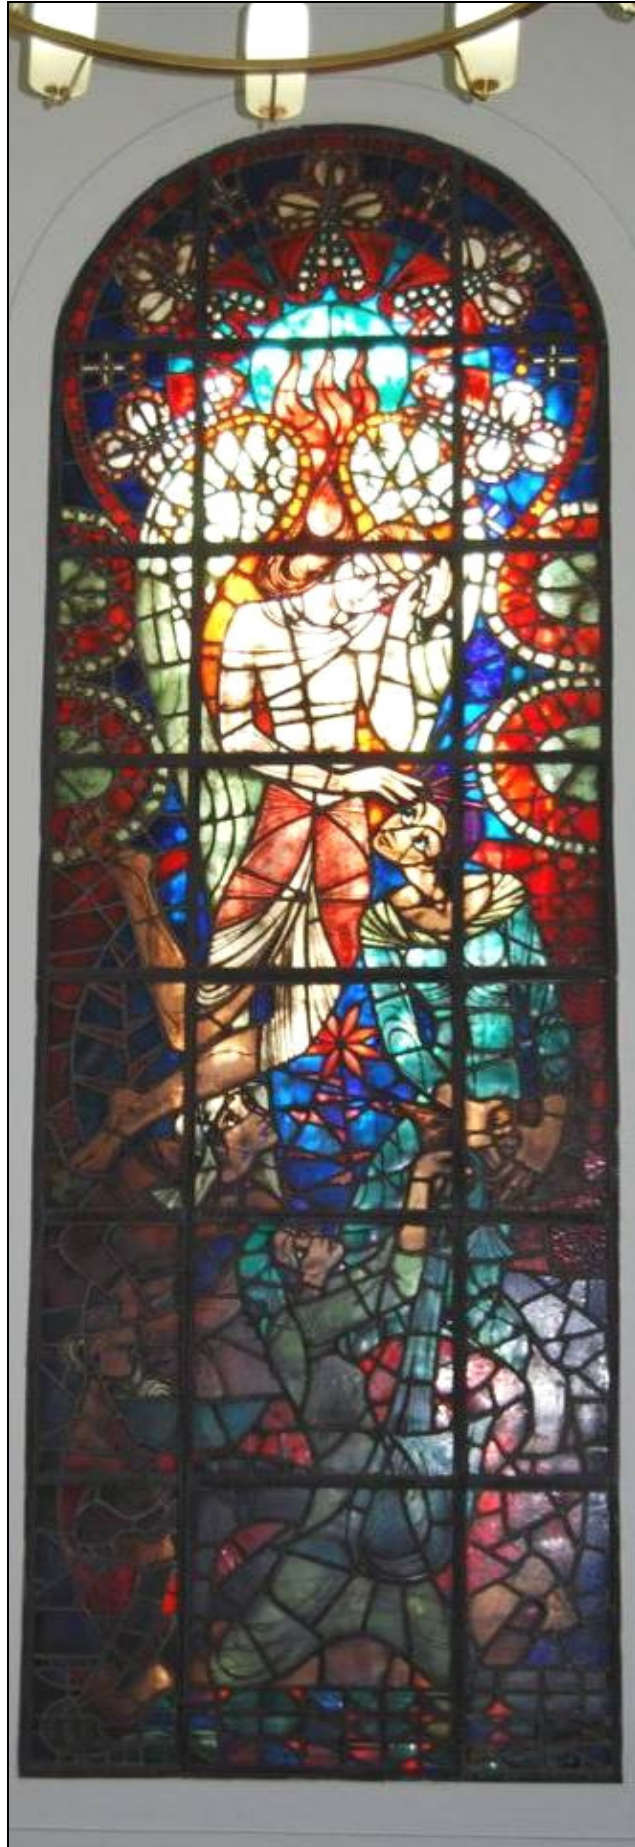
Plate 10: Ervin Bossanyi Stained Glass Window

6.2.17 Opposite the door to the spiral staircase, in the south side of the room, is a half-turn stair with landings. The stair has a metal railing with balusters, and at the top of the stairwell, a wrought iron panel with a central fleur-de lys is lit by a decorative stained glass window. The window was designed and made by Ervin Bossanyi, the colours inspired by a visit to Chartres, and is entitled '*The Angel Blesses the Women Washing Clothes*'. The glass is set in a structure of 21 panes, the window having an arched top. It was worked on during 1937-42, and finally installed in 1947-8. The image shows an angel resting her hand on one of three women washing clothes (Tate Gallery 2012). Light to the window is occluded by mature trees to the southeast (Plate 10) (Figure 6).

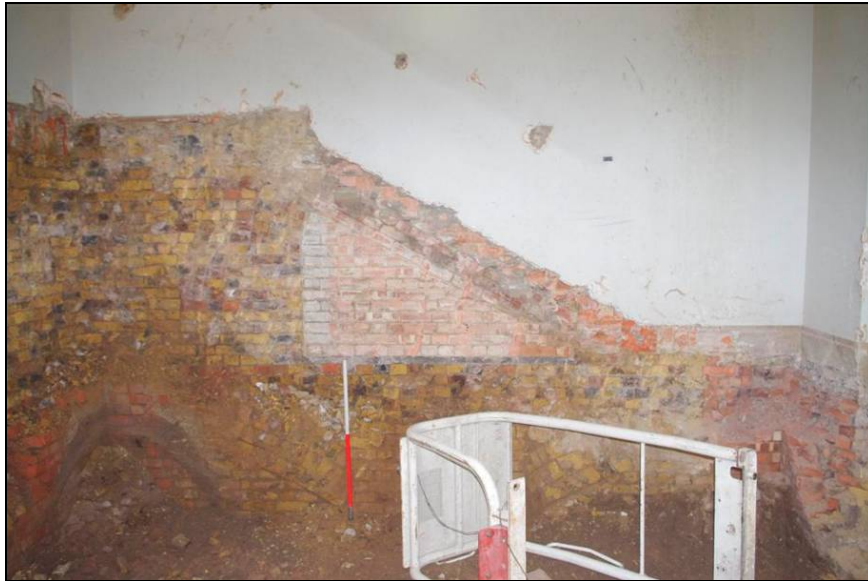
- 6.2.18 The stairs were removed as part of the new transformation works. These were removed, and the basement floor level reduced. The stairs were pre-formed concrete step units with metal-edged treads and a grey laminate surface. They appeared to be original to the building, with no evidence of intrusive tying-in rods in the brickwork behind (Plate 11).

Plate 11: Stairs Removed below Ervin Bossanyi Stained Glass Window

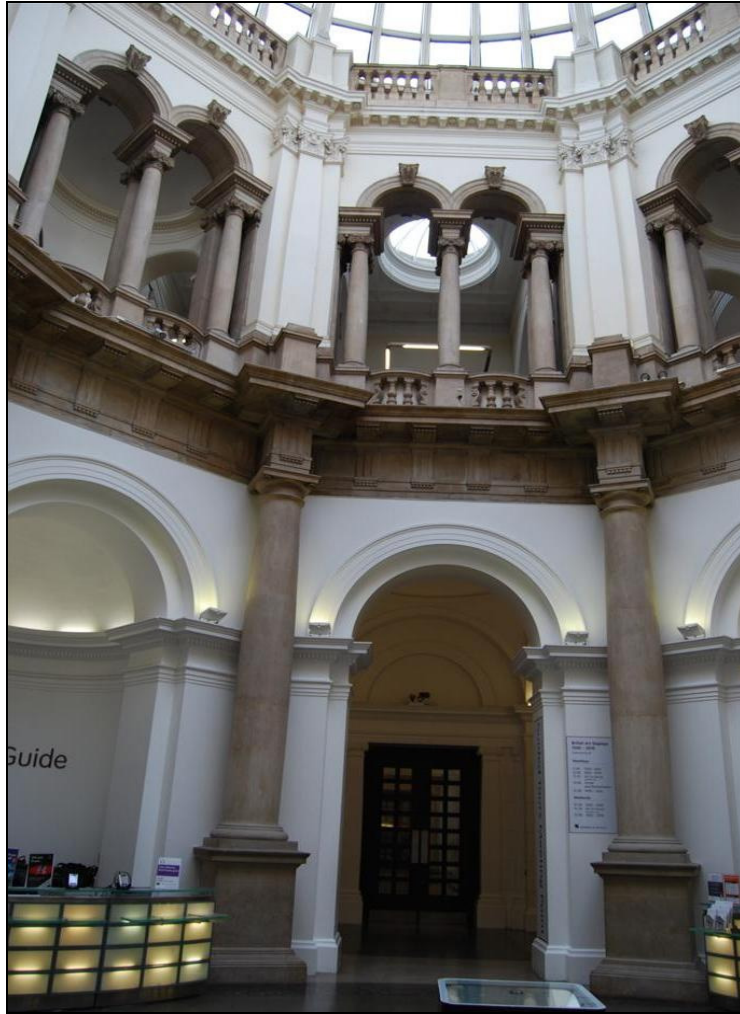
Plate 12: Rotunda

- 6.2.22 The spiral staircase leads anticlockwise to a gallery floor around the rotunda. The cornice at the top of the principal level columns forms the edge of the upper level, which has a low balustrade around it. The eight bays of the octagon are spanned by twin arches rising from three Ionic columns (Plate 12). The arches have a central keystone with a floral pattern. At each corner, square pilasters rise to the base of the dome, with Corinthian capitals. The cornice includes a dentil course, with a balustrade above, before the dome springs curving to its semicircular vault.
- 6.2.23 The dome is formed of eight principal ribs, rising from the corners of the inner octagon, with four common ribs between and regular horizontal glazing bars. The centre of the dome is panelled, with a small lantern above (Plate 13).

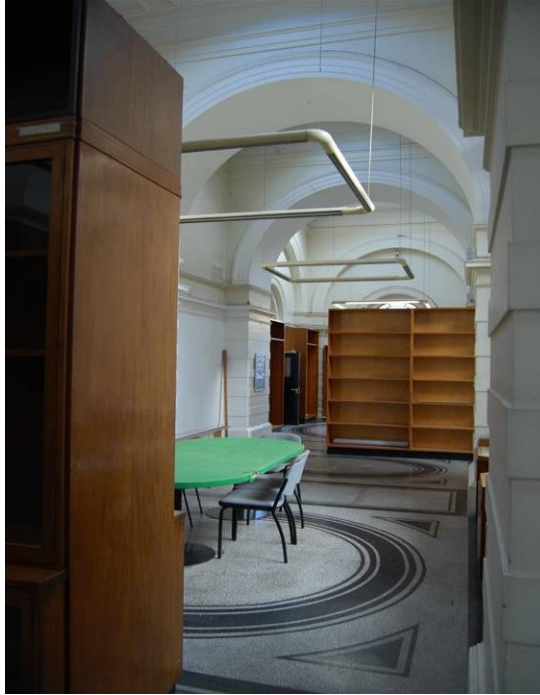
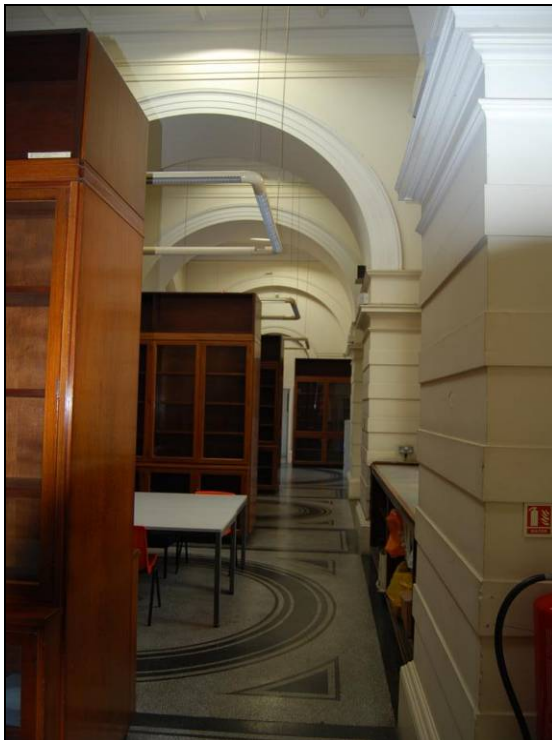
signifier of structural movement (Figure 7). The rest of the Rotunda is in fine condition. There are three bays each side, plus corner bays of this square area. The northeast bay holds the spiral stairs from the principal level, the southeast corner has a meeting room, the other two corner bays have access routes westwards. Each bay is defined by square pilasters with smooth rustication and cornice above, the pilasters against the outer walls and the back of the central void. The floors are polished terrazzo with circular inlays and borders in each bay (Plates 14-16).

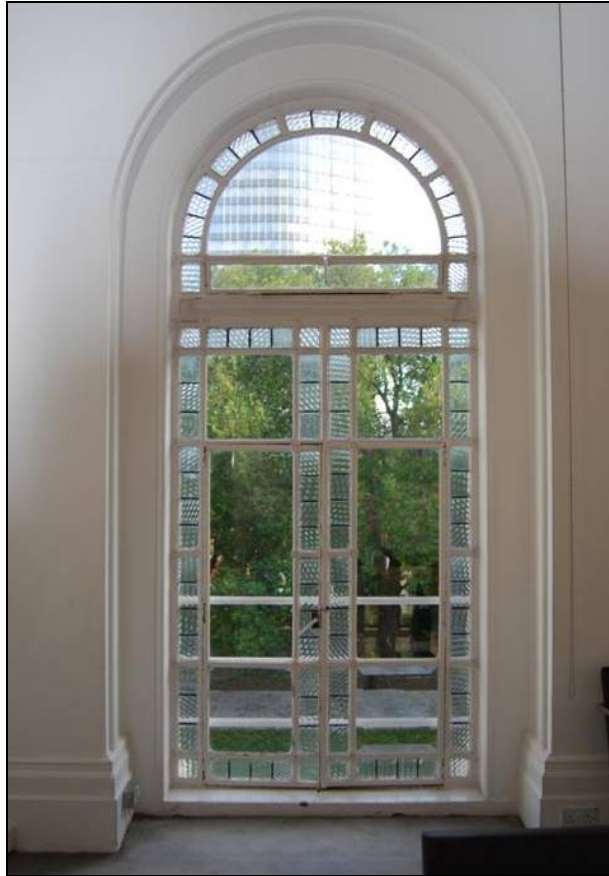
Plate 17: Meeting Room Window, looking East

6.2.25 A suite of rooms above the portico on the upper level were used as the board and meeting rooms and had an associated store, kitchenette and lavatory. This was formerly a single space with two small rooms in the northwest and southwest corners, rather than the group of rooms present prior to transforming the Tate, each formed by board and studwork partitions. The original room had three large walk-in windows facing east, and one large window in the north and south walls (Plate 17). Two smaller windows with splayed reveals are likely to have always been partitioned off. These splayed windows lit a toilet (**Room T1D.09**) and a washroom (**Room T1D.03**). All partitions were removed during refurbishment works, leaving a rectangular room. The main room (**T1D.05**) was in the centre of the suite: this was the Director's room, lit by one of the windows in the east wall, looking towards the Thames. The glazing of the window includes a surround of textured glass; small panes with incised lines horizontally, vertically, or diagonally, which is the same form of glazing present in the stairwell of the spiral stairway to the north. In this window, however, the main glazing is set in vertical units.

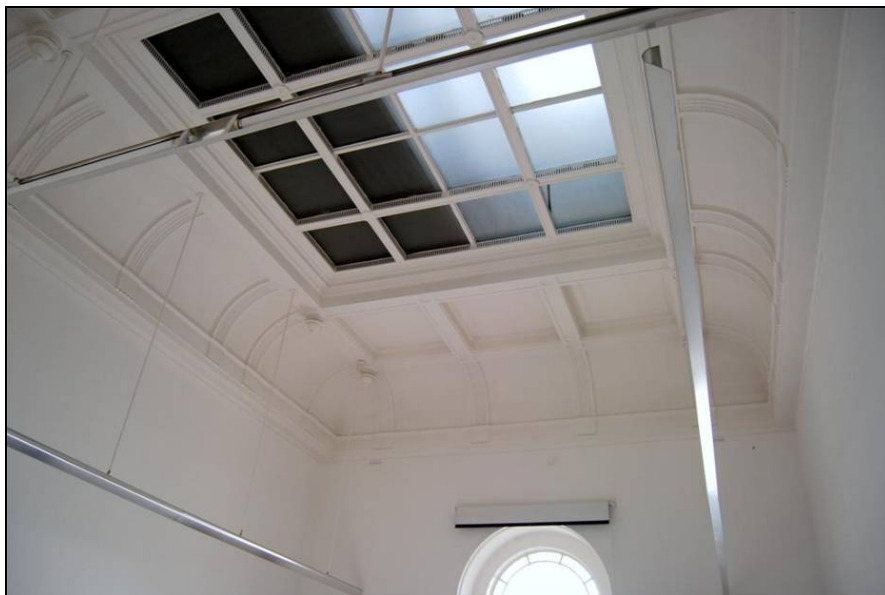
Plate 18: Director's Meeting Room, Pre-works

6.2.26 To the north and south were two meeting rooms (Rooms **T1D.04** and **T1D.10**), with accesses along short corridors from the upper level of the Rotunda (Rooms **T1D.01** and **T1D.09**). Each of the meeting rooms and Director's room had a ceiling with a curved junction to the ceiling, supported by struts (Plate 18). Light panels in the ceiling allow light from a glazed roof above. The struts and ceiling joists are all steel beams.

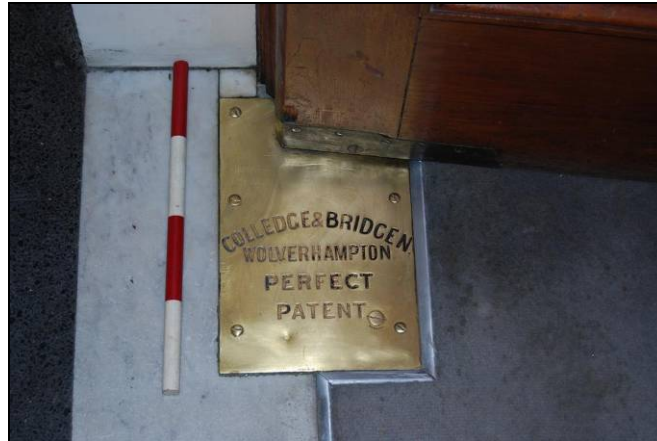
Plate 19: Door Plate to Rooms above Portico

door hangs on three hinges. The doors from the upper rotunda were semi-glazed, with a bevelled glass top panel. These doors were mounted on brass plates in the floor (Plate 19). The plates were stamped with their makers' name: Colledge and Bridgen Wolverhampton, with the phrase 'Perfect Patent' beneath. Brass door furniture with piercing and scrollwork is likely to have been manufactured by the same company. The company was set up by Charles Colledge in 1870, Harvey Bridgen joined in 1876, and by 1914, Whitakers Red Book describes them as lock manufacturers (Graces Guide 2013).

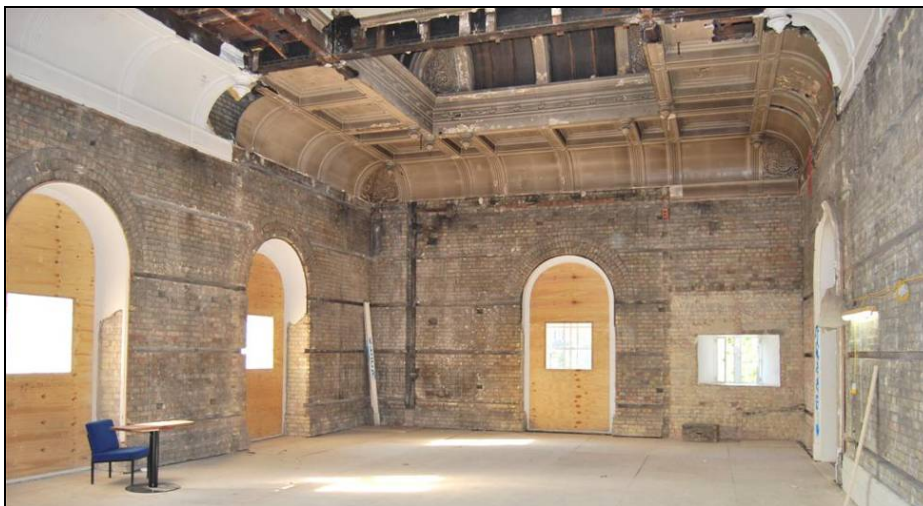
Plate 20: Partitions Removed, Meeting Rooms

- 6.2.29 Removal of the partitions and modern surfaces showed hidden details that had been obscured (Plates 20-22). The details included incised carving on the curved ceiling supports and floral mouldings in the four corners of the single space. The curving walls rise inwards to an inner frame holding a flat ceiling. A secondary raised section is supported by girder trusses with curved struts to a higher level, its inner frame decorated with architrave and a dentil course. Each junction of the principal structural members is furnished (where surviving) with a turned finial. None of this was visible in 2011, when the initial survey was carried out. A door in the west wall, beyond the ceiling, gives access to and from the roof beyond.

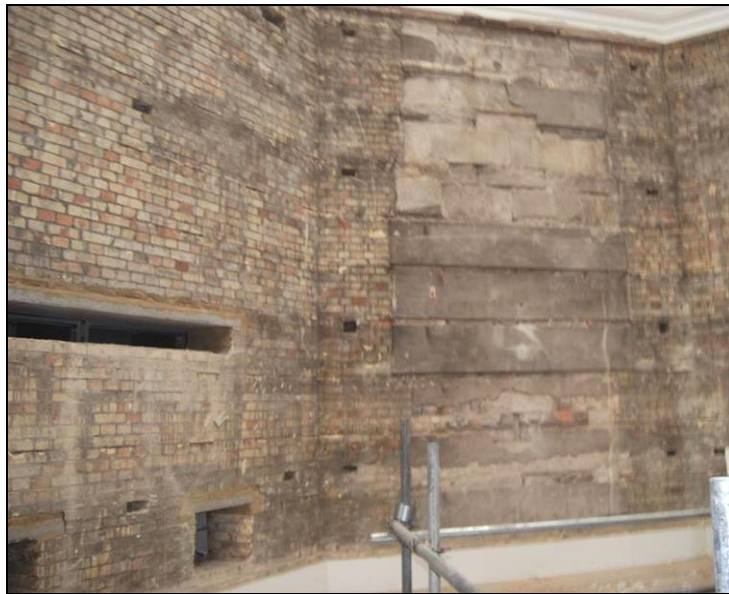
6.3.4 This room was located in the northeast corner of the north group of rooms, and was not specified for recording in the brief. This room most recently was part of the Tate's shop, holding children's books and gifts. Externally square, this room is octagonal in plan, with brick walls forming the angles, behind which run ducts and, in the southwest corner of the room, a spiral staircase to a flat roof above. The walls of the room behind the plasterwork are buff brick in English Bond, and the large arched recesses apparent on the exterior are formed of large intersecting stone blocks 0.56m wide (Plate 23).

Plate 23: Stone Blocks Form the Rear of the Arched Recesses, Room T8P.31

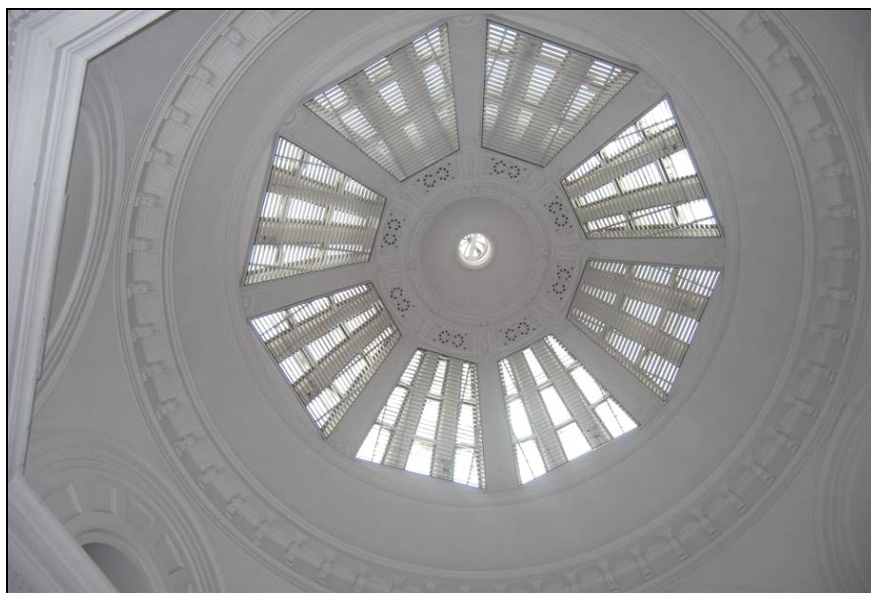
6.3.5 The skirting had a stepped-in ogee mould atop a flat board, and was removed as part of the plaster strip. This was identical to Room 39, giving a feeling of symmetry of construction. The plaster on the room walls was removed, showing it to have been laid over studs across the walls.

Plate 24: Underside of Domed Roof Above Room T8P.31

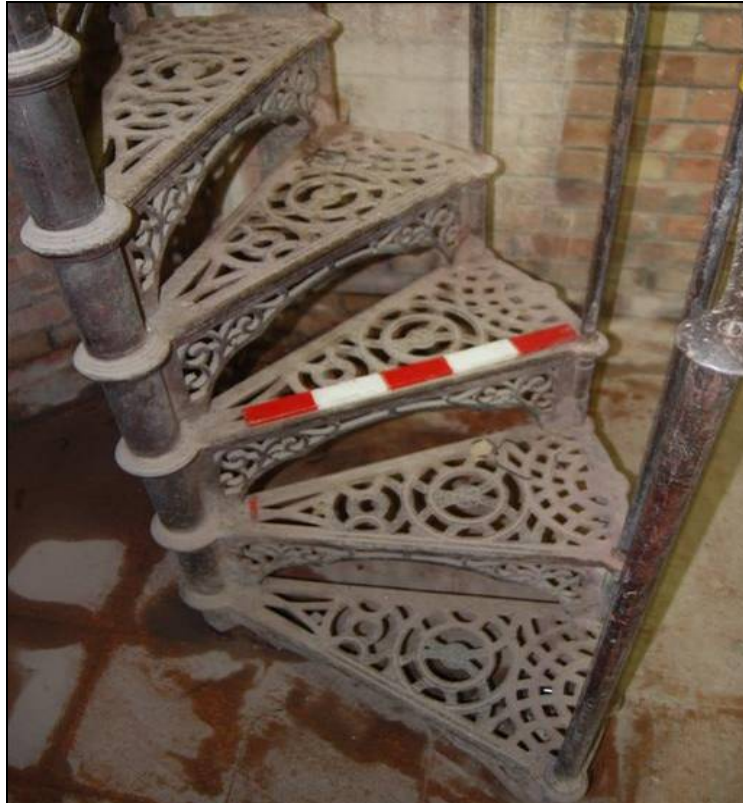
- 6.3.6 The architrave has been retained, which steps out in a series of ogee moulds to the grand decorative ceiling, rising in stages to an eight-sided glazed dome. This continues the stylistic theme of the roof of the rotunda (Plate 24).
- 6.3.7 The spiral staircase in the southwest corner of the room was formed of a series of triangular pierced cast iron treads with composite newel blocks. Pierced risers and side panels are separate units. The treads are pierced with a series intersecting concentric circles, whereas the pattern of the risers is foliate (Plate 25) (Figure 10).

Plate 25: Spiral Stair.

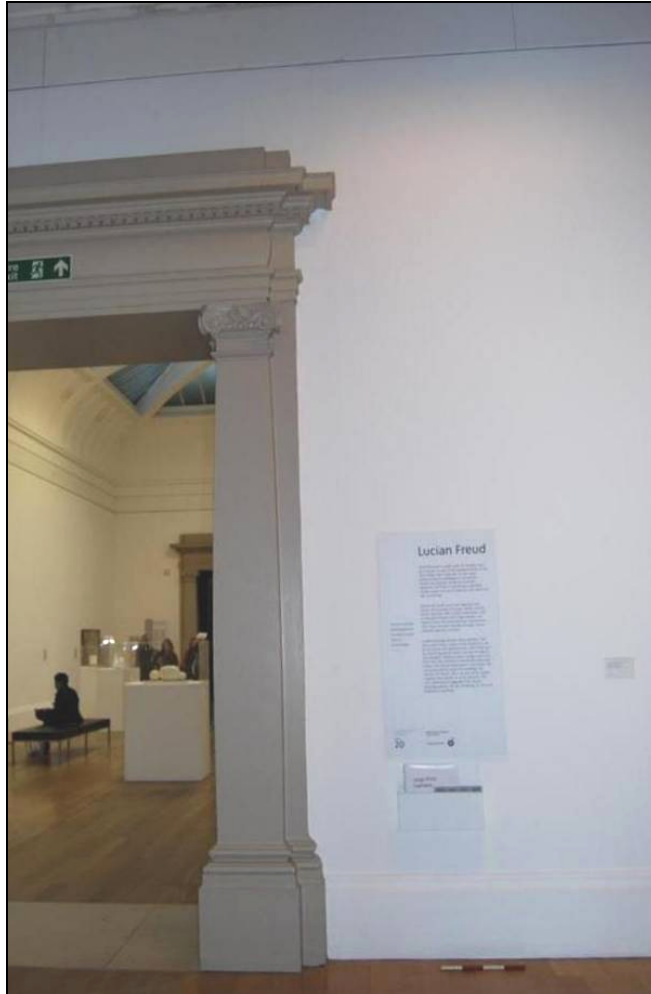
- 6.3.10 The fourth doorway, in the northern wall, is a modern addition added when the gallery was extended in the 1980s. This has a concrete lintel inserted into the regular English bond yellow-brick construction.

Plate 26: Western doorway detail of Room T8P.32

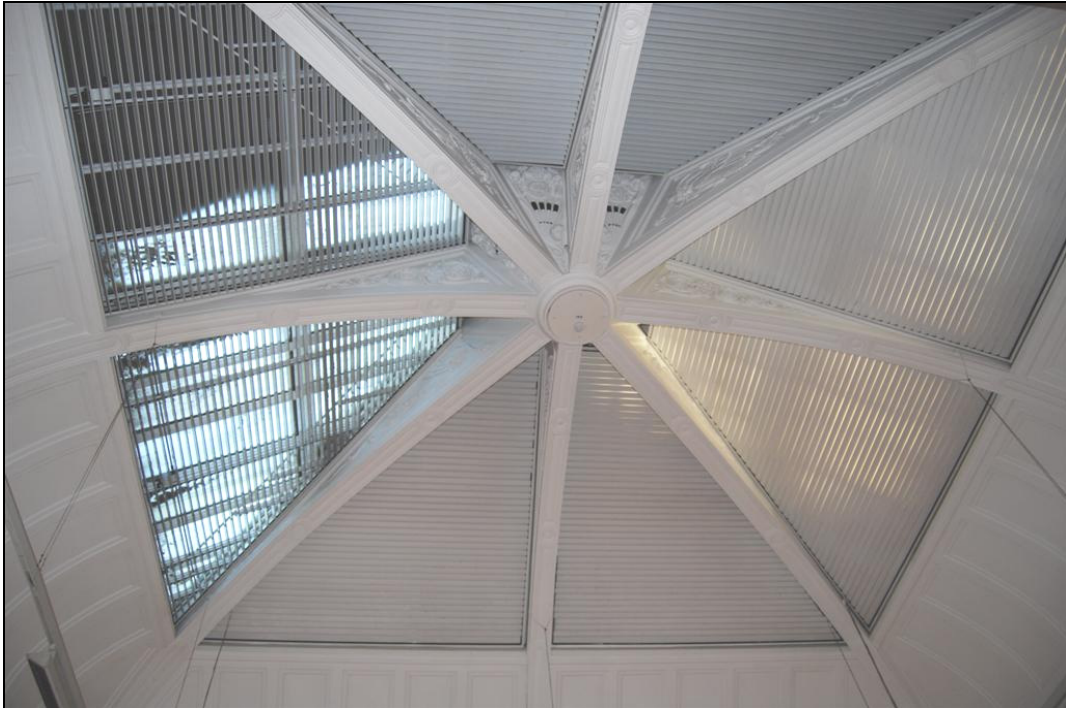
- 6.3.11 Apart from the neo-classical doorways, the most decorative part of the room is the roof assembly, which allows diffuse light into the gallery. The roof assembly comprises four crossing trusses that spring from wall plates, forming a pavilion roof. The trusses are formed of a series of iron girders, boxed in with decorative plaster panels. The trusses rise from the corners and from the middle of the sides. A simple moulded cornice is at the top of the walls, and each of the eight panels formed by the trusses has rectangular plaster panels rising to a purlin, above which is the glazing. The trusses widen towards the centre of the room, and meet at a central circular hub. The underside of each truss is decorated with a series of roundels and rectangular panels. The sides of the trusses are alternately decorated with two different relief-moulded patterns. The trusses that span the corners have panels with winged lions, whereas the trusses from the sides are decorated with floral decoration (Plates 27 and 28).

Plate 27: Overview of Roof Assembly, Room T8P.32

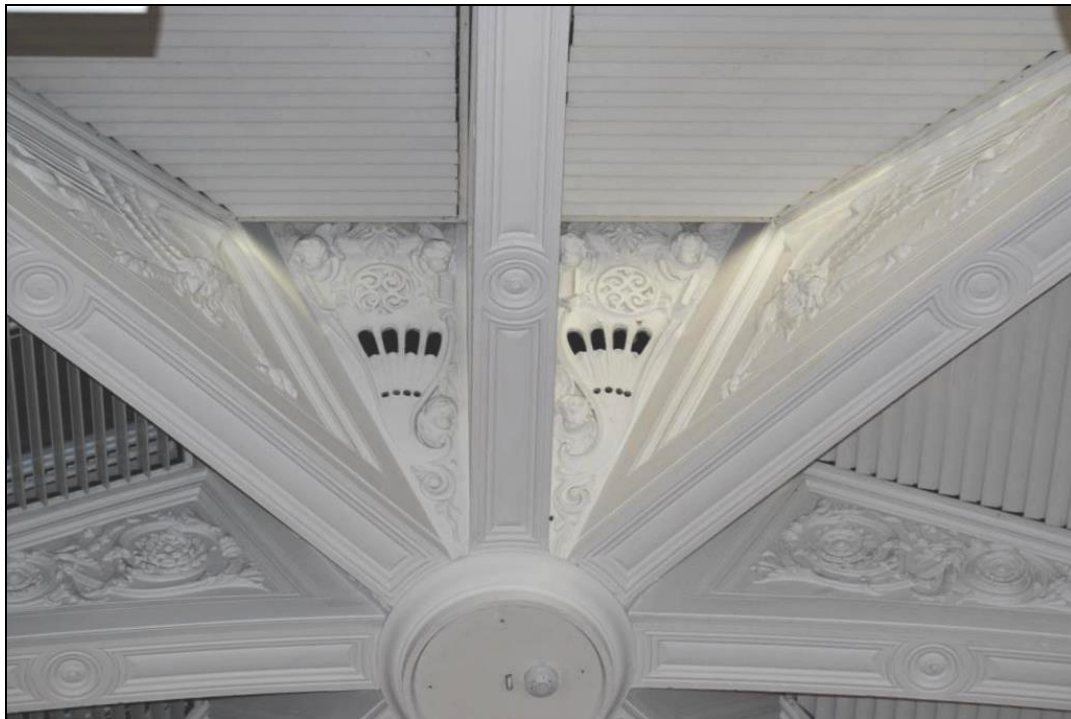
Plate 28: Detail of Moulded Decoration, Roof Trusses, Room T8P.32

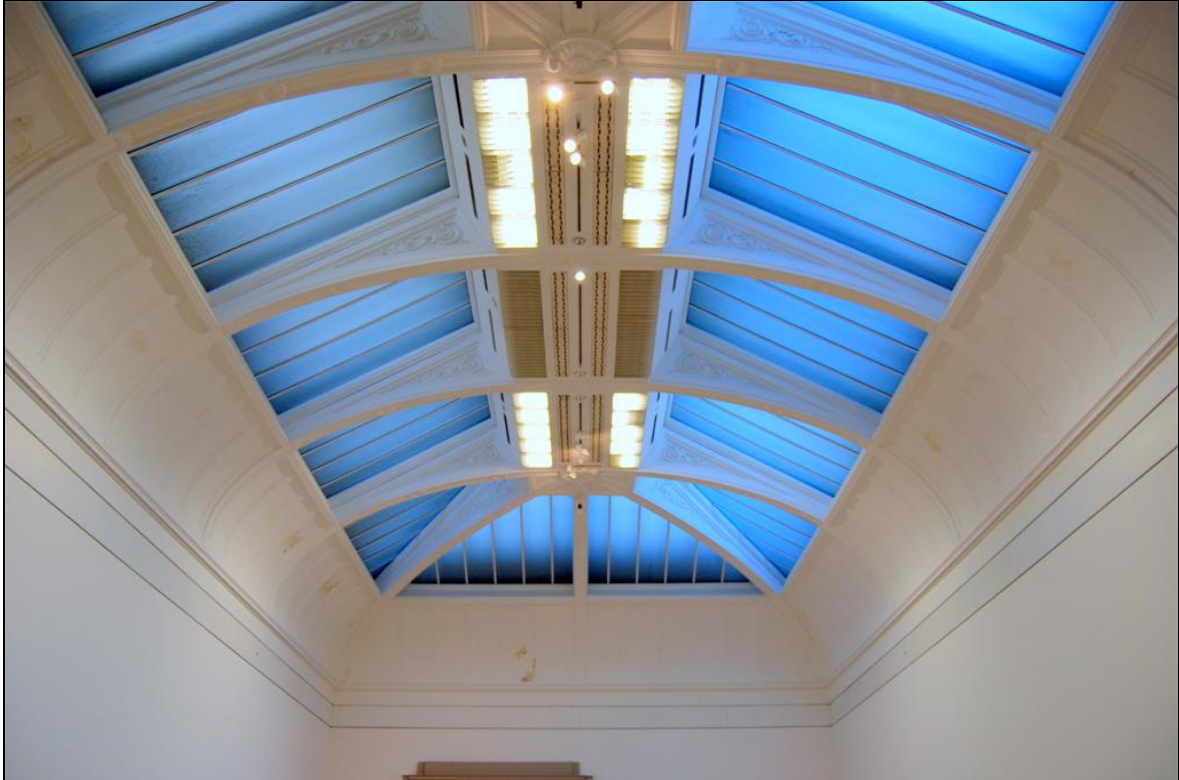
- 6.3.14 The moulded skirting is not like that in any of the other rooms. It comprises a board 0.32m wide, topped by an inset concave mould, stepping in at the top with a wide roll. The doorways of the room have composite neoclassical form, as in Room T8P.32.
- 6.3.15 The base of each of the trusses has an elliptical profile across the room. The lower register of the roof has a series of rectangular panels between each truss, and each truss is decorated with a floral spray within a triangular panel on the sides. The underside of each truss has a series of round cornered rectangular panels with a roundel in between (Plate 29).

Plate 29: Roof assembly, Room T8P.33

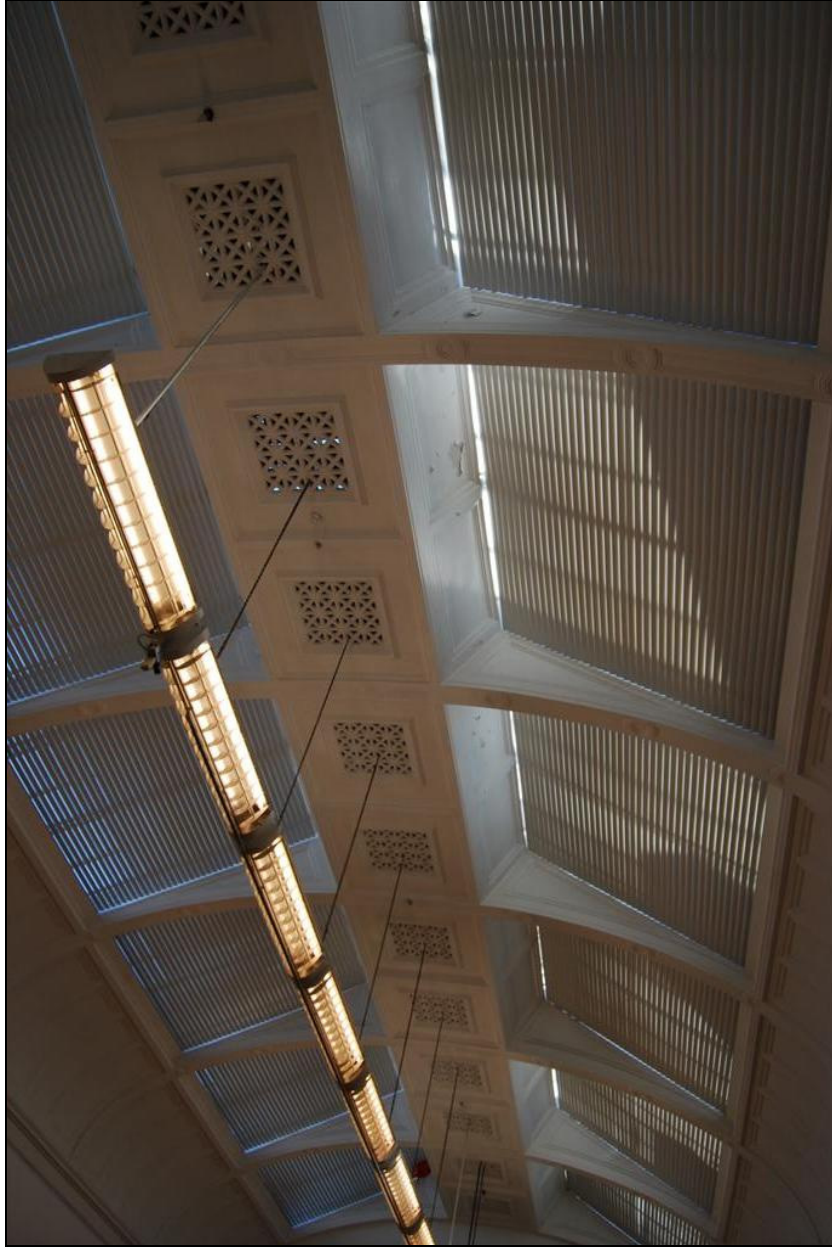
Plate 30; Roof structure of Gallery 35

- 6.3.19 A total of seven roof trusses support the pitched roof, each a composite girder construction with an elliptical underside and a pitched upper edge (Plate 30). There is one truss at each end of the room; five span the rest of the space equally. The trusses are generally plain, with undecorated panels on the sides. This contrasts with the high level of decoration in Rooms T8P.30 to 33. The underside of the trusses are decorated with rectangular panels with rounded corners; roundels separate each panel. The trusses carry a ventilation duct along the centre of the ceiling. There are two square

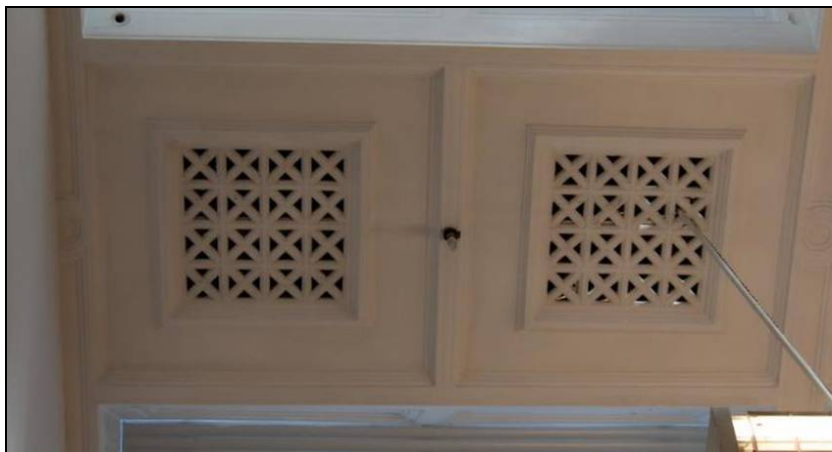
Plate 31: Detail of Ceiling Grills

grilles between each truss for airflow (Plate 31). The lower register of the elliptical roof is spanned by curved rectangular panels above a relatively plain cornice.

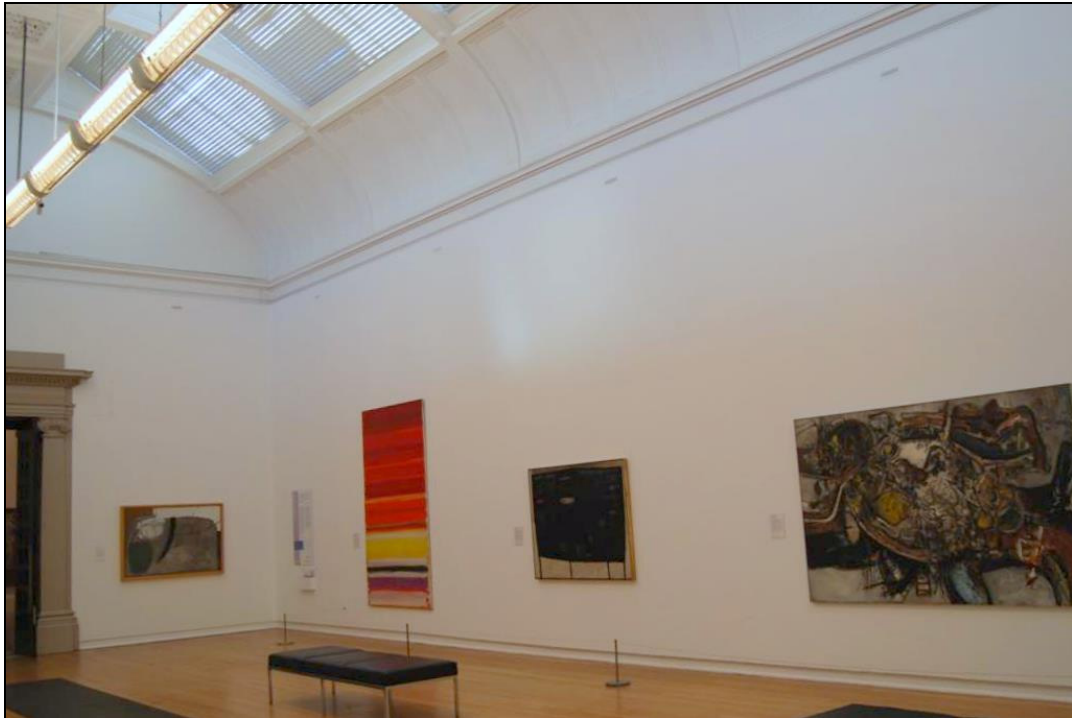
- 6.3.20 The skirting board of the room also differs from that in the eastern galleries, being shaped with a wide roll mould at the base, rising with a board to 0.31m, with a square bead above, and rolling concavely to the wall (Plate 32).

Plate 32: Gallery 35 Looking Northwest
