Tate Britain, Tate Gallery, Millbank, City of Westminster; Report on a Historic Building and Archaeological Watching Brief

Planning Application: 10/0351/FULL, 10/02946/LBC, 10/02945/FULL

AOC Project No: 30855

Date: July 2013

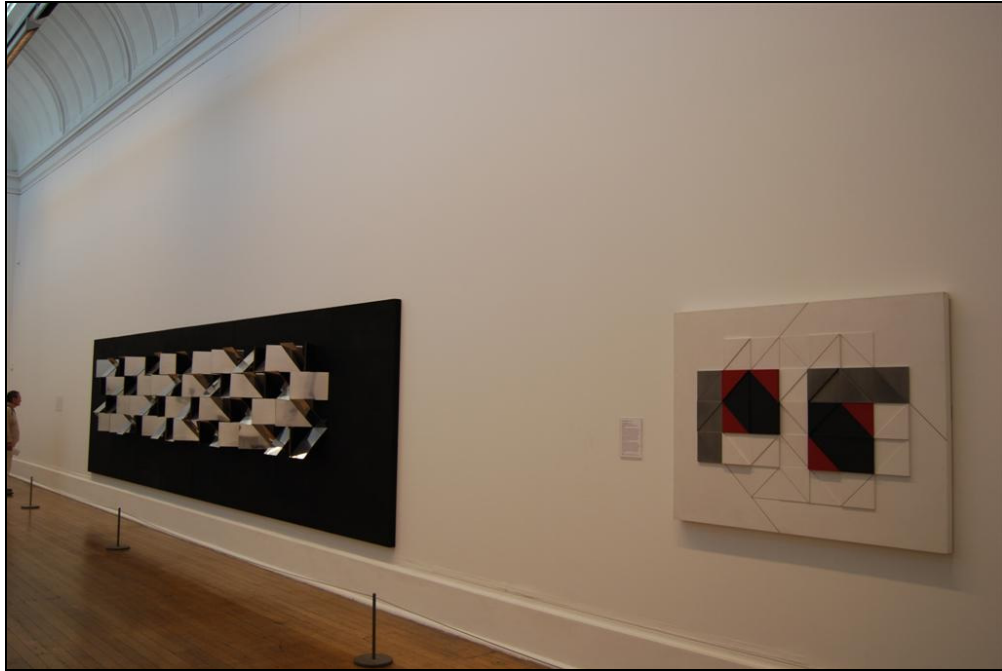
Plate 33: Wall of Gallery 36.

- 6.3.22 South of Gallery 35, Room T8P.36 is known as Gallery 36. The room is oriented north-south, measuring 19.4m by 9.6m. The room is constructed in the same way as Gallery 35 with the same fittings of skirting, shaped with a wide roll mould at the base, rising with a board to 0.31m, with a square bead above, and rolling concavely to the wall (Plate 33).

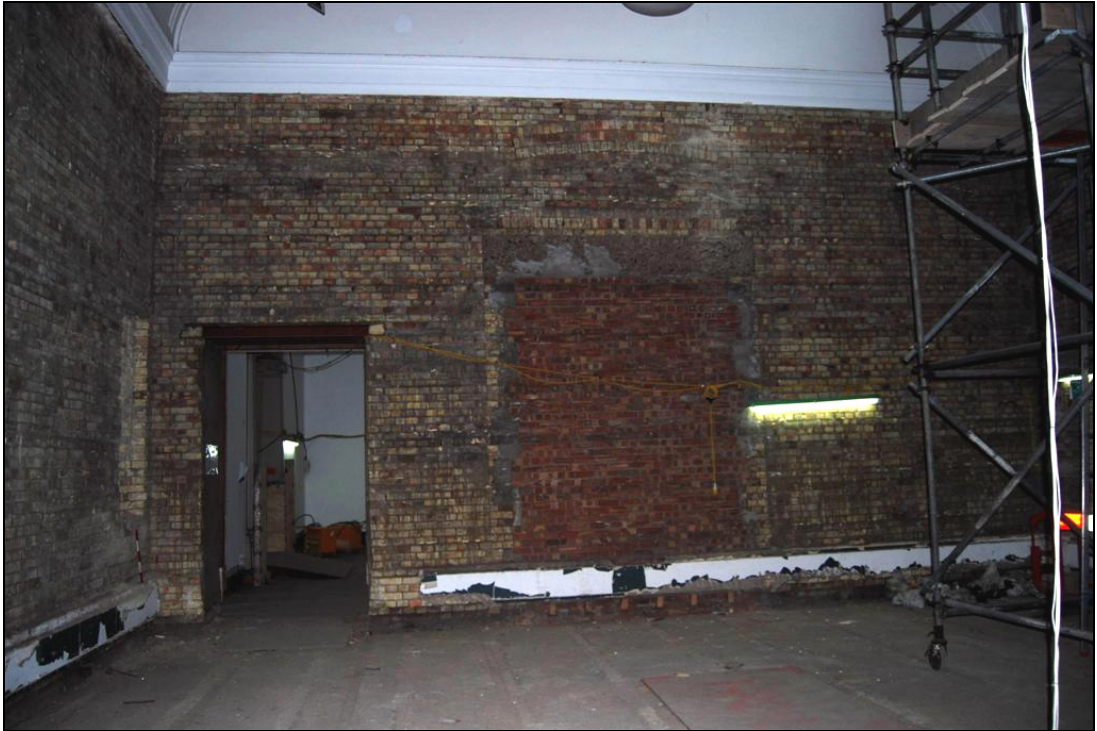
Plate 35: Original Doorway , North Wall of Gallery 36

- 6.3.23 The room contains a neoclassical doorway to the south, whereas the northern entrance is a narrow opening with no moulding. This is an alteration to an original layout, with a central doorway now blocked with red brick. A scar in the brickwork shows it to have had a pedimented lintel and a relieving arch built into the brickwork above. The roof construction is also identical to Gallery 35, comprising a series of girder assemblies with a pitched top and elliptical underside. The panels in the sides of each truss are plain, and the underside decorated with round-ended relief panelling and roundels, and an identical roof construction and décor. The plainly decorated trusses and panels are all present (Plates 33 to 35).

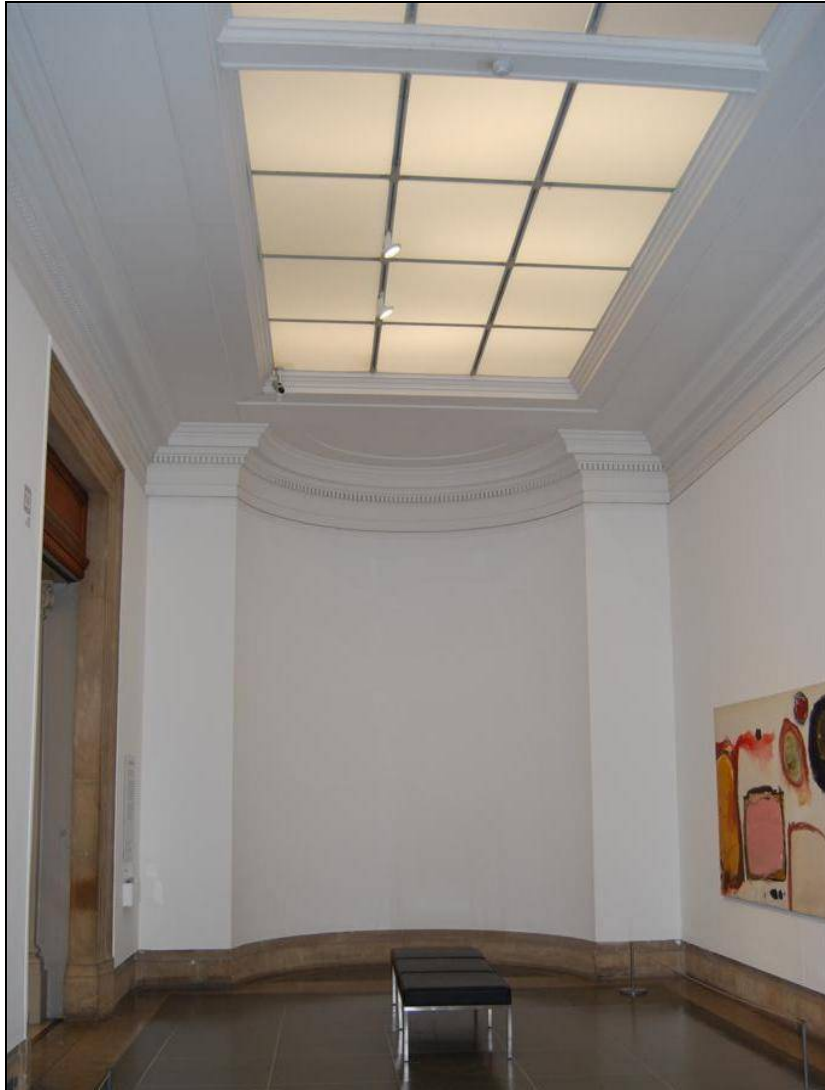
Plate 36: Gallery 37 looking west

- 6.3.26 Room T8P.37 lies south of Galleries 36 and 38, and has apsidal ends formed from a lightweight, single-brick thickness wall inset within the room's basic structure (Figure 8) (Plate 36). The skirting is simply painted on the wall sides, and is not raised in any relief. The walls are plain, and rise to a flat ceiling with a decorative cornice. The cornice is has elements of neoclassical entablature: at the base is a moulded architrave, with a plain fascia above. Above this is a square dentil course, topped by a four-section rounded cornice.
- 6.3.27 Light to the room is artificial, the lights behind opaque ceiling panels suspended beneath a concrete panel floor above. The light panels are supported on a lightweight frame (Plate 37).

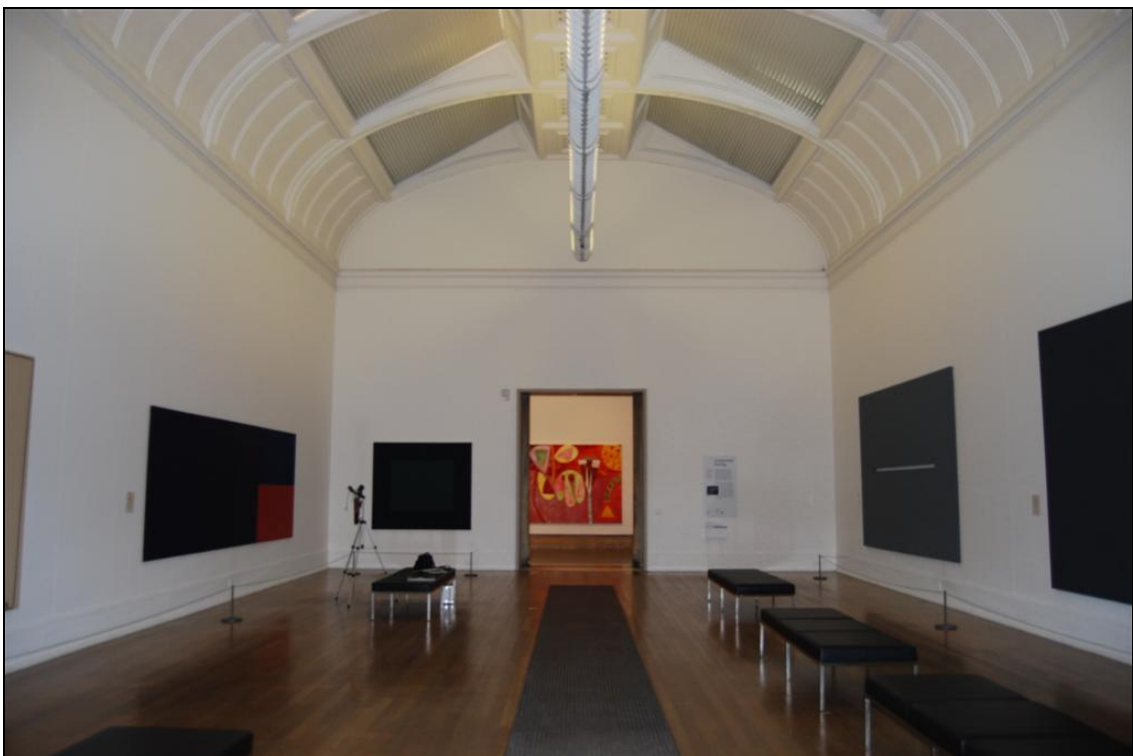
Plate 38: Gallery 38, Looking South

6.3.28 Gallery 38 is the same size as Gallery 36, and located immediately west of it (Plate 38). Doorways in the north and south ends of the rooms are furnished with the neoclassical porticos typical of this

entire part of the gallery. The room measures 19.4m by 9.6m. The room is constructed in the same way as Room 35m with the same fittings of skirting shaped with a wide roll mould at the base, rising with a board to 0.31m, with a square bead above, and rolling concavely to the wall.

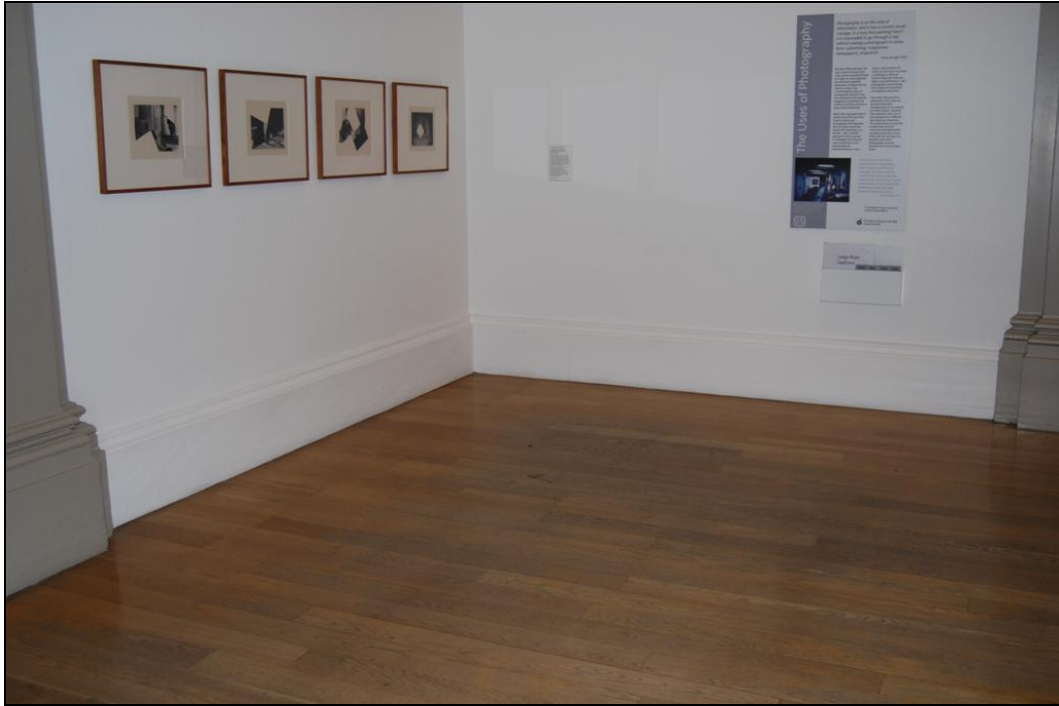
- 6.3.31 The northwestern of the suite of rooms is Room T8P.39, known as Gallery 39, and the end room of the north side of the gallery before it was extended westwards. Two of the three doors in this room have neoclassical porticoes: those in the east and south walls. The third doorway, leading west, is a plain opening with no architectural elements.
- 6.3.32 The room is skirted with a board different to all the other rooms of this northern side of the gallery: it is 0.3m high, with an incised ogee mould above. Its presence may indicate that this room had been redecorated, possibly when the new doorway westwards was added (Plate 39).

Plate 39: Gallery 39, Detail of Skirting and Doorframe Plinths

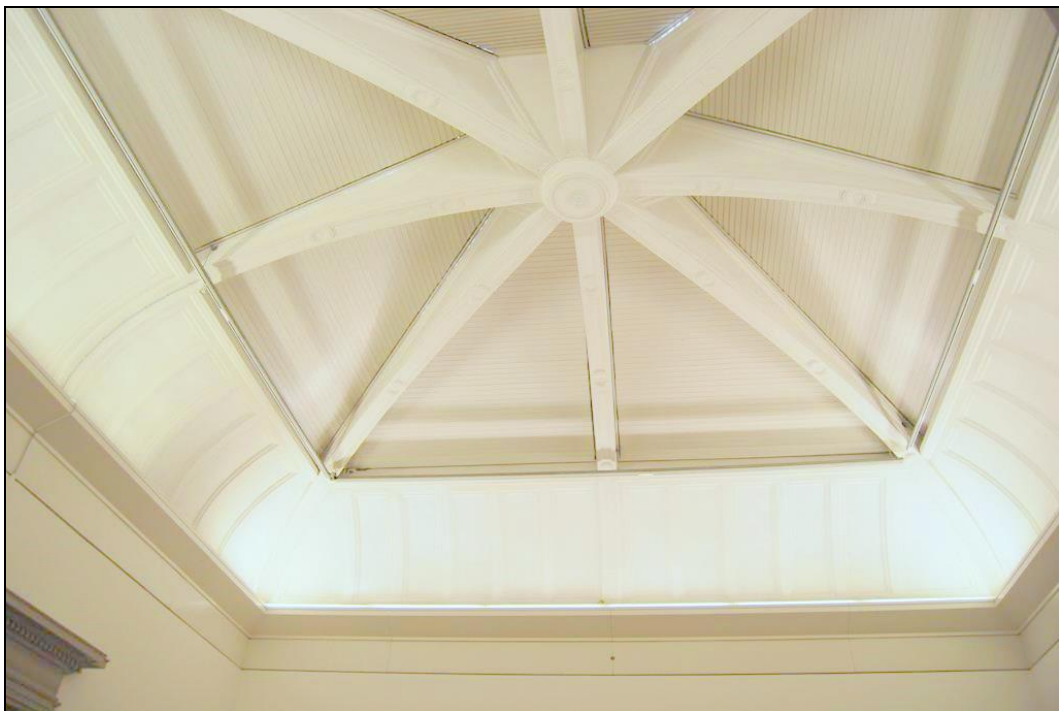
- 6.3.33 Apart from the neo-classical doorways, the most decorative part of the room is the roof assembly, which allows diffuse light into the gallery. The roof assembly comprises four crossing trusses that spring from wall plates, forming a pavilion roof. The trusses are formed of a series of iron girders, boxed in with plaster panels. The trusses rise from the corners and from the middle of the sides. A simple moulded cornice is at the top of the walls, and each of the eight panels formed by the trusses has rectangular plaster panels rising to a purlin, above which is the glazing. The trusses widen towards the centre of the room, and meet at a central circular hub. The underside of each truss is decorated with a series of roundels and rectangular panels. The sides of the trusses are plain, consistent with Rooms T9P.35, 36 and 38 (Plate 40).

Plate 40: Gallery 39, Roof Detail

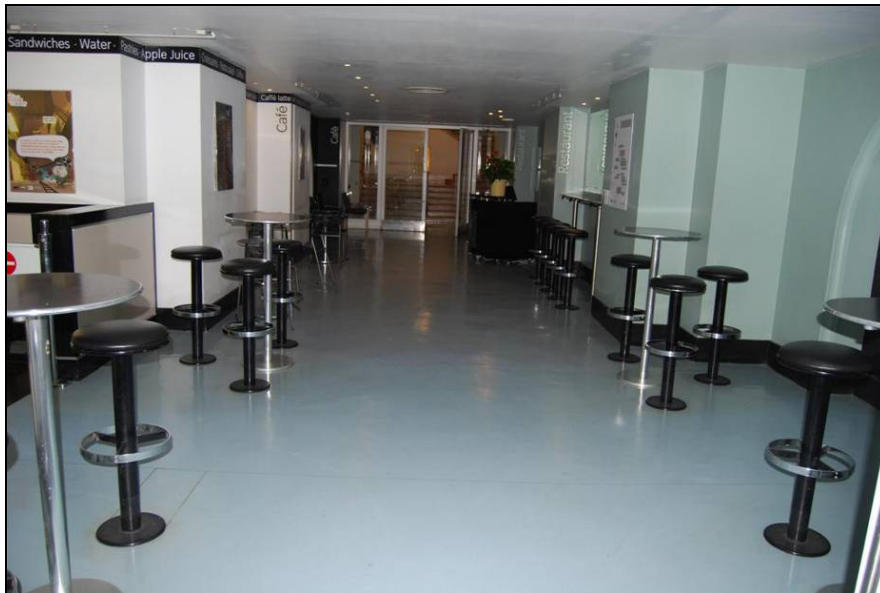
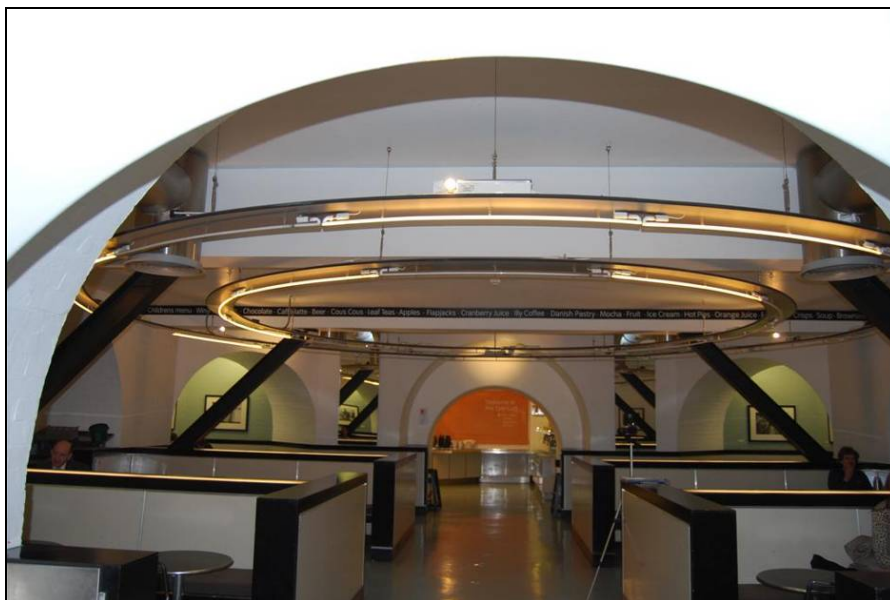
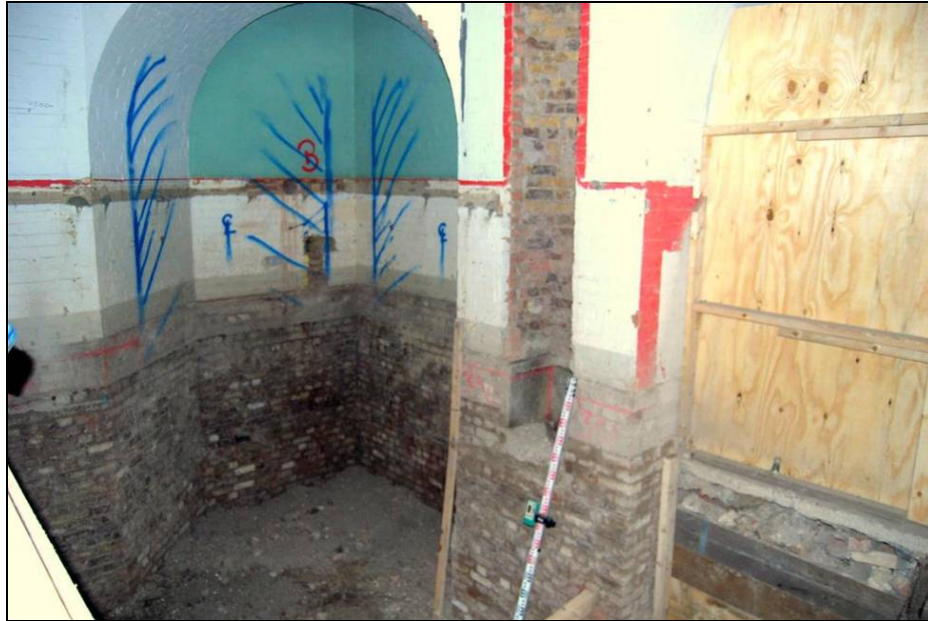
6.3.1 The largest of the rooms on the ground floor prior to the transformation of the Tate is the Café, located on and around the base of the Rotunda (Plates 41-43). This space featured food preparation areas, food serving counters, and seating within the central structure of the Rotunda. The main structural brick piers, when used as a café, were plastered with low arches spanning the main structural parts. These have been removed, and it became apparent that the arches were insubstantial in comparison to the main supports. The central Rotunda area is crossed by two axial passageways, with alcoves in the corners. These alcoves had steel girders spanning the angles.

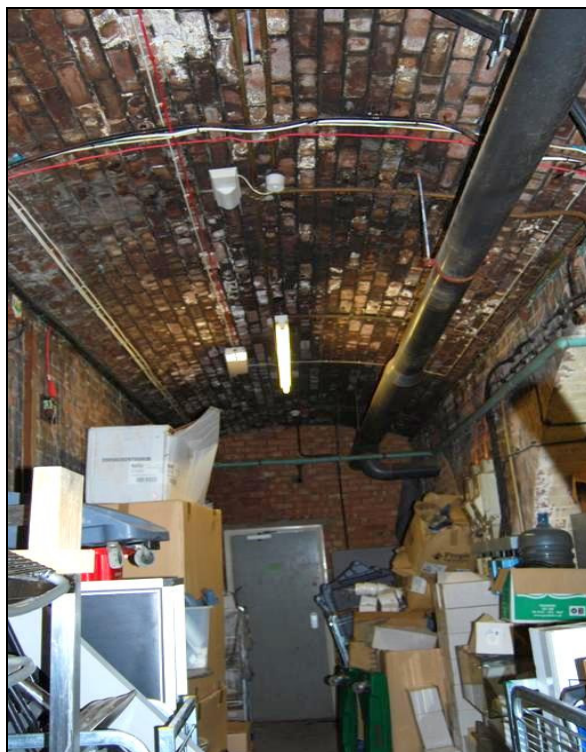
Plate 44: Storage Area with Stores.

- 6.3.2 To the east of the Rotunda base, under the portico, until 2011, were toilet facilities for visitors (Figure 11), both occupying rooms of roughly 54 sqm (Rooms **T1G.8** and **T1G.16**). With modern surfaces and fittings, these were of low historical and architectural interest. A photographic record was made. Both rooms had storage areas beyond, lying beneath and behind semi-circular stone clad bays (Rooms **T1G.8.1** and **T1G16.1**). These two small rooms were both lit by iron-framed arched windows that typify the fenestration of this lowest level.
- 6.3.3 Beneath the entrance steps was a further group of rooms used as storage areas, also accessed from the east edge of the Rotunda (Plate 44). This area was unplastered, with bare brickwork visible, and generally packed with stores and equipment. No significant architectural remains were observed (Rooms **T1G.9-15**).

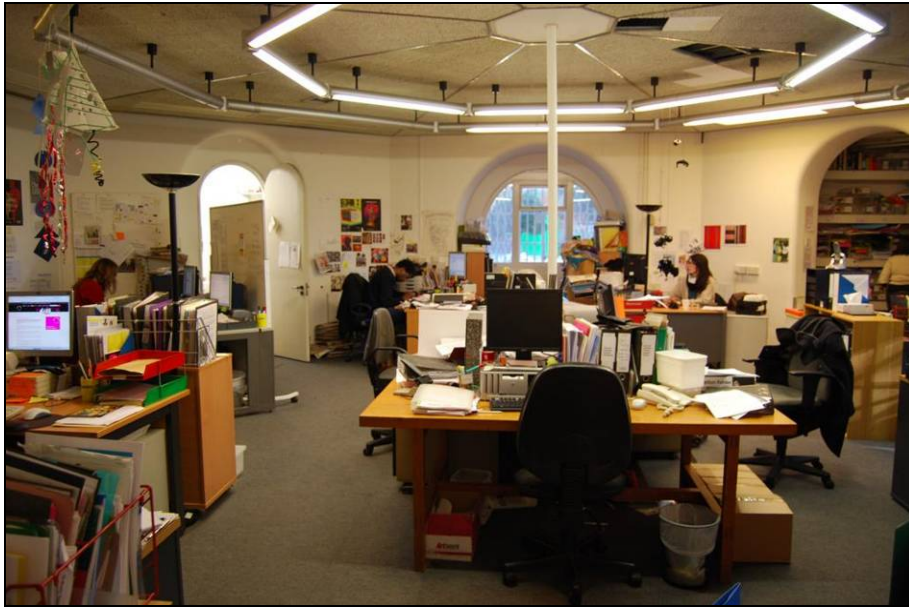
Plate 45: Room T8G.8.5, looking North

- 6.3.4 Other work was carried out in six partitioned rooms beneath Galleries 30-35. The northwest room (Room **T8G.8.5**) is an octagonal space within a square block, with cupboard space behind three of the angles in the corners (Plate 45). The fourth corner, in the southwest, contains a metal stair that winds anticlockwise to the top of the gallery. This has since been removed. The room was recently used as part of the education department of the gallery. No new information was observed during a strip of the surfaces.

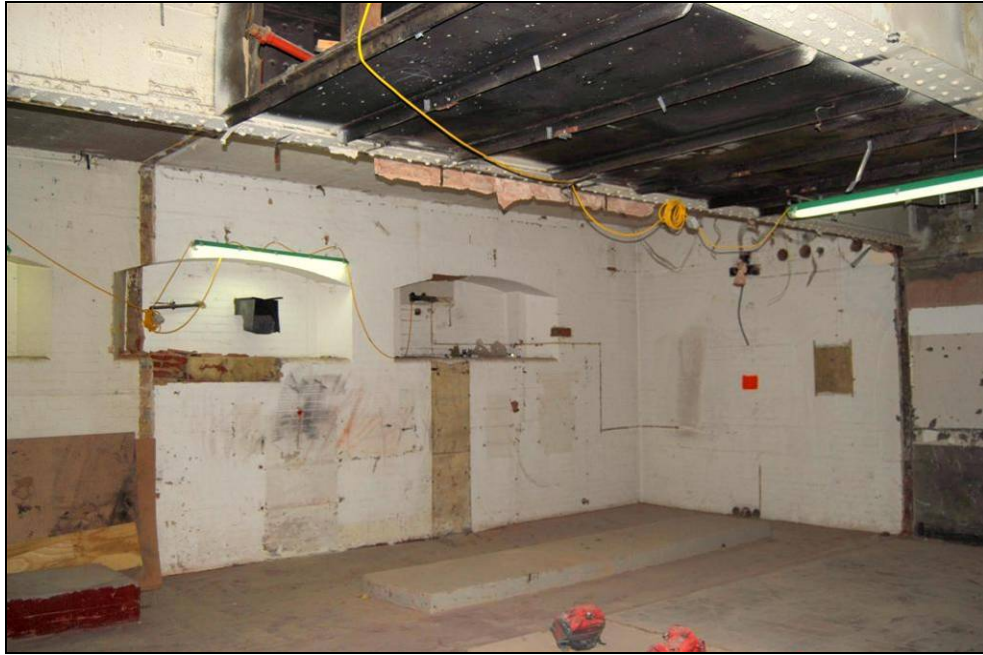
- 6.3.6 West of this, a room beneath Gallery 33 (Room **T8G.8.11**) revealed one blocked doorway with a flat lintel, and three blocked windows with wide eastern reveals in the west wall, The bricks used in the blocking were of general 20th century date, and cannot be further dated. In the room north of this, formerly a second suite of toilets (Rooms **T8G.8.6-8.10**), three further windows with splayed reveals were recorded in the western wall (Plate 46). This is part of the initial, 1897 construction of the gallery. In the north wall are three blocked arched windows, of dimensions consistent with the windows on the east front at this level. These were blocked, presumably, when the gallery was extended northwards in 1987.

Plate 46: Blocked window in room T8G.9

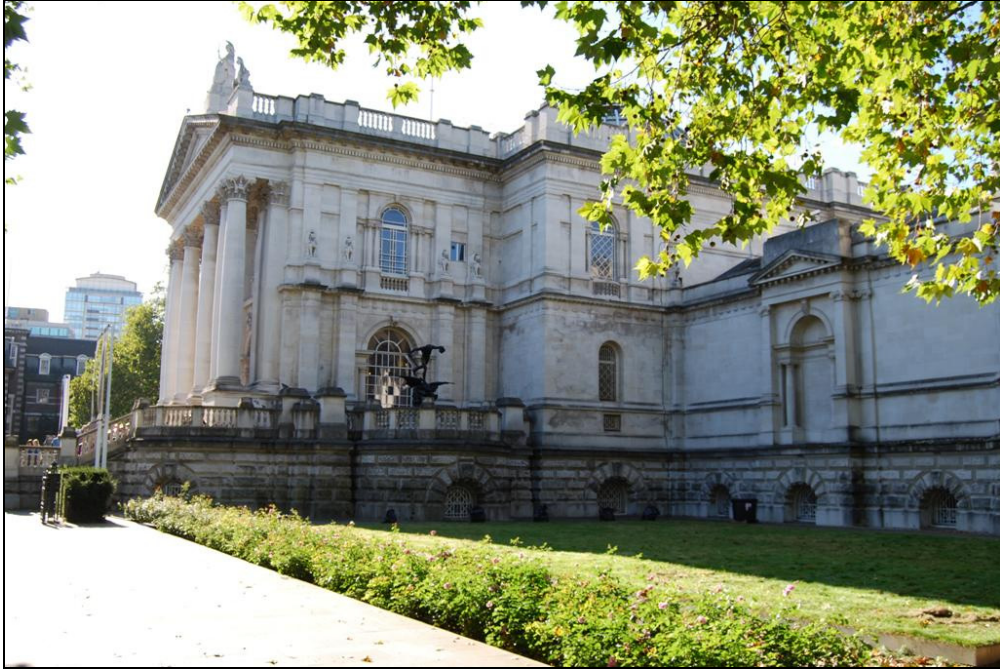
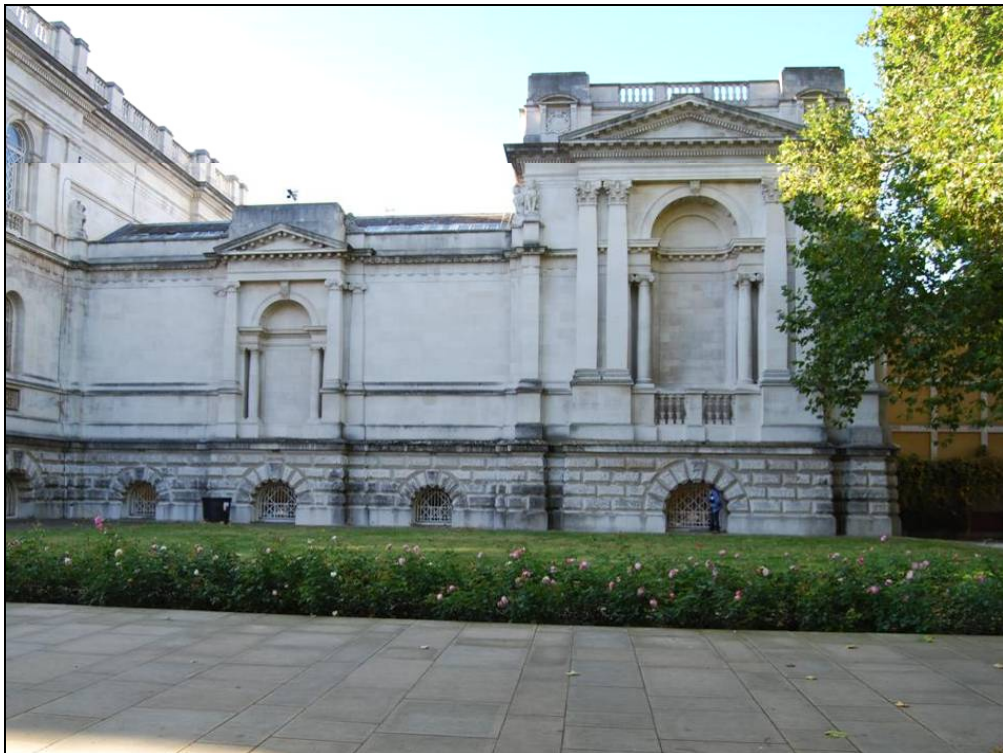
6.3.9 Part of the transformation works involved reducing the ground outside the north part of the east front, altering windows to become doors to provide plant access during the works. The ground reduction enables ramp access into the lower level. The external detail of the ground floor windows and their setting was surveyed, photographed and drawn (Figure 12). The materials and style of the elevation is consistent around the steps, the sides of the portico, and along the east face of the Tate, and is all part of the first phase of 1897 (Plates 47-48).

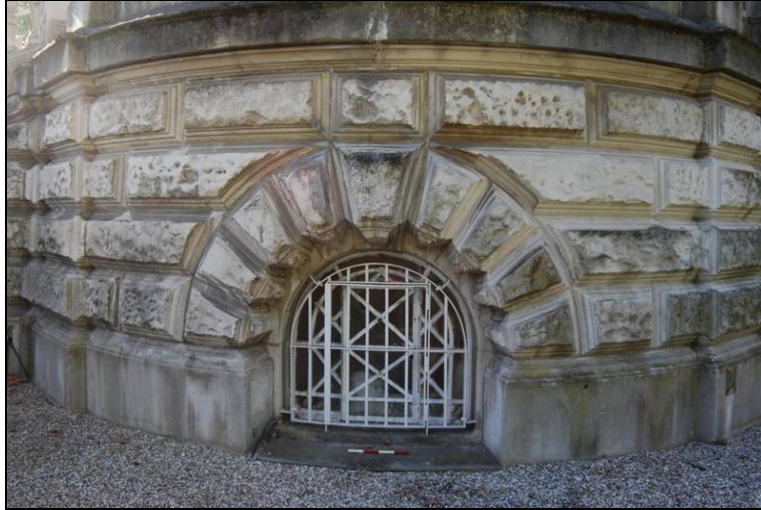
6.3.10 The lower parts of the wall are brick, with facing blocks of Portland stone above ground level (Plates 49-52). At ground level, a wide plinth is the lowest course, surmounted by four courses of cyclopean rusticated blockwork. These are probably not rough hewn, but skilfully cut to appear so. The windows on the ground level have their sills flush with the ground surface outside; the internal floor was 1.06m lower than the sill in 2010. The floor has since been lowered.

6.3.11 Each window setting has the same form: rusticated voussoirs and a keystone form stilted arches in which the window is set. The edges of the voussoirs are moulded with ogee and roll moulding, with a resultant saw-tooth effect around the arch. Each window has an outer glazed border with metal glazing bars, and inner triangular and square panes fill the arch. Windows have various casements set in them, missing glazing bars. Each junction of glazing bars is decorated with a cast rose stud 42mm across

Plate 49: Window Detail to Room T1G.16.1 Type D

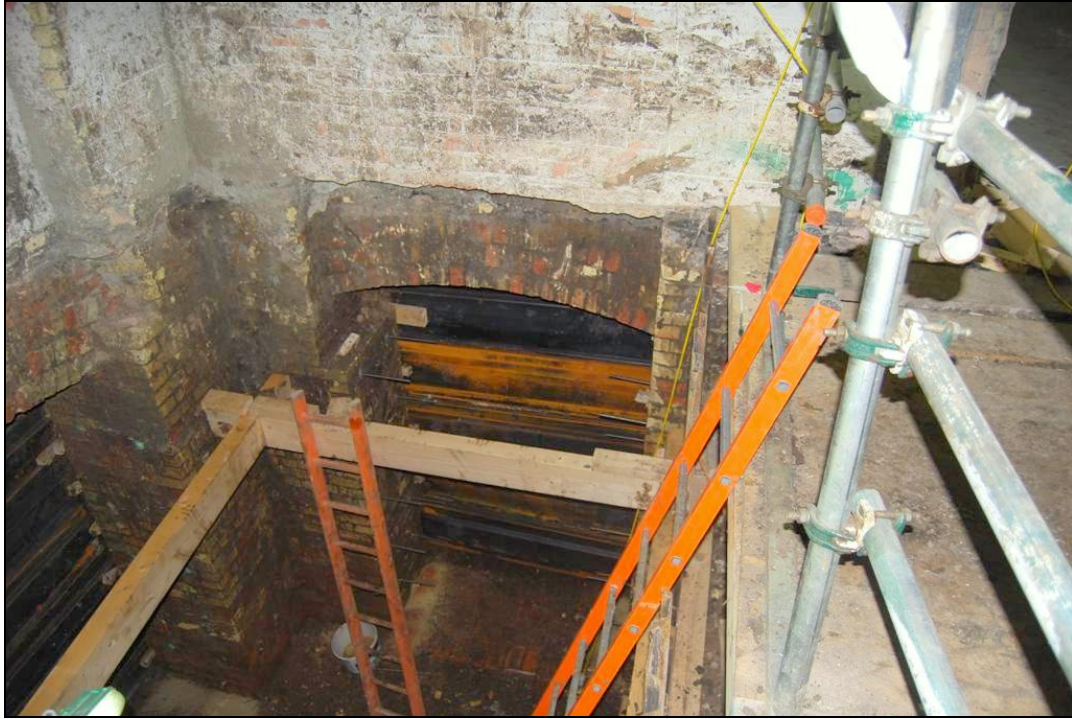
- 6.4.3 The rubble layer was cut by a construction trench [3] for the walls of this part of the Tate. The sides of the cut were steep, at c. 75° to a depth of 3.5m (-0.65mOD), and the walls built within them have a stepped foundation course before the body of the walls rise to the ground floor and beyond. The north and east walls of this room are constructed of yellow bricks measuring 230mm by 110mm by 70mm, bonded with cement mortar and laid in English Bond. The walls are 0.80m thick up to floor level. The structure is given reduced weight and additional strength by the use of segmental brick relieving arches (Plate 53). The eastern wall [2] has six relieving arches [10, 11, 13, 15, 16 and 24]

and the north wall [5] has one (14). The construction trench and voids beneath the arches were filled with mixed mottled greyish brown clayey silt containing lenses of bluish grey silty clay and blocks of rubble (4). The backfilled construction cut was sealed by a layer of rubble up to 0.45m thick (6), which was effectively no more than a layer of hardcore for a concrete slab that formed the floor of the room (1). This slab lay at 3.04mOD.

Plate 53: Excavation of Trench 4

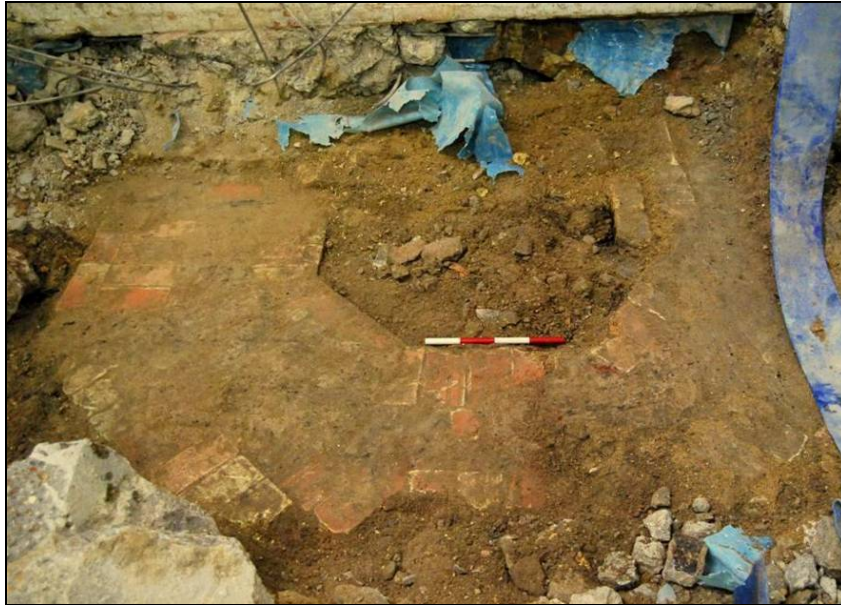
- 6.4.19 The soil horizon (910) and concrete footing (912) were cut by a foundation trench for the east wall of Room T9G.3 [915] and an associated chimney base [920]. The base of the cut lay deeper than the extent of the groundworks, and was not seen. The edge of the cut lies up to 1.00m west of the wall; like the walls of the room, this wall was in yellow bricks, measuring 230mm by 110mm by 70mm, laid in English bond and bonded with cement mortar [914]. The construction trench was filled with uncompacted mixed brown silt and clay, with occasional brick inclusions (916). In the southeast corner of the room was a polygonal brick structure extending 2.4m from the wall and bonded to it, thus indicating contemporaneity. This was the base of a chimney [902], and had a flue continuing eastwards for 2.7m before terminating in brick blocking (Plates 54 and 55). The base of the structure measured 2.4m by 2.6m, and it stepped in at 1.58mOD to measure 2.40m by 2.00m. The sides of this sub-octagonal chimney base then rose vertically to a flat truncation at 2.42mOD, which is the surviving height of the brickwork. It was constructed of red and cream-coloured bricks measuring 220mm by 110mm by 60mm, bonded in English bond with a grey sandy mortar. After construction, the cut was backfilled with, firstly, a fill of dark grey sandy clay silt (905) and then a fill of greyish brown clayey silt above (904). The walls surround a flue that leads in from the east; the flue is 1.10m wide, the walls of the base up to 0.80m thick around it. As the flue runs under the wall, it has a vaulted brick ceiling, the arch formed of two courses of brick. The flue is 1.5m high, and the floor is brick. An additional skin of bricks [911], weakly cemented, lines the flue. There were two deposits within the flue. The lowest fill was soot (906), and was 0.4m deep, proving this had been a chimney. The secondary fill was mixed brown sandy clay with brick rubble inclusions (903), a general post-demolition backfilling event.

Plate 54: Base of Chimney

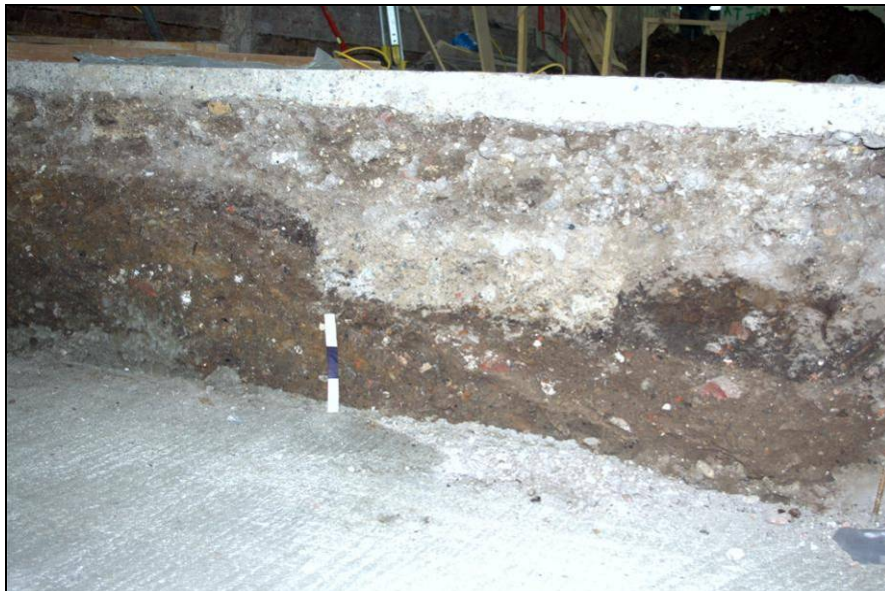
Plate 56: Truncated foundation (1005) in Room T8G.

- 6.4.24 There were no horizons that could be proved to be surfaces associated with the penitentiary, nor brickwork that could be part of the foundations. The truncated mortar footings and made ground (1008) were sealed by a layer of loosely compacted brick and mortar rubble (1007) that was up to 0.35m deep, and probably derives from the superstructure of the penitentiary. This demolition horizon was cut by the construction trench for the Tate Gallery [1002], that was backfilled with loose mixed greyish brown sandy silt and rubble (1001). An additional cut in the centre of the room [1004], held a concrete strip foundation (1003) which supported iron columns that supported the floor above. The sequence was sealed by concrete (1000) that formed the floor of the Tate. This was 0.54m thick.

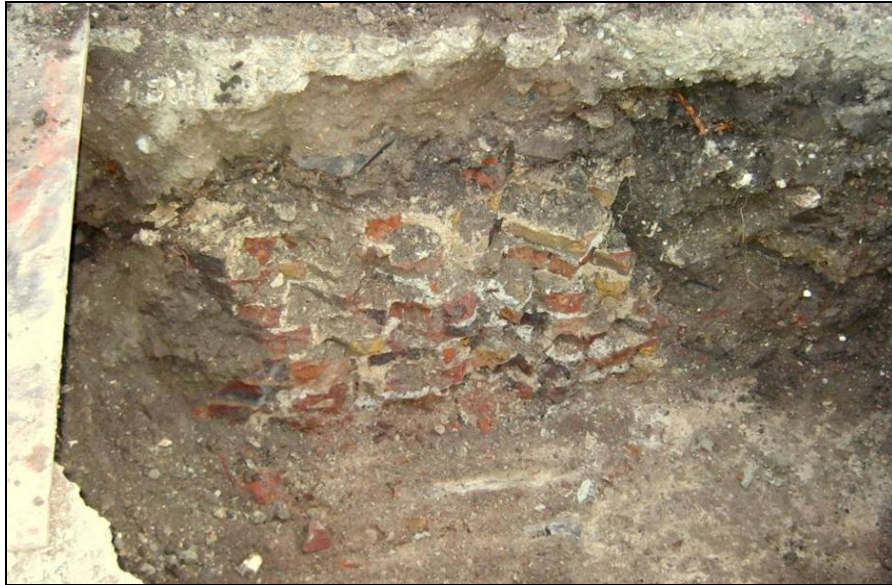
- 6.4.29 The earliest archaeological feature seen in this area was a brick wall or footing 0.70m wide [1302] (Plate 57), constructed of fine-grained red and yellow bricks measuring 230mm by 110mm by 65mm, and built in English bond with a sandy cement mortar. Its surface was at 2.18mOD, and was seen for a depth of 1.16m, and is still preserved beneath the impact of the new layout, except were cut by services trenches to 1.02mOD. This is a substantial foundation, and the orientation and mid-19th century size of the bricks indicate that this is not part of the Tate, and is therefore an element of the penitentiary. The top of the wall had been robbed, with a patch of loose rubble remaining (1301). The bricks did not lie in a visible cut, rather the ground that was seen in the trenches made up after the wall was built.

Plate 57: Wall Footing (1302)
